RELICENSING STUDY 3.1.1

2013 FULL RIVER RECONNAISSANCE

**Northfield Mountain Pumped Storage Project (No. 2485)
and Turners Falls Hydroelectric Project (No. 1889)**

SEPTEMBER 2014

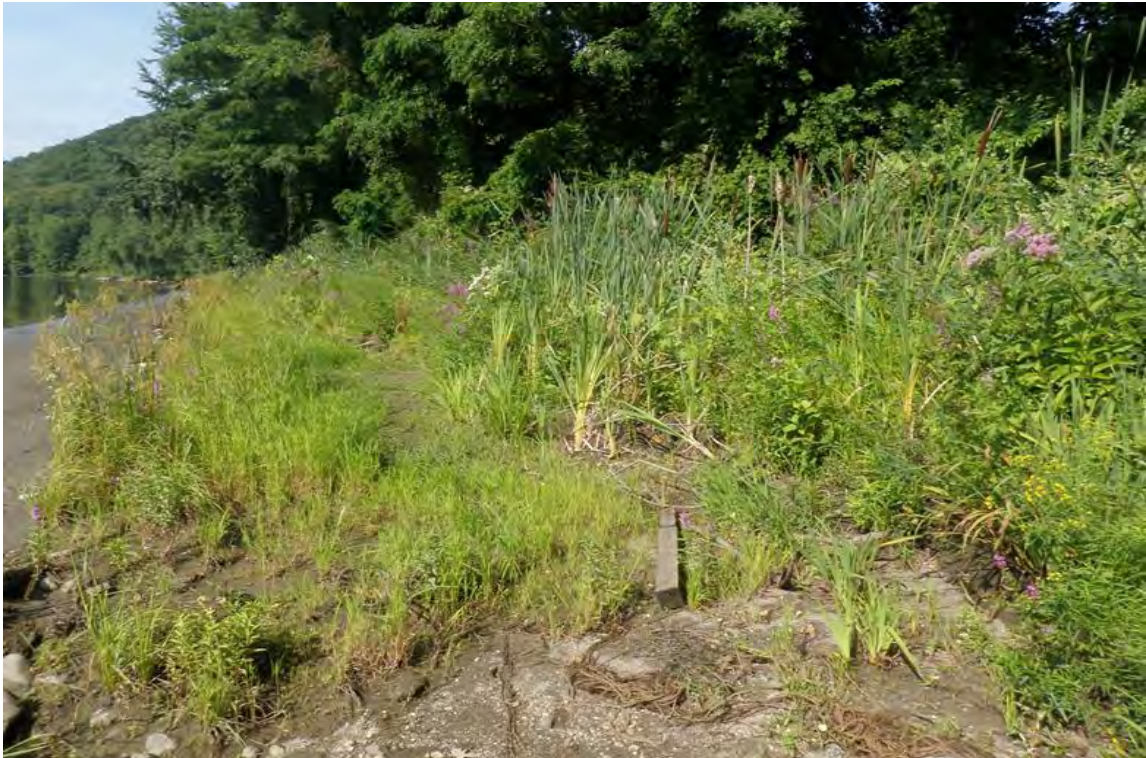
Figure 6.22 Vegetation planted on lower riverbank at stabilization site

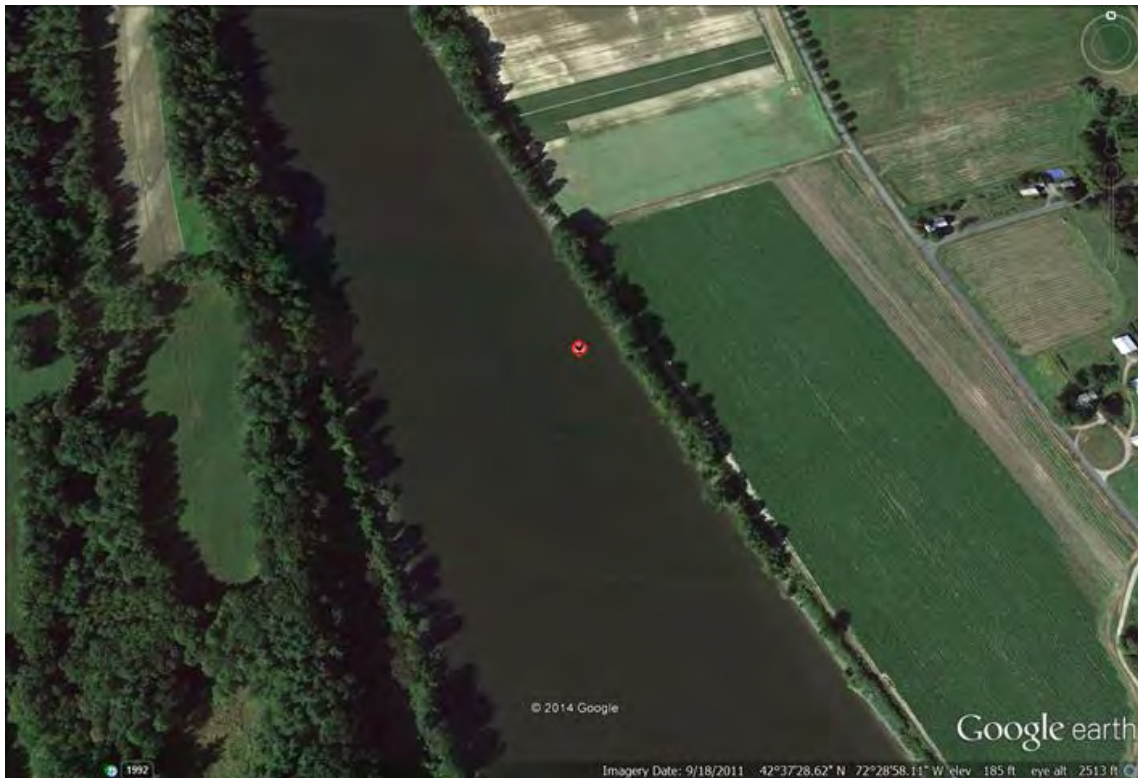
Figure 6.31 Aerial view of eroded riverbank adjacent to agricultural land-use

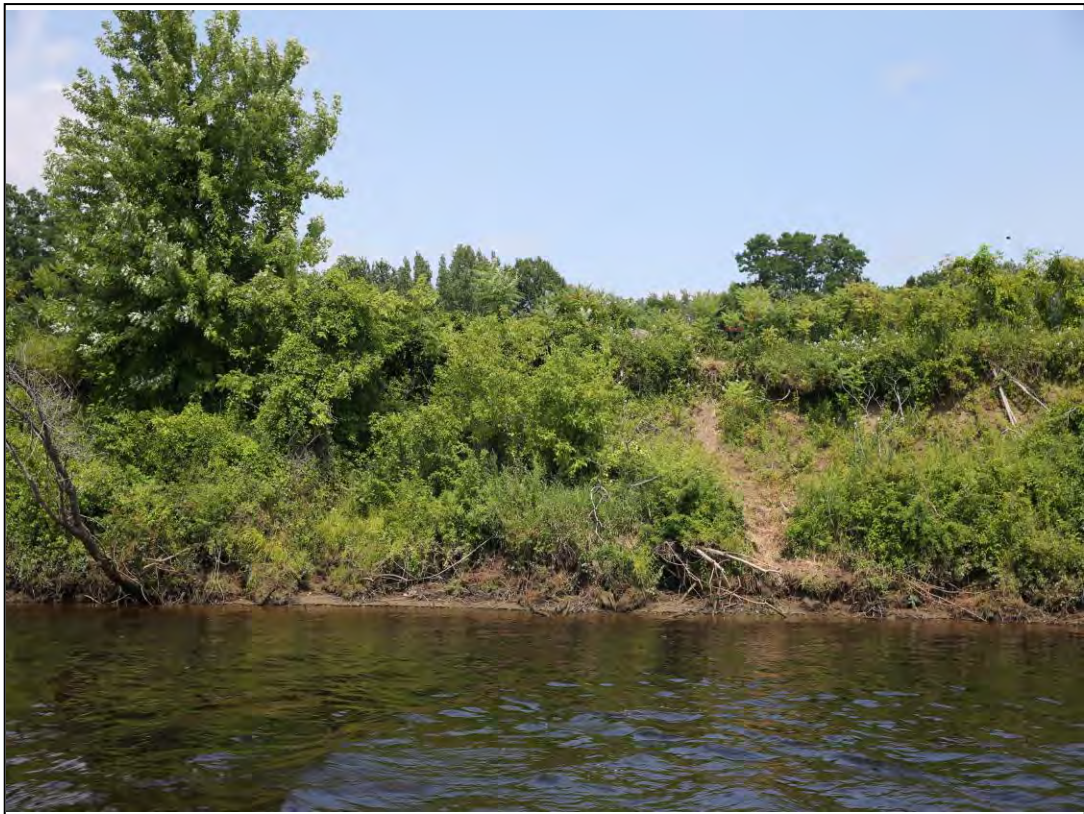
Photo 54: Bonnette Farm- Post Construction 2014.
