**Relicensing Study 3.1.2**

**Northfield Mountain / Turners Falls  
Operations Impact on Existing Erosion and  
Potential Bank Instability  
Study Report**

**Volume III – Appendices**

**Northfield Mountain Pumped Storage Project (No. 2485) and  
Turners Falls Hydroelectric Project (No. 1889)**

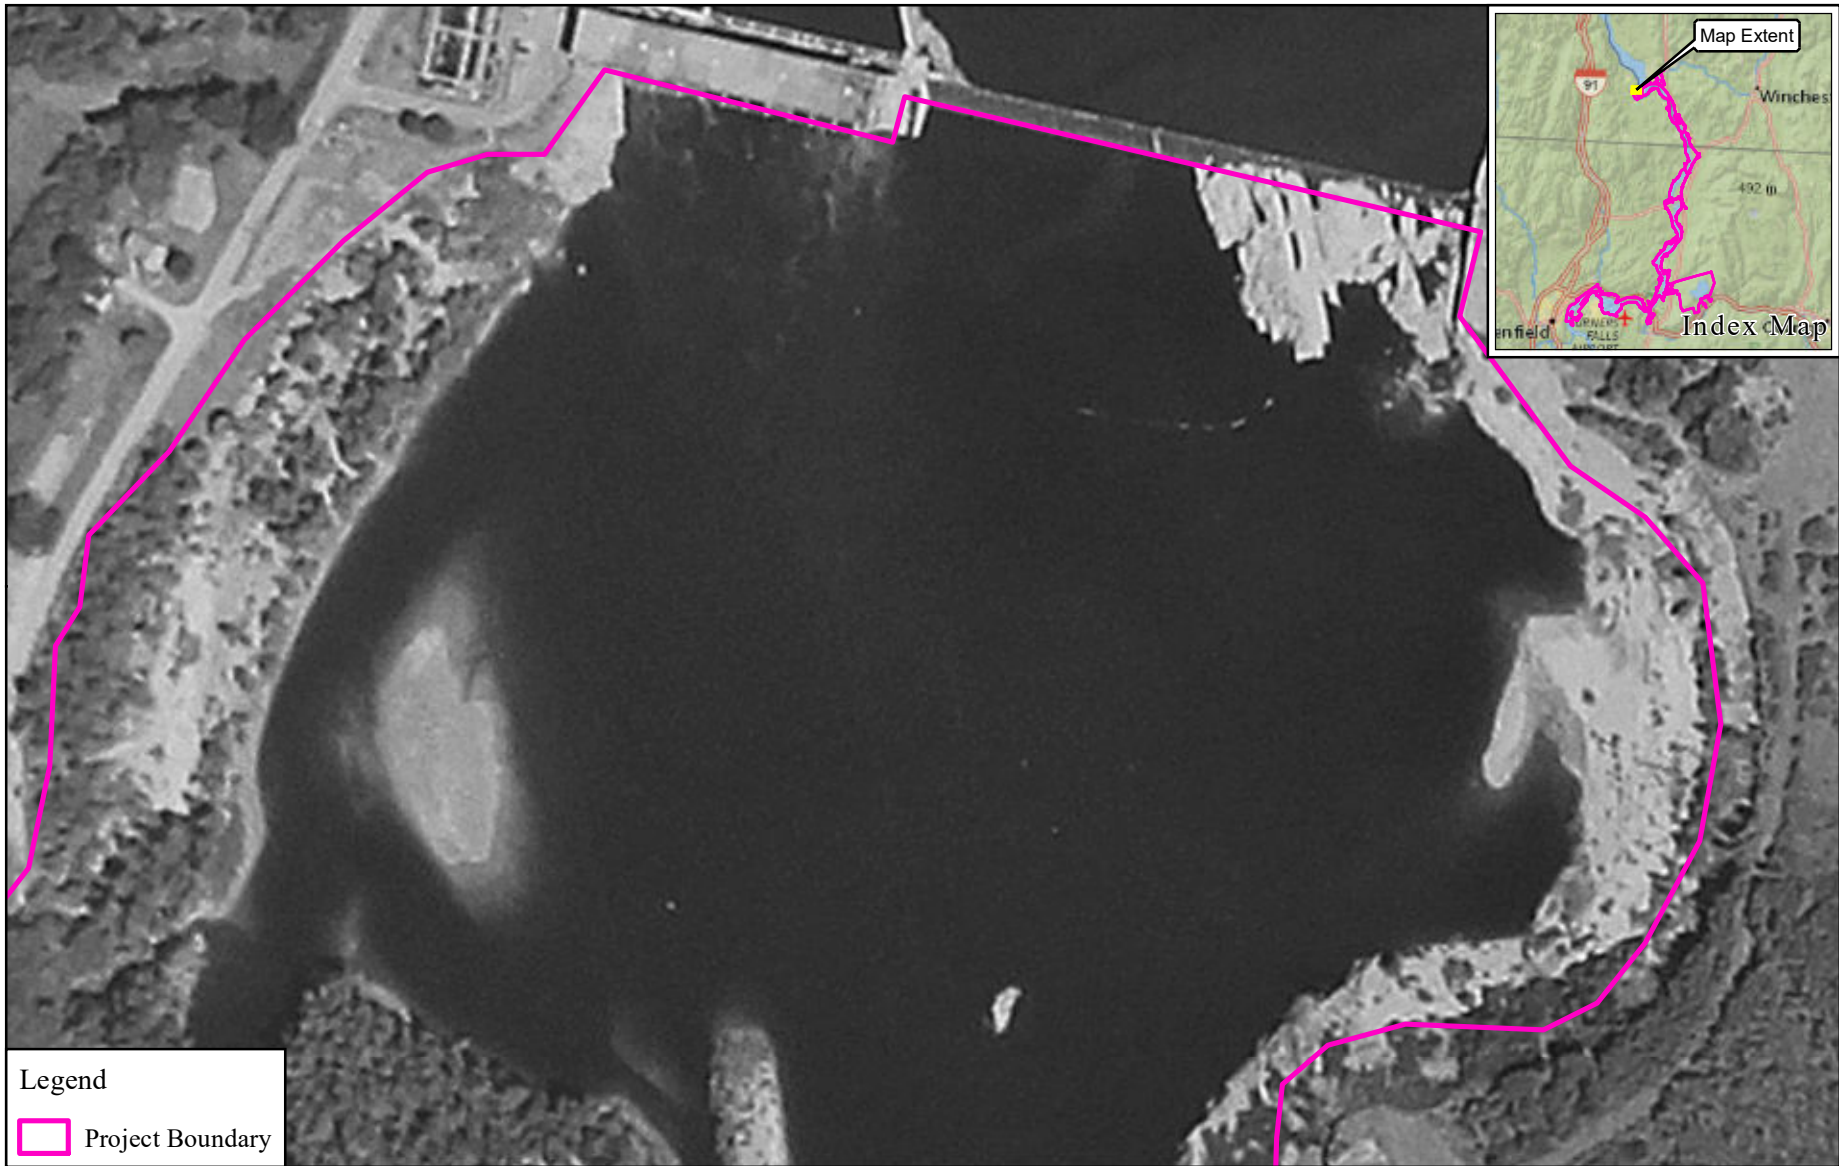
The 1952 photograph shows that the top of left bank is near the project boundary line (indicated in fuchsia). Recent photographs show that erosion has progressed beyond the line such that the bottom of the upper bank is beyond the line. The 2008-2010 and the Online Imagery were taken at relatively high flow conditions and show the turbulence and eddying associated with the release of flow through the left gates of Vernon Dam as well as the general turbulence in this reach of the river at these levels of flow.

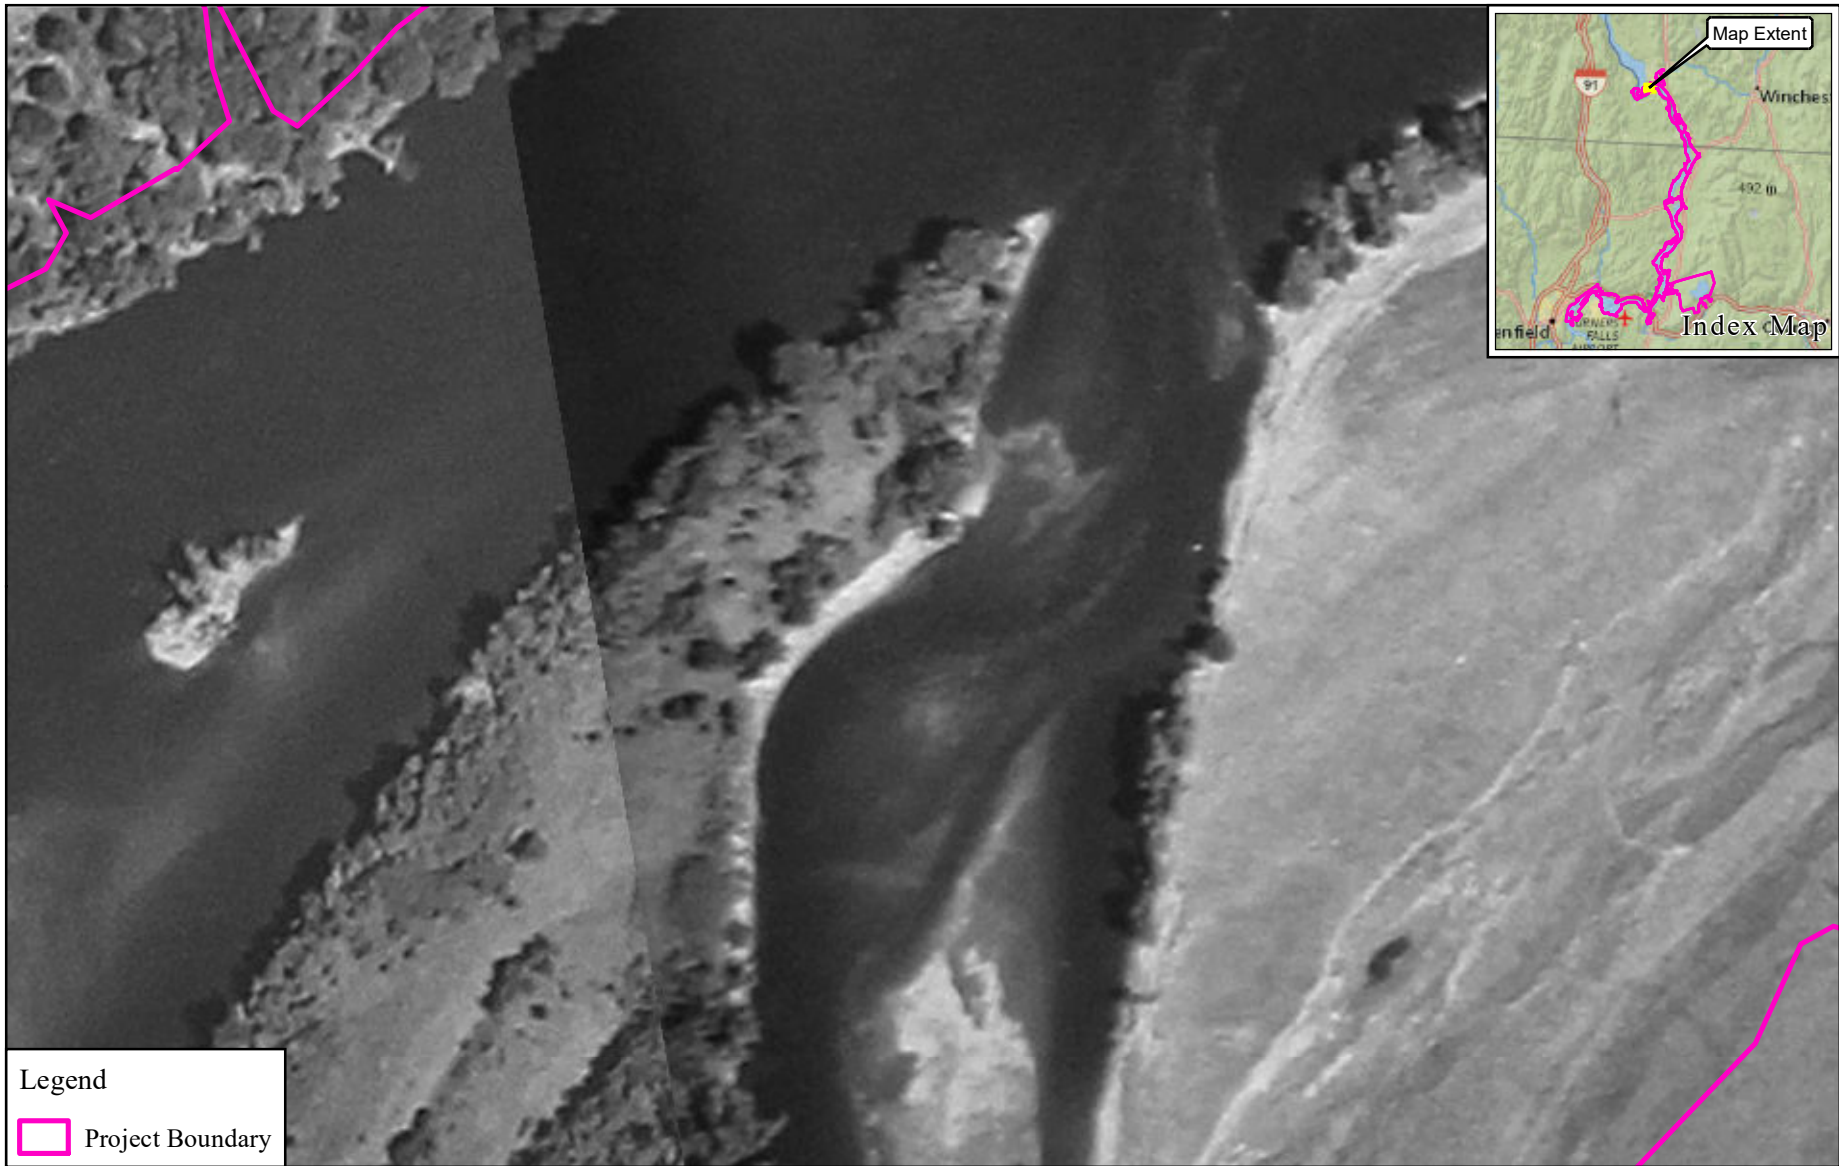
The 1952 photograph shows that there is little vegetation along the right bank of the river, bars and small vegetated islands to the left of the main island, and shallow flow conditions on both sides of the island. By the 2008-2010 set of photos, the downstream tip of the island had narrowed but the potentially eroded right bank which in 1952 had little to no vegetation on the bank had some establishment of vegetation on the bank. The 2014 and Online Imagery are similar to the 2008-2010 photograph.

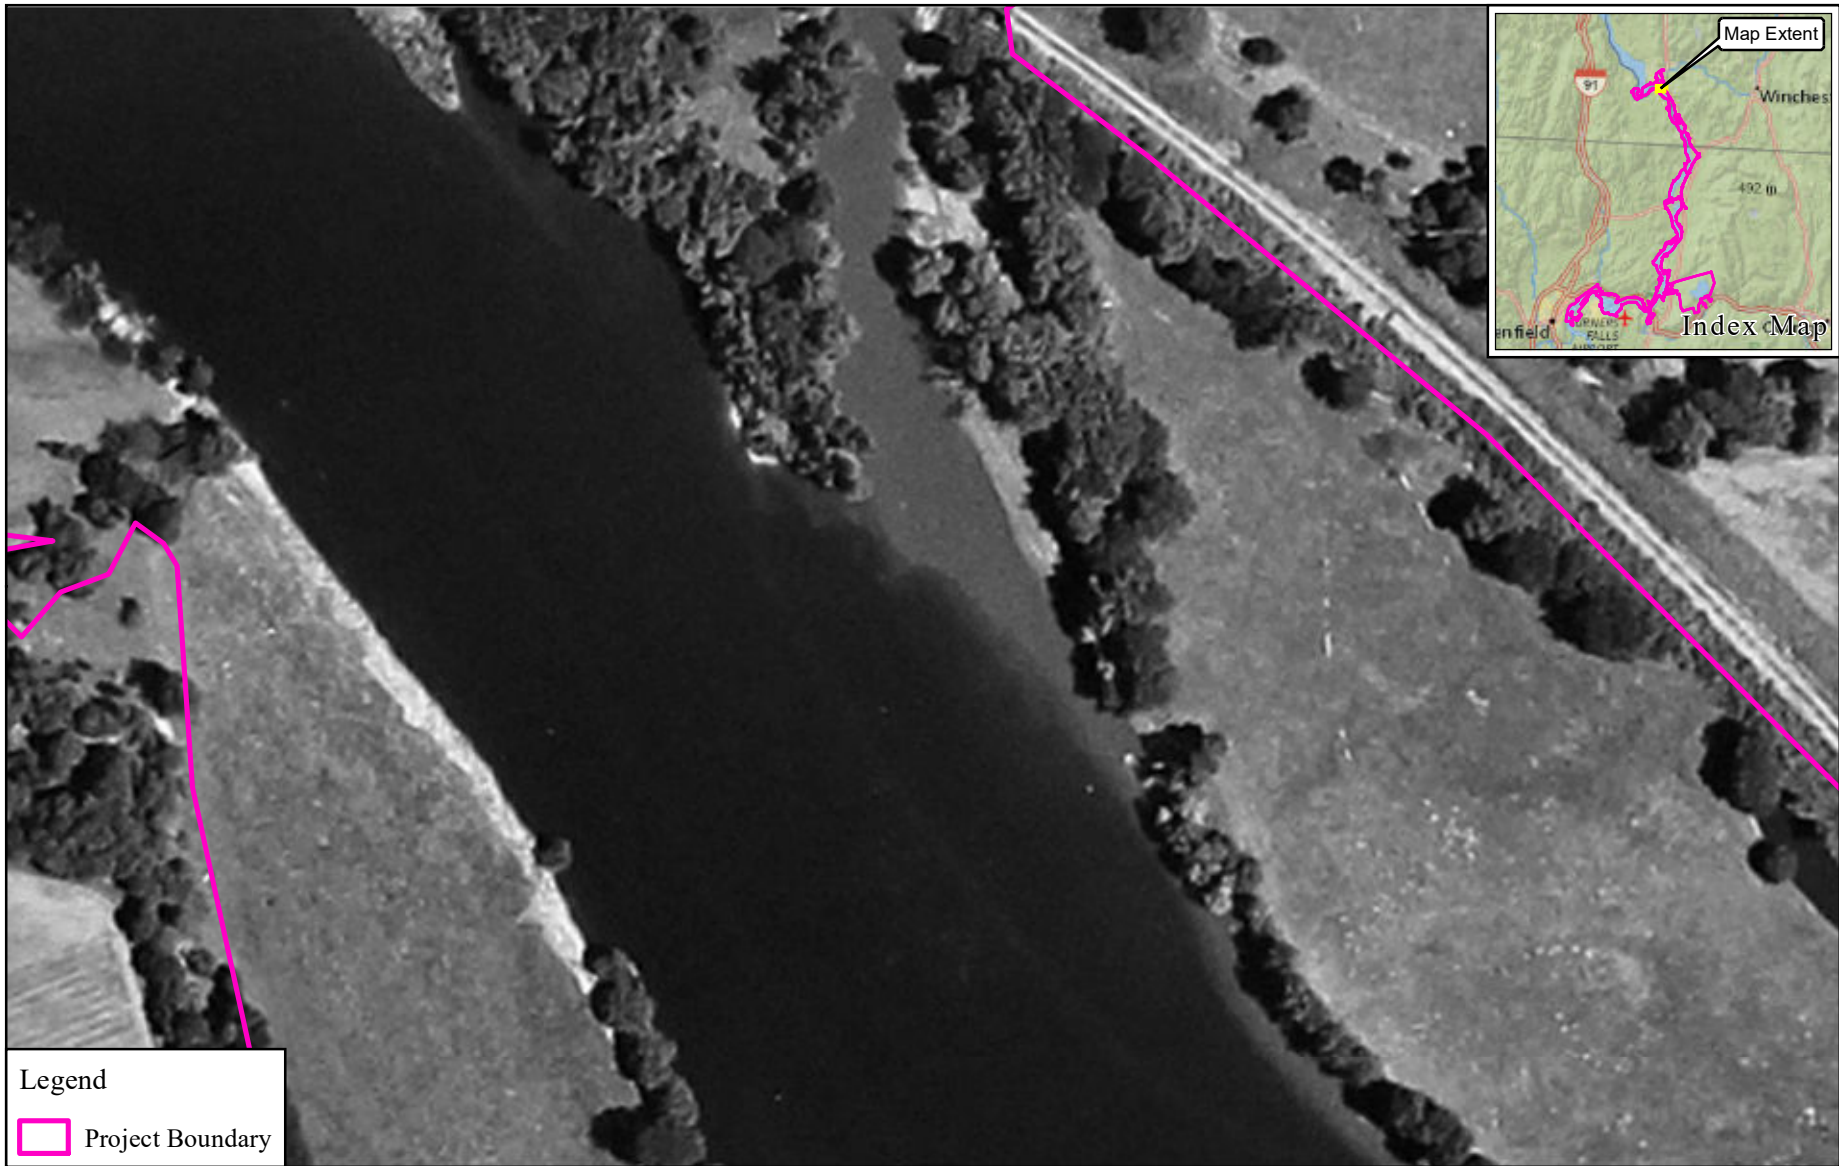
The 1952 photograph shows that the right bank of the river, opposite the confluence with the Ashuelot River, is eroded with no upper riverbank vegetation between the agricultural field and the river. The 2008-2010 and other recent photographs show an increase in riverbank vegetation along this same section of riverbank. On the Ashuelot side, upstream of the confluence the tip of land appears to have narrowed over time since 1952 and there is some decrease in the narrow riparian zone of upper riverbank vegetation downstream of the confluence.

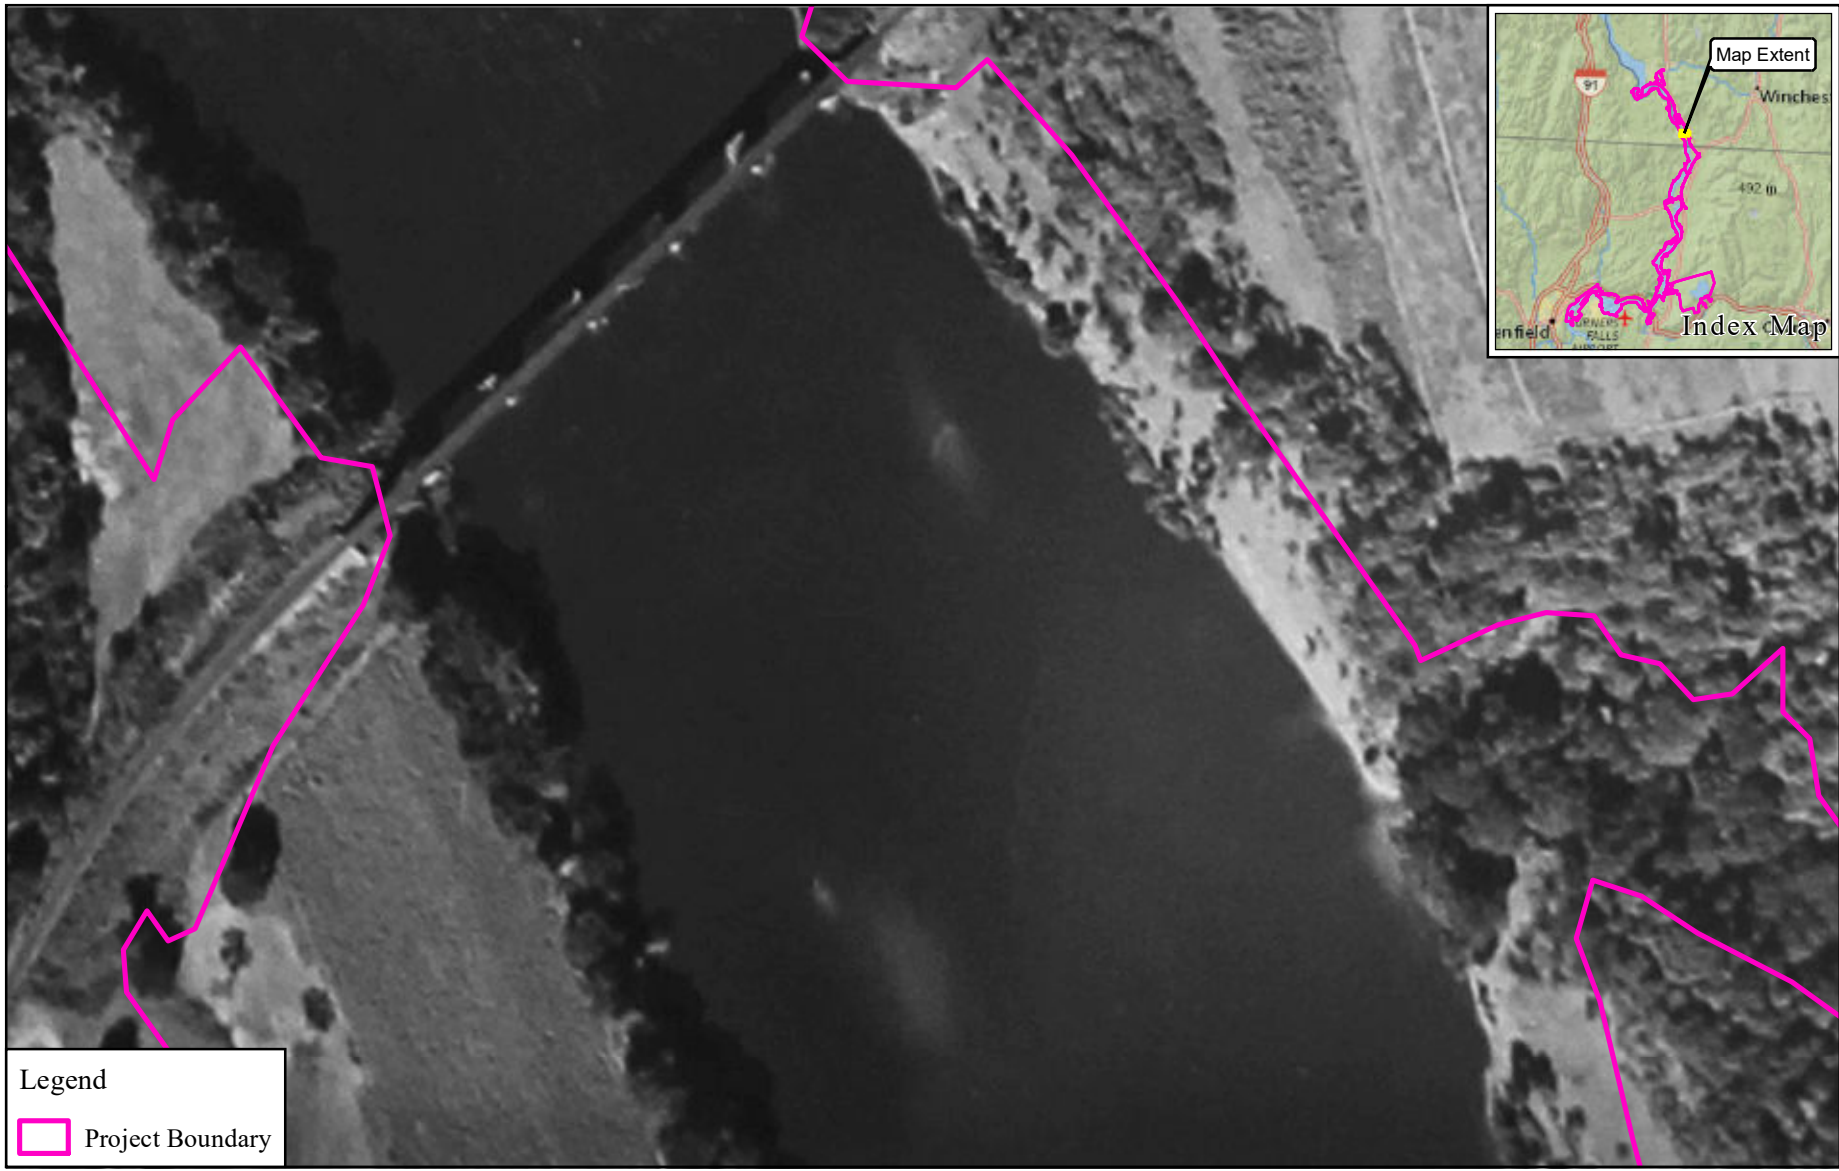
In the vicinity of the railroad bridge which has been subsequently abandoned and partially removed, in 1952 the right bank downstream of the bridge supports a band of riparian vegetation while the left bank is sparsely vegetated. In 1962, in the same location on the right bank erosion is evident with the bank shifting landward and no riparian vegetation remaining. On the left bank, a small erosion scallop has formed just downstream of the bridge with segments of reduced riparian vegetation. The bridge super-structure had been removed by the 1990s photograph, with all piers left standing in the river. By the 2008-2010 set of photographs, one of the piers had fallen into the river, probably due to scour around its base and no supporting structure to provide stability from above. The right bank is the Kendall site which was stabilized in 2008 through implementation of the ECP. Subsequent photos show the stabilized right bank and increased riparian vegetation along the left bank.

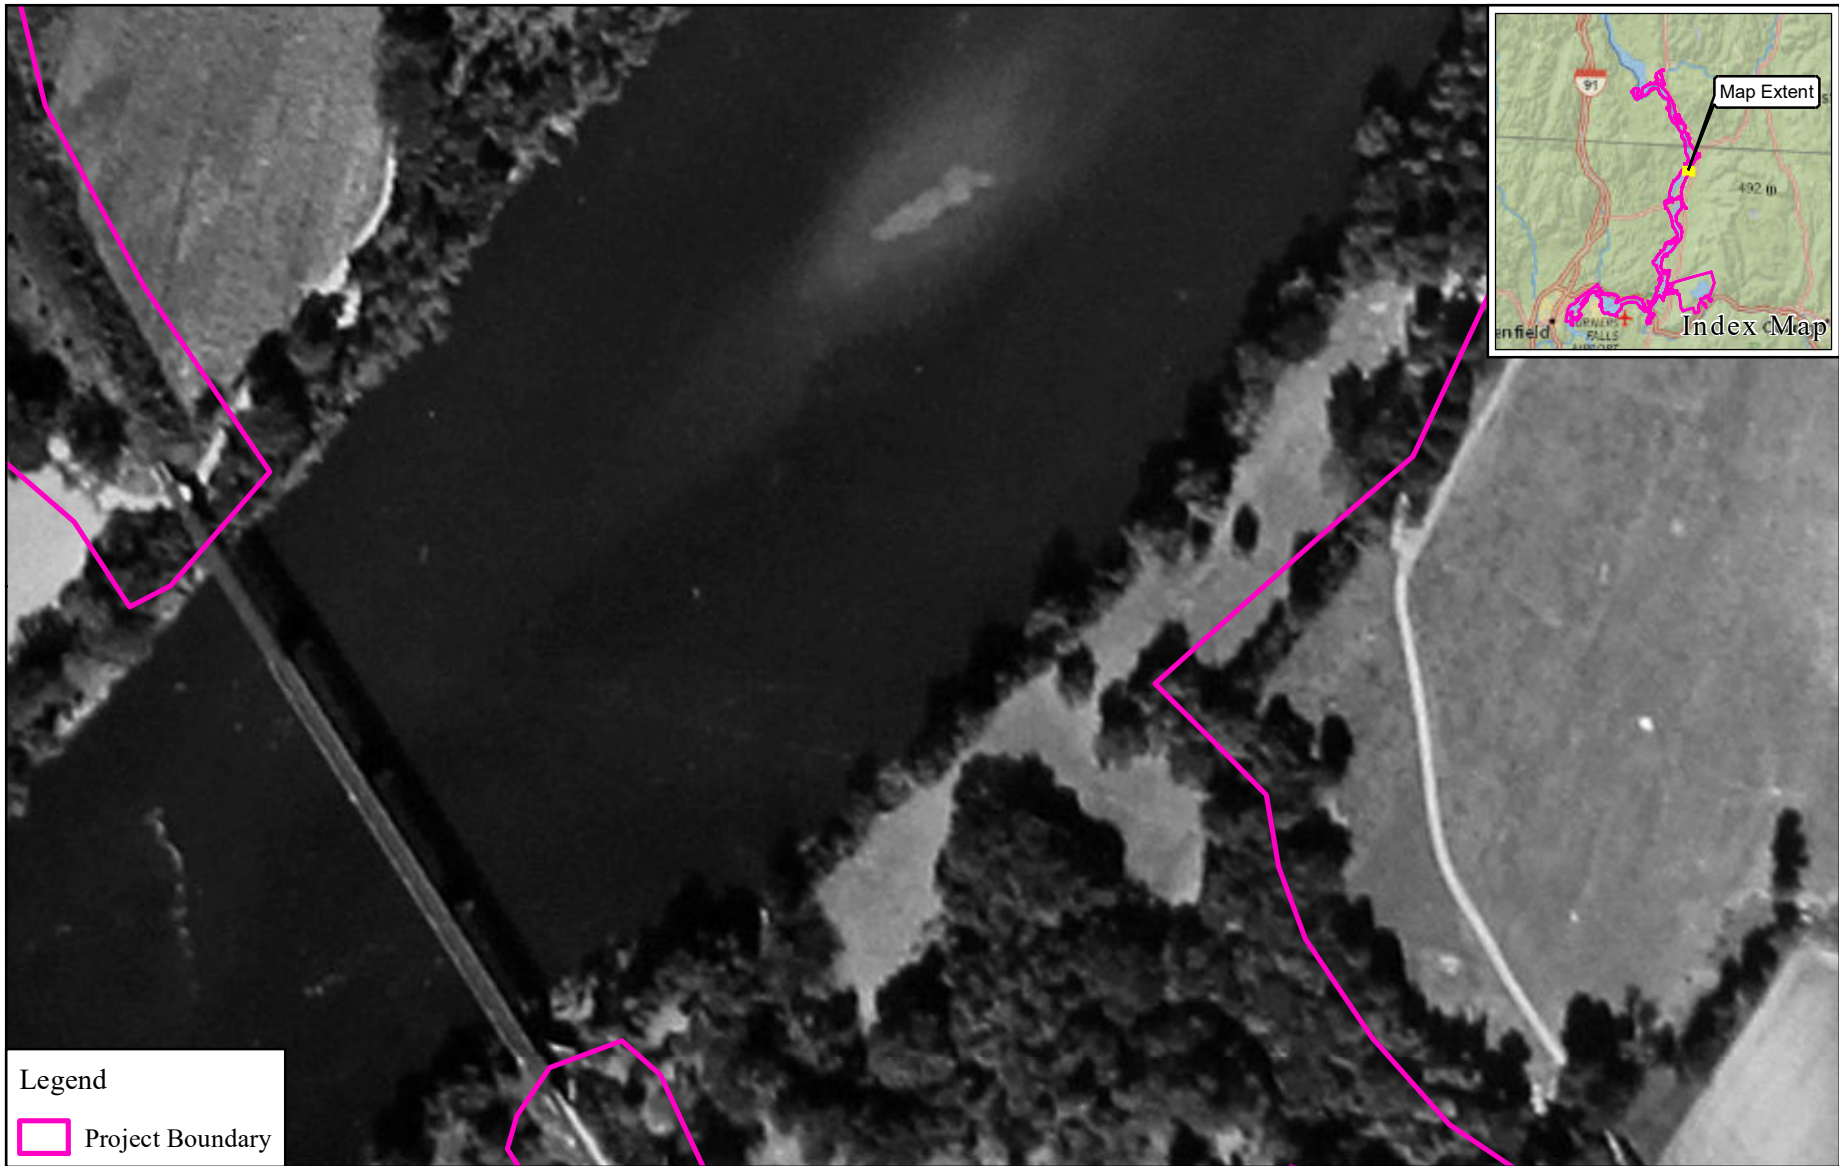
In the 1952 photograph, a band of riparian vegetation is found along both banks of the river upstream of the Schell Bridge. The extent of vegetation appears to be relatively consistent along the right bank through the series of photographs. On the left bank; however, the 1960s photograph shows erosion and a significant reduction in riparian vegetation. This area was called the Country Road Site, which was stabilized in 2006 through the ECP as shown in the 2008-2010 and more recent photographs.

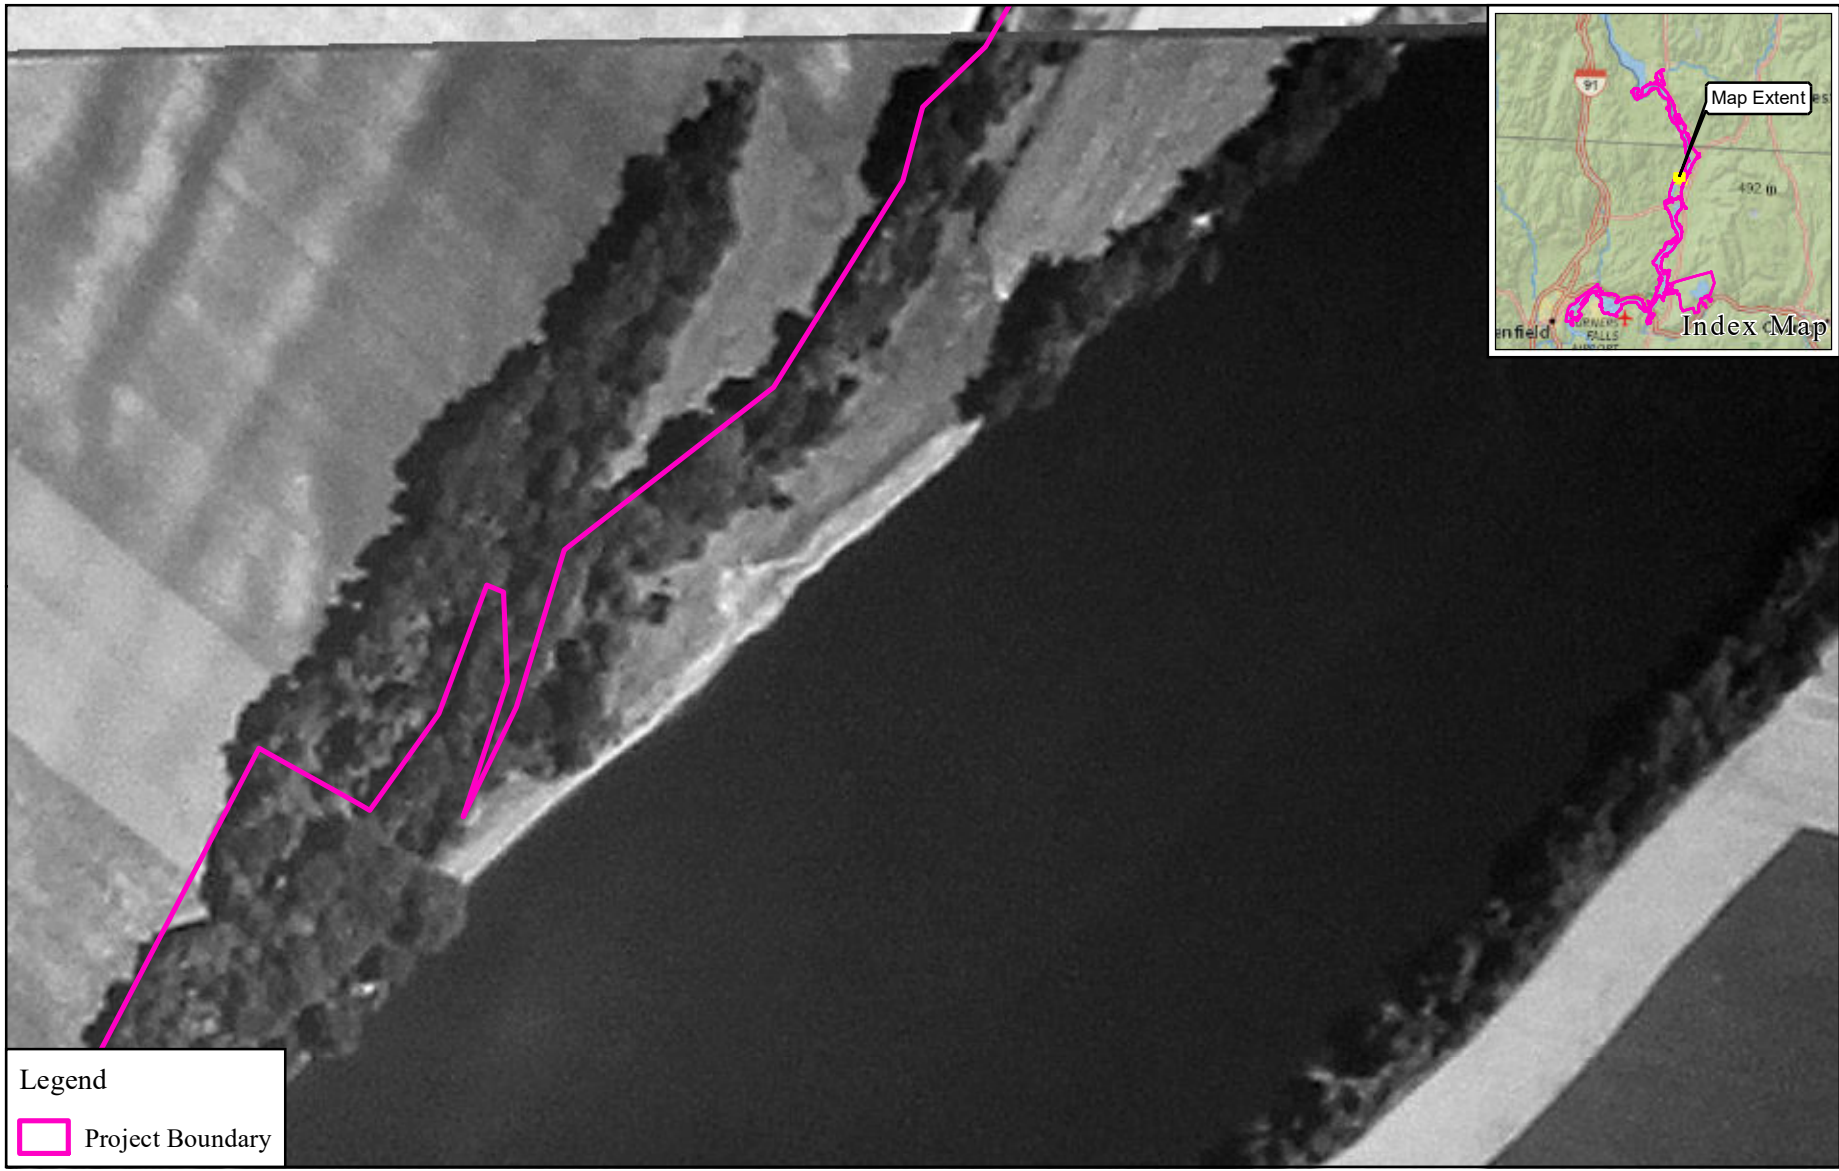
In the 1952 and 1960s photographs, there is an eroded section of riverbank with no significant riparian vegetation. During the 1990s, this site was selected for erosion repair, known as the Wickey site (constructed in 1996).

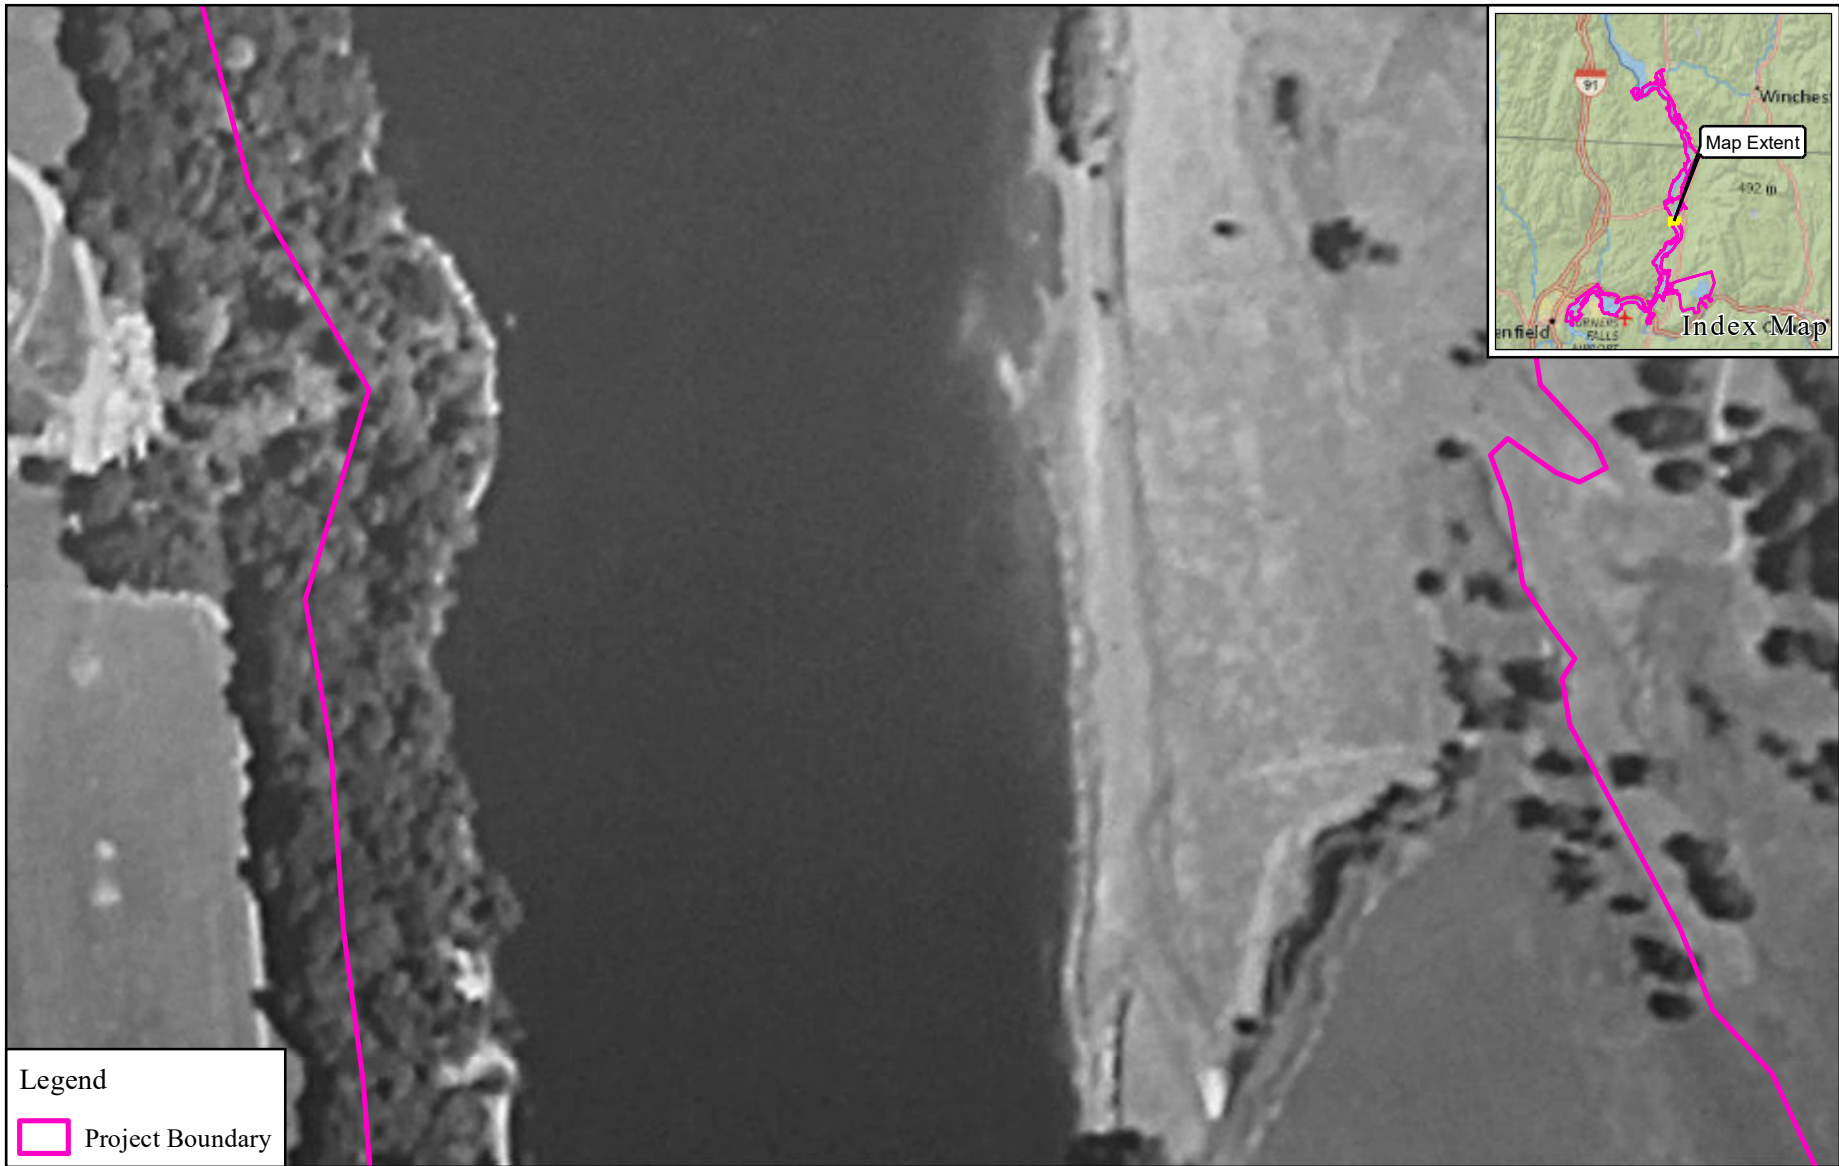
The left riverbank across the river from the Mt. Hermon School was eroded and absent riparian vegetation on the 1952 and 1960s photographs. A strip of riparian vegetation has become established along this riverbank as can be seen in the 1990s and subsequent photographs.

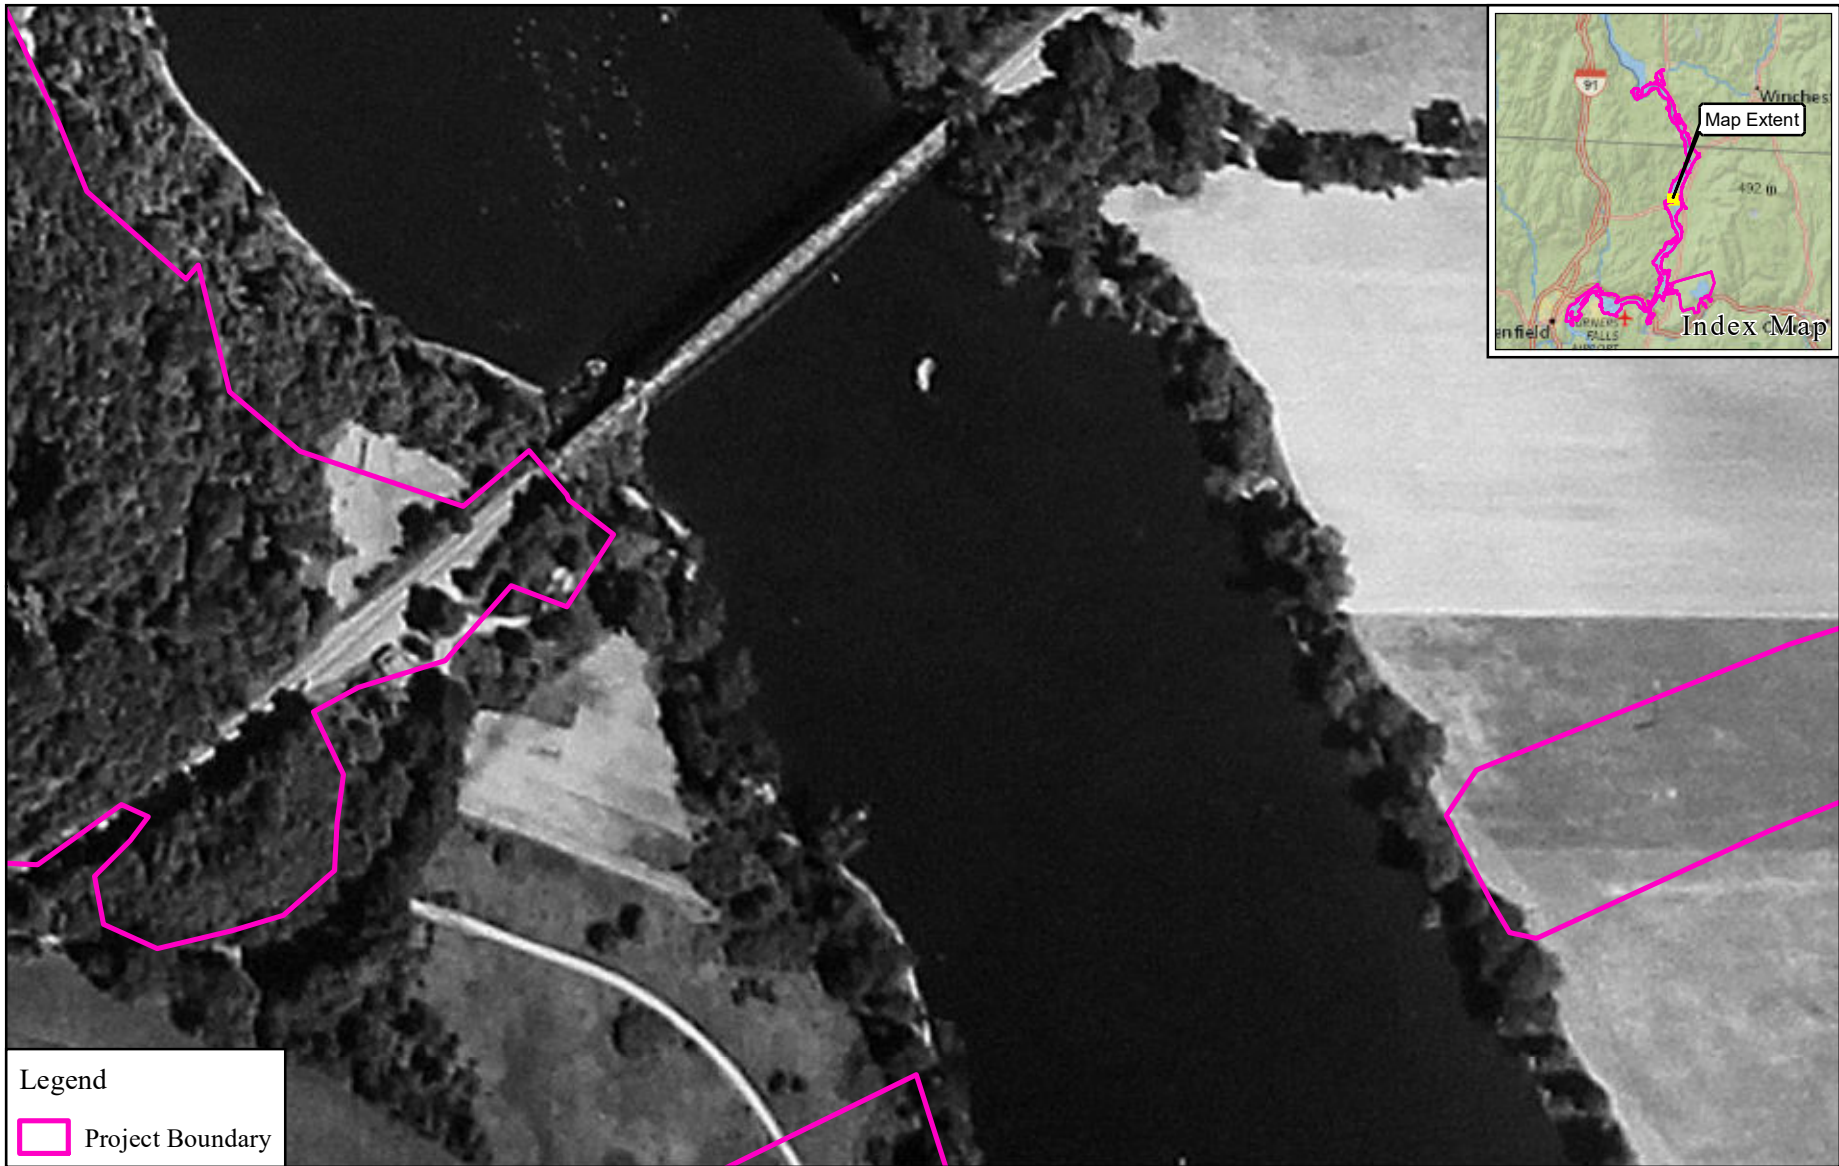
The right bank upstream of the bridge was stabilized in 1997 (Crooker) and no additional stabilization was conducted because of the unique and extreme hydraulics associated with the river in this reach where the bridge is located.

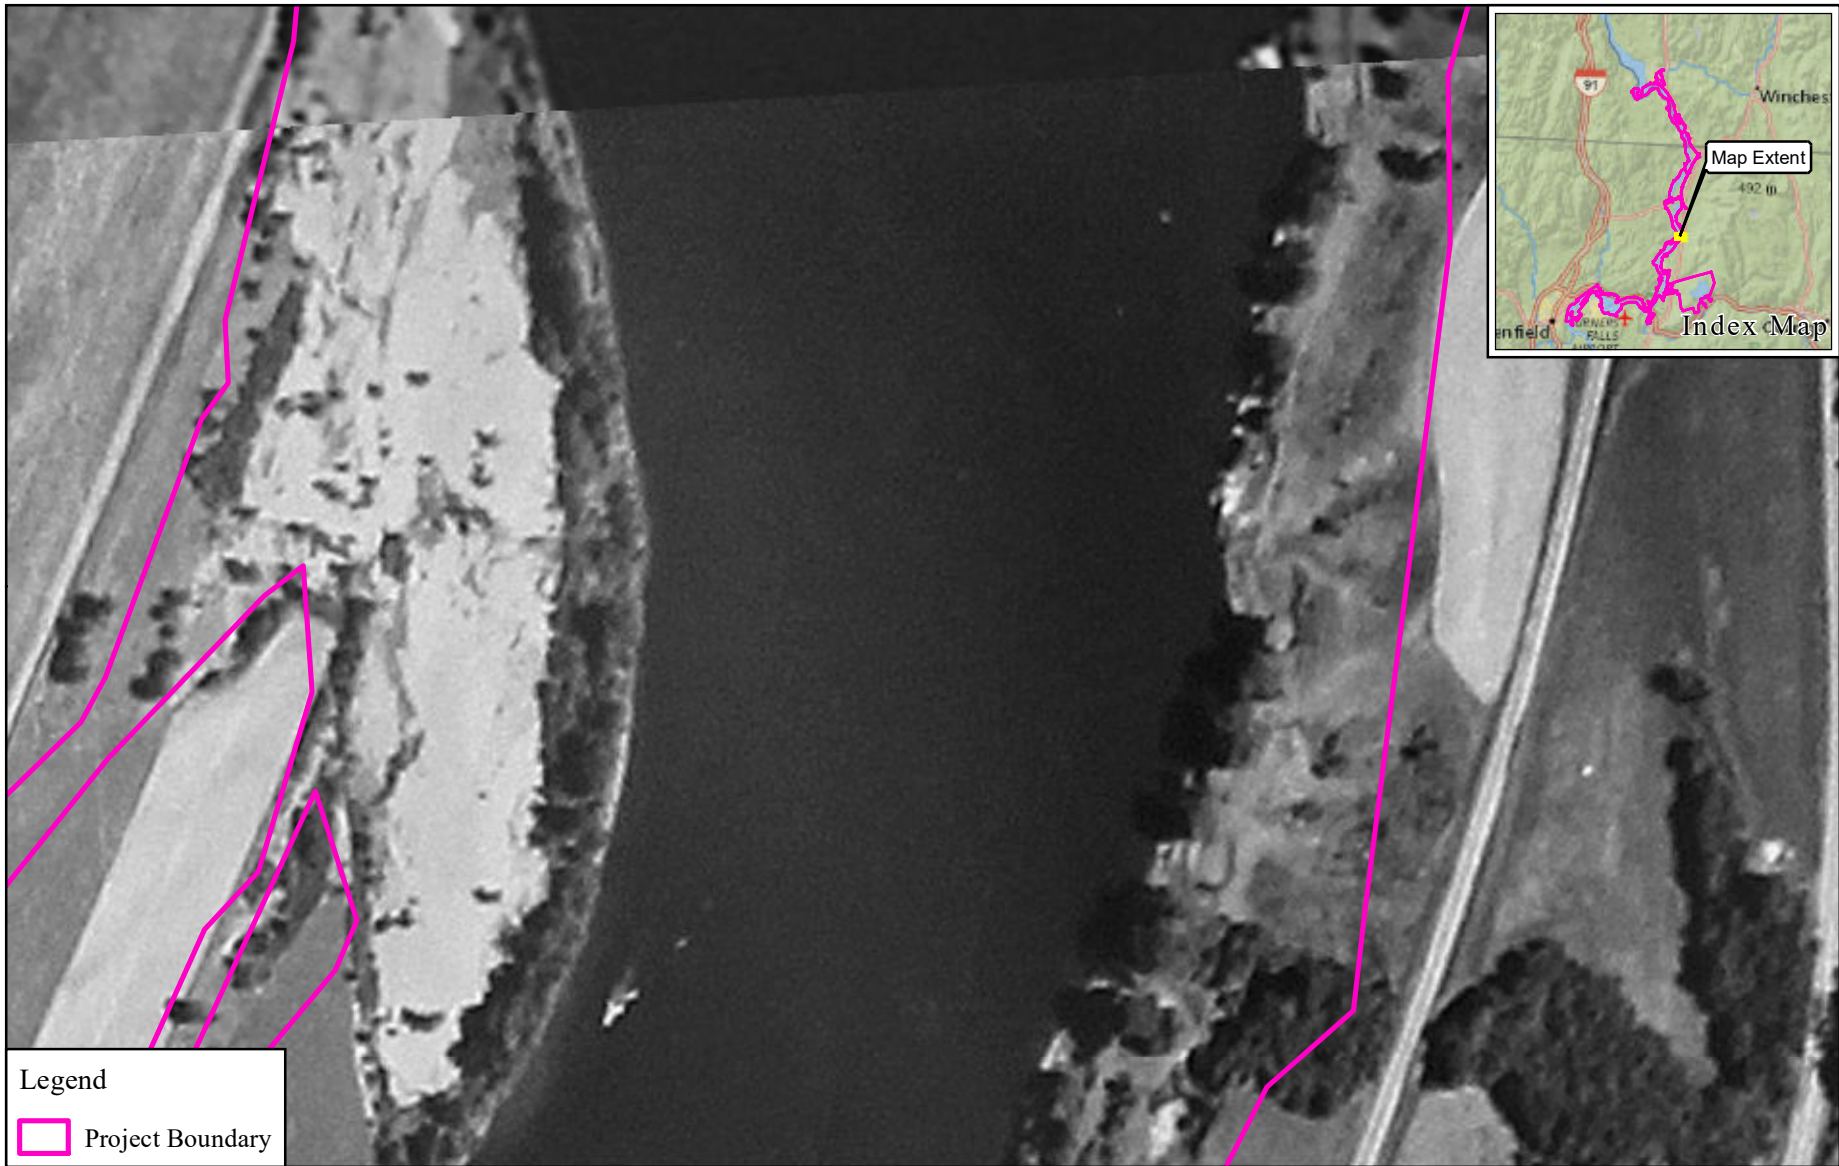
At a bend in the river upstream of Kidds Island the 1952 photograph shows a reach with some riparian vegetation. The 1960s photograph shows erosion and associated decrease in riparian vegetation. The right bank is the Urgiel downstream site which was stabilized in 2005 as shown in the 2008-2010 and subsequent photographs. The riparian vegetation has become denser over the years on the right bank.

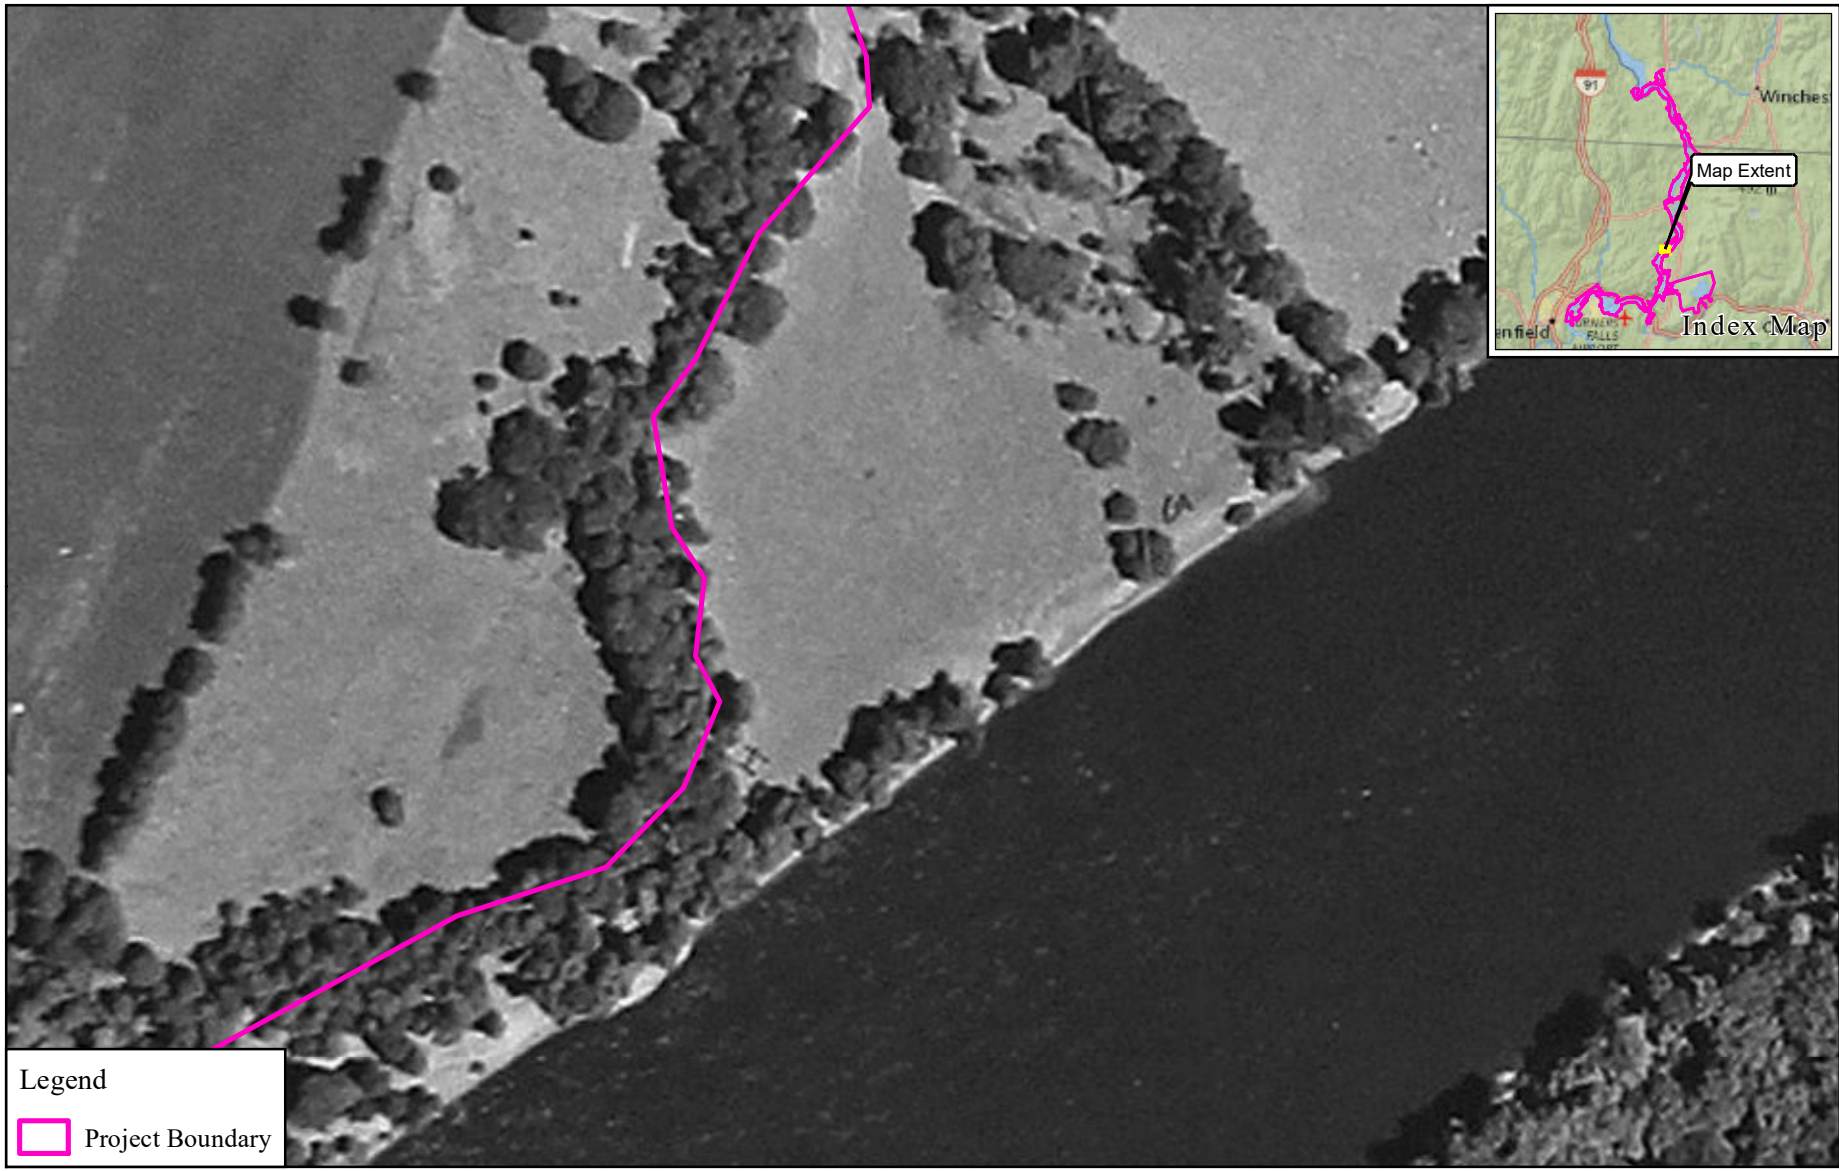
The right bank downstream of Otter Run was sparsely vegetated in 1952. By the 1990s photograph no riparian vegetation can be seen on the bank. This reach of the river is in the vicinity of Kidds Island where camping and significant boating activity occurred until recent years. This eroded area was identified in the ECP and is known as the Flagg site. The portion of the Flagg site downstream of Otter Run was restored in 2000 but has been affected by cattle which, while there has been an increase in vegetation and stability, the vegetation is limited by the effect of cattle.
