**Relicensing Study 3.1.2**

**Northfield Mountain / Turners Falls  
Operations Impact on Existing Erosion and  
Potential Bank Instability  
Study Report**

**Volume III – Appendices**

**Northfield Mountain Pumped Storage Project (No. 2485) and  
Turners Falls Hydroelectric Project (No. 1889)**

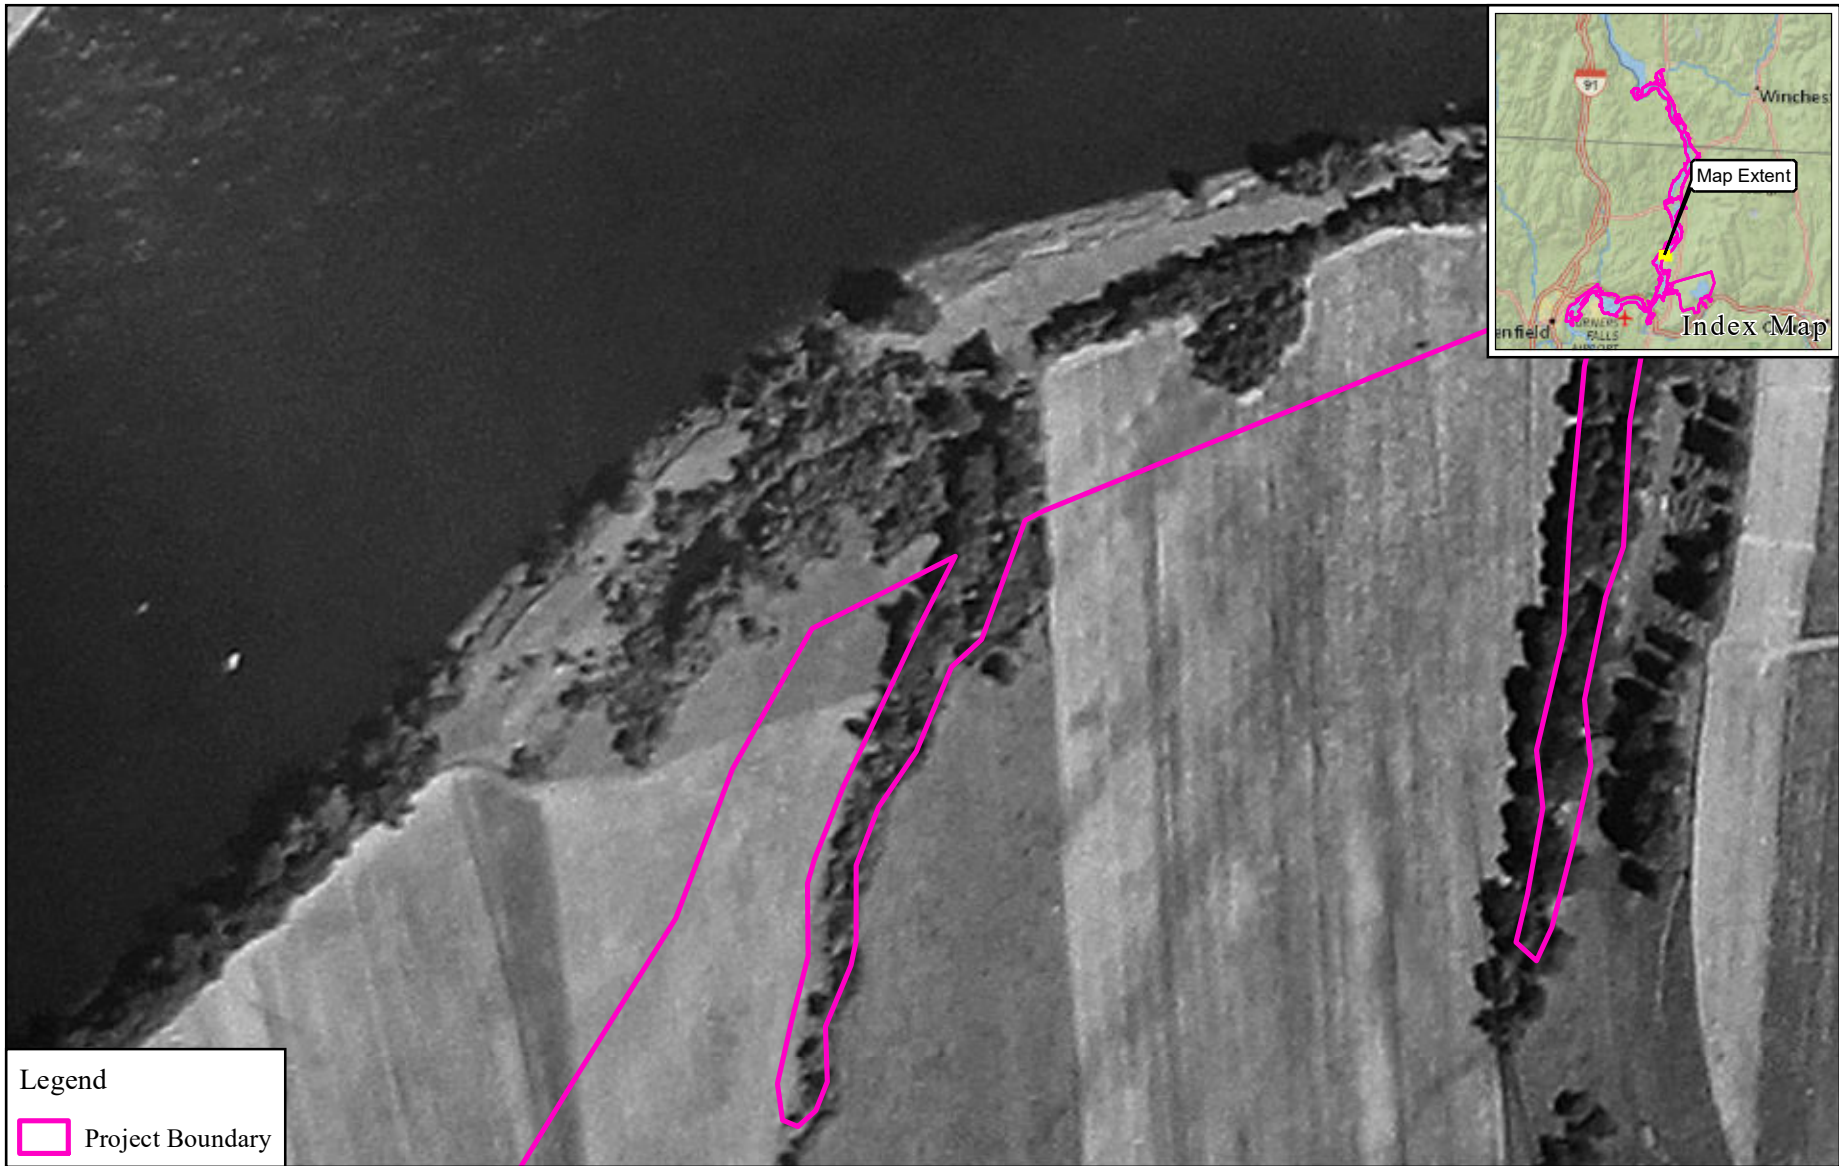
On the left bank downstream of Kidds Island the 1952 and 1960s photographs show eroded conditions with little riparian vegetation. By the 1990s, the narrow remnants of a field appear to have been eroded away and into another band of riparian vegetation.

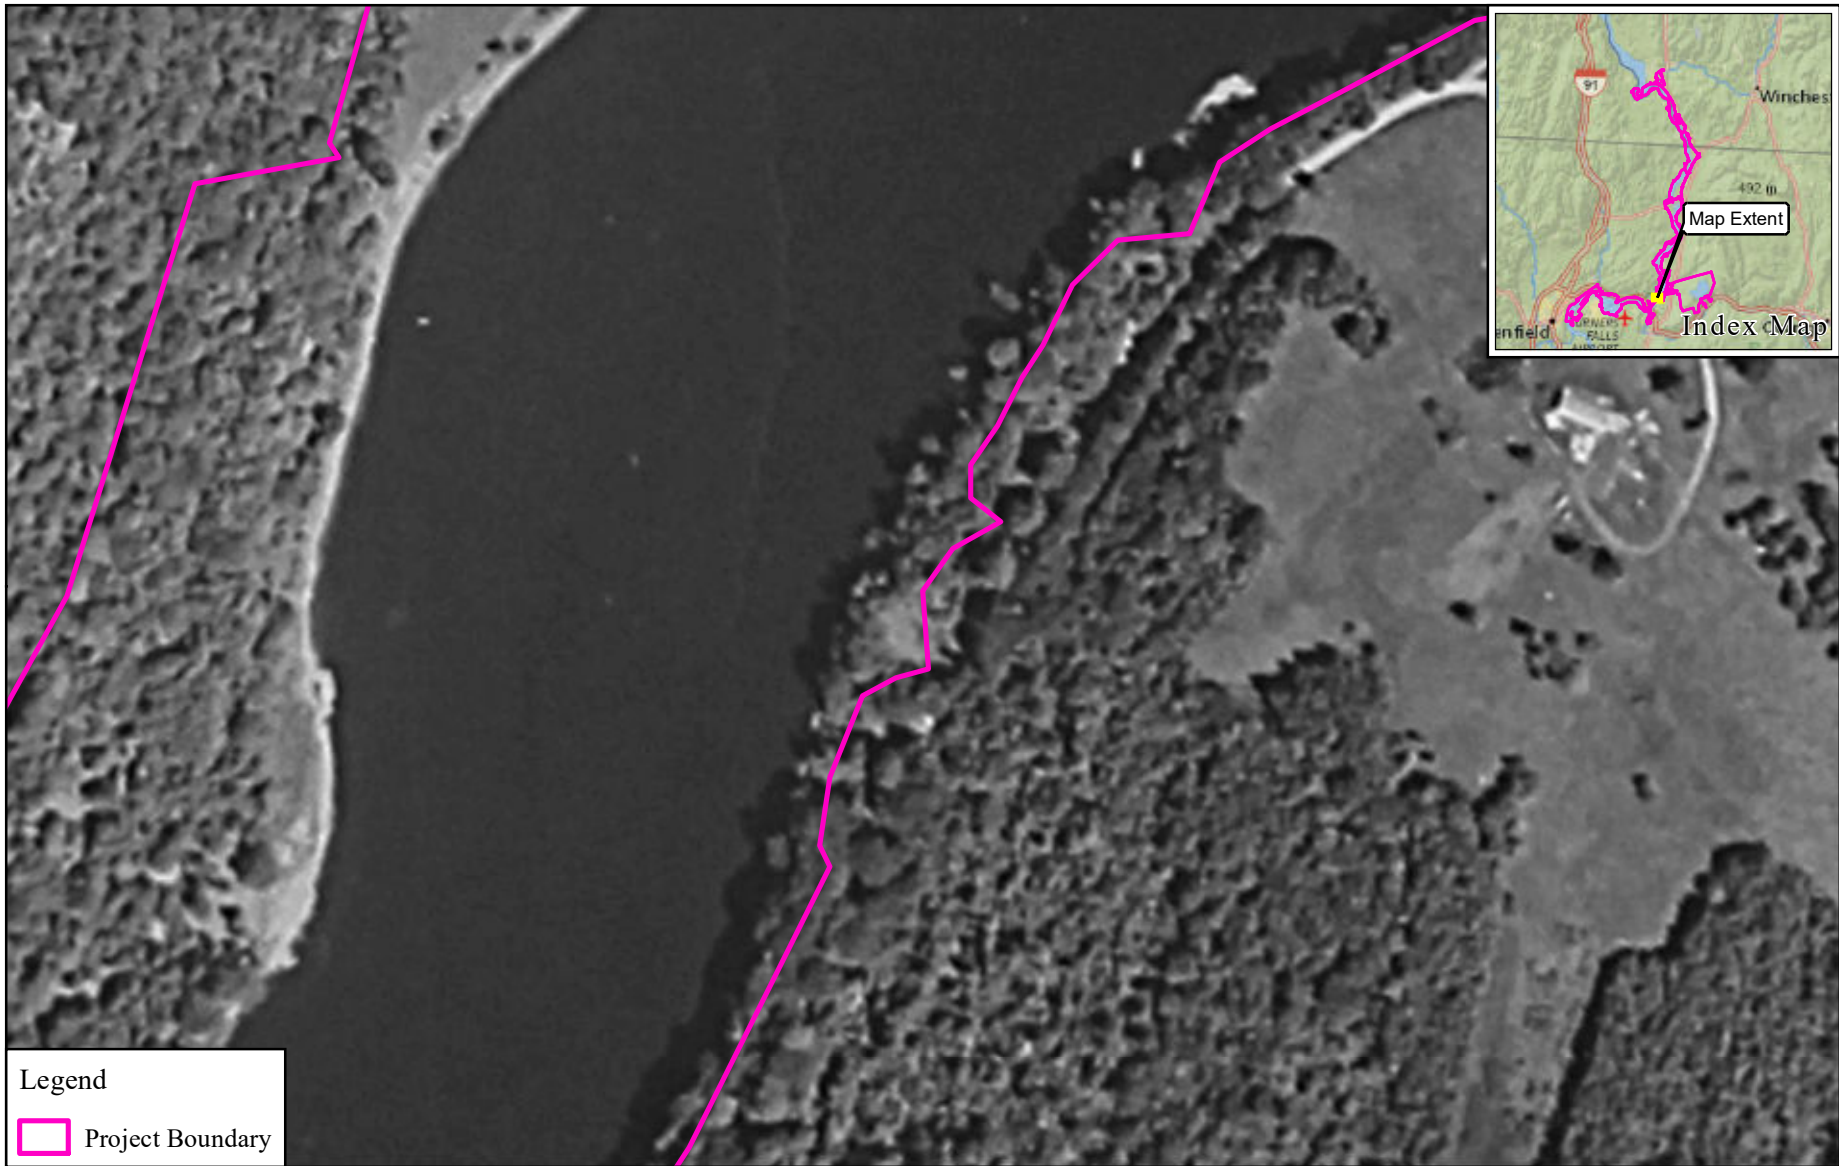
On the inside of the bend along the left bank erosion has occurred over time with the bank moving landward compared to the project boundary line as noted in changes in the bank from the 1952 to 1960s and subsequent photographs. This area was stabilized in 2003 through the ECP and is called the River Road Site.

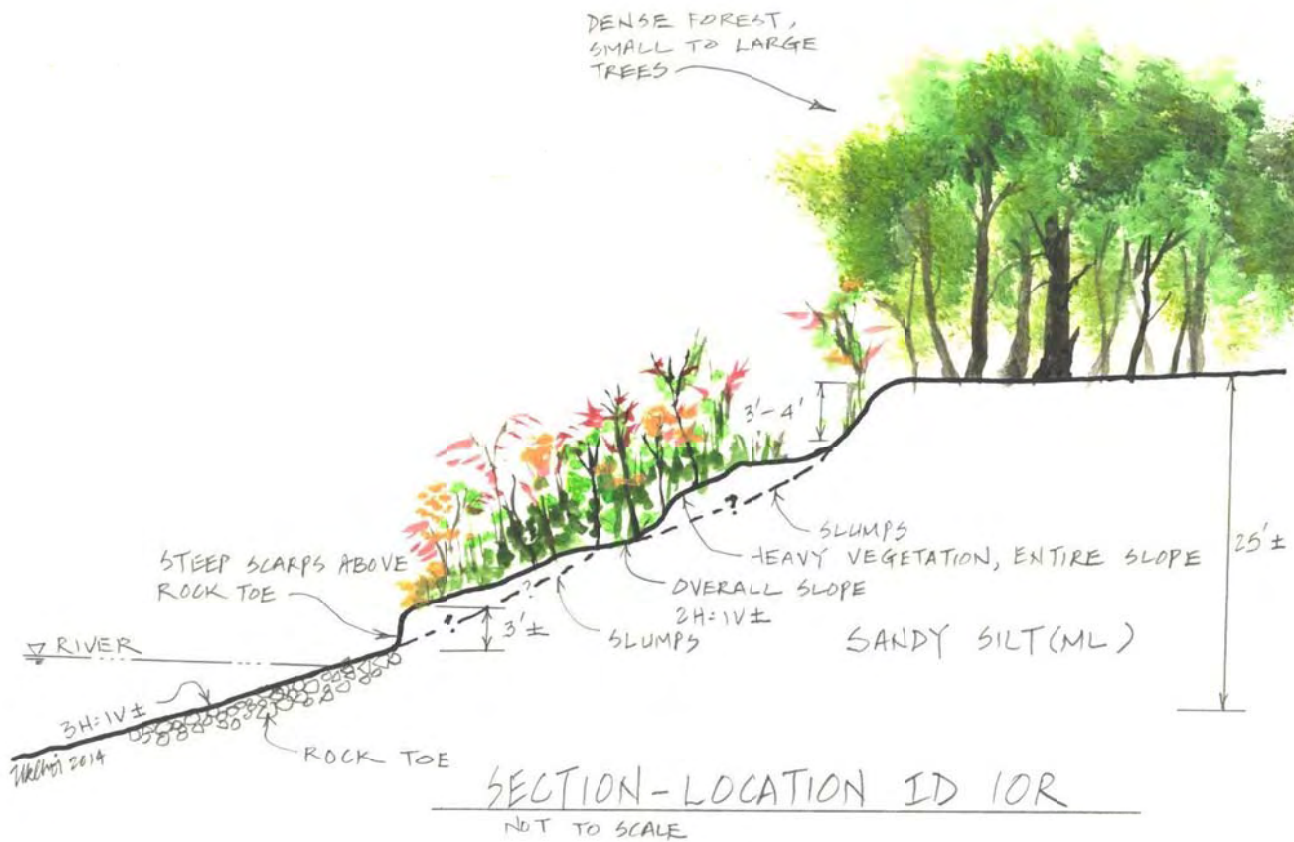
- Little erosion at rock toe, with no depressions or movements observed.
- Some slumping above rock toe, mid-slope, and near the top of slope of Upper Bank.

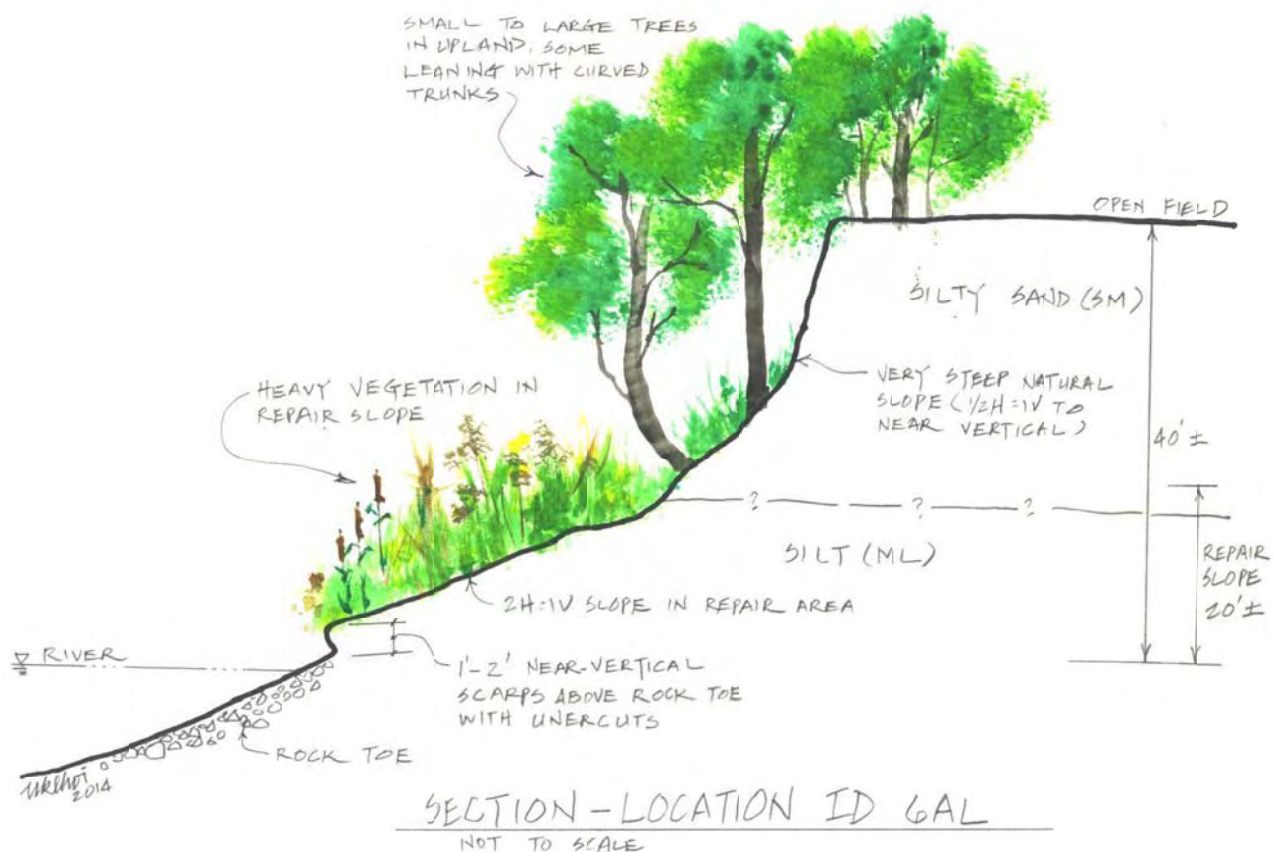
- Little erosion at rock toe, with no depressions or movements observed.
- 1' – 2' high near-vertical scarps just above the rock toe, with minor undercuts.
- Very steep natural upland slope above repaired area.
- Some leaning trees in natural upland slope, some with curved trunks.

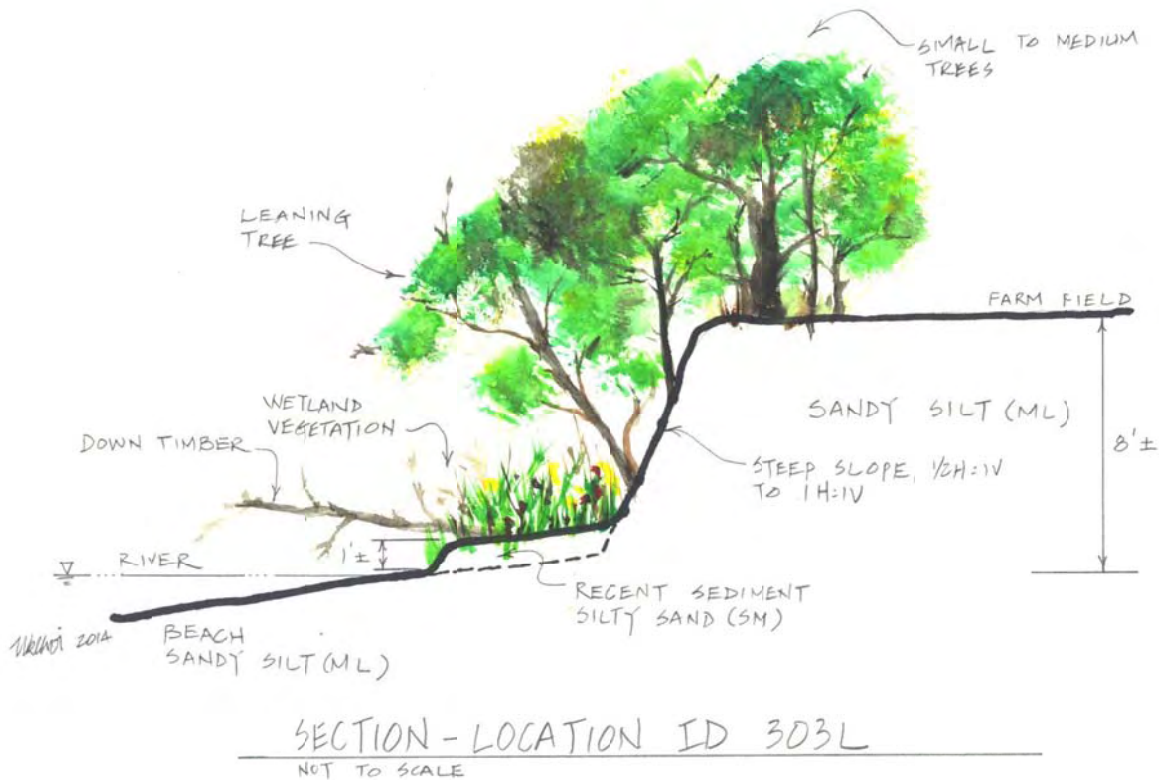
- No erosion observed on Lower Bank, the top of which was filled with recent sediments.
- Steep slopes, entire Upper Bank.
- Some undercuts with exposed roots.
- Leaning trees.
- Few down timber
