Relicensing Study 3.1.2

**Northfield Mountain / Turners Falls
Operations Impact on Existing Erosion and
Potential Bank Instability
Study Report**

Volume II – Main Report

**Northfield Mountain Pumped Storage Project (No. 2485) and
Turners Falls Hydroelectric Project (No. 1889)**

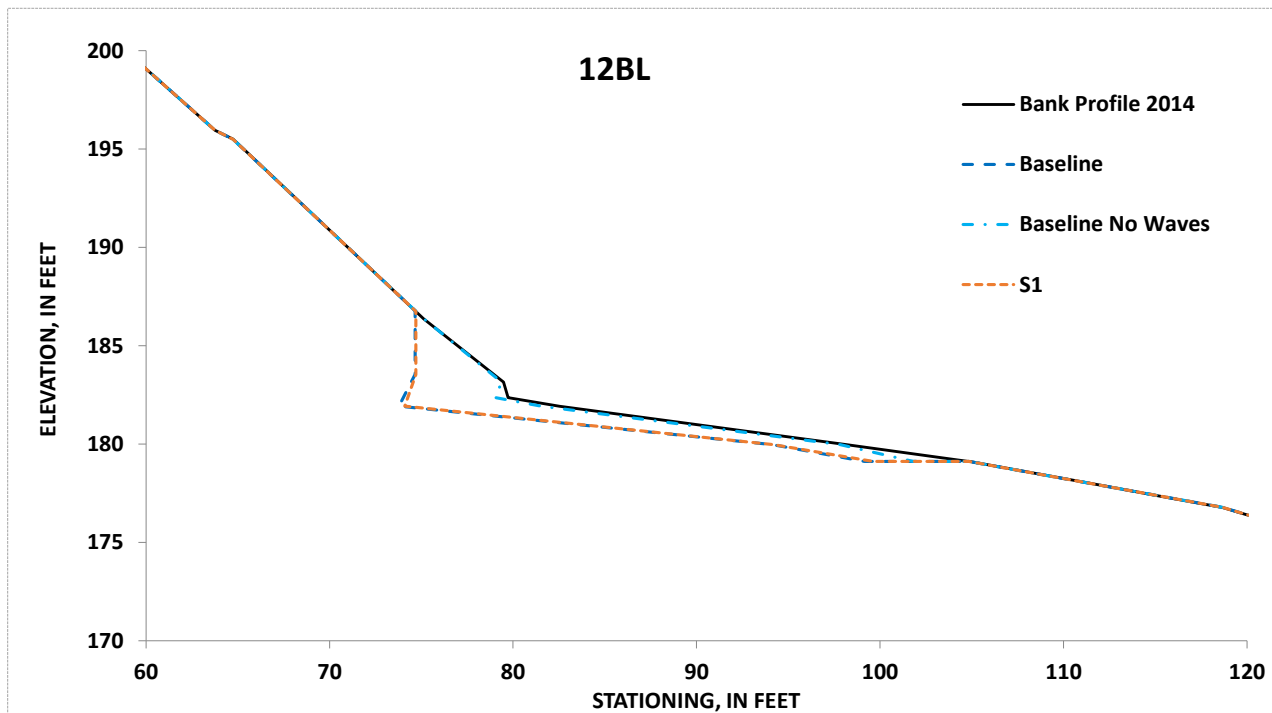
Figure 5.4.2.2-2: Example of the Important Effect of Boat Waves in the Lower TFI (Reach 1) showing the Greater amount of Hydraulic Erosion (Undercutting) between the Baseline Condition with Waves as Compared to the Baseline Condition Without Waves at Site 12BL

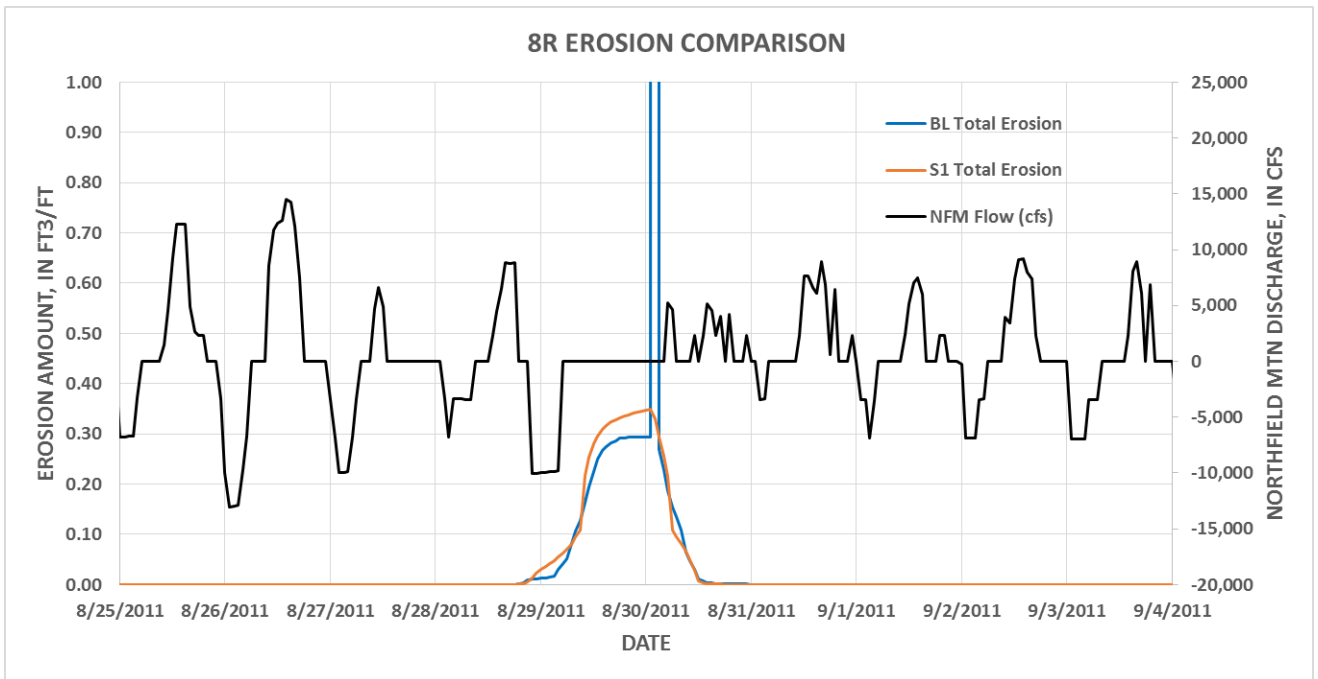
Figure 5.4.23-4 – Timing of large, geotechnical failure during Hurricane Irene for the Baseline Condition but not during Scenario 1 when NFM is idle.

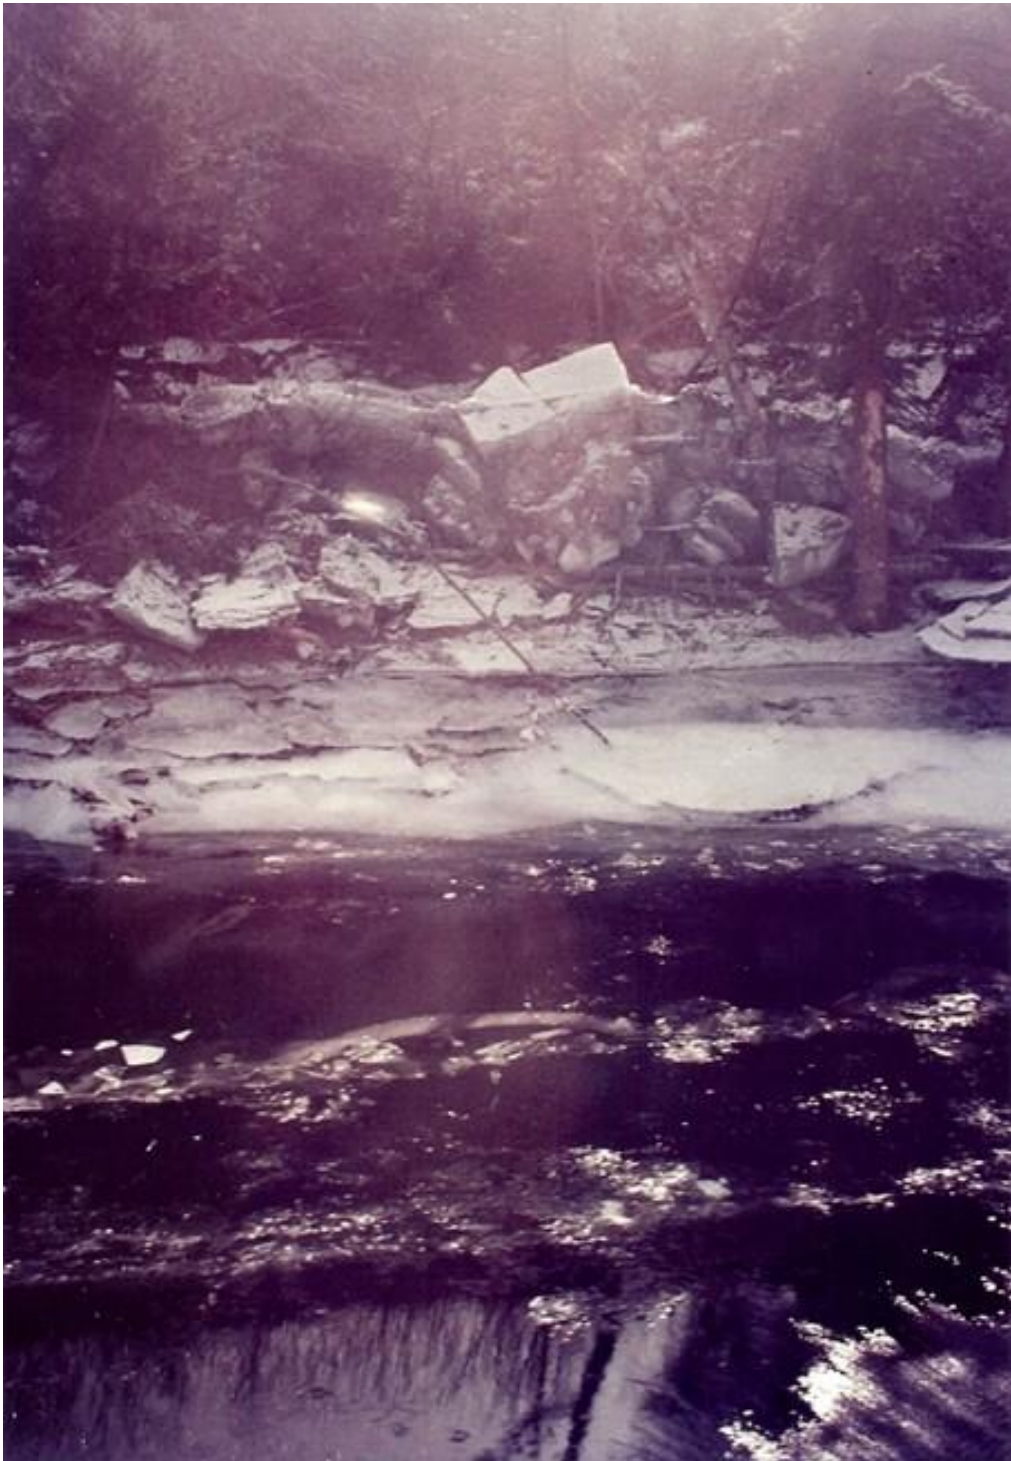
Figure 5.5.5.3-3 Ice Damage to Riparian Vegetation in the Bellows Falls Impoundment – 1992
