Analysis of Erosion in the Vicinity of the Route 10 Bridge Spanning the Connecticut River

# Analysis of Erosion in the Vicinity of the Route 10 Bridge Spanning the Connecticut River

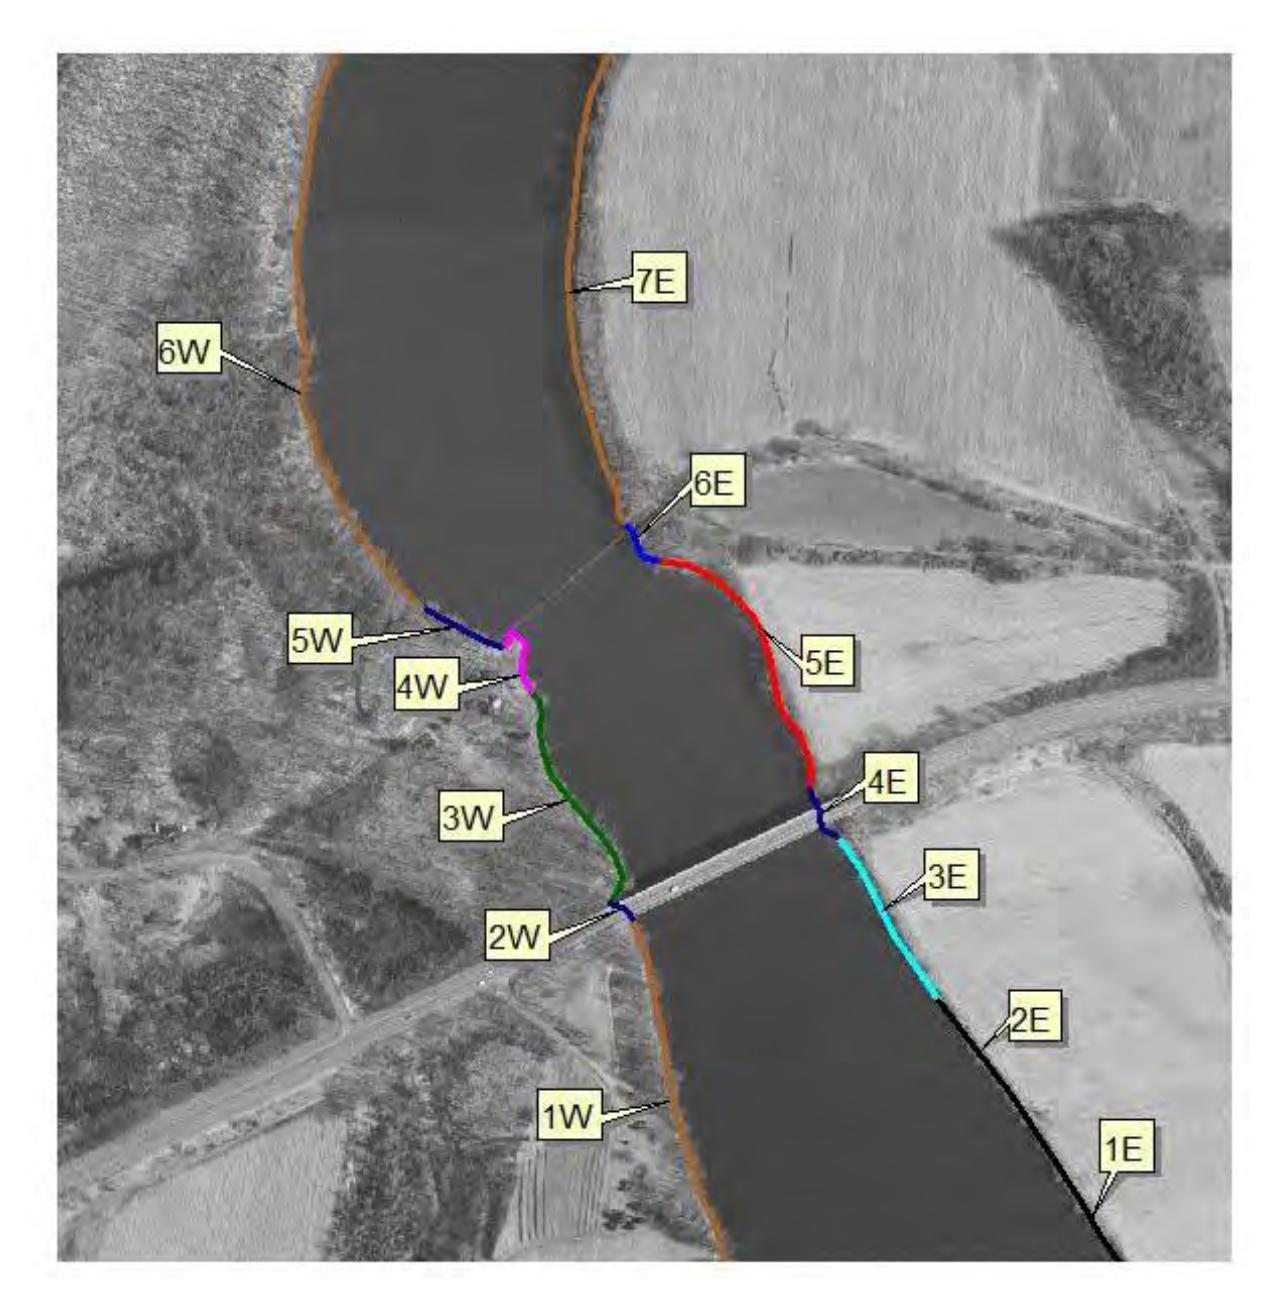
Figure 4. Riverbank Characteristics near Route 10 Bridge

Downstream of the bridge (Segment 1W) on the right descending bank (west side of the river), the riverbank has a relatively flat lower slope and a moderate to steep to near vertical areas of upper river bank. The banks in this area consist primarily of relatively fine sand. There is considerable woody debris deposited on the lower banks. The upper banks are vegetated with areas of trees and some shrubs and herbaceous vegetation. While generally moderately well vegetated, there are small patches of sparse vegetation and other areas that are more heavily vegetated.

Upstream of the bridge (Segment 3W) on the right descending bank has been protected against erosion for several hundred feet. The toe of the slope has been covered with cobble-sized rip-rap. On top of the rip-rap, coir logs can be seen in some areas. The upper slope has been cut back to a moderate slope and is heavily vegetated with shrubs, trees, and herbaceous vegetation. Upstream of this area the rip-rap toe continues (and transitions to a rock outcrop) but above the rock is grass lawn area associated with the home that exists quite far up the bank. Going farther upstream the natural rock outcrop continues to the hook-shaped rock point (4W). Some trees and shrubs grow on top of the soil found above the rock outcrop area. Upstream of the rock outcrop (on the right descending bank) the lower bank consists of small rocks to sand (5W). The upper banks

On the left descending bank (east side of the river) downstream of the Route 10 Bridge, the USACE constructed experimental bank protection. The first segment consists of small concrete blocks glued on fabric placed on the lower bank (3E). The upper bank is vegetated with trees, shrubs and herbaceous vegetation. The next two segments consist of used automobile tires banded together on the lower riverbank slope with a vegetated upper bank (trees, shrubs, and herbaceous vegetation). In one of the segments, the tires are stacked and stepped back to create a moderate slope (2E). For the most downstream segment, the tires are laid on a moderate slope on their sides with tires touching at their circumference so their circular shape is visible (1E). Upstream of the bridge, the lower bank consists of sand and is relatively flat-sloped (5E). The upper riverbank is generally steep with some areas of moderate to vertical slopes. There is some vegetation but fairly limited. This segment is actively eroding and extends several hundred feet. The next segment has a rip-rapped toe, where the old Bennett Meadow Bridge used to be (6E). The upper river bank consists of silt and sand and lies on a moderate slope. It is vegetated with trees and some shrubs and herbaceous vegetation. Beyond the old segment of rip-rap, the lower riverbank consists of sand lying on a relatively flat slope (7E). The upper riverbanks continue (moderate sandy slope) with vegetation consisting of trees, shrubs and herbaceous vegetation.

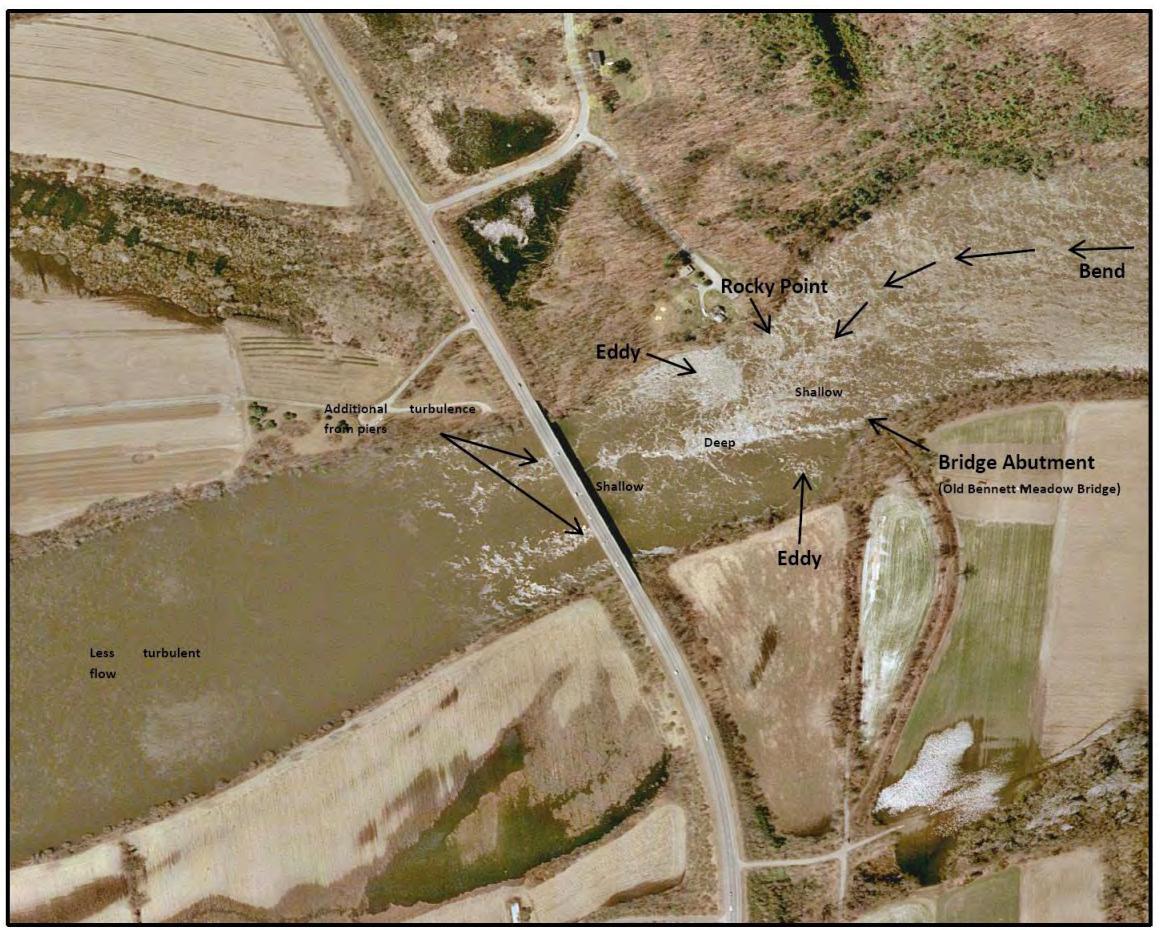
Figure 9. Flow characteristics in the vicinity of the Route 10 Bridge

As can be seen in Figure 9, a recent aerial photograph (MASSGIS, photo date April 2001) shows turbulence at the water surface in the reach of river upstream and through the Route 10 Bridge due to the bend, constriction and narrowing through the rock outcrop and old bridge abutment, acceleration of flow, extreme and rapid depth changes, separation zone and eddy, and the bridge piers. Once the flow has gone through these intense hydraulic changes, note that downstream of the Route 10 Bridge, the flow becomes much more tranquil as indicated by the much calmer water surface.

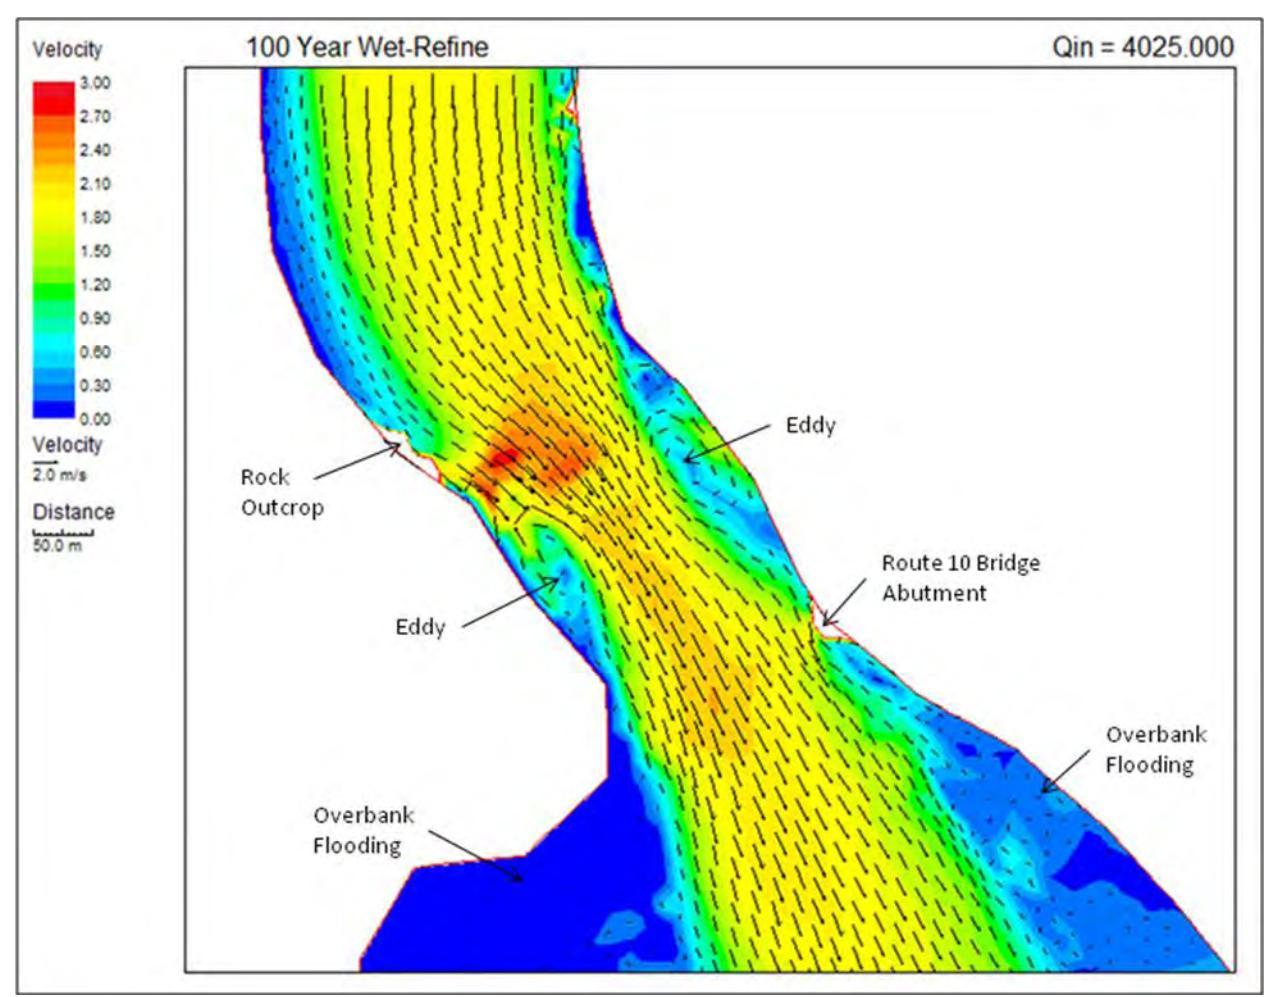
Figure 11. River-2D Results, 100-Year Flow

Figure 11 is an example of the velocity vectors computed by this model showing the formation of eddies in the vicinity of the Route 10 Bridge for the 100-year flow. The eddies are shown by the black velocity vectors showing a circular pattern near both riverbanks just downstream of the rocky point and between the old Bennett Meadow Bridge and the Route 10 Bridge. Appendix E presents the results of the River-2D model in this reach of interest for the 1.05 to 10-year events. The magnitudes of the velocities are shown by the length of the black velocity vectors and also by the colors. The blue color represents low velocities while the red color represents high velocities (ranging from 0-3 feet per second). Note on Figure 11 the small white area outlined in red representing the rock outcrop. The model shows that the rock outcrop accelerates the flow (as noted by the red shading and the longer arrows). Note the formation of eddies (circulatory pattern of velocity vectors) just downstream of the rock outcrop adjacent to both banks of the river. Acceleration of flow and the formation of eddies on one or both banks occurs for other flows (see Appendix E) and is consistent with flow patterns observed in this part of the river.

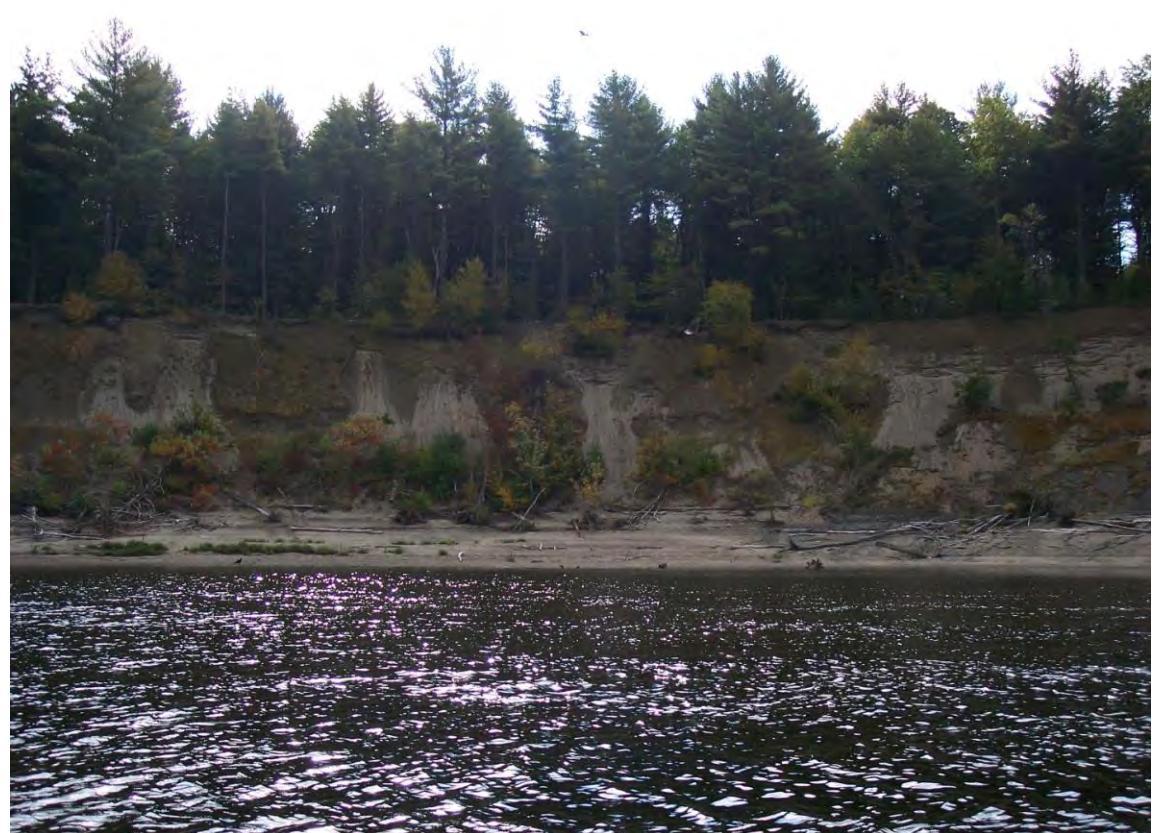
Figure 12. Riverbank Erosion downstream of Vernon Dam

Perhaps the area of most significant erosion along the Turners Falls Impoundment is located just downstream of the Vernon Dam on the left descending bank (east). Simons & Associates visited the site and conducted an evaluation of erosion at this location for New England Power in 1996. In this evaluation we stated, "As water flows downstream of the dam along the left side (looking downstream) it forms a large eddy which circulates to the left in a counter clockwise direction into and around the eroded area." This large eddy has caused what is the most significant erosion of any part of the Turners Falls Impoundment. Figure 12 shows a water level view at relatively low flow and Figure 13 is an aerial view of the erosion caused by the eddy as high flows are discharged from the Vernon Dam spillway. As can be seen in Figure 13, a white-water jet is being discharged over the spillway at high velocity that induces a strong eddy and associated turbulence.

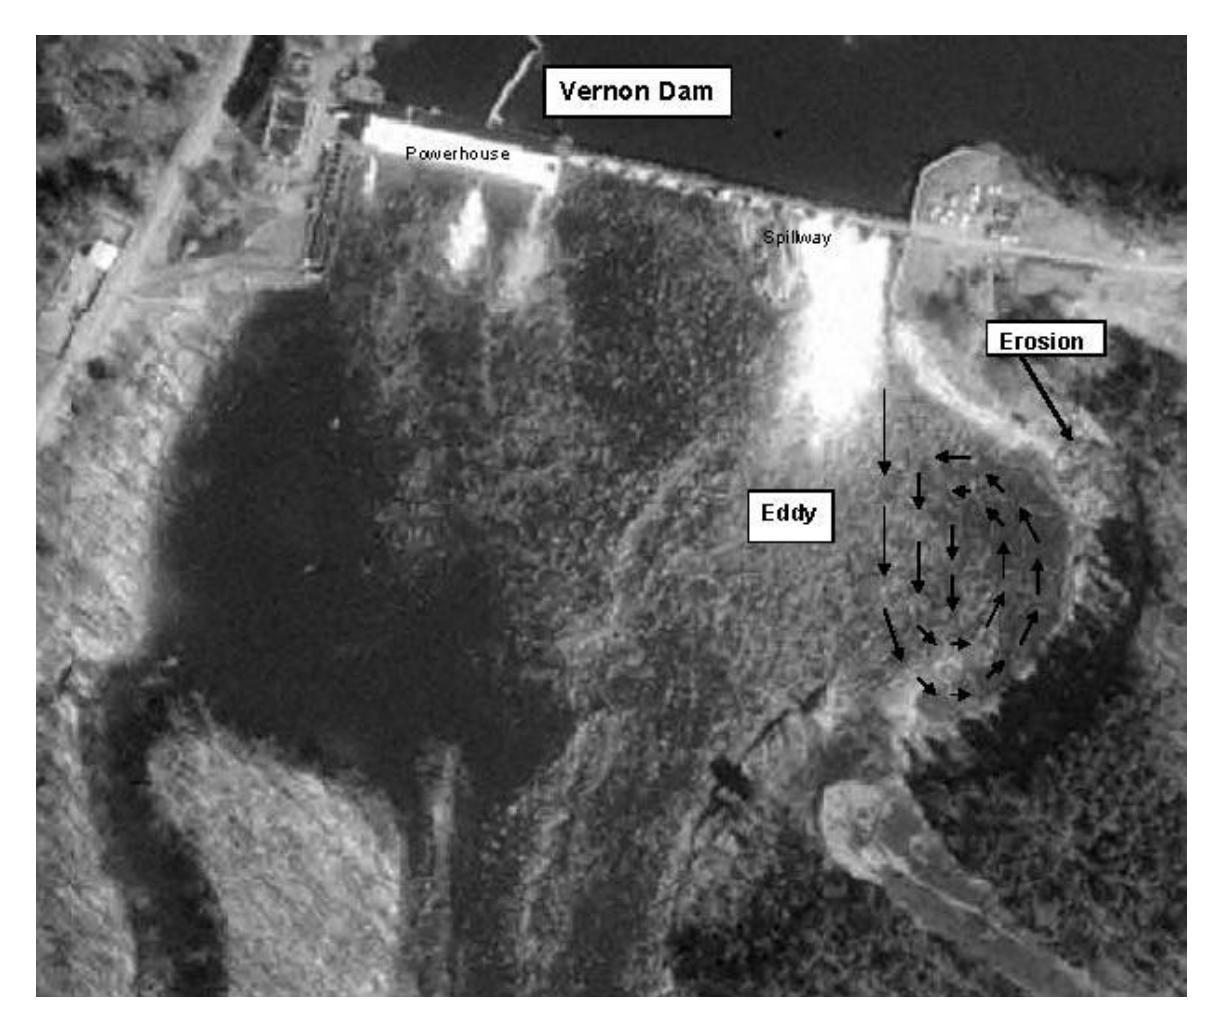
Figure 13. Eddy-induced erosion downstream of Vernon Dam

Appendix F presents additional photographs of this very significant eddy-induced erosion taken from boat and ground. Based on the aerial photo (April 2001 in the Massachusetts GIS), the toe of the eroded slope is about several hundred feet back from a straight line along the bank from the left abutment of the Vernon Dam (looking downstream) to the point on the bank downstream of the eddy-induced erosion where the power-line tower is located. The horizontal distance along this eroded slope from the toe to the top is about 150 feet. This eroded bank is about 90 feet high. This segment of eroded riverbank is larger than any other eroded bank in the Turners Falls Impoundment. These photos clearly show the erosive effect of such a large-scale eddy on the riverbanks in the Turners Falls Impoundment and confirm that significant erosion is occurring independent of Turners Falls and Northfield Mountain operations since this erosion is located far away from the effect of these projects where backwater and fluctuations due to these projects are not significant.

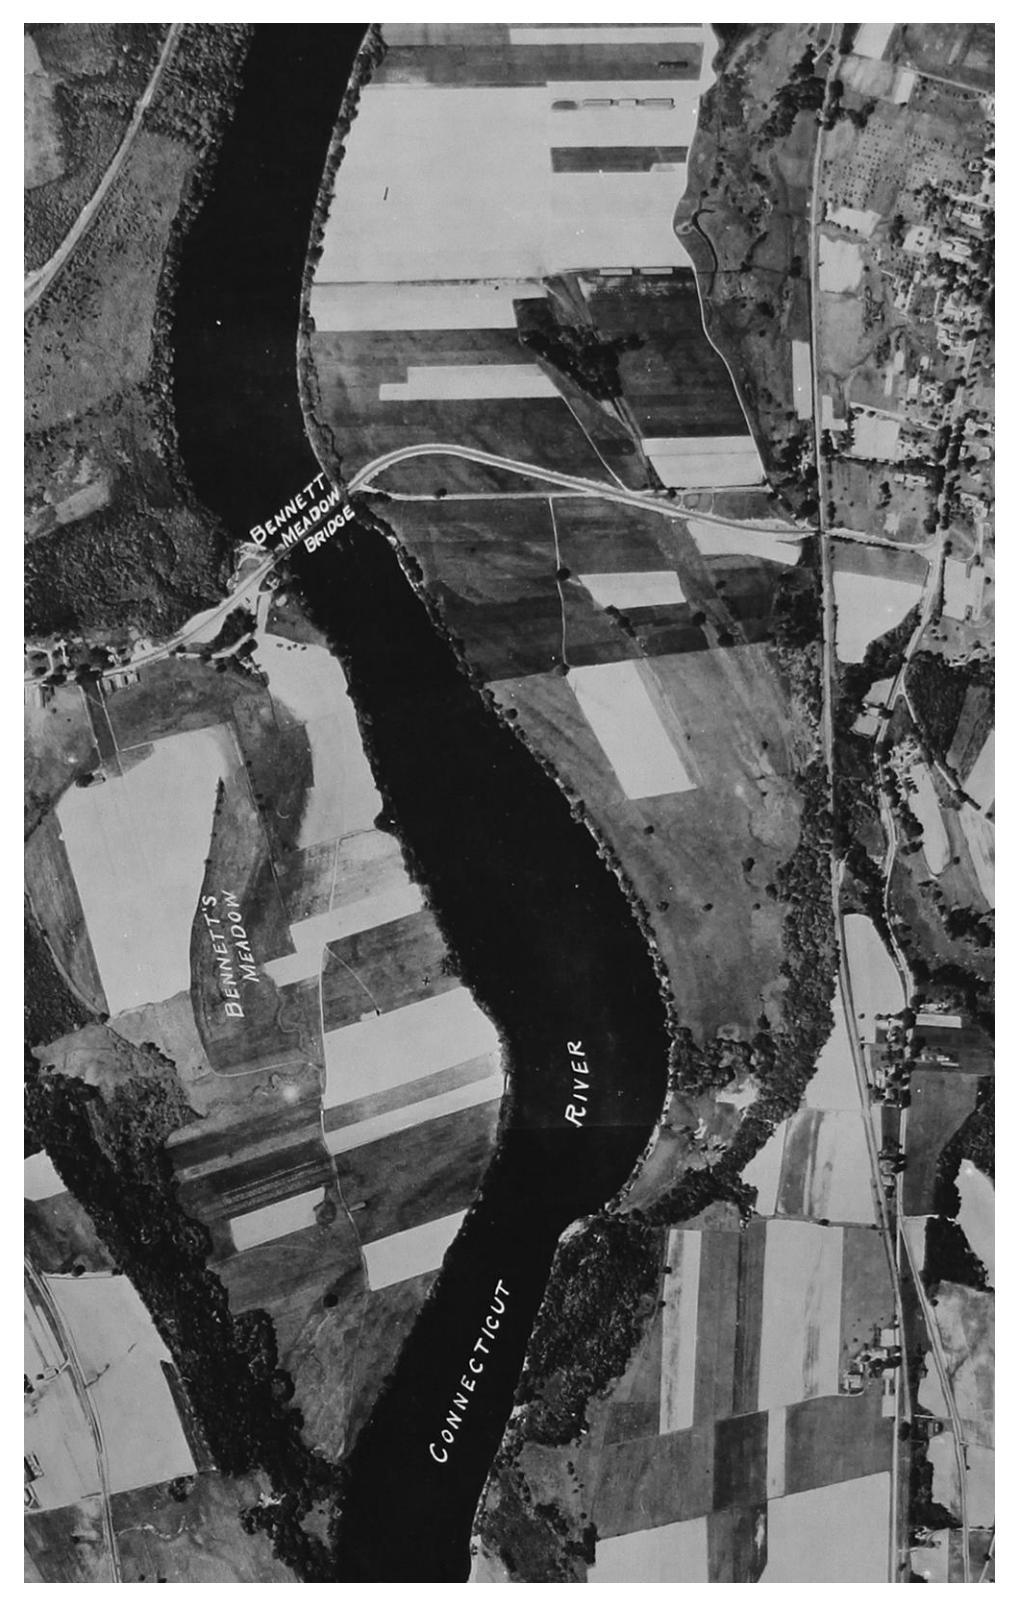
Connecticut River, Bennett Meadow Bridge - 1929

1929 – The 1929 photograph shows the old alignment of the Bennett Meadow Bridge as it crossed the river in basically a perpendicular direction from a rock point on the west bank (right descending bank – in the direction of flow). This bridge alignment took advantage of the rock point extending out into the river making this location as narrow as possible (to minimize the span and cost of the bridge). The bridge abutment on the east bank (left descending bank) was constructed on the bank itself and did not extend significantly out into the river channel. As the river flows downstream, it bends significantly to the left. Once the river passed the rocky point on the west bank, the bank developed a curved shape back in a westward direction as the river width expanded indicating that some erosion along the west bank was likely occurring beyond the normal width expansion from the narrow section where the bridge was located. On the east bank there is a small but abrupt change in the bank alignment that appears to indicate some local erosion is occurring. The east bank also exhibits some mild curvature indicative of a more general pattern of erosion as well.

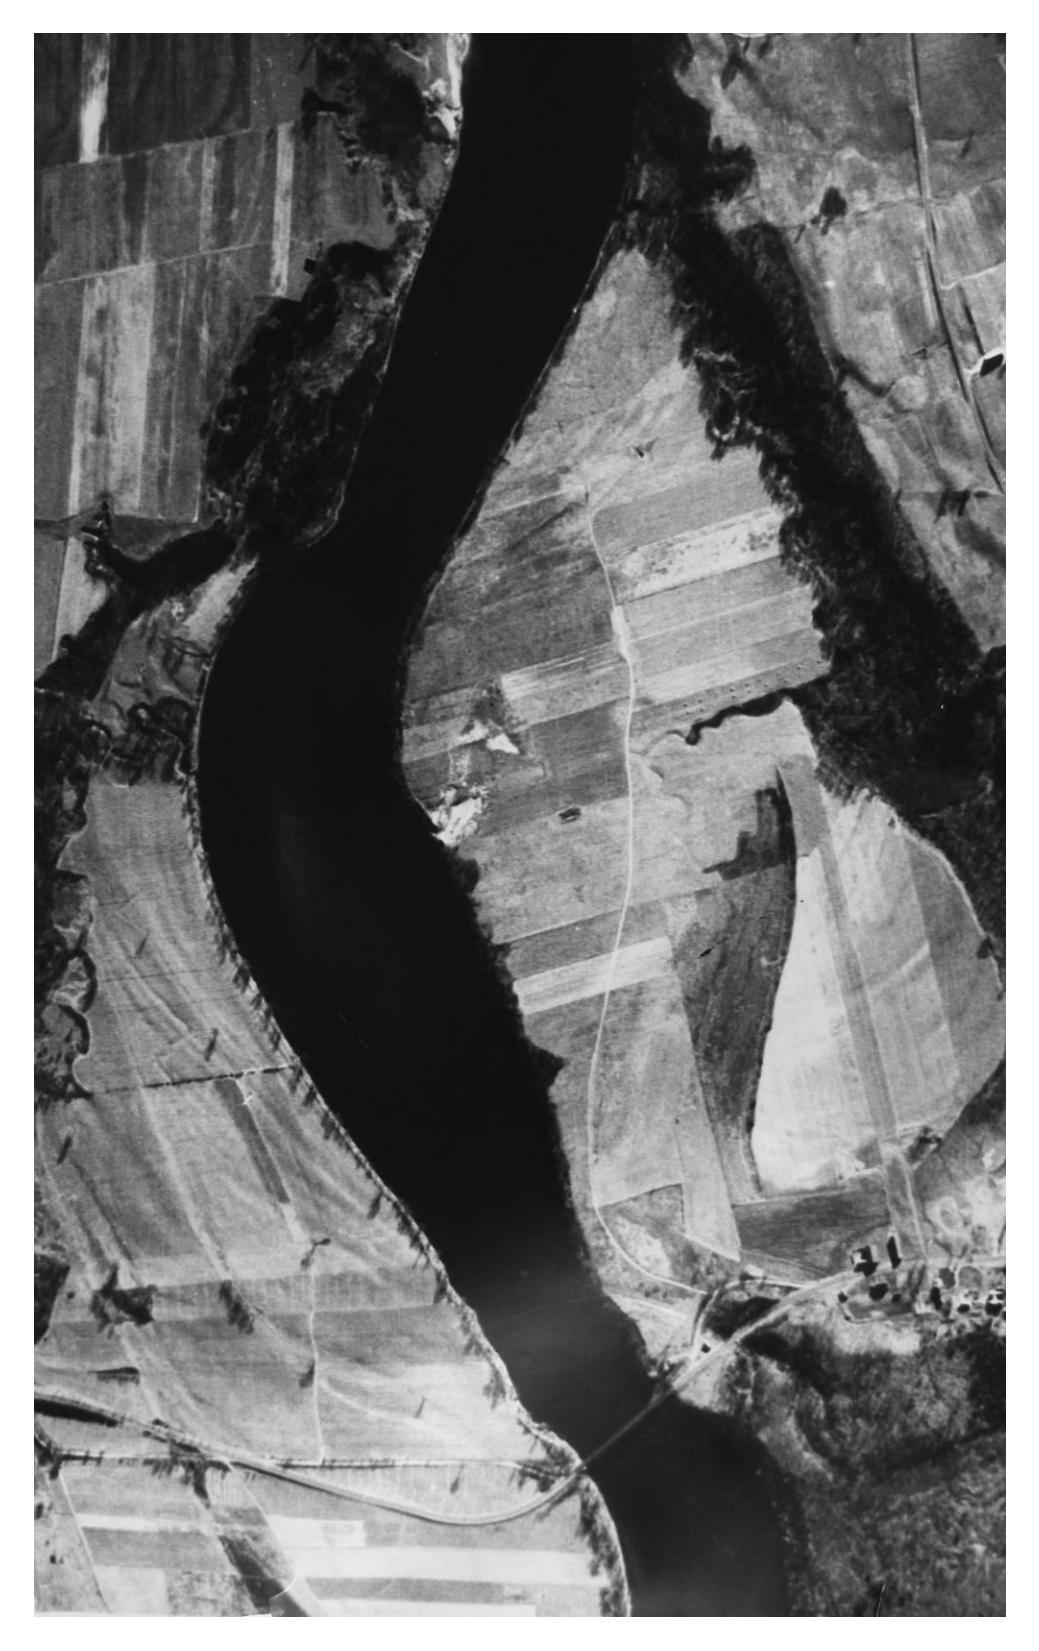
Connecticut River, Bennett Meadow Bridge - 1939

1939 – The river shows similar riverbank alignment and characteristics compared to the 1929 photograph. The area of localized but abrupt change in bank alignment on the east bank noted in 1929 has eroded more, and the curved area indicating more general erosion appears somewhat more pronounced.

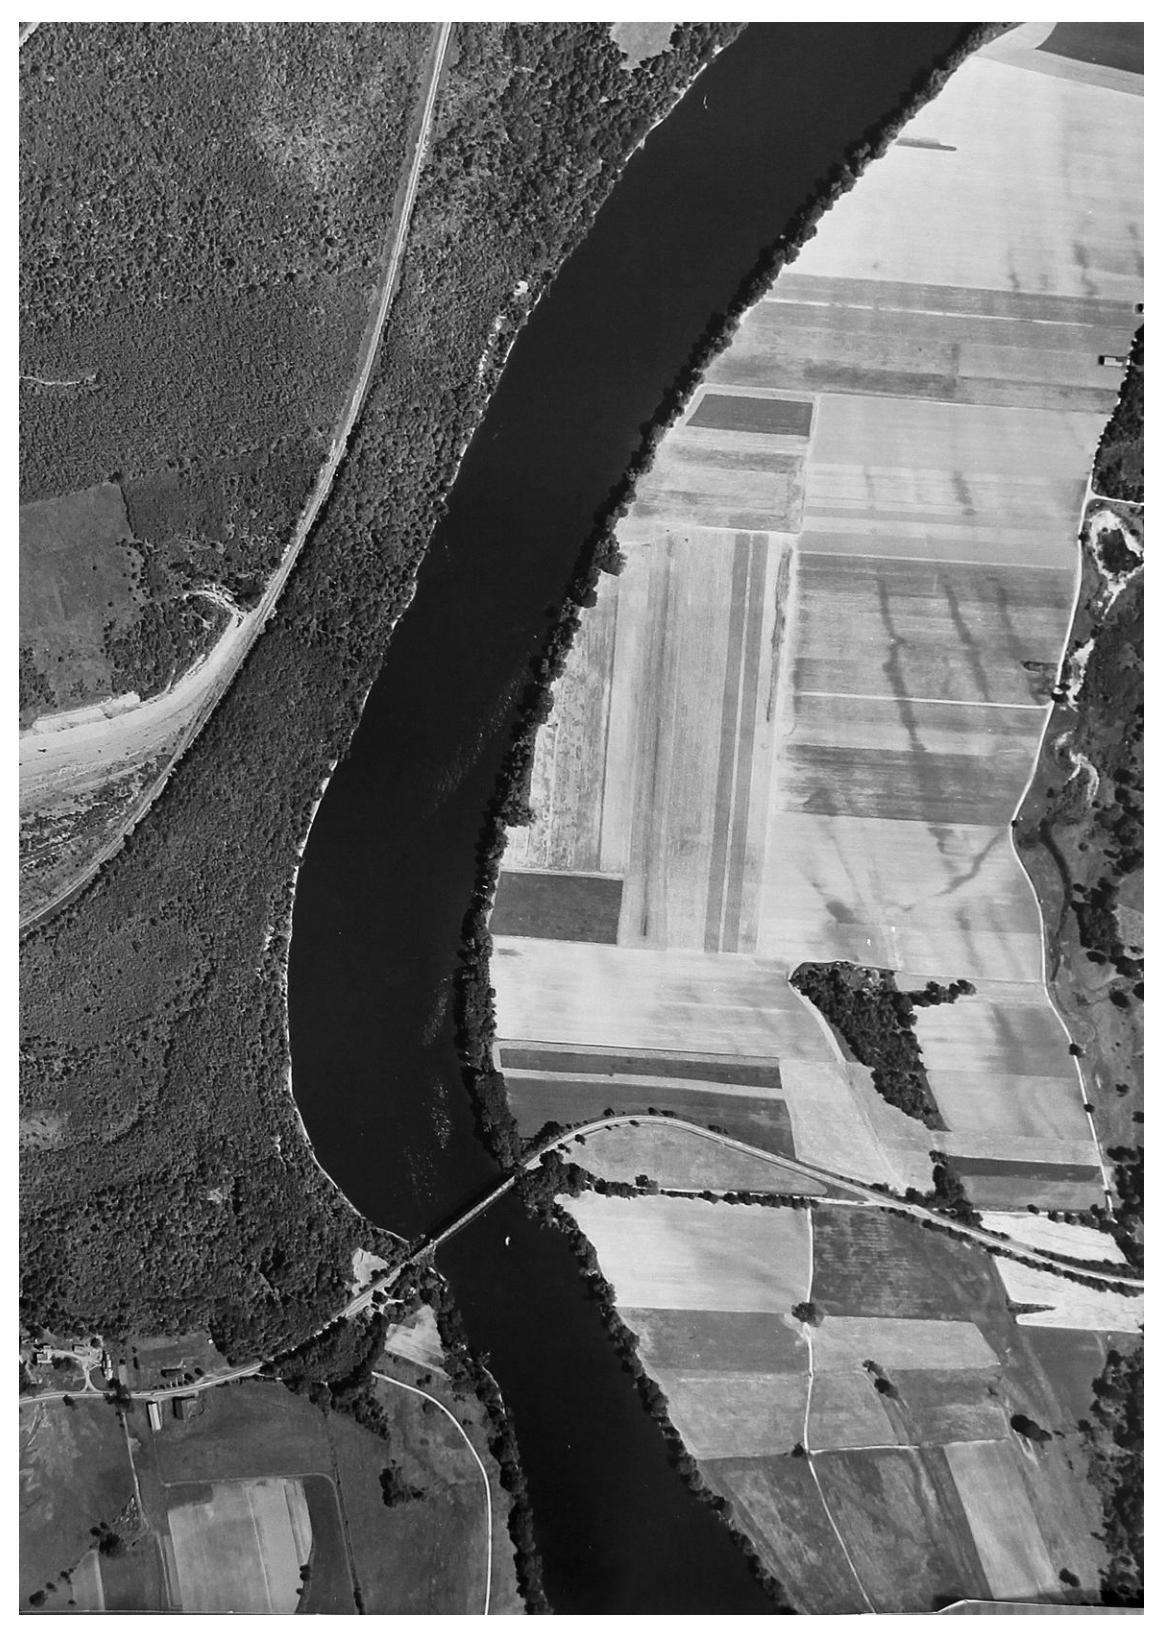
Connecticut River, Bennett Meadow Bridge - 1952

1952 – Again, the riverbank alignment appears similar to the previous photographs. There appears to be increased curvature of the riverbanks in the landward direction on both banks downstream of the bridge indicating ongoing erosion. There were several fallen trees on the east bank downstream of the bridge.

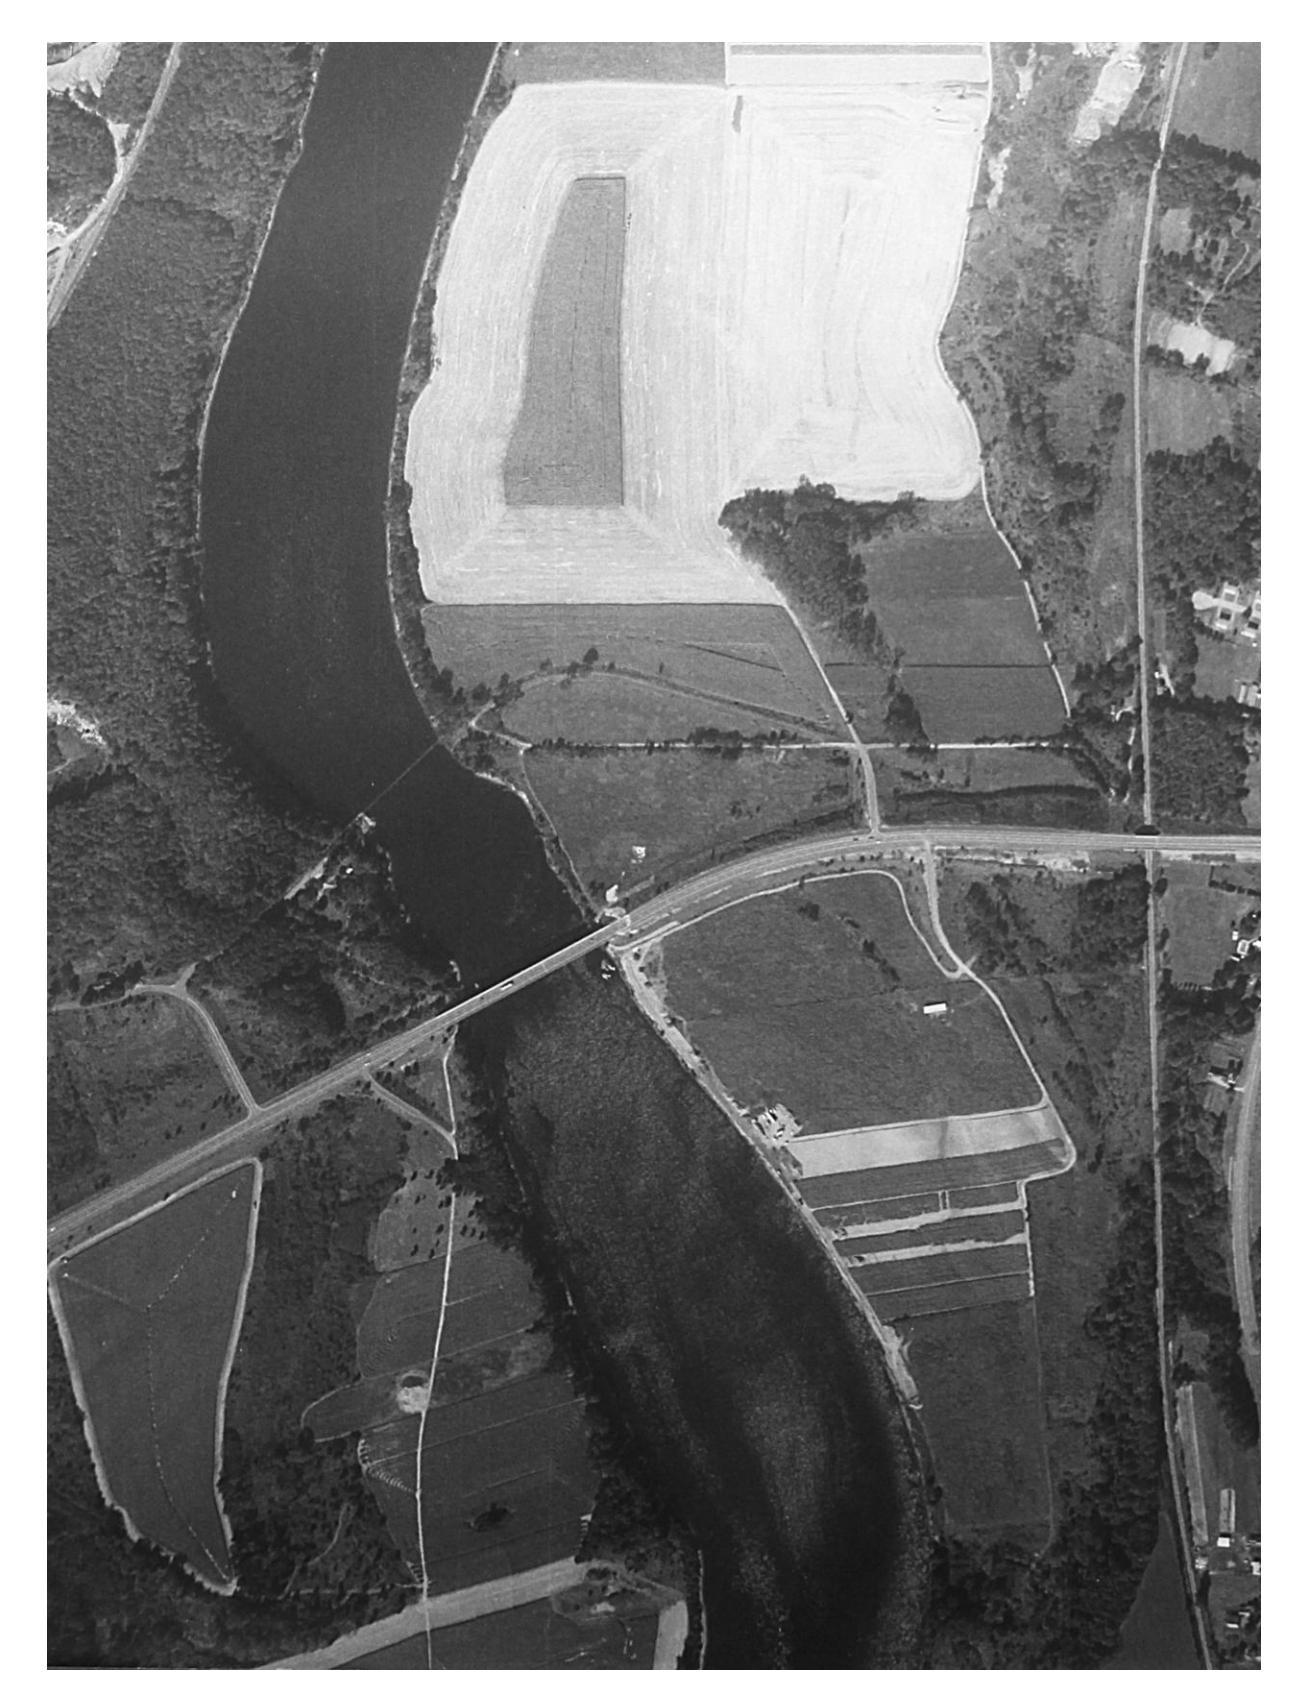
Connecticut River, Route 10 Bridge - 1980

1980 – This photograph shows that the old Bennett Meadow Bridge had been removed and the new Route 10 Bridge had been built (finished in 1969). The new bridge is located about 800 feet downstream of the old bridge. This photograph shows fewer trees along the east bank with a short distance showing no trees. There is more pronounced curvature indicating ongoing erosion of both banks in the same area where erosion had been occurring in the previous photographs (downstream of the old bridge location).
