# **RELICENSING STUDY 3.6.2**

# **RECREATION FACILITIES INVENTORY AND ASSESSMENT ADDENDUM**

**Northfield Mountain Pumped Storage Project (No. 2485)  
and Turners Falls Hydroelectric Project (No. 1889)**

**JUNE 2015**

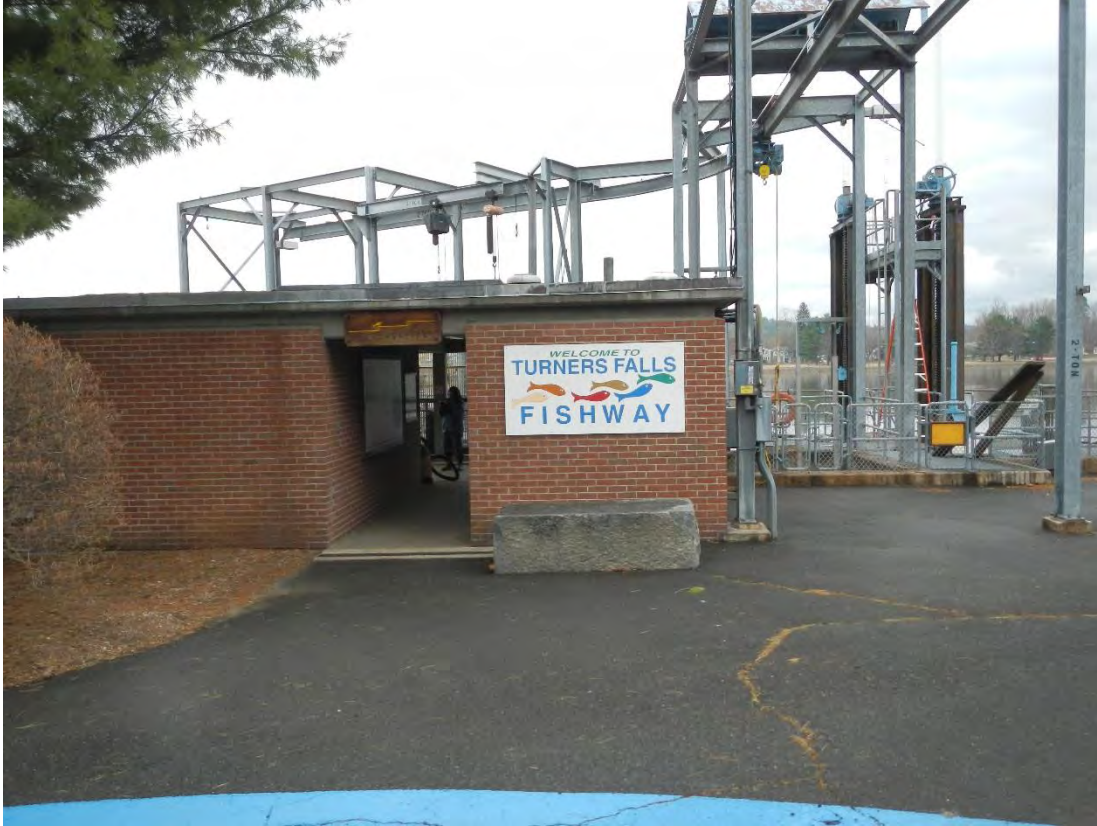
**Figure 4.3-1 Fishway Viewing Facility Entrance**

The fishway viewing facility was observed to be functioning as intended and the amenities within the facility, including the restrooms, were in good condition. The fishway viewing facility therefore receives a Category rating of 4. At the time of the April 2015 field visit, the picnic tables were functional but it was noted that they would be more appealing and possibly used more frequently if the tops were replaced. At the time of the field visit, plans, however, were already underway to replace the table tops and bench tops during the spring of 2015. As of June 2015, upgrades to the picnic tables are in progress. Therefore, upon completion of the upgrades, they would receive a Category rating of 4.

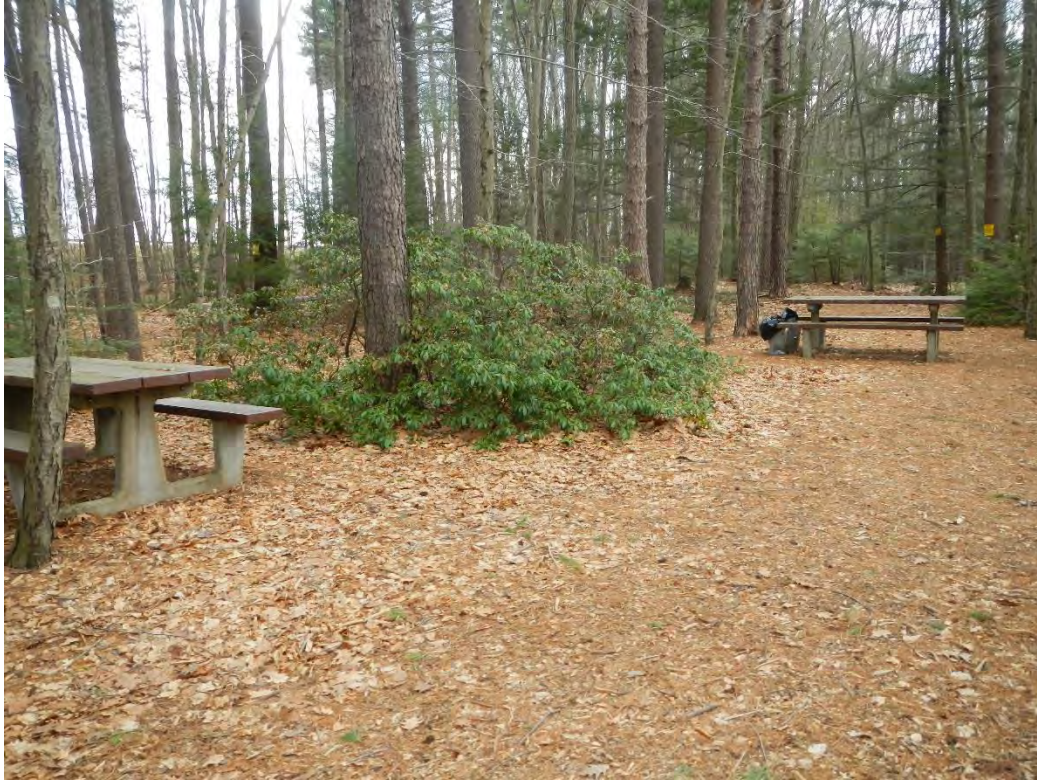
**Figure 4.3-3 Cabot Woods Fishing Access Picnic Area**

visit. As noted above, the informal trails are located on a steep bank. The picnic table tops on two of the tables and two bench tops showed signs of wear.

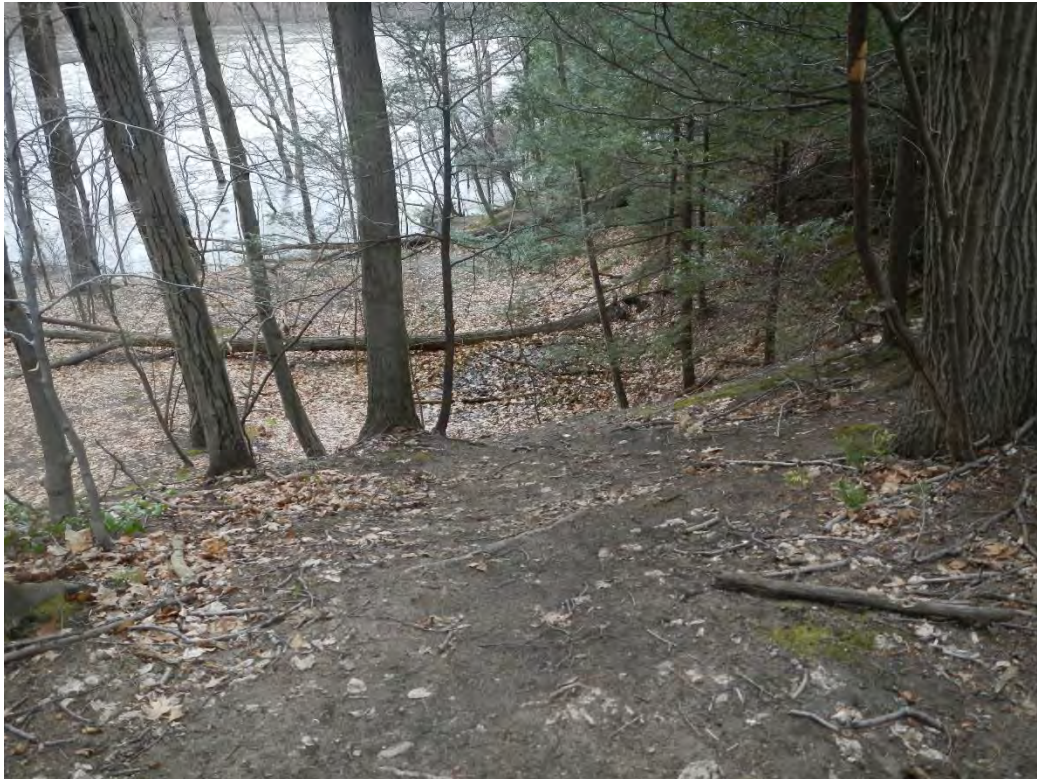
**Figure 4.3-4 Cabot Woods Fishing Access Informal Trail**

It appears that anglers and others that desire to access the shoreline are utilizing several informal angler access trails that traverse the steep bank to the bypass reach. The location of the most frequently used informal access trails are shown on the field site map ([Appendix A](#), Site 23 Lower Parking Area). At the time of the April 2015 site visit, approximately eight (8) informal access trails were noted. The access to the shoreline along these trails is steep, making it difficult to launch hand carry boats in this area. Swimming is discouraged at this site. There are “No Swimming” signs posted along the top of the bank of the bypass reach indicating that water flows change rapidly; there are dangerous currents, and there are underwater hazards.

There was compaction of the soils in the vicinity of informal trails to the shoreline of the bypass reach and small pockets of minor erosion were noted on some of the informal trails at the time of the April 2015 site

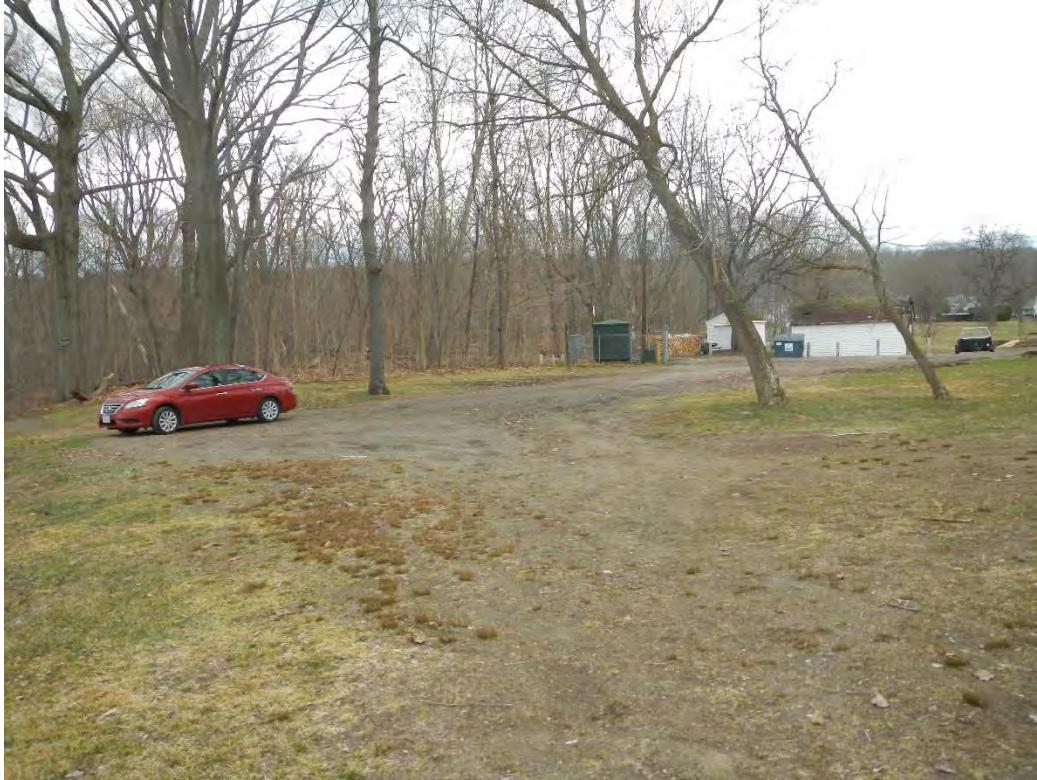
**Figure 4.3-6 Poplar Street Access Site Parking Area**

The Poplar Street Access Site ([Figure 4.3-6](#) and [4.3-7](#)) is an informal site located outside the Turners Falls Project boundary, downstream of Cabot Station, on Poplar Street in Montague, Massachusetts. This site is owned by FirstLight and is utilized for carry-in boat access, fishing and as the downstream put-in location for the Canoe Portage. The shoreline is accessible by a steep informal trail, which is not ADA accessible. Some erosion along the informal trail leading to the put-in was observed. As noted previously, a new field site map was drawn of this site ([Appendix A](#), Site 25). This site was assessed as a potential access point for recreational boaters in Study No. 3.6.3 *Whitewater Boating Evaluation*.

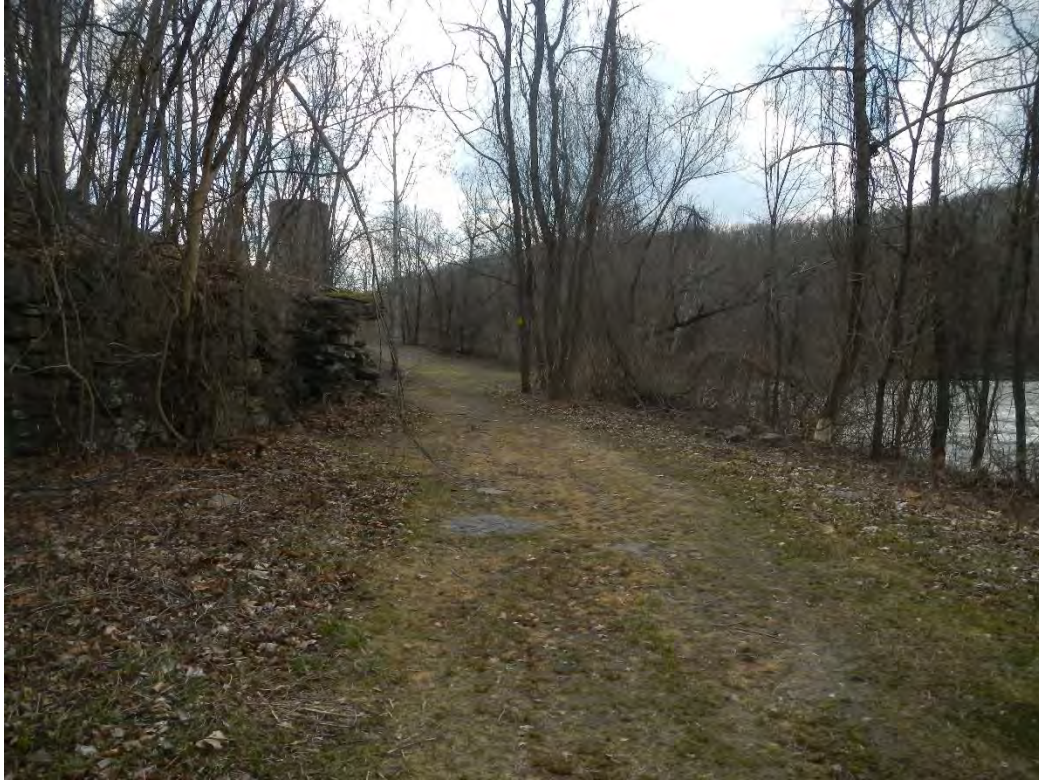
**Figure 4.3-8 Downstream Put-in Abandoned Roadway Access**

The put-in ([Figure 4.3-8](#) and [4.3-9](#)) downstream of Turners Falls Dam is an informal site located within the Turners Falls Project boundary in Turners Falls, Massachusetts between the power canal and the bypass reach. This site is located immediately downstream of the Turners Falls Fishway on river left. This site is owned by FirstLight and is used informally for angling and launching of carry-in boats. Individuals access the site on foot or by bicycle along a grassy abandoned roadway. The slope is too steep for ADA access. As noted previously, a field site map for this area was drawn ([Appendix A](#), Site 26). This site, also known as the fishway put-in site, was assessed as a potential put-in for recreational boaters in Study No. 3.6.3 *Whitewater Boating Evaluation*.

Evidence of use at the site included minor amounts of garbage, graffiti and minor soil compaction near the shoreline. An unauthorized, informal fire ring was noted during the April 2015 site visit.

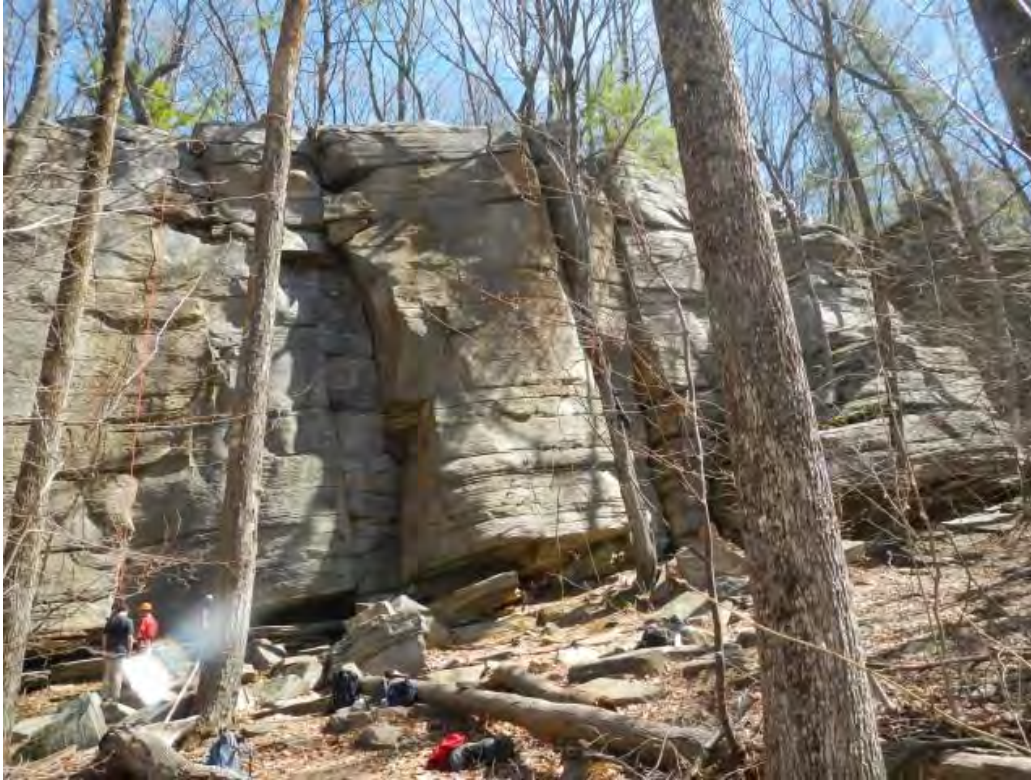
**Figure 4.3-10 Rose Ledge Climbing Area**

The Rose Ledge Climbing Area ([Figure 4.3-10](#)) is an informal climbing area located within the Northfield Mountain Project boundary. The climbing area is on land owned by FirstLight and is accessed by an informal foot path stemming from the NMTTC trail system's Lower Ledge Trail. As noted previously, a field site map for this site was drawn ([Appendix A](#), Site 27).

The parking area associated with the NMTTC (Site 12) was assessed as part of the ISR submitted in September 2014. The NMTTC, including the trails that might be used to access the Rose Ledge Climbing Area, are assessed in Study 3.6.7 *Recreation Study at Northfield Mountain, Including Assessment of Sufficiency of Trails for Shared Use*. Evidence of site use and condition observed during the April 2015 site visit included compaction at the base of the rock face and unauthorized improvements such as anchors for safety ropes at the top of the ledge.

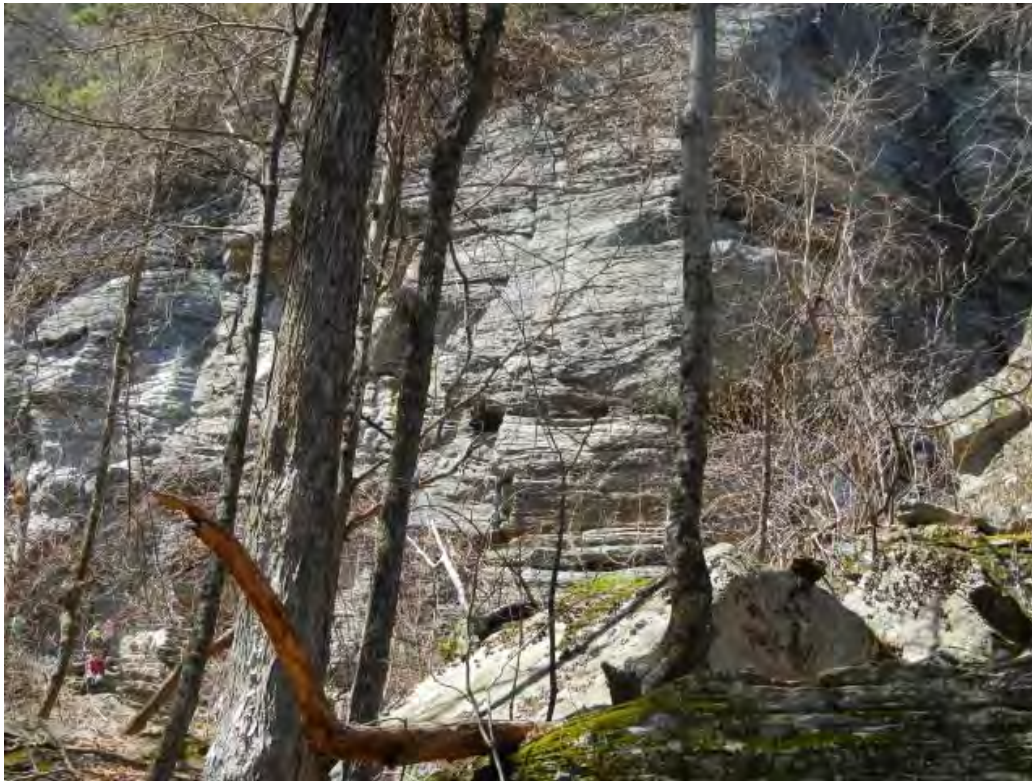
**Figure 4.3-11 Farley Ledge Climbing Area**

The Farley Ledge Climbing Area ([Figure 4.3-11](#)) is an informal climbing area located partially within the Northfield Mountain Project boundary. A portion of the area is owned by FirstLight. Individuals access the site via an informal foot trail located on private property. As noted previously, a field site map for this site was drawn ([Appendix A](#), Site 28).

The parking areas associated with the climbing area were not assessed because they are located outside the Project boundary and not owned by FirstLight. Evidence of use of the climbing area included compaction at the base of the rock face and unauthorized improvements such as anchors for safety ropes at the top of the ledge.
