Relicensing Study 3.1.2

**NORTHFIELD
MOUNTAIN/TURNERS FALLS
OPERATIONS IMPACT ON
EXISTING EROSION AND
POTENTIAL BANK
INSTABILITY**

Updated Study Report Summary

**Northfield Mountain Pumped Storage Project (No. 2485)
and Turners Falls Hydroelectric Project (No. 1889)**

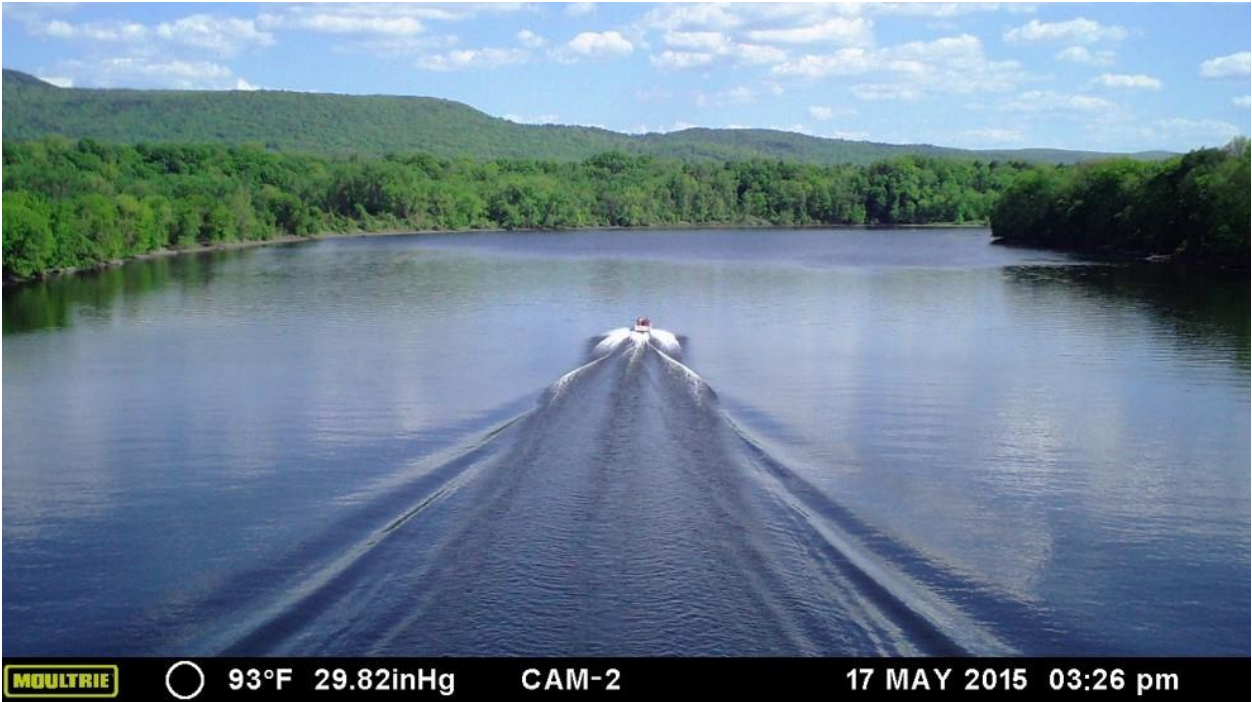
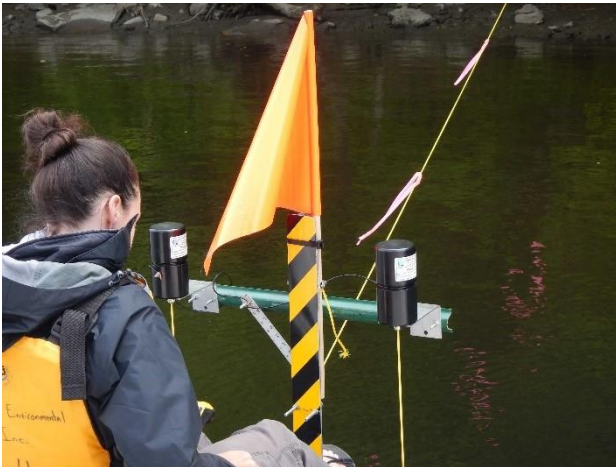
The collected data is then analyzed using a custom developed image processing tool to measure the speed, location, and passage time of the boat as well as to estimate the type, shape, and size of boats as they pass.

Clockwise from top: (1) digital image of a passing boat captured by the camera mounted to the Route 10 Bridge; (2) wave logger located just downstream of the Route 10 Bridge; and (3) Dual wave loggers located just upstream of the French King Bridge

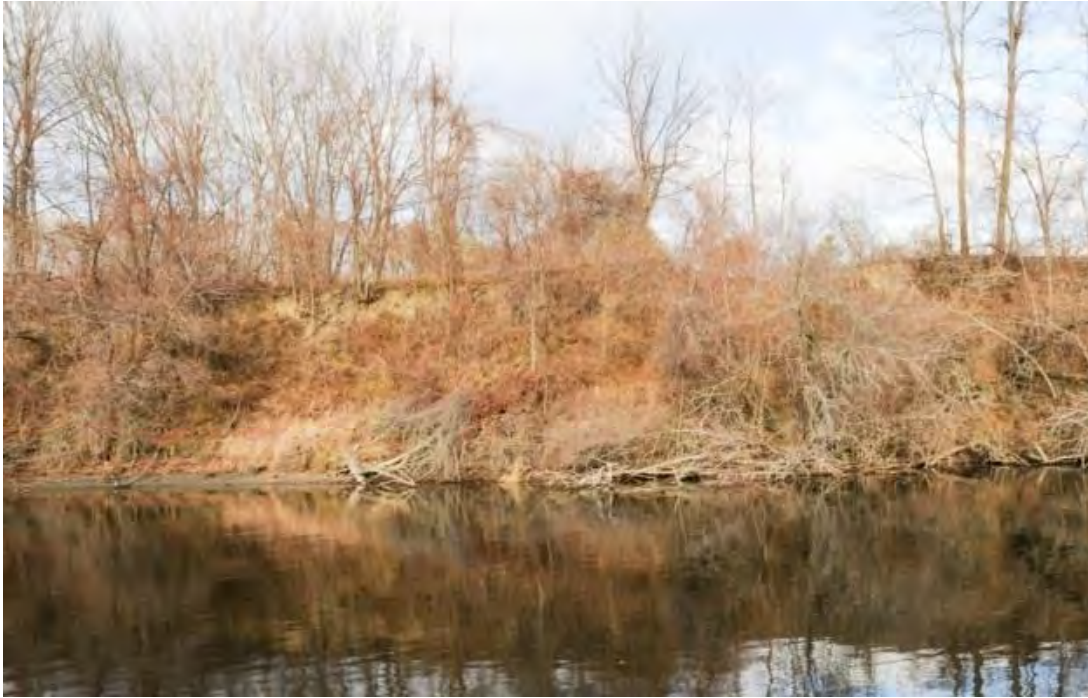
As a result, many areas of erosion were missed, and some were incorrectly categorized. Some examples of areas that were missed are shown below.

Cropped version of FirstLight photo DSC_1164. Shot November 2013. Located along segment 513, classified as **none/little** extent of erosion.

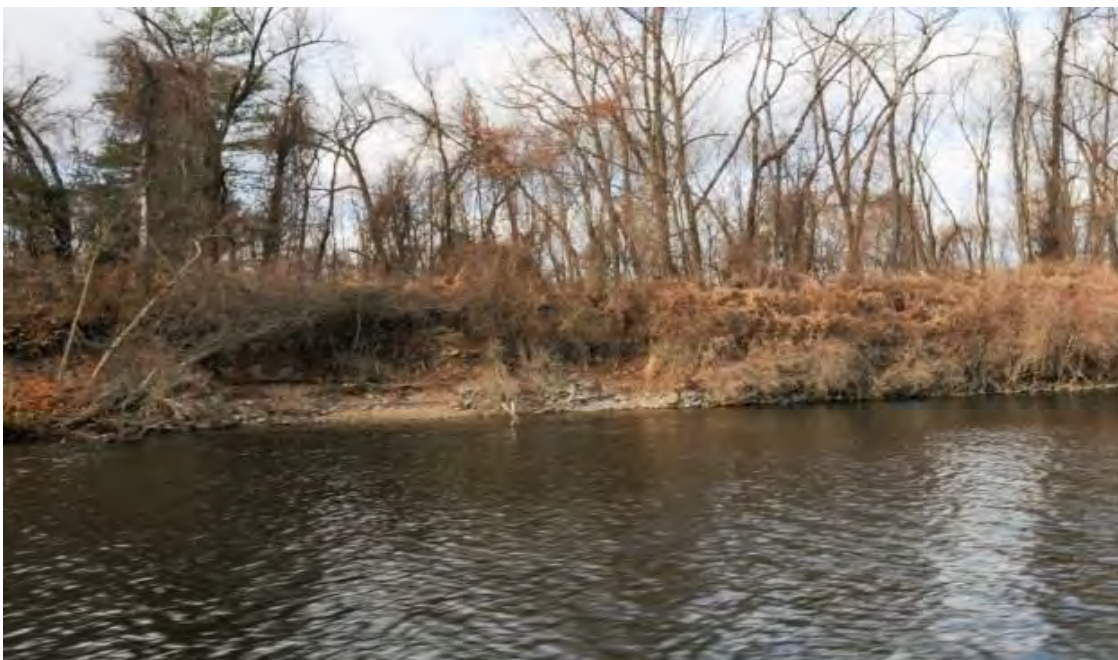
Cropped version of FirstLight photo DSC_1192. Shot November 2013. Located along segment 515, classified as **none/little** extent of erosion.

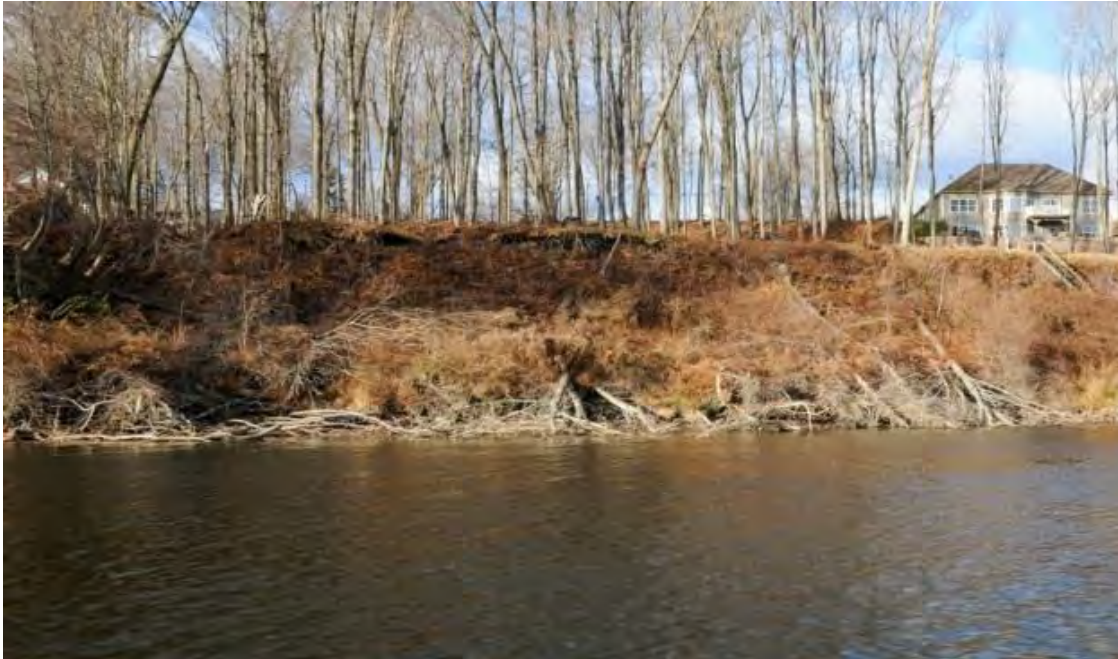
Cropped version of FirstLight photo DSC_1203. Shot November 2013. Located along segment 515, classified as **none/little** extent of erosion.

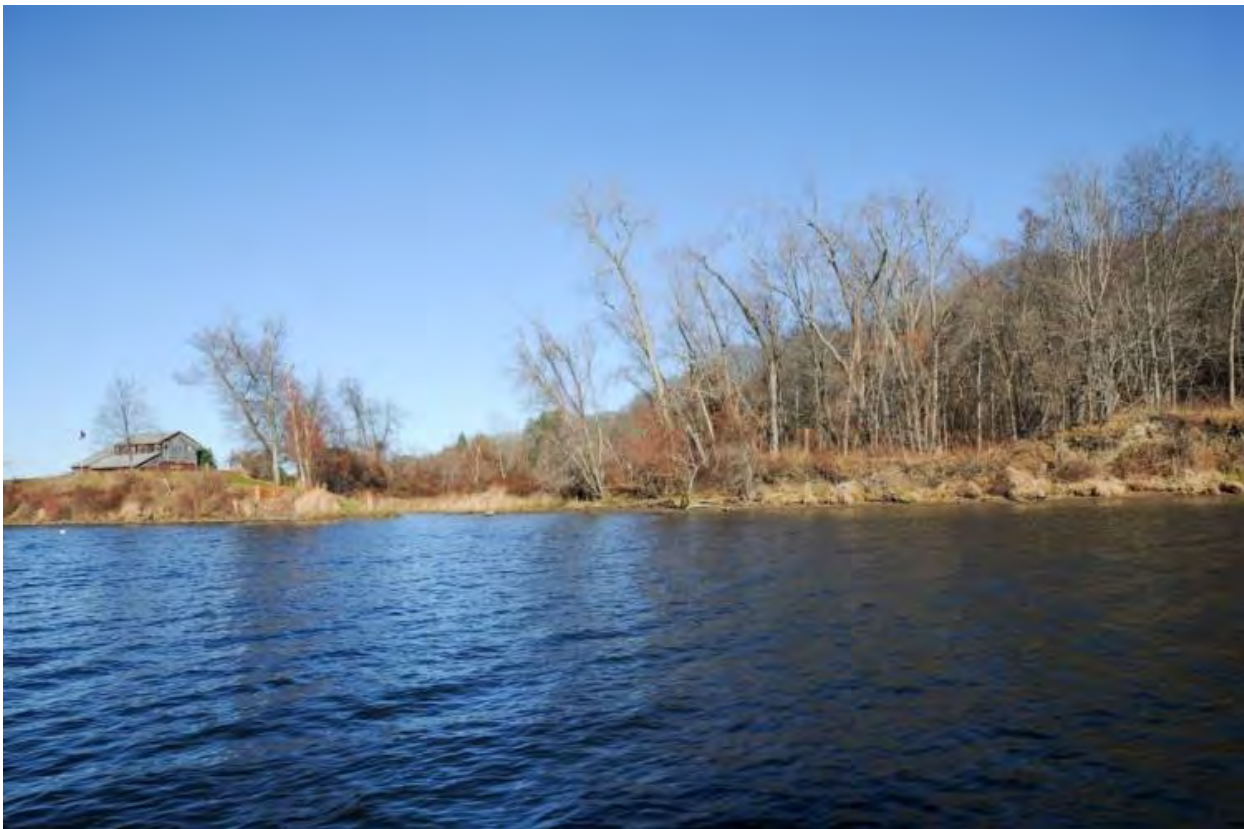
A look at the segments shown in Appendix G of the FRR indicate many segments straddle the upstream and downstream ends of tributary confluences. These include the Ashuelot River (segment 308), Newton Brook (517), Bottom Brook (509), Mallory Brook (499), Bennett Brook (465), Merriam Brook (126), Otter Run (441), and Ashuela Brook (438). Two segments shown on Appendix G maps seem to mostly be composed of a confluence: segment 88 at Pine Meadow Brook and segment 55 at the Millers River. How these could have bank characterizations is a mystery. For example, if one looks at DSC_0606 (below), one can see the Shearer house on the downstream end of segment 89. Segment 88, a segment 200 ft long, is to the right and shows submerged aquatic vegetation at the confluence of Pine Meadow Brook on the left, and then bank on the right. This segment was characterized as steep upper river bank slope, low upper river bank height, indicators of erosion (notch, exposed roots, creep/leaning trees), stable stage of erosion, and none/little extent of erosion. Though there is no erosion in the part of the segment that is a tributary meeting the Connecticut River, one would have a hard time concluding that the remaining bank has <10% of erosion, even though we could not know for sure where the segment break point was. Certainly including the tributary would “dilute” the extent of erosion in this segment.

FirstLight photo DSC_0606. Shot November 2013. Shearer property is on downstream end of segment 89. Tributary and downstream bank located along segment 88, classified as **none/little** extent of erosion.

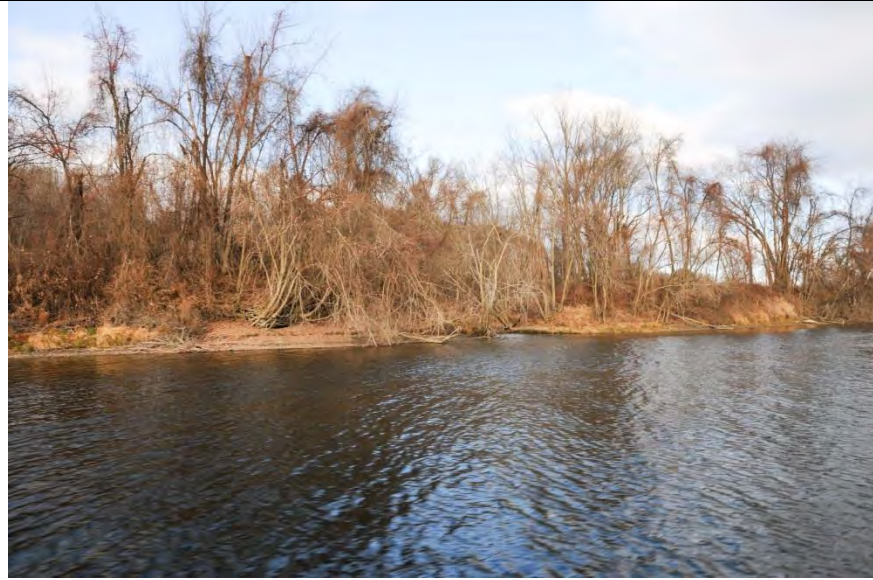
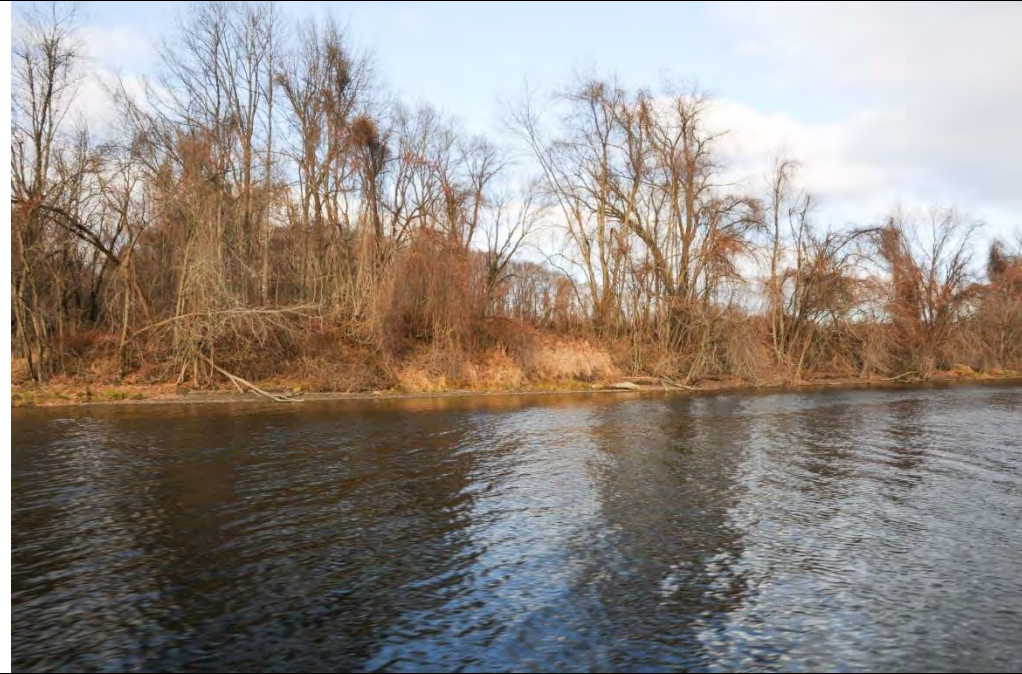
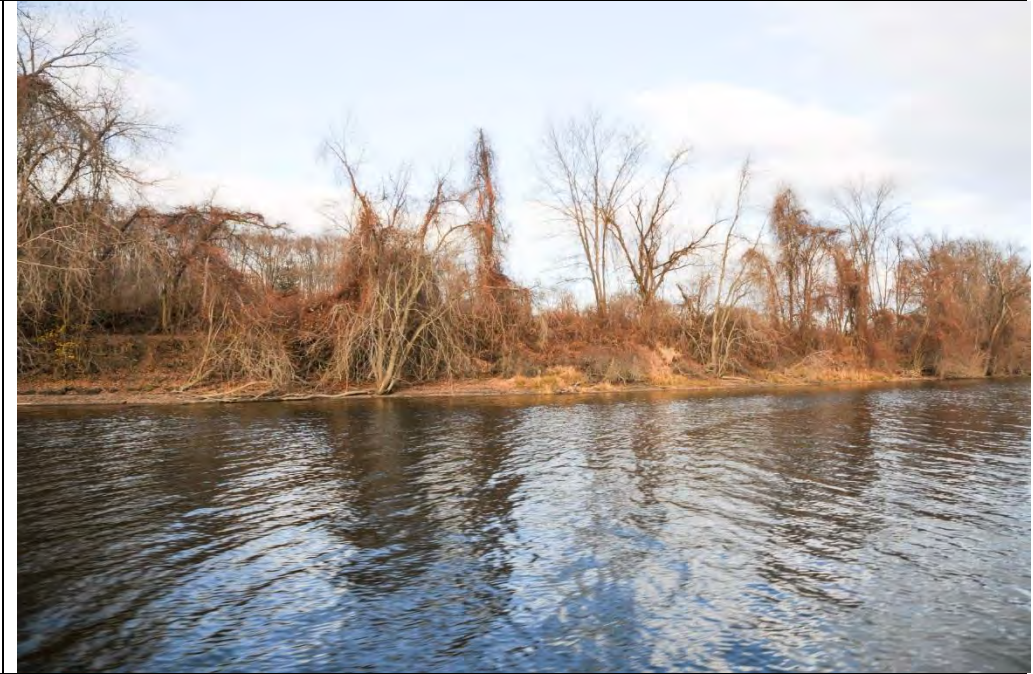
FirstLight Characterization of Segment 517 Photos DSC_1216-1218
 Length 190 m
 Bank Height - High >3.7 m
 Extent of Current Erosion: **None/Little** (Less than 70 square meters of erosion along the 700 sq. m segment)
 Stage of Erosion: **Stable** (Riverbank does not exhibit types or indicators of erosion)
 All Indicators of Potential Erosion: Creep/Leaning Trees

CRSEC Notes: Other Indicators of Erosion Observed: Notching (undercut); Exposed Roots.
 Other Types of Erosion Observed: Slides, Falls

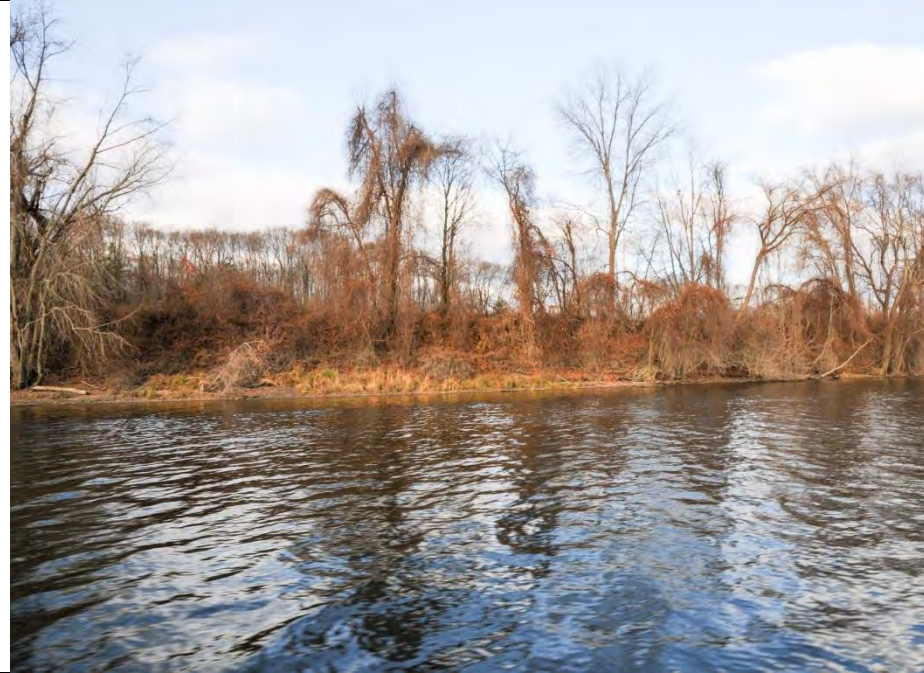
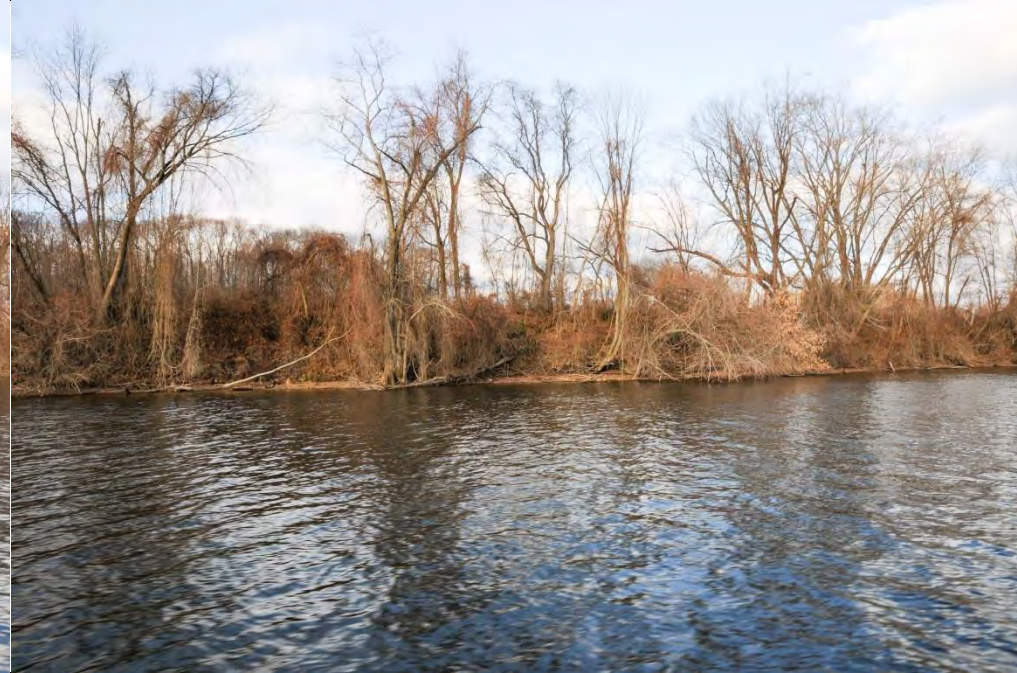
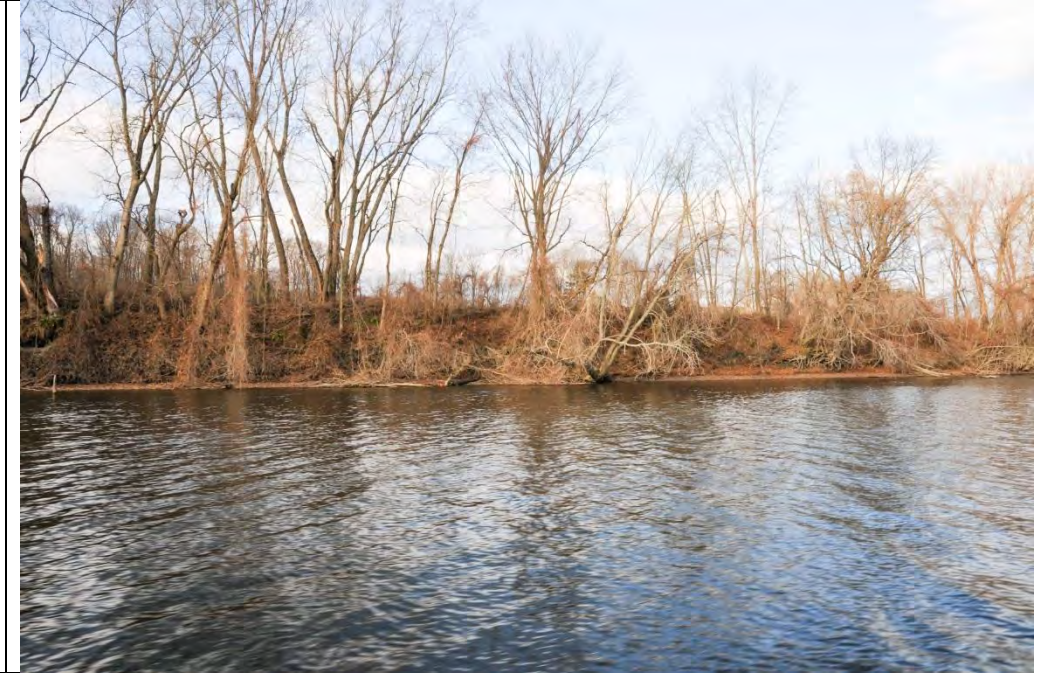
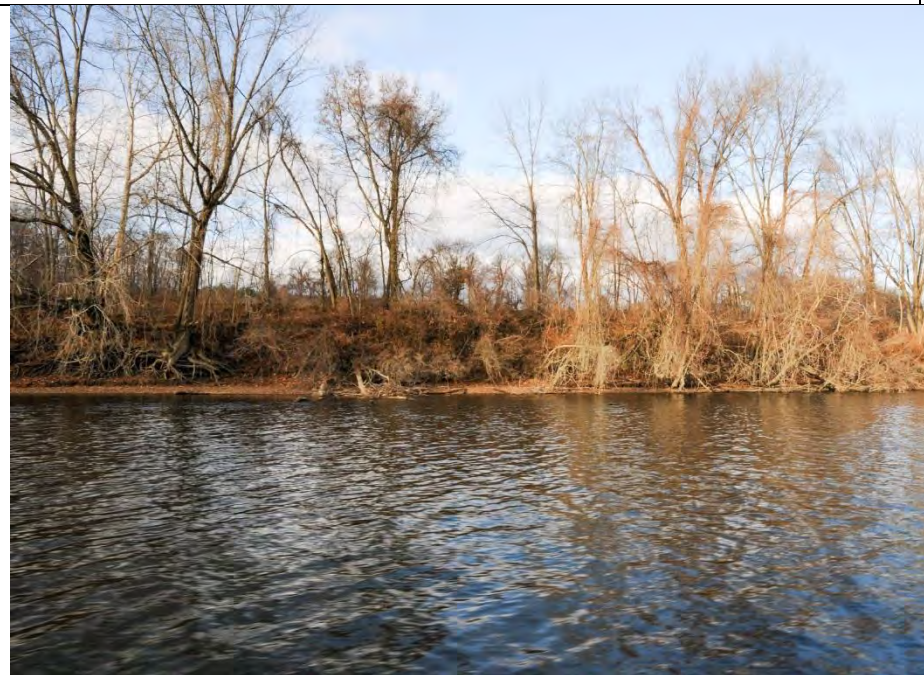
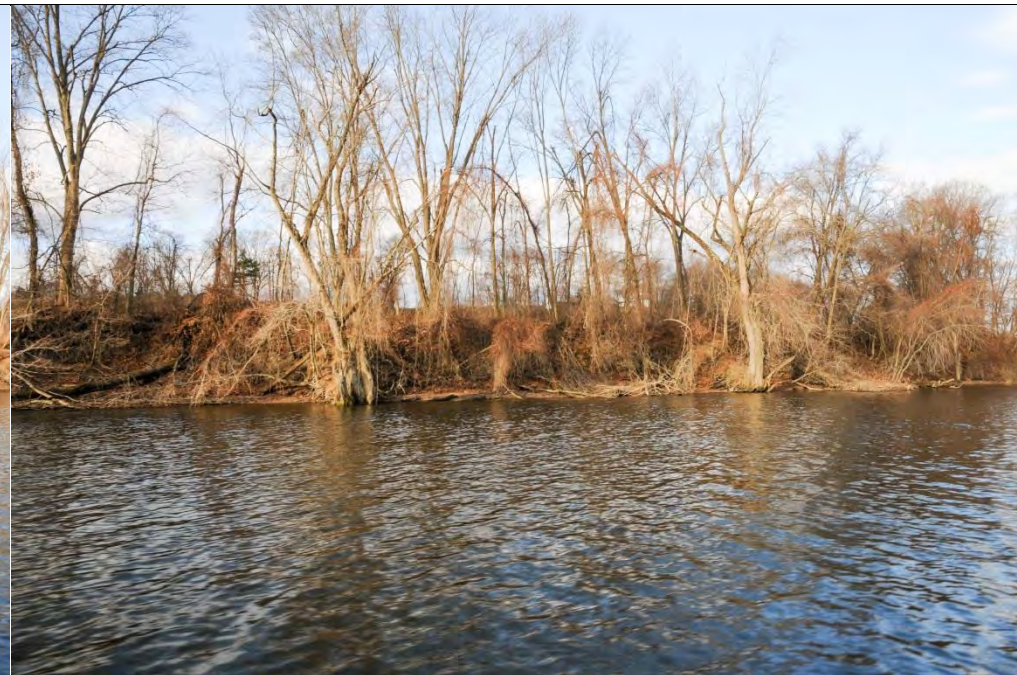
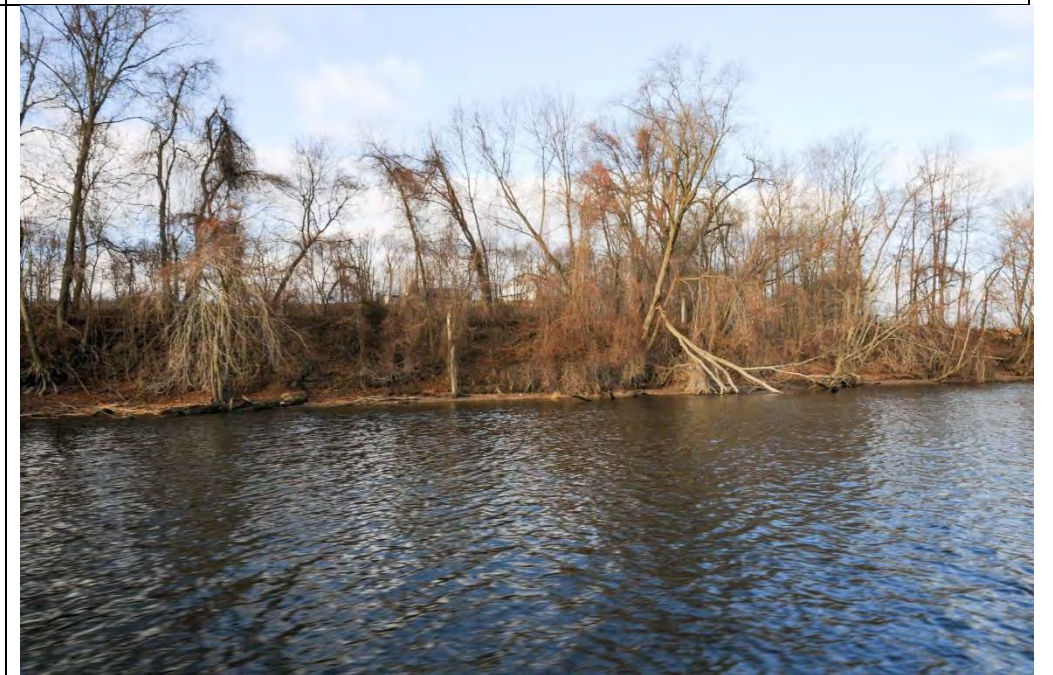
All Indicators of Potential Erosion: Creep/Leaning Trees, Exposed Roots.

Type of Erosion: Undercut

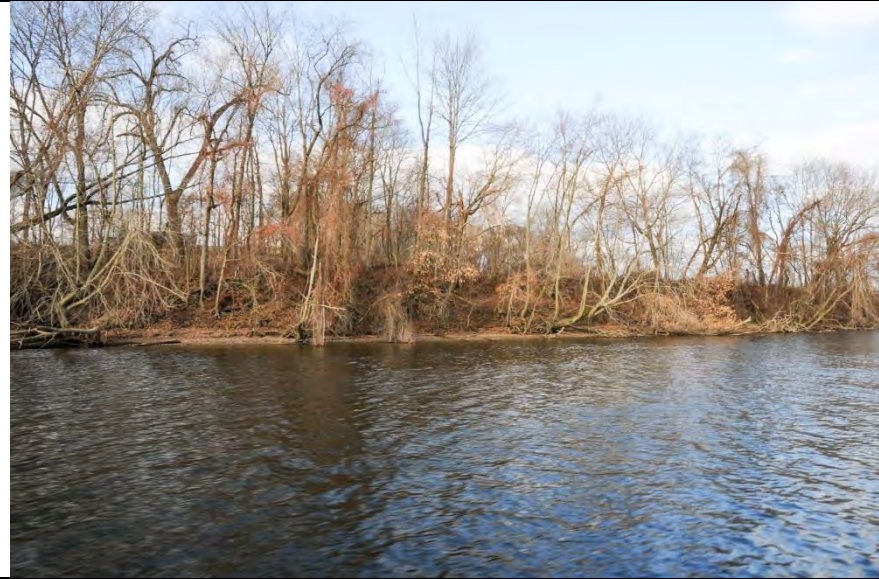
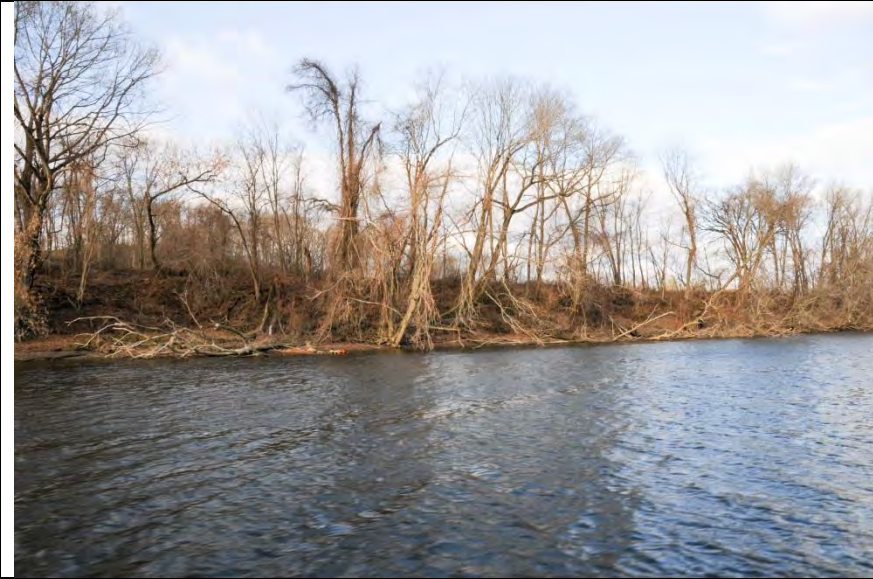
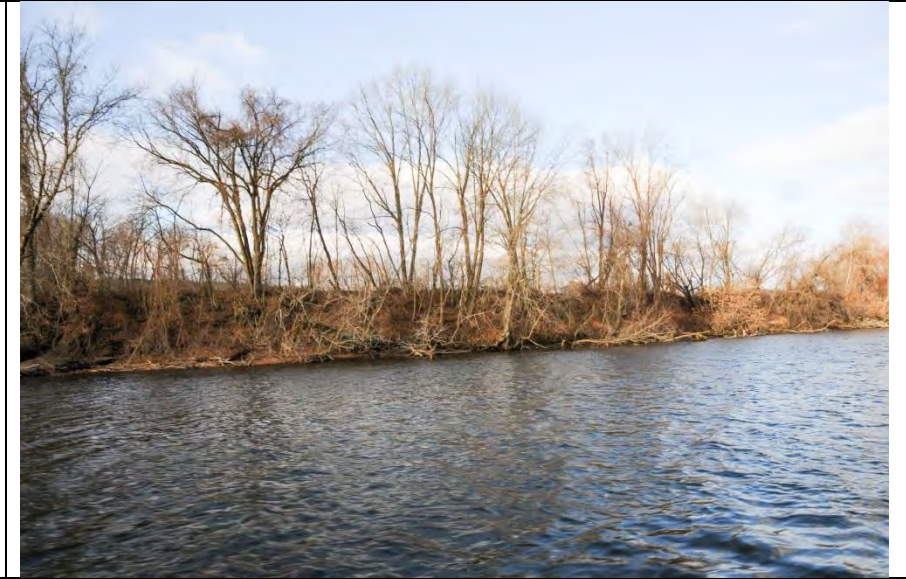
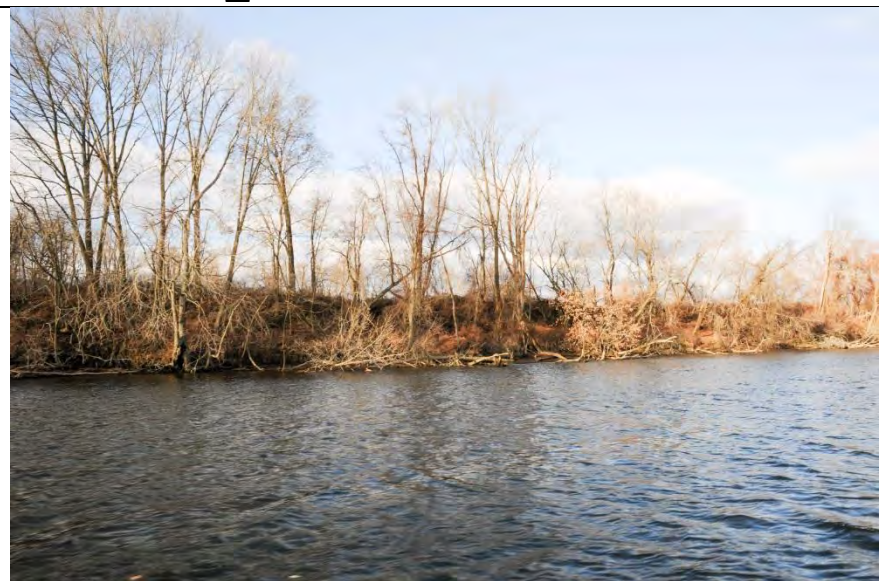
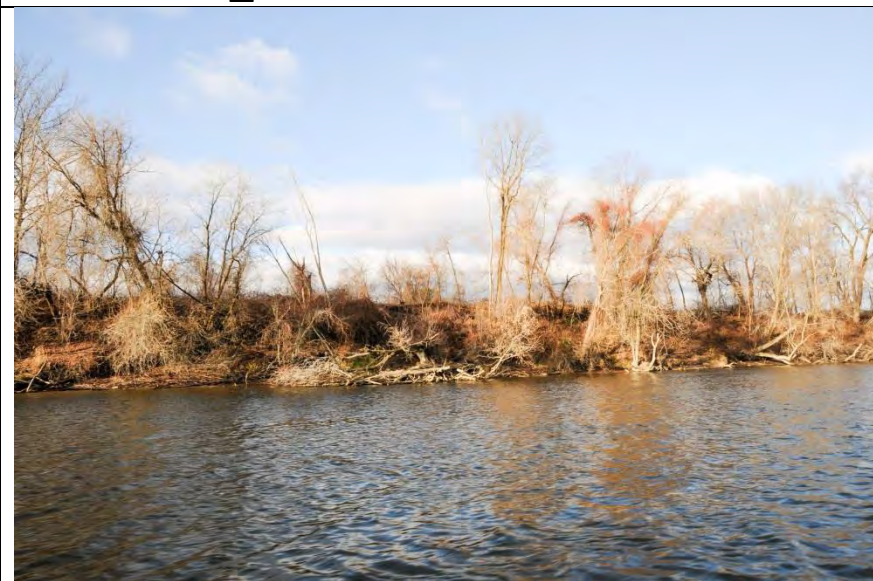
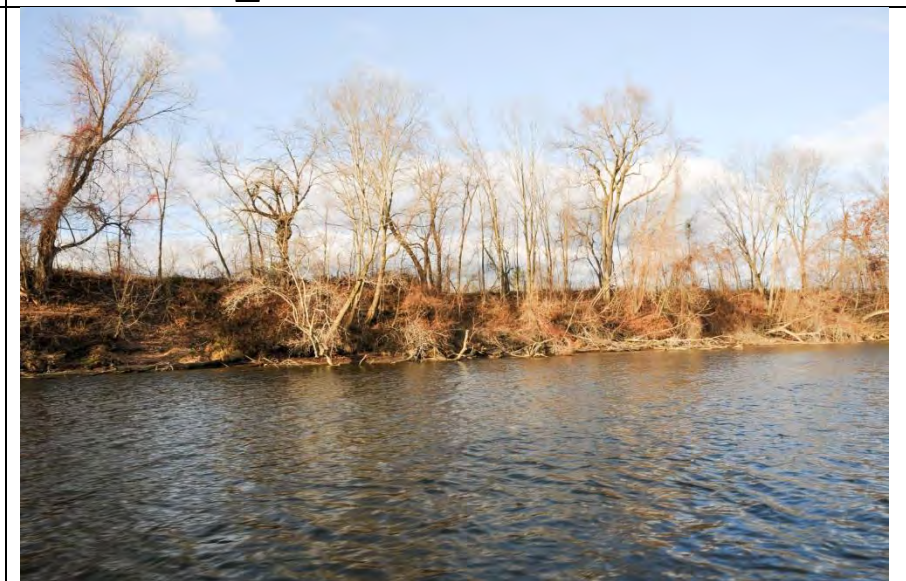
FirstLight Characterization of Segments 522-525. Photos DSC_1225-1233.

All Indicators of Potential Erosion: Overhanging Bank, Creep/Leaning Trees, Exposed Roots.

Type of Erosion: Undercut, Topples

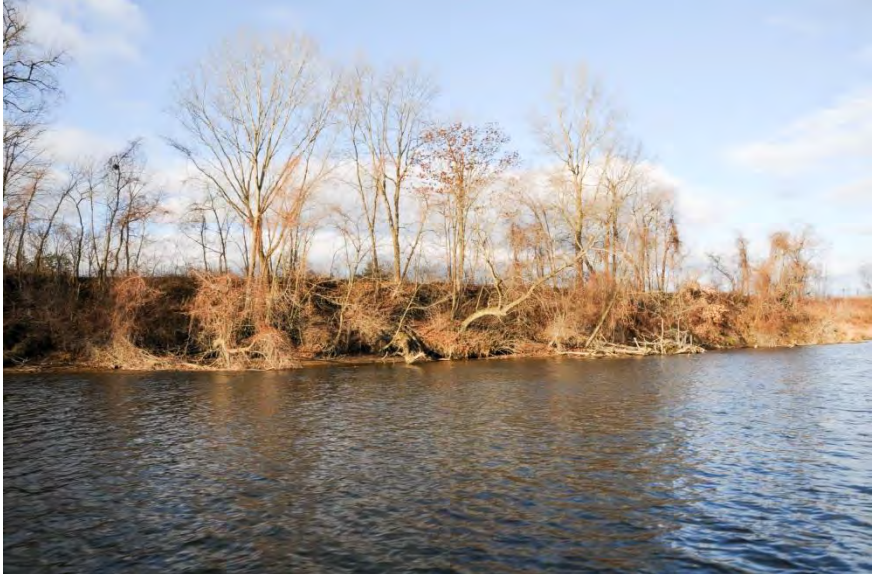
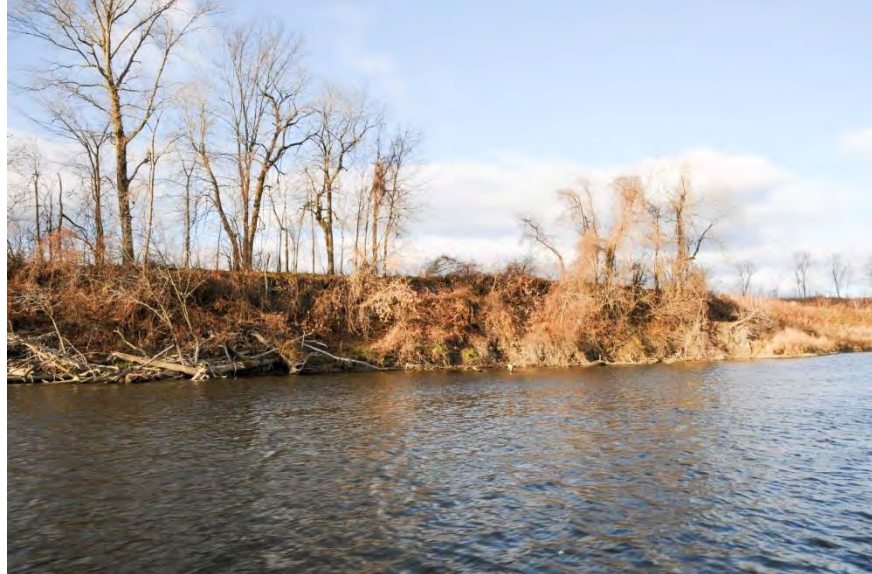
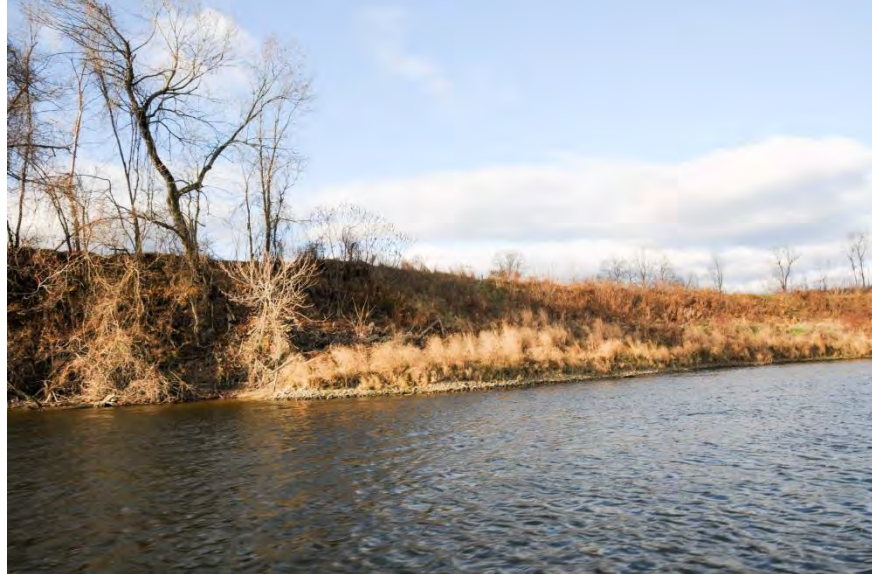
Photo DSC _1231	Photo DSC _1232	Photo DSC _1233
Photos DSC_1232 and 1233 taken downstream of Kendall Restoration Site		
<p>Land-Based Observation Point #21 done just downstream of Kendall Restoration Site. Representative Segment 3,000 feet (Station Number 765 to 795). Includes all of Segments 517-525 described above and shown in photos DSC_1216-1233.</p> <p>CRSEC Notes: Description of Land-Based #21 and profile of bank conditions are a more accurate representation of conditions. This information does not align with the 2013 FRR classification of these segments as None/Little and Stable.</p>

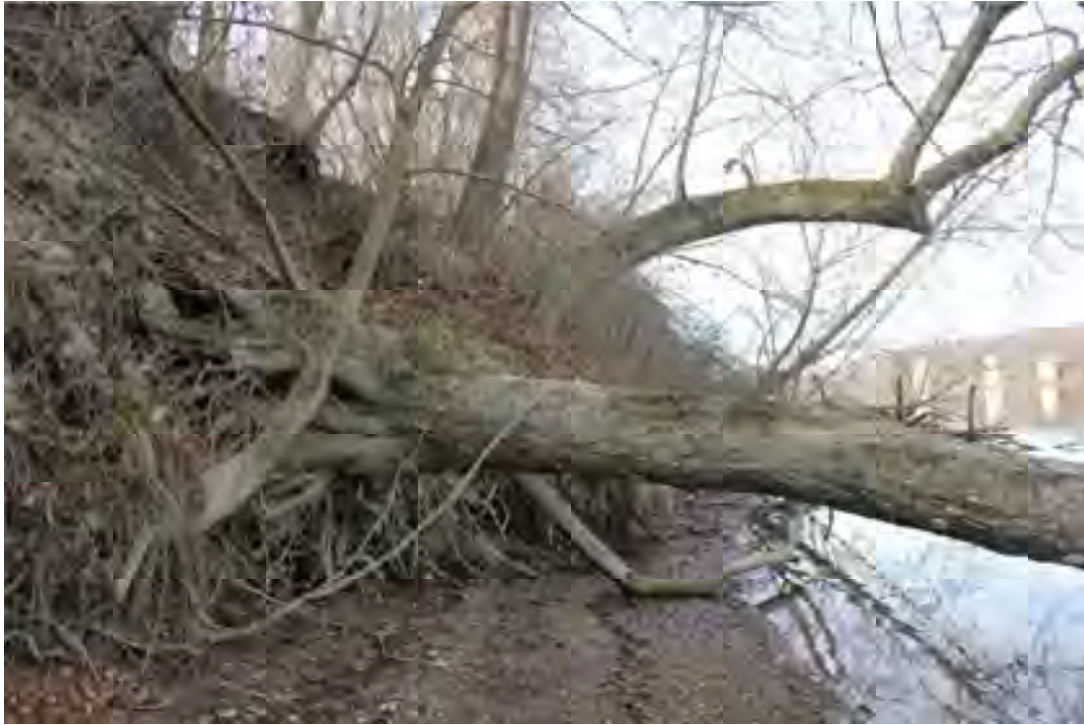
Photo No. 664

**2013 Connecticut River Full River Reconnaissance
Land-Based Observations Photographs Reference No. 664 - 668
Observation Point No. 21 - November 15, 2013**

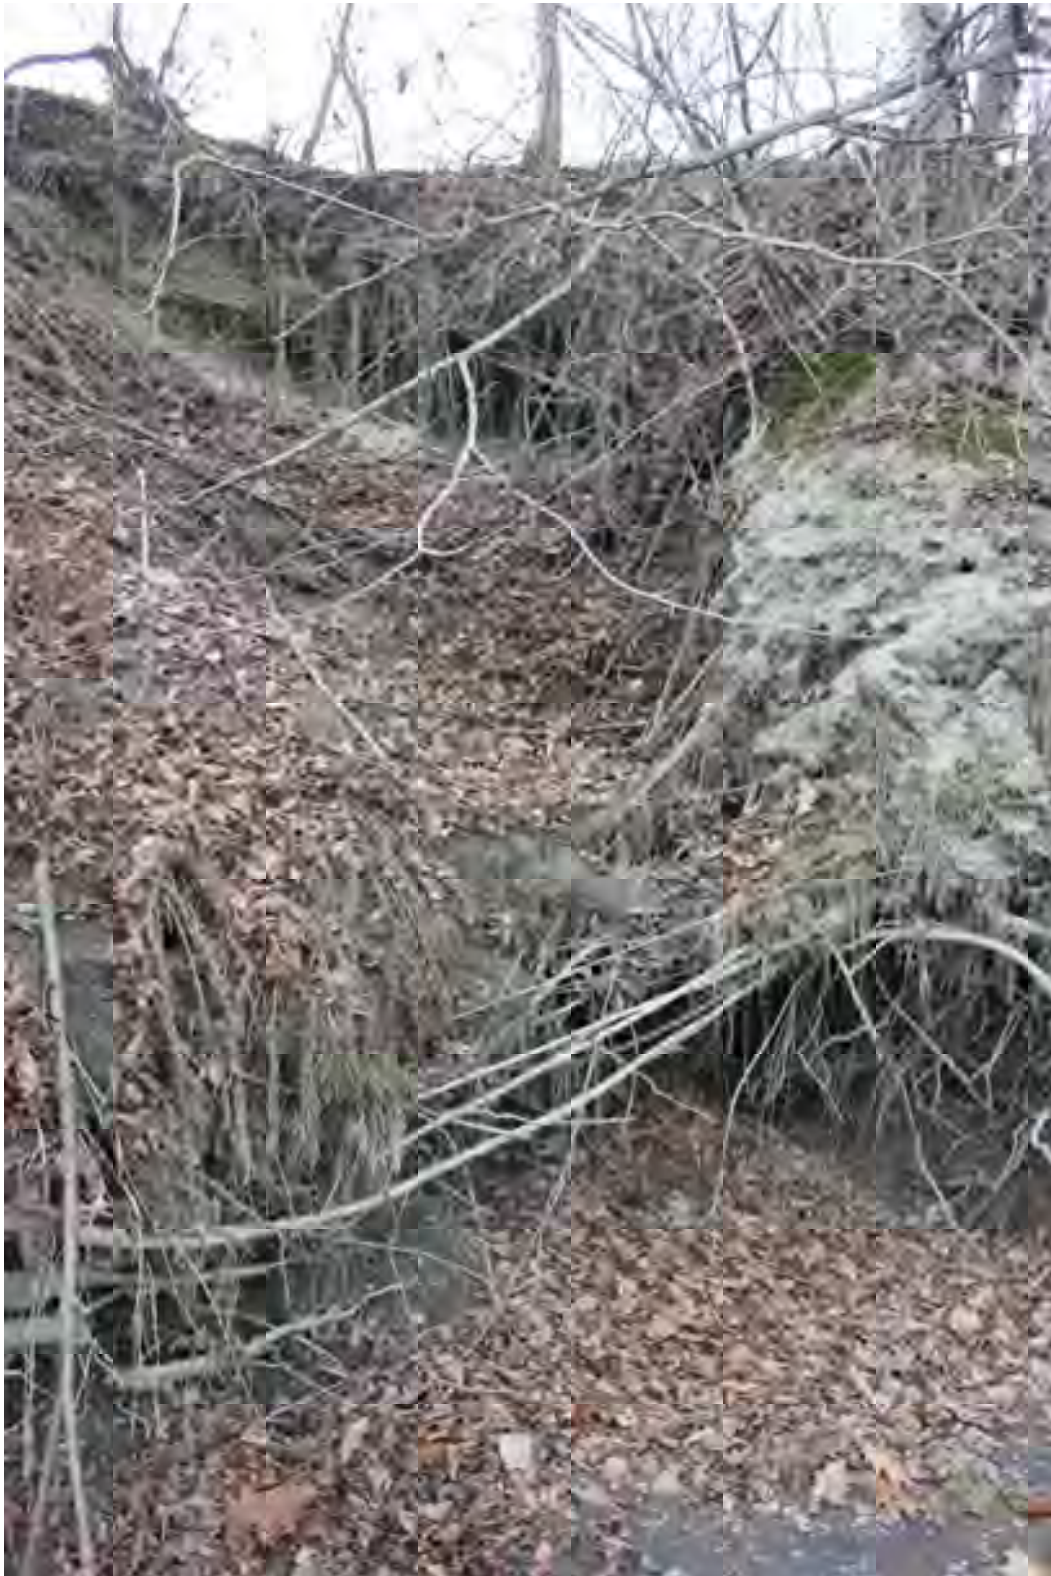
Photo No. 665

2013 Connecticut River Full River Reconnaissance
Land-Based Observations Photographs Reference No. 664 - 668
Observation Point No. 21 - November 15, 2013

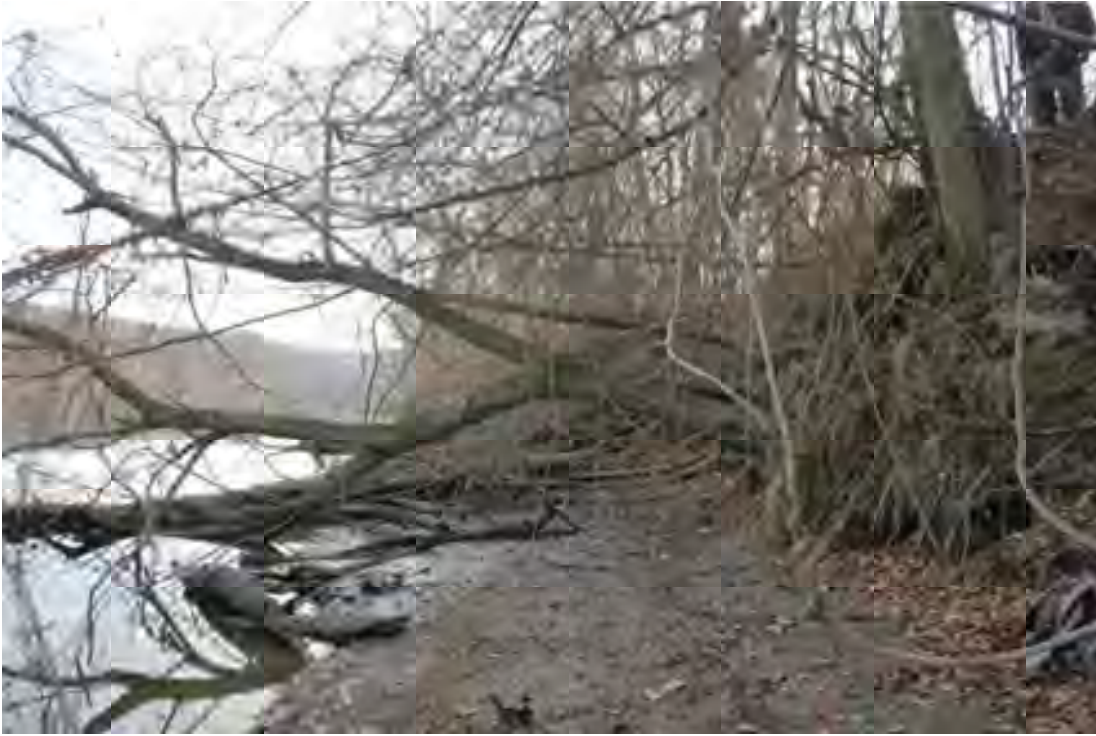
Photo No. 666

**2013 Connecticut River Full River Reconnaissance
Land-Based Observations Photographs Reference No. 664 - 668
Observation Point No. 21 - November 15, 2013**

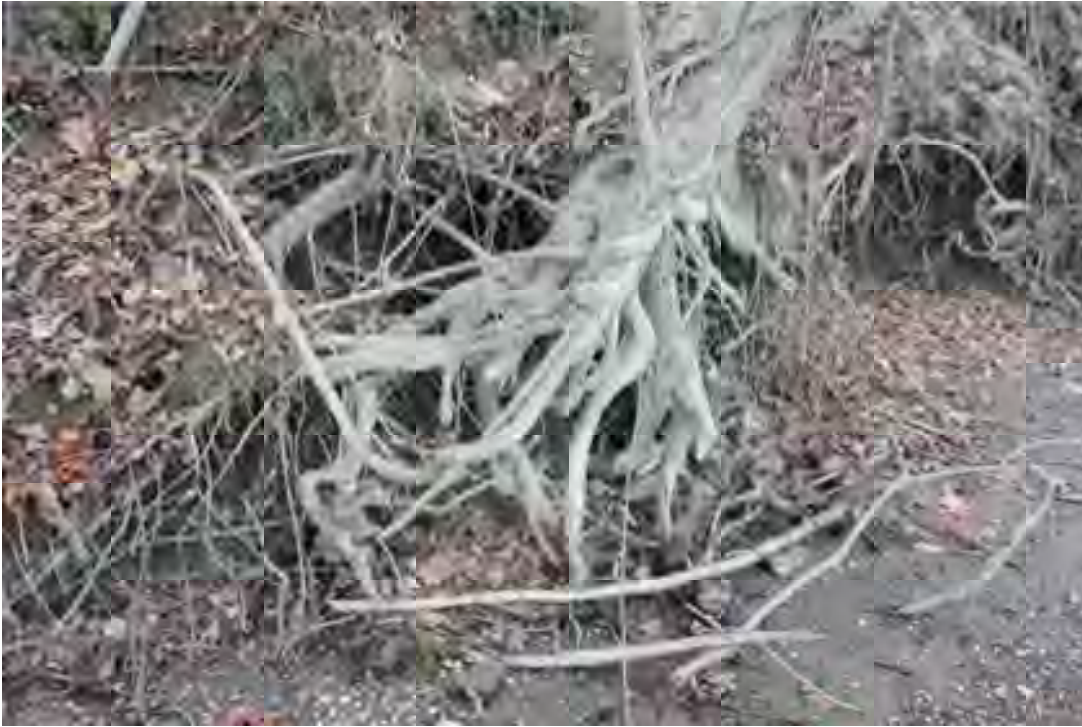
Photo No. 668

**2013 Connecticut River Full River Reconnaissance
Land-Based Observations Photographs Reference No. 664 - 668
Observation Point No. 21 - November 15, 2013**
