Relicensing Study 3.1.2

**Northfield Mountain / Turners Falls
Operations Impact on Existing Erosion and
Potential Bank Instability
Study Report**

Volume I – Executive Summary and Summary Report

**Northfield Mountain Pumped Storage Project (No. 2485) and
Turners Falls Hydroelectric Project (No. 1889)**

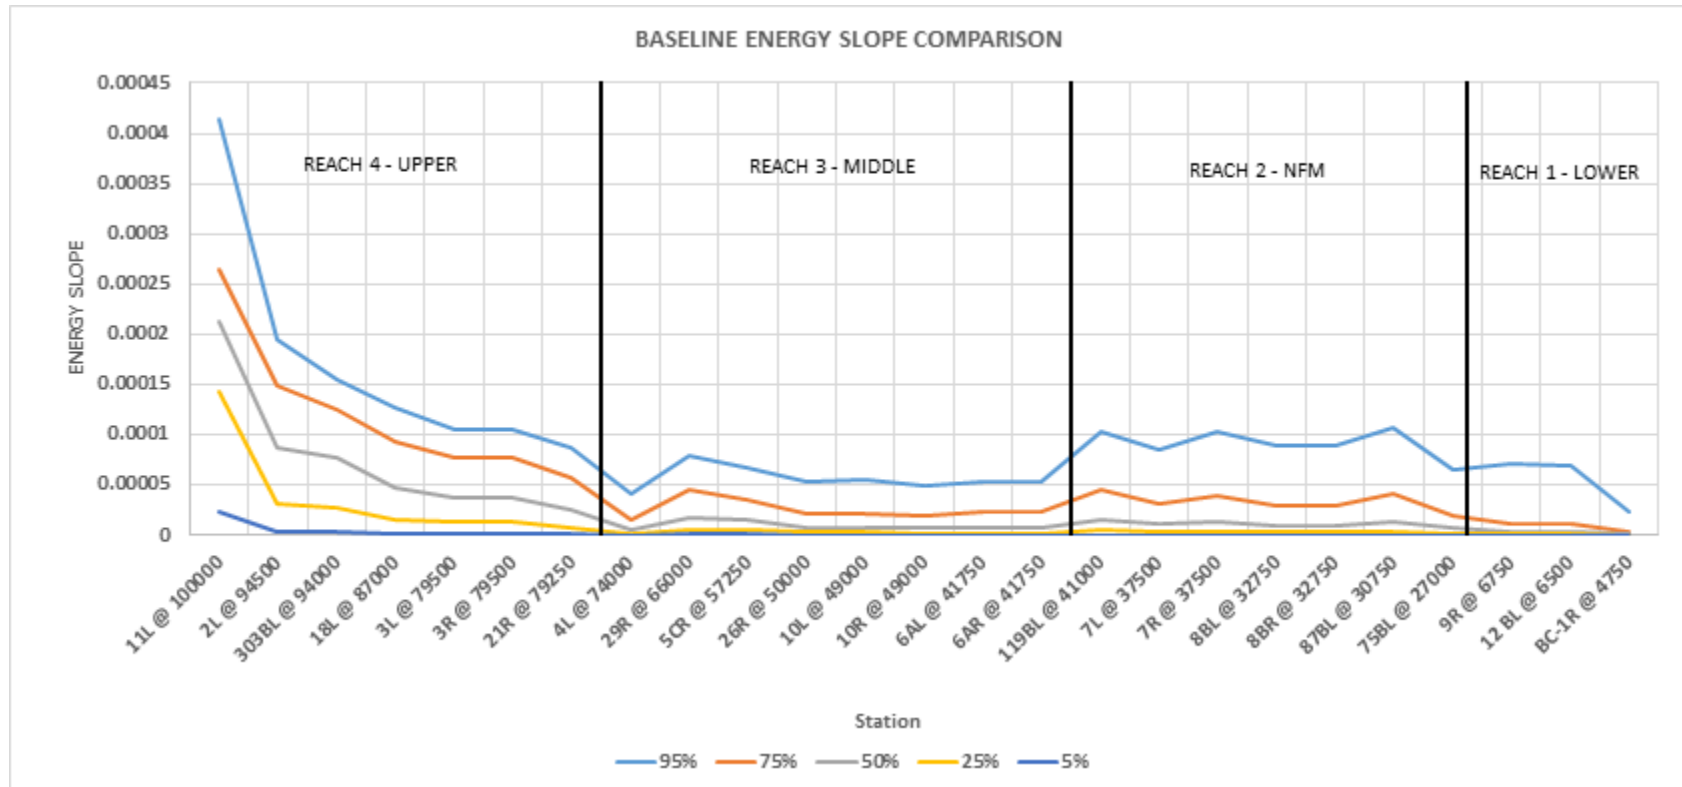
Figure 2: Distribution of Energy Grade Slope Lines throughout the Turners Falls Impoundment

EGL slope was used to identify the variability of hydraulic forces throughout the TFI and to determine the geographic extent where a hydropower project could potentially have an impact on riverbank erosion. Given the clear delineation and characteristics of each hydraulic reach it is unlikely that a hydropower project can have an impact on erosion processes outside of the hydraulic reach in which it is located. While a hydropower project can impact water level fluctuations and flow outside of its hydraulic reach, the magnitude of those impacts are so minor that they do not affect the EGL slope outside of their given reach. For example, even though Northfield Mountain operations can impact the water surface elevation in reaches 3 and 4 at flows which exceed the erosion flow threshold at the detailed study sites, the impacts are so negligible that corresponding changes to the EGL slope do not occur. Thus, given the hydraulic characteristics of each reach it is unlikely that Northfield Mountain operations can impact erosion processes outside of reach 2.

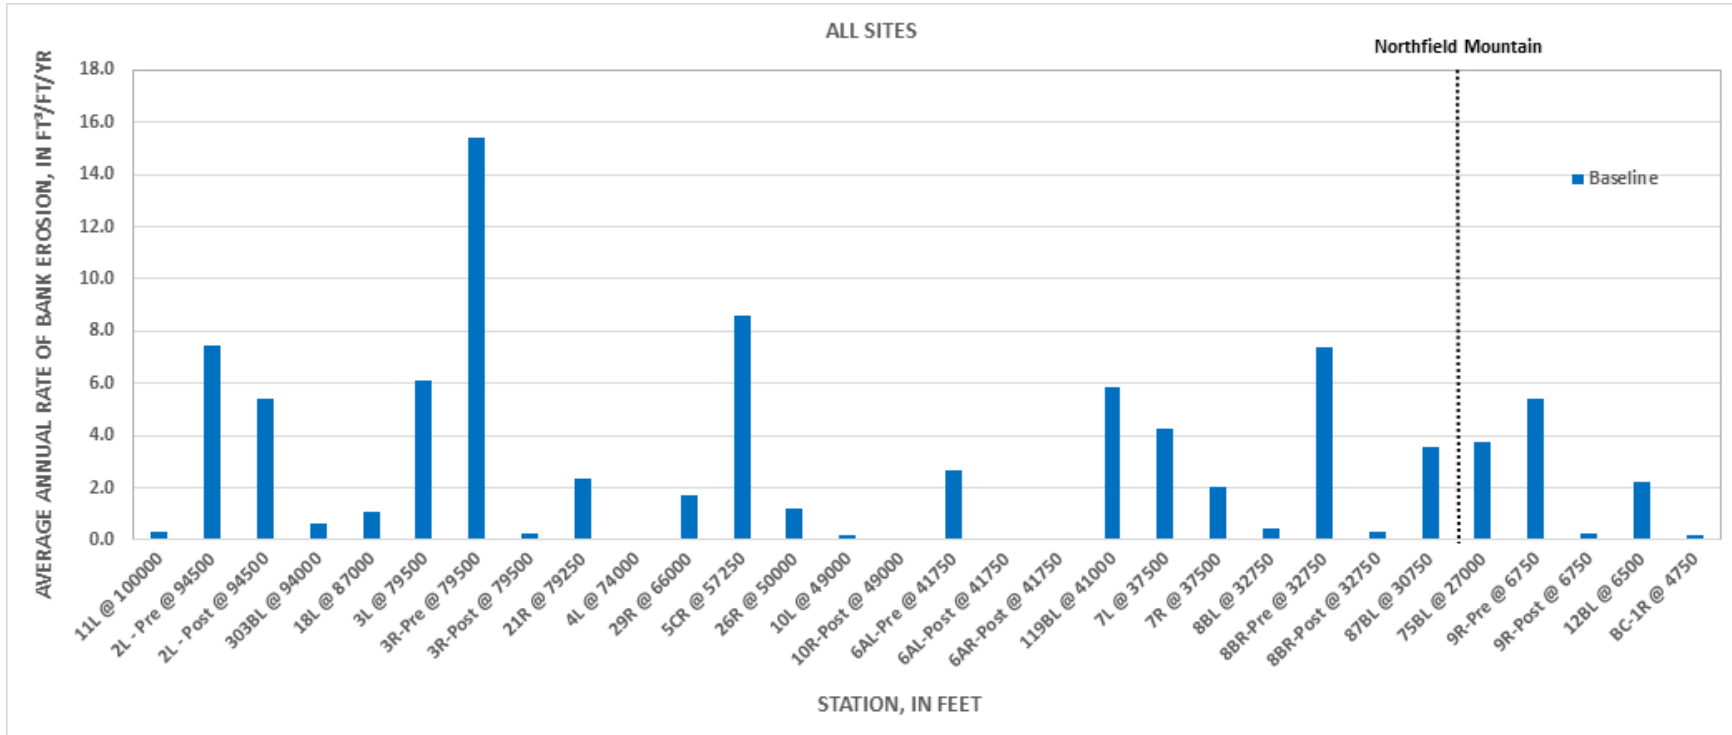
Figure 4: Spatial Distribution of Bank Erosion Rates for all Sites under the Baseline Condition (wave on)

For the Baseline Condition (wave on), simulated rates of bank erosion along the reach range from very close to $0 \text{ ft}^3/\text{ft}/ \text{yr.}$ to $15.4 \text{ ft}^3/\text{ft}/ \text{yr.}$ at site 3R under pre-restoration conditions. Other sites with bank-erosion rates higher than the 75th percentile for the non-restored sites include 5CR ($8.6 \text{ ft}^3/\text{ft}/ \text{yr.}$), 8BR-pre-restoration ($7.4 \text{ ft}^3/\text{ft}/ \text{yr.}$), 3L ($6.1 \text{ ft}^3/\text{ft}/ \text{yr.}$), 119 BL ($5.9 \text{ ft}^3/\text{ft}/\text{yr.}$) and 9R pre-restoration ($5.4 \text{ ft}^3/\text{ft}/ \text{yr.}$). Of these six highest rates, three of the sites have been restored. Restoration measures have been very effective in reducing bank-erosion rates by about an order of magnitude throughout the TFI, with an average reduction of 93%. Median bank-erosion rates for the non-restored and restored sites are 1.9 and $0.21 \text{ ft}^3/\text{ft}/ \text{yr.}$, respectively. [Figure 4](#) depicts the spatial distribution of erosion rates for all sites under the Baseline Condition.
