6 SUMMARY EVALUATION OF THE CAUSES OF EROSION

FIRSTLIGHT HYDRO GENERATING COMPANY
 Northfield Mountain Pumped Storage Project No. 2485
 Turners Falls Hydroelectric Project No. 1889

STUDY 3.1.2

Northfield Mountain Pumped Storage Project (No. 2485) and Turners Falls Hydroelectric Project (No. 1889)
 STUDY 3.1.2 NORTHFIELD MOUNTAIN / TURNERS FALLS OPERATIONS IMPACTS ON EXISTING
 EROSION AND POTENTIAL BANK INSTABILITY

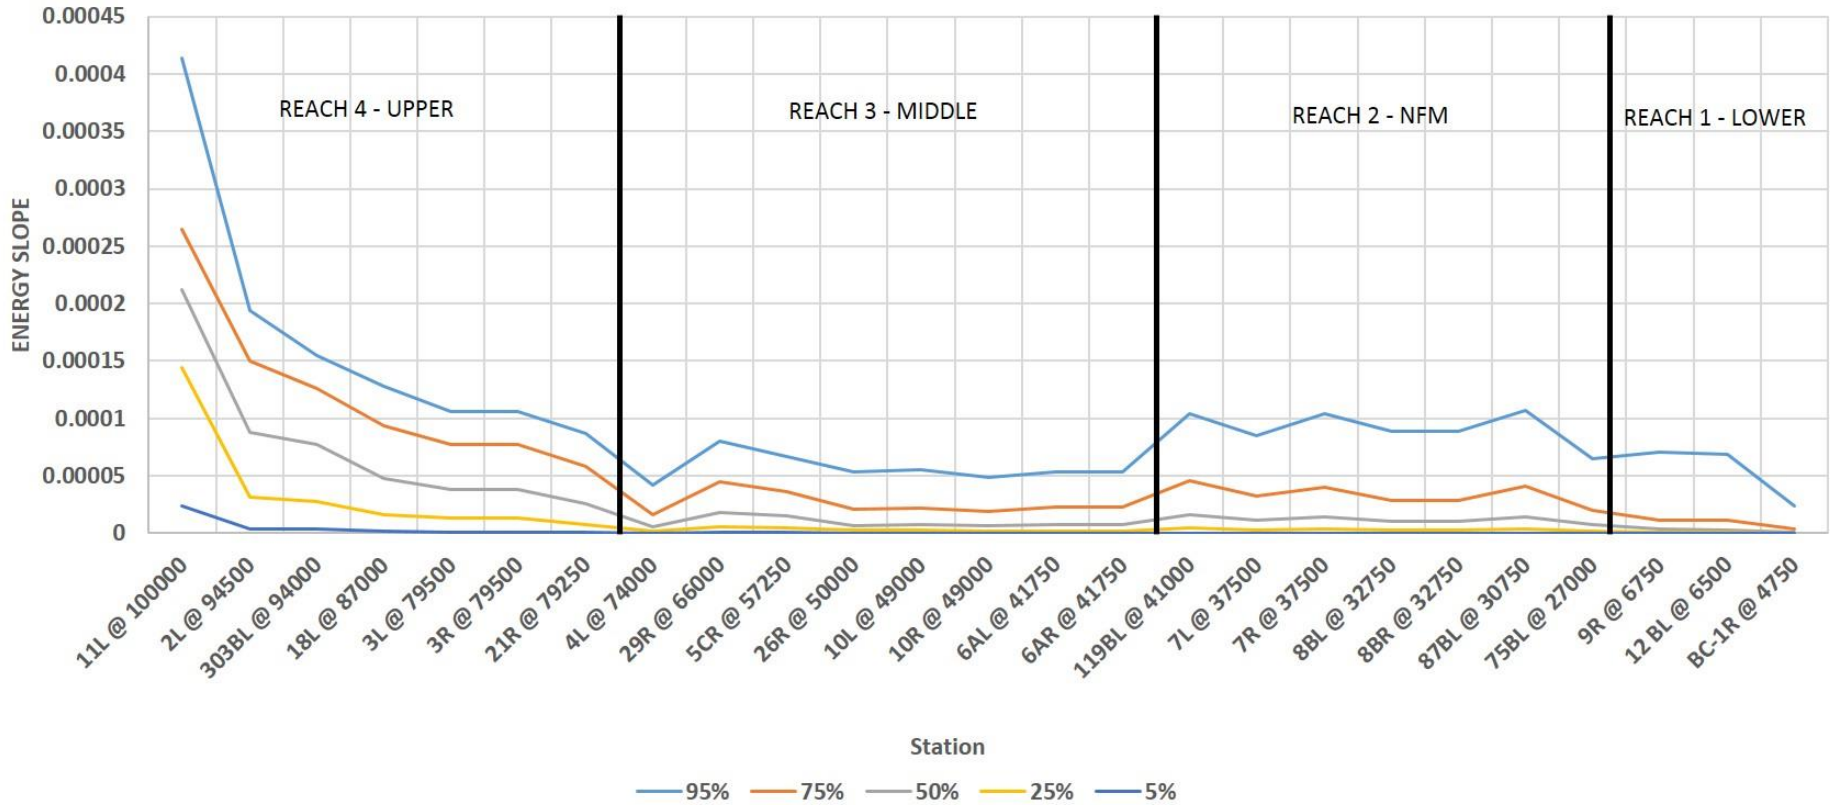
Figure 6.1.2.1-1: Energy slope trends through the Turners Falls Impoundment

The hydraulic reaches were first established by examining the energy grade line slope from the Baseline Condition HEC-RAS run at the 25 detailed study sites. From this initial analysis four hydraulic reaches were clearly identified ([Section 5.4.1](#)). In order to determine if the hydraulic reaches identified based on the results of the Baseline Condition modeling run were representative and accurately portrayed the geographic extent of a given hydropower projects impact, the results of the HEC-RAS scenarios were analyzed over a range of flow and operating conditions. The range of flows at each detailed study site were segmented into the following three ranges:

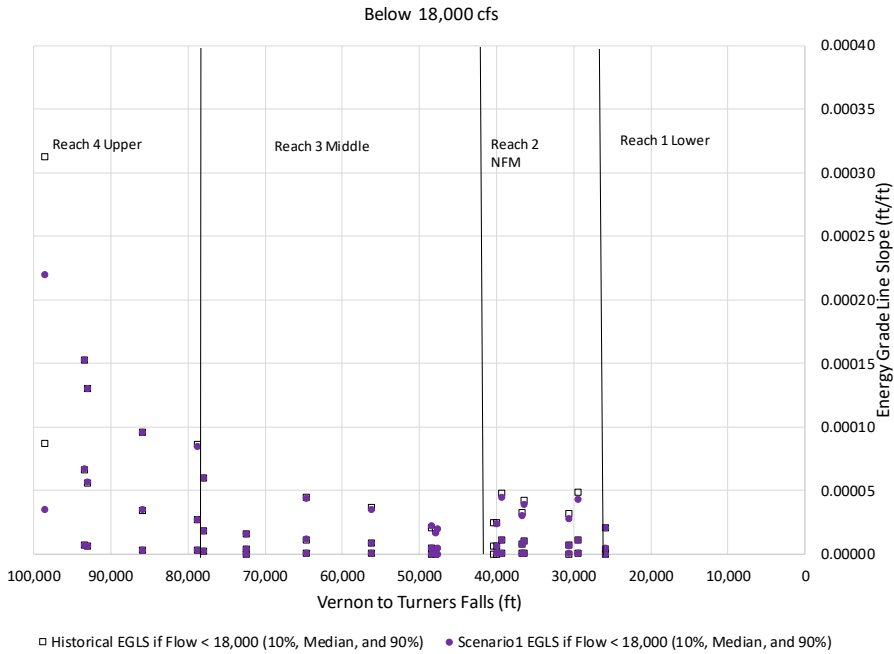
Figure 6.1.2.2-1: Energy slope trends through the Turners Falls Impoundment at flows less than 18,000 cfs

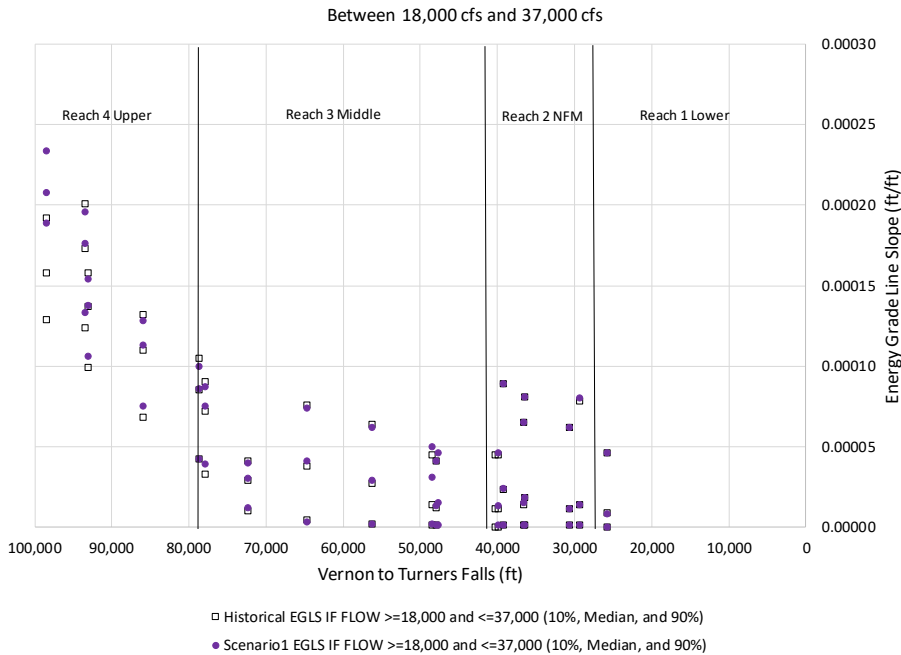
Figure 6.1.2.2-2: Energy slope trends through the Turners Falls Impoundment at flows between 18,000 and 37,000 cfs

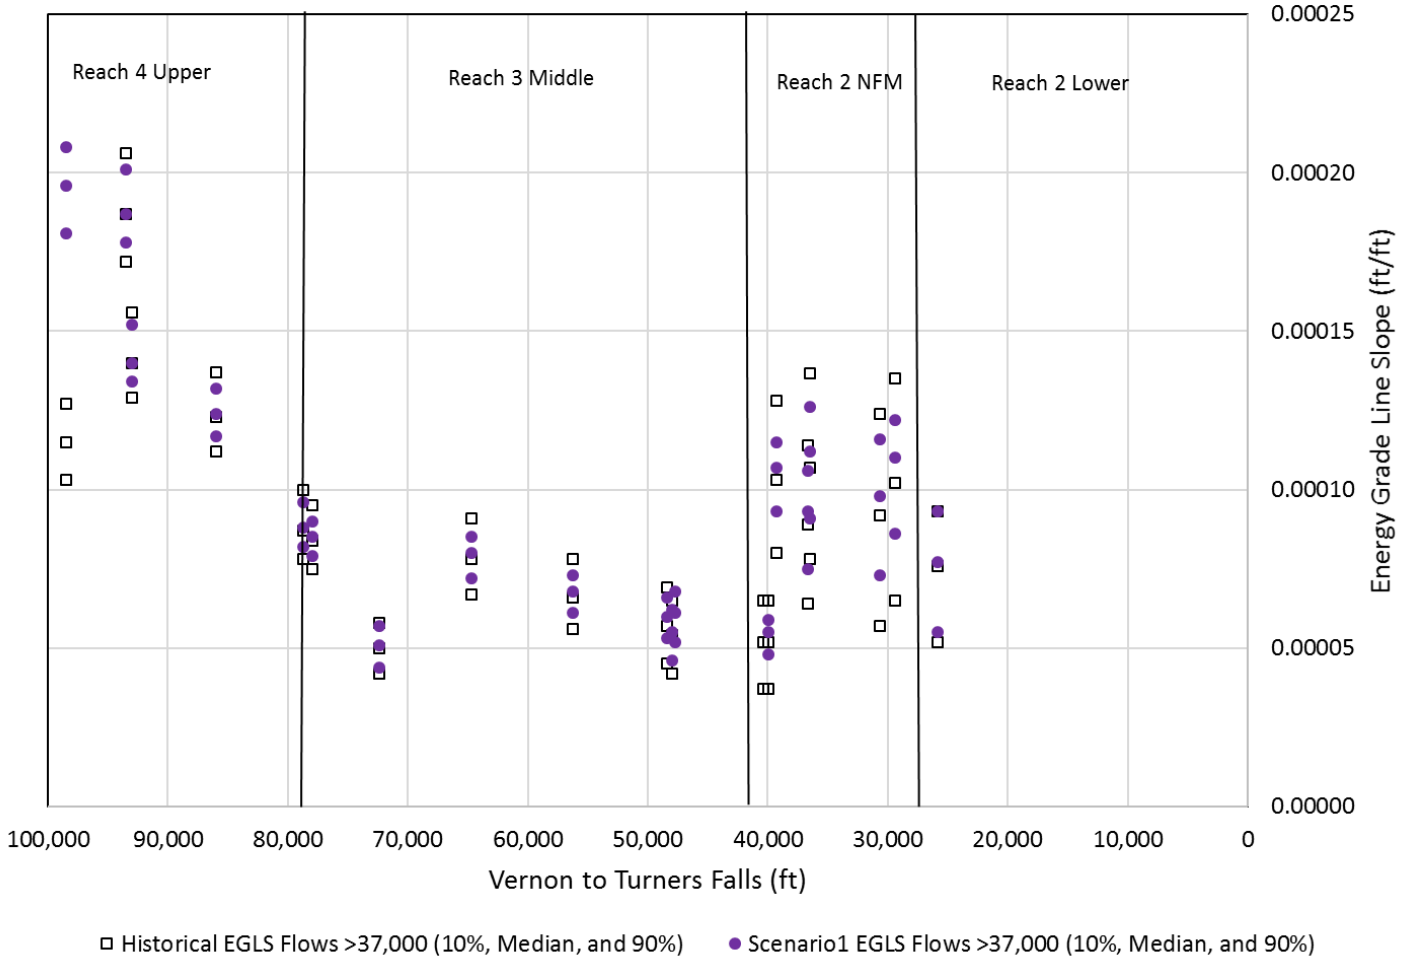
Figure 6.1.2.2-3: Energy slope trends through the Turners Falls Impoundment at flows over 37,000 cfs

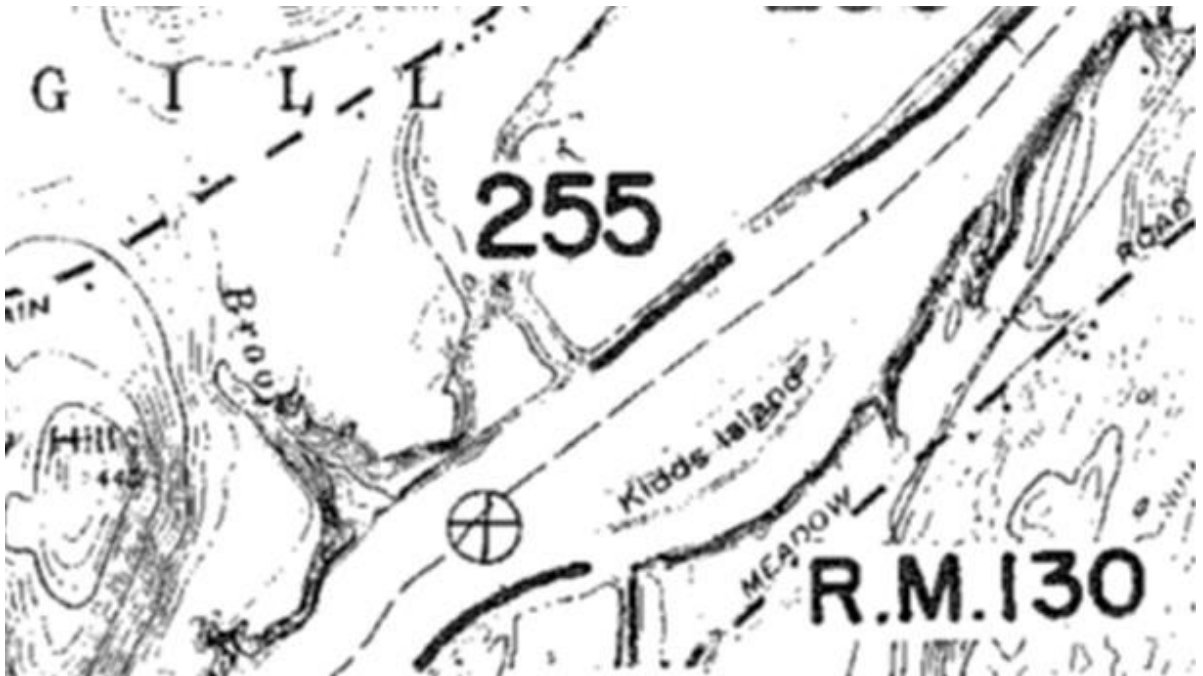
Figure 6.1.4.1-2 TFI USACE Index Site 255 (USACE, 1979)

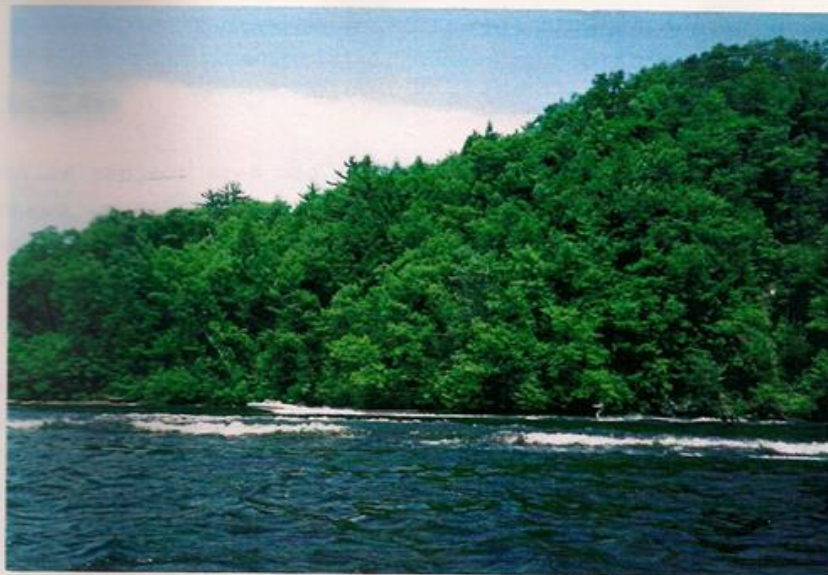
Power boating, including water skiing, is a growing recreational activity along the river - July 4, 1990.

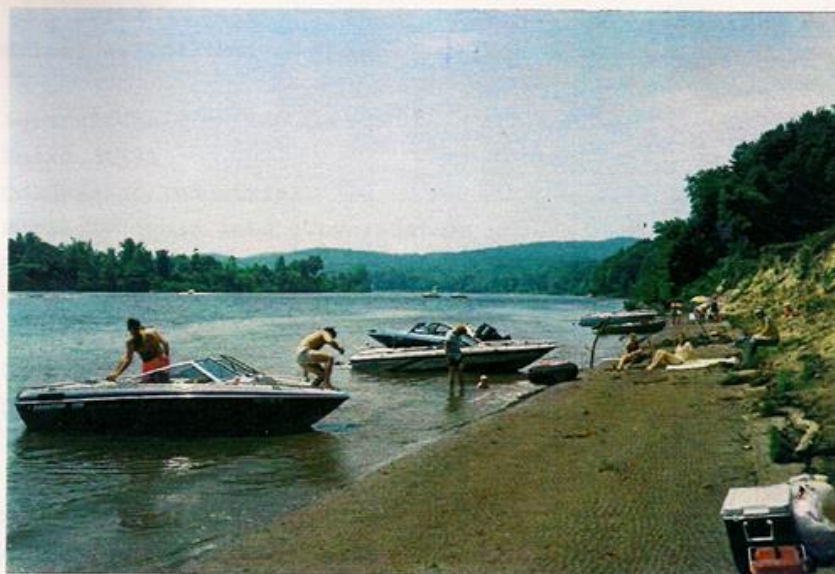
The long, exposed beach west of Kidds Island is a popular summer recreational spot for boaters - July 4, 1990.
