Analysis of Erosion in the Vicinity of the Route 10 Bridge Spanning the Connecticut River

# Analysis of Erosion in the Vicinity of the Route 10 Bridge Spanning the Connecticut River

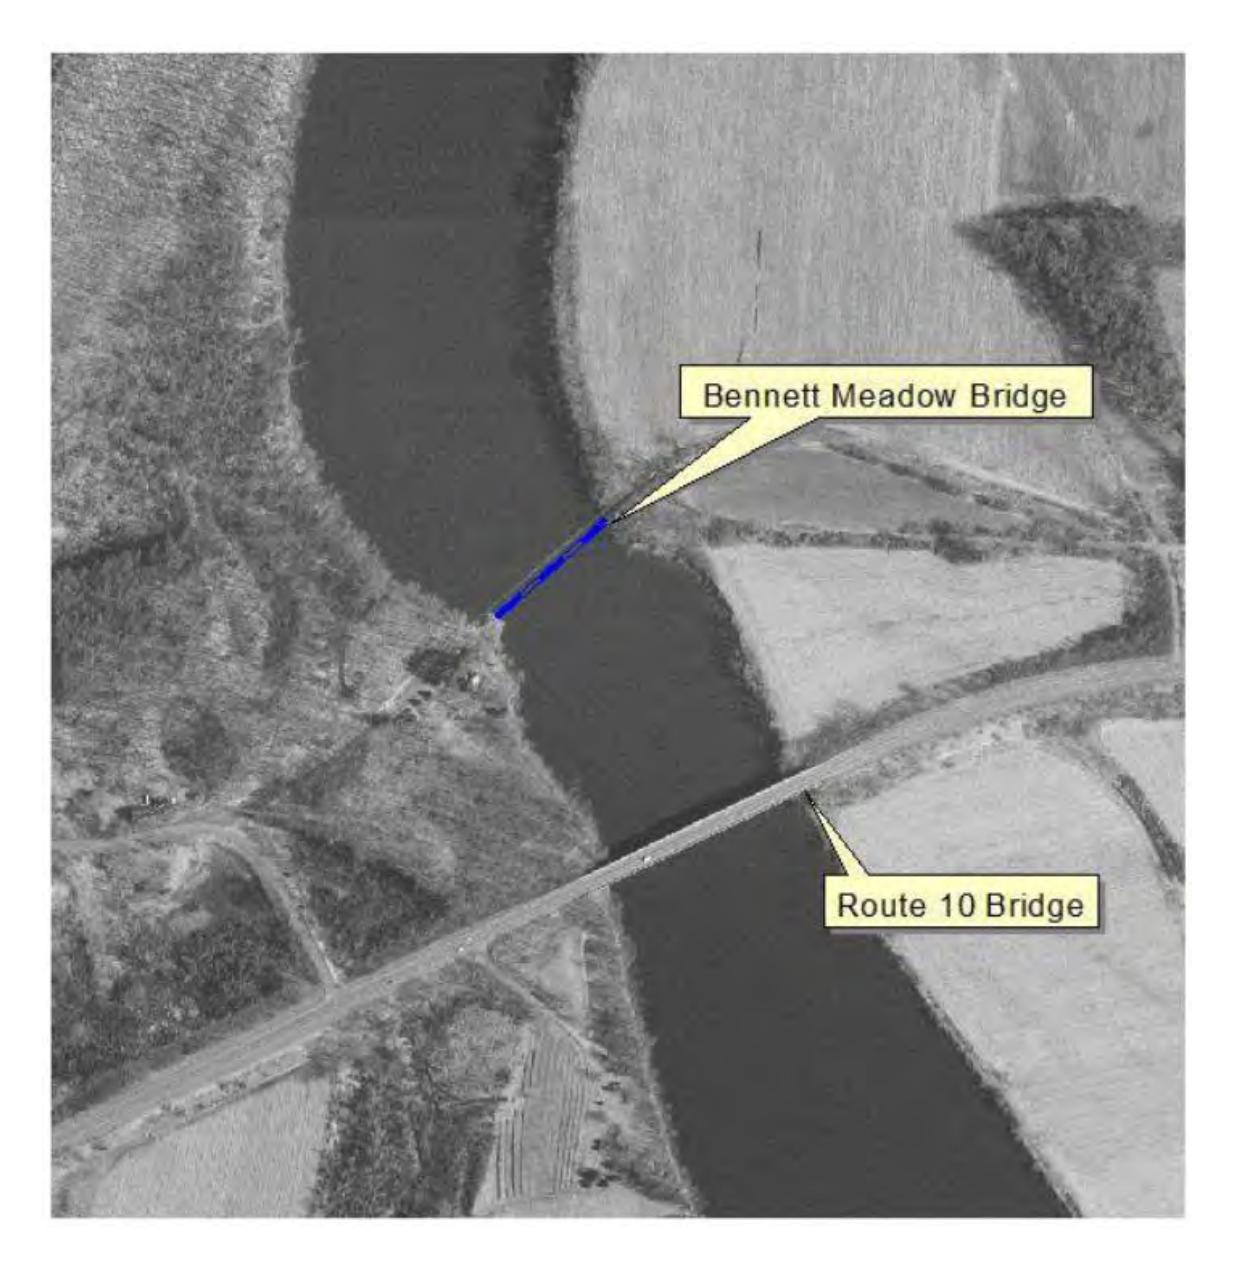
Figure 3. Connecticut River near Route 10 Bridge

Erosion has been occurring in the vicinity of the Route 10 Bridge for decades. To address the question of whether hydroelectric operations are responsible for this erosion, it is necessary to understand the actual causes of erosion at this location and the hydraulic forces acting on the riverbanks. This requires the collection and use of various types of data, including: channel geometry, hydraulics (depths, velocities, flow patterns), and bank material. Based on these data, hydraulic and erosion analyses coupled with geomorphic analysis provide insight into the causes of erosion at this location.

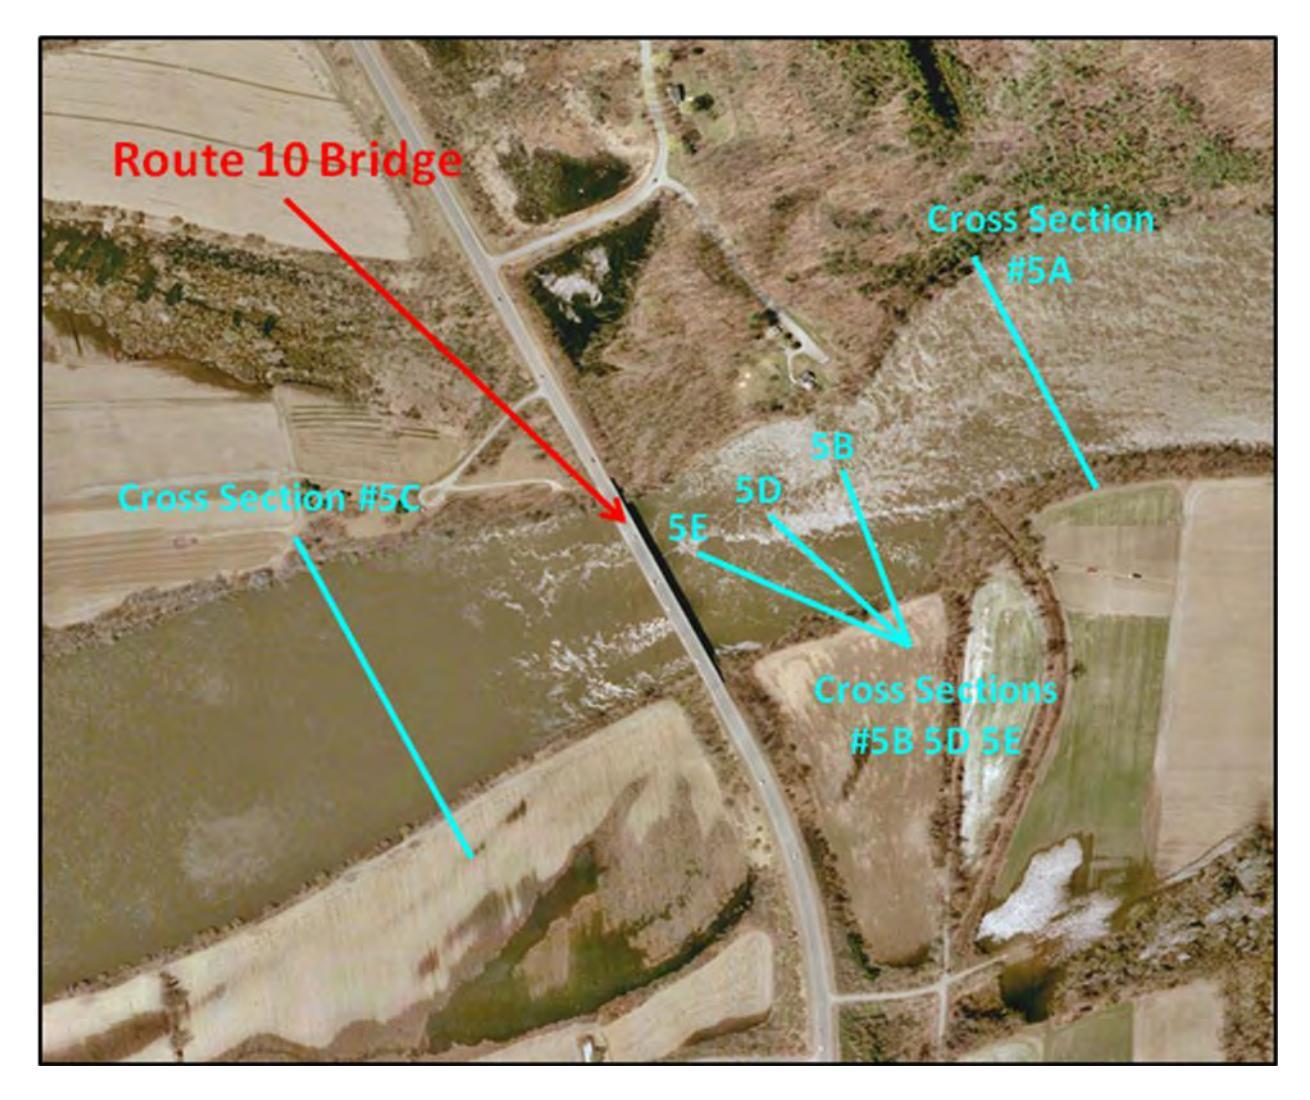
Figure 6. Cross Section Locations near Route 10 Bridge (after North by Northeast, 2004)

A comparison of cross-section graphs through the 1990s (1990-1997) shows changes in cross-sections at the surveyed locations (see Appendix A "Long Term Riverbank Plan for the Turners Falls Pool of the Connecticut River," Simons & Associates, 1998). At 5A, the data show very little change in the cross-section below the typical impoundment level. Near to above the typical water level, there appeared to be some fluctuation in bank line that appears to vary with some aggradation and some degradation. At cross-section 5B on the east bank, there appears to be some bank erosion of the near vertical upper bank of something on the order of about 10 feet horizontally. 5C shows relatively

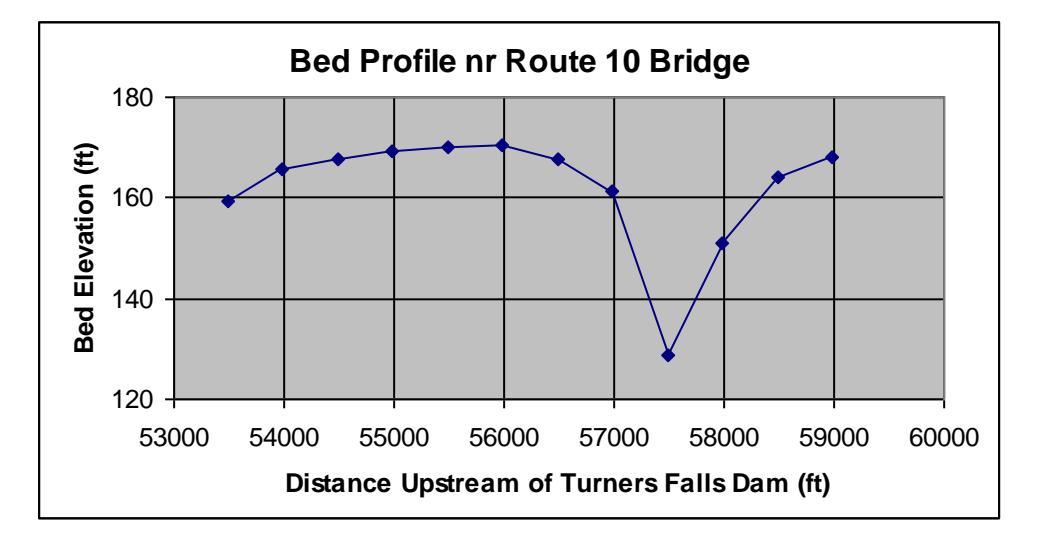
Figure 8. Riverbed Profile near Route 10 Bridge (from cross-section data in Woodlot, 2007)

- At the same time, the channel bed drops rapidly; reaching a maximum depth of about 54 feet about 500 feet upstream of the Route 10 Bridge (see Figure 8)
- Just as rapidly as the river deepens, it then shallows to a depth of about 16 feet as the river bends slightly back to the right.
- A large eddy forms along the east bank of the river between the old Bennett Meadow bridge abutment and the Route 10 Bridge abutment.
- The Route 10 Bridge Piers cause some obstruction to the flow and cause additional turbulence.

While there are several deep areas along the Turners Falls Pool, it should be noted that the deep area just upstream of the Route 10 Bridge is the deepest area over a distance from the confluence of Millers River into the Connecticut River to the Vernon Dam, a distance of approximately 16 miles.

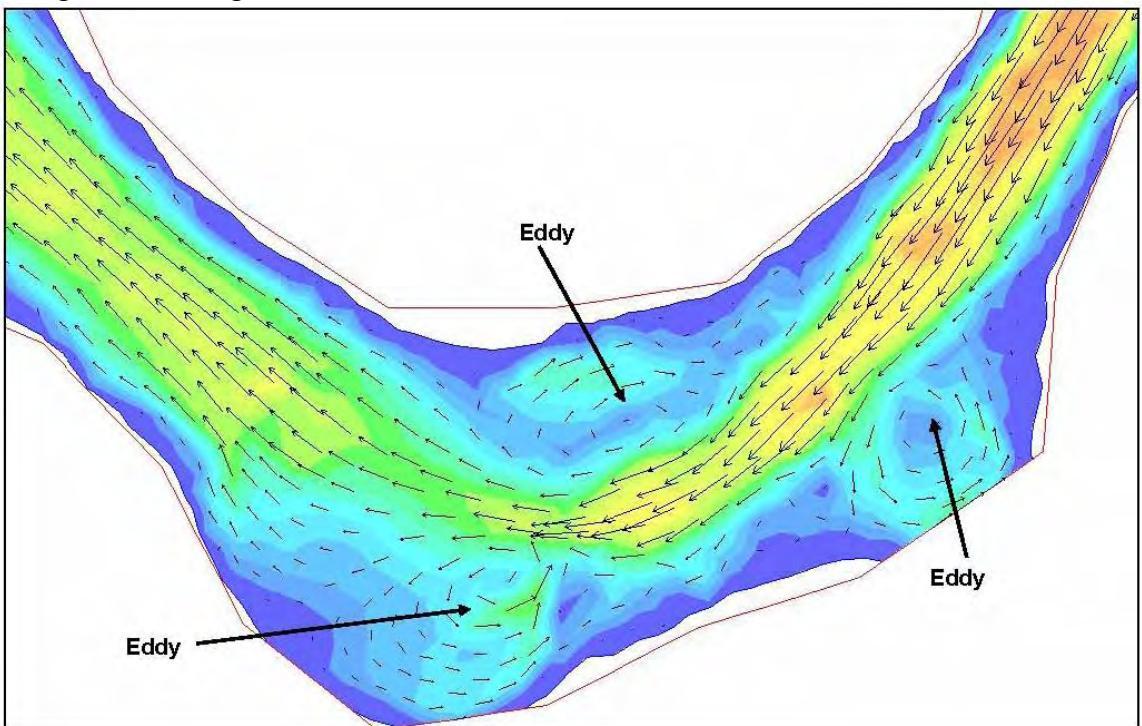
Figure 10. Eddy formation near confluence with Millers River (based on model results from Woodlot, 2007)

the formation of eddies, where flow swirls in a circular pattern counter to the river's main direction of flow – an observation of flow conditions found in the vicinity of the Route 10 Bridge. Figure 10 is an example of the simulation of eddy formation shown in the model output, in this case where Millers River discharges into the Turners Falls Impoundment. The arrows show the velocity vectors which indicate the direction and magnitude of velocity (by the length of the arrow). The magnitude of the velocity is also shown by the color, where lower velocities are blue and higher velocities are indicated by yellow, orange and red.

As noted above, an eddy is a circular pattern of flow that separates or breaks away from the main direction of flow and flows towards the riverbank, then upstream along the bank, before completing a circular pattern returning again to a downstream direction farther away from the bank. Eddies typically form when there is an obstruction in the flow pattern or a relatively abrupt change in the bank alignment such that the main current continues in its ongoing path and cannot immediately follow the obstruction or change in bank alignment.
