RELICENSING STUDY 3.1.1

2013 FULL RIVER RECONNAISSANCE

**Northfield Mountain Pumped Storage Project (No. 2485)
and Turners Falls Hydroelectric Project (No. 1889)**

SEPTEMBER 2014

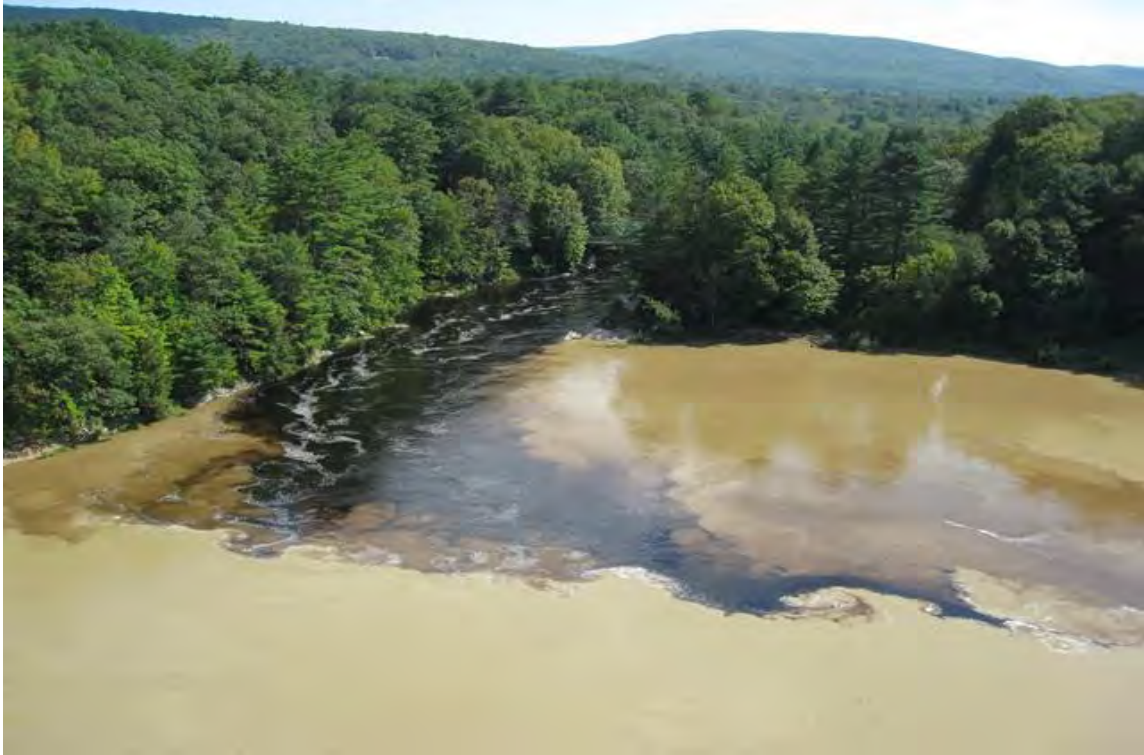
Figure 6.6 Contrast of sediment laden water in the Impoundment due to Tropical Storm Irene with Millers River

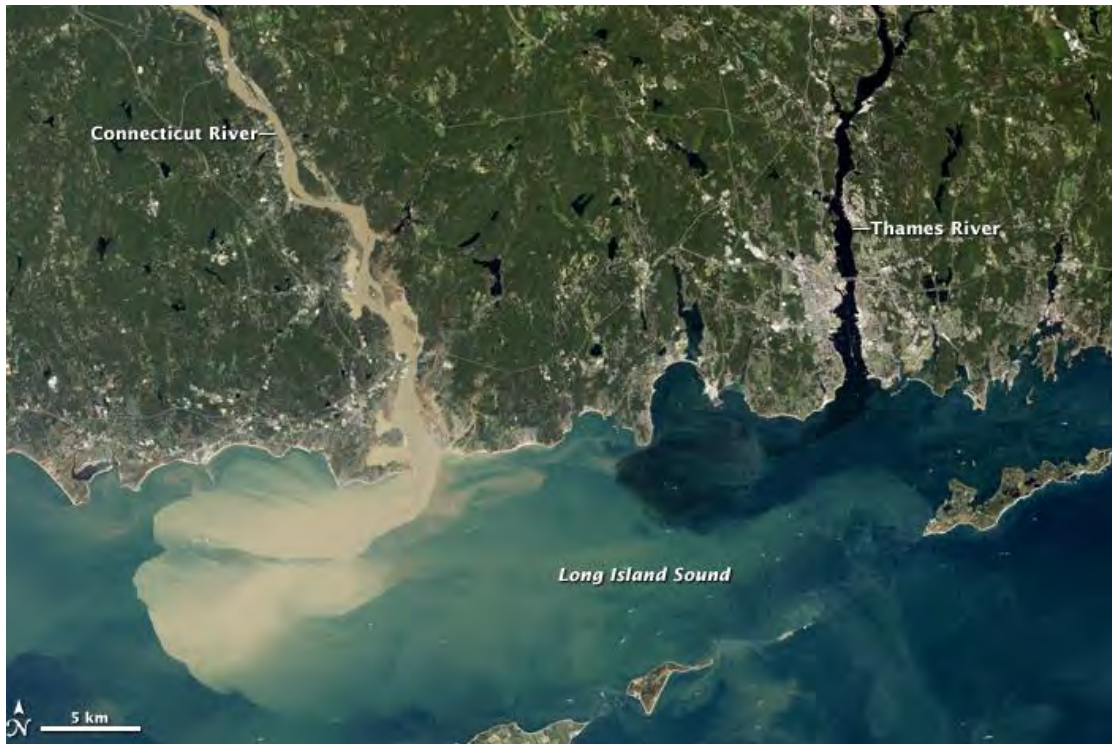
HI photo 508

Figure 6.7 Turbid water from Connecticut River flowing into Long Island Sound during Tropical Storm Irene

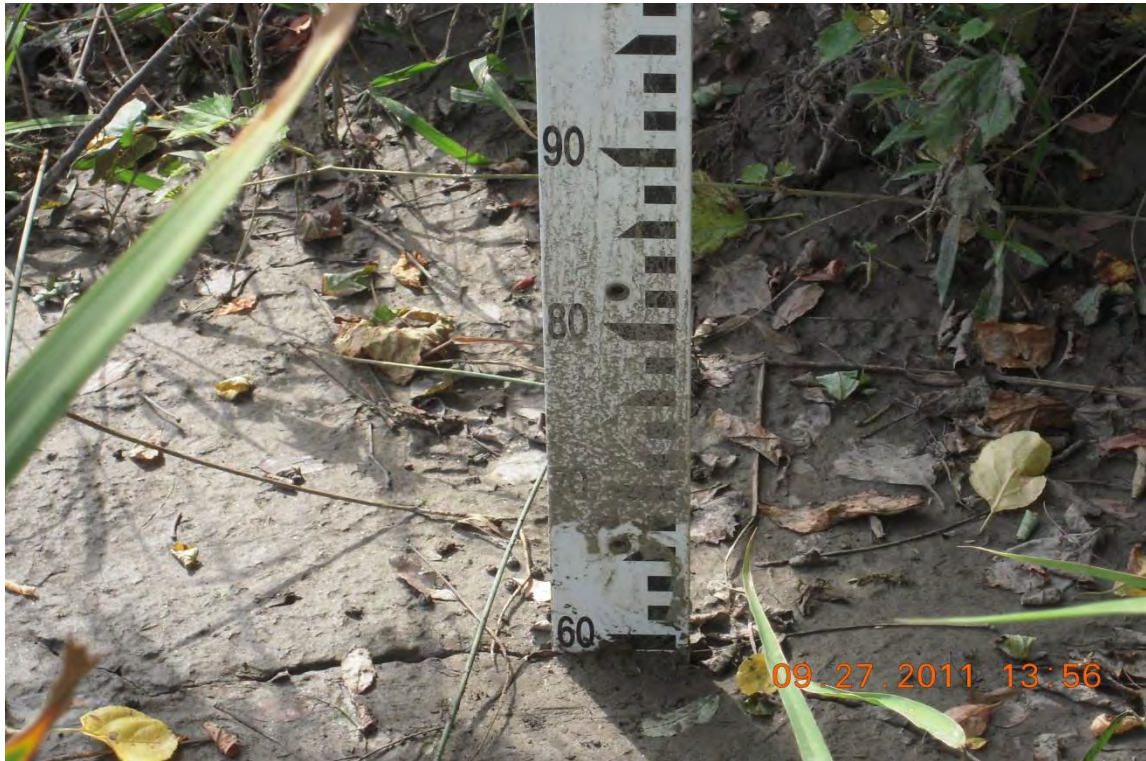
HI photo 239

Examples of lower riverbank deposition resulting from Irene can be found in [Figures 6.9 - 6.11](#). While some of the sediment deposited as a result of Tropical Storm Irene was subsequently washed away, some of it remained and provided additional media for recruitment of aquatic or other low-lying riparian vegetation. This vegetation was found to have colonized and is growing on the layer of deposited sediment.

Figure 6.10 Sediment deposition due to Tropical Storm Irene

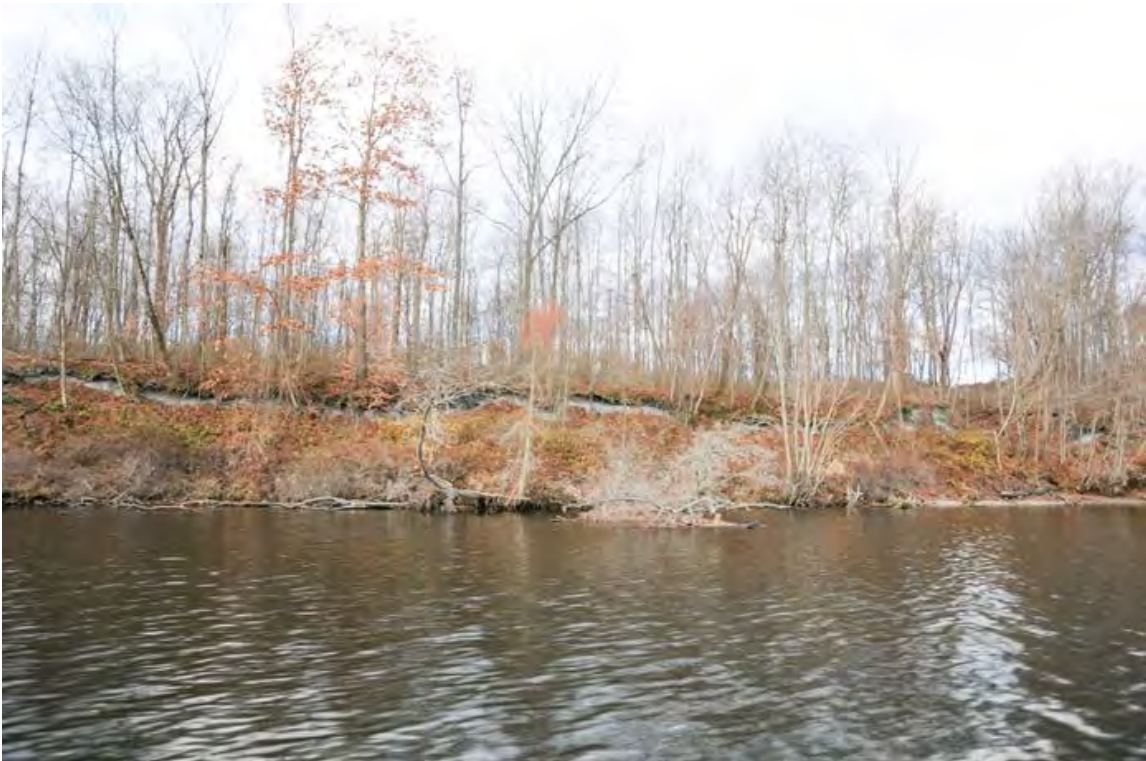
photo 6779

A linear erosion feature was observed in 2013 extending longitudinally along the river through a portion of the Urgiel Upstream site and continuing upstream over a distance of several hundred feet ([Figure 6.15](#)). The manifestation of this feature is a vertical shift on the order of a foot to several feet in height where apparently the lower part of the bank has shifted downward exposing this vertical scarp. It does not appear that the lower bank is separating horizontally from the upper bank so it is not a tension crack but instead is a vertical shift. The fact that this feature extends through a variety of terrain from a stabilized segment to a natural segment and crosses perpendicular features such as a local drainage features suggests that the cause for this shift is the result of something deeper below the surface farther down the bank into the river itself. This area is part of a complex of detailed study sites (10L, 10R, and 26) where continued

Figure 6.15 Linear erosion feature

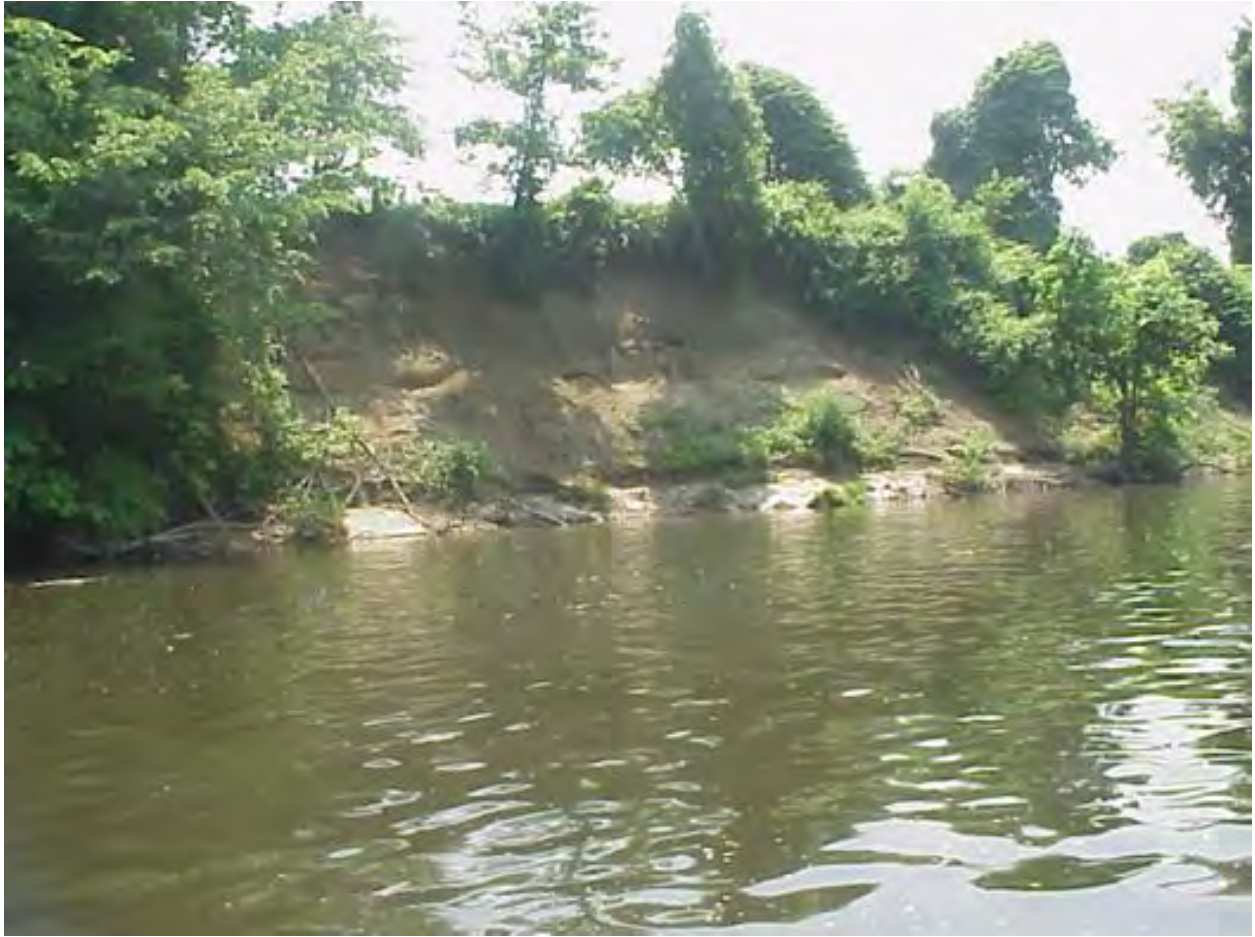
Figure 6.17 Example of Erosion Site prior to stabilization (Skalski, Site 6 – 1998)

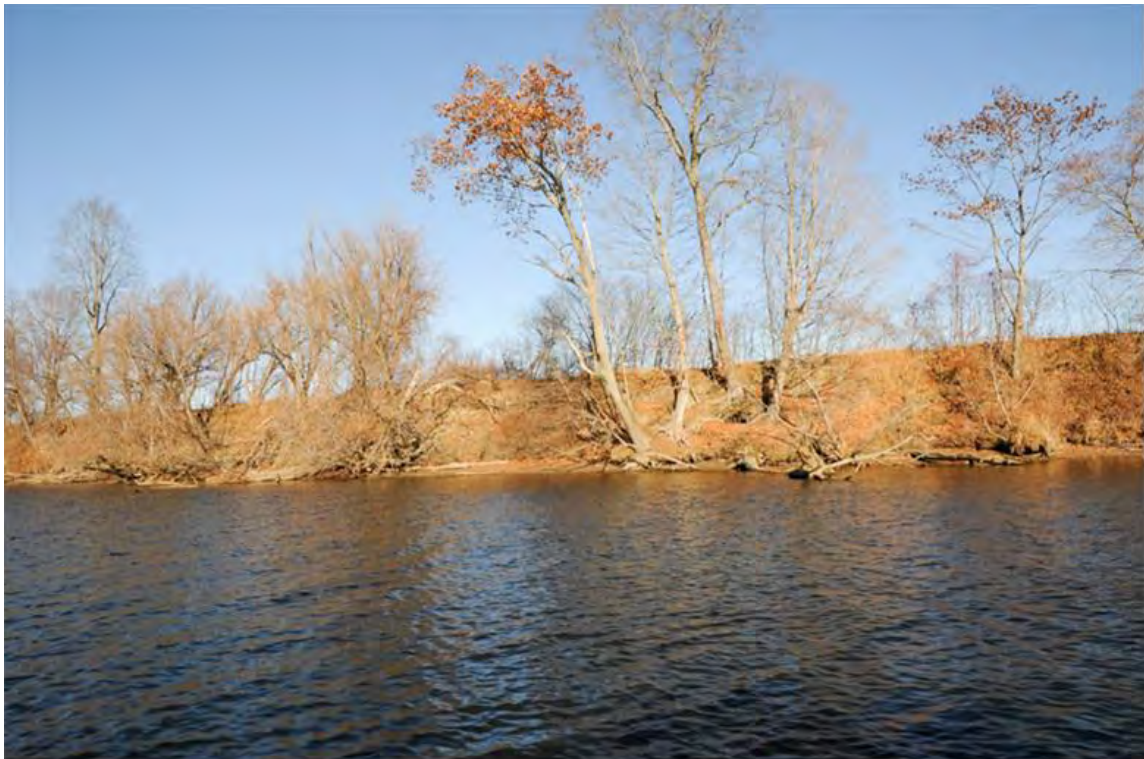
Figure 6.20 Eroded site (Segment 90), 2013

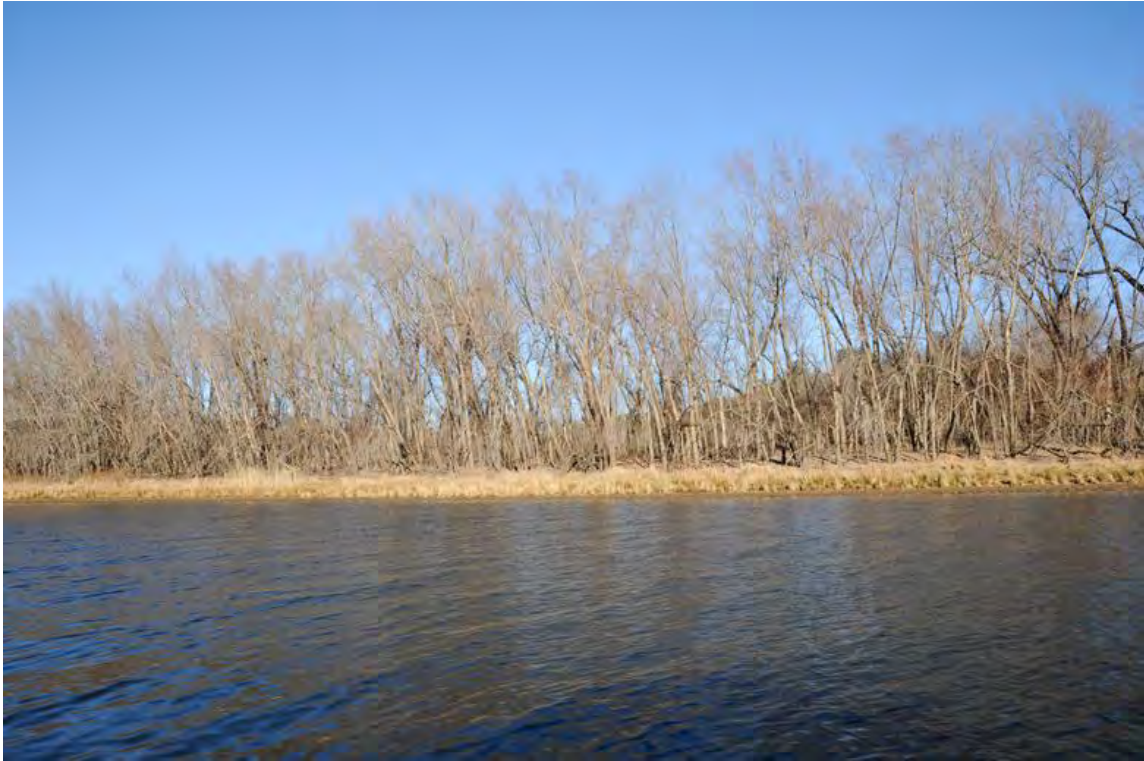
904

Figure 6.23 Flat, vegetated bank

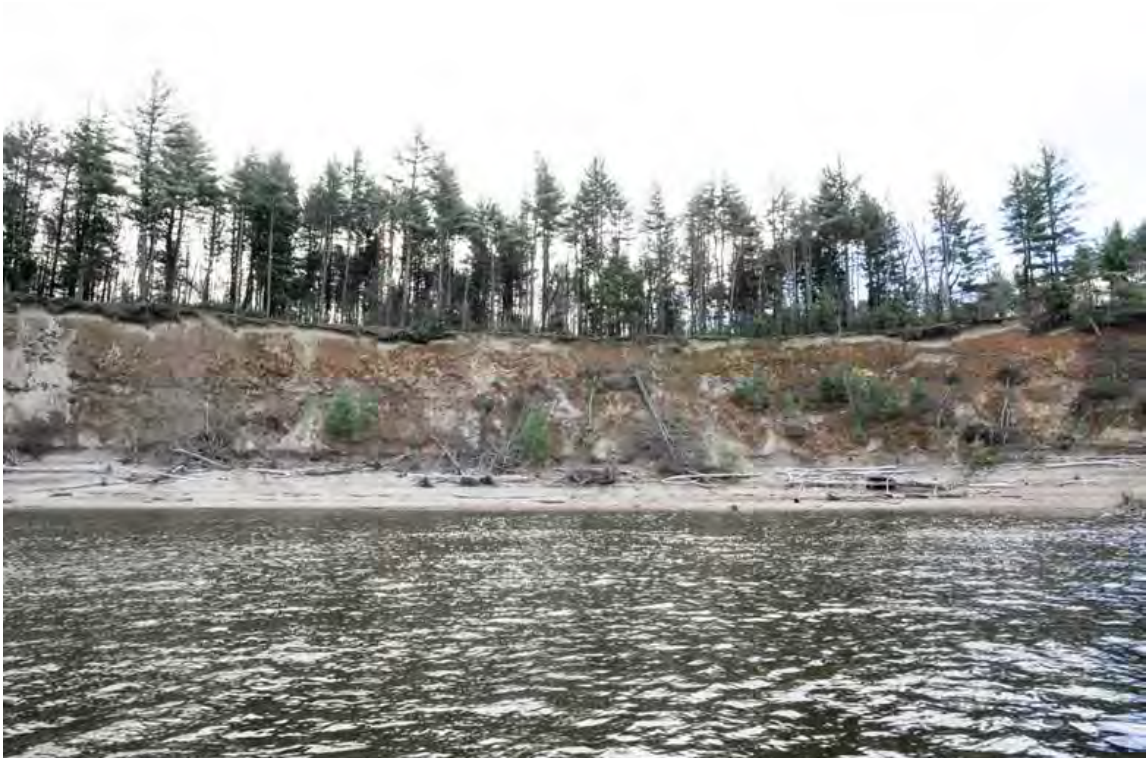
1403

Figure 6.26 Steep-Overhanging bank with little vegetation

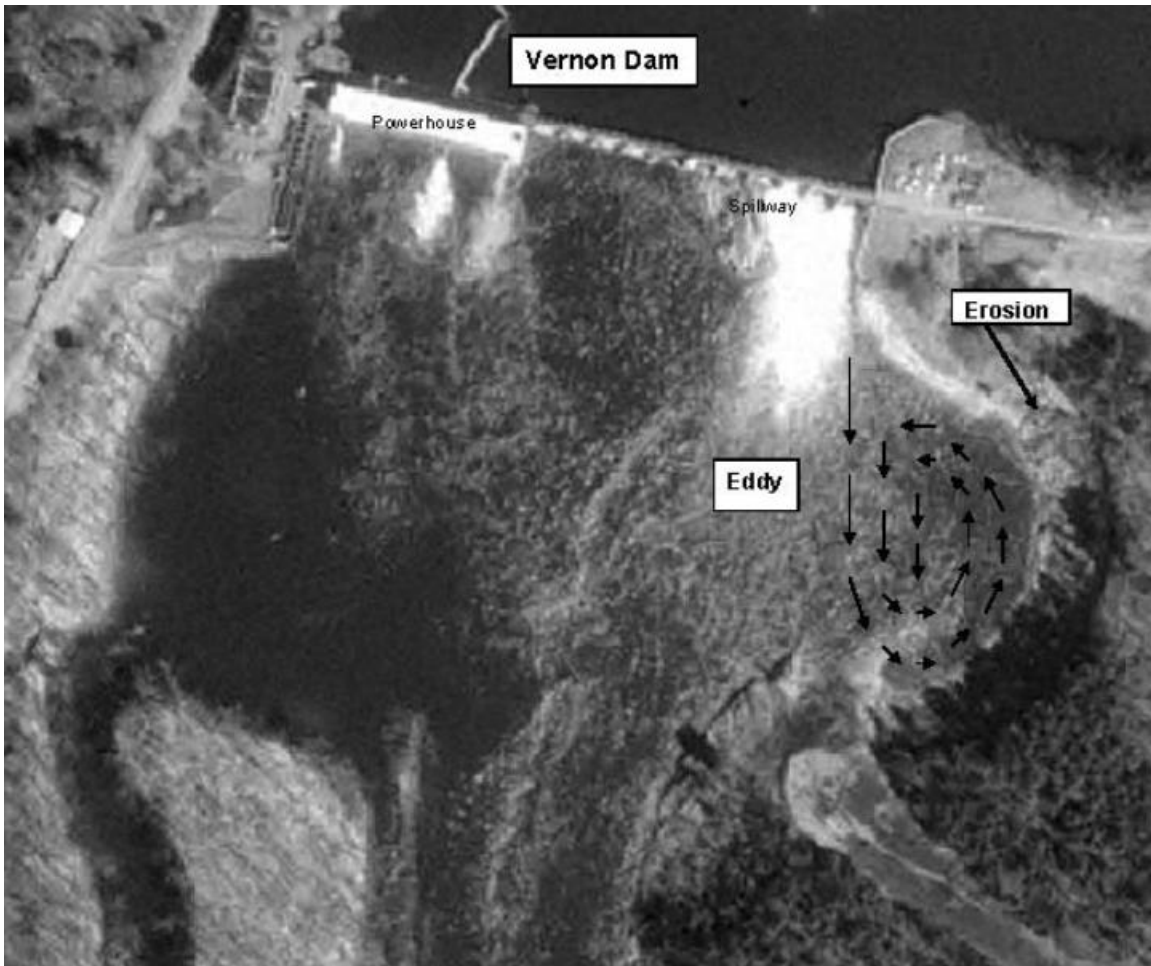
Various types and degrees of erosion found in the Impoundment can be observed at locations with a wide variety of adjacent land-uses. Two of the most severe areas of erosion that were identified in the 1998 FRR, and continue to be so in 2013, are located immediately downstream of Vernon Dam ([Figure 6.27](#)) and just upstream of the Route 10 Bridge ([Figure 6.28](#)). As discussed in the report titled “*Analysis of Erosion in the Vicinity of the Route 10 Bridge Spanning the Connecticut River*,” ([Simons, 2012](#)), severe erosion which has occurred at these locations are due to extreme hydraulic conditions and eddy formation. The associated developed land-use (i.e. a dam and a bridge) combined with the riverine and geomorphic features present at these locations have created the extreme hydraulic conditions which result in the observed extensive erosion.

Figure 6.27 Eddy-induced erosion at Vernon Dam

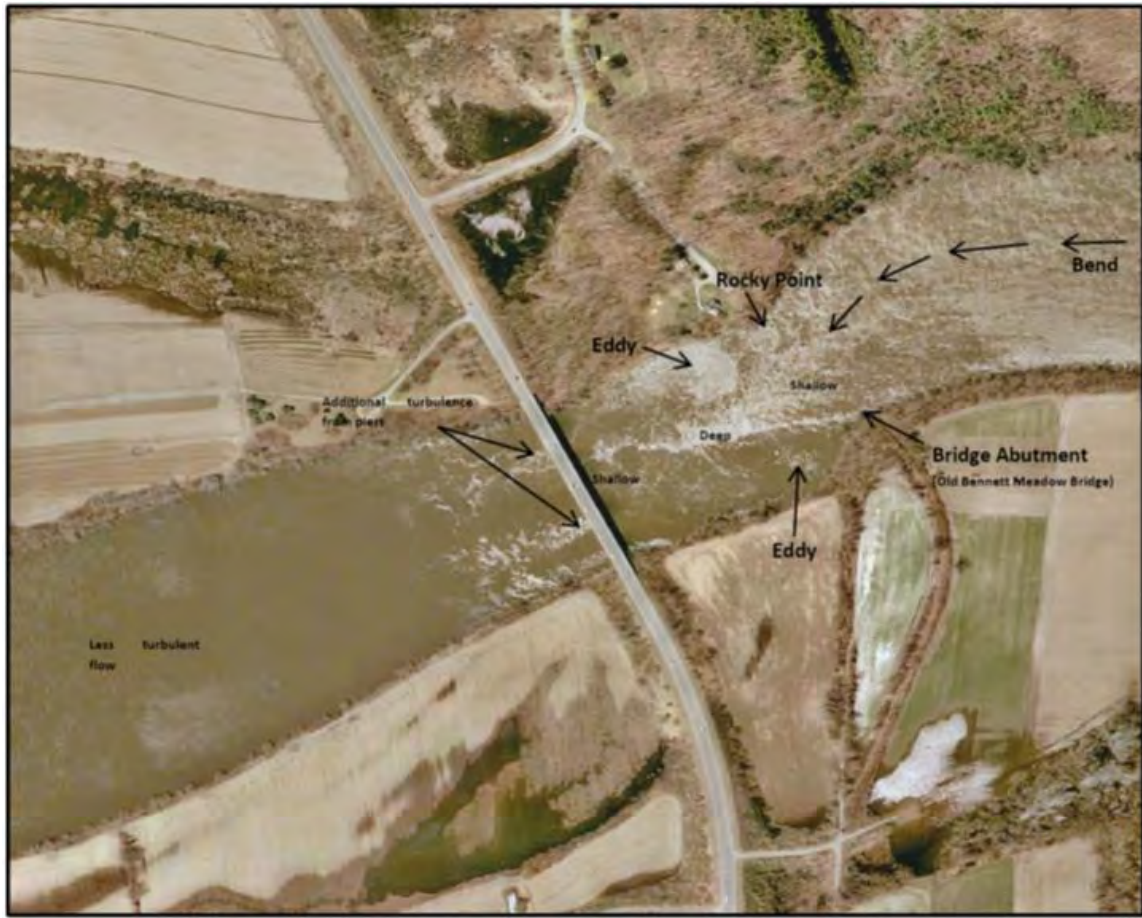
Figure 6.28 Eddy-induced erosion at Route 10 Bridge

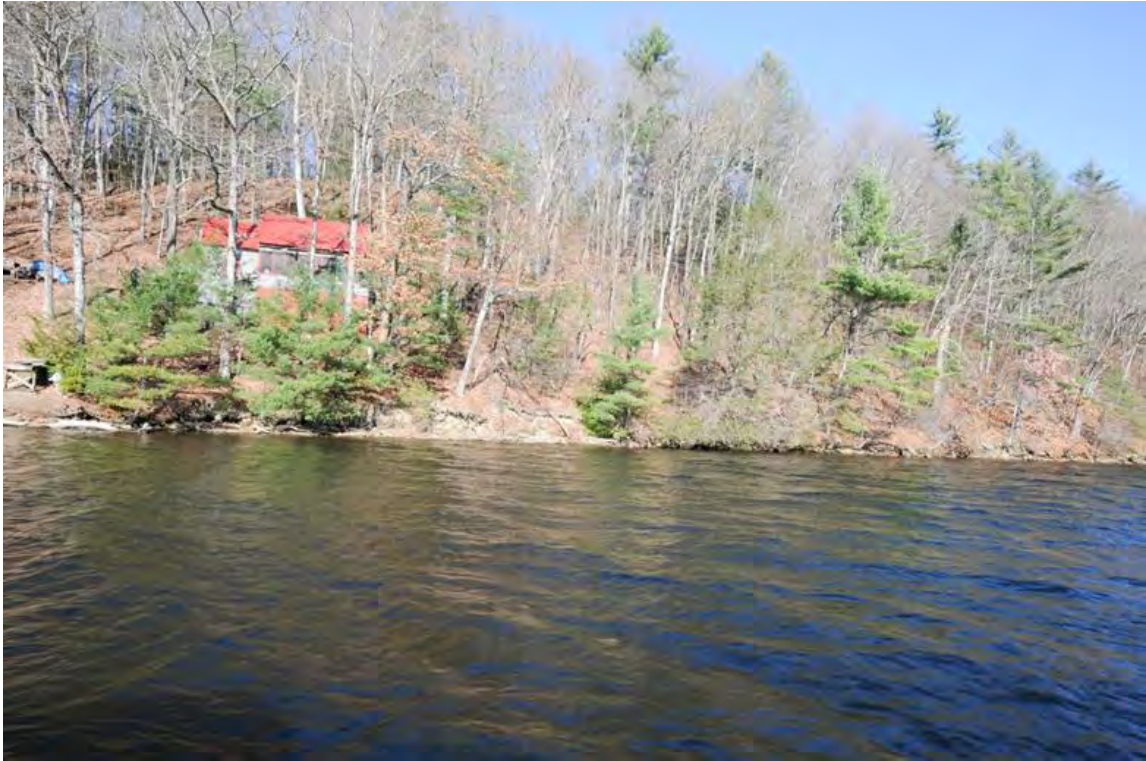
439

Erosion has also been observed in areas where houses and other associated development are located in close proximity to the river. An example of erosion in close proximity to a house is shown in segment 388 ([Figure 6.29](#)). As shown in the figure undercutting, overhanging bank, and exposed roots were observed at this location in close proximity to the structure. In several instances where houses have been built close to the river, riparian vegetation has also been cleared which can adversely affect riverbank stability.

Figure 6.29 Erosion adjacent to seasonal Camp 2-W

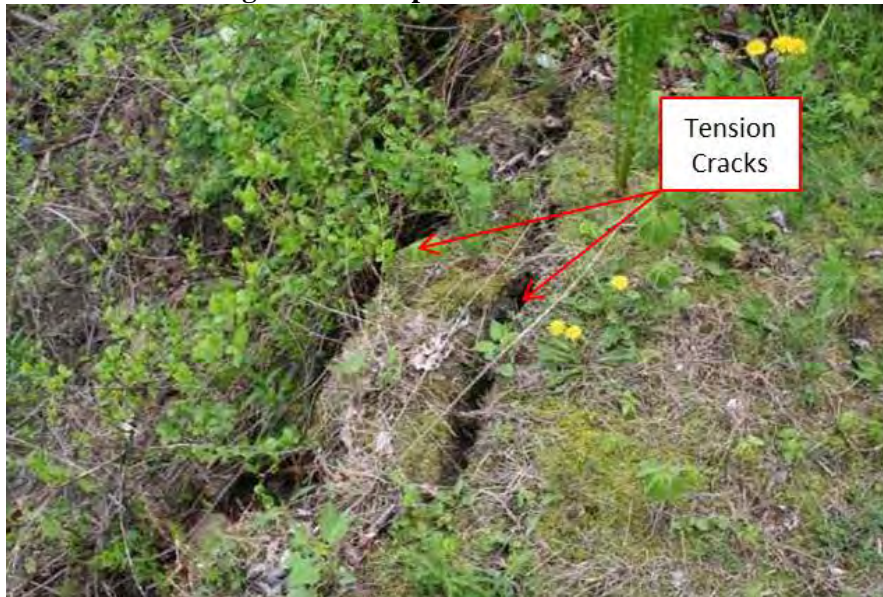
Figure 3: Example of Tension Cracks

Field observations will be based on the criteria found in [Table 4](#) and will include: 1) gathering basic positional attribute information of the features identified; 2) identifying the locations of sensitive receptors; and 3) identifying and investigating indicators of potential erosion or bank instability that would not be readily visible from a boat. Indicators of potential erosion (excluding tension cracks) such as exposed roots, creep, overhanging banks, and notching are anticipated to be more easily identifiable from a boat than from walking along the riverbanks. As a result, these features will not be investigated in-depth as part of this task but will instead be included in the boat-based survey discussed in [Task 2b](#). The primary focus of the land-based assessment will be to identify the location of and investigate tension cracks or other indicators of potential erosion that will not be clearly identifiable from a boat. For the purpose of this study tension cracks are defined as a cracks formed at the top edge of a bank that potentially could lead to topples or slides ([Field, 2007](#)). [Figure 3](#) depicts an example of a tension crack.

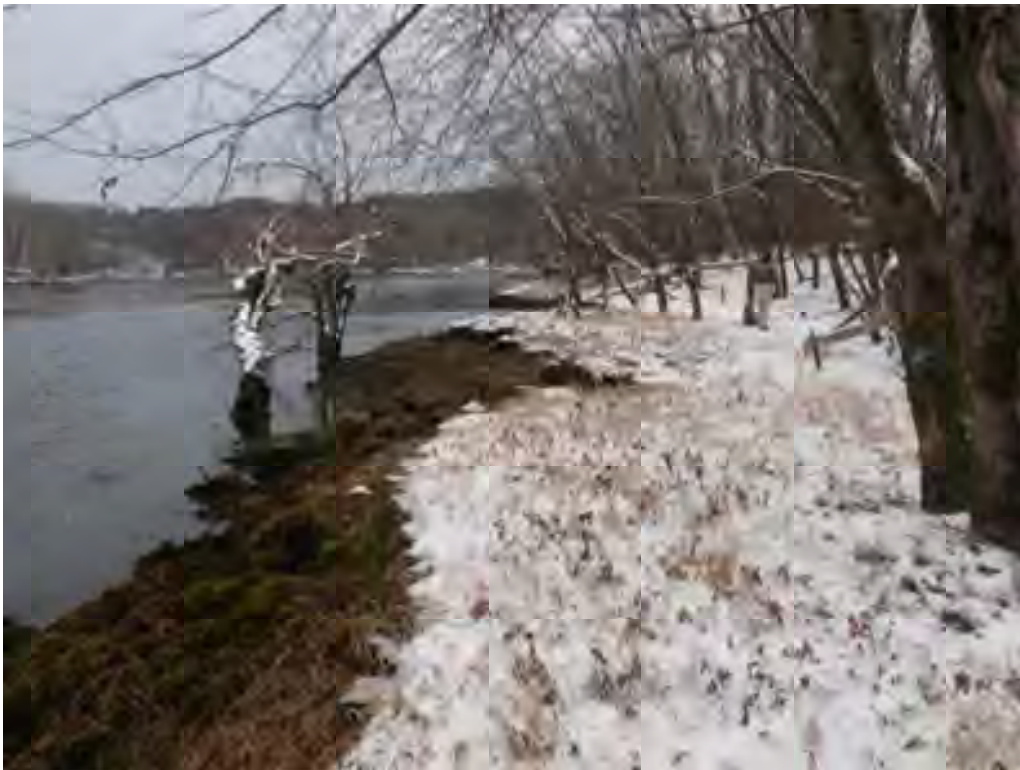
Photo No. 59 (*Island left bank, note stunted crushed sycamores along bench and floodplain forest at top*)

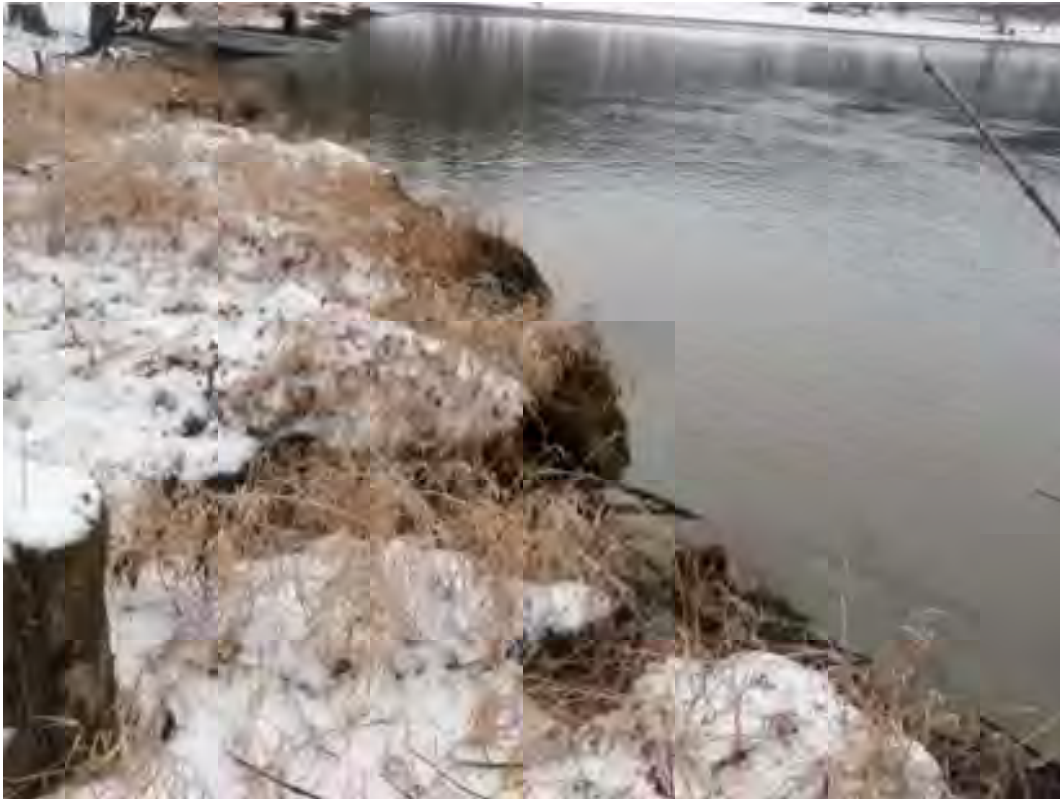
Photo No. 56 (*fluvial scouring along upstream end of island*)

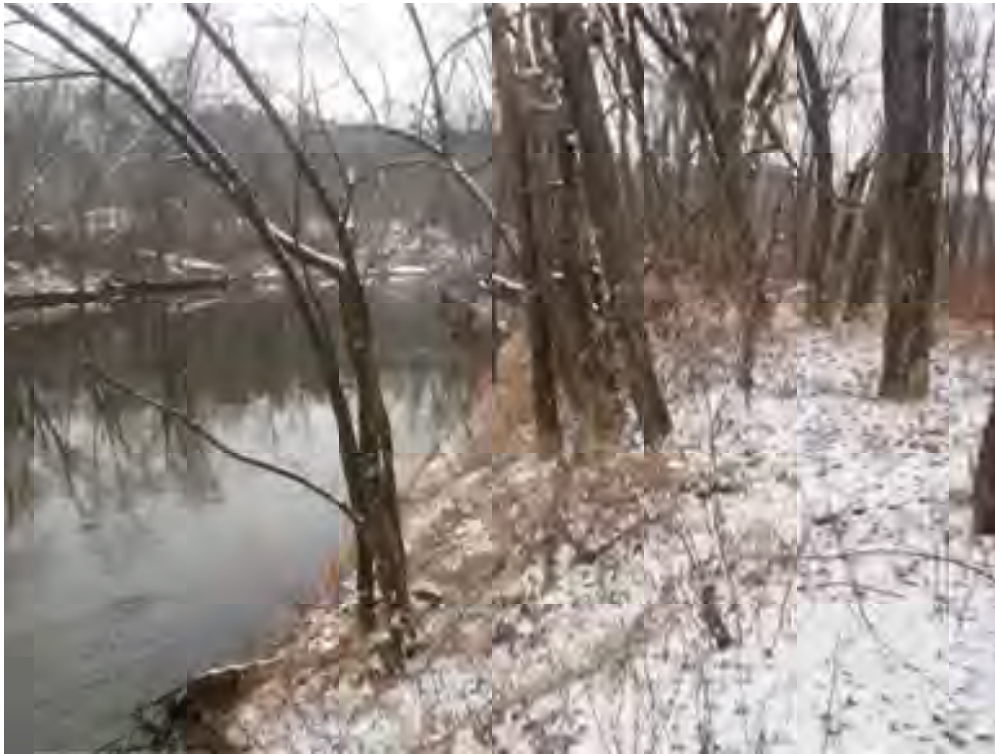
Notes: Steep slope with pockets of fluvial and mass-wasting erosion, some falls, some undercutting

Photo No. 61 (*Vernon Island right bank, steeper and higher bank than island left*)

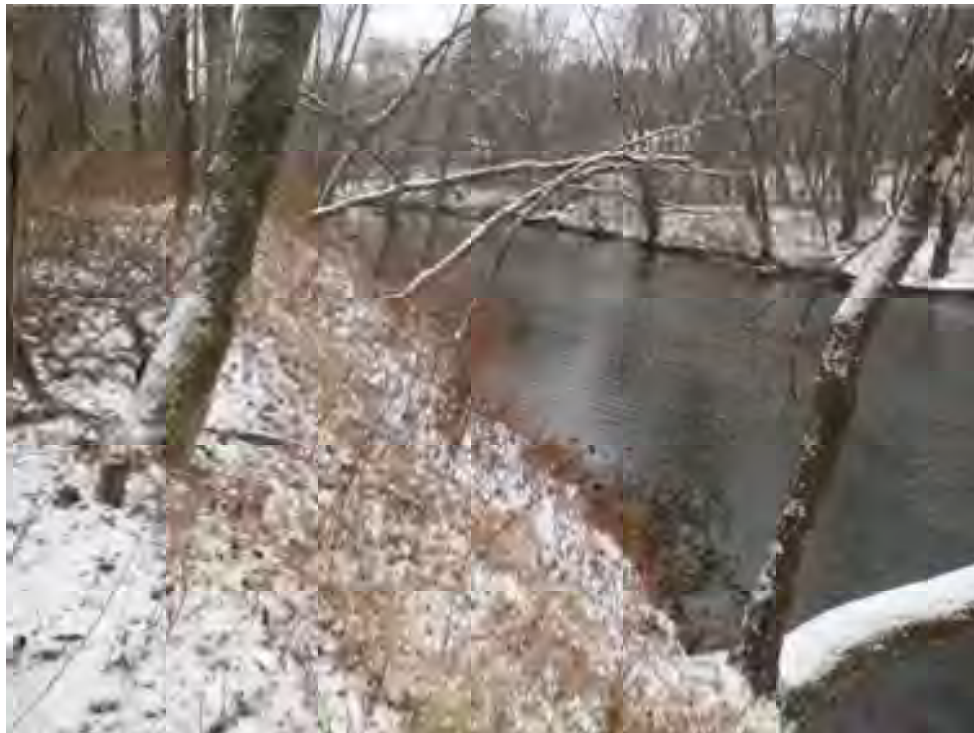
Photo No. 62 (*Vernon Island right bank, steeper and higher bank than left, and more invasive veg*)

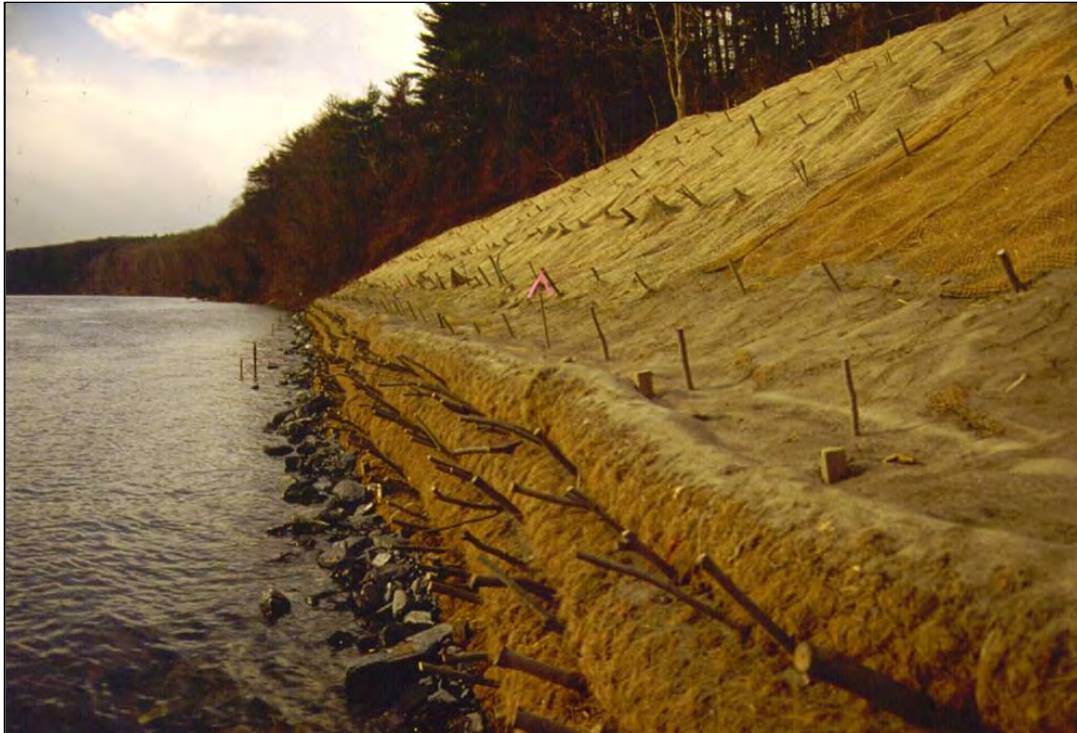
Photo 1: Wickey following construction, 1996

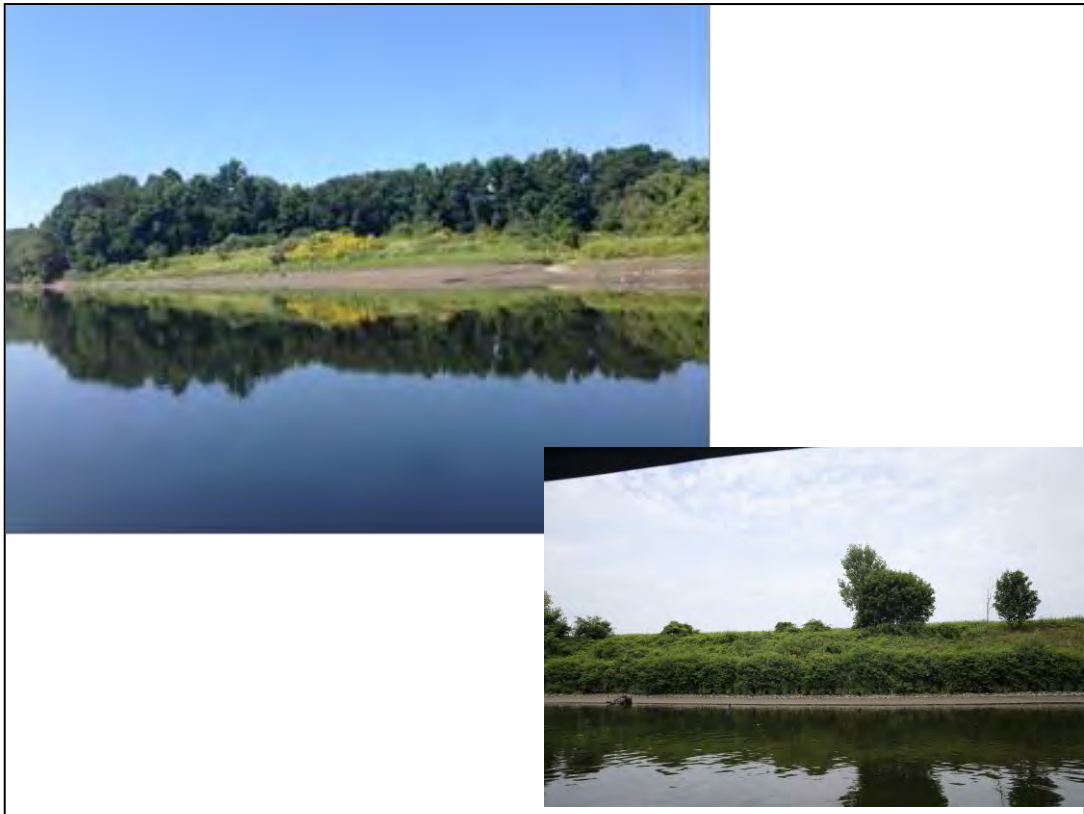
Photo 10: Flagg Farm -Post Construction 2014 downstream (upper photo) upstream (lower photo)

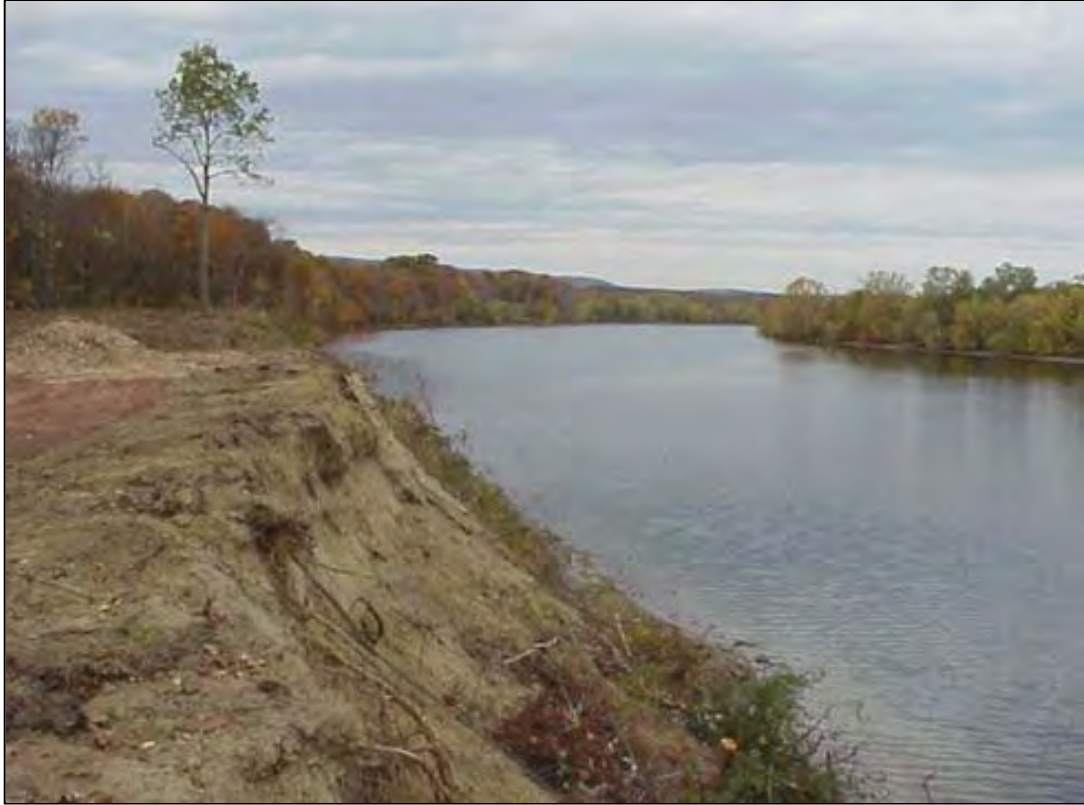
Photo 11: Urgiel Upstream pre- construction, 2001

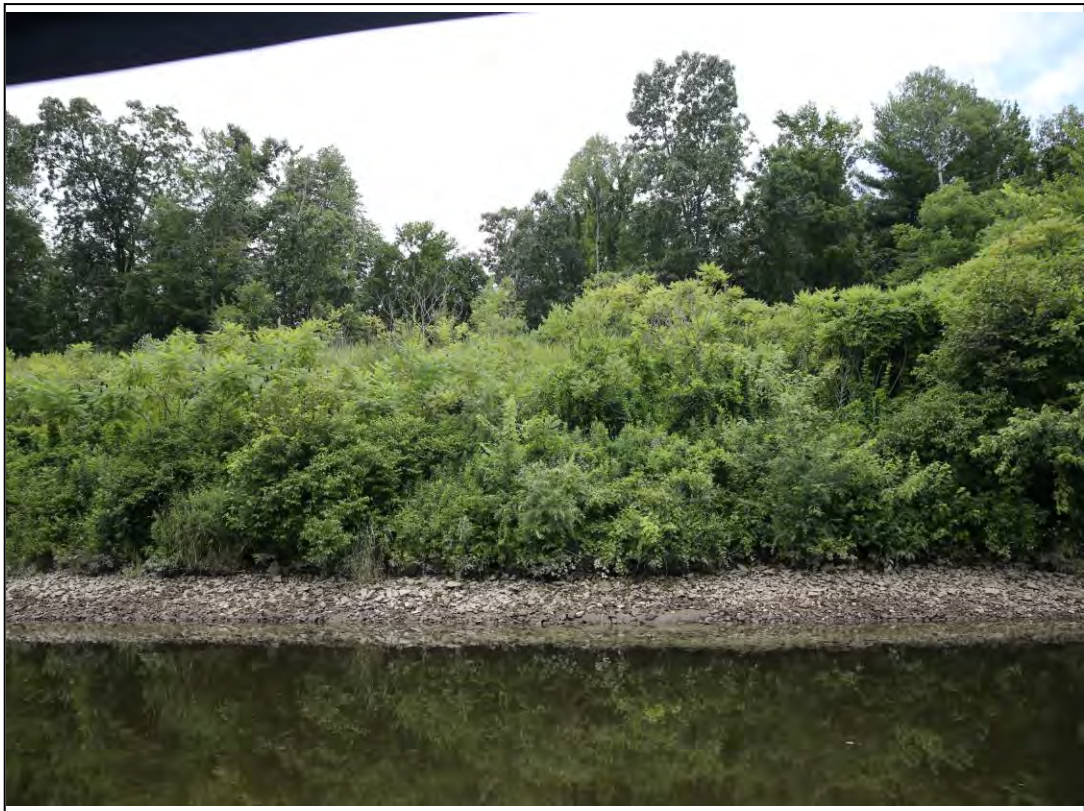
Photo 12: Urgiel Upstream -Post Construction 2014

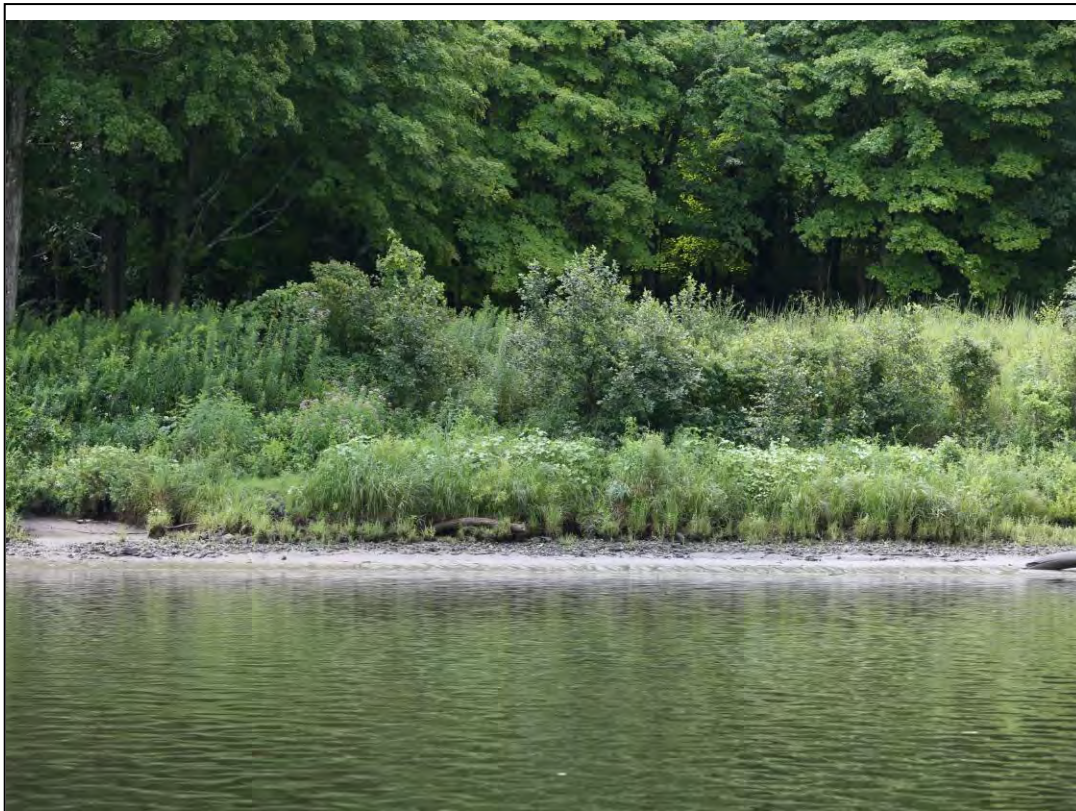
Photo 14: Durkee Point -Post Construction 2014

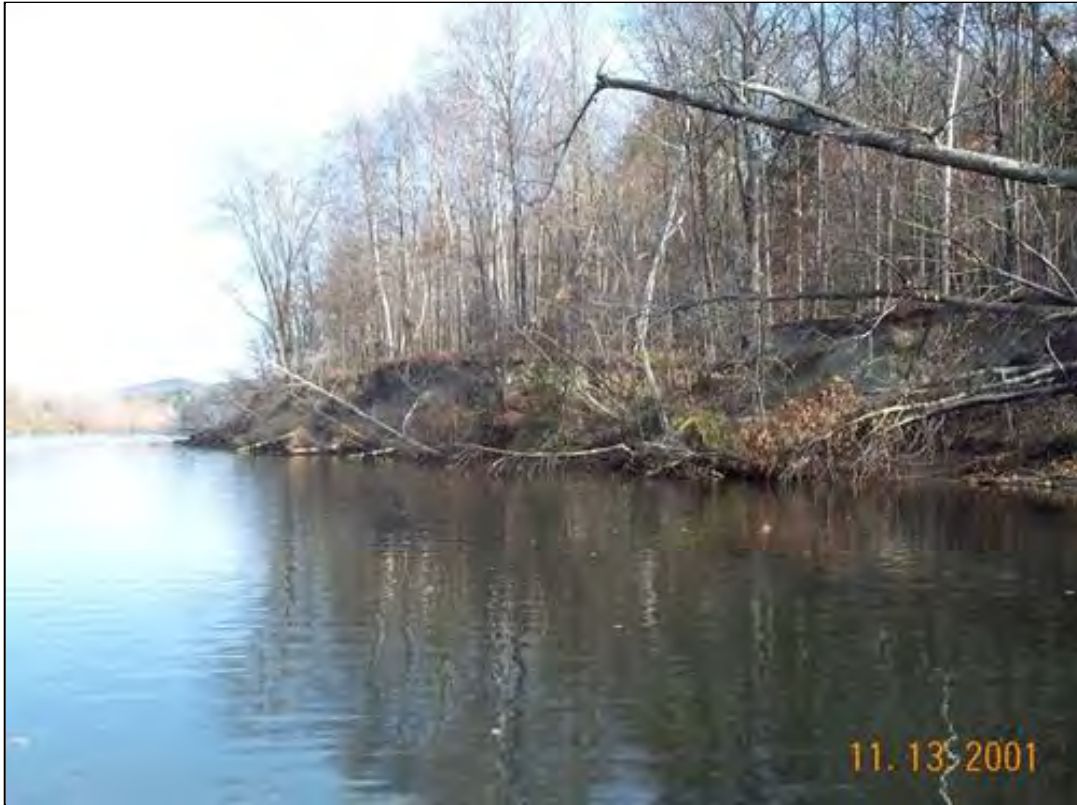
Photo 15: River Road pre- construction, 2001

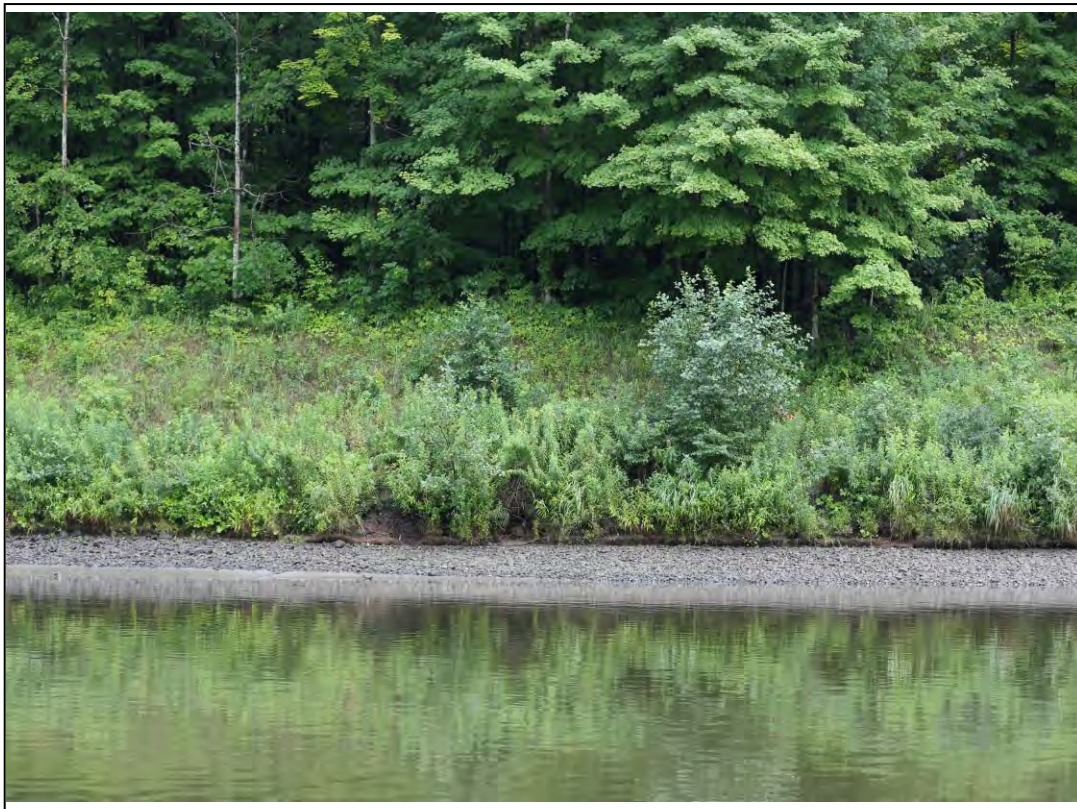
Photo 16: River Road-Post Construction 2014

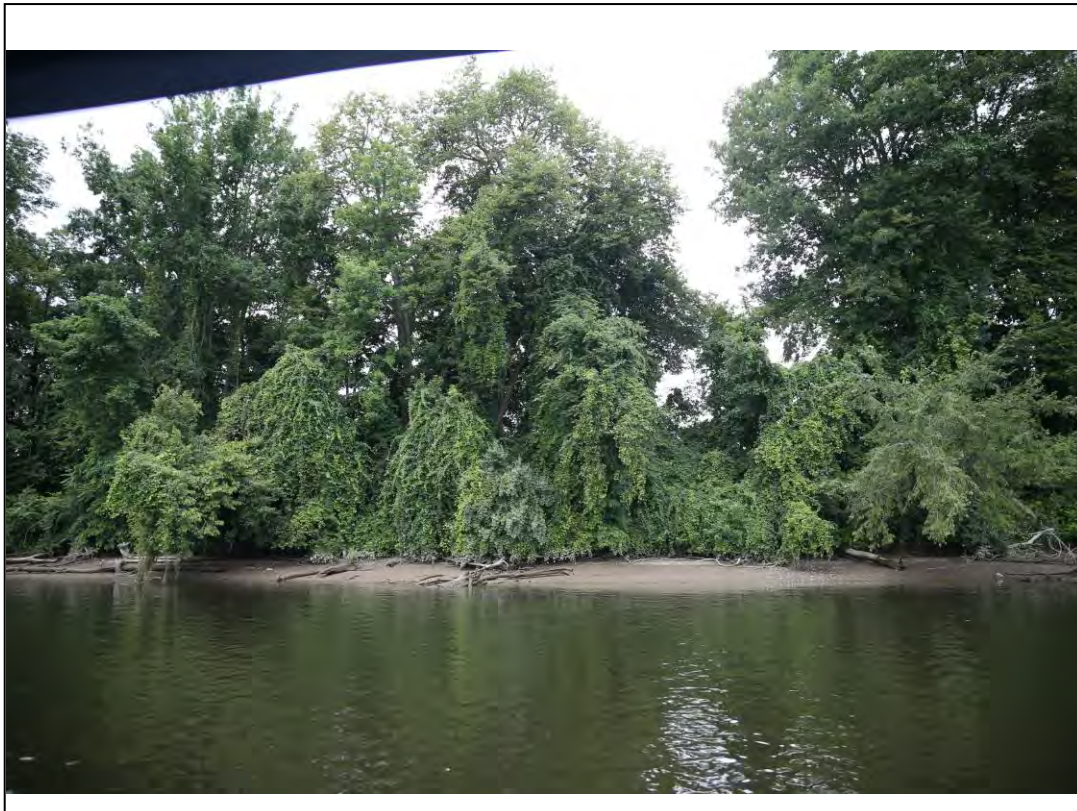
Photo 22: Bennett Meadow, Post Construction 2014

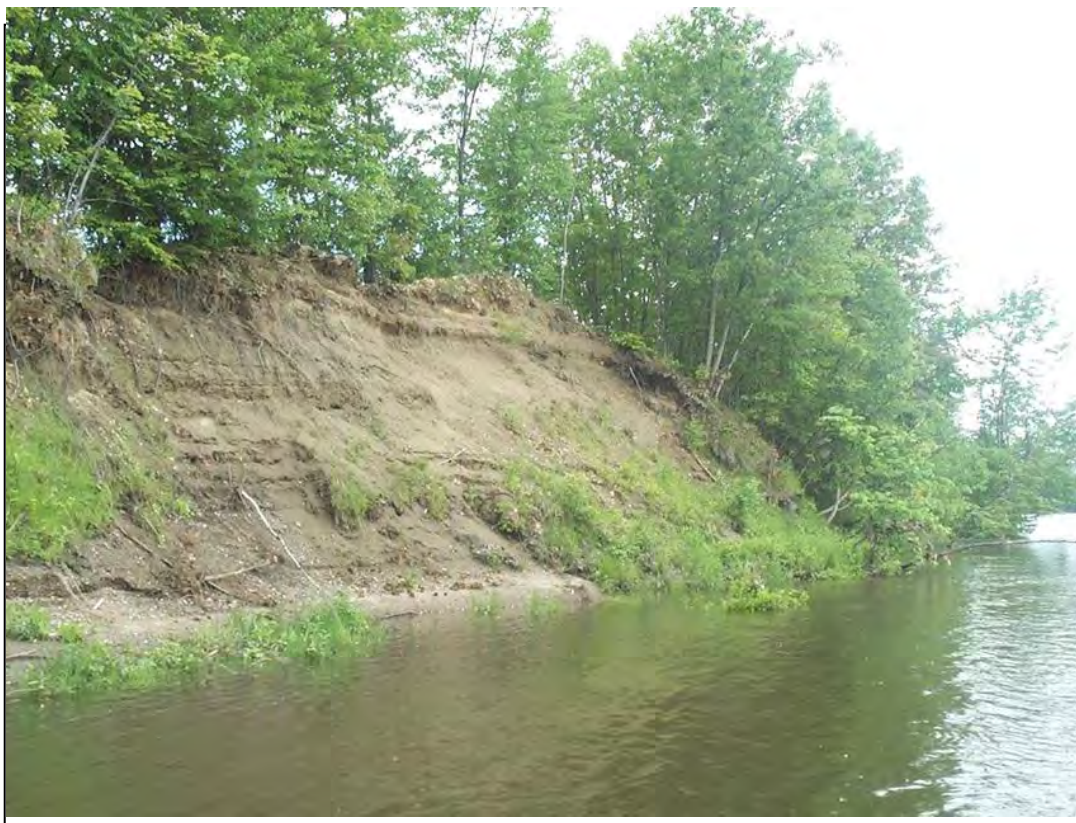
Photo 23: Urgiel Downstream- pre-construction, 2005
