RELICENSING STUDY 3.1.1

2013 FULL RIVER RECONNAISSANCE

**Northfield Mountain Pumped Storage Project (No. 2485)
and Turners Falls Hydroelectric Project (No. 1889)**

SEPTEMBER 2014

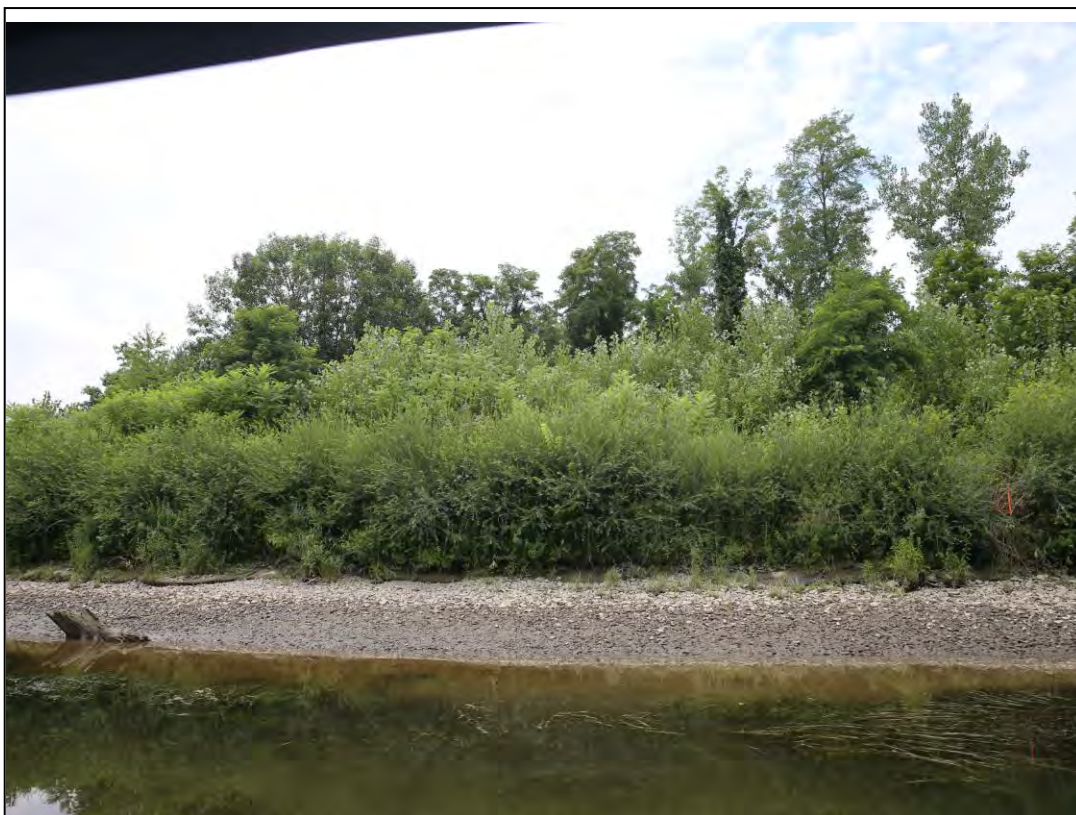
Photo 24: Urgiel Downstream, Post Construction 2014

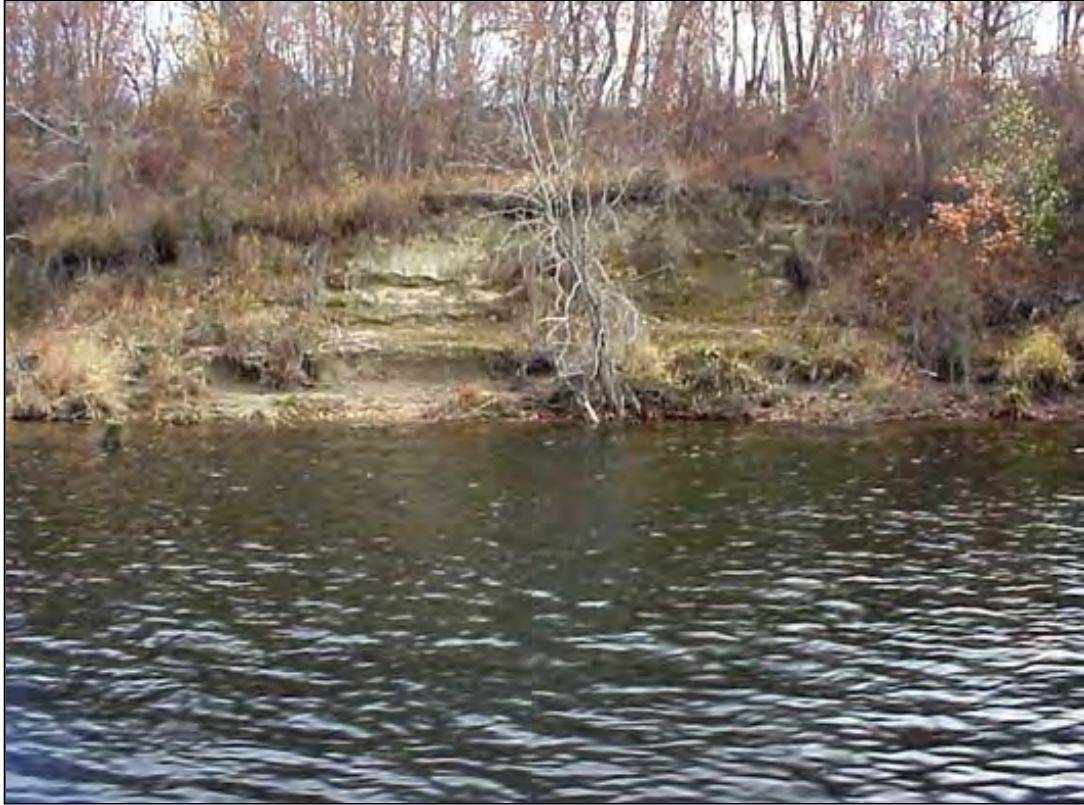
Photo 25: Country Road- pre-construction, 2006

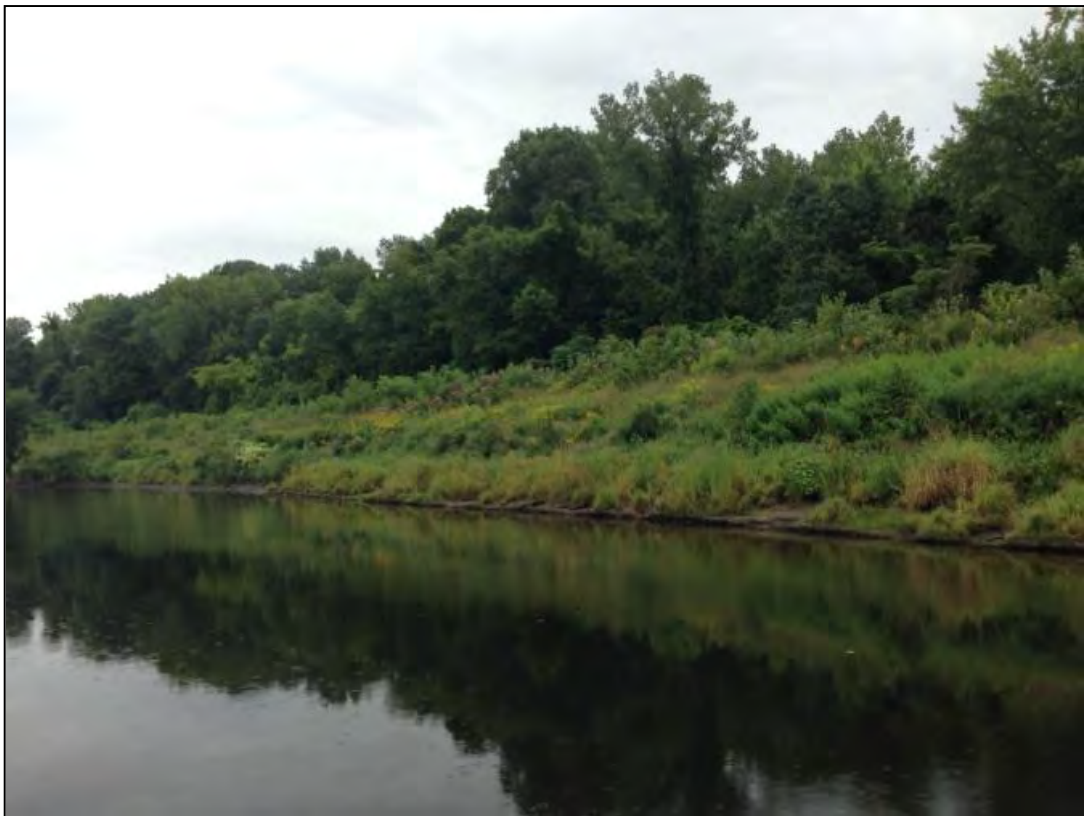
Photo 26: Country Road- Post Construction 2014

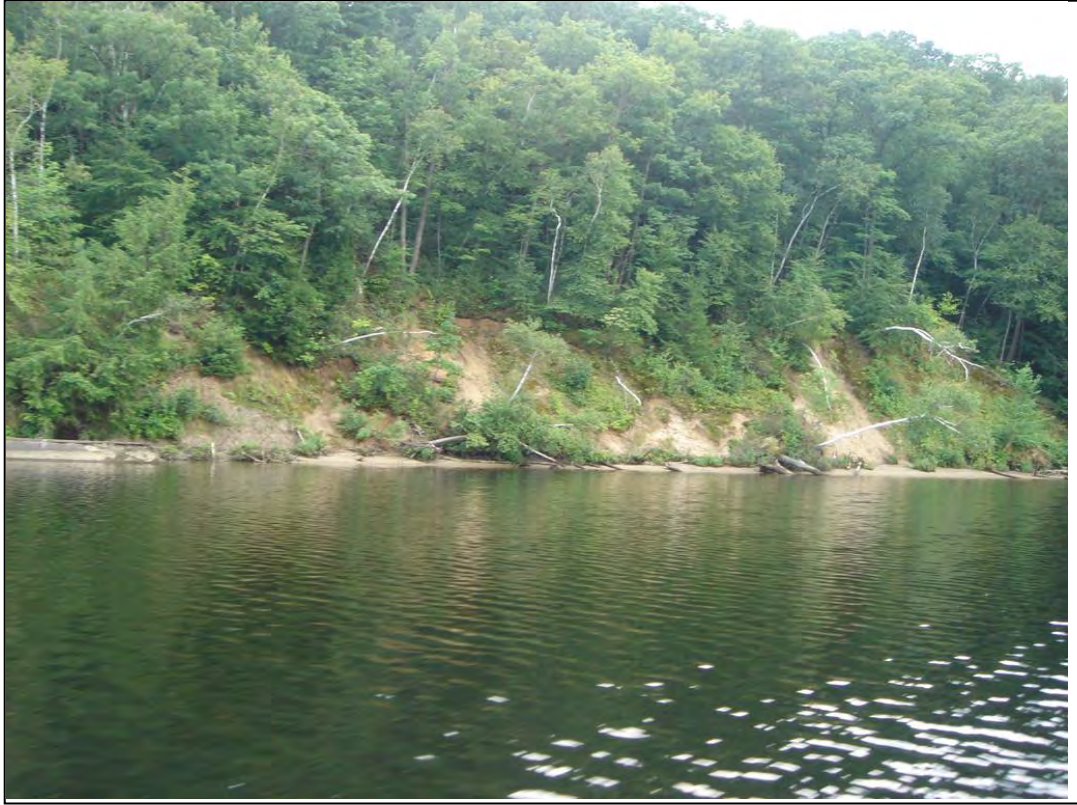
Photo 27: Campground Point- pre-construction, 2008

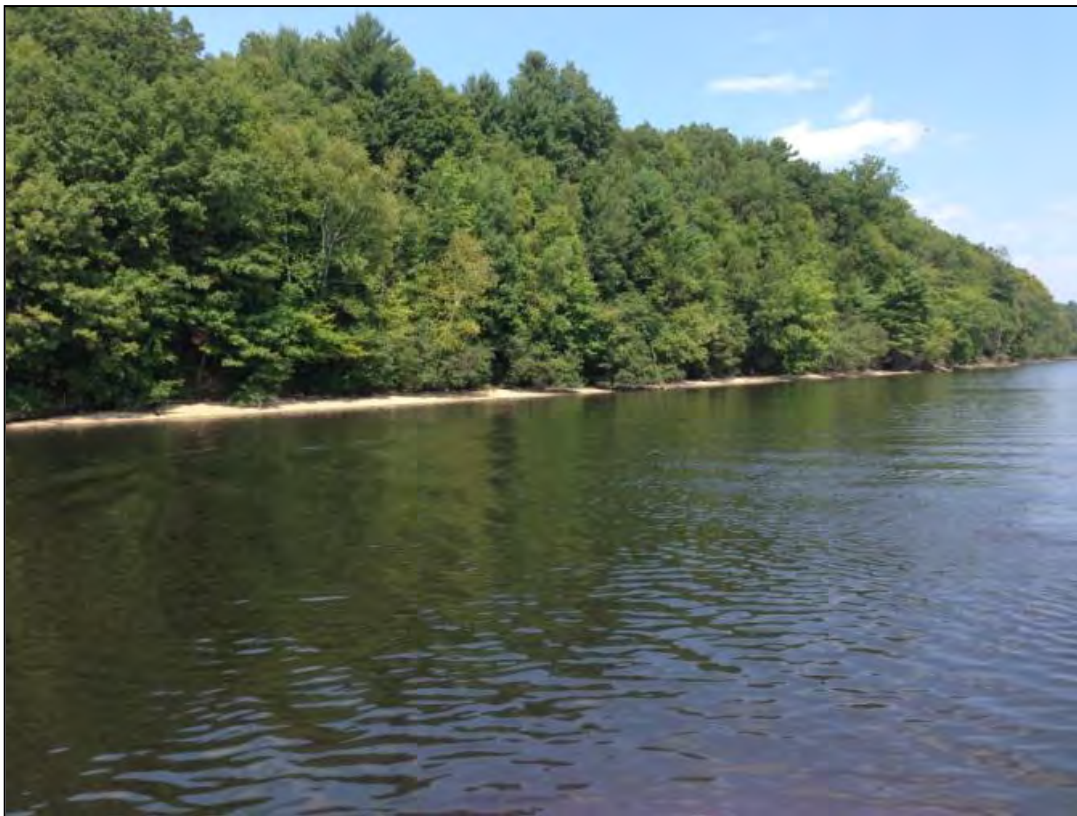
Photo 28: - Campground Point- Post Construction 2014

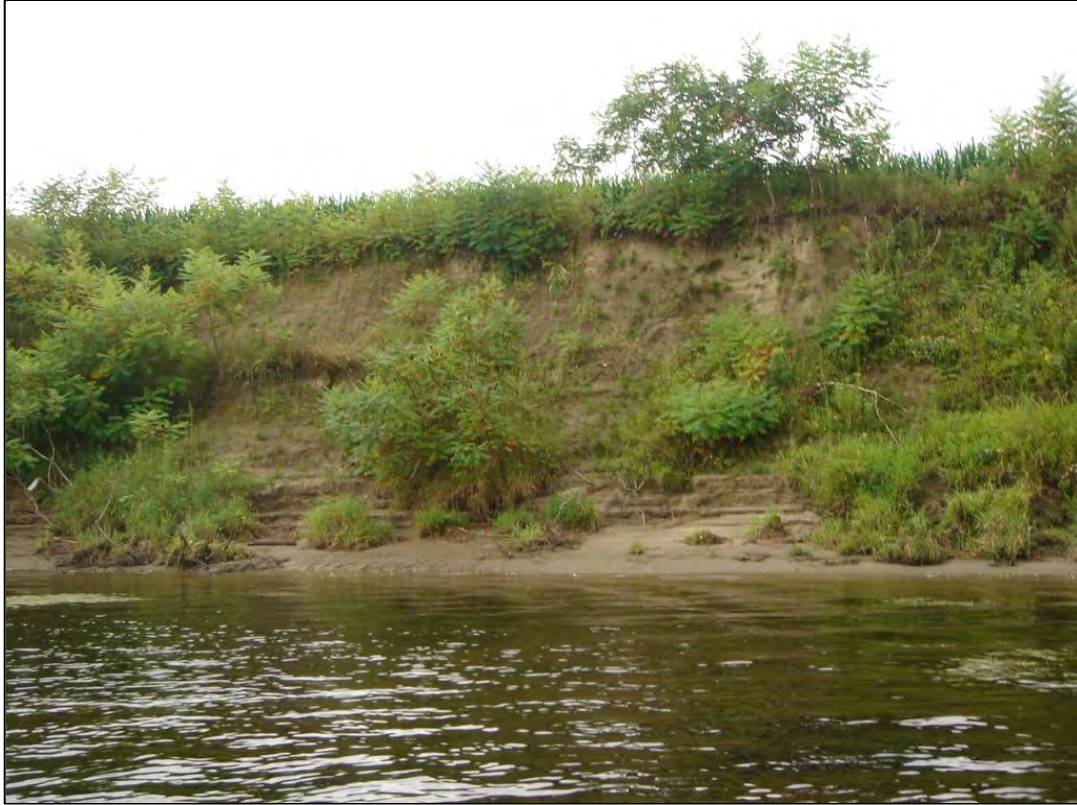
Photo 31: Kendall Farm- pre-construction, 2008

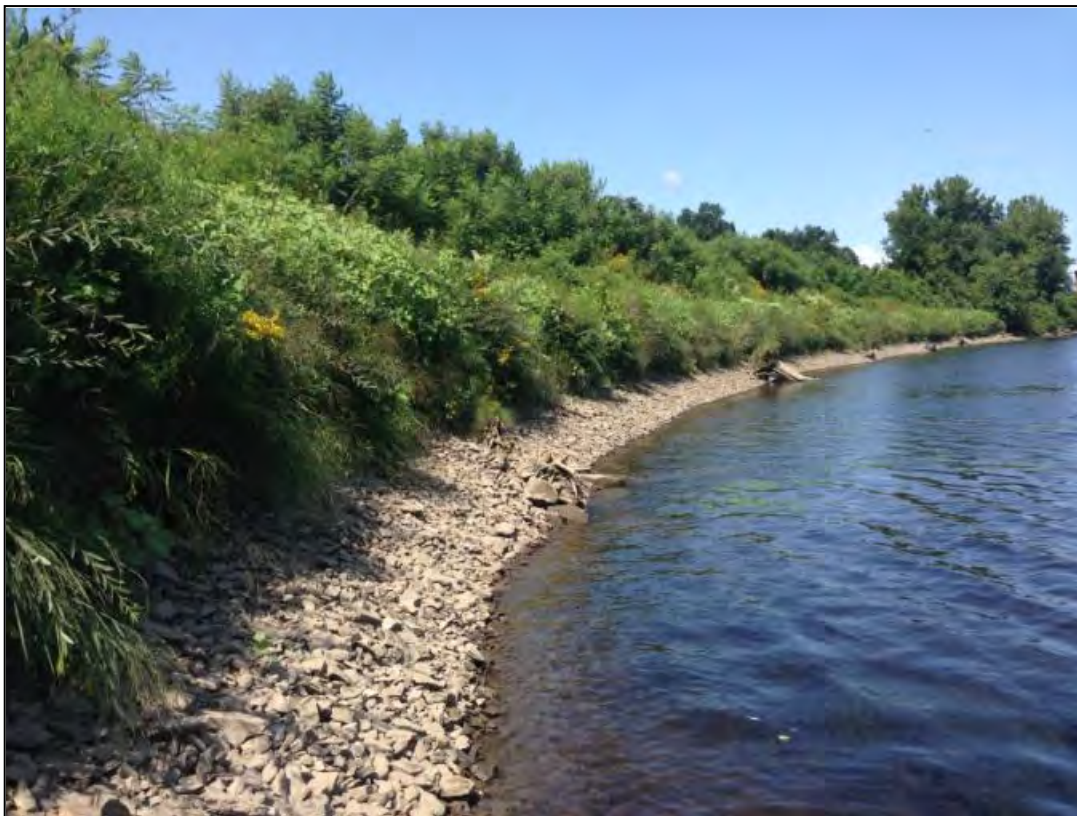
Photo 32: Kendall Farm- Post Construction 2014

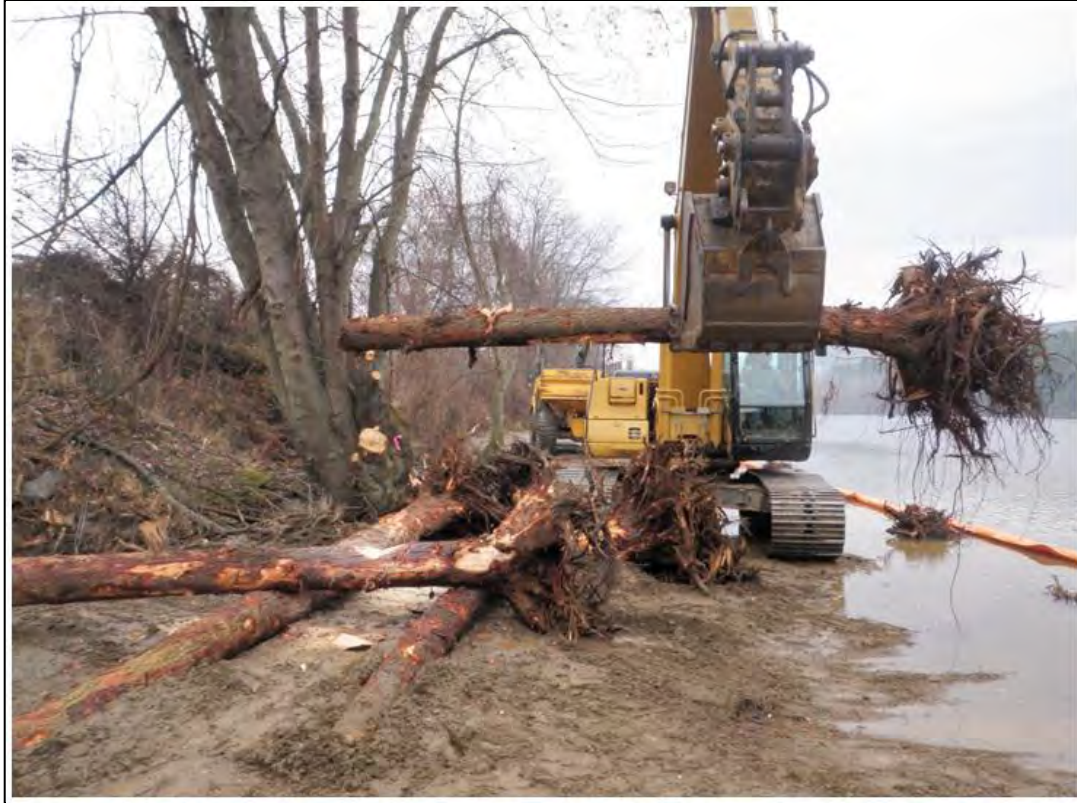
Photo 33: Lower Split River Farm- construction 2009

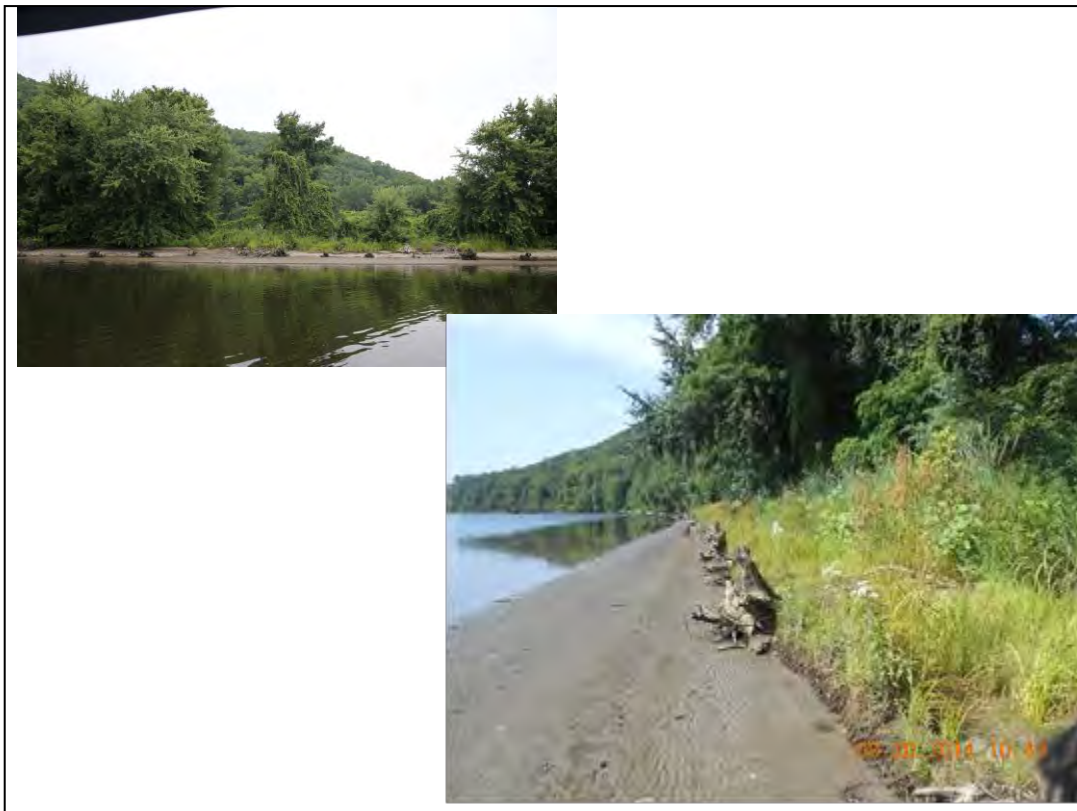
Photo 34: Lower Split River Farm- Post Construction 2014. Bank Detail from August, 2014

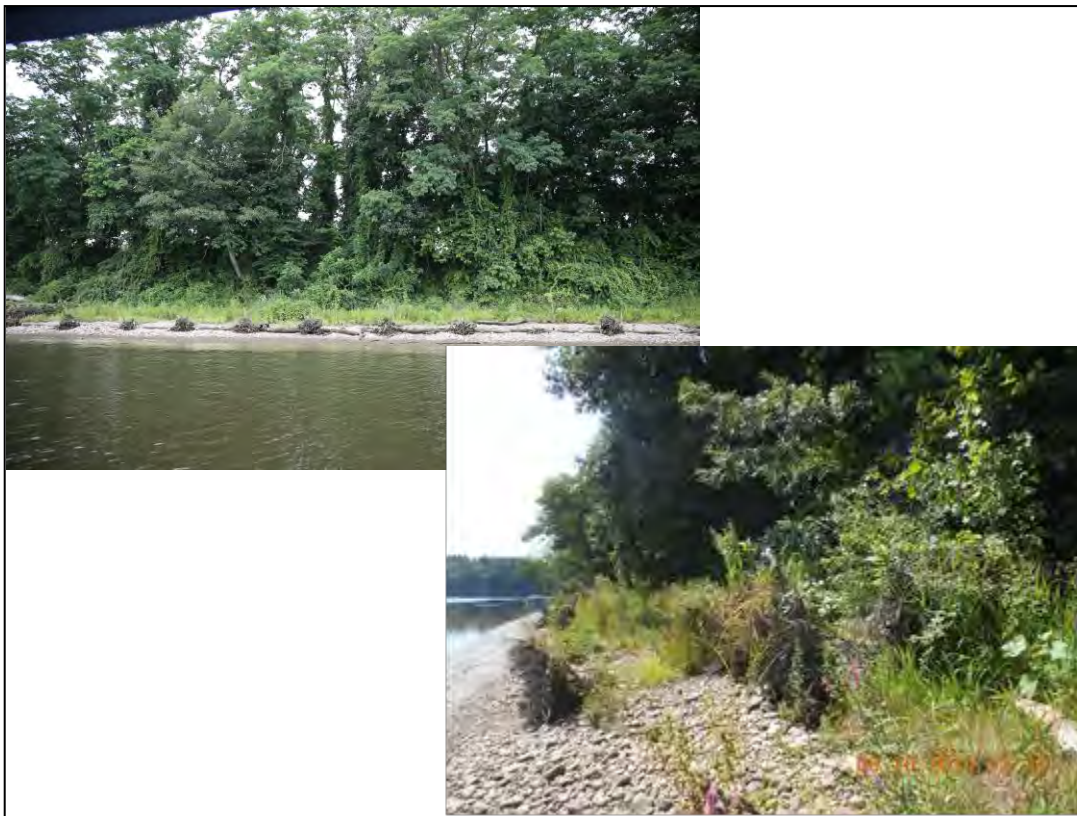
Photo 36: Upper Split River Farm I- Post Construction 2014. Detail from August, 2014

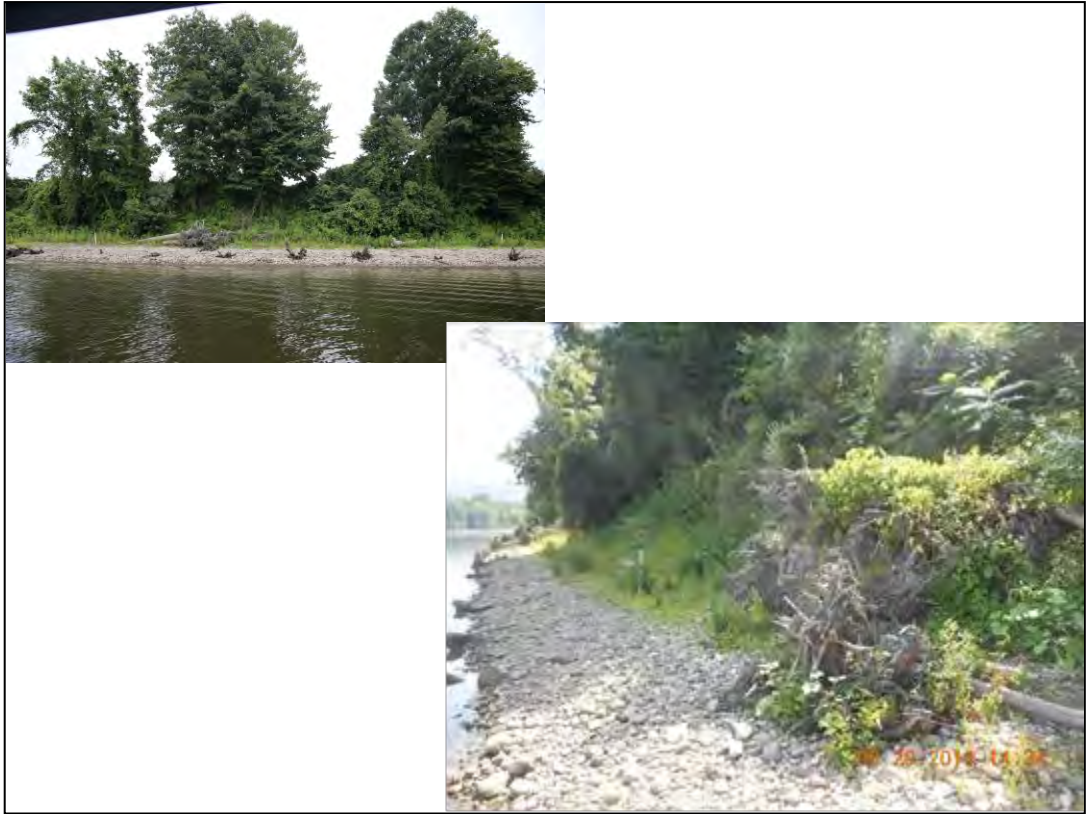
Photo 38: Upper Split River Farm II- Post Construction 2014. Detail from August, 2014

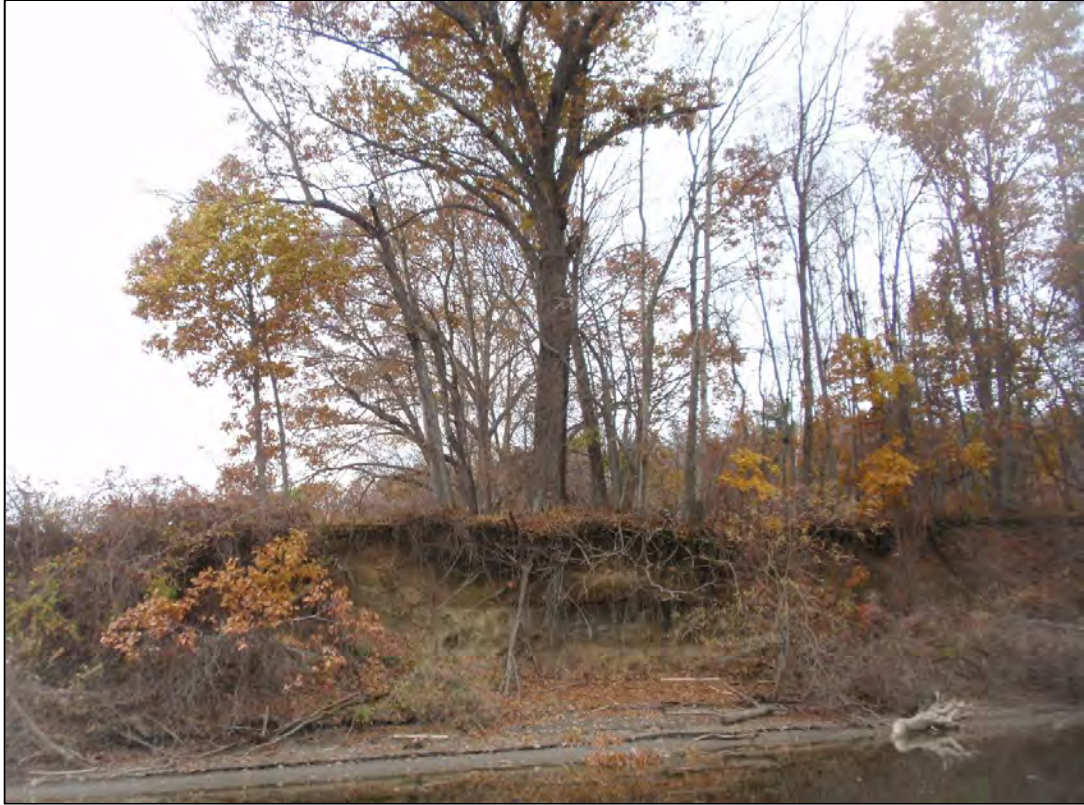
Photo 39: Bathory/Gallagher & Wallace/Watson pre-construction 2012

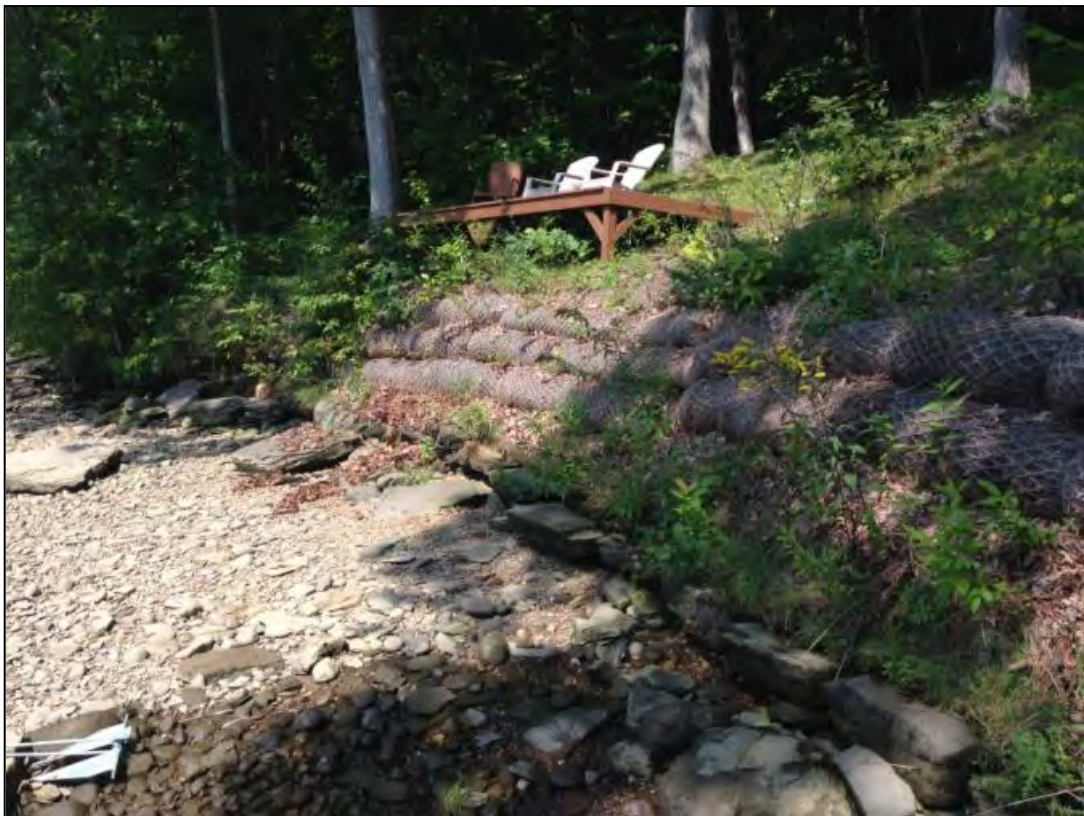
Photo 42: Camp 2W Post Construction 2014.

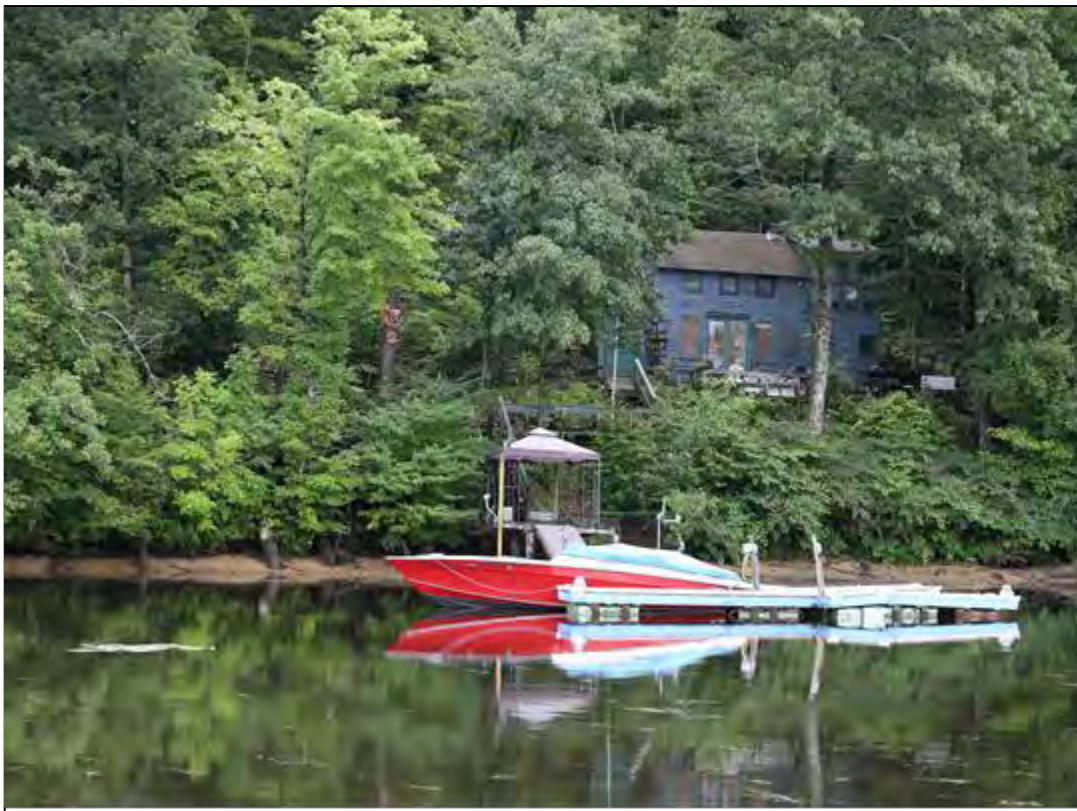
Photo 44: Camp 2E Post Construction 2014.

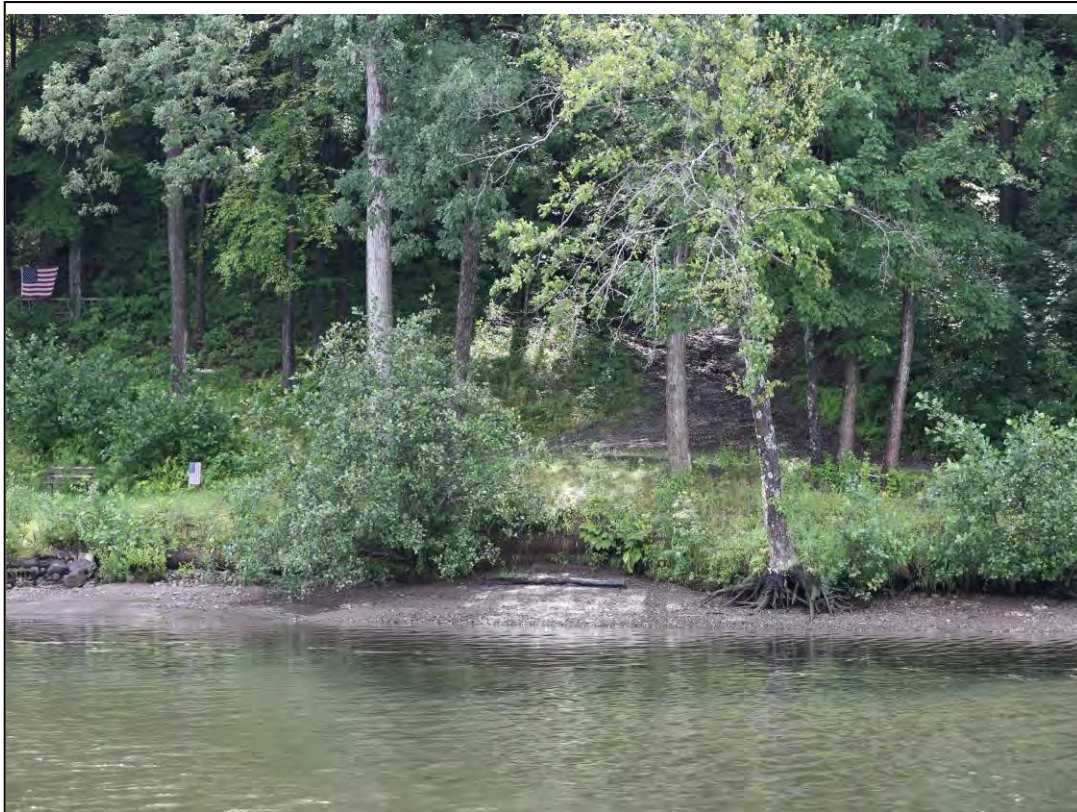
Photo 46: Camp 6E Post Construction 2014.

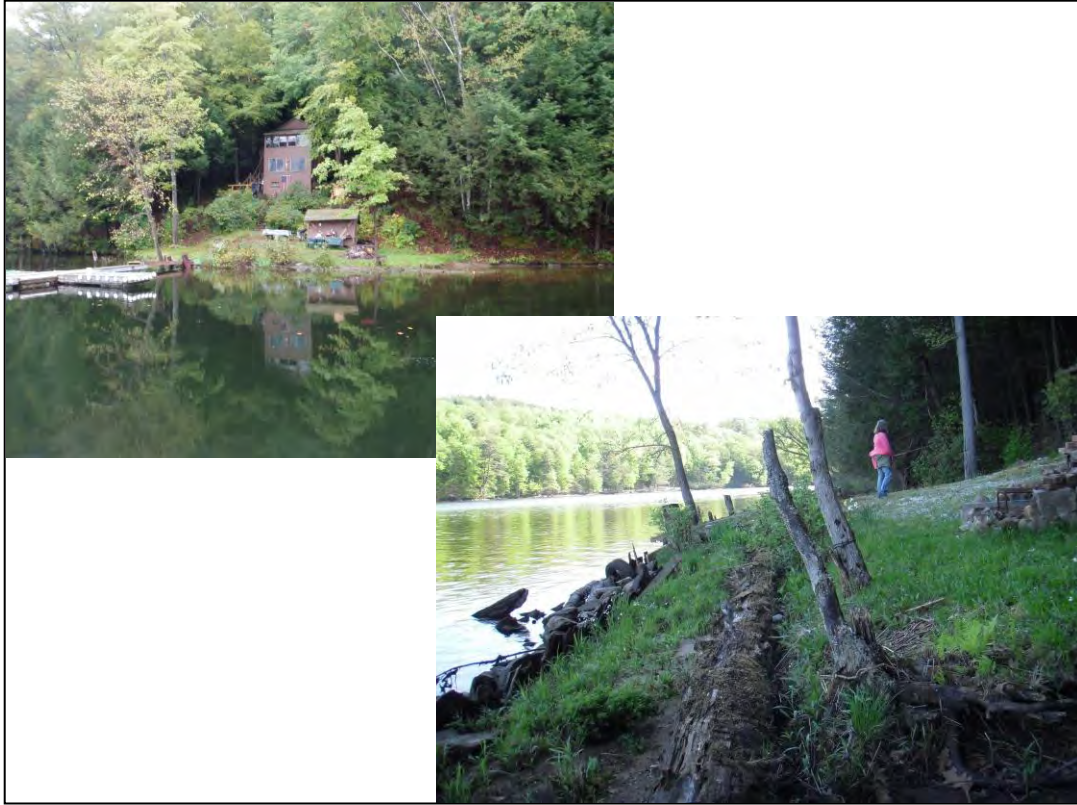
Photo 47: Camp 7E pre-construction 2011, detail of bank

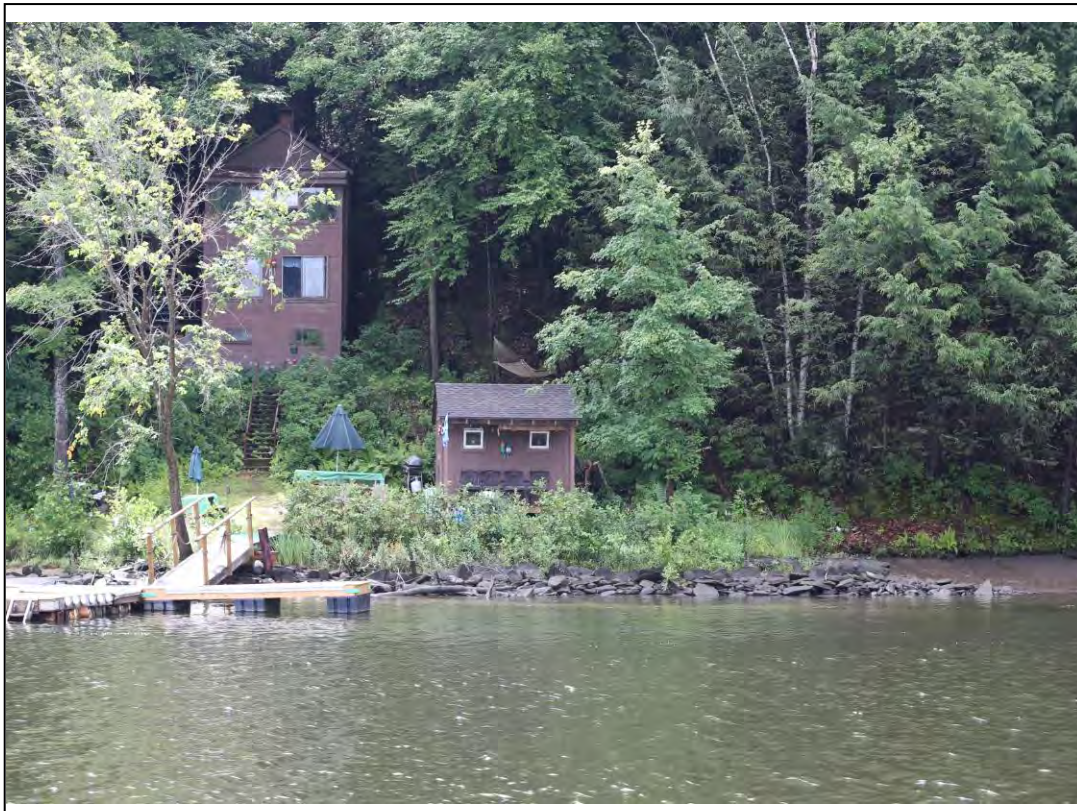
Photo 48: Camp 7E Post Construction 2014.

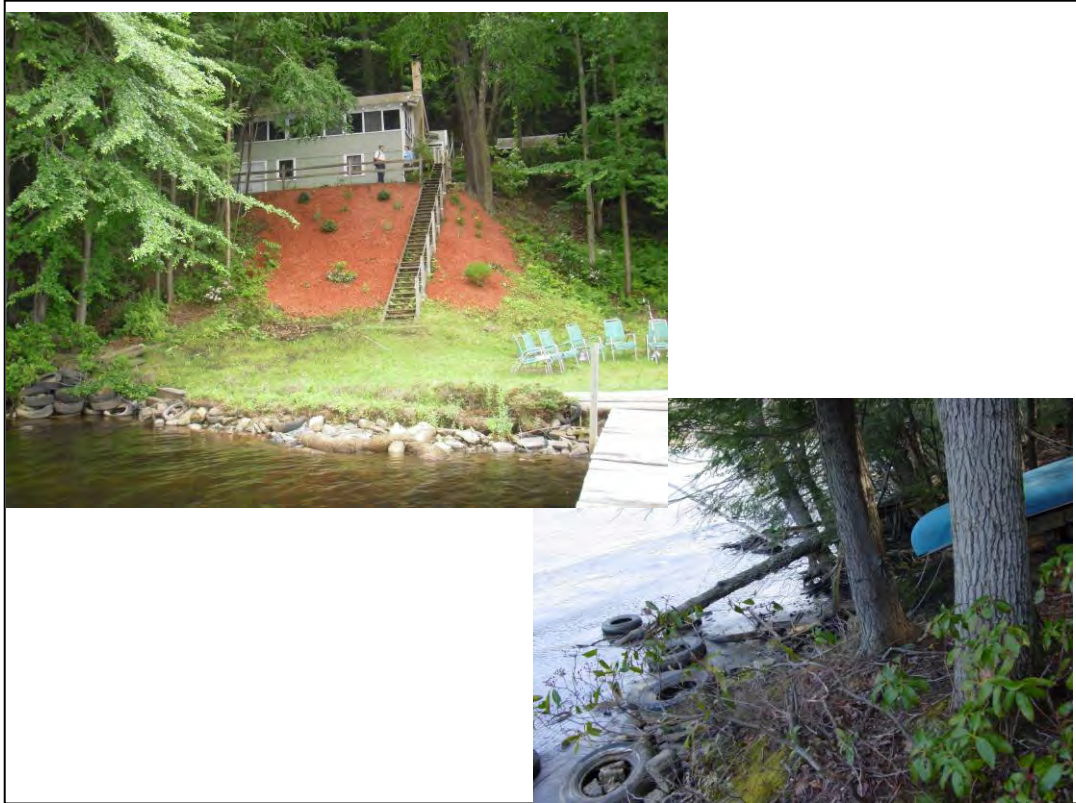
Photo 49: Camp 8E pre-construction 2011. Detail of bank

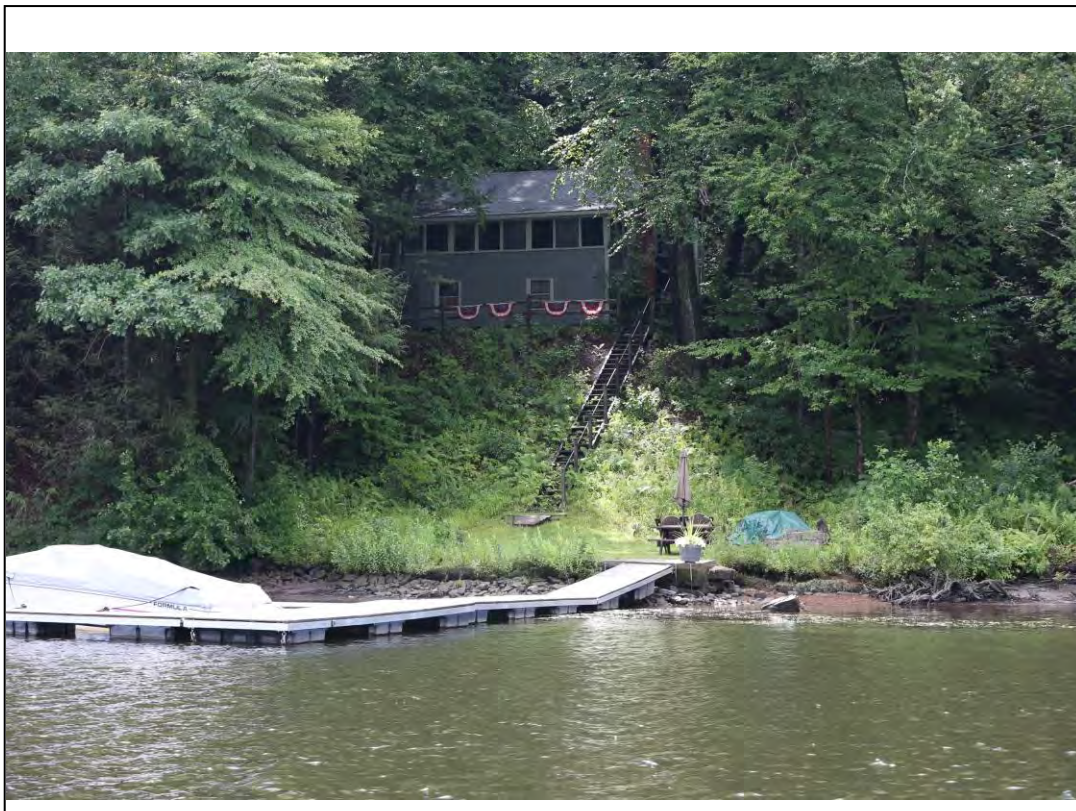
Photo 50: Camp 8E Post Construction 2014.

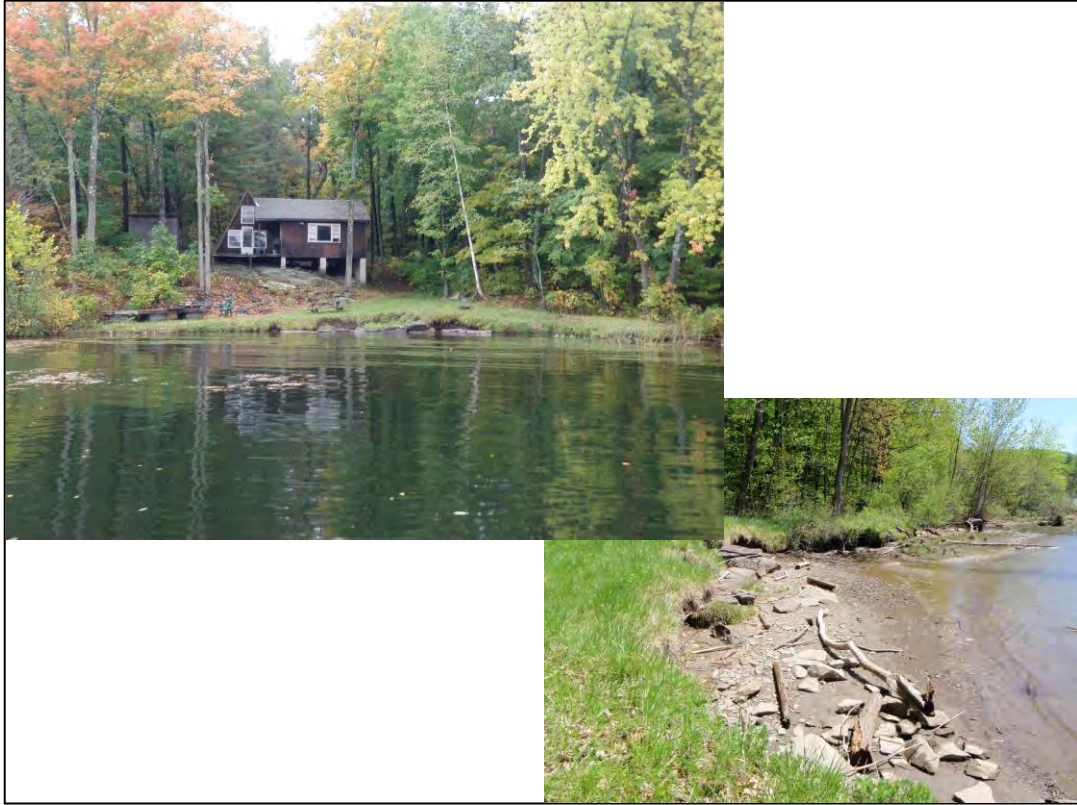
Photo 51: Camp 10W pre-construction 2011. Detail of bank

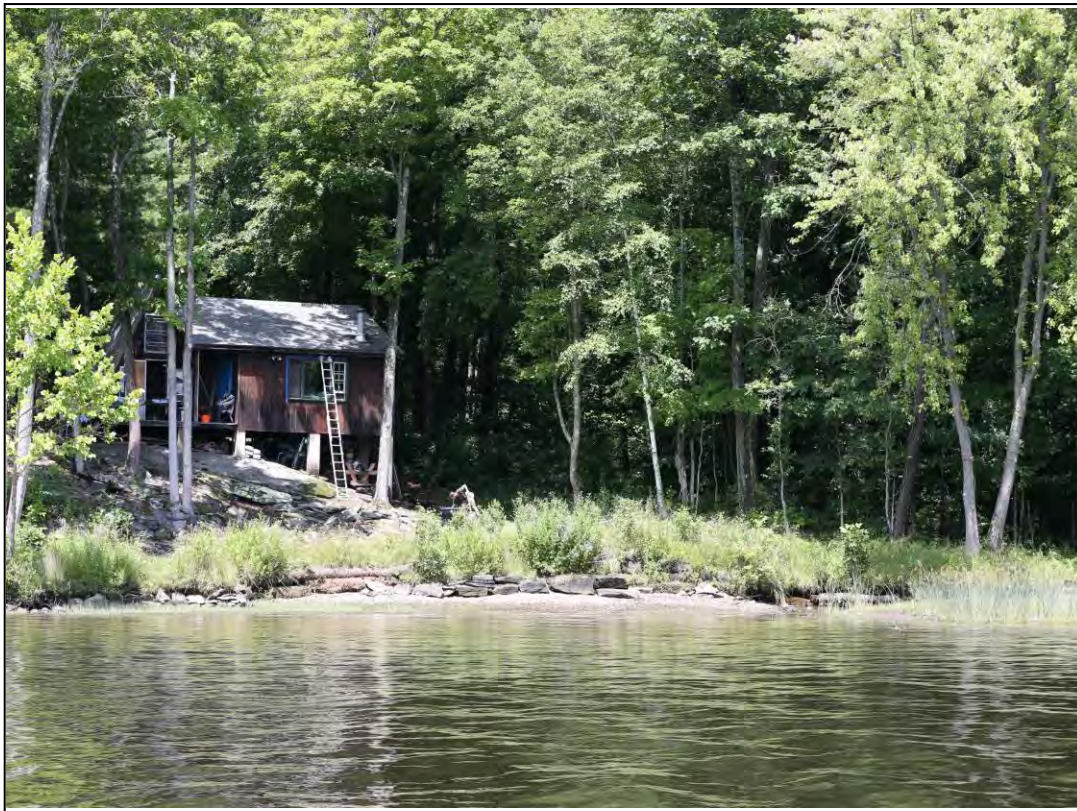
Photo 52: Camp 10W Post Construction 2014.

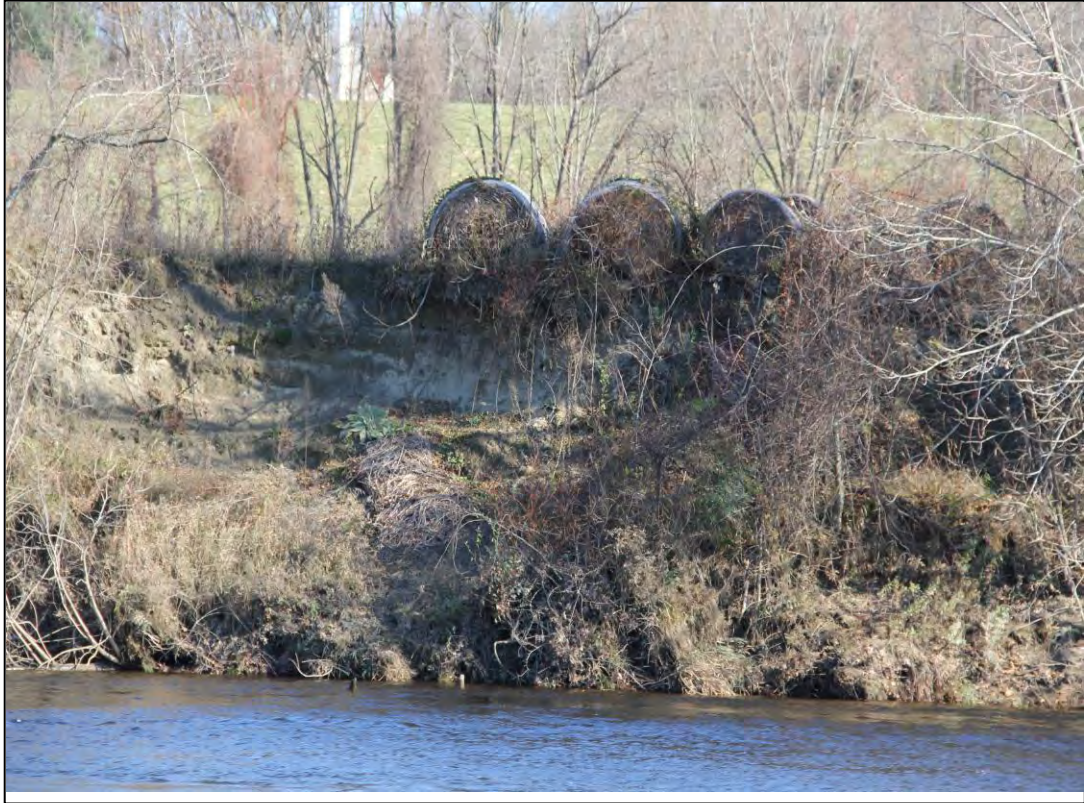
Photo 53: Bonnette Farm pre-construction 2012.

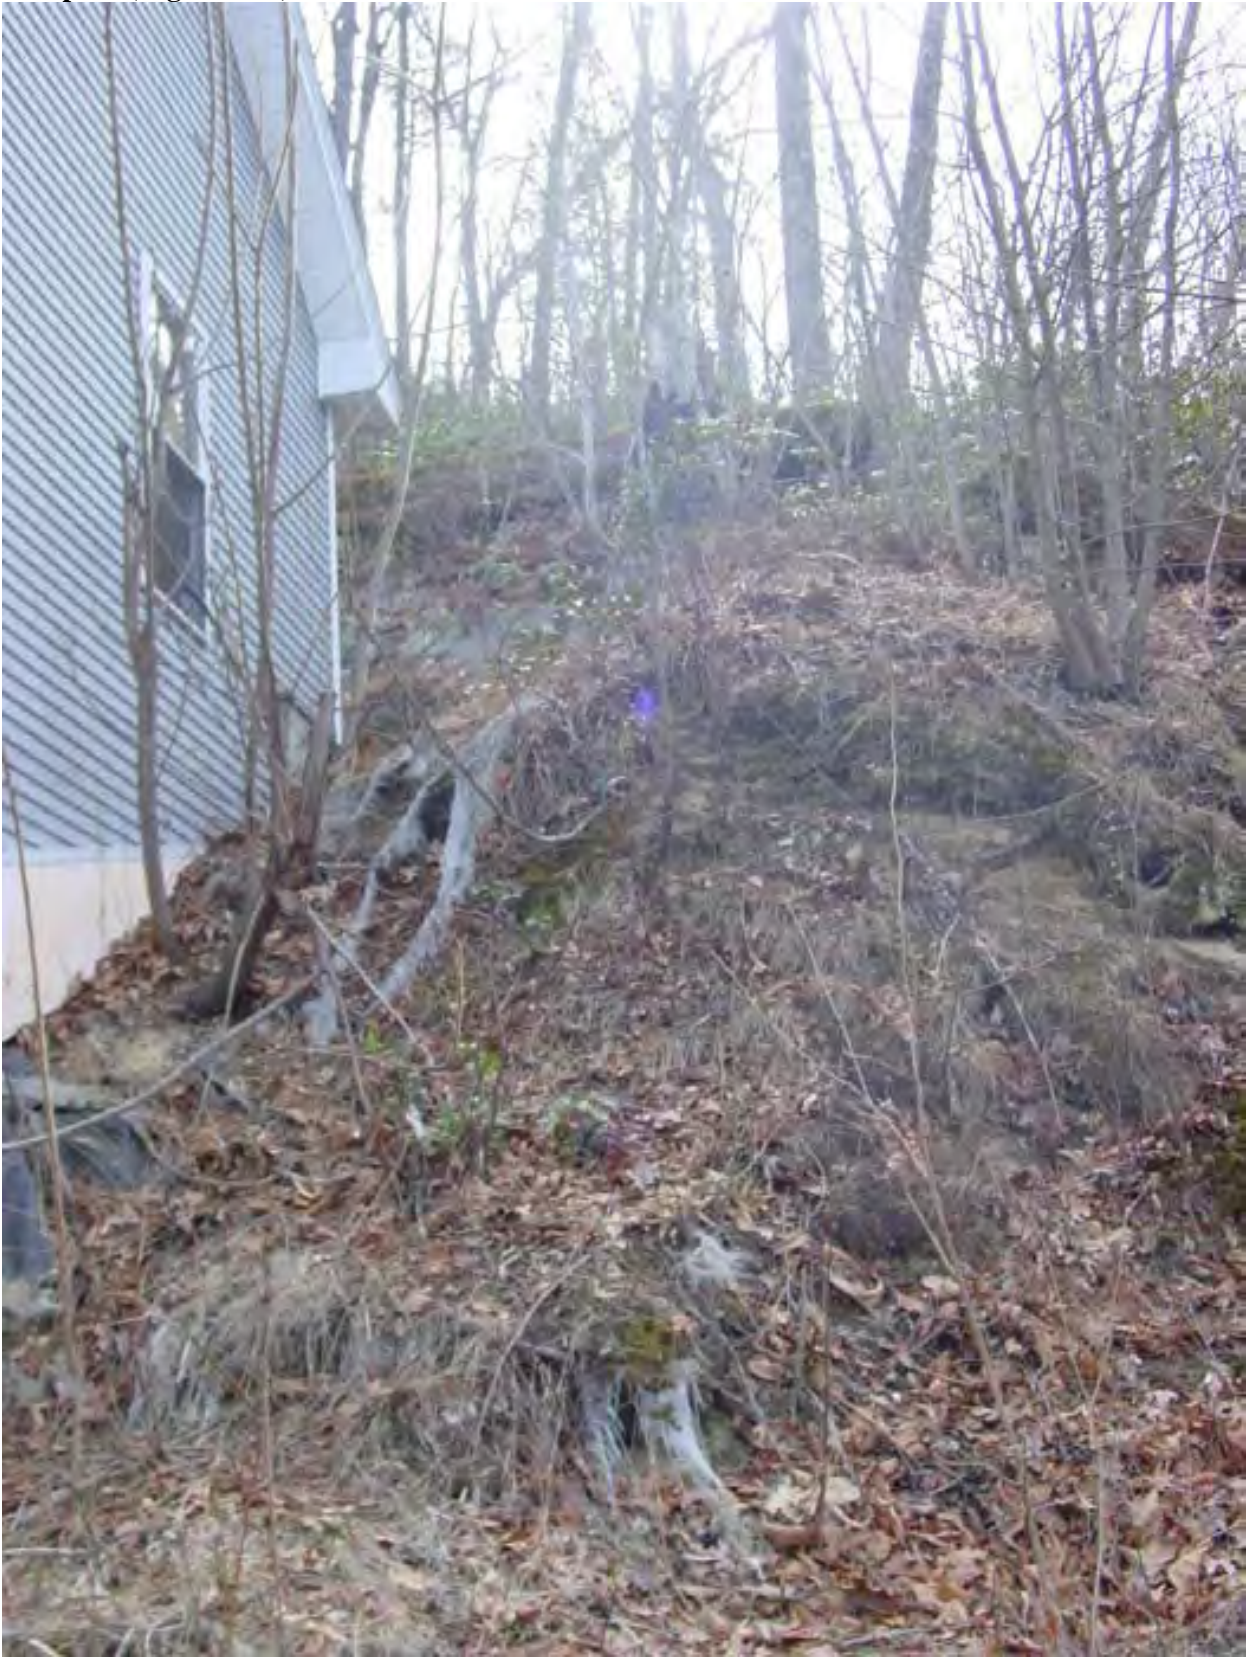
Camp 4E (Segment 25)

Riverbank Features	Characteristics
Upper Riverbank Slope	Moderate
Upper Riverbank Height	High
Upper Riverbank Sediment	Silt/Sand
Upper Riverbank Vegetation	Moderate
Lower Riverbank Slope	Moderate
Lower Riverbank Sediment	Boulders
Lower Riverbank Vegetation	None-Very Sparse
Type of Erosion	Slide
Potential Erosion Indicators	Creep/Leaning Trees, Other
Stage of Erosion	Eroded
Extent of Erosion	Some
