**Relicensing Study 3.1.2**

**Northfield Mountain / Turners Falls  
Operations Impact on Existing Erosion and  
Potential Bank Instability  
Study Report**

**Volume III – Appendices**

**Northfield Mountain Pumped Storage Project (No. 2485) and  
Turners Falls Hydroelectric Project (No. 1889)**

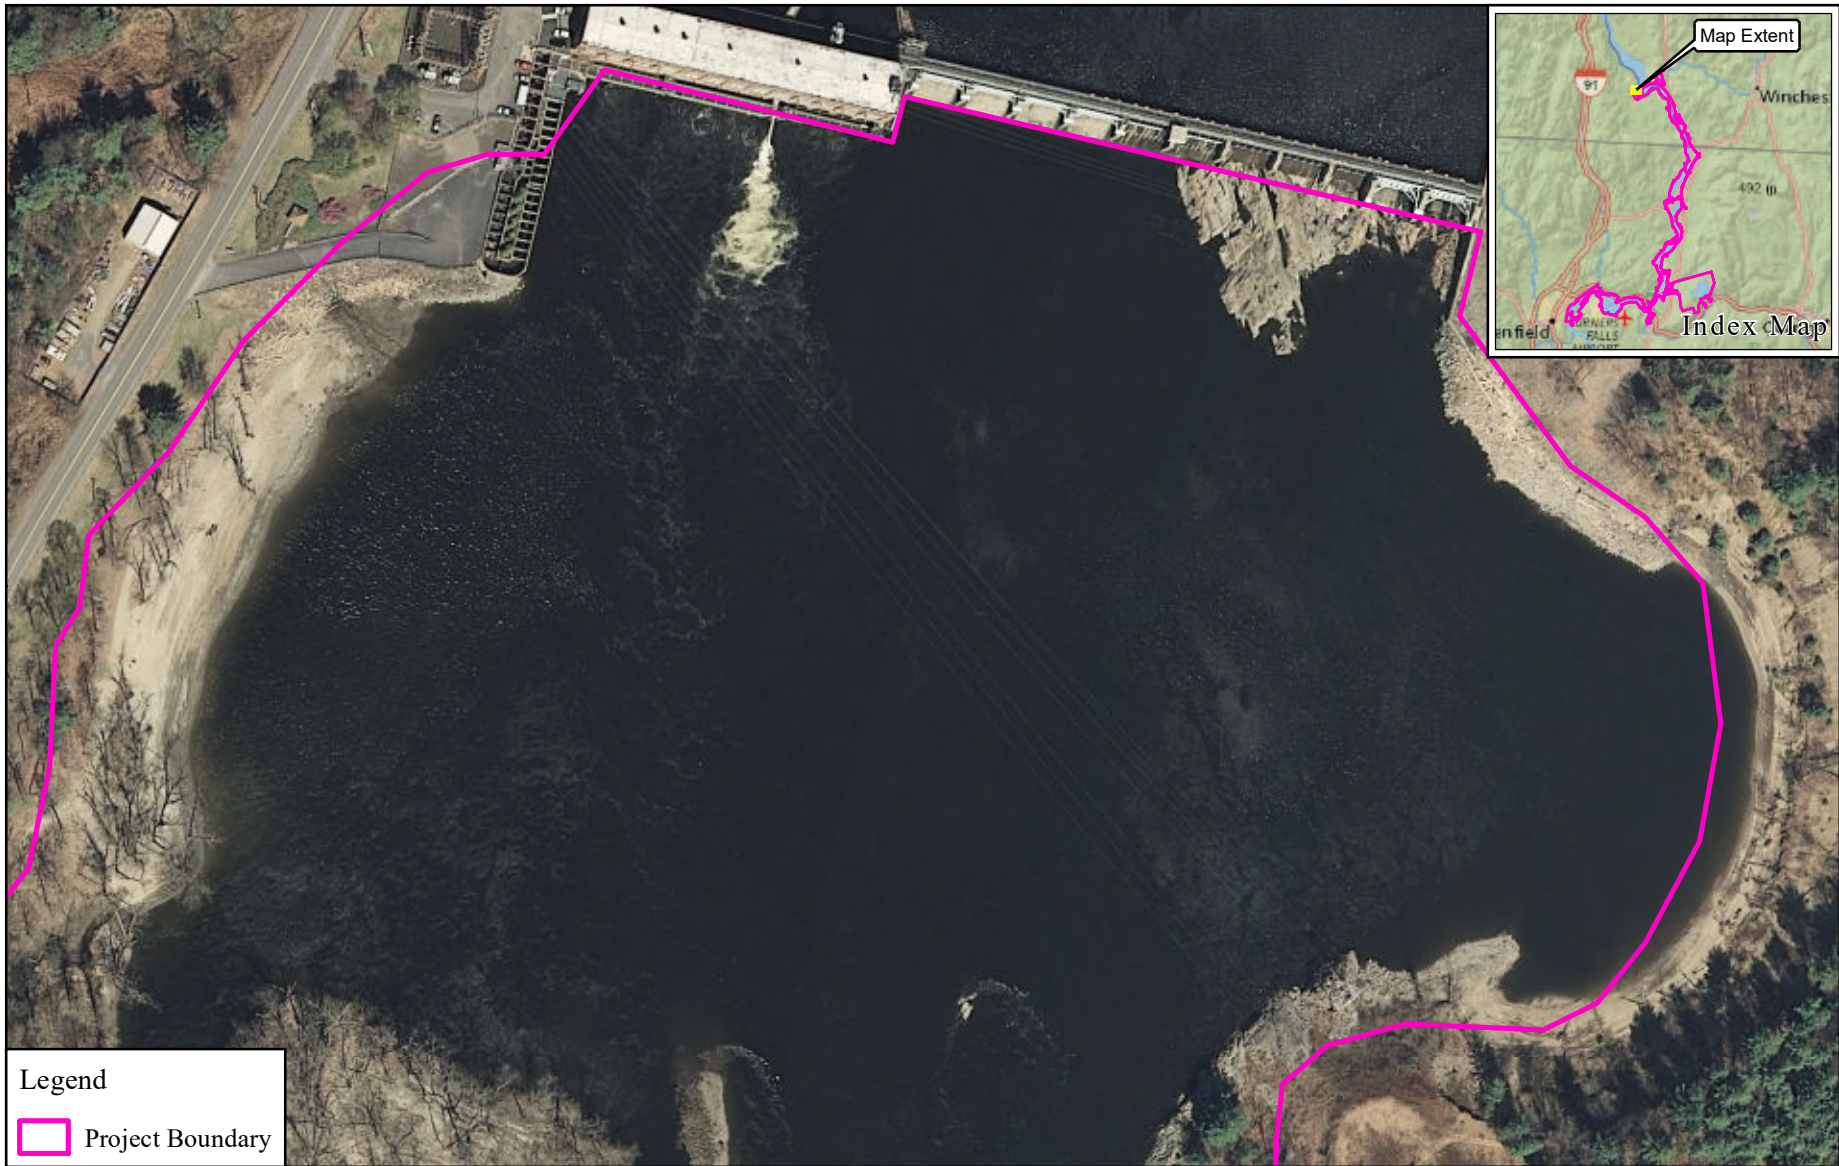
Vernon Dam  
 1952 Imagery  
 (Source: North by Northeast Survey Company)

The 1952 photograph shows that the top of left bank is near the project boundary line (indicated in fuchsia). Recent photographs show that erosion has progressed beyond the line such that the bottom of the upper bank is beyond the line. The 2008-2010 and the Online Imagery were taken at relatively high flow conditions and show the turbulence and eddying associated with the release of flow through the left gates of Vernon Dam as well as the general turbulence in this reach of the river at these levels of flow.

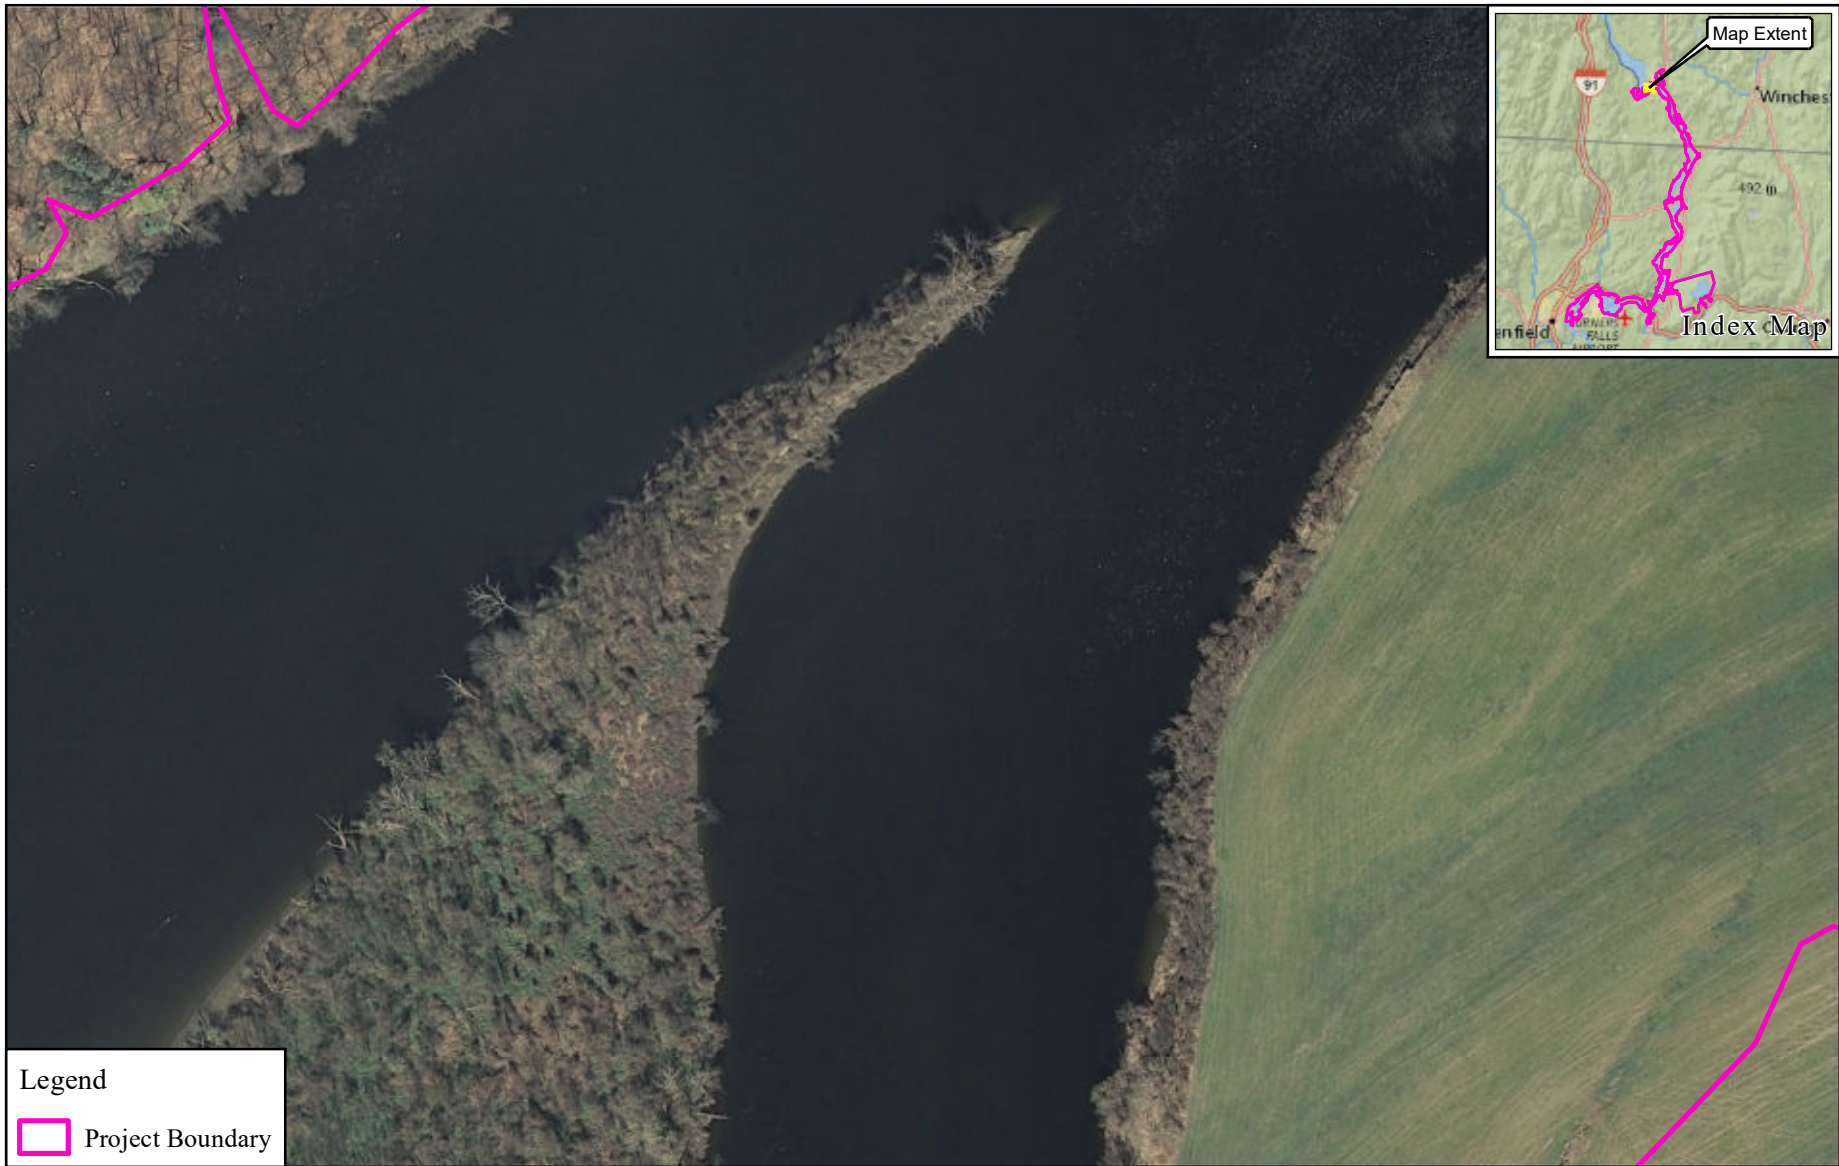
Stebbins Island  
 1952 Imagery  
 (Source: North by Northeast Survey Company)

The 1952 photograph shows that there is little vegetation along the right bank of the river, bars and small vegetated islands to the left of the main island, and shallow flow conditions on both sides of the island. By the 2008-2010 set of photos, the downstream tip of the island had narrowed but the potentially eroded right bank which in 1952 had little to no vegetation on the bank had some establishment of vegetation on the bank. The 2014 and Online Imagery are similar to the 2008-2010 photograph.

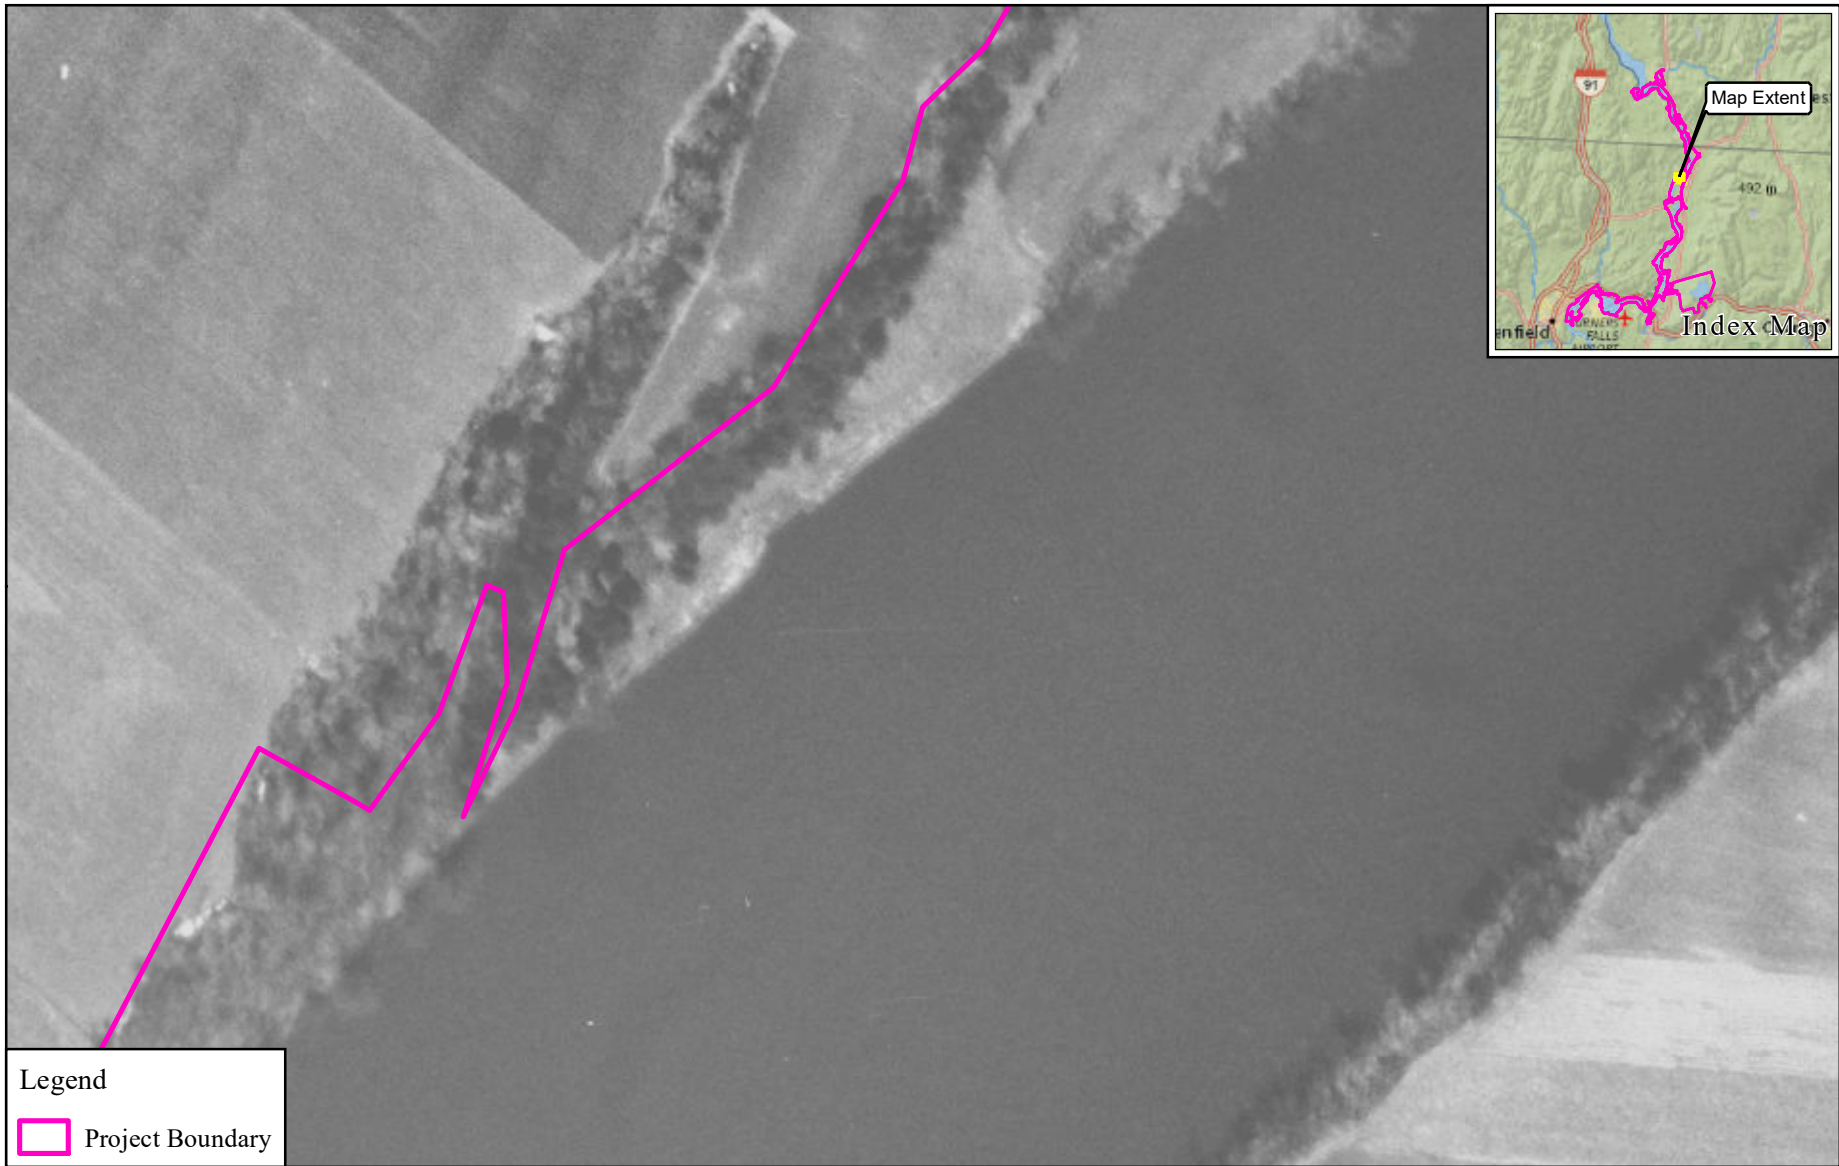
Wickey  
 1952 Imagery  
 (Source: North by Northeast Survey Company)

In the 1952 and 1960s photographs, there is an eroded section of riverbank with no significant riparian vegetation. During the 1990s, this site was selected for erosion repair, known as the Wickey site (constructed in 1996).

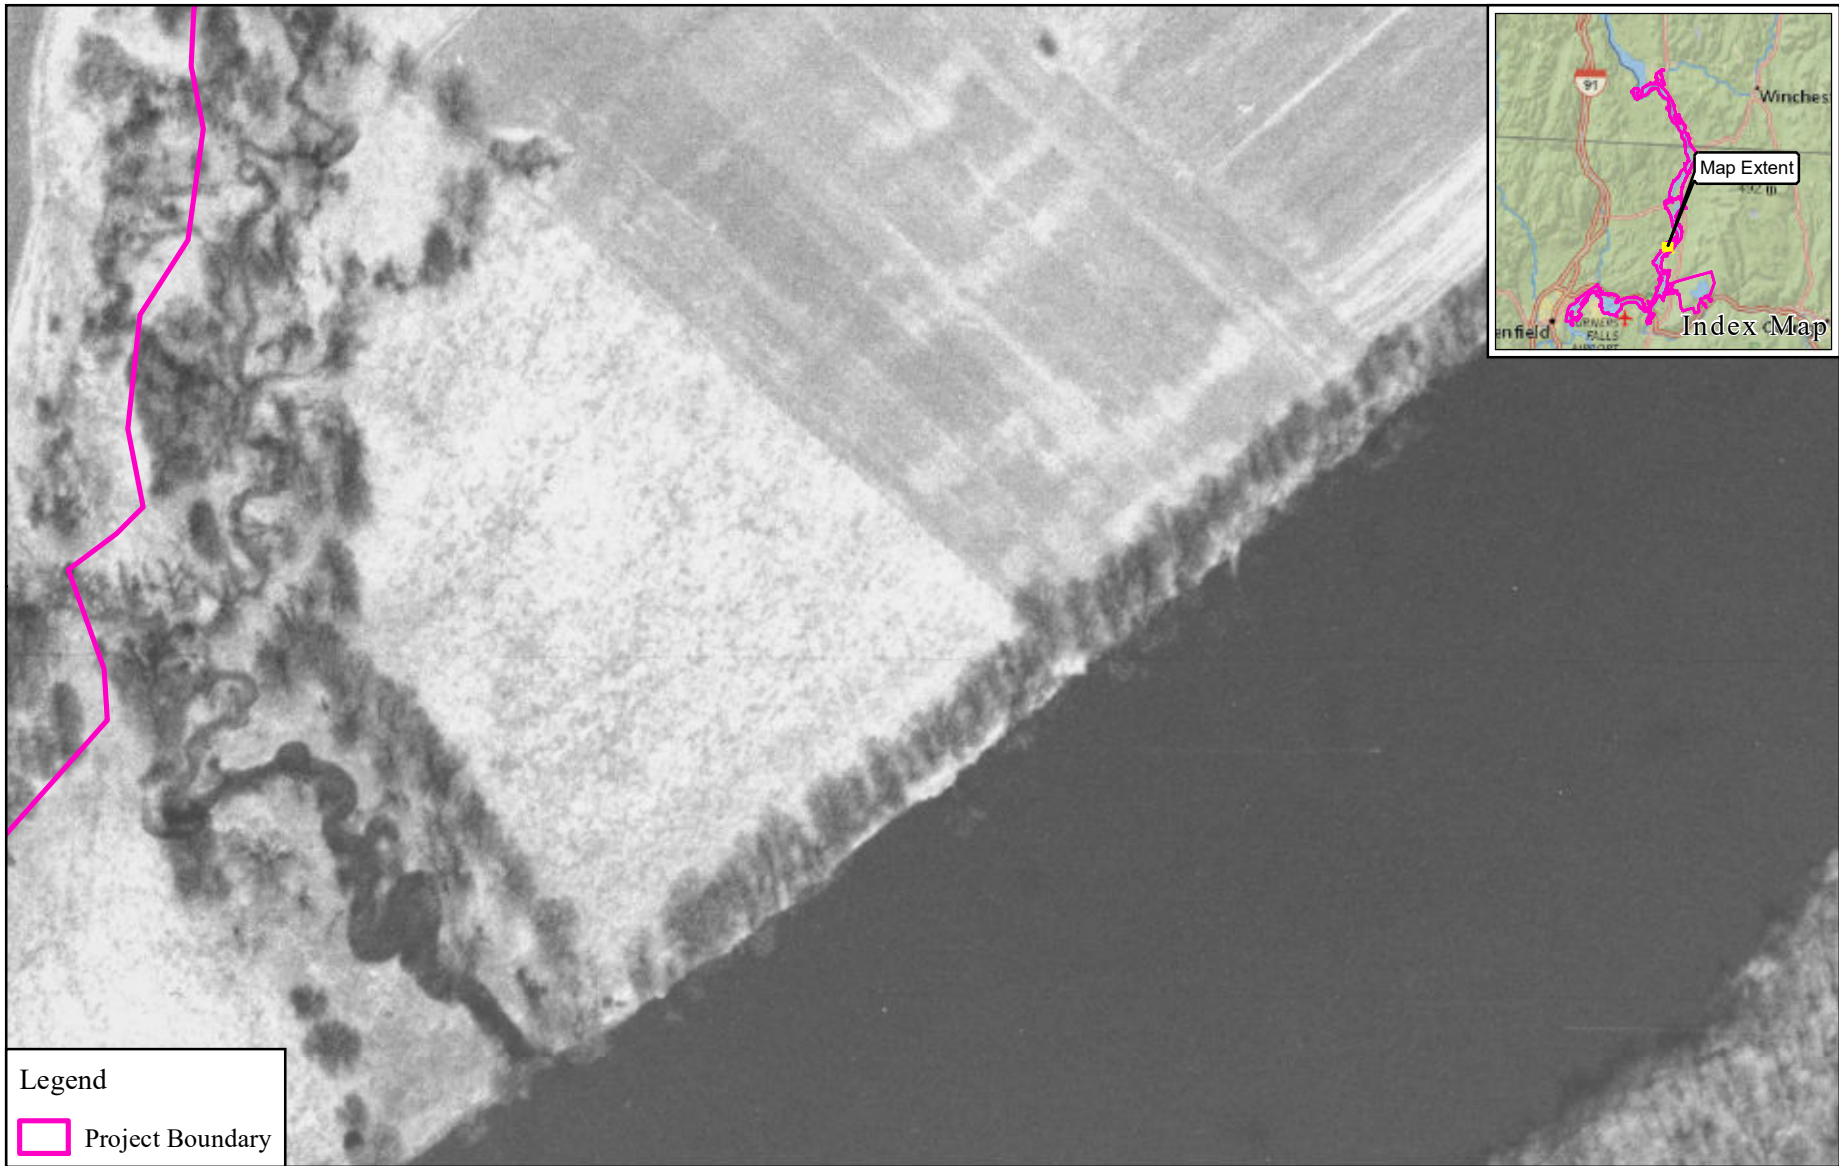
Flagg (upstream of Otter Run)  
 1952 Imagery  
 (Source: North by Northeast Survey Company)

The right bank upstream of Otter Run follows the same pattern as the segment downstream from 1952 through the 1990s photographs with sparse riverbank vegetation in the 1950s and 1960s and virtually no riparian vegetation and erosion evident in the 1990s. This upstream site was stabilized in 2000 as part of the Flagg site through the ECP. This segment of the site was fenced off without access to cattle and is now densely vegetated and has a rock toe with aquatic vegetation growing on the lower riverbank. The riparian vegetation can be seen in the recent photographs.

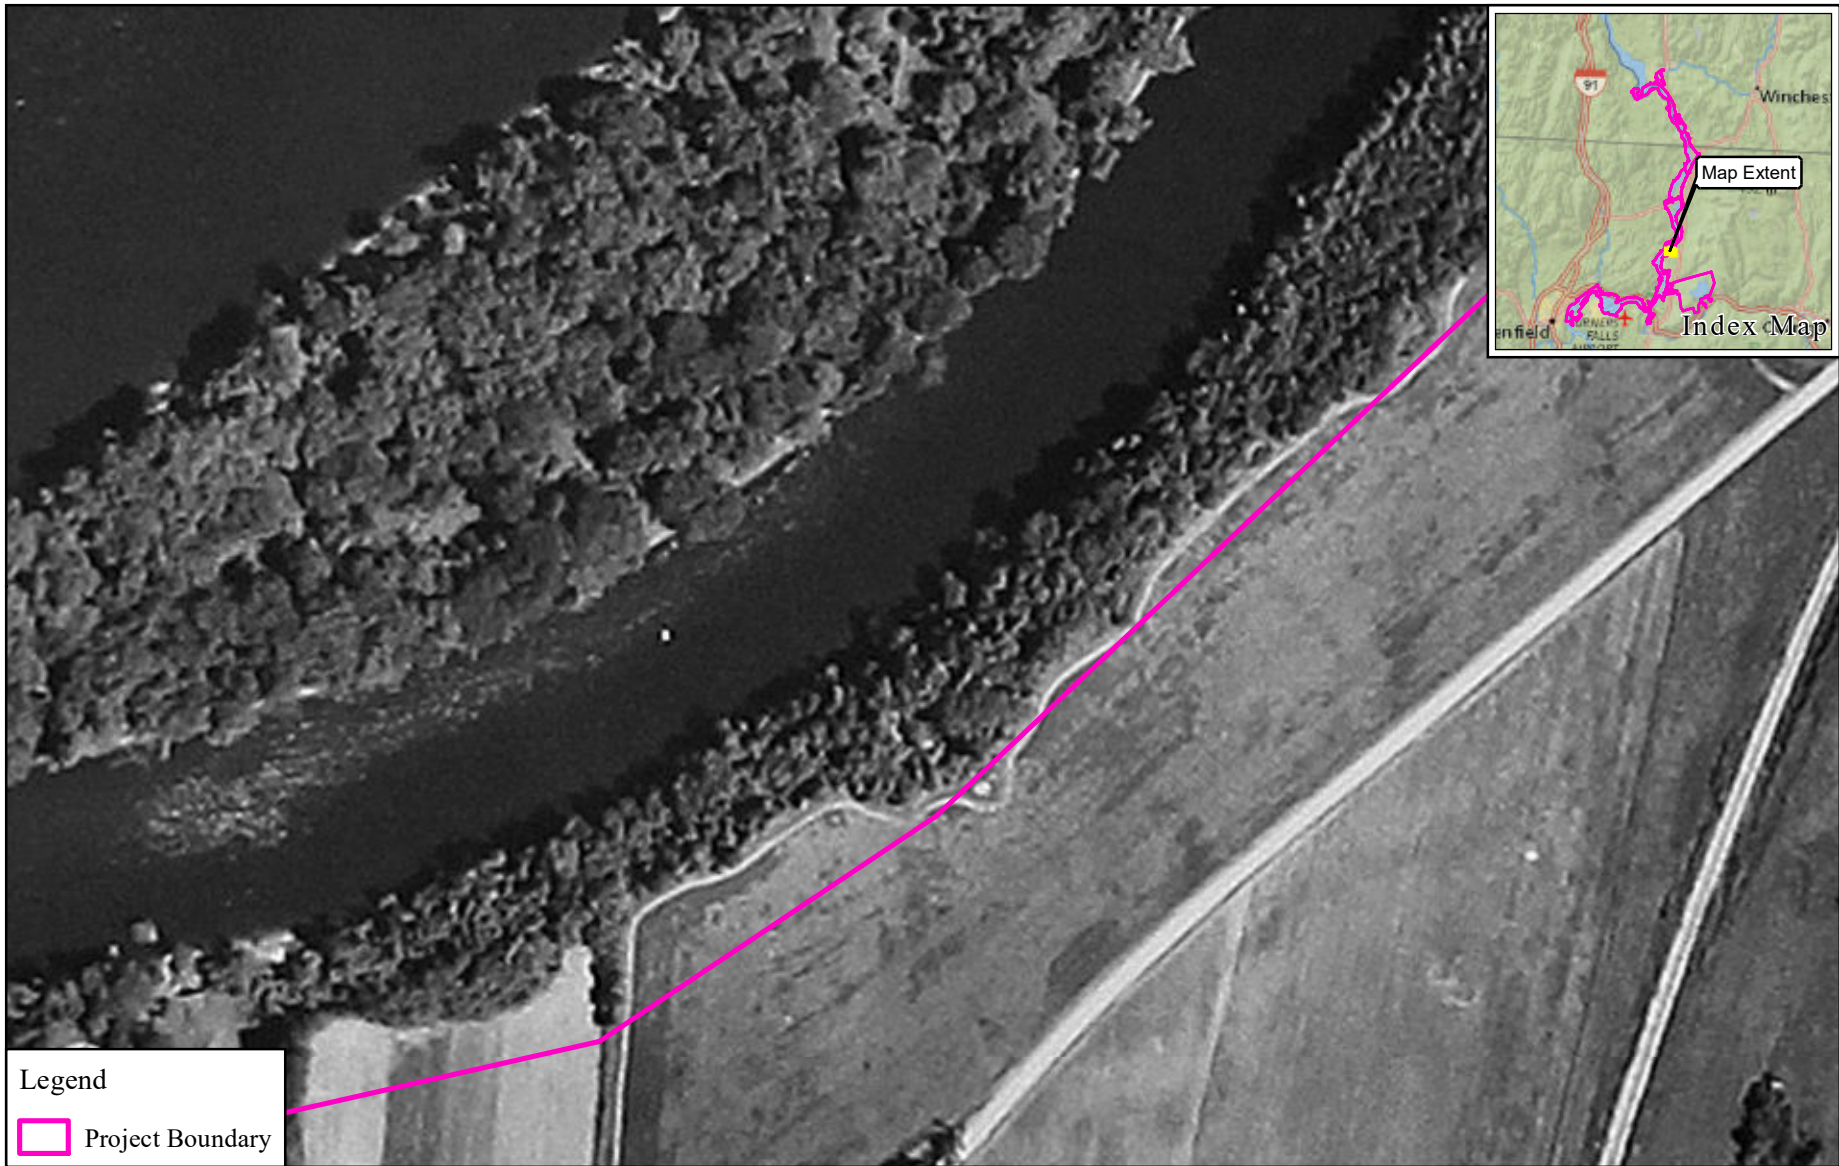
Skalski  
 1952 Imagery  
 (Source: North by Northeast Survey Company)

The left bank of the river in the vicinity of Kidds Island has a band of riparian vegetation in the 1952, 1960s and 1990s photographs. While not apparent in the photographs, erosion had been occurring along this bank and was identified in the ECP and stabilized in 2004 as the Skalski site as can be seen in the more recent photographs with a rock toe and vegetated upper bank.

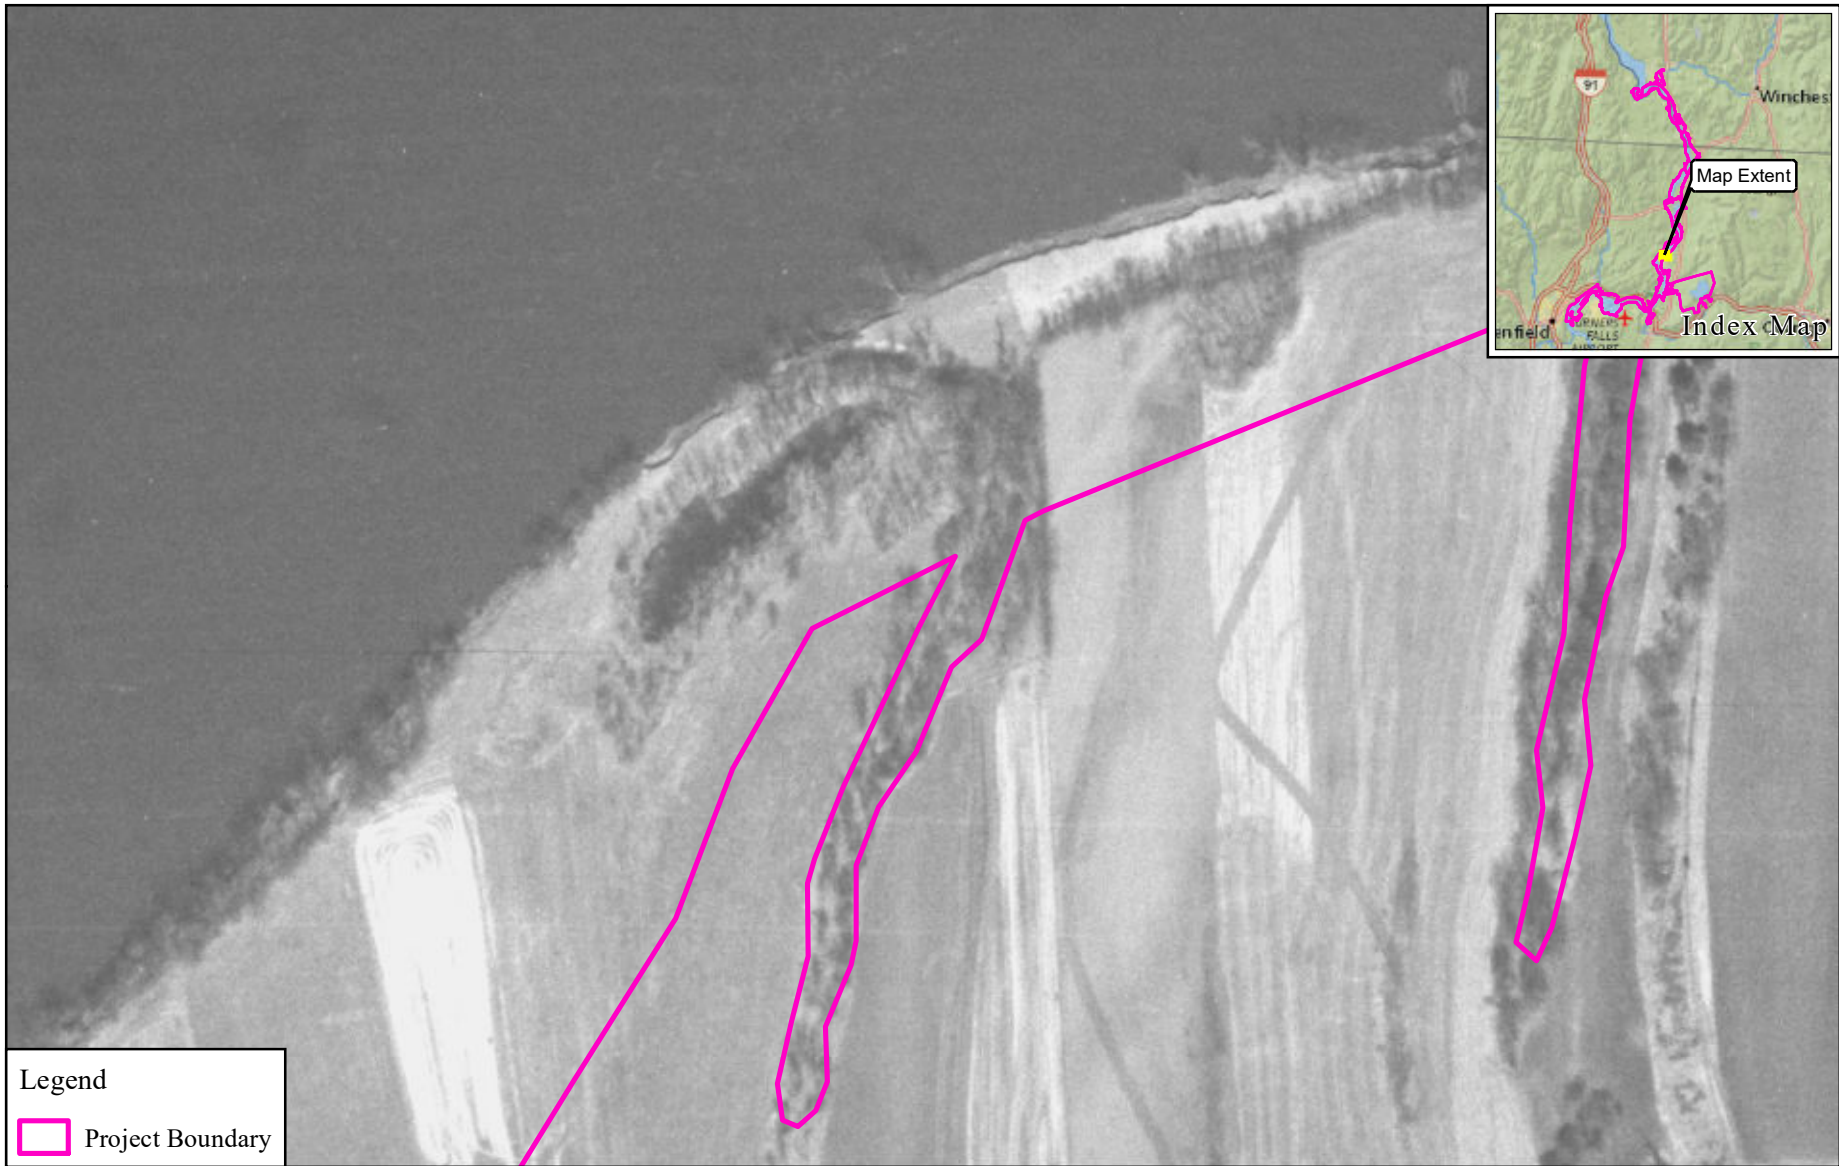
Left Bank Downstream of Kidds Island  
1960's Imagery  
(Source: USGS)

On the left bank downstream of Kidds Island the 1952 and 1960s photographs show eroded conditions with little riparian vegetation. By the 1990s, the narrow remnants of a field appear to have been eroded away and into another band of riparian vegetation.

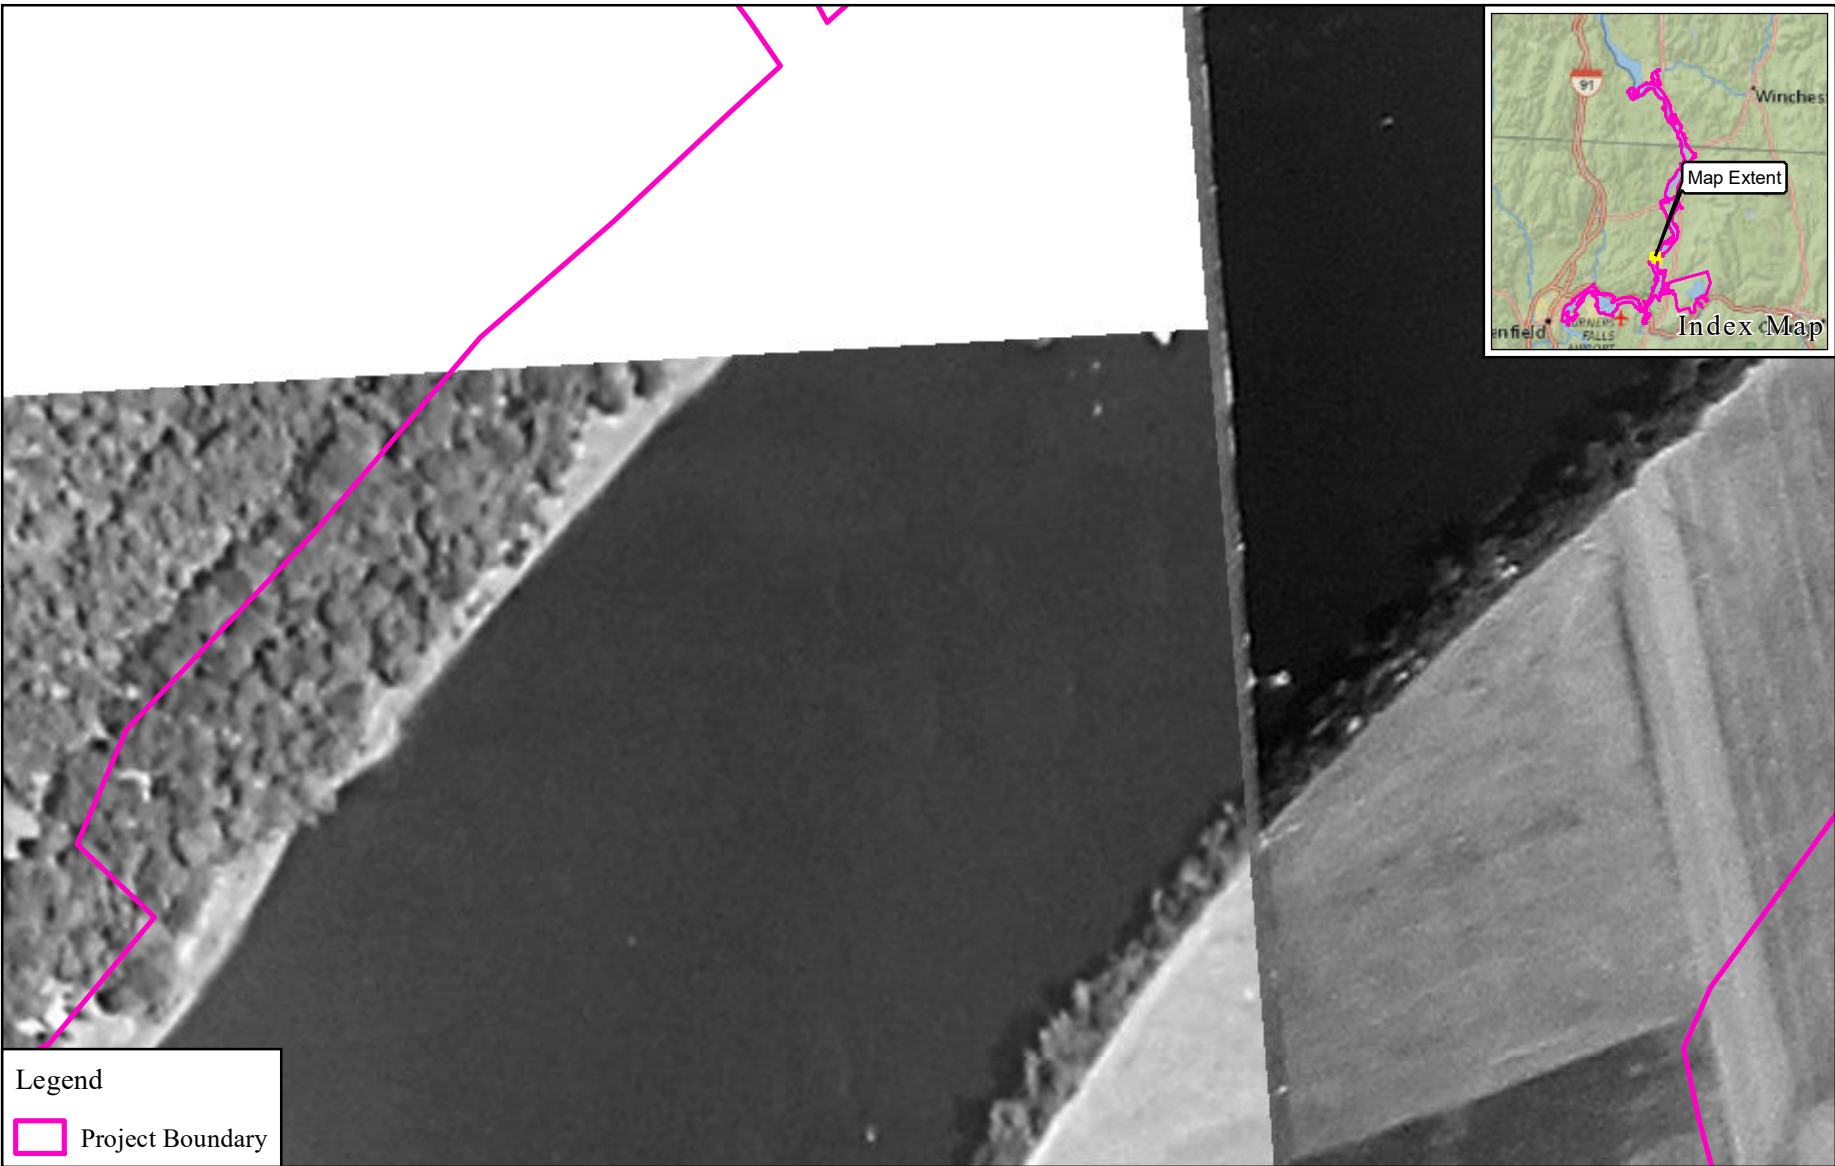
L'Etoile  
1952 Imagery  
(Source: North by Northeast Survey Company)

Another few thousand feet downstream of Kidds Island on the left bank is another area adjacent to an agricultural field with a very narrow band of riparian vegetation which appears to have narrowed over time from 1952 to the 1990s. In 1998 stabilization occurred at what was called the L'Etoile site which can be seen in subsequent photographs.

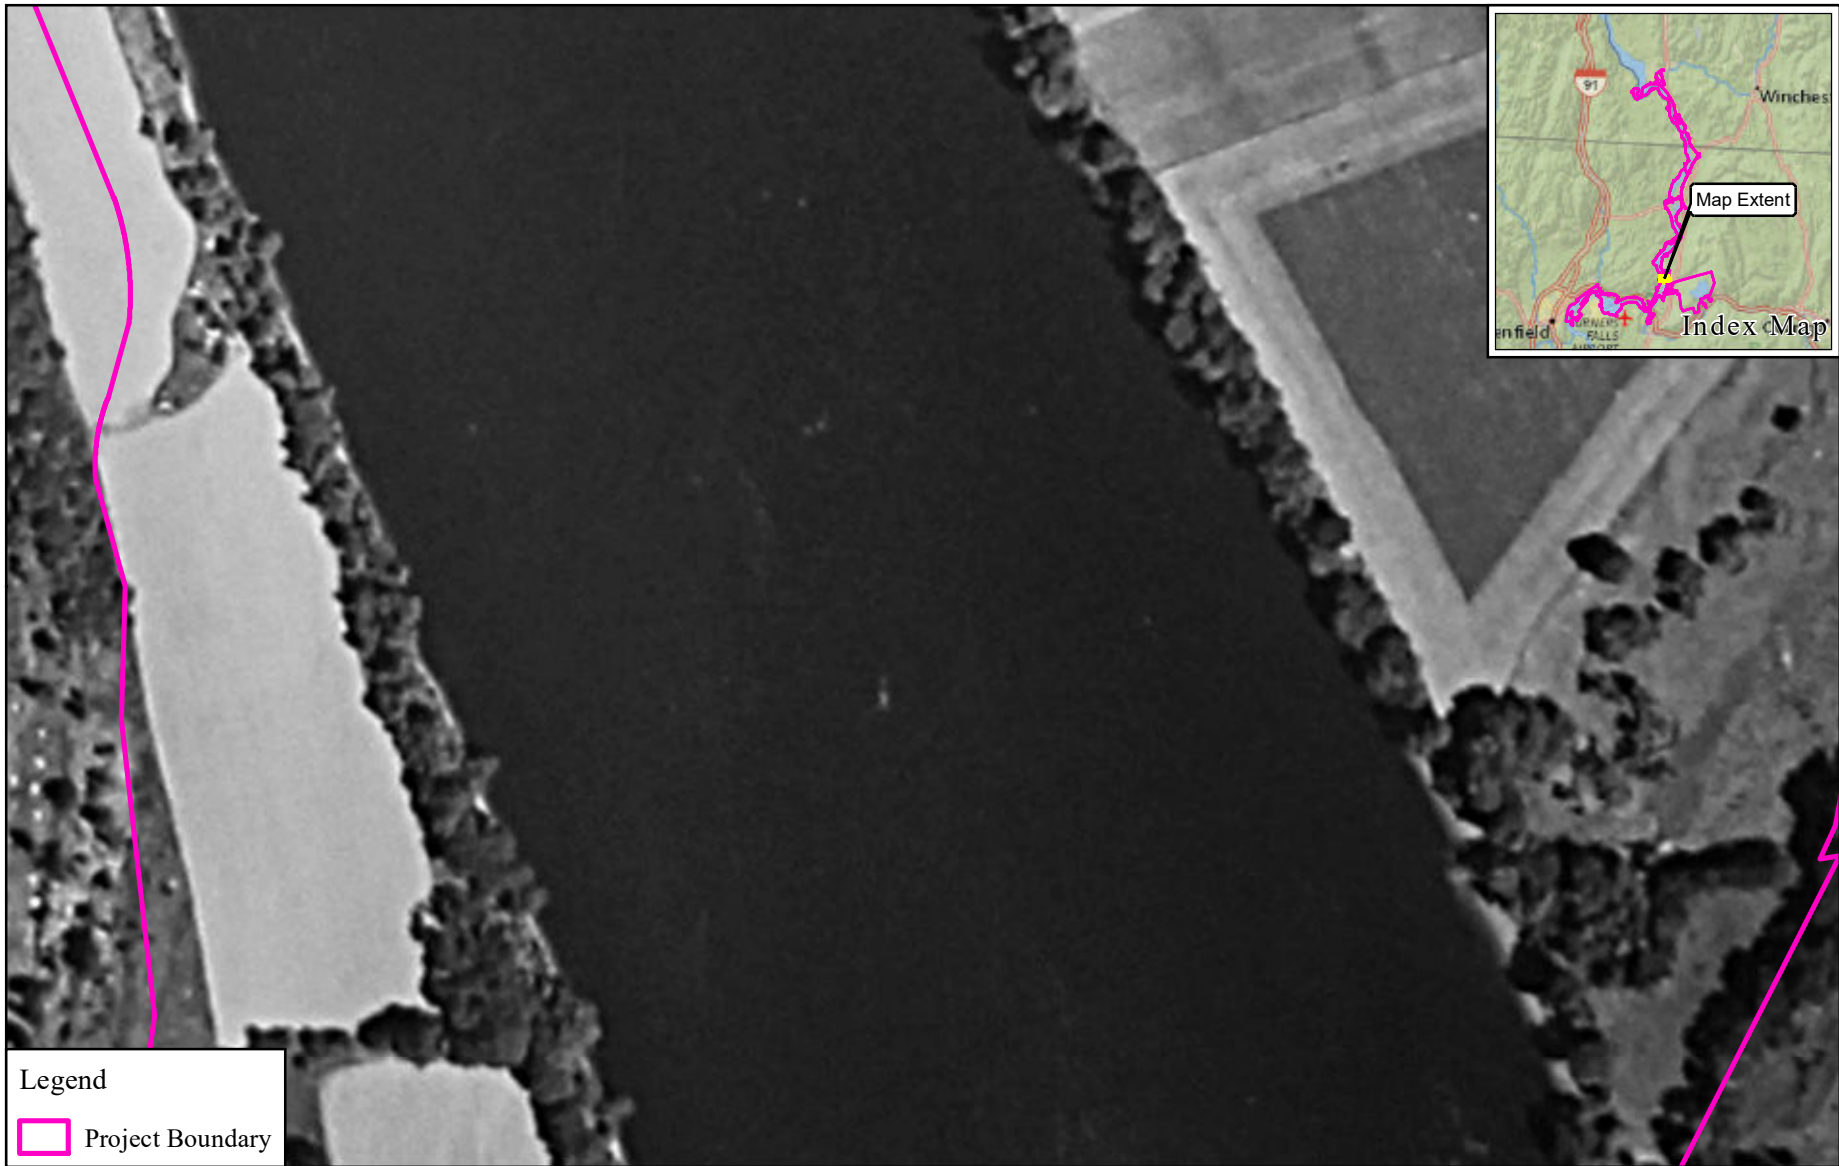
Shearer/Bathory-Gallagher  
 1952 Imagery  
 (Source: North by Northeast Survey Company)

Upstream of the tailrace along both banks there was a band of riparian vegetation in the 1952 photograph. By the 1960s photograph the riparian zone appear to have decreased and erosion is evident. The left bank was stabilized in 1996 (Shearer site) and the right bank was stabilized through the ECP as the Bathory/Gallagher site in 2012 as can be seen on recent photographs.

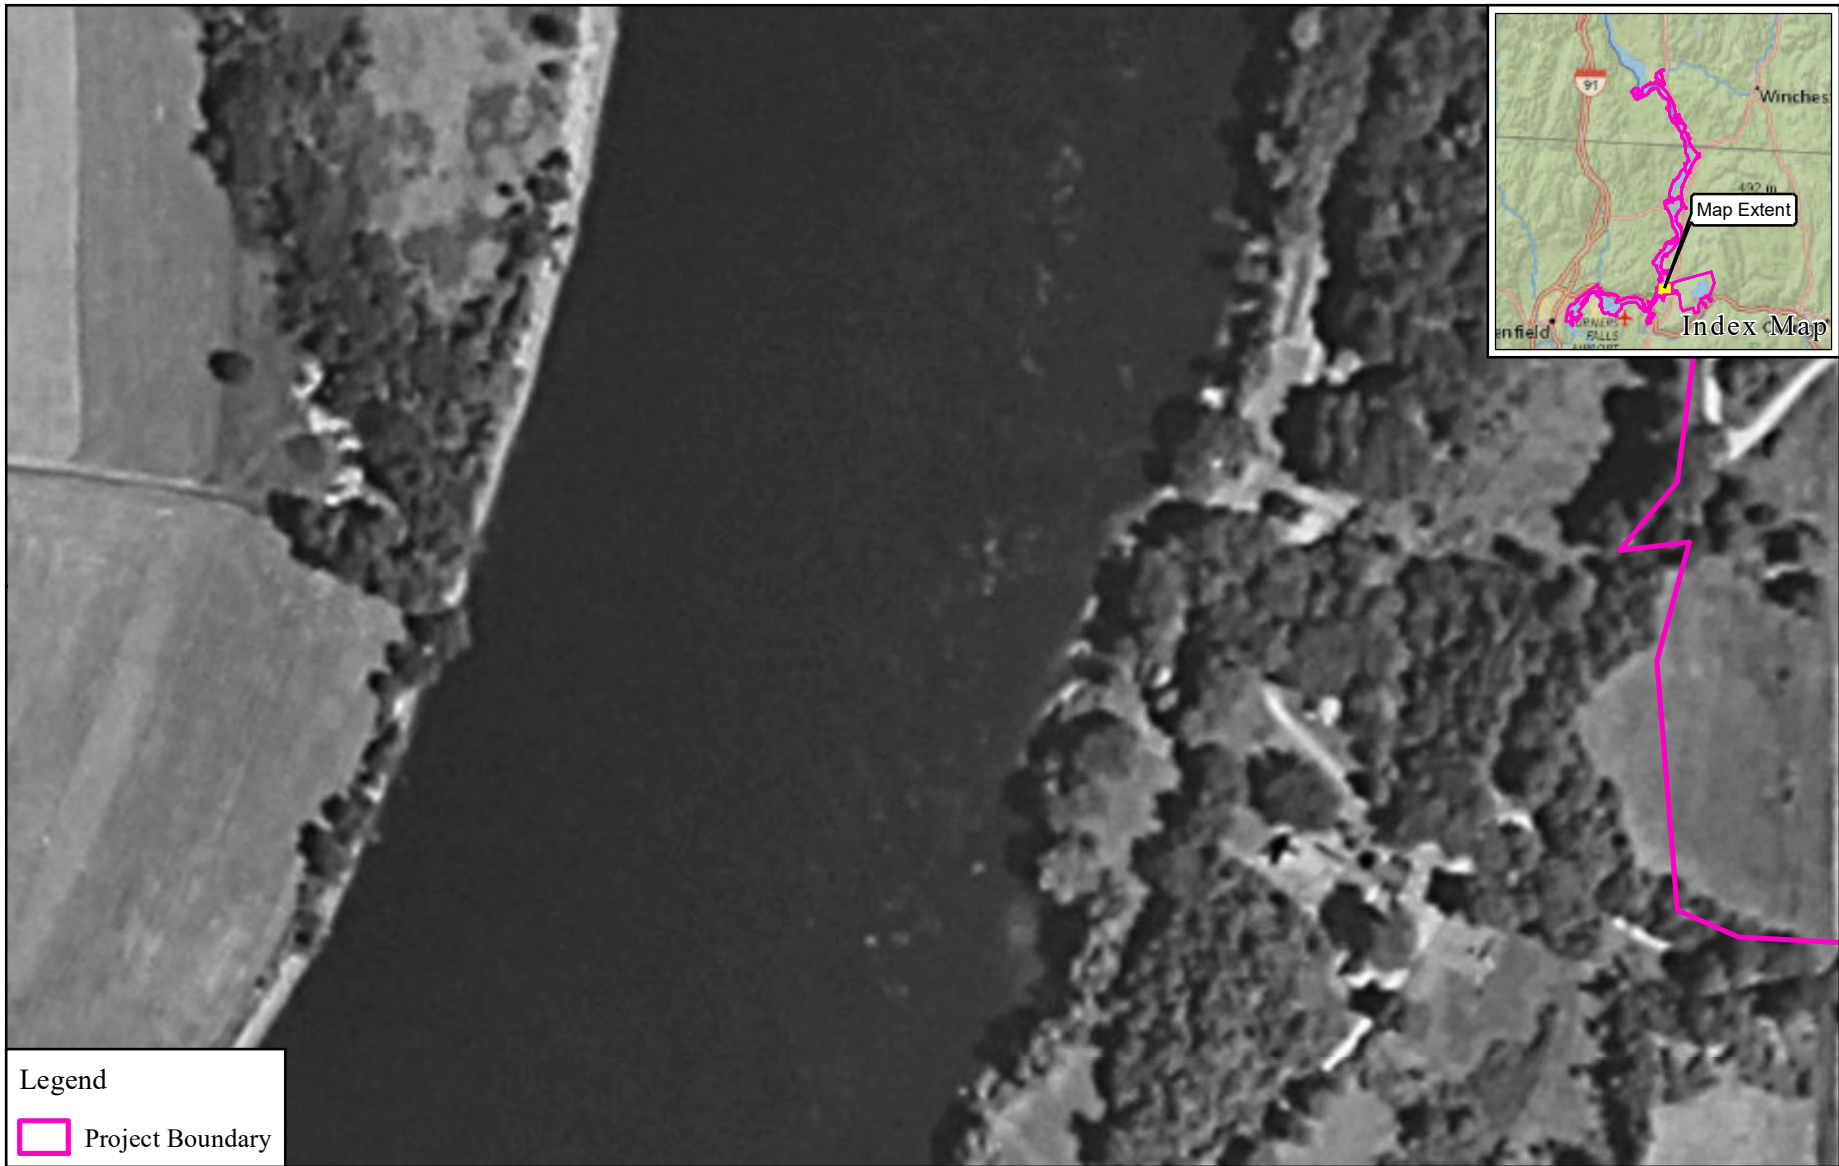
Upper Split River  
 1952 Imagery  
 (Source: North by Northeast Survey Company)

The right bank of the river in this location is eroded and has little riparian vegetation in the 1952 and 1960s photographs. The lower part of the photograph of the right bank was stabilized using rock (see discussion of tailrace in next segment) while the upper part of the photograph of the right bank was selected as the Upper Split River site and was stabilized in 2010 using a gravel beach and large woody debris as can be seen on the 2014 photograph.

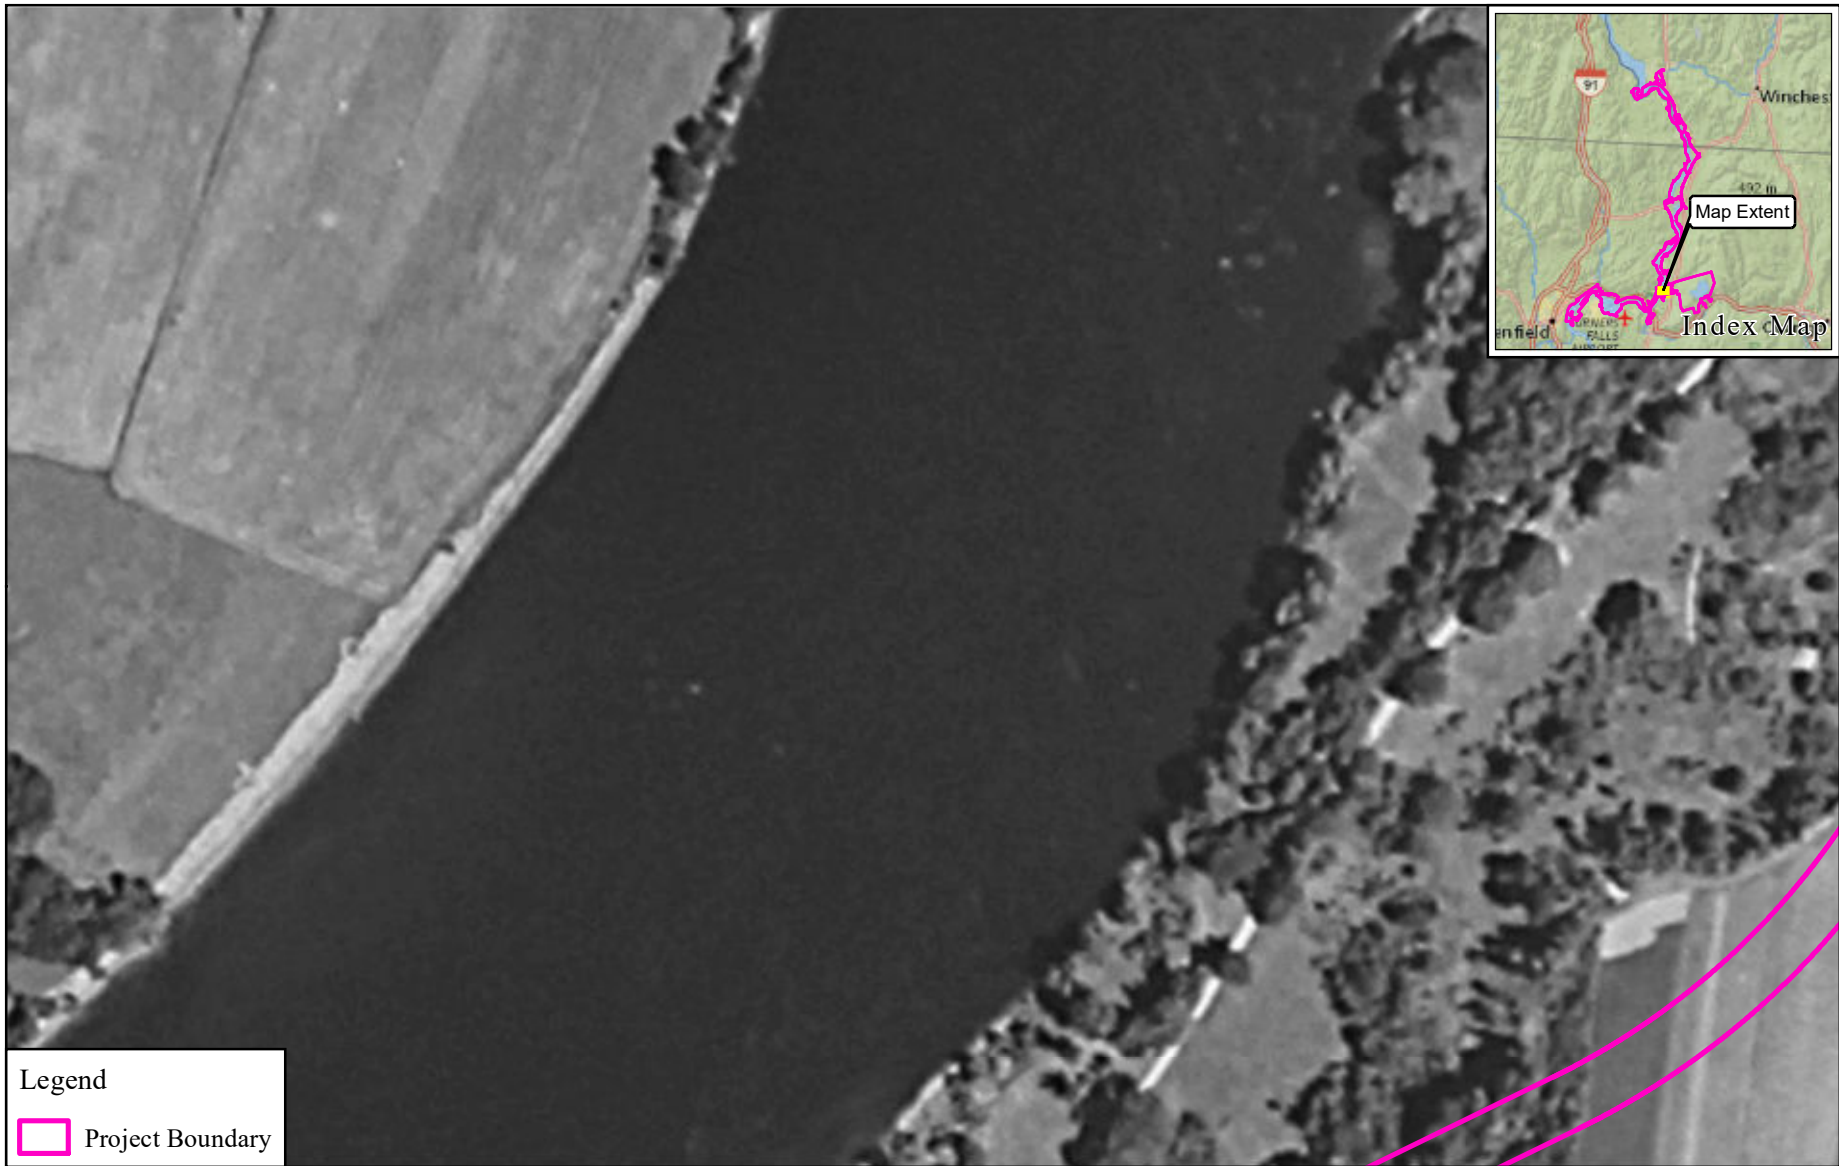
Northfield Mountain Tailrace  
 1952 Imagery  
 (Source: North by Northeast Survey Company)

The right bank across the river from the future tailrace for Northfield Mountain appears to be eroded and devoid of riparian vegetation in the 1952 and 1960s photographs, before the construction of the project. Rock from project construction was used to stabilize this eroded bank during the construction process. The rock has stabilized the toe of the bank and riparian vegetation has become established above the rock.
