**Relicensing Study 3.1.2**

**Northfield Mountain / Turners Falls  
Operations Impact on Existing Erosion and  
Potential Bank Instability  
Study Report**

**Volume III – Appendices**

**Northfield Mountain Pumped Storage Project (No. 2485) and  
Turners Falls Hydroelectric Project (No. 1889)**

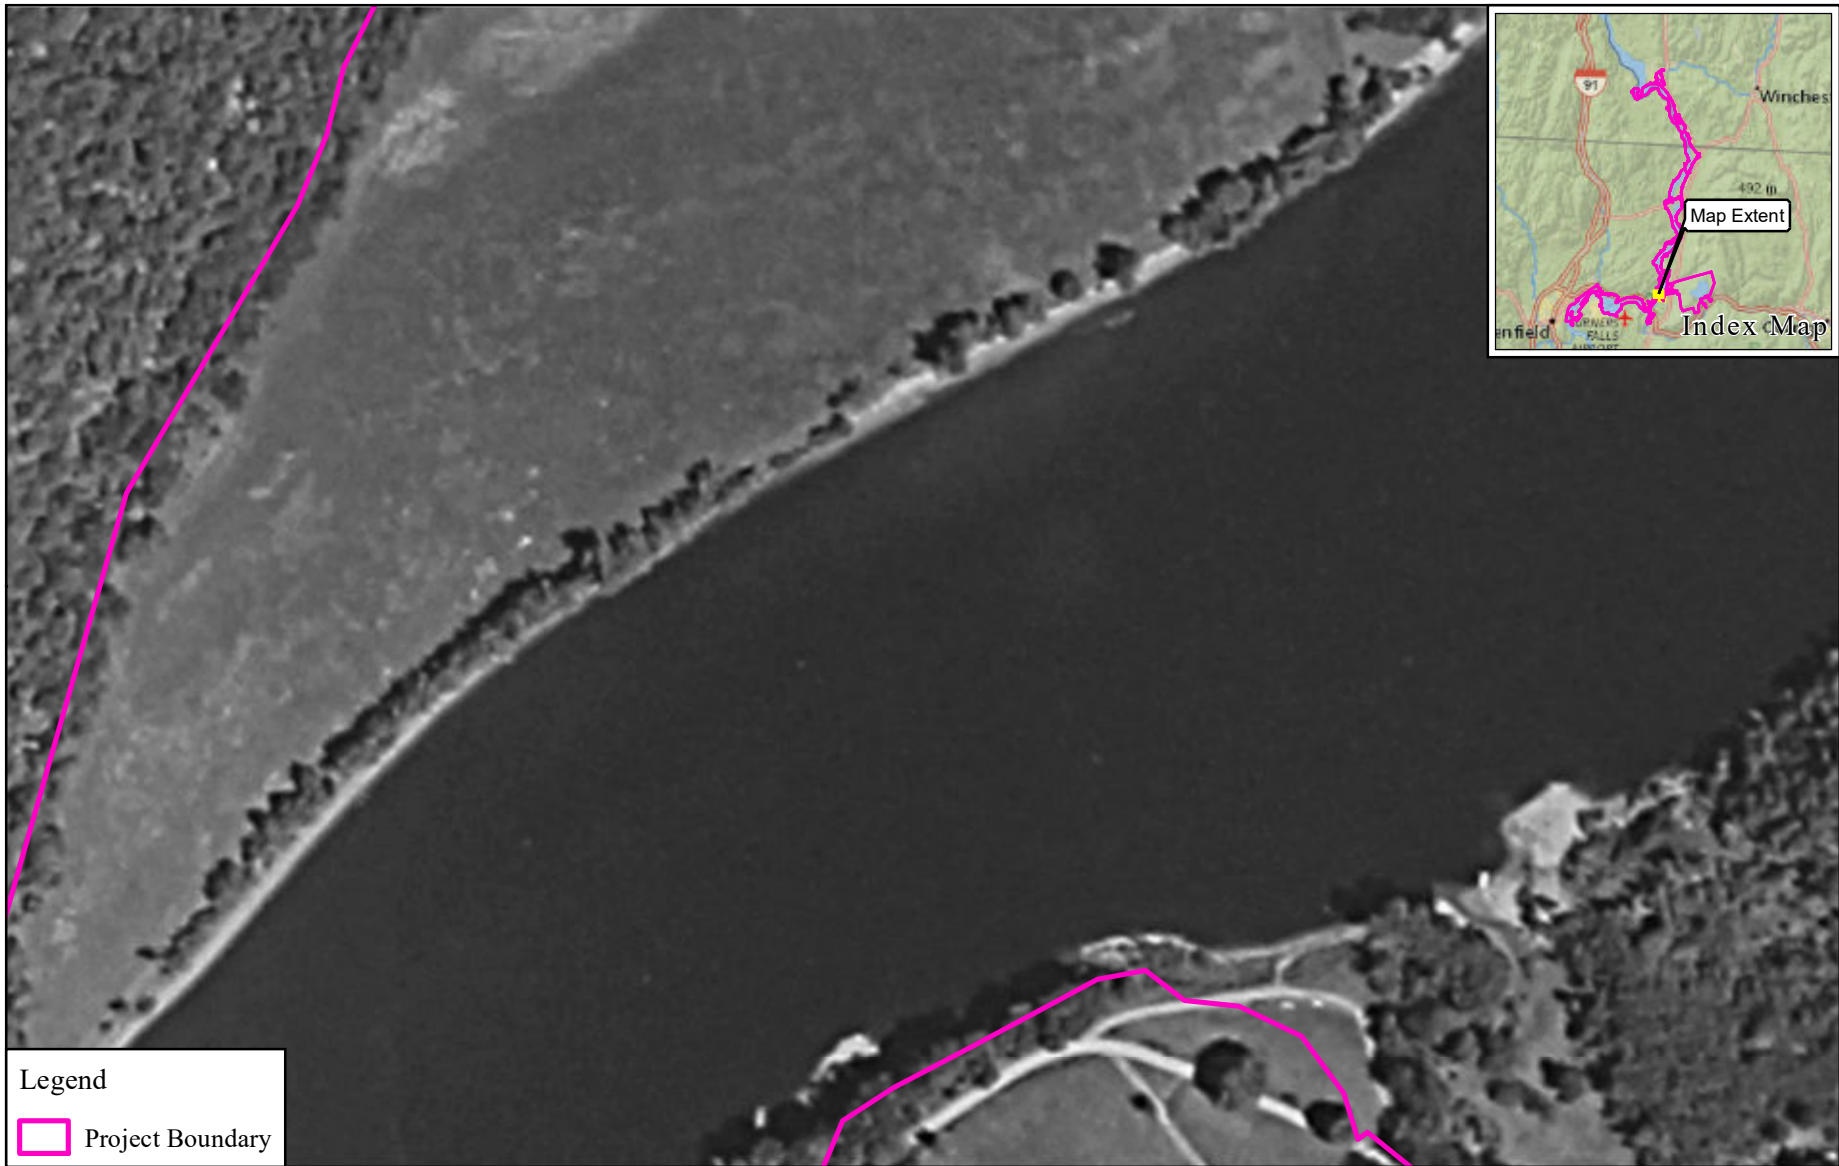
Lower Split River  
 1952 Imagery  
 (Source: North by Northeast Survey Company)

The right bank in the 1952 photograph is sparsely vegetated with apparent erosion as is a segment of the left bank. By the 1960s photographs erosion of the left bank segment is apparent while the right bank remains sparsely vegetated with some erosion. The right bank sight is called the Lower Split River site which was stabilized in 2009 and the left bank segment is called Durkee Point and was stabilized in 2003, both through implementation of the ECP.

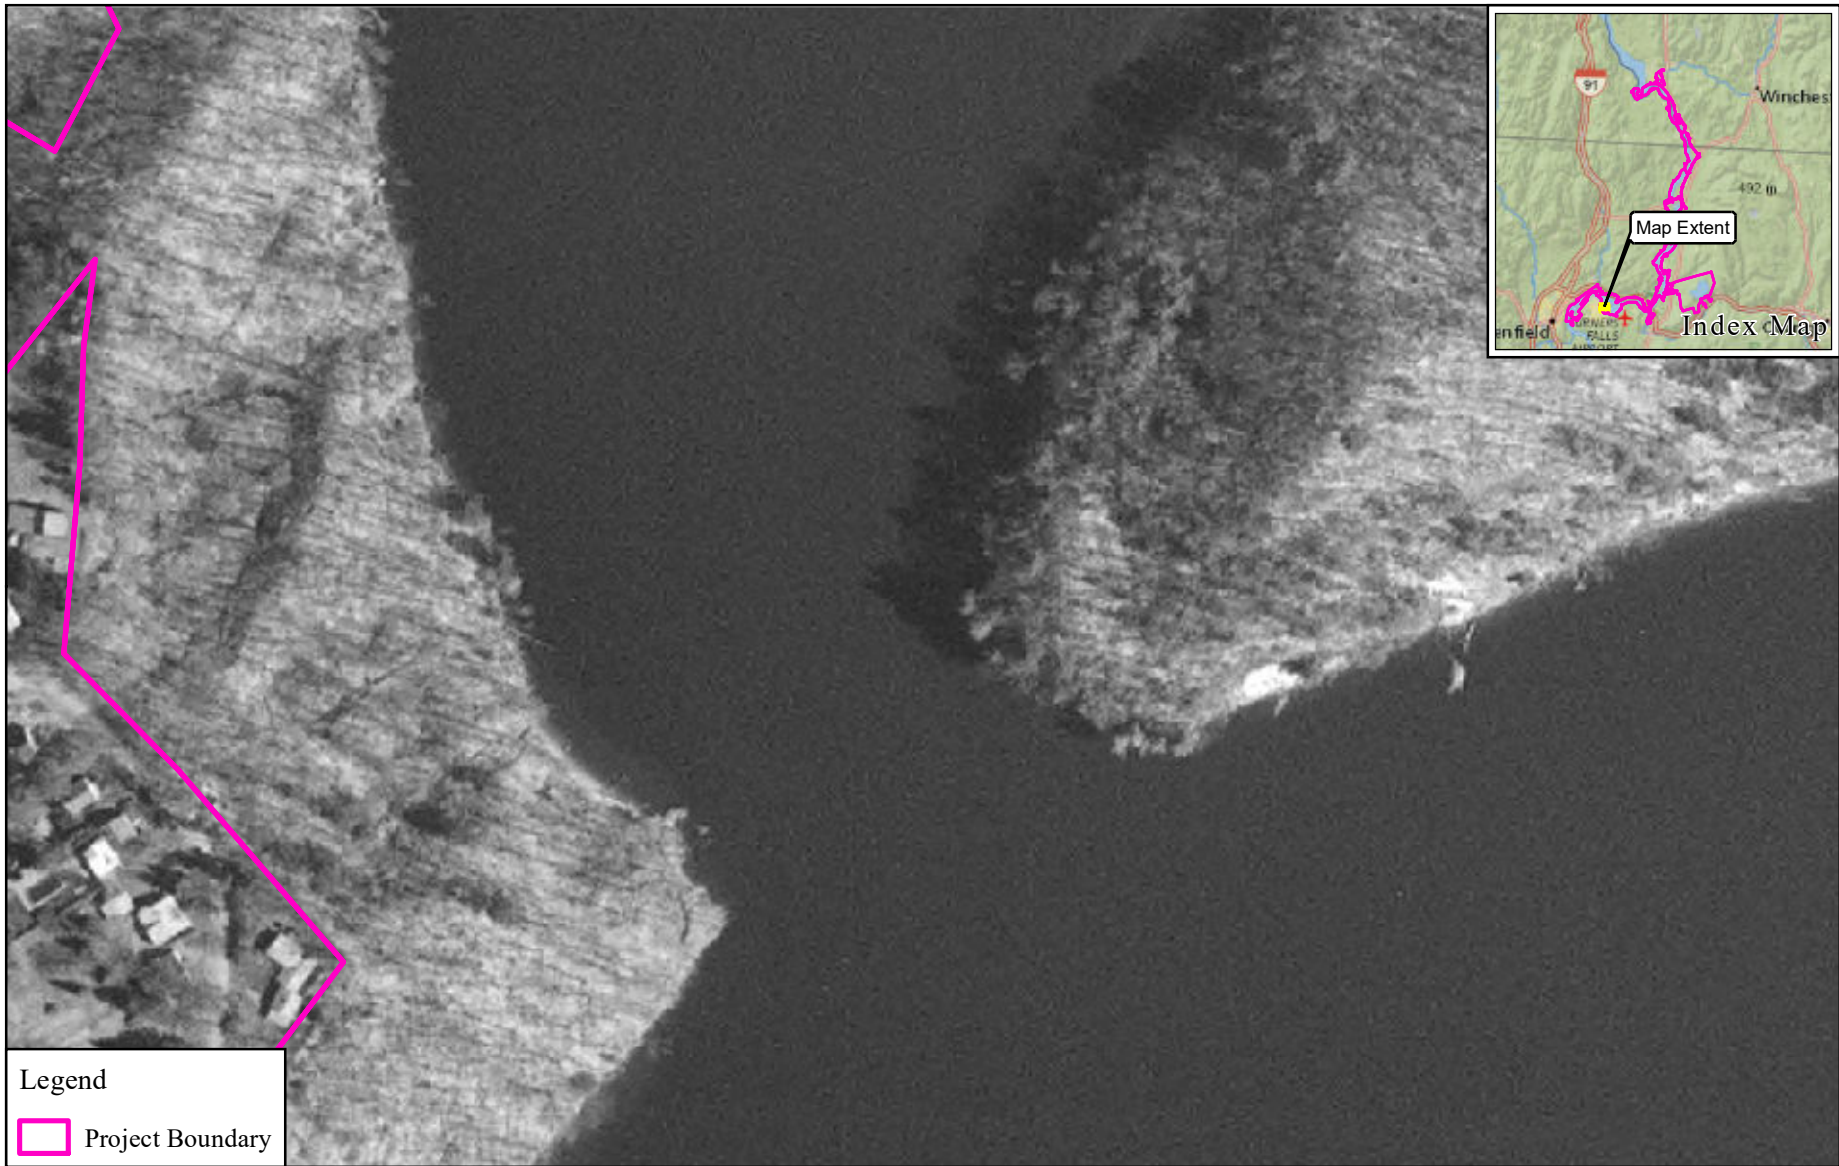
Campground Point  
 1990's Imagery  
 (Source: MassGIS)

Campground Point is the peninsula that separates Barton Cove from the reach of river leading upstream to French King Gorge. Some erosion is evident in the earlier photographs such as 1952 continuing through the 2008 photograph, when it was stabilized as part of the ECP in 2008 as the Campground Point Site. The 2014 photograph shows an increase in vegetation on the stabilized site.

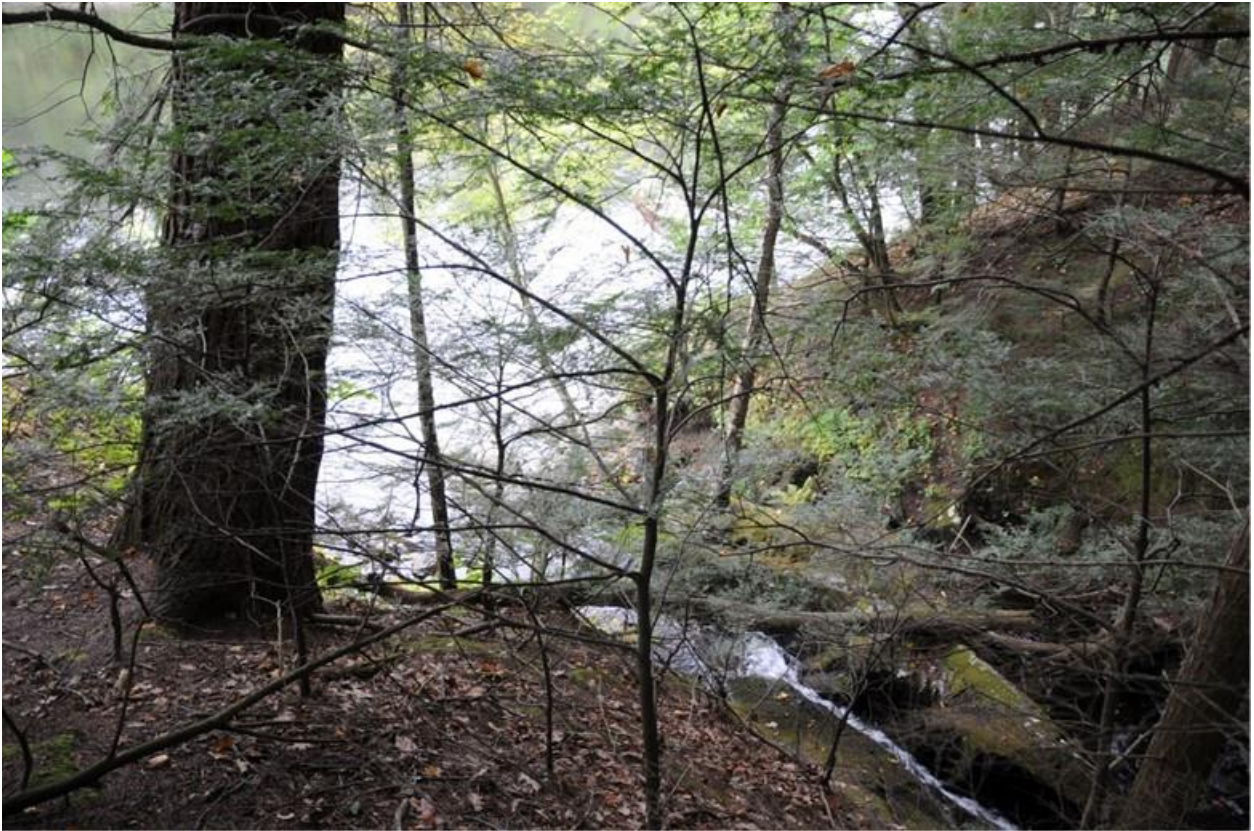
**Figure C-2 Right bank upstream-most upland erosion feature (Stream)**

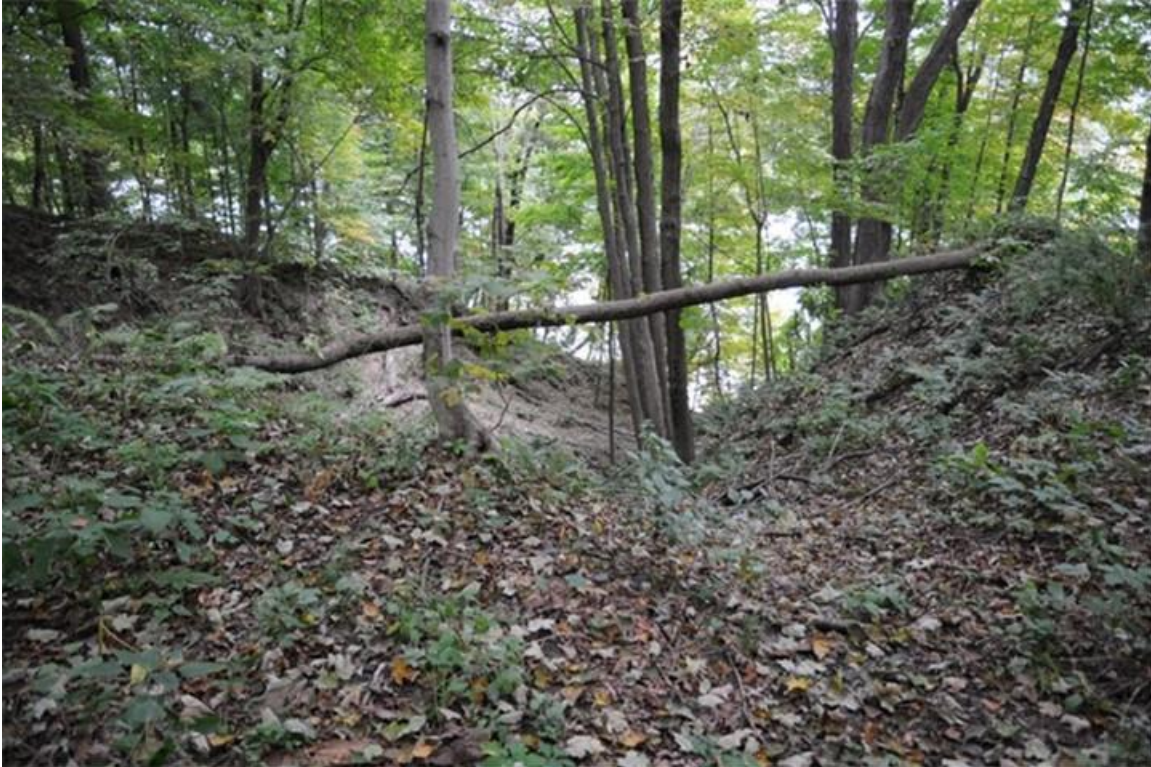
**Figure C-4. Looking downhill into ravine (Photo 272, 9/29/2015)**

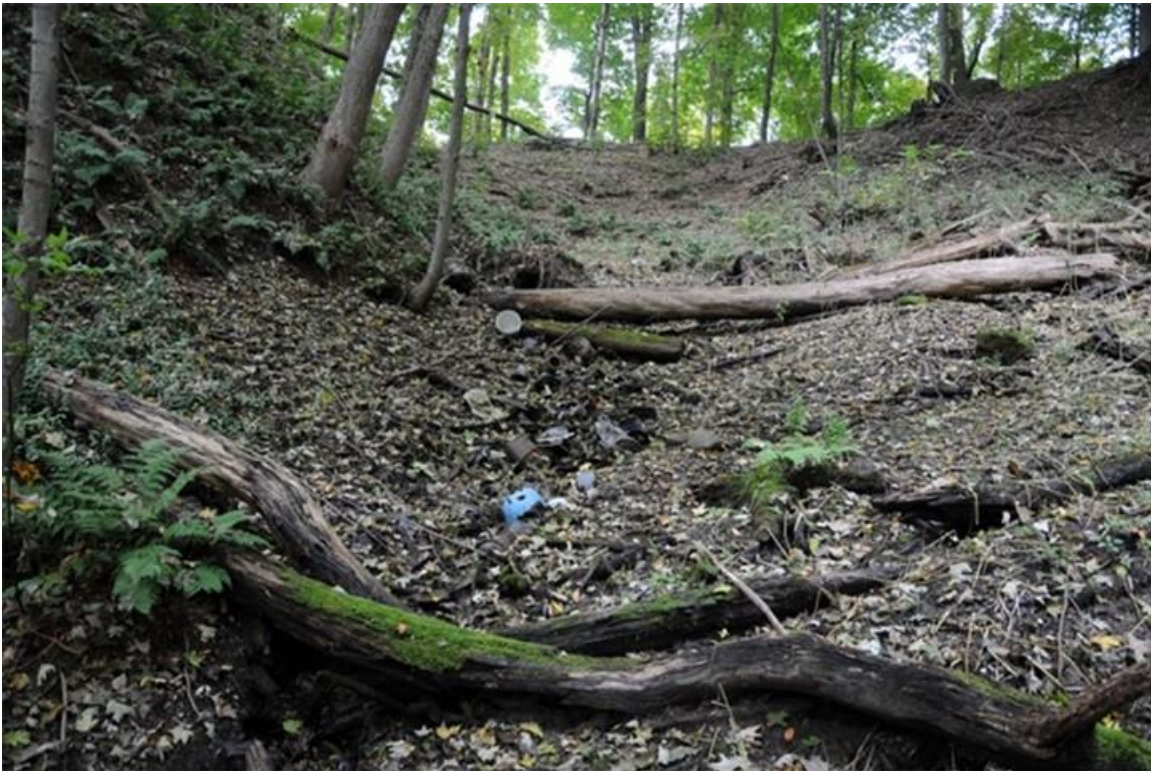
**Figure C-5. From ravine looking uphill (Photo 288, 9/29/2015)**

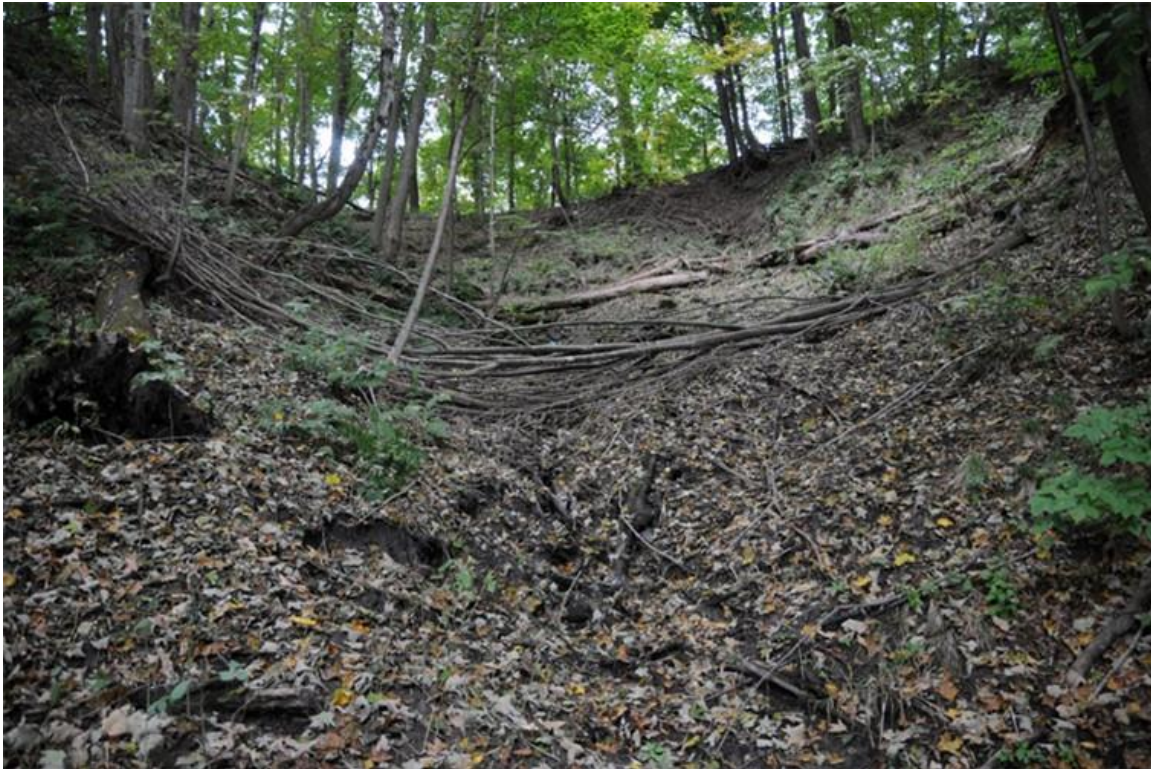
**Figure C-6 From second ravine looking uphill (Photo 316, 9/29/2015)**

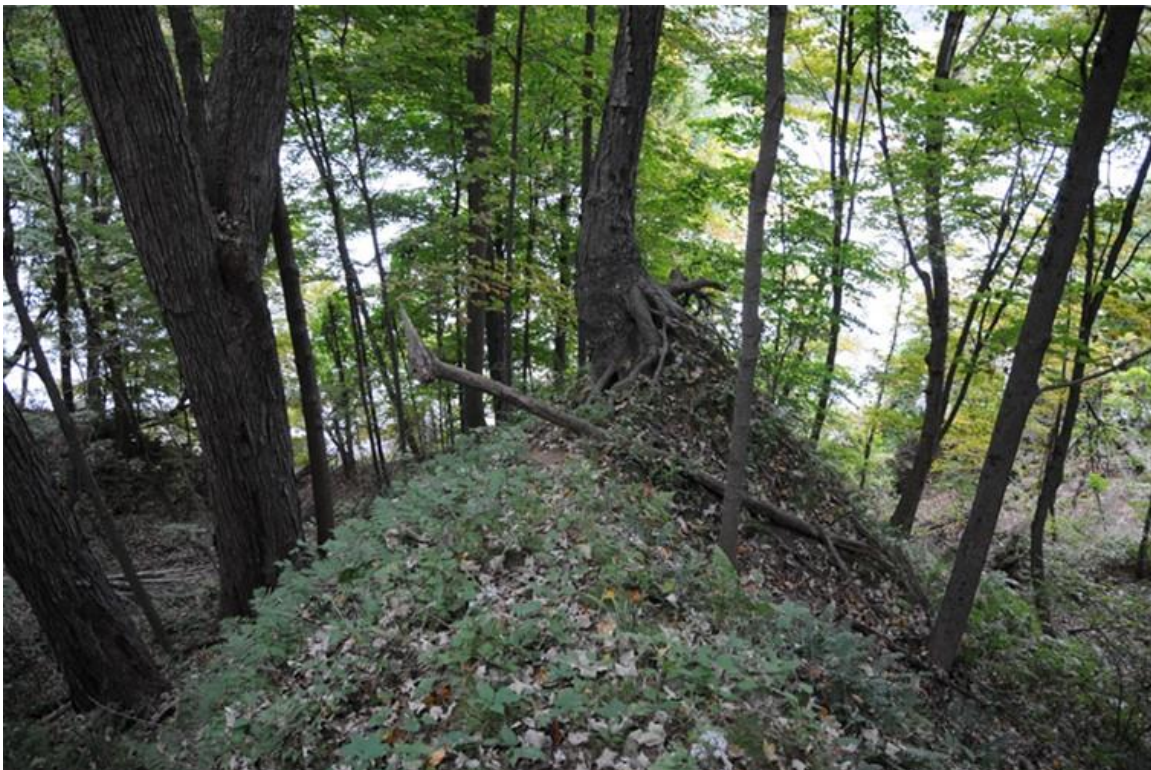
**Figure C-7 Divide between two ravines (Photo 325, 9/29/2015)**

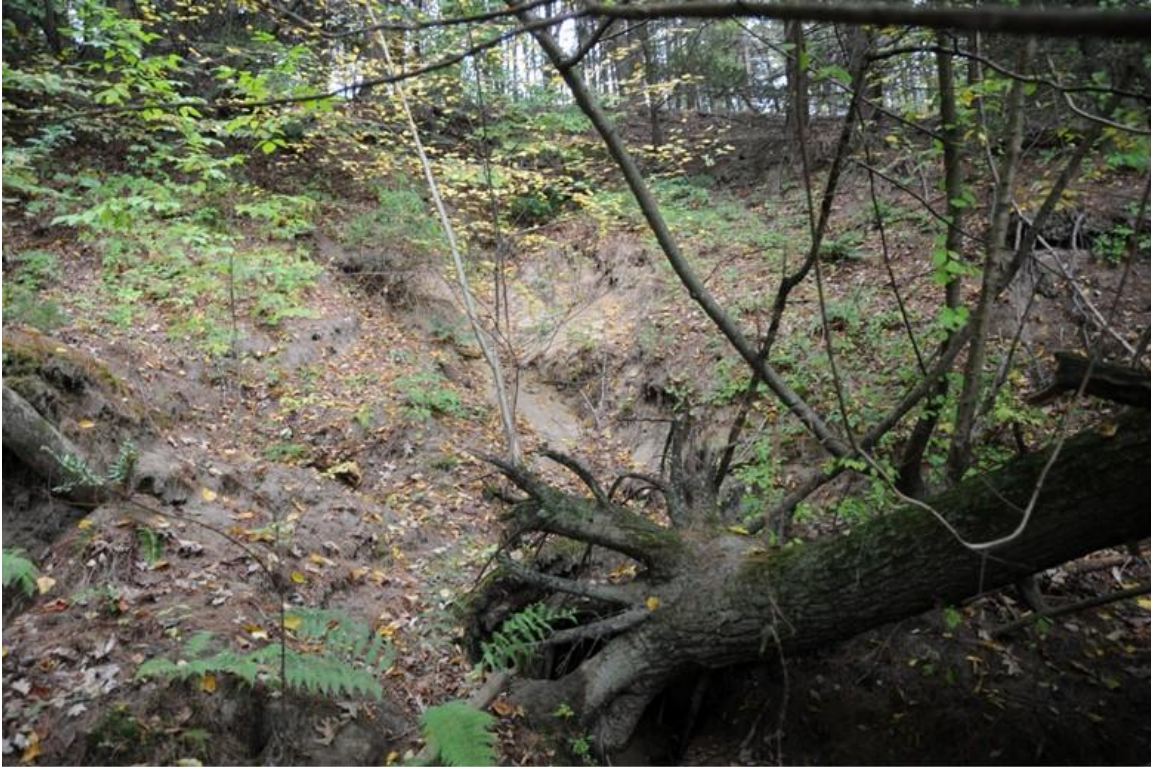
**Figure C-12 Upland erosion feature (Photo 9517)**

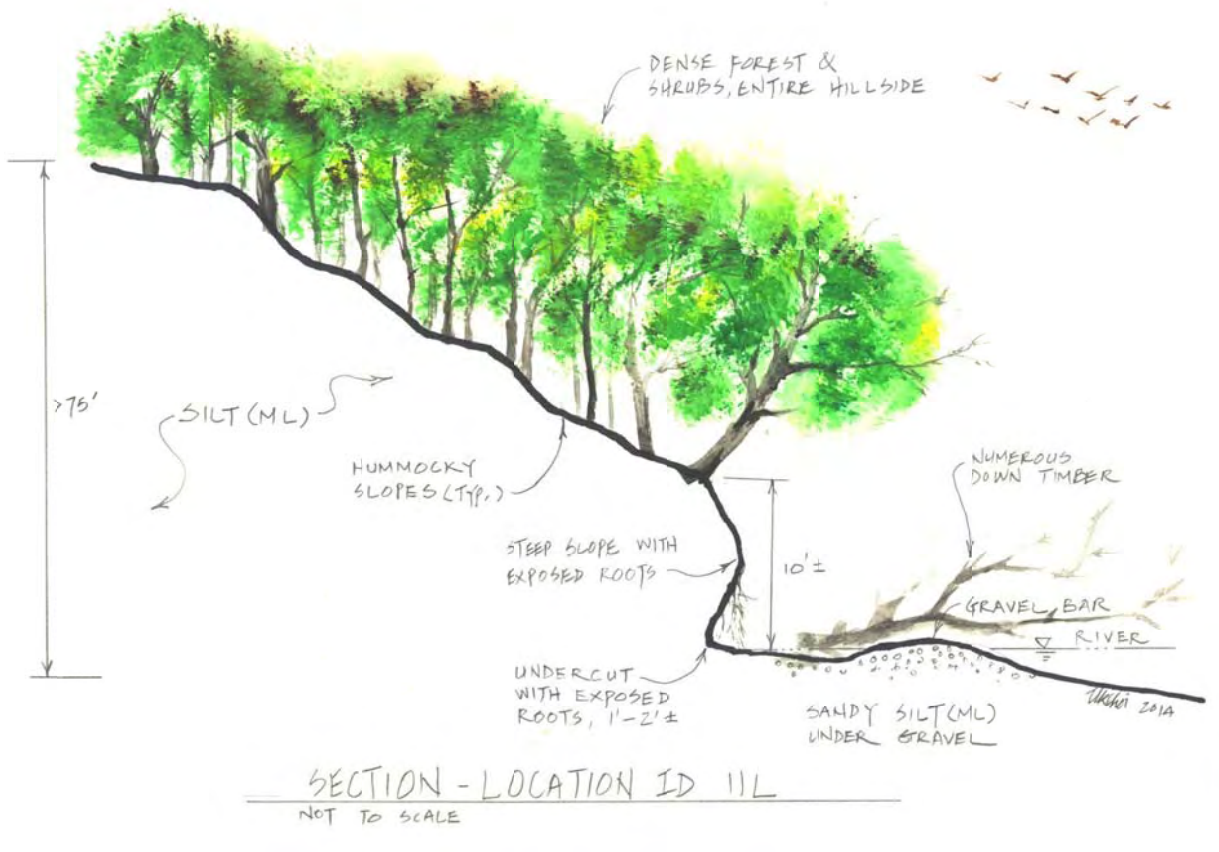
## Site Sketch:

- Steep slope at river level (lower 10 feet of Upper Bank)
- Mass wasting with hummocky terrain in upland
- Undercuts with exposed roots
- Some leaning trees
- Numerous down timber

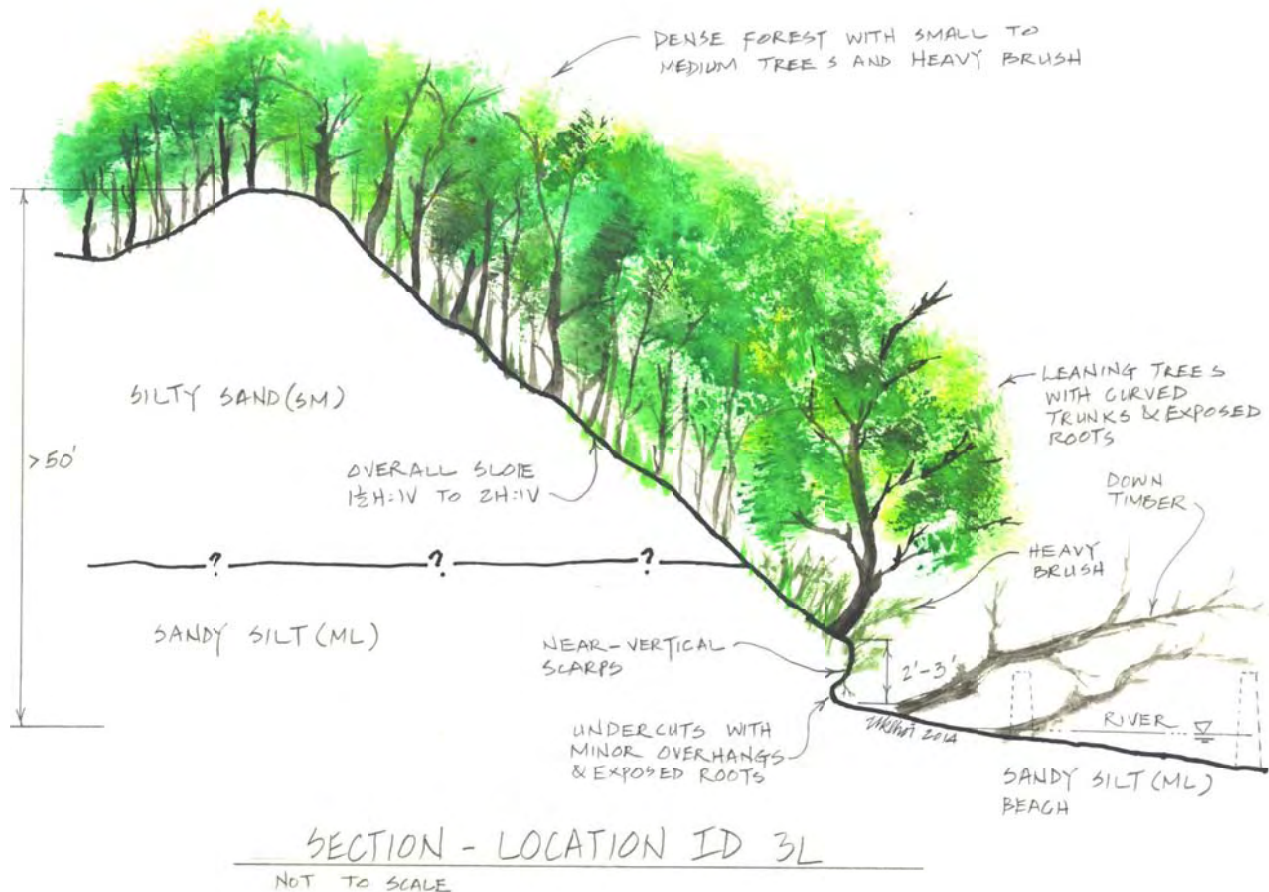
## Site Sketch:

- Near vertical scarps with undercuts and exposed roots at river level
- Minor overhangs
- Leaning trees with curved trunks
- Some mass-wasting near river level

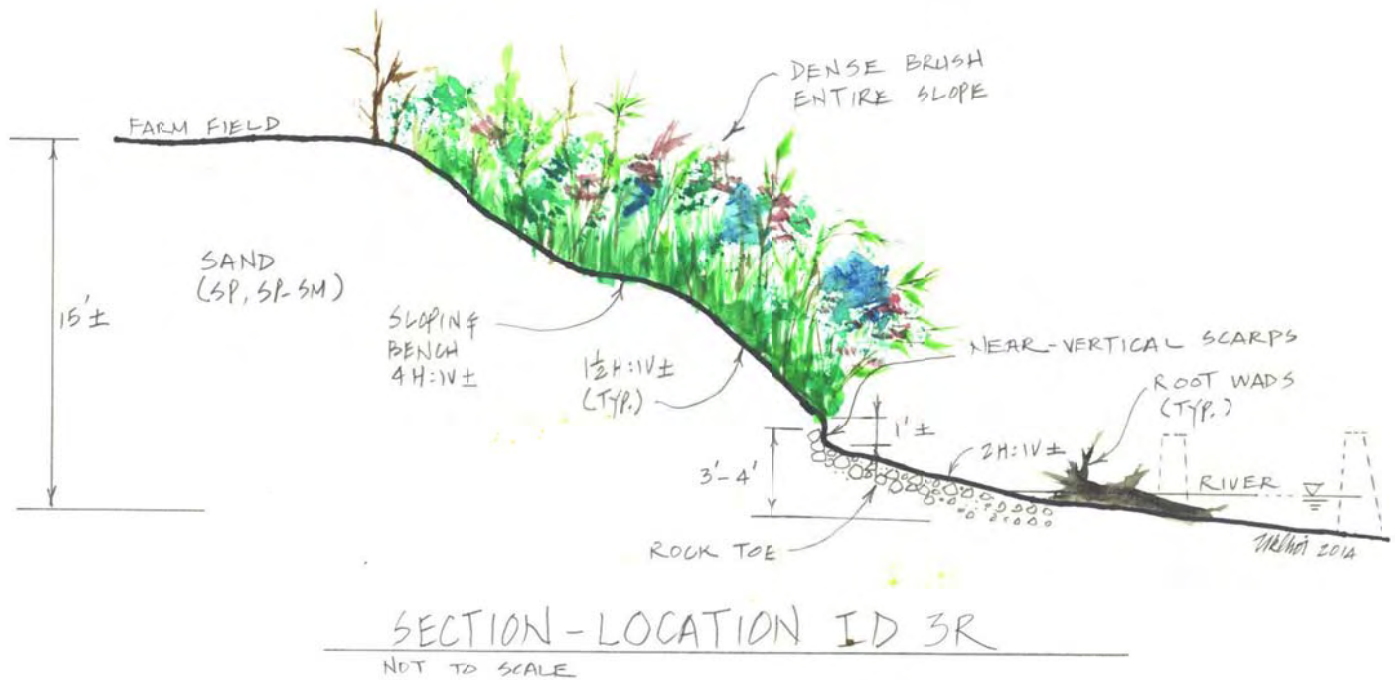
## Site Sketch:

ROCK TOE – 1" – 4" riprap rock, angular, hard, minor deterioration.

- Little erosion of stabilized slope.
- Minor near-vertical scarps near the top of rock toe

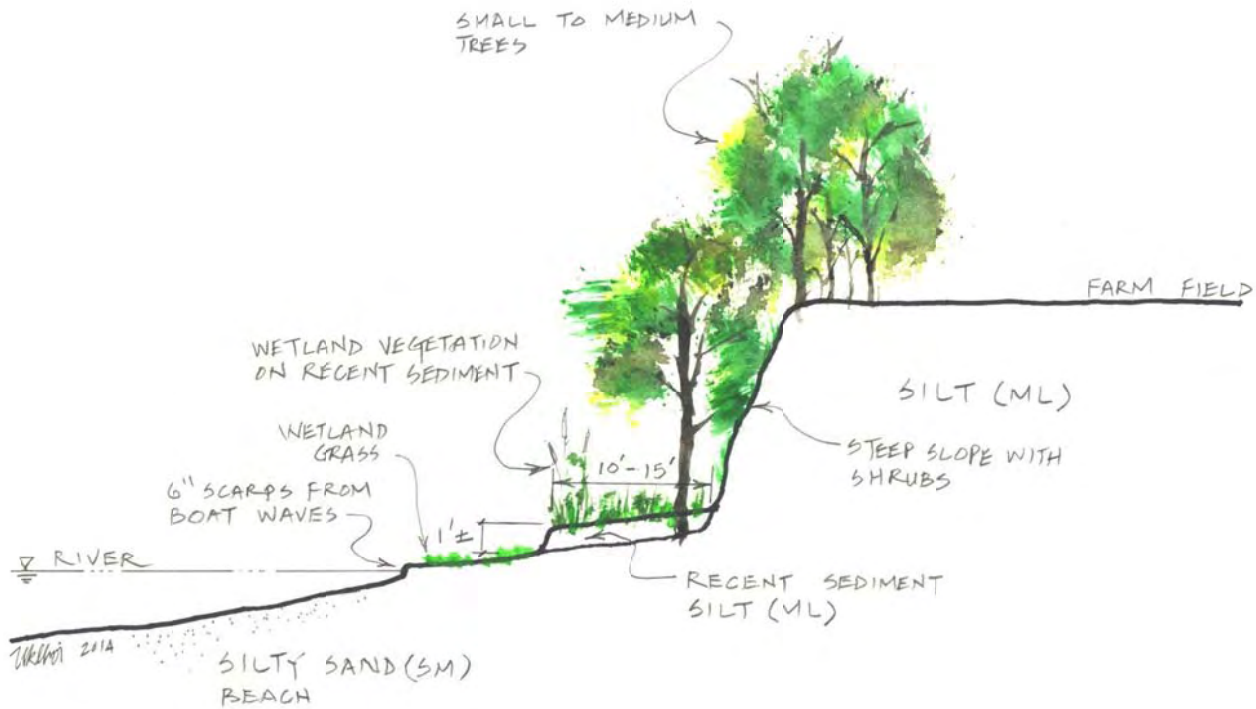
SECTION - LOCATION ID 4L  
NOT TO SCALE

- Steep slope, entire Upper Bank.
- Minor erosion of recent sediment where there was no wetland vegetation.
- 6-inch deep erosion scarp at river level from boat waves.

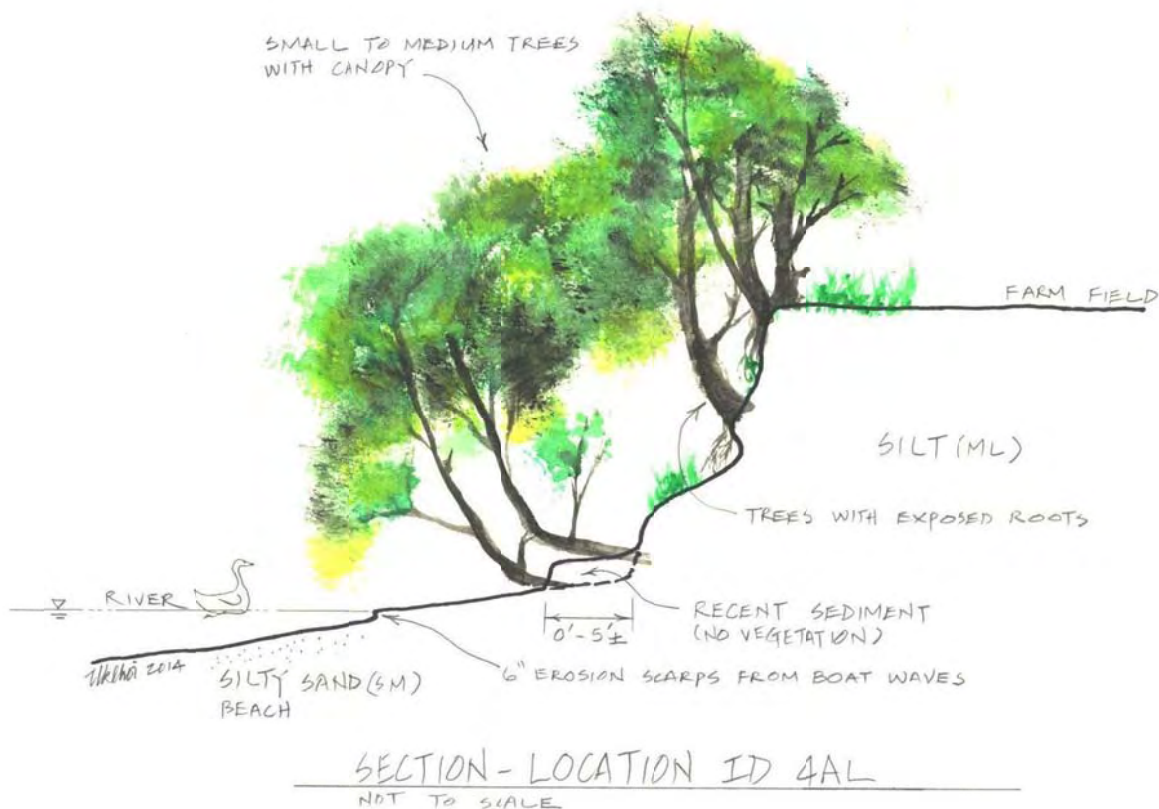
## Site Sketch:

- Steep slope, entire Upper Bank.
- Leaning trees and undercuts at toe of Upper Bank, some with exposed roots
- Overhangs with exposed roots near top of Upper Bank
- Significantly less recent sediment compared with Site 4L which is just 100 feet away. Little to no wetland vegetation on recent sediment.
- 6-inch deep erosion scarp at river level from boat waves

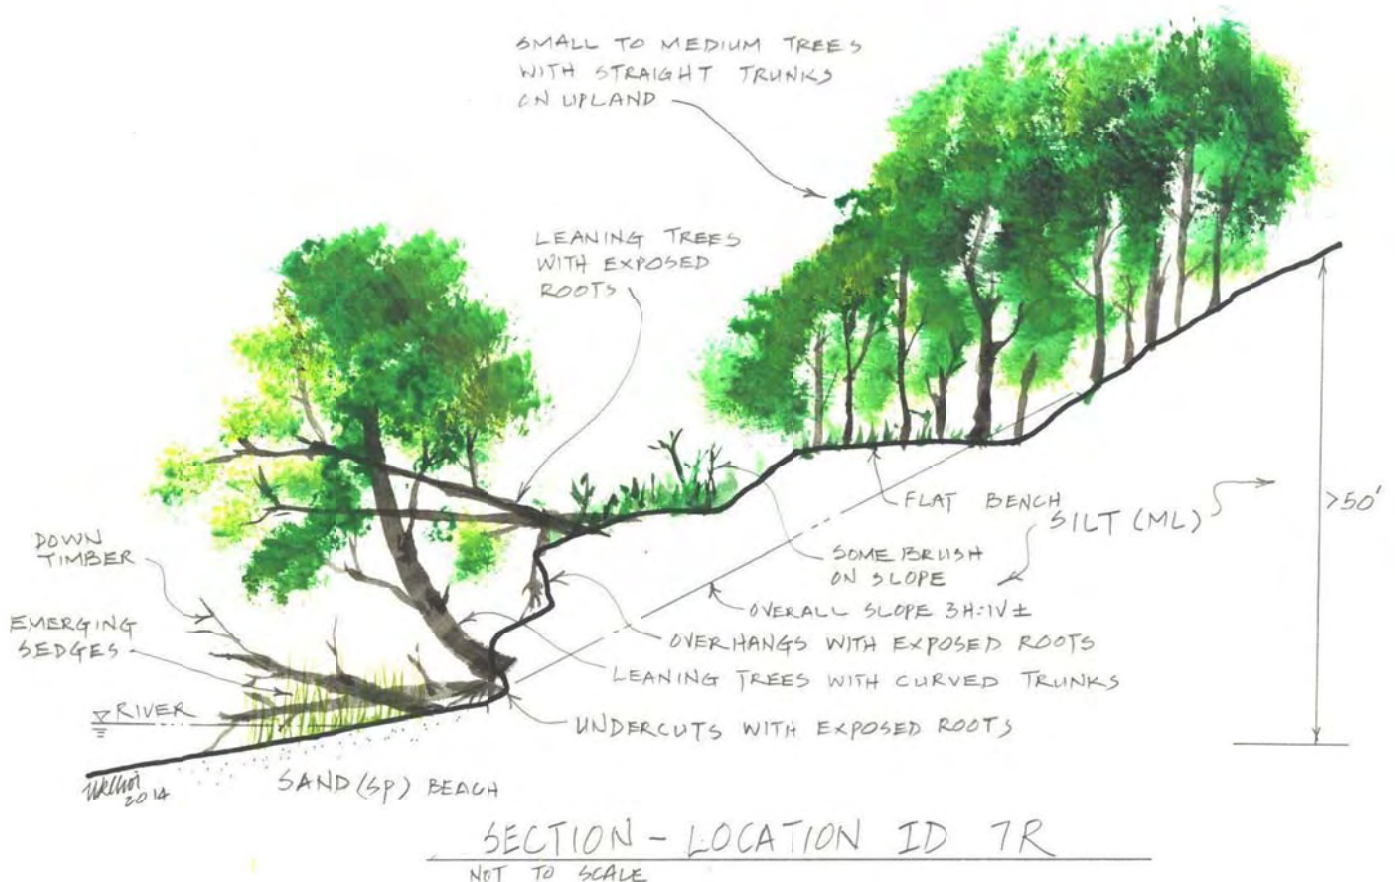
- Undercuts with exposed roots at river level.
- Mass-wasting along entire slope.
- Trees on upland area have straight trunks, suggesting the trees post-date the mass-wasting movement.
- Leaning trees with exposed roots at river level and bottom of Upper Bank, some with curved trunks.
- Large scour hole (20' wide x 40' long x 15 feet deep) at mid-slope, with flowing groundwater at bottom of hole.

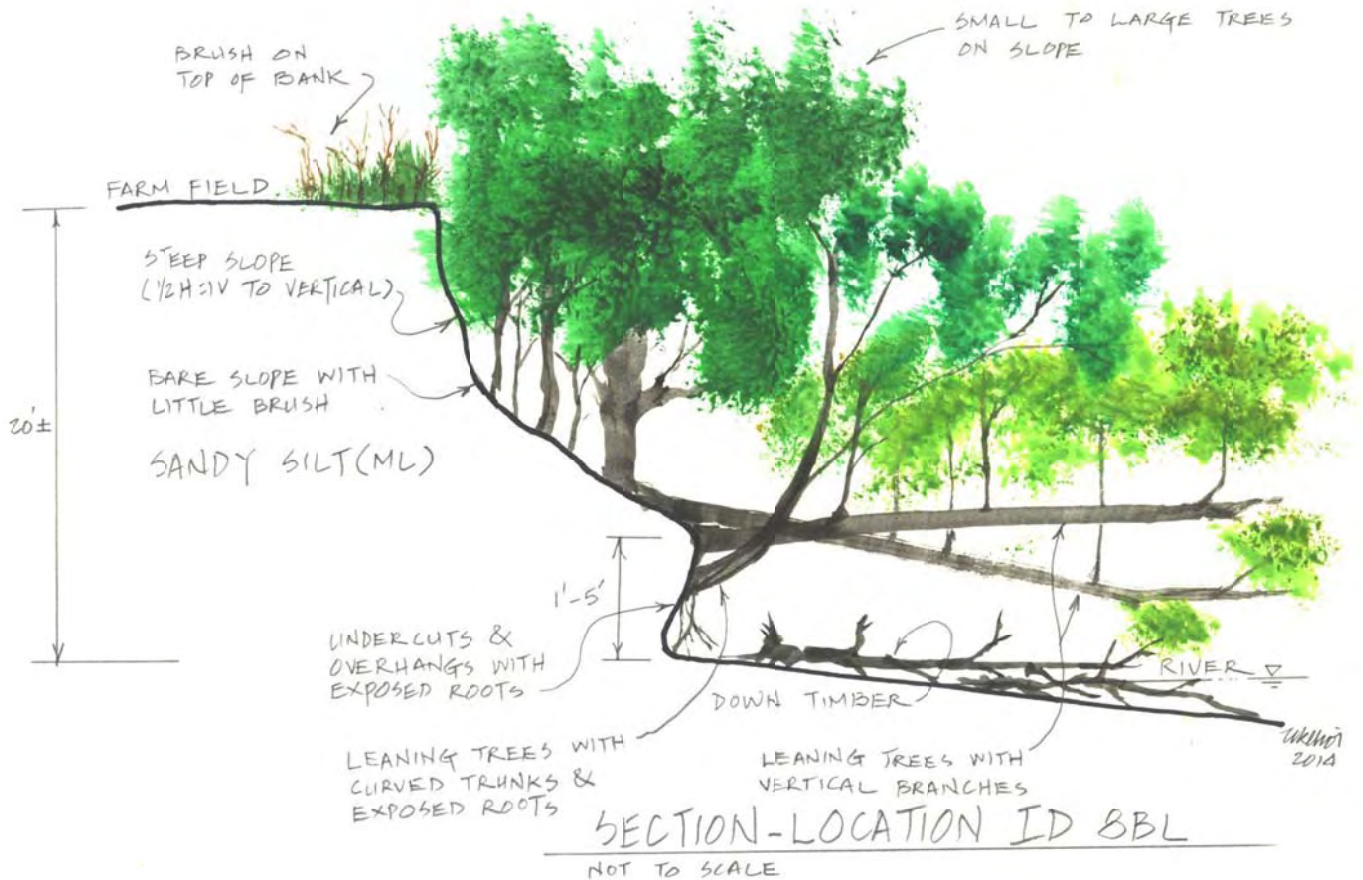
- Mass-wasting entire slope on Upper Bank.
- Undercuts and overhangs with exposed roots near river level.
- Leaning trees with exposed roots near river level.
- Very steep slope along entire Upper Bank.
