**Relicensing Study 3.1.2**

**Northfield Mountain / Turners Falls  
Operations Impact on Existing Erosion and  
Potential Bank Instability  
Study Report**

**Volume III – Appendices**

**Northfield Mountain Pumped Storage Project (No. 2485) and  
Turners Falls Hydroelectric Project (No. 1889)**

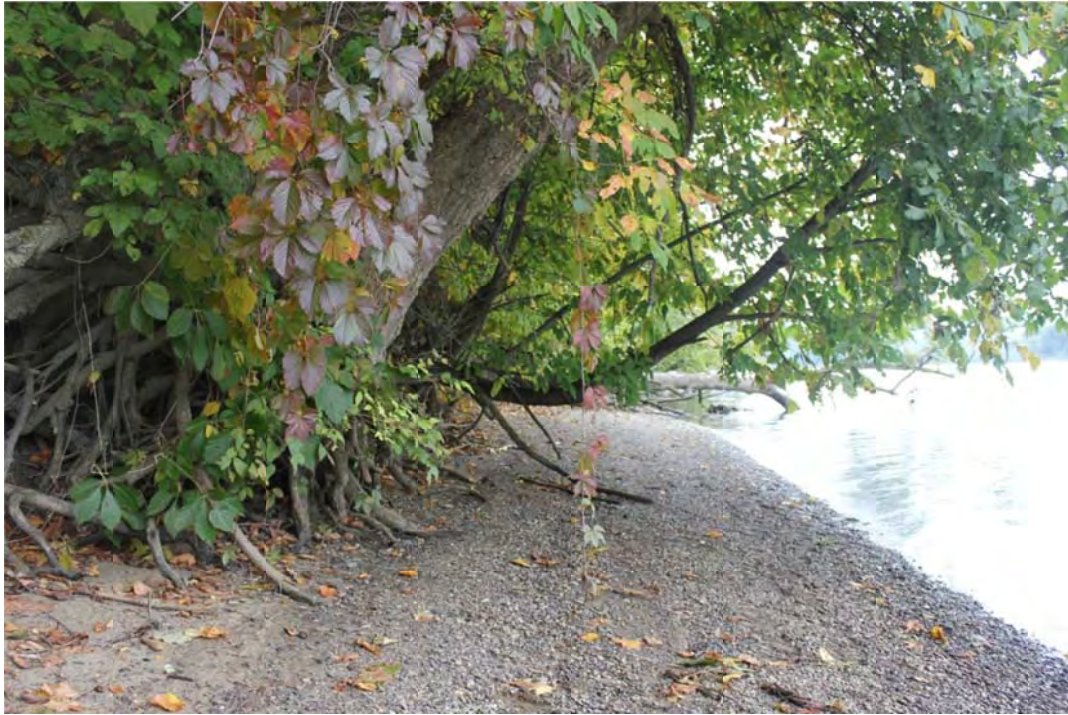
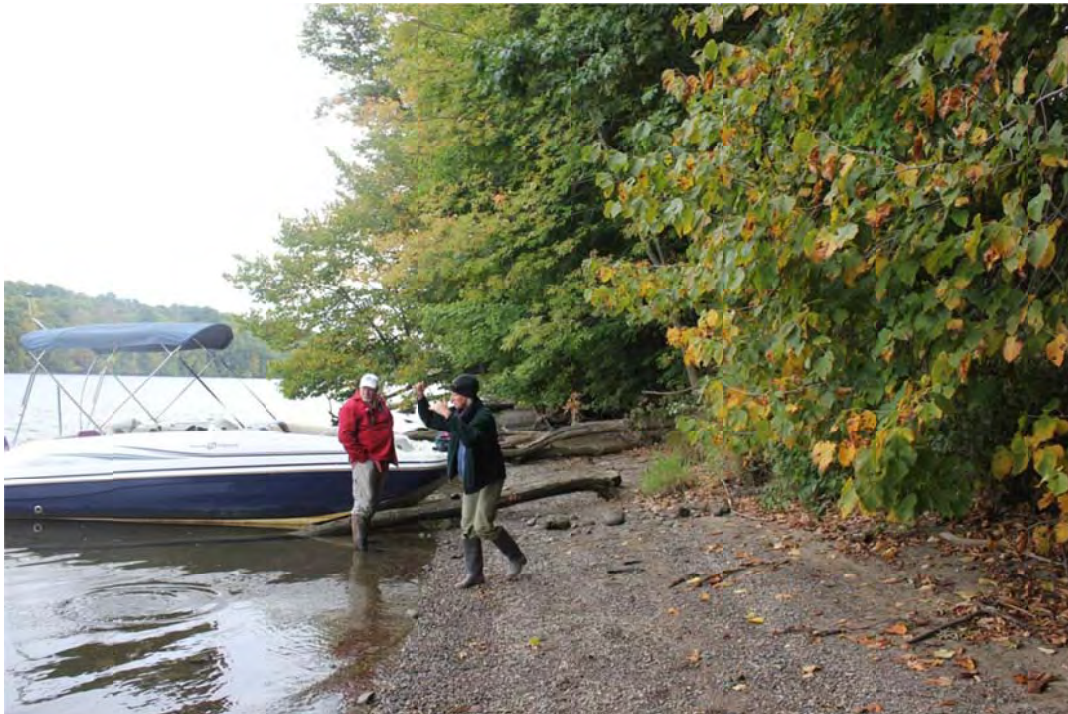
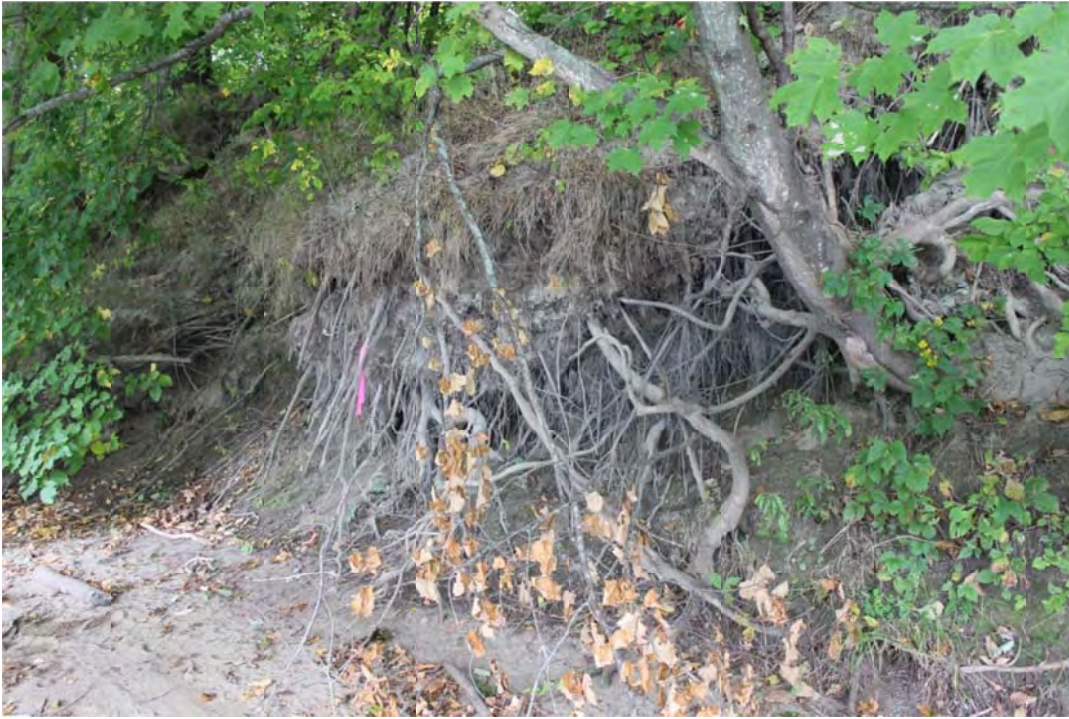
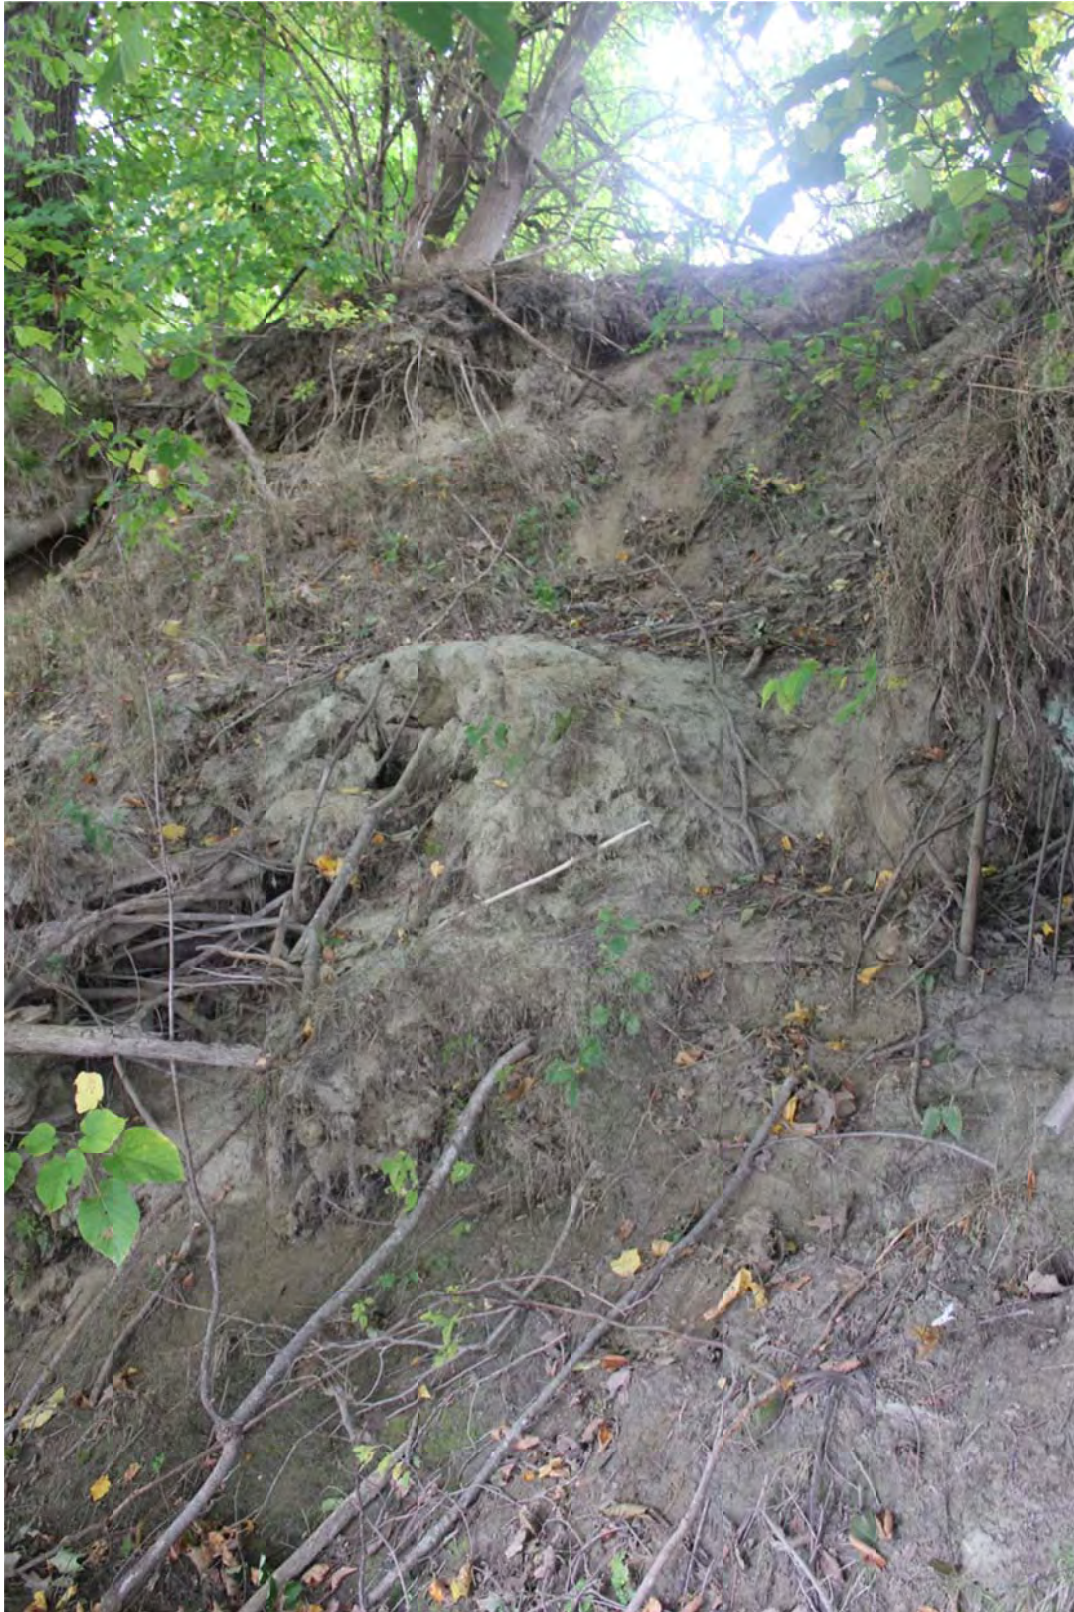
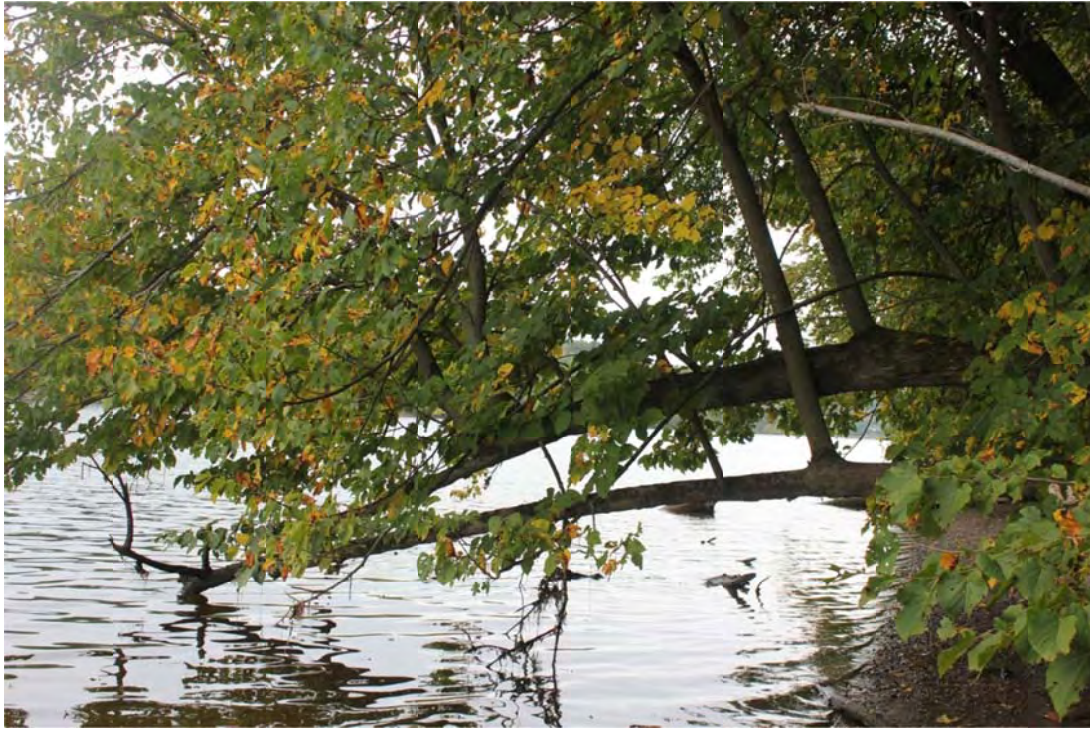
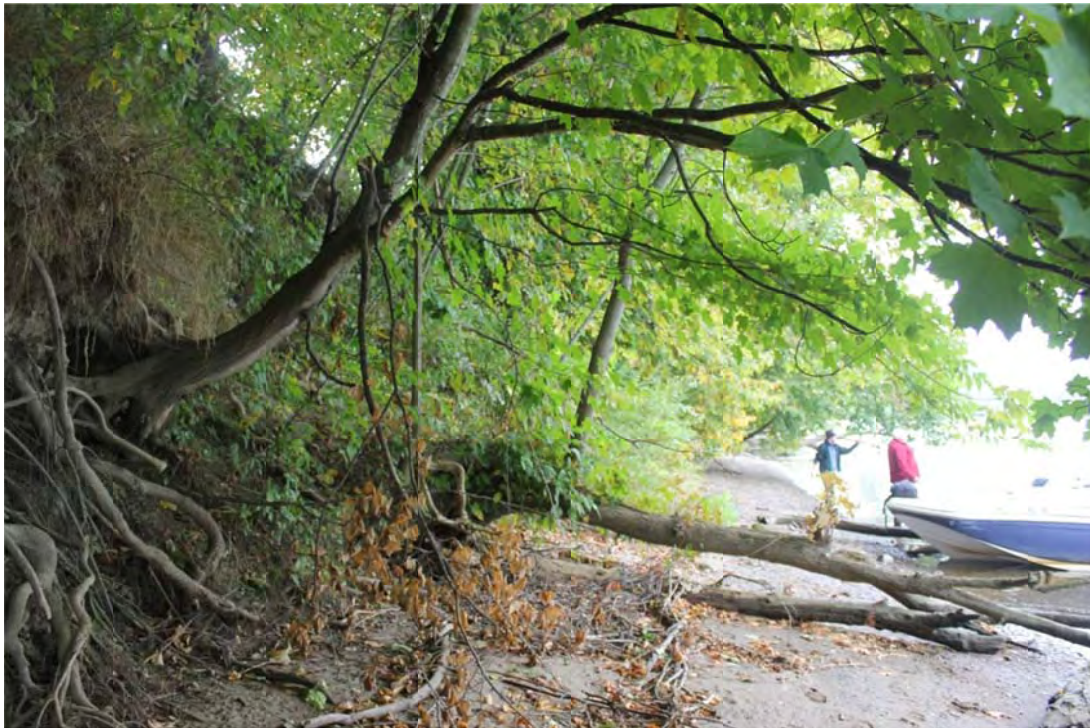
Bank is steep with near vertical slope at top, bare slopes where it is too steep to support vegetation, undercuts and overhangs with exposed roots, leaning trees with curved trunks and exposed roots, and downed trees.

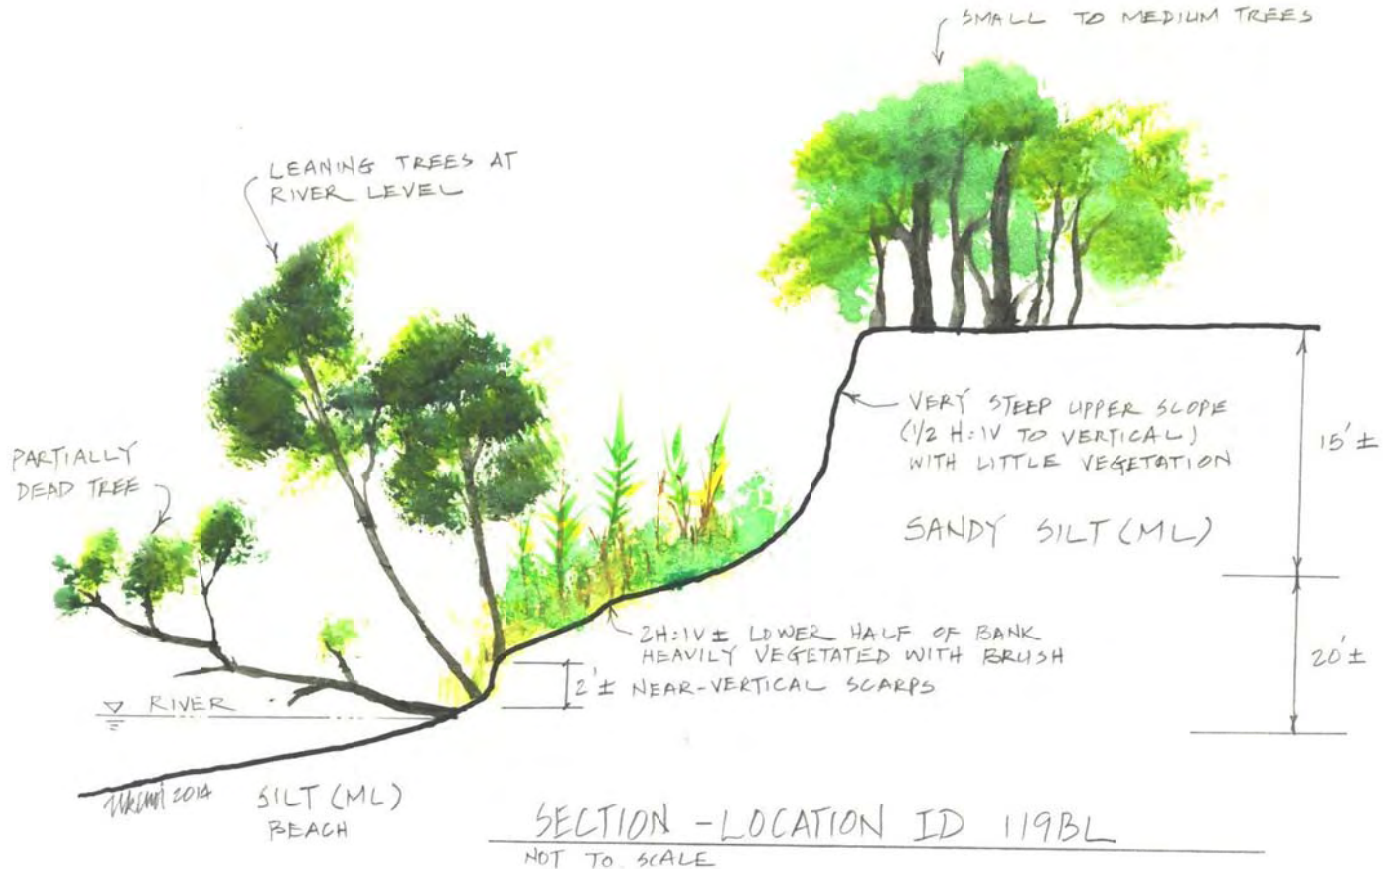
- Leaning trees at river level.
- Numerous small slumps on lower half of Upper Bank slope
- Very steep slopes at upper half of Upper Bank
- Near-vertical scarps at river level

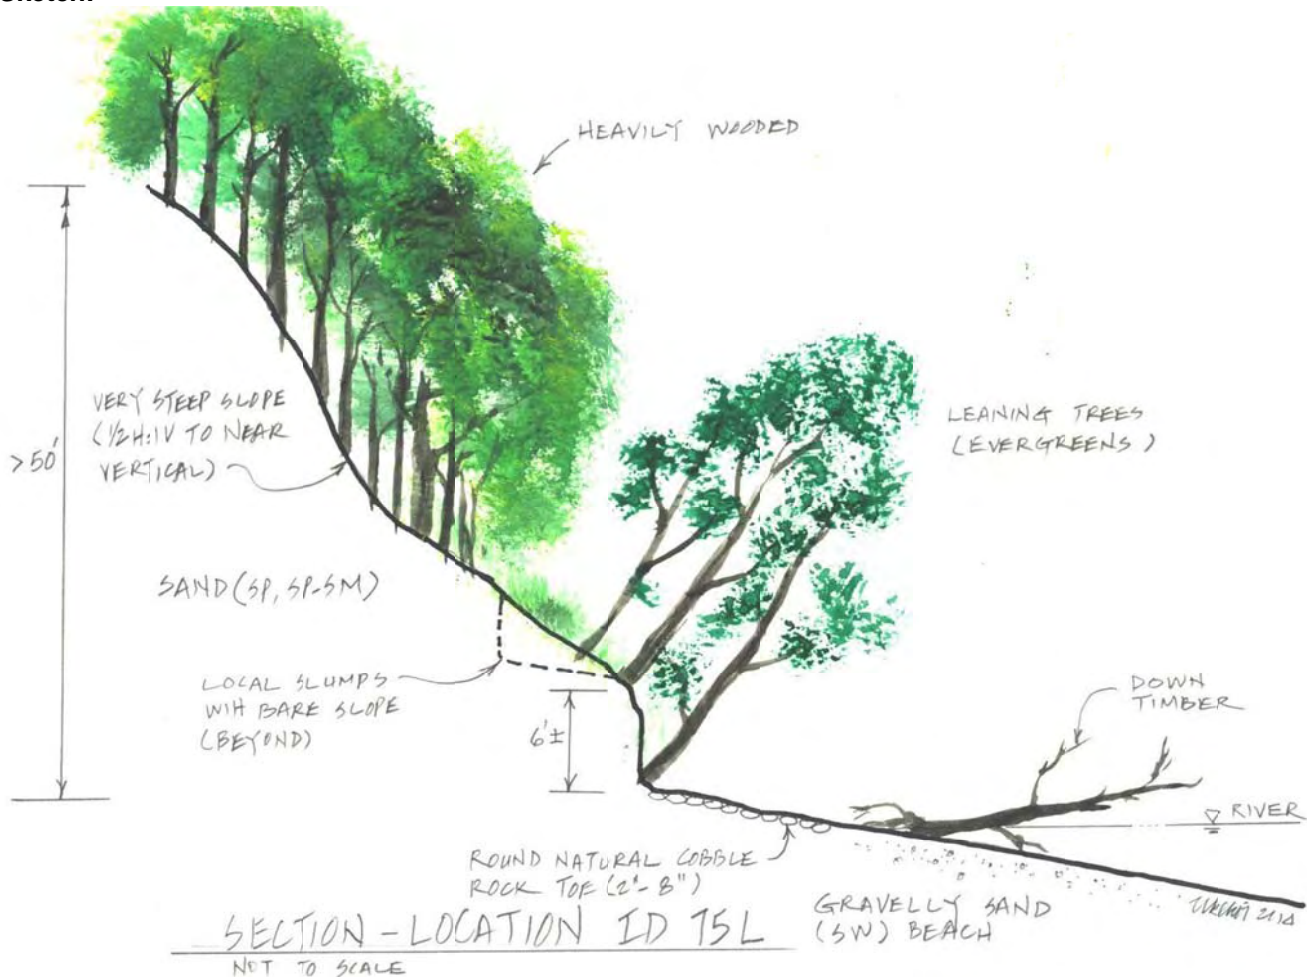
- Very steep slope, entire Upper Bank.
- Near-vertical slope at river level, with some undercuts, leaning trees and exposed roots
- Local slumps and mass-wasting with bare slope, lower half of Upper Bank

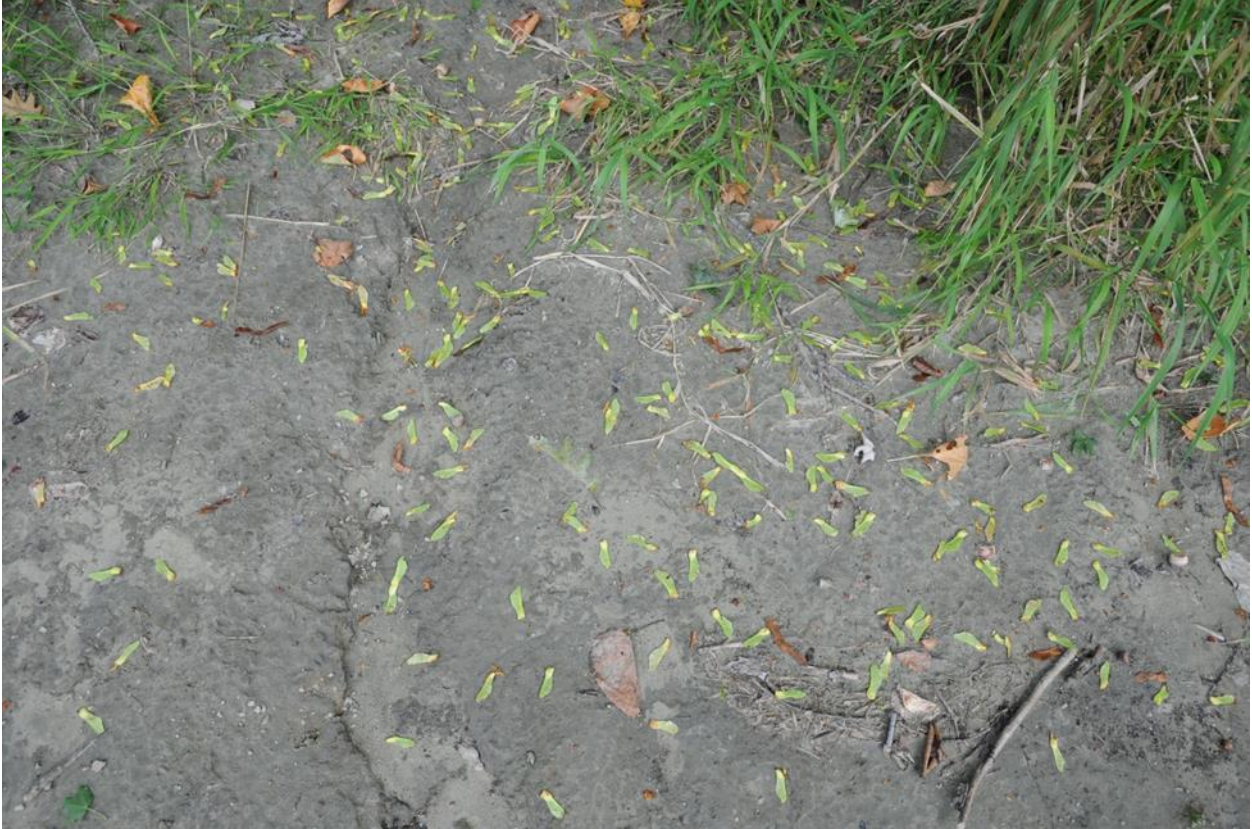
**Figure J-4.1 Maple seeds (photo 0202, 9/28/2015)**

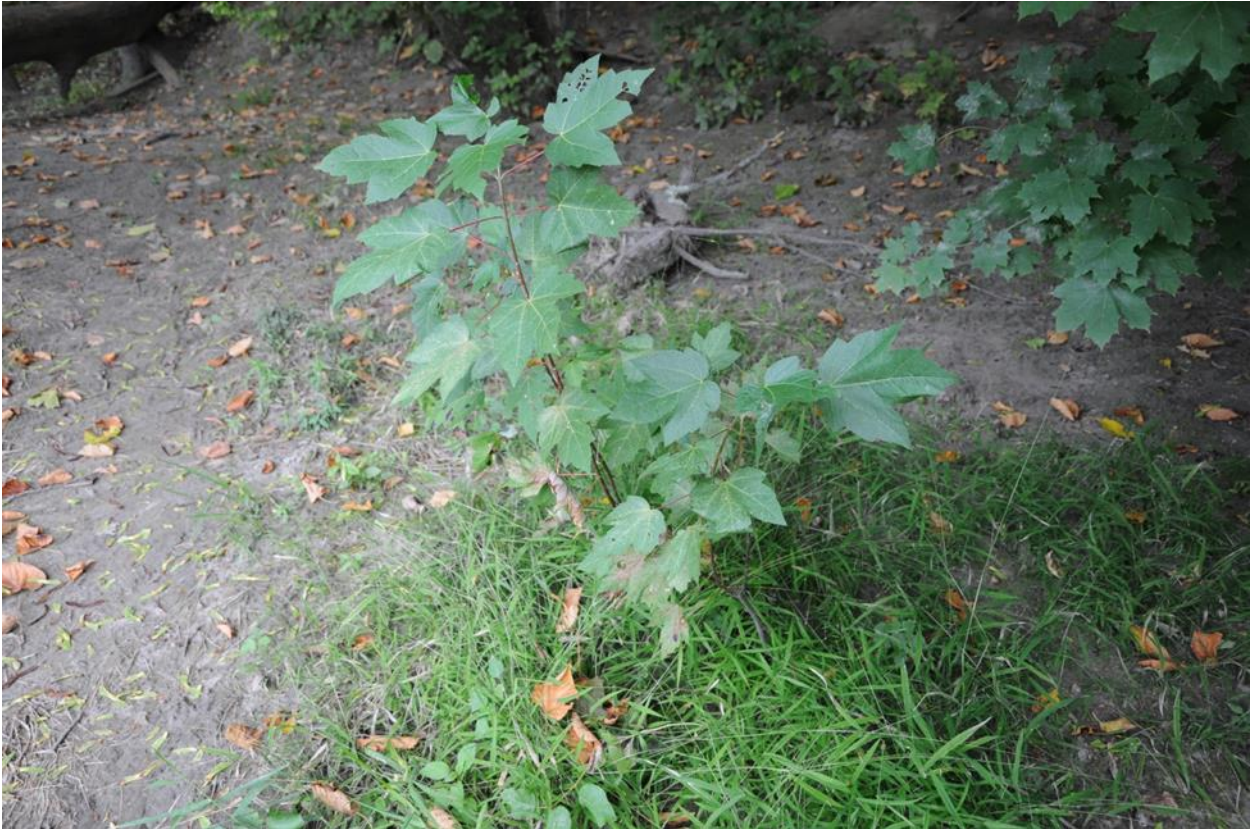
**Figure J-4.3 Maple seedlings (photo 0203, 9/28/2015)**

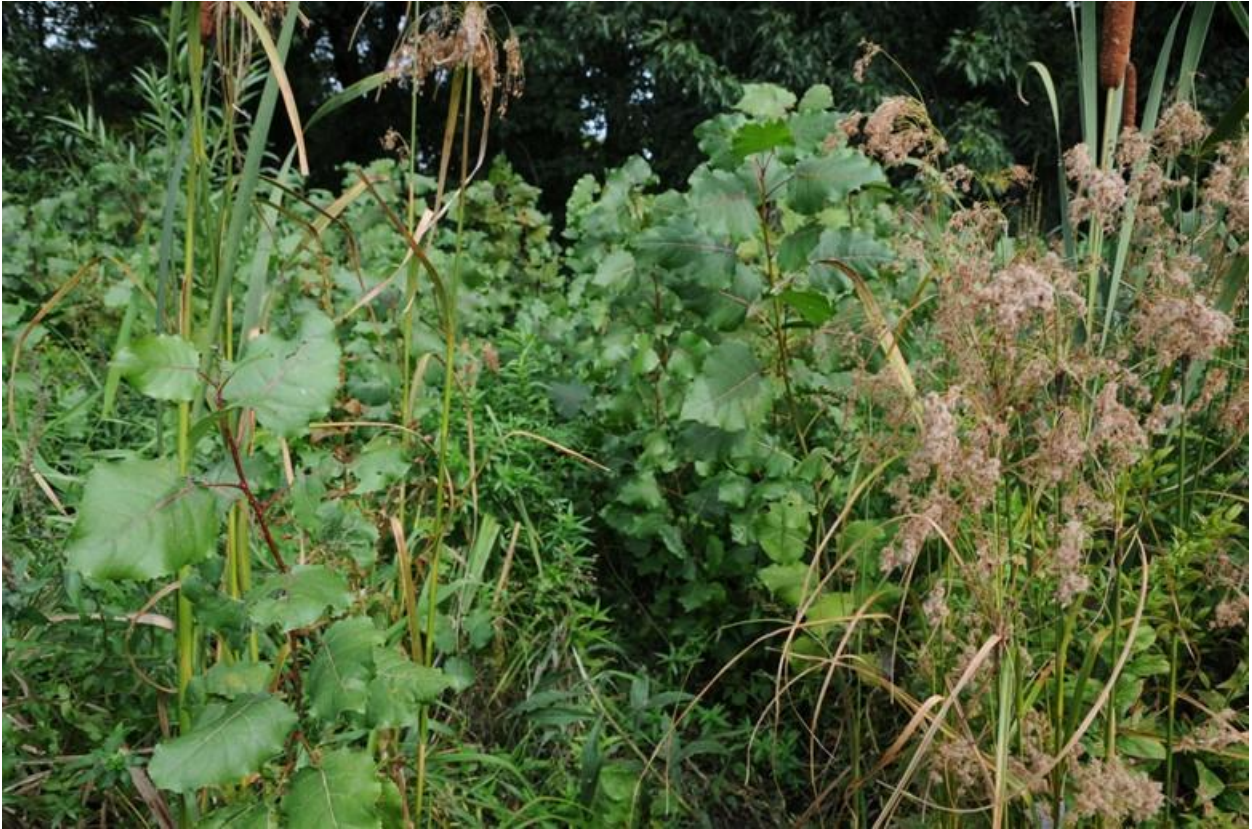
**Figure J-4.5 Cottonwood seedlings (photo 0204, 9/28/2015)**

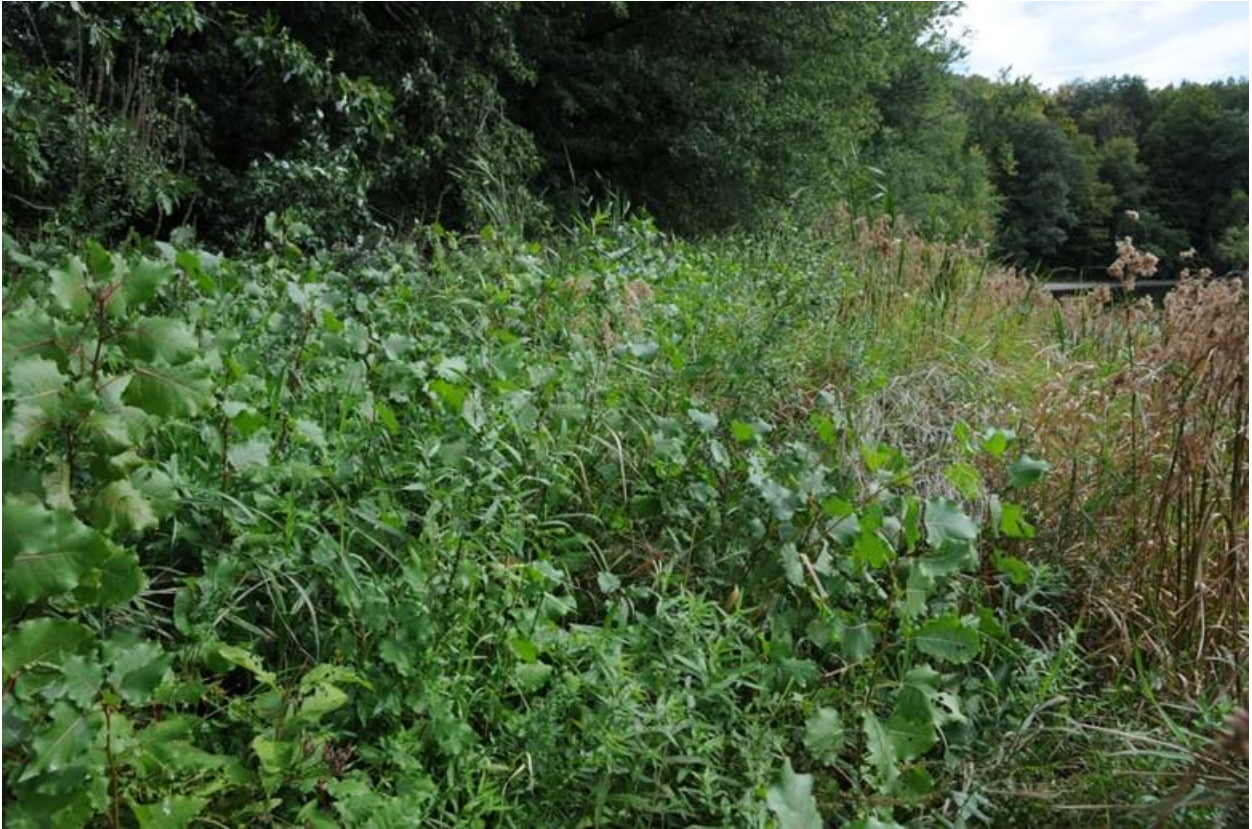
**Figure J-4.7 Cottonwood seedlings (photo 0206, 9/28/2015)**

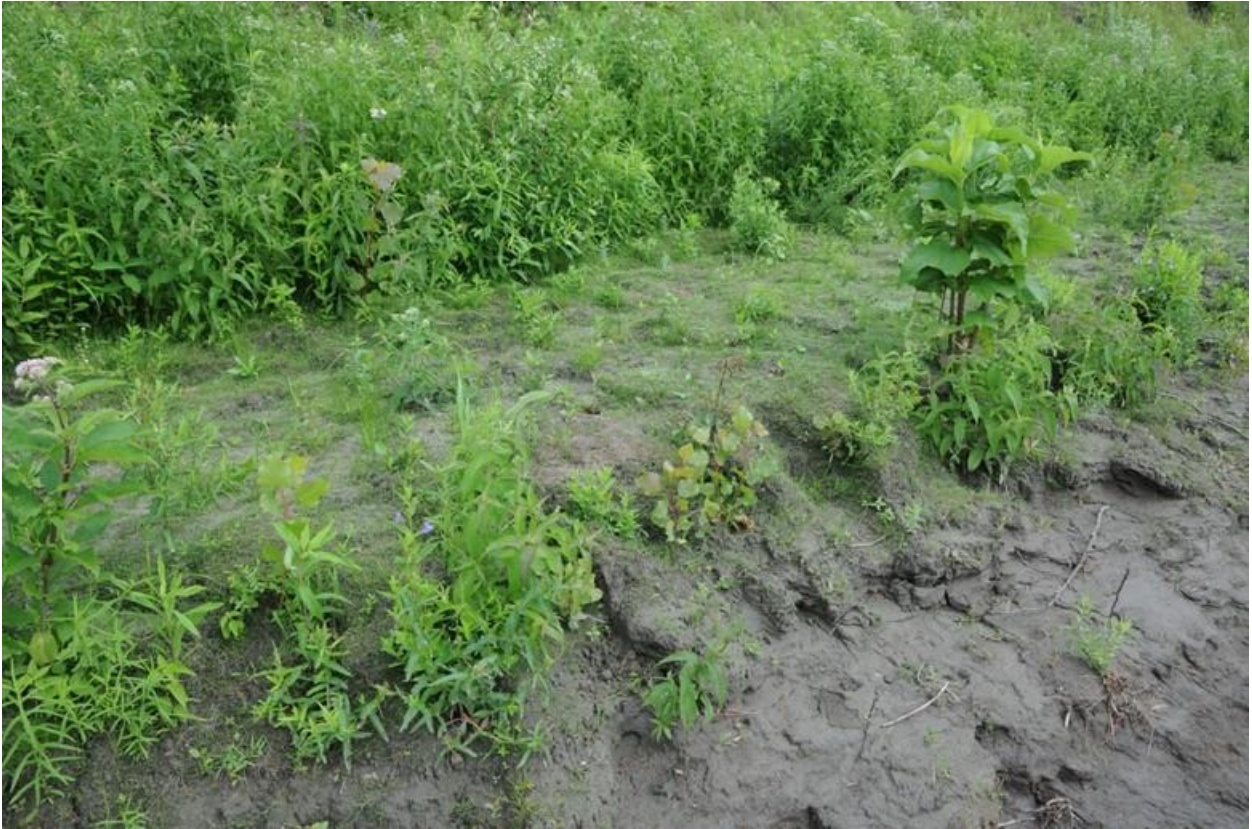
**Figure J-4.9 Cottonwood seedlings (photo 6576, 7/15/2014)**

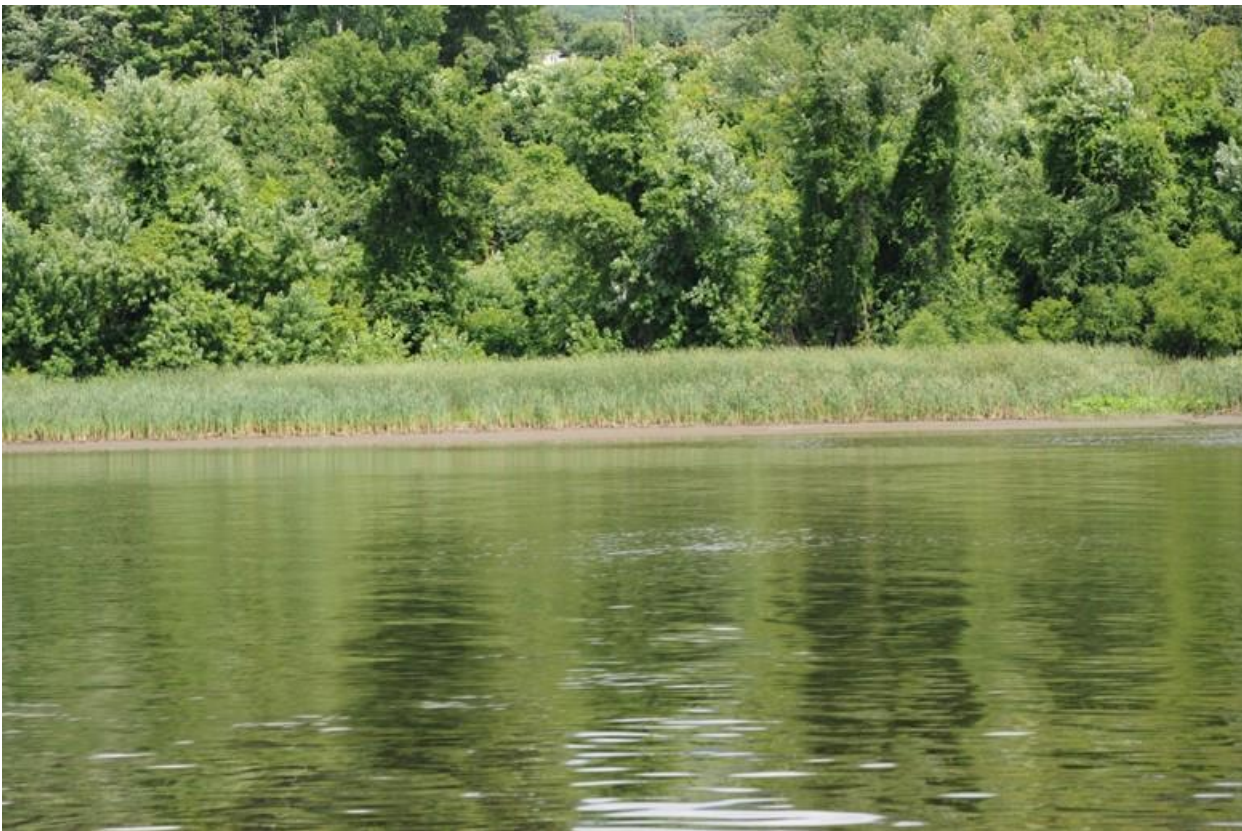
**Figure J-4.11 Lower riverbank vegetation (photo 6779, 7/17/2014)**

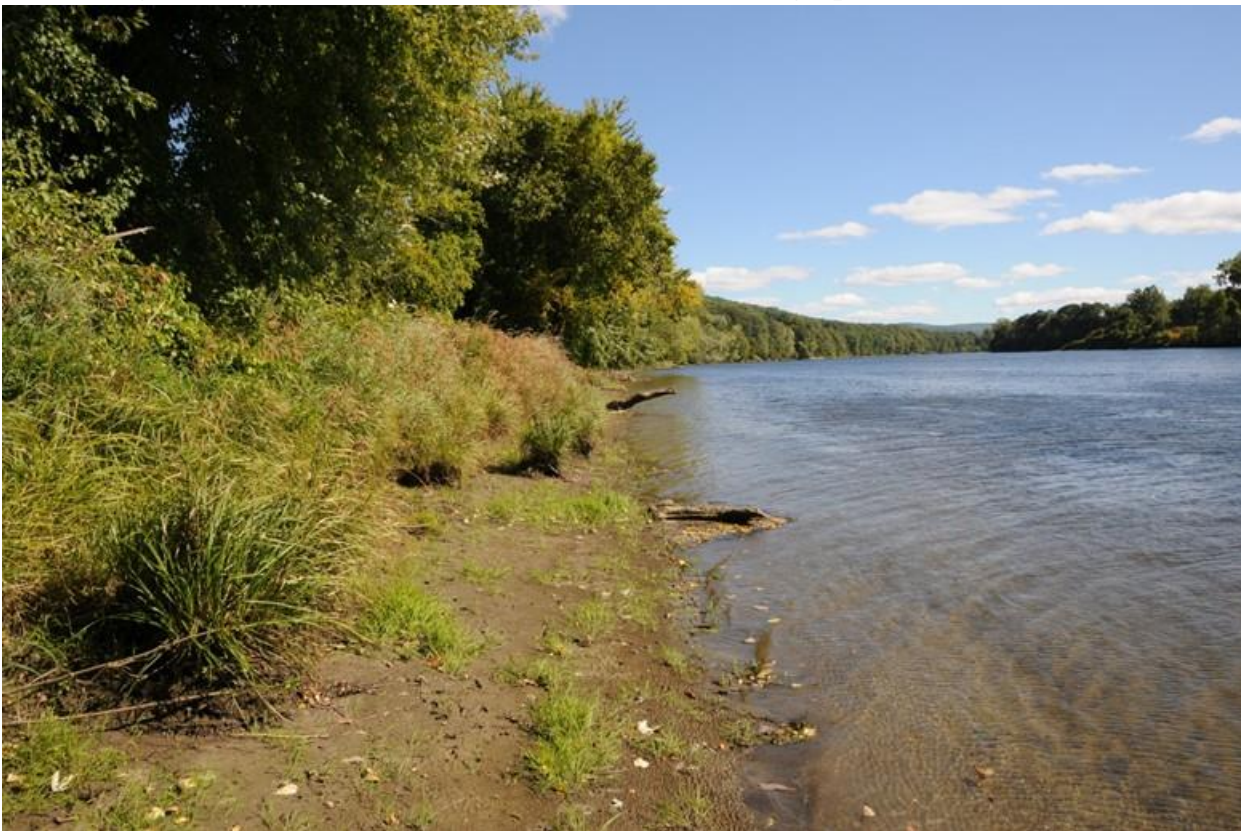
**Figure J-4.13 Lower riverbank vegetation with seedlings (photo 9203, 9/22/2014)**

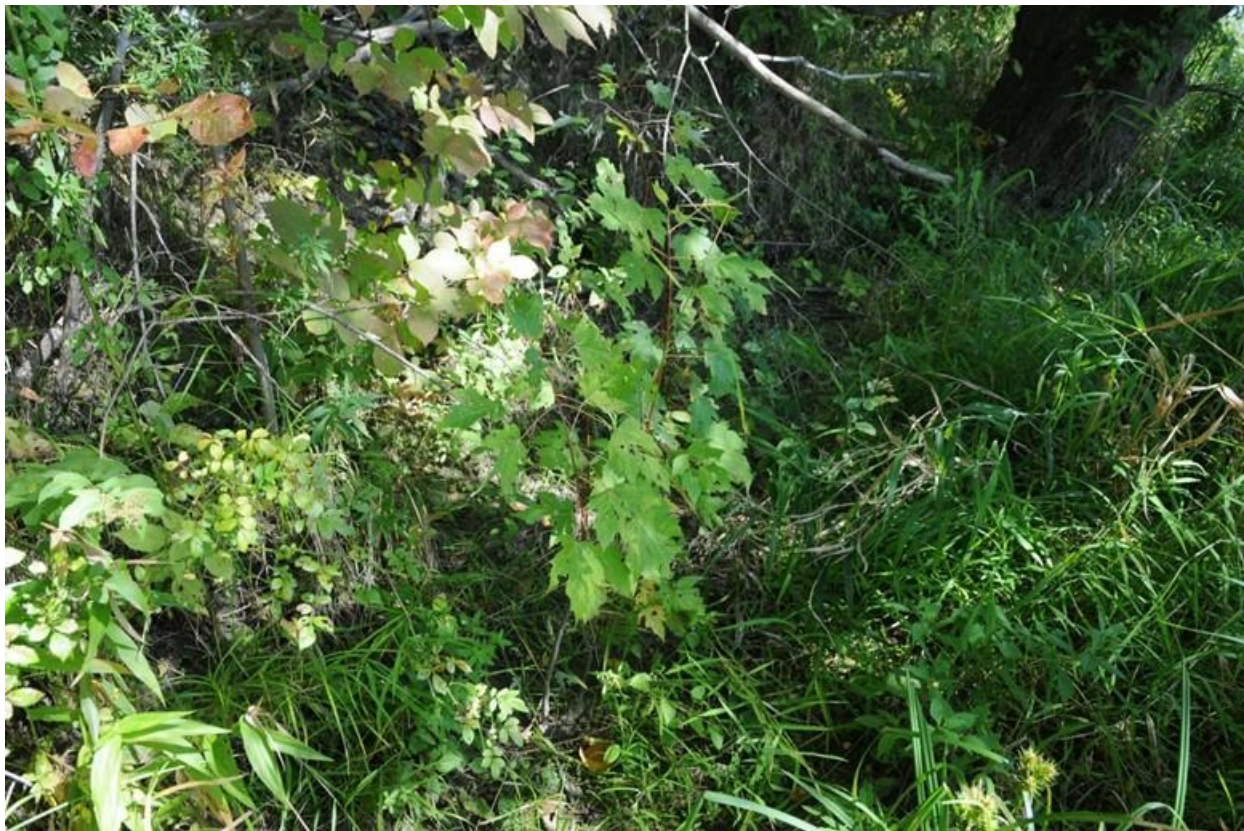
**Figure J-4.15 Maple seedling (photo 9217, 9/22/2014)**

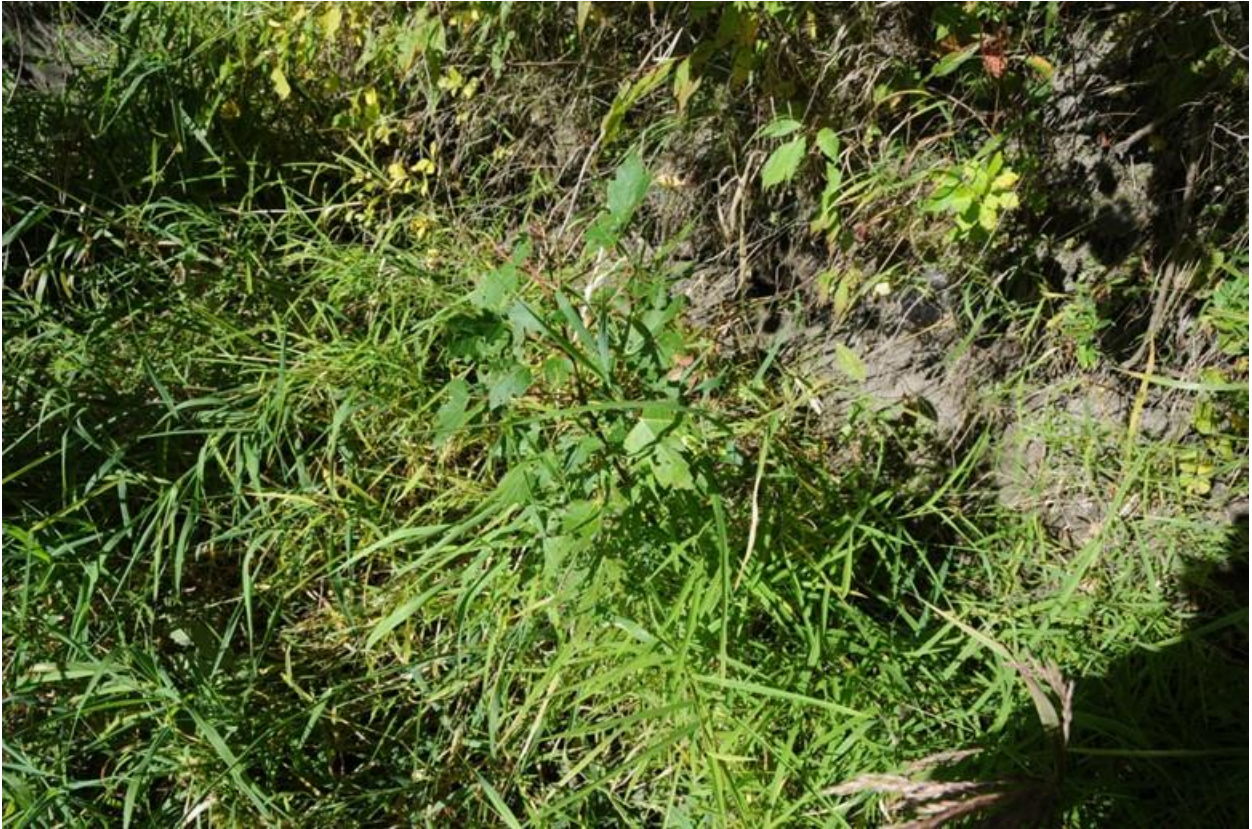
**Figure J-4.17 Maple seedling (photo 9218, 9/22/2014)**

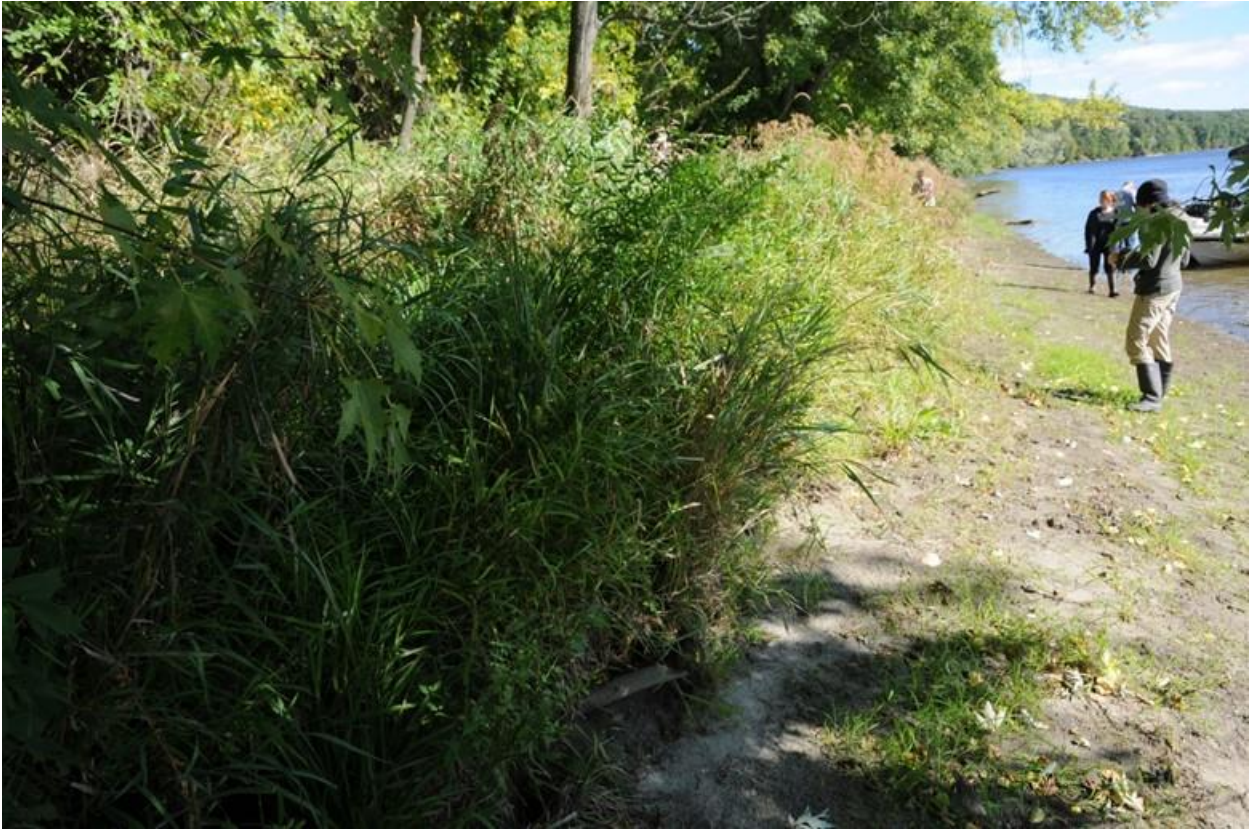
**Figure J-4.19 Maple sapling (photo 9219, 9/22/2014)**

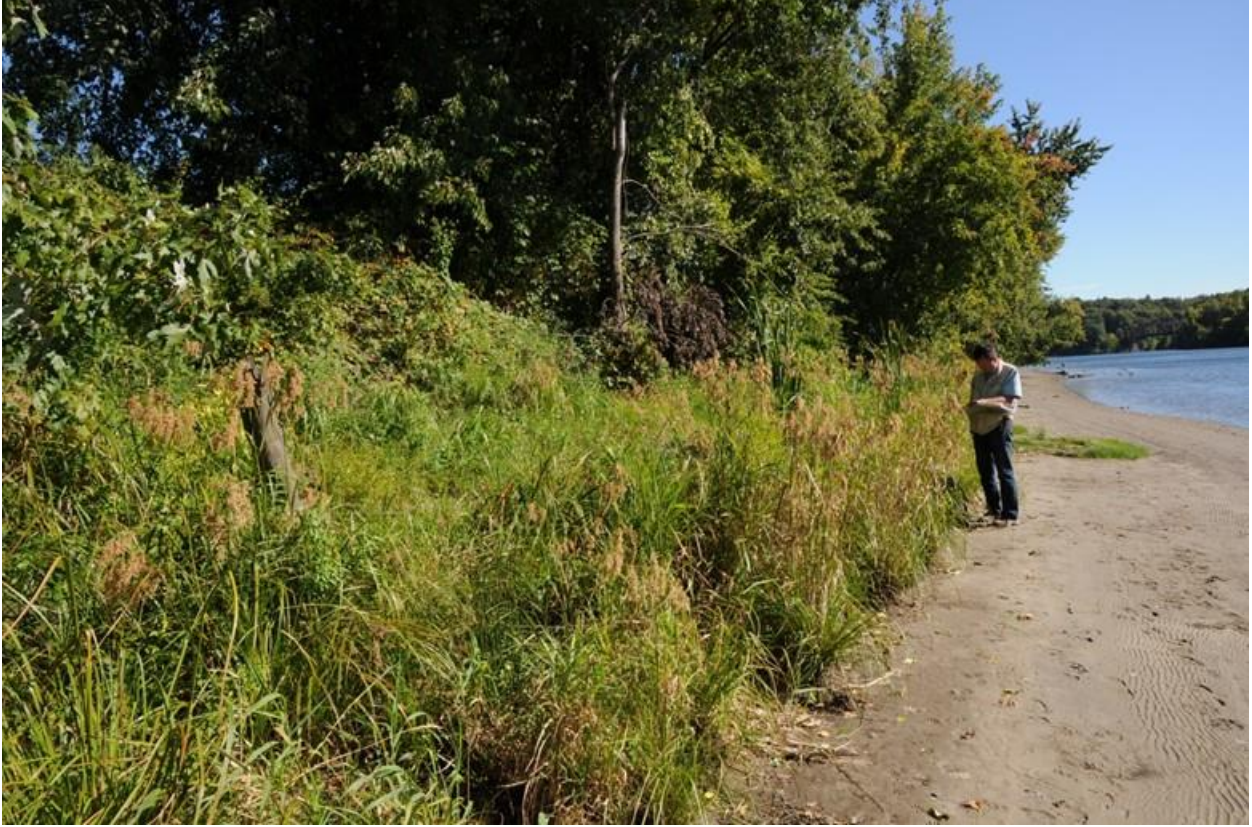
**Figure J-4.21 Lower riverbank vegetation with seedlings (photo 9297, 9/23/2014)**

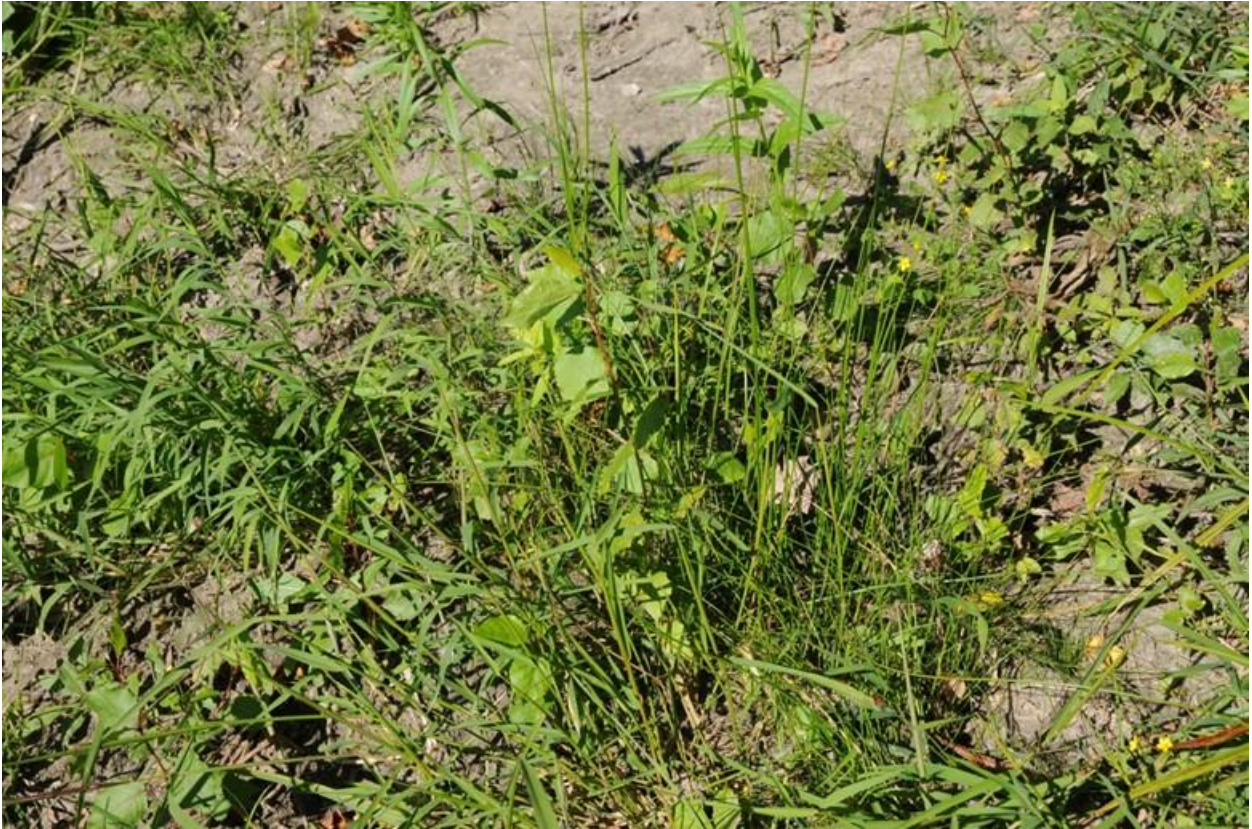
**Figure J-4.23 Cottonwood seedlings (photo 9298, 9/23/2014)**

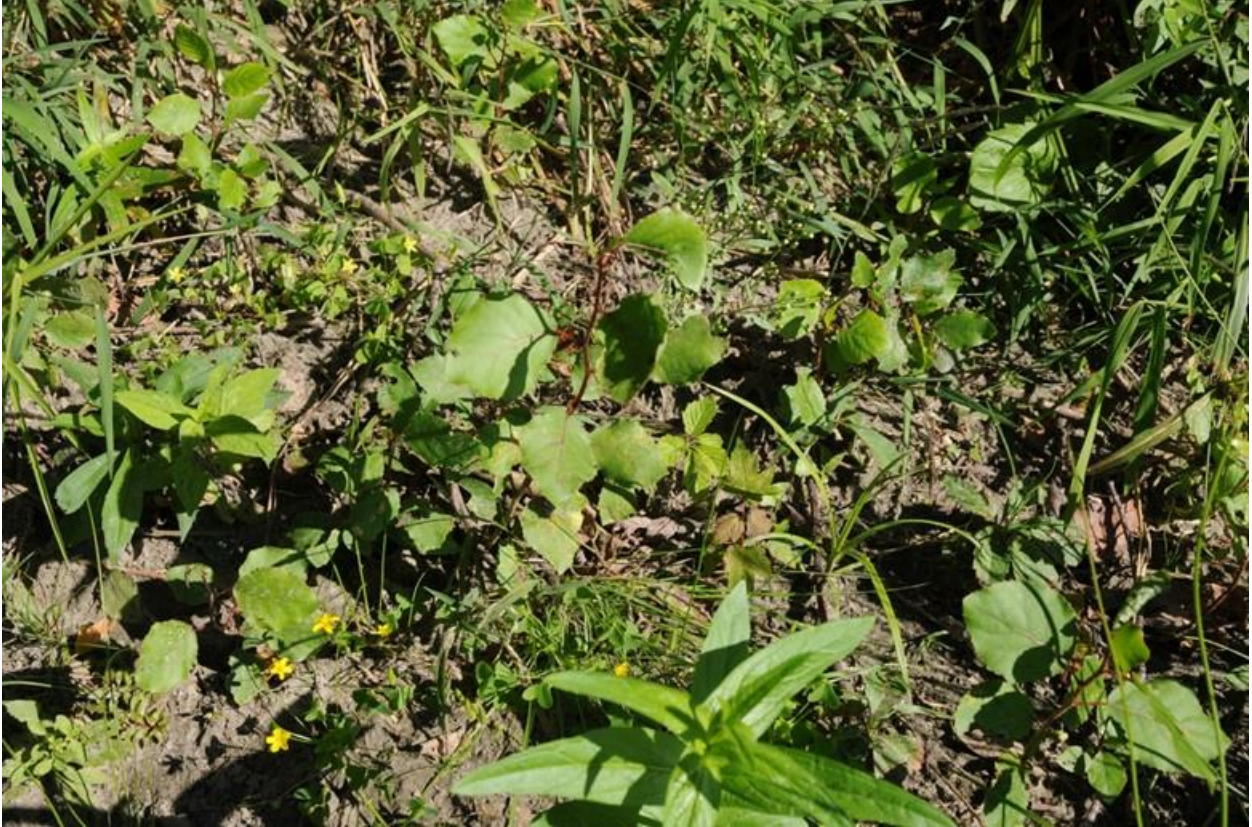
**Figure J-4.25 Cottonwood seedlings (photo 9299, 9/23/2014)**

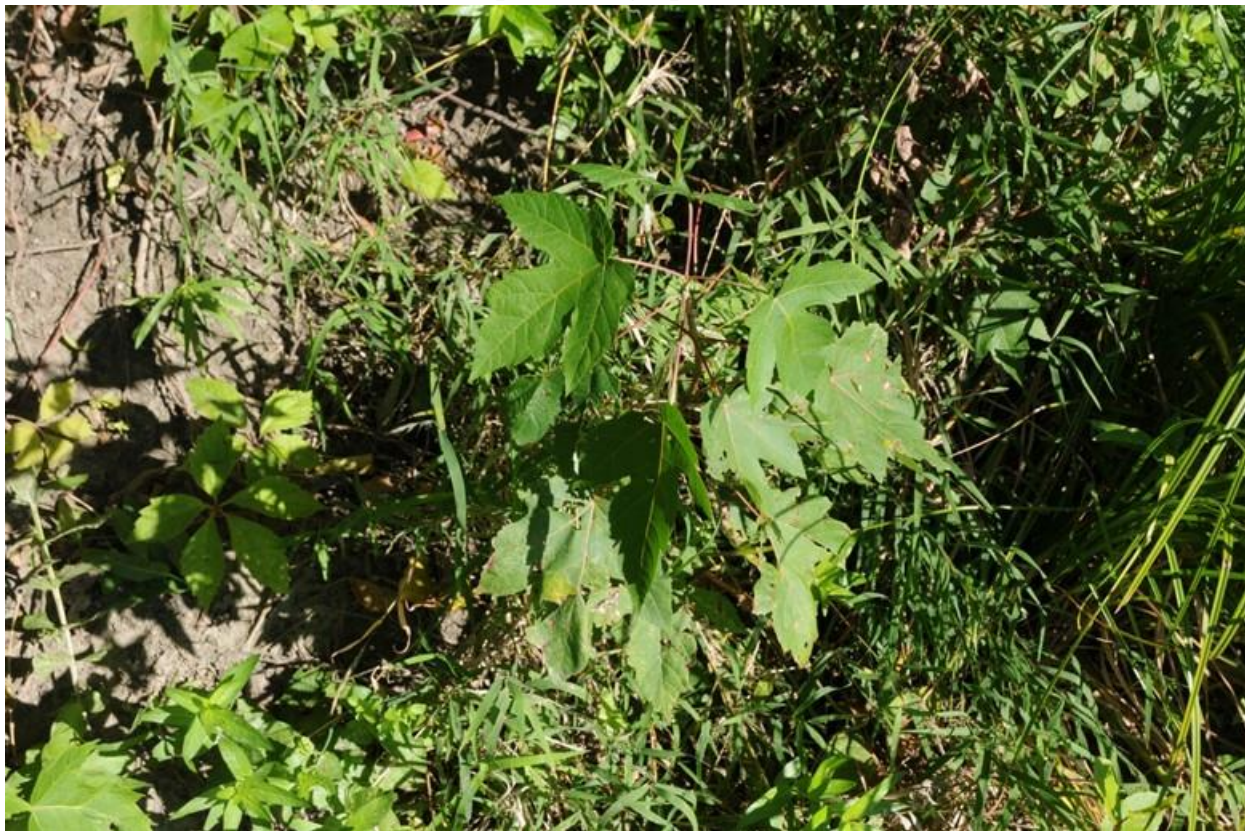
**Figure J-4.27 Maple seedlings (photo 9300, 9/23/2014)**
