**Relicensing Study 3.1.2**

**Northfield Mountain / Turners Falls  
Operations Impact on Existing Erosion and  
Potential Bank Instability  
Study Report**

**Volume III – Appendices**

**Northfield Mountain Pumped Storage Project (No. 2485) and  
Turners Falls Hydroelectric Project (No. 1889)**

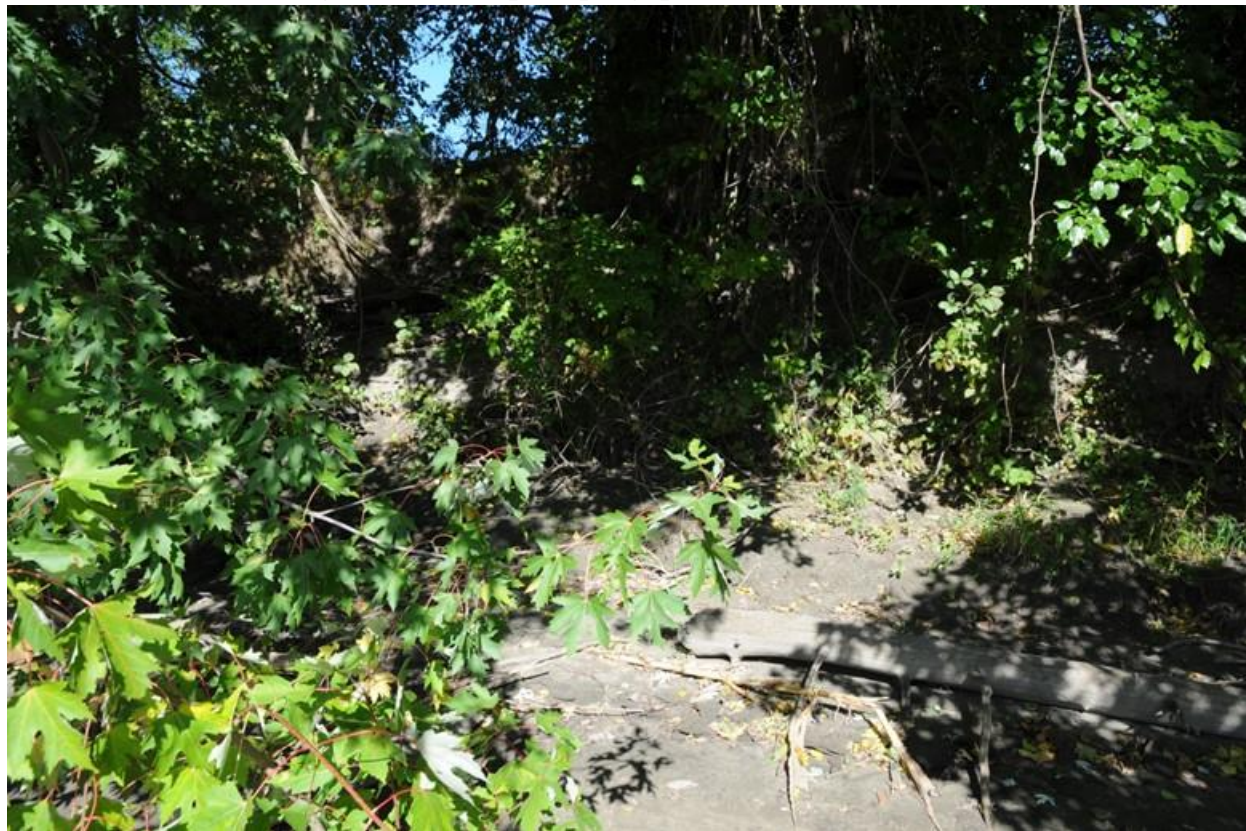
**Figure J-4.29 Maple sapling (photo 9307, 9/23/2014)**
