Relicensing Study 3.1.2

**Northfield Mountain / Turners Falls
Operations Impact on Existing Erosion and
Potential Bank Instability
Study Report**

Volume II – Main Report

**Northfield Mountain Pumped Storage Project (No. 2485) and
Turners Falls Hydroelectric Project (No. 1889)**

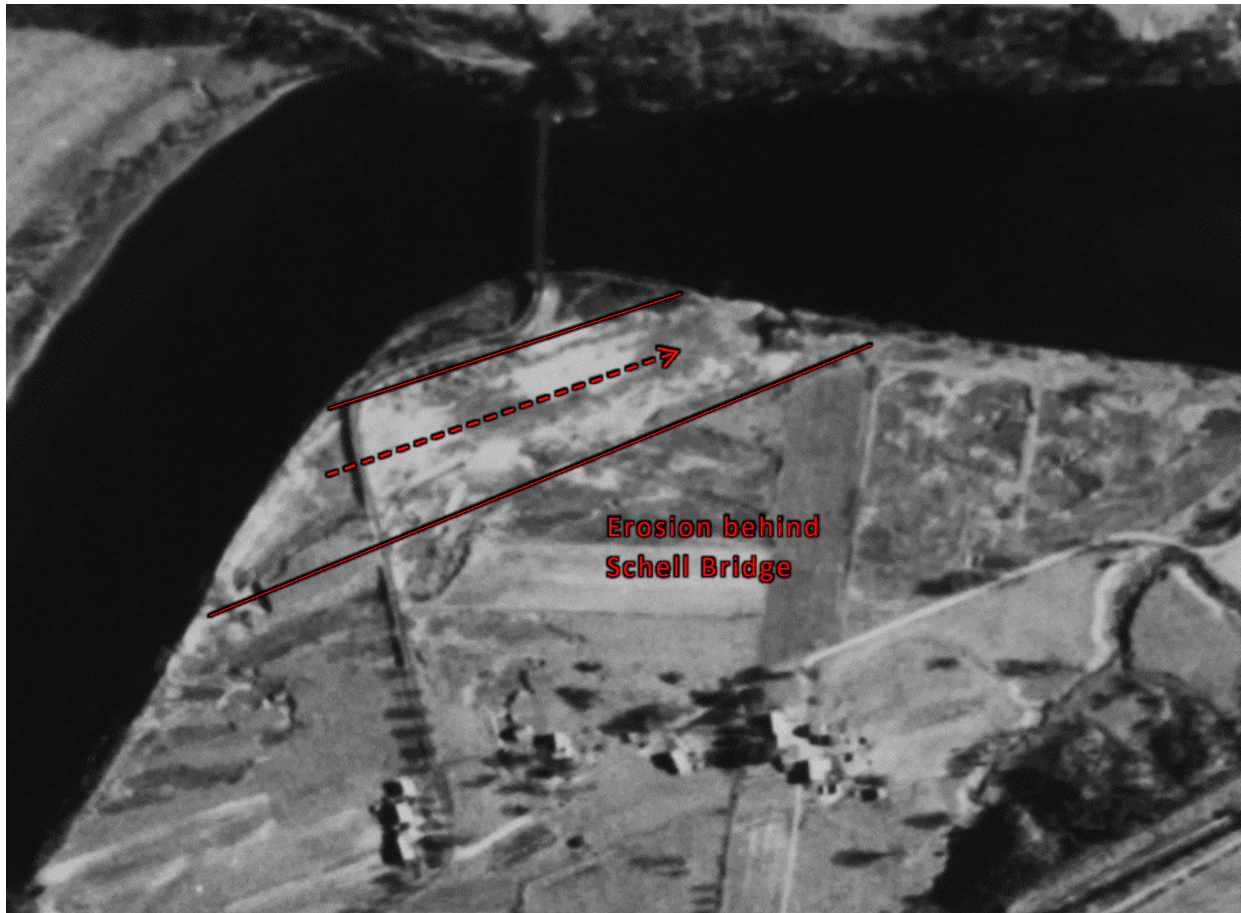
Specific to the TFI, the flood of 1936 caused significant erosion and channel change at several locations. As noted in Field ([2007](#)), the flood of 1936 spread across the floodplain with enough force that a new channel 20 ft. deep across was cut across Moose Plain and around Schell Bridge. Similar avulsion channels were also observed immediately north of Munns Ferry, across Bennett Meadow near the Rt. 10 Bridge, and on Pine Meadow downstream of Kidds Island; however, only the channel north of Munns Ferry is believed to have formed as a result of the 1936 flood, the others may have been the result of earlier floods ([Field, 2007](#)).

Figure 2.3.2-6 Erosion behind Schell Bridge, 1939 (c)

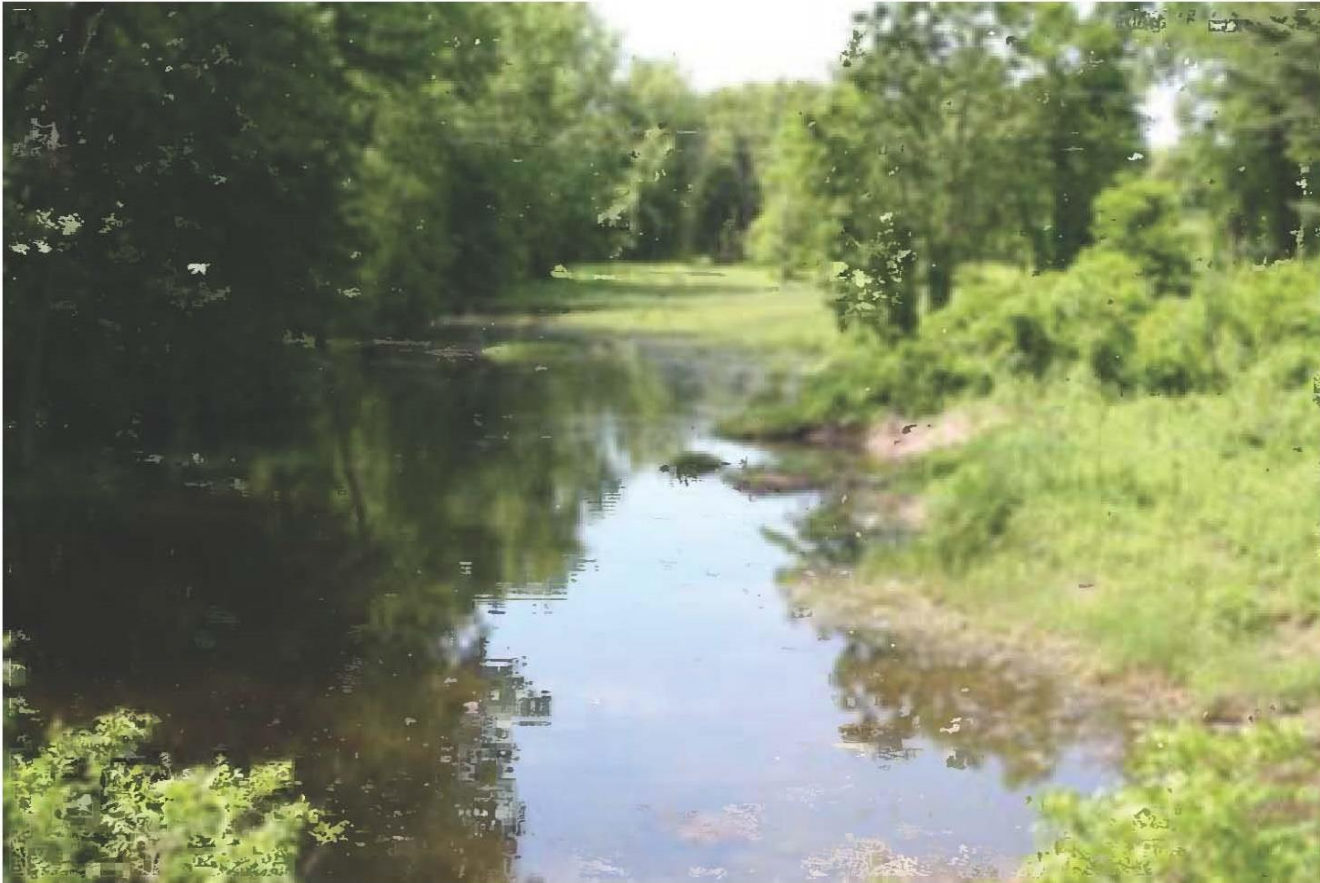
Figure 2.3.2-7 Abandoned avulsion channel behind Schell Bridge (d) (Field, 2007)

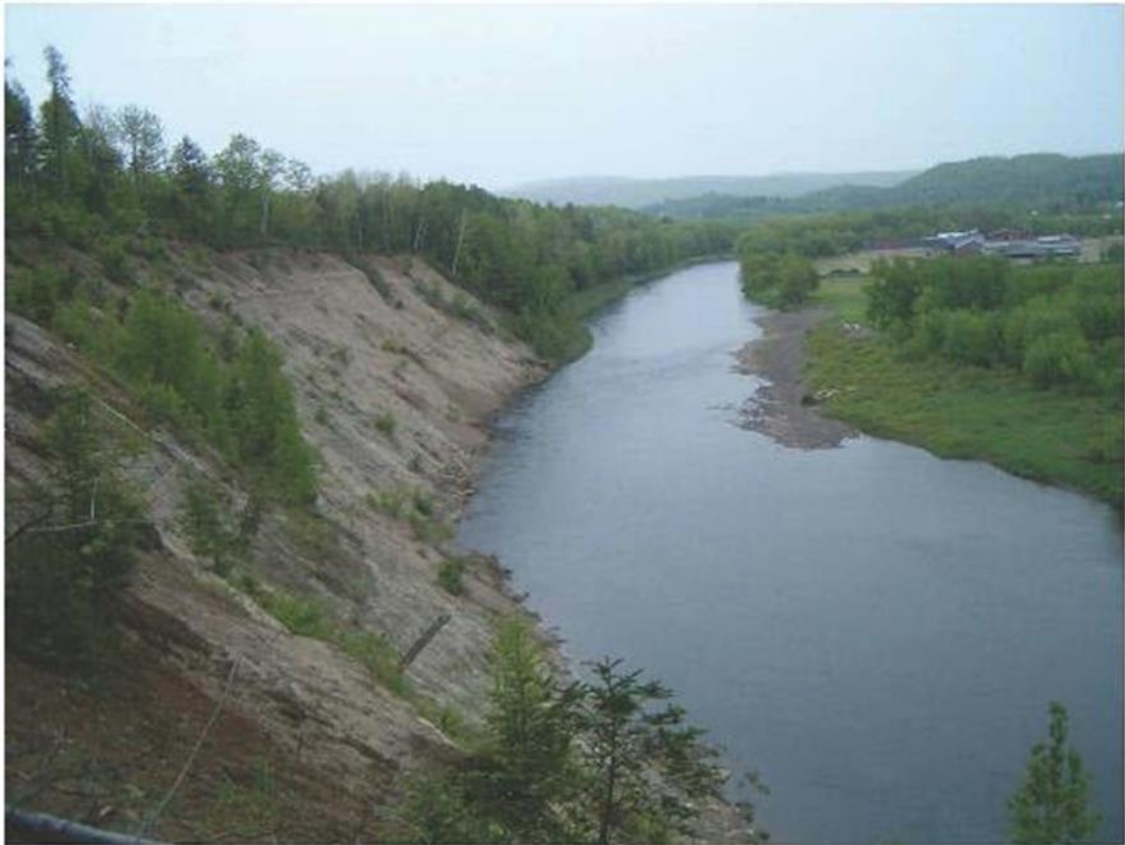
Note: Near Brunswick Springs, VT

Figure 2.5-1: Erosion of Glacial Outwash Deposits in Un-impounded Reach of Connecticut River (Field, 2004)

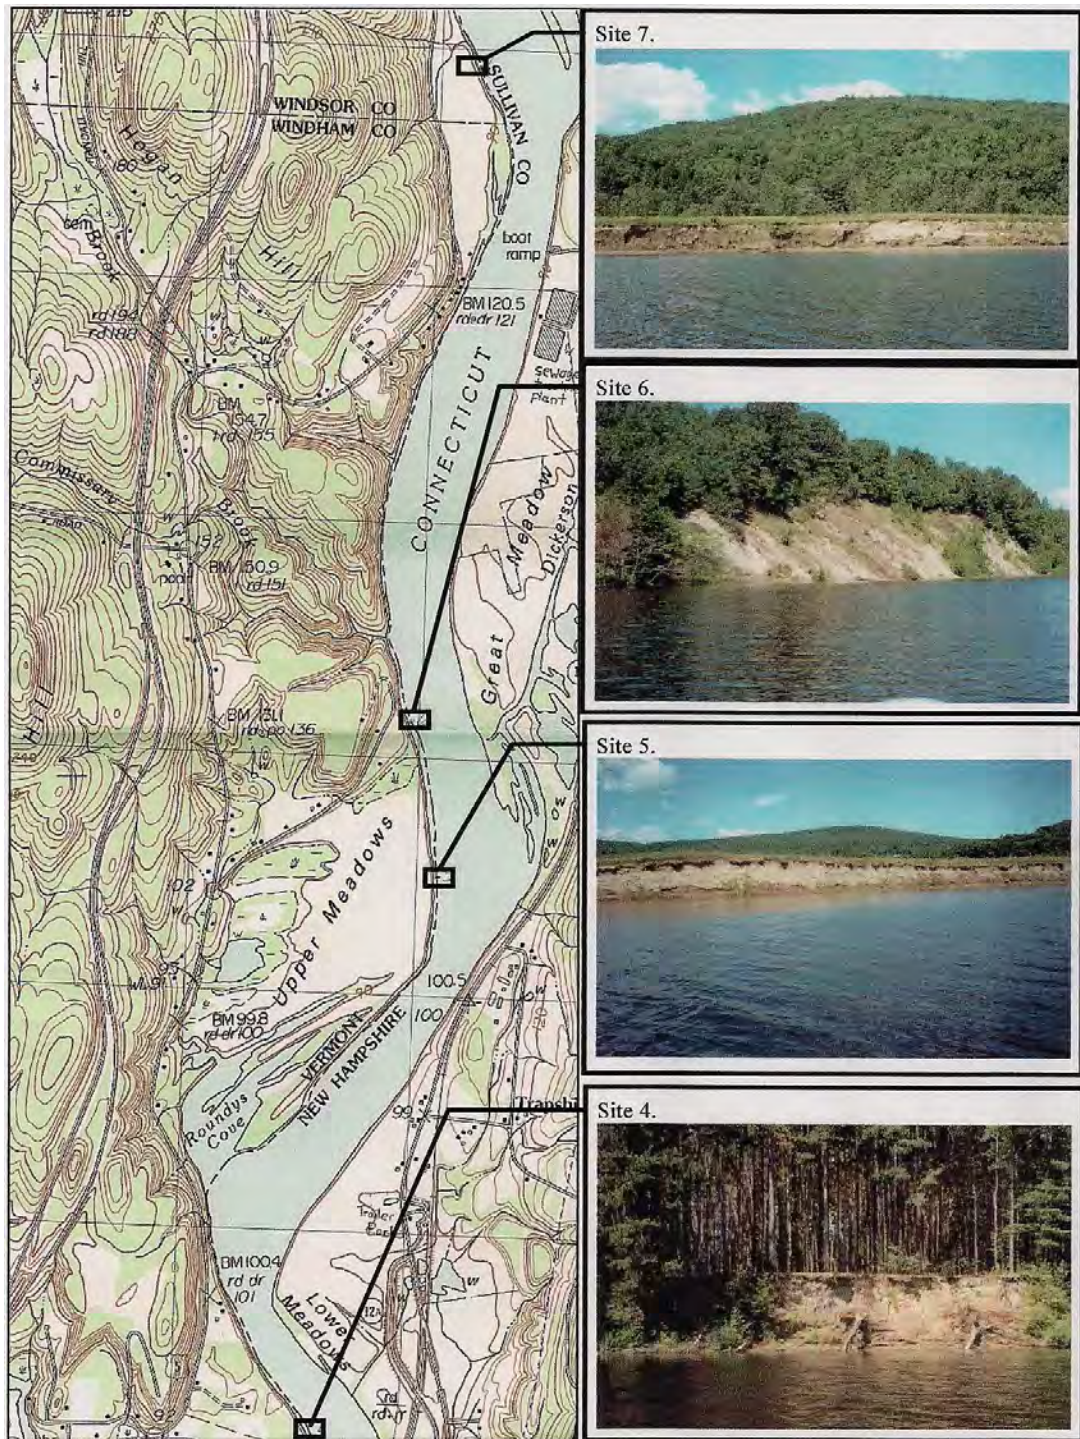
Figure 2.5-2: Erosion sites 4-7, Bellows Falls Impoundment (1997)

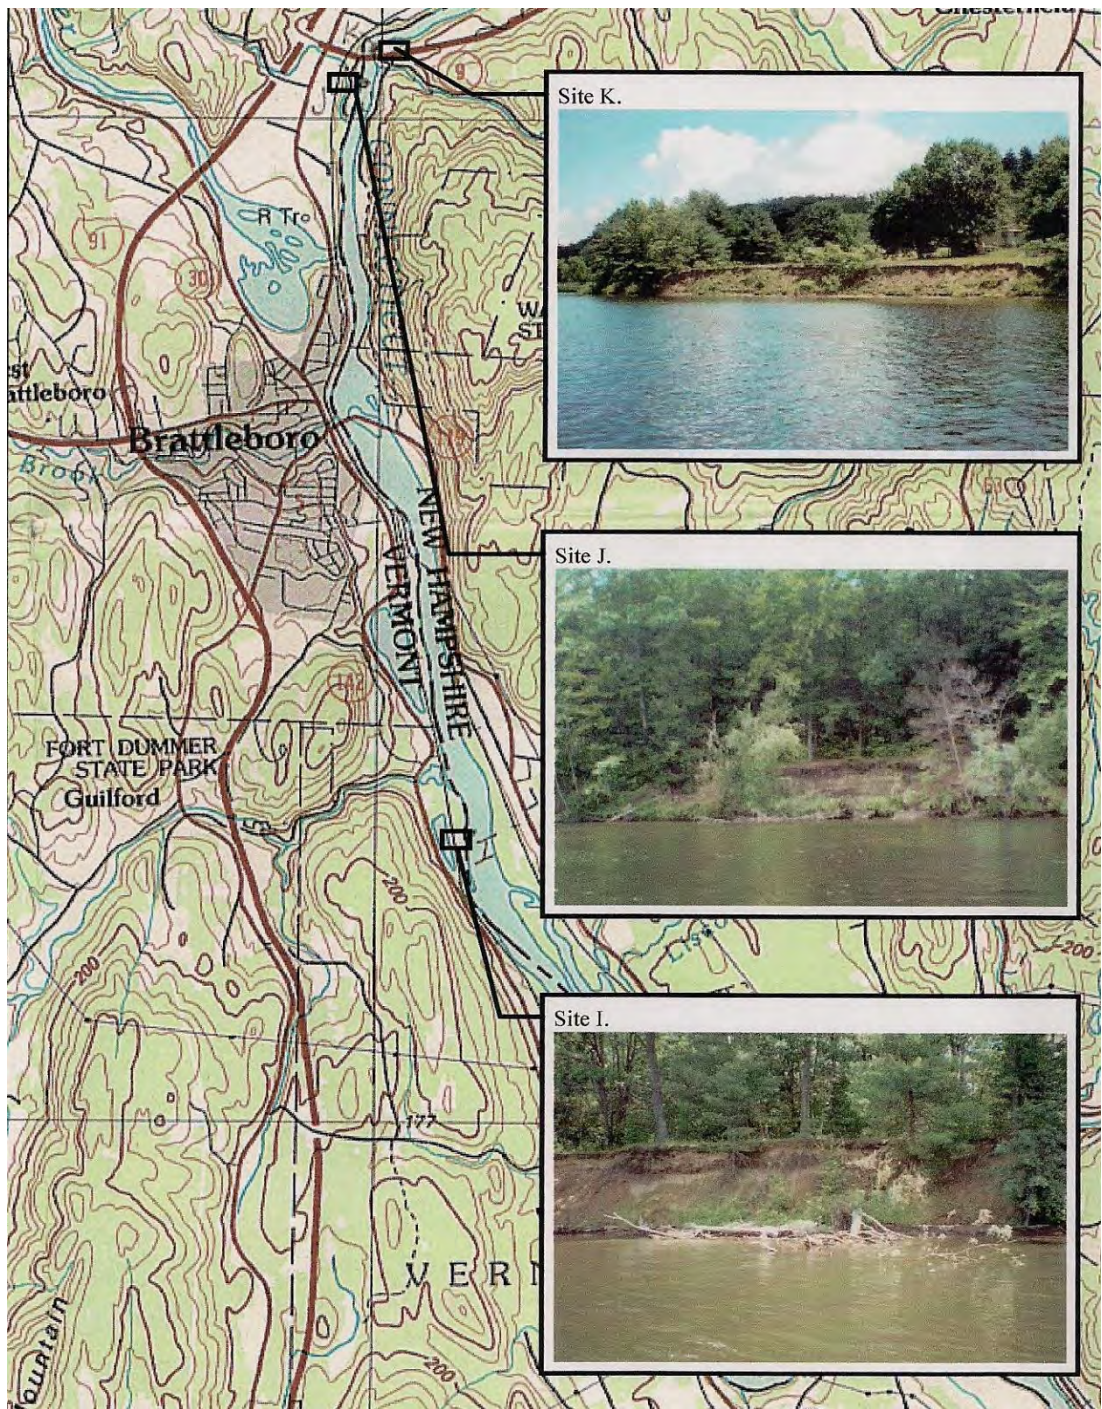
Figure 2.5-3: Erosion sites I-K, Vernon Impoundment (1997)

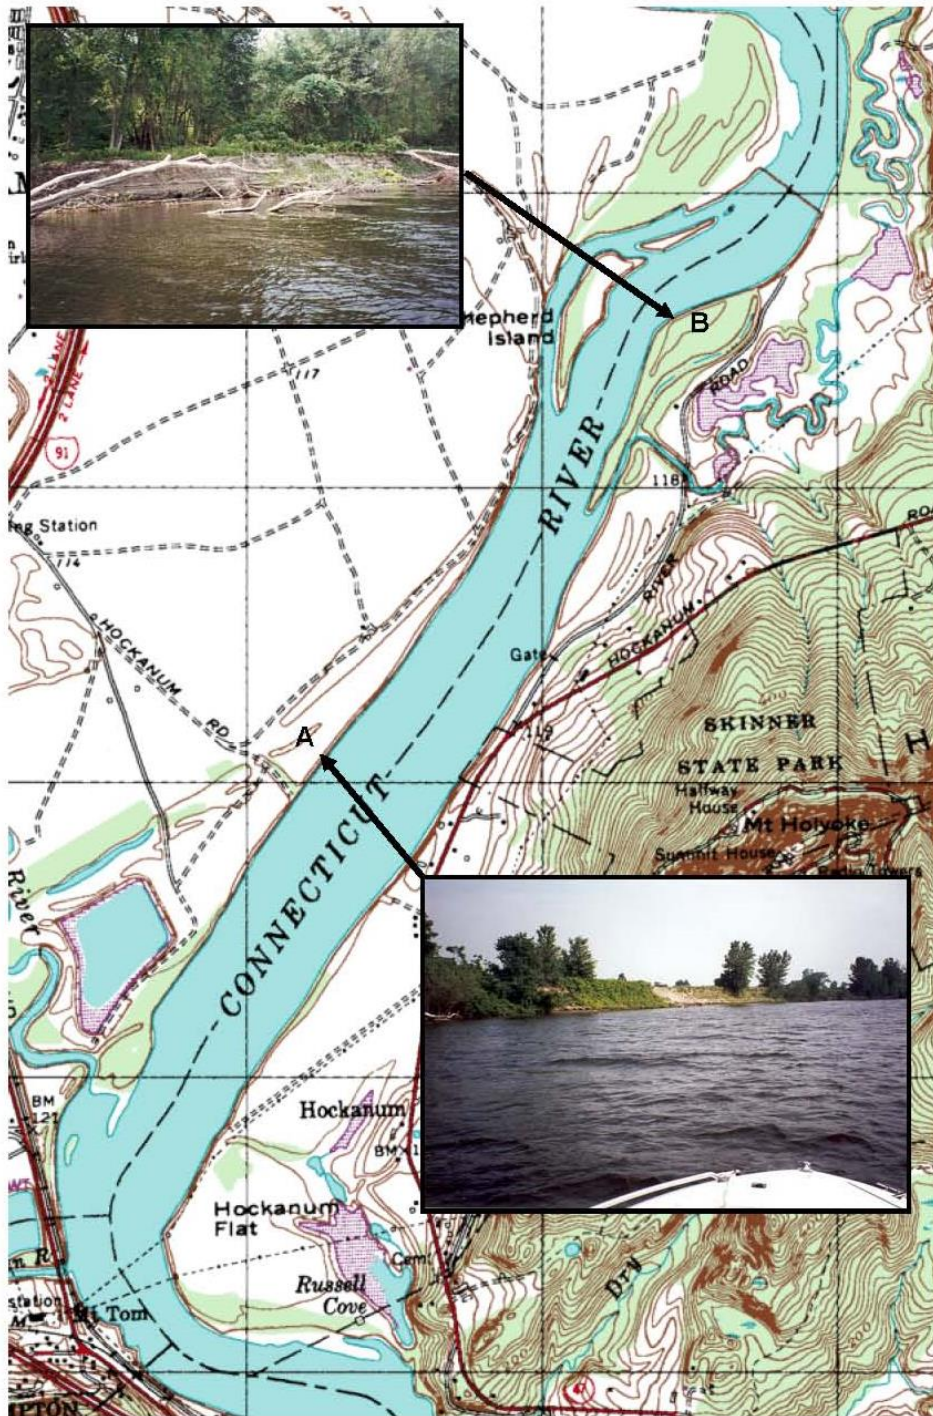
Figure 2.5-4 Erosion sites A and B, Holyoke Impoundment (1997)

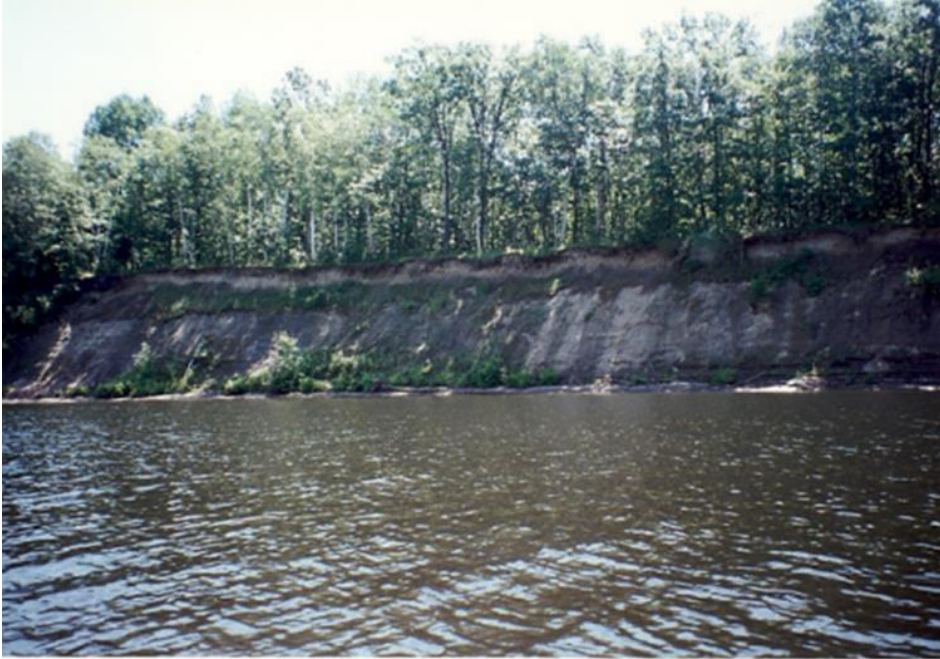
The erosion sites identified in 1997 were revisited in 2008 to photographically document any changes that might have occurred since 1997. Sets of photographs showing 1997 and 2008 images at the same sites are presented in [Figures 2.5-5](#) and [2.5-6](#) for the Bellows Falls Impoundment; Vernon – [Figures 2.5-7](#) and [2.5-8](#); and Holyoke – [Figures 2.5-9](#) and [2.5-10](#). For these three impoundments, erosion sites in 1997 were observed to be in the same eroding condition in 2008.

Figure 2.5-5: Bellows Falls Impoundment – Location 8 (1997)

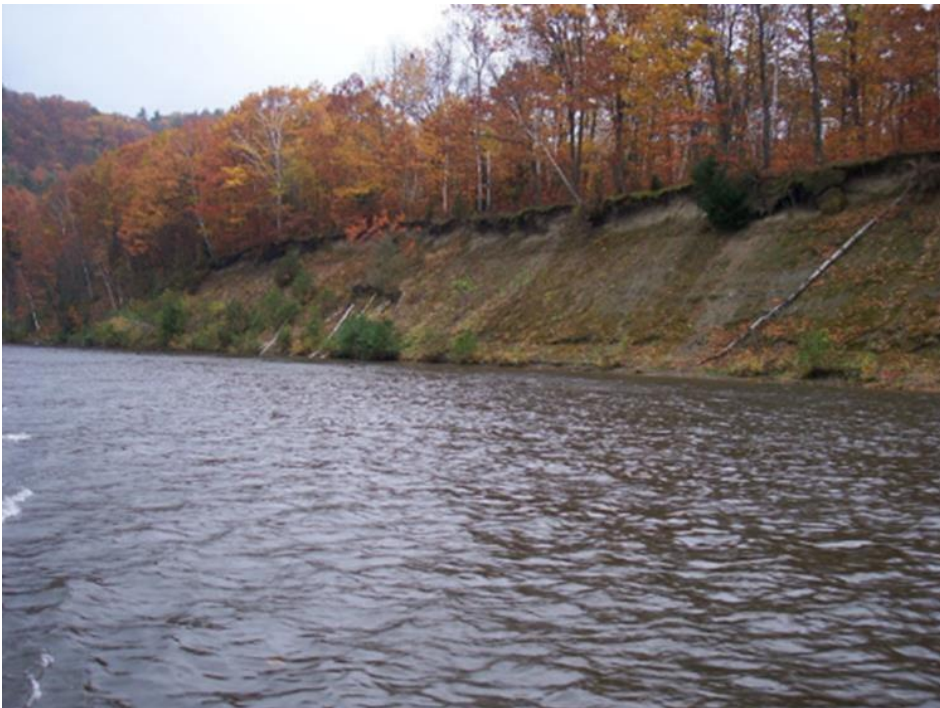
Figure 2.5-6: Bellows Falls Impoundment – Location 8 (2008)

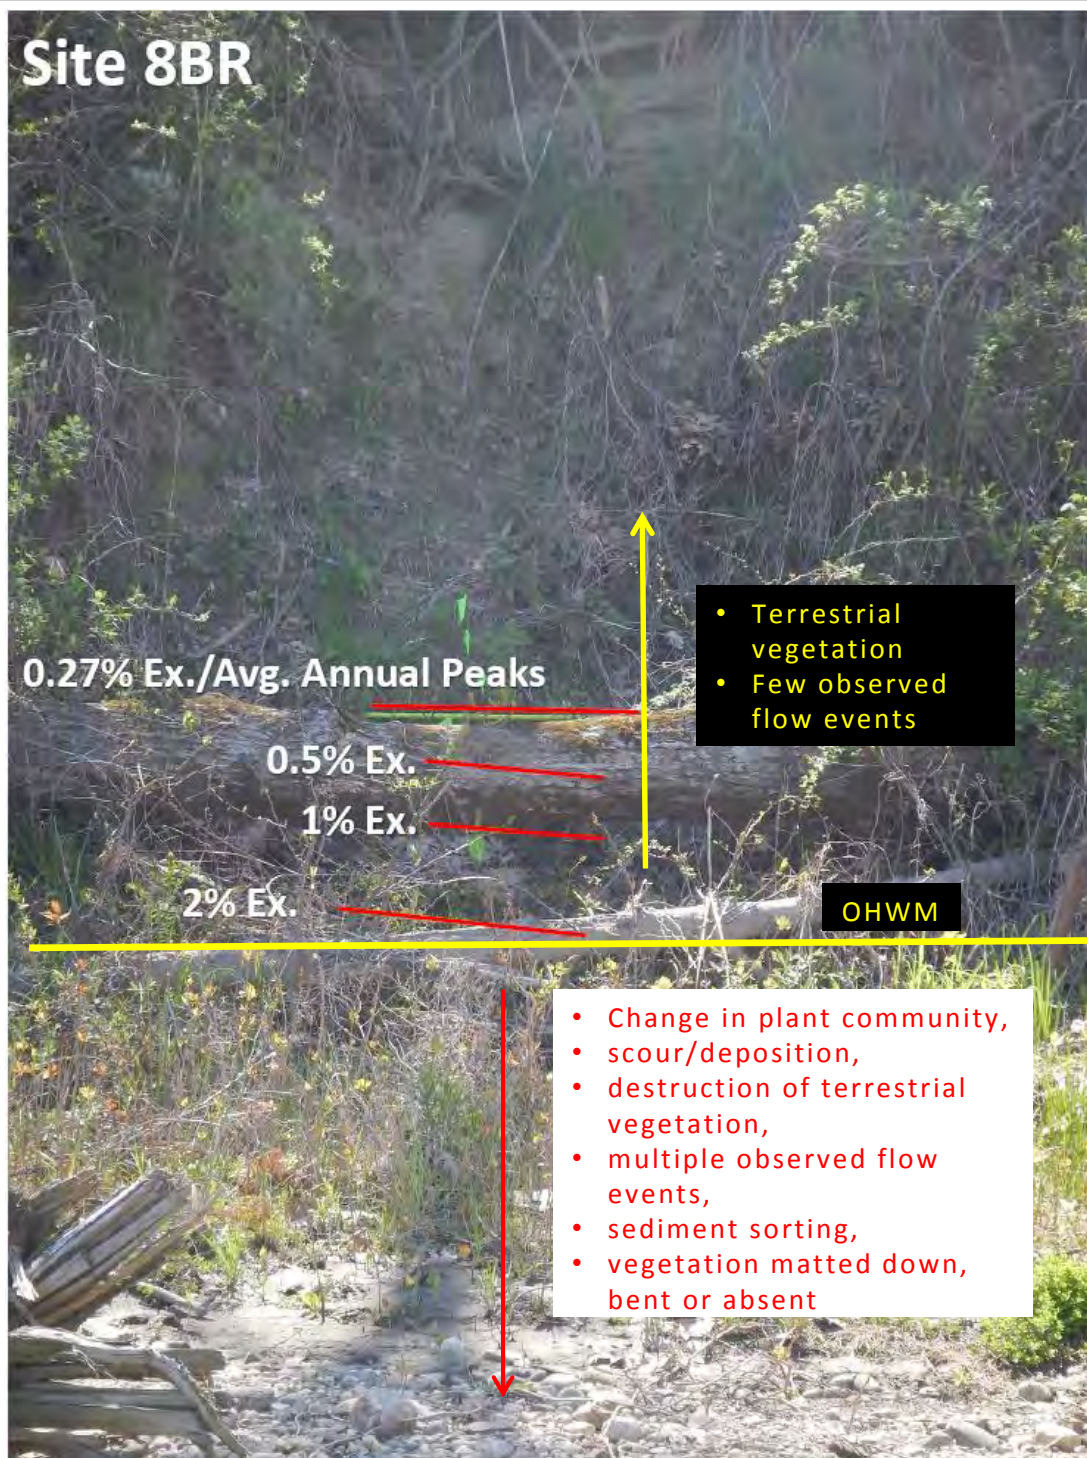
Figure 4.2.4.1-2. Physical characteristics of OHWM at Site 8BR

Photographs of the riverbanks at a number of sites along the TFI were then labeled with observed physical characteristics as well as a range of water levels from the water level-duration analysis to help determine which statistical measure should be used to define an appropriate water level to represent the ordinary high water mark ([Figures 4.2.4.1-2](#) through [4.2.4.1-8](#)). These figures show the OHWM which is marked as a horizontal yellow line, with physical characteristics labeled above and below the OHWM as observed at each site. At many of these sites there are multiple physical characteristics that identify the OHWM, while at some there are none visible since they are below water.

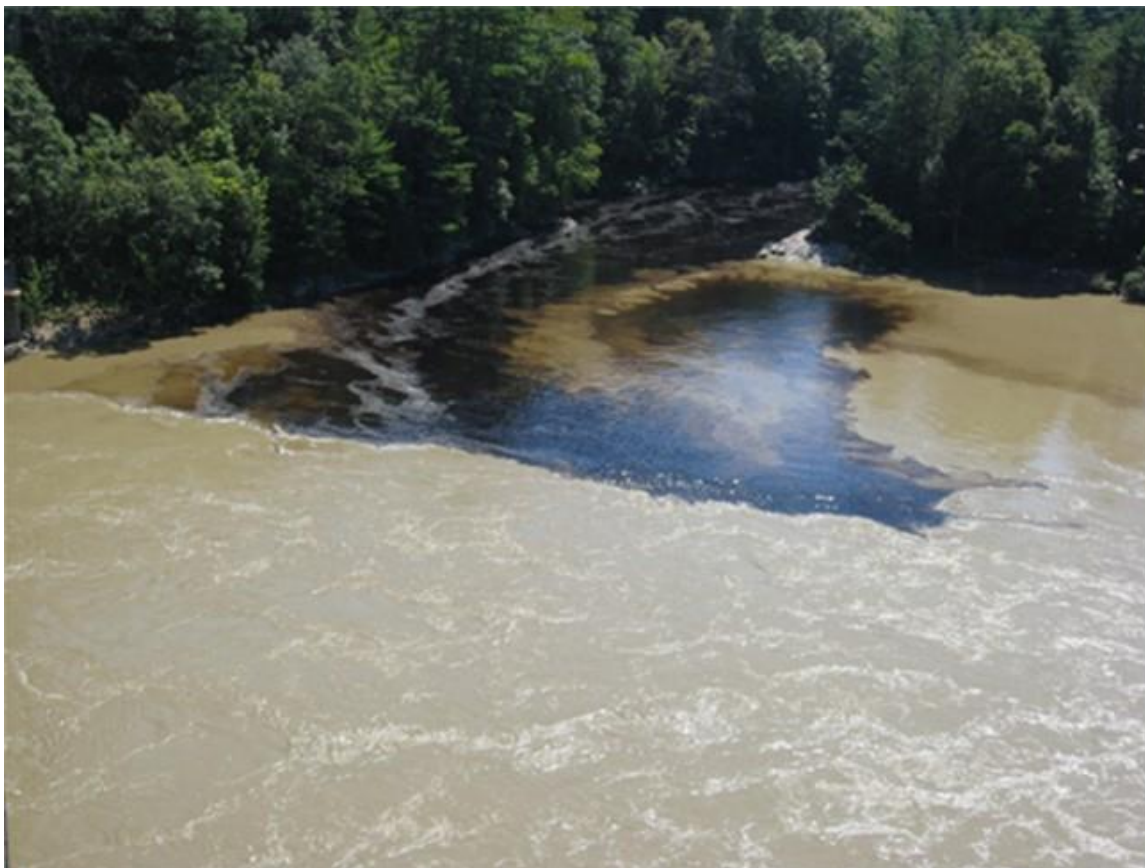
Historic suspended sediment samples and photographs collected during Tropical Storm Irene further demonstrate the strong relationship between flow and SSC values. [Figure 5.3-3](#) demonstrates the contrast between the Millers River and the Connecticut River as affected by Tropical Storm Irene in August 2011. As observed in the figure, the relatively clear water from the Millers River flowed into the sediment laden Connecticut River in a classic, swirling mixing zone. SSC values taken from the Millers River ranged from non-detect (ND, <5 mg/L) to 6.5 mg/L while SSC values measured in the Connecticut River during the same period ranged from 140 to 1,900 mg/L.⁴⁰ As a point of comparison, the median SSC value observed during Study No. 3.1.3 for flows greater than 35,000 cfs was 145 mg/L.

Figure 5.3-3 Millers River Confluence with the Connecticut River (TFI), August 2011

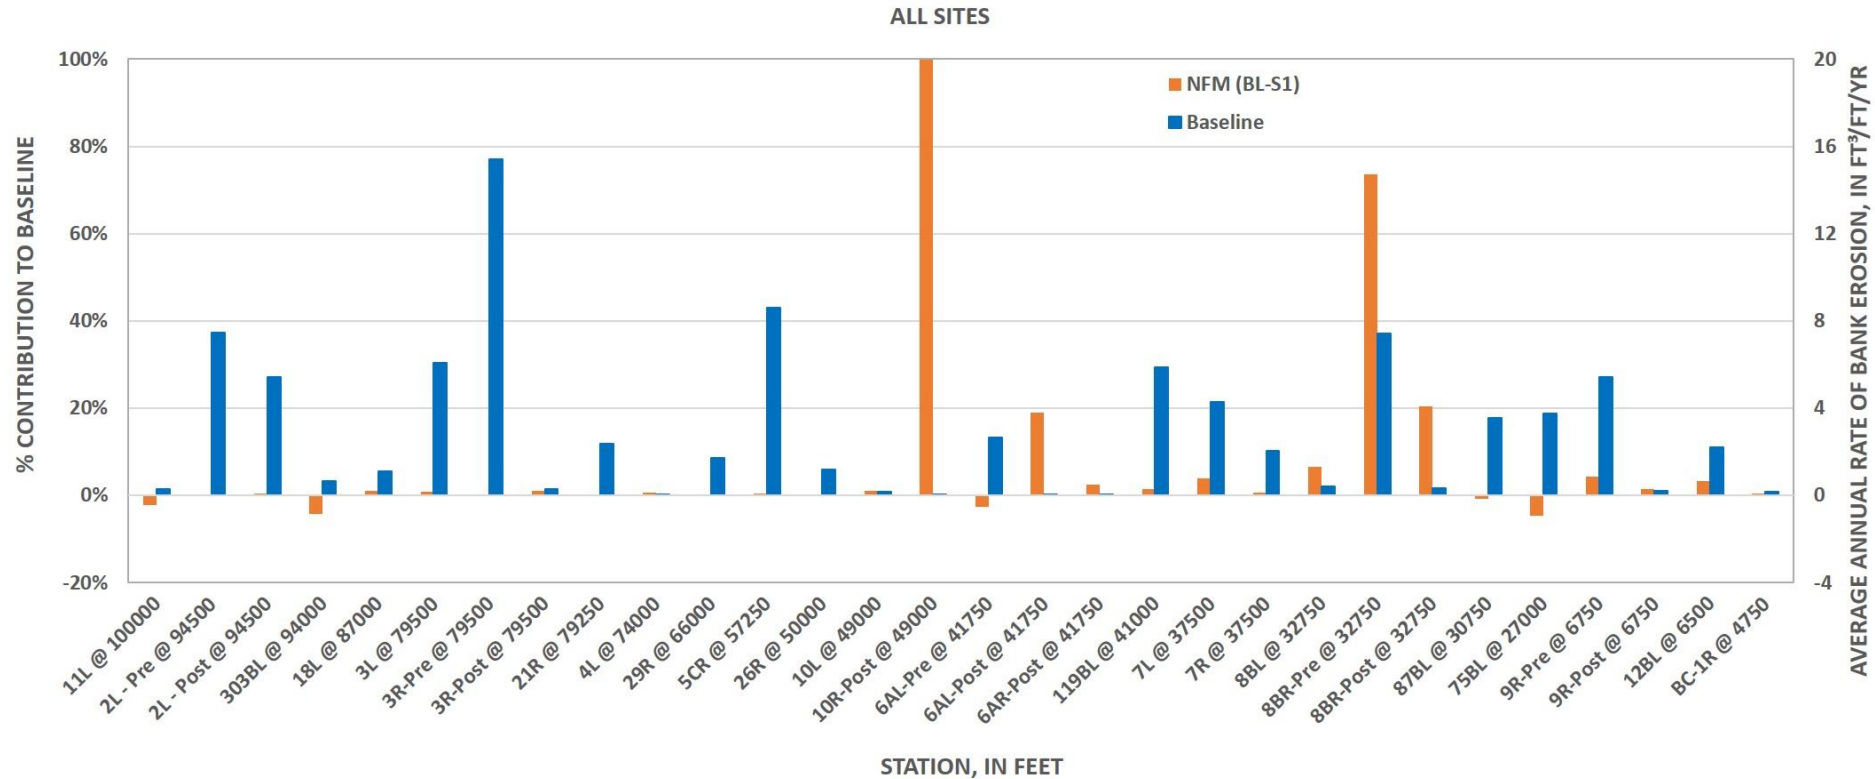
Figure 5.4.2.2-3: Contribution of Erosion Rates Due to Project Operations Compared to Erosion Rates for the Baseline Condition

Results need to be taken in context of the total amount of erosion at a particular site to interpret relative impact of the Project

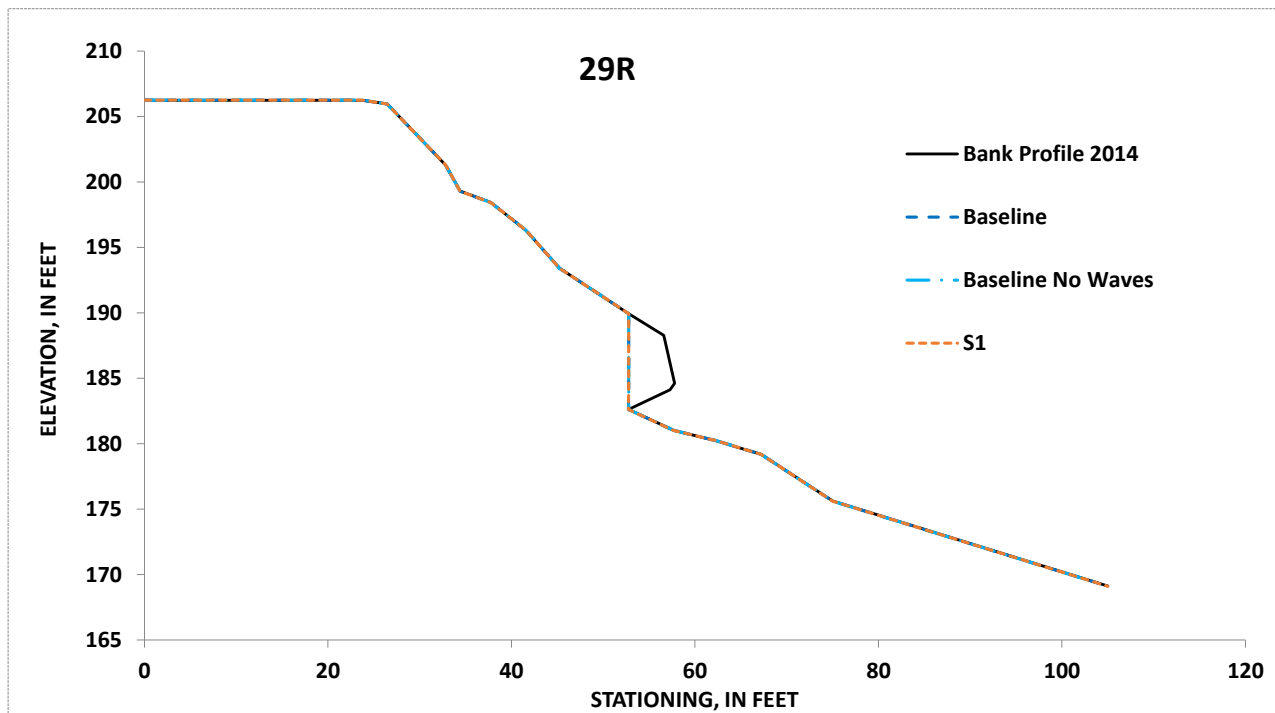
Figure 5.4.2.2-6: Bank profile for site 29R at Station 66,000 Showing Pronounced Undercut at the Start of the Simulations

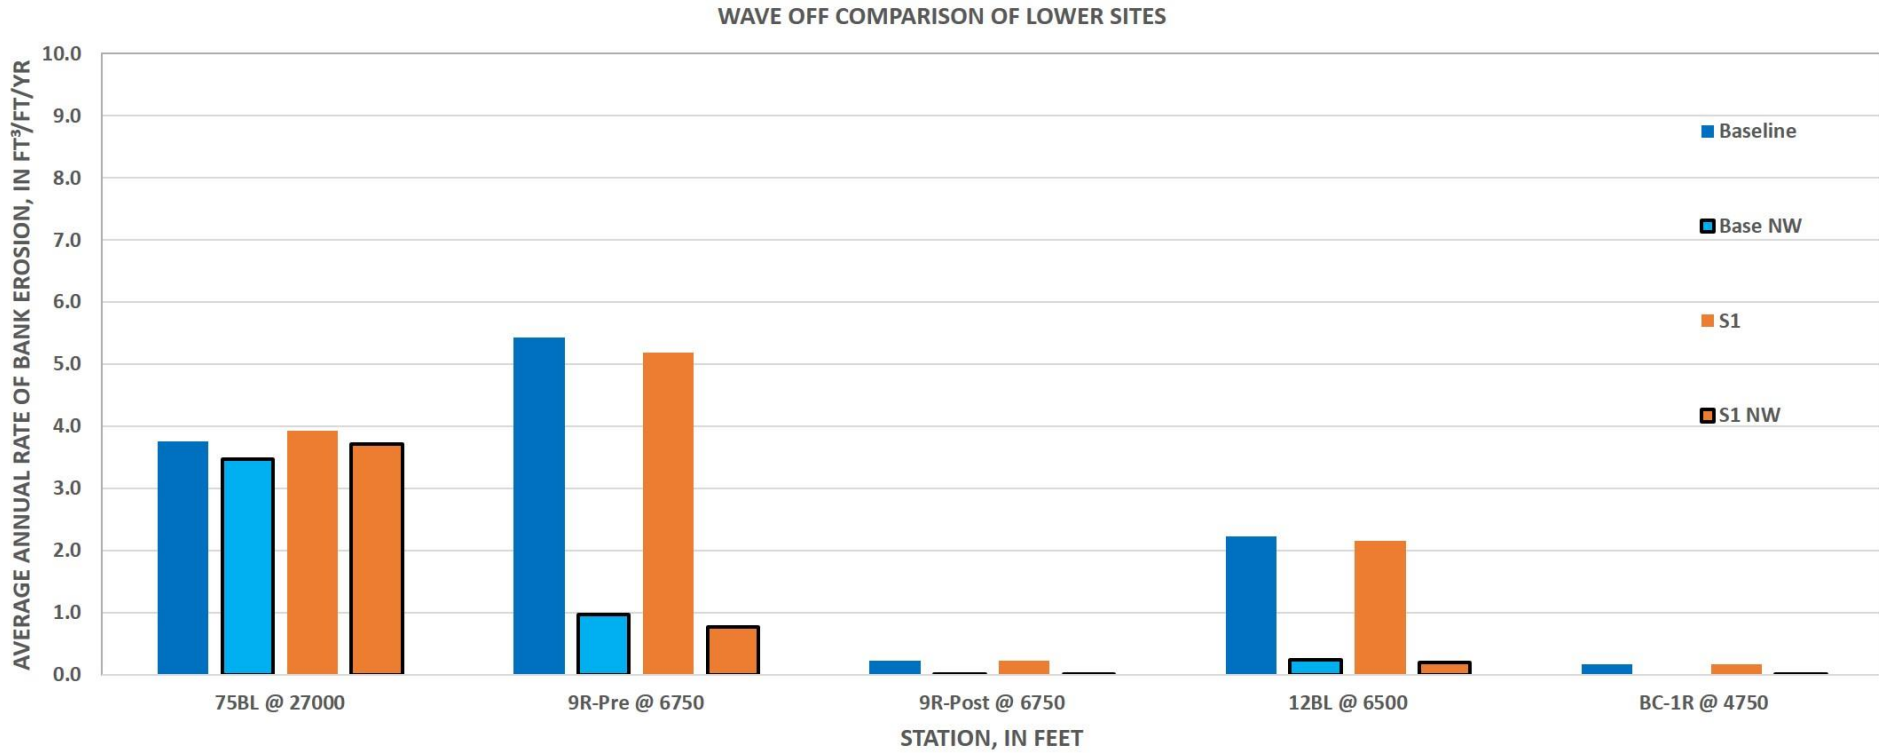
Site/Condition	Station	Dates		Baseline (Waves on)	Baseline (Waves off)	S1 (Waves on)	S1 (Waves off)
	ft	Start	End	ft ³ /ft/y	ft ³ /ft/y	ft ³ /ft/y	ft ³ /ft/y
75BL	27000	01/01/00	08/27/14	3.76	3.47	3.93	3.72
9R-Pre	6750	06/02/00	06/30/08	5.43	0.97	5.19	0.77
9R-Post	6750	07/01/08	08/26/14	0.23	0.00	0.22	0.00
12BL	6500	01/01/00	08/27/14	2.22	0.24	2.15	0.19
BC-1R	4750	06/05/00	08/26/14	0.168	0.00	0.167	0.00

Figure 5.4.2.3-1 Comparison of Bank-erosion Rates with and without Boat-generated Waves for Sites in the Lower Turners Falls Impoundment

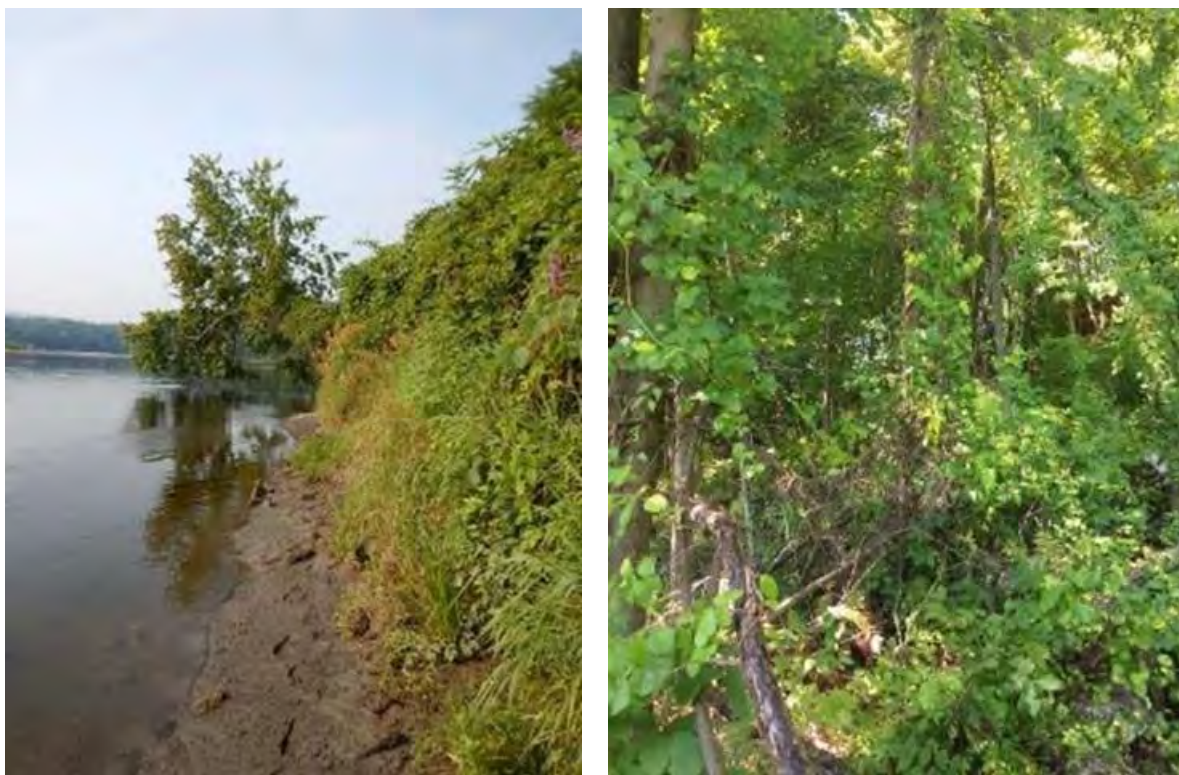
BSTEM runs at this site show that under the Baseline Condition, 2.72 ft³ of erosion occurred per foot of bank, during the 2005-2014 flow period, averaging 0.297 ft³/ft/y ([Table 5.4.3-1](#)). This results in the 9th lowest erosion rate for the Baseline Condition, placing it between the 10th and 15th percentiles of erosion rates along the reach. The modeling also indicates that all 100% (0.297 ft³/ft/y) of the erosion is due directly to hydraulic processes, and none of the bank erosion is the result of larger geotechnical failures.

Figure 5.4.3.1-1: Photos at Site 11L

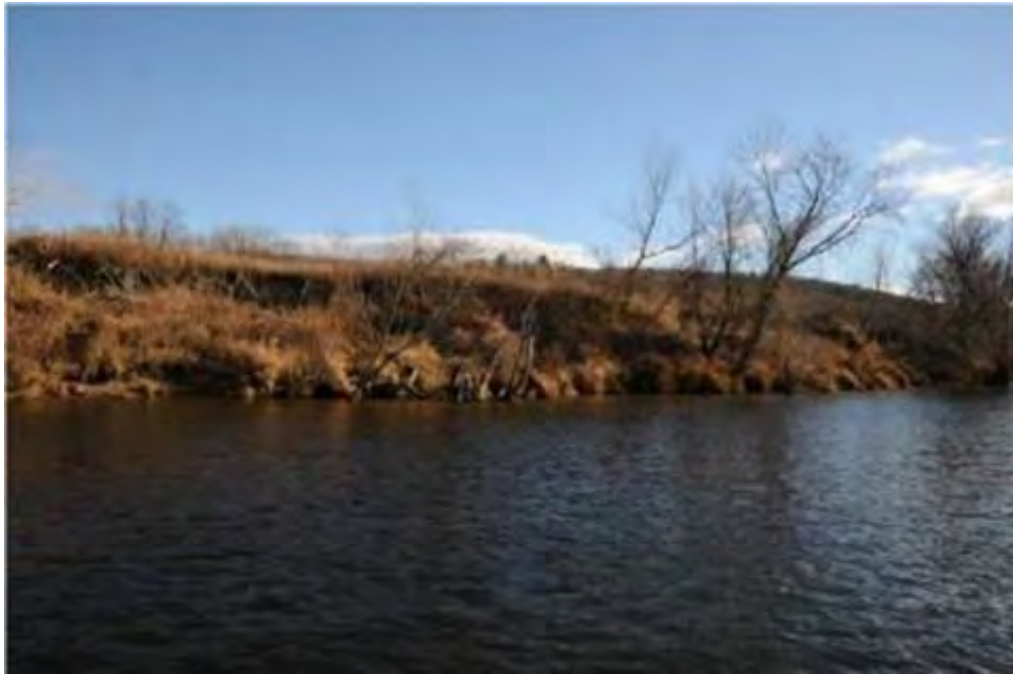
The river at site 2L Pre-restoration (at station 94,500) has steep to vertical, very sparsely vegetated, moderately-high banks. The site is located, at the Bonnette Farm, just below the mouth of the Ashuelot River, south of Stebbins Island. The bank is roughly 18 feet tall, with a silty-sand bank and beach. Moderate vegetation was noted in the 2013 FRR for the Upper Riverbank slope, with very sparse to no vegetation on the lower riverbank slope ([Figure 5.4.3.2-1](#)).

BSTEM runs at this site show that under the Baseline Condition, 90 ft³ of erosion occurred per foot of bank, during the 2000 to 2012 flow period prior to restoration, averaging 7.48 ft³/ft/y ([Table 5.4.3-1](#)). This results in the 3rd highest erosion rate for the Baseline Condition, placing it between the 90th and 95th percentiles of erosion rates along the reach. The modeling also indicates that 48% (3.56 ft³/ft/y) of the erosion is due directly to hydraulic processes, whereas the other 52% (3.92 ft³/ft/y) is the result of geotechnical processes and associated mass failures.

Figure 5.4.3.2-1: Photo at Site 2L Pre Restoration

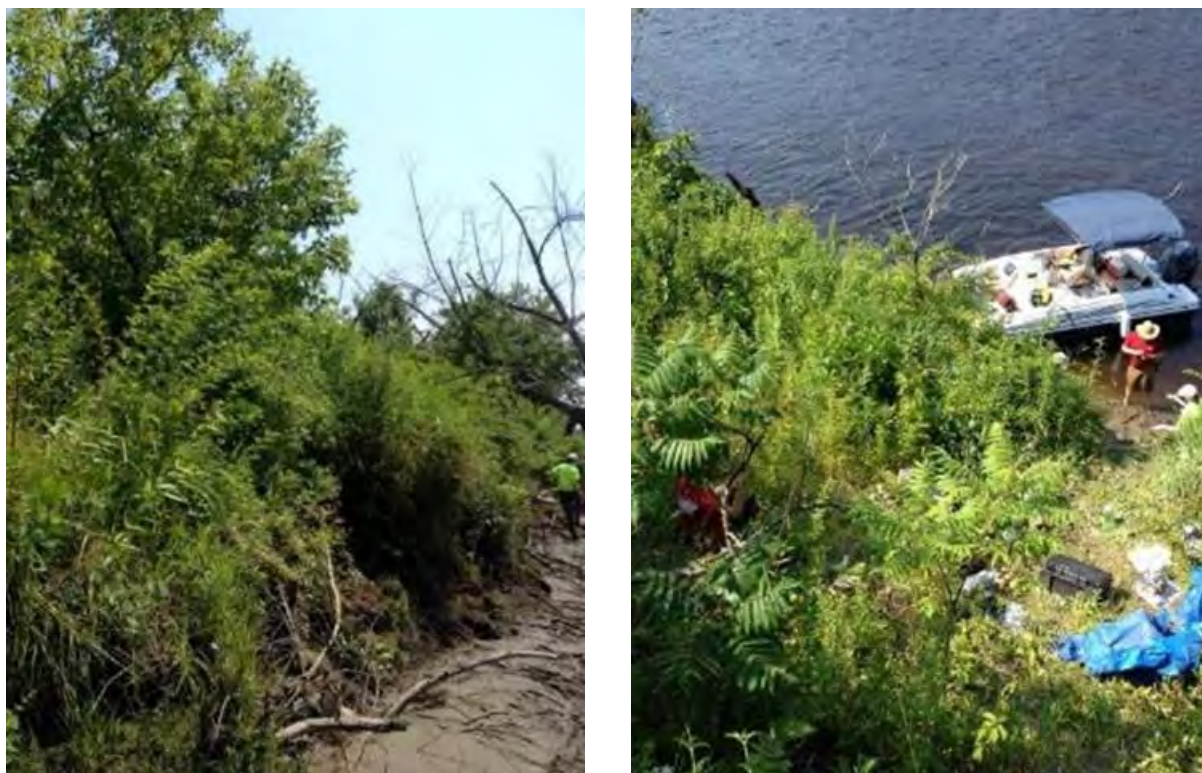
BSTEM runs at this site show that under the Baseline Condition, 11.7 ft³ of erosion occurred per foot of bank during the 2012 to 2014 flow period after restoration activities, averaging 5.42 ft³/ft/y ([Table 5.4.3-1](#)). This results in the 8th largest erosion rate for the Baseline Condition, placing it between the 70th and 75th percentiles of erosion rates along the reach. The modeling also indicates that all of the erosion is due directly to hydraulic processes, and none of the bank erosion is the result of geotechnical failures.

Figure 5.4.3.3-1: Photos at Site 2L Post Restoration

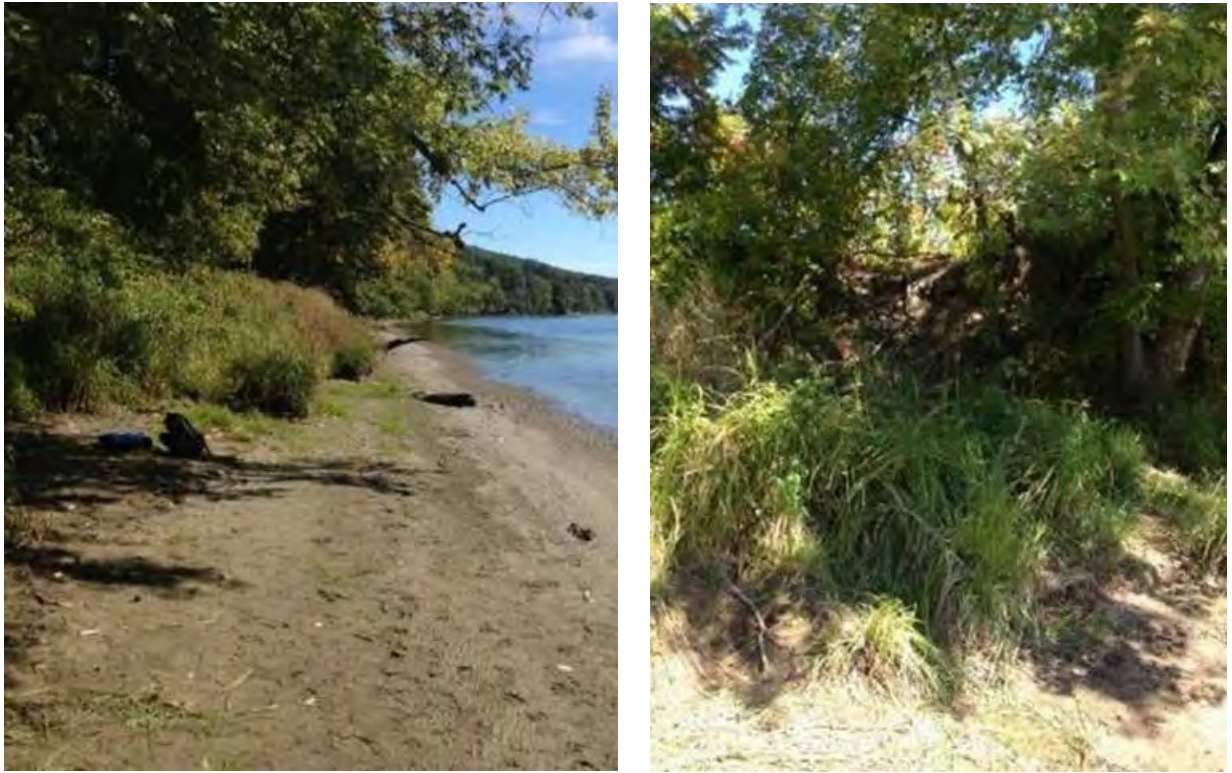
The river at site 303BL has steep to vertical, sparsely vegetated banks, located at station 94,000, downstream of Stebbins Island, immediately downstream of site 2L. The bank is roughly 16 feet tall with a sandy toe ($d_{50}=0.11$ mm) and a silty bank face. The bank is vegetated mostly with grasses and small shrubs, but contains a few American elm, Green ash, and Silver maple trees. A significant amount of bare soil and exposed roots were noted on the bank face, and undercutting was present. No historical cross sections exist for this site. The site was surveyed in 2014 and this geometry was used as a starting point for the model runs ([Figure 5.4.3.4-1](#)).

BSTEM runs at this site show that under the Baseline Condition, 9.48 ft³ of erosion occurred per foot of bank, during the 2000-2014 flow period, averaging 0.647 ft³/ft/y ([Table 5.4.3-1](#)). This results in the 12th lowest erosion rate for the Baseline Condition, placing it between the 20th and 25th percentiles of erosion rates along the reach. The modeling also indicates that 96% (0.622 ft³/ft/y) of the erosion is due directly to hydraulic processes, whereas only 4% (0.025 ft³/ft/y) is the result of geotechnical processes and associated mass failures. Bank undercutting and a large number of exposed roots were noted during fieldwork, supporting the predicted high percentage of hydraulic erosion compared to geotechnical erosion.

Figure 5.4.3.4-1 Photos at site 303BL

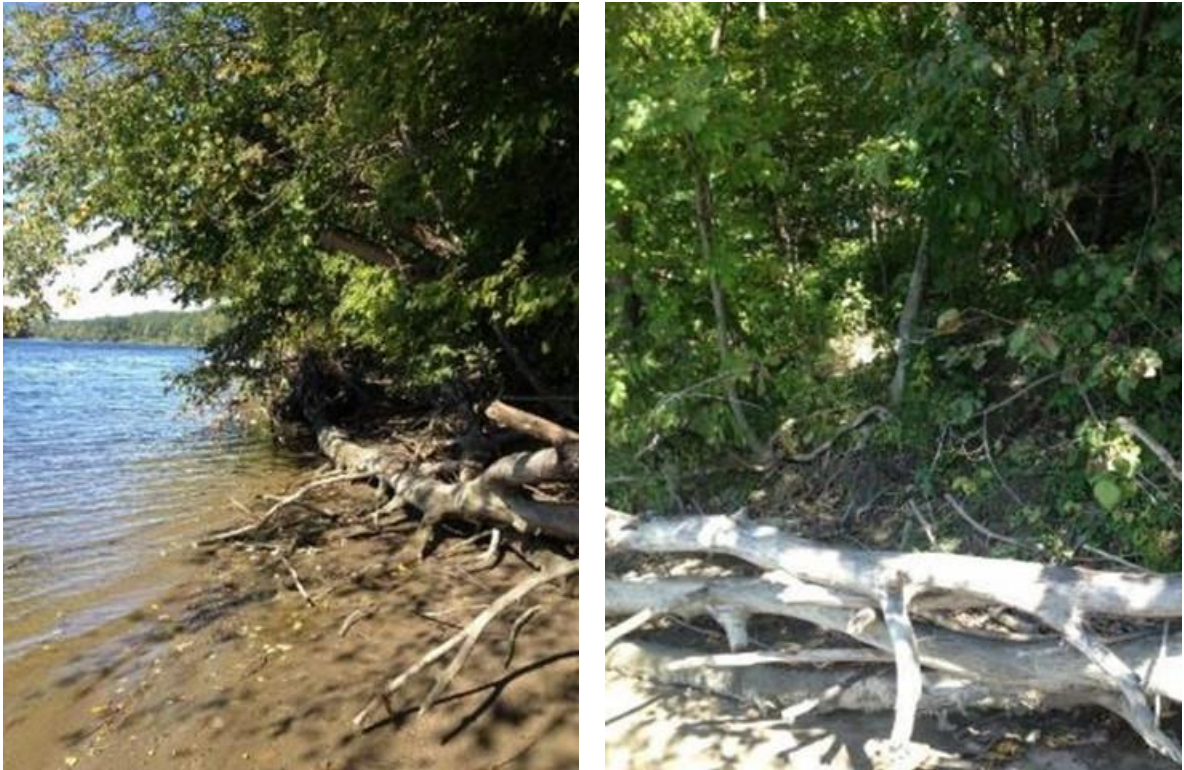
The river at site 18BL has steep to vertical, sparsely vegetated banks. It is located at station 87,000, roughly 5,000 ft downstream of Upper Island. The bank is roughly 23 feet tall, with a sandy-loam bank toe and bank face. The bank is vegetated mostly with grasses and small shrubs, but contains a few American elm, American sycamore, Green ash, and Red oak trees. A significant amount of bare soil and exposed roots were noted on the bank face, and undercutting was present. No historical cross sections existed for this site. A 2014 survey was used as the starting geometry for the model runs ([Figure 5.4.3.5-1](#)).

BSTEM runs at this site show that under the Baseline Condition, 16.0 ft³ of erosion occurred per foot of bank during the 2000-2014 flow period, averaging 1.09 ft³/ft/y ([Table 5.4.3-1](#)). This results in the 13th lowest erosion rate for the Baseline Condition, placing it between the 25th and 30th percentiles of erosion rates along the reach. The modeling also indicates that 76% (0.83 ft³/ft/y) of the erosion is due directly to hydraulic processes, whereas remaining 24% (0.26 ft³/ft/y) is the result of geotechnical processes and associated mass failures. This is also shown in ([Figure 5.4.3.5-4](#)), as a very gradual smooth shape, with few large spikes that would indicate the prevalence of mass wasting.

Figure 5.4.3.5-1 Photos at site 18BL
