Relicensing Study 3.1.2

**Northfield Mountain / Turners Falls
Operations Impact on Existing Erosion and
Potential Bank Instability
Study Report**

Volume II – Main Report

**Northfield Mountain Pumped Storage Project (No. 2485) and
Turners Falls Hydroelectric Project (No. 1889)**

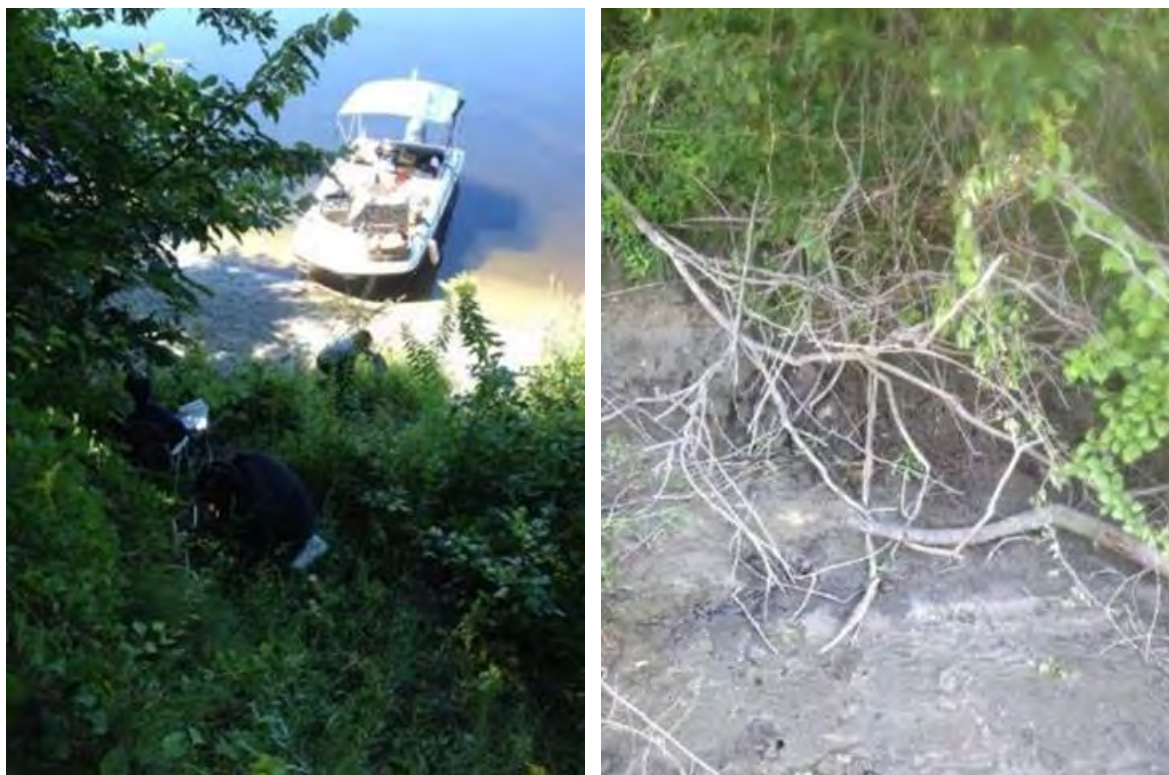
BSTEM runs at this site show that under the Baseline Condition, 89.2 ft³ of erosion occurred per foot of bank during the 2000-2014 flow period, averaging 6.09 ft³/ft/y ([Table 5.4.3-1](#)). This results in the 5th highest erosion rate for the Baseline Condition, placing it between the 80th and 85th percentiles of erosion rates along the reach. The modeling also indicates that 86% (5.25 ft³/ft/y) of the erosion is due directly to hydraulic processes, whereas the remaining 14% (0.84 ft³/ft/y) is the result of geotechnical processes and associated mass failures.

Figure 5.4.3.6-1 Photos at site 3L

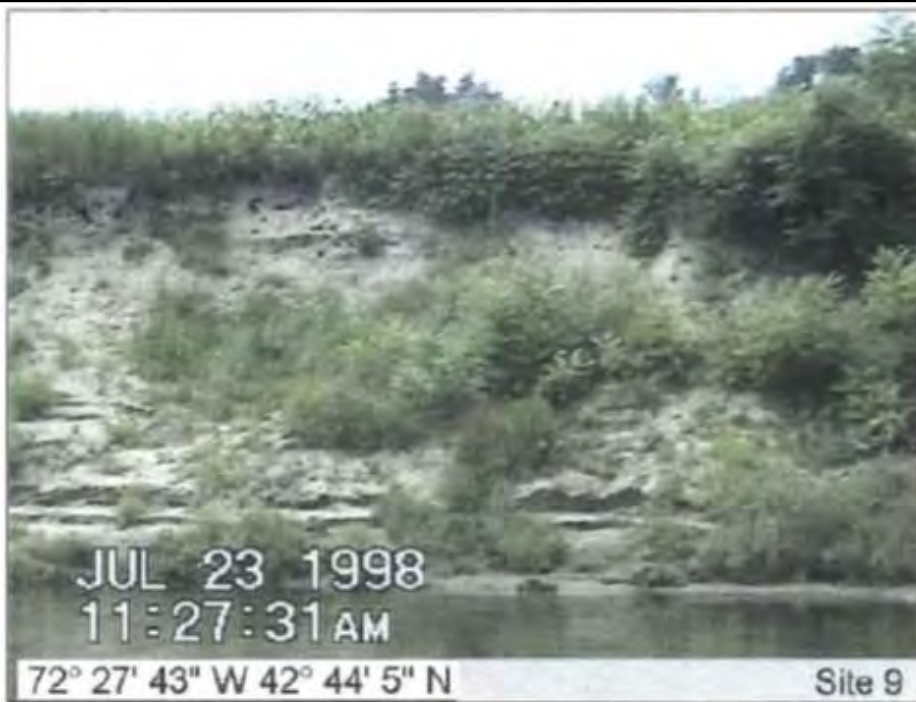
Right bank, 1998

BSTEM runs at this site show that under the Baseline Condition, about 100 ft³ of erosion occurred per foot of bank, during the 2000 to 2006 flow period prior to restoration, averaging 15.4 ft³/ft/y ([Table 5.4.3-1](#)). This results in the highest erosion rate for the Baseline Condition, placing it between the 95th and 100th percentiles of erosion rates along the reach. The modeling also indicates that 42% (6.51 ft³/ft/y) of the erosion is due directly to hydraulic processes, whereas the other 58% (8.91 ft³/ft/y) is the result of geotechnical processes and associated mass failures.

Figure 5.4.3.7-1 Photos from 1998 at site 3R Pre Restoration (Labeled as 1998 FRR/ECP-Site 9)

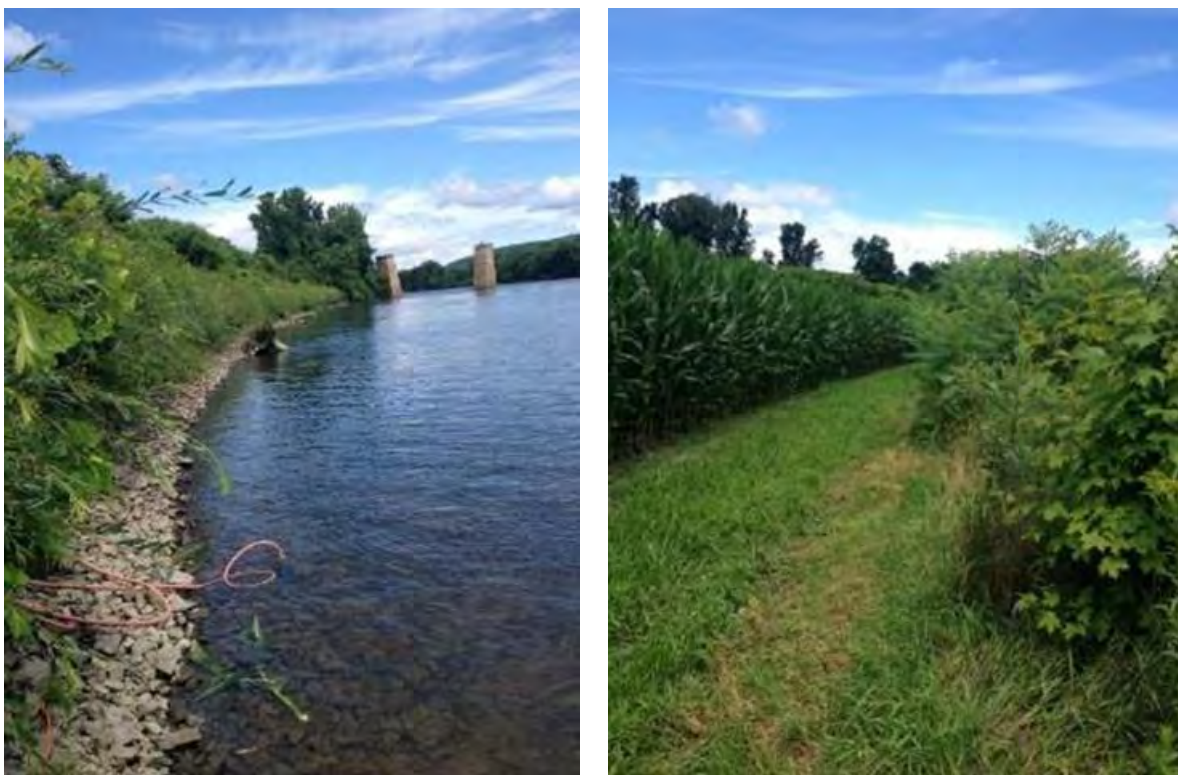
BSTEM runs at this site show that under the Baseline Condition, 1.75 ft³ of erosion occurred per foot of bank, during the 2006 to 2014 flow period after restoration activities, averaging 0.285 ft³/ft/y ([Table 5.4.3-1](#)). This results in the 8th lowest erosion rate for the Baseline Condition, placing it between the 10th and 15th percentiles of erosion rates along the reach. The modeling also indicates that all 100% (0.285 ft³/ft/y) of the erosion is due directly to hydraulic processes, and none of the bank erosion is the result of larger geotechnical failures. The minimal amount of hydraulic erosion that is occurring is within the level of the placed rock at the toe, indicating that the rock may be slightly undersized for the flows.

Figure 5.4.3.8-1 Photos at site 3R Post Restoration

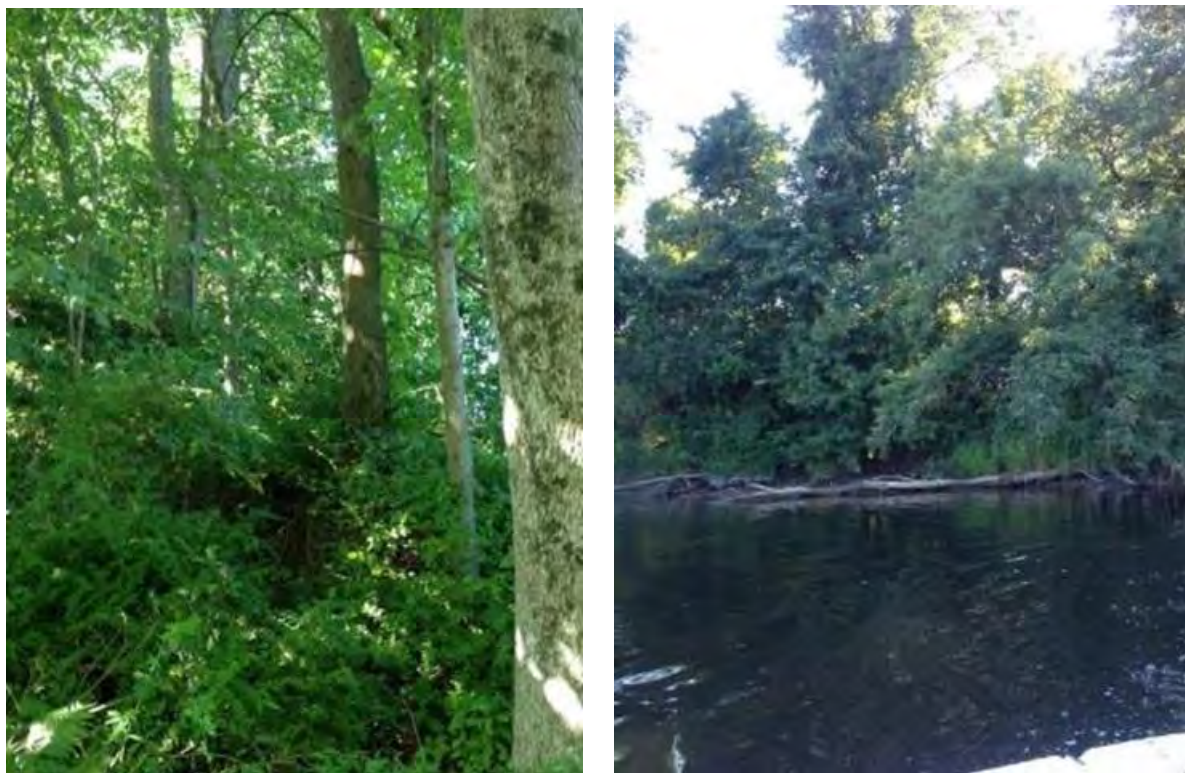
Figure 5.4.3.9-1: Photos at site 21R

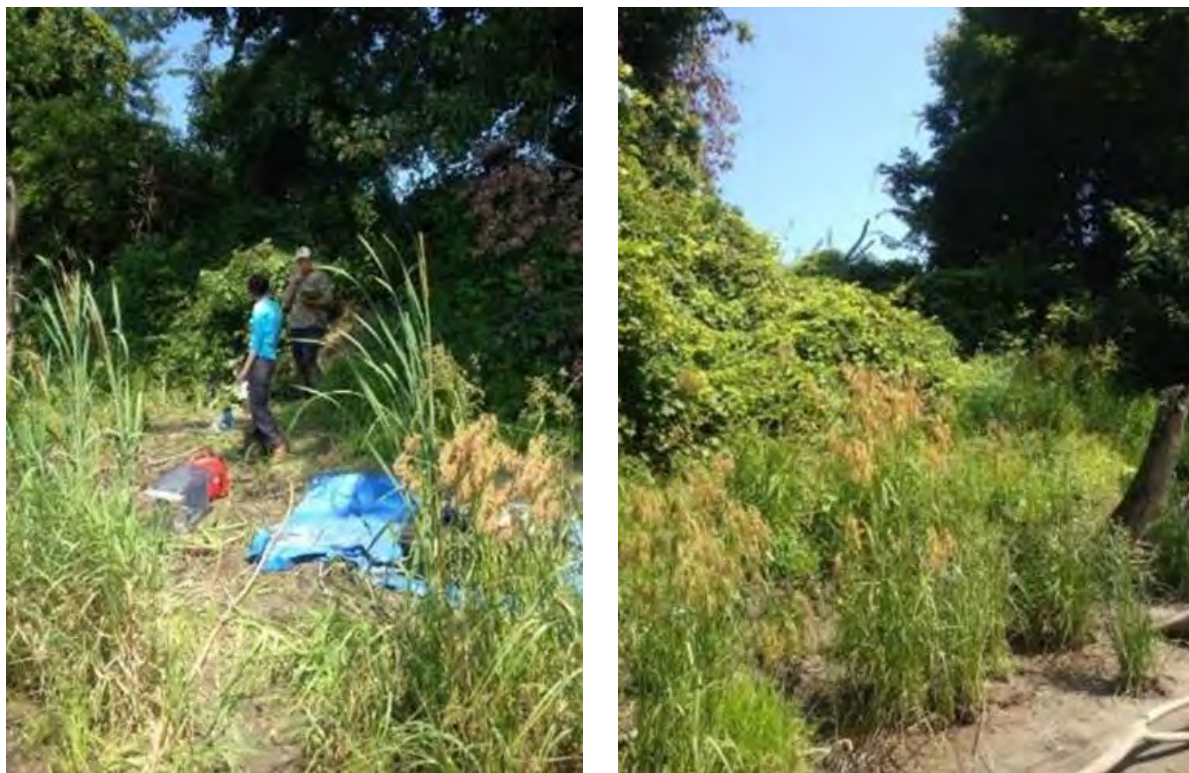
Figure 5.4.3.10-1 Photos at site 4L

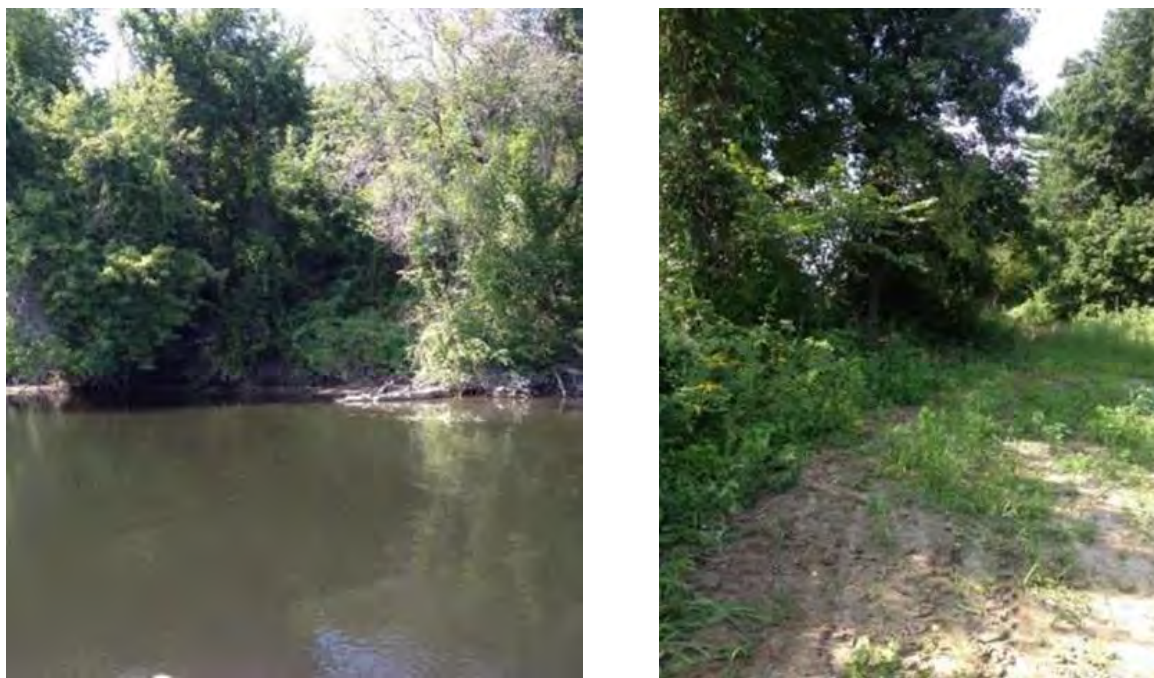
Figure 5.4.3.11-1 Photos at site 29R

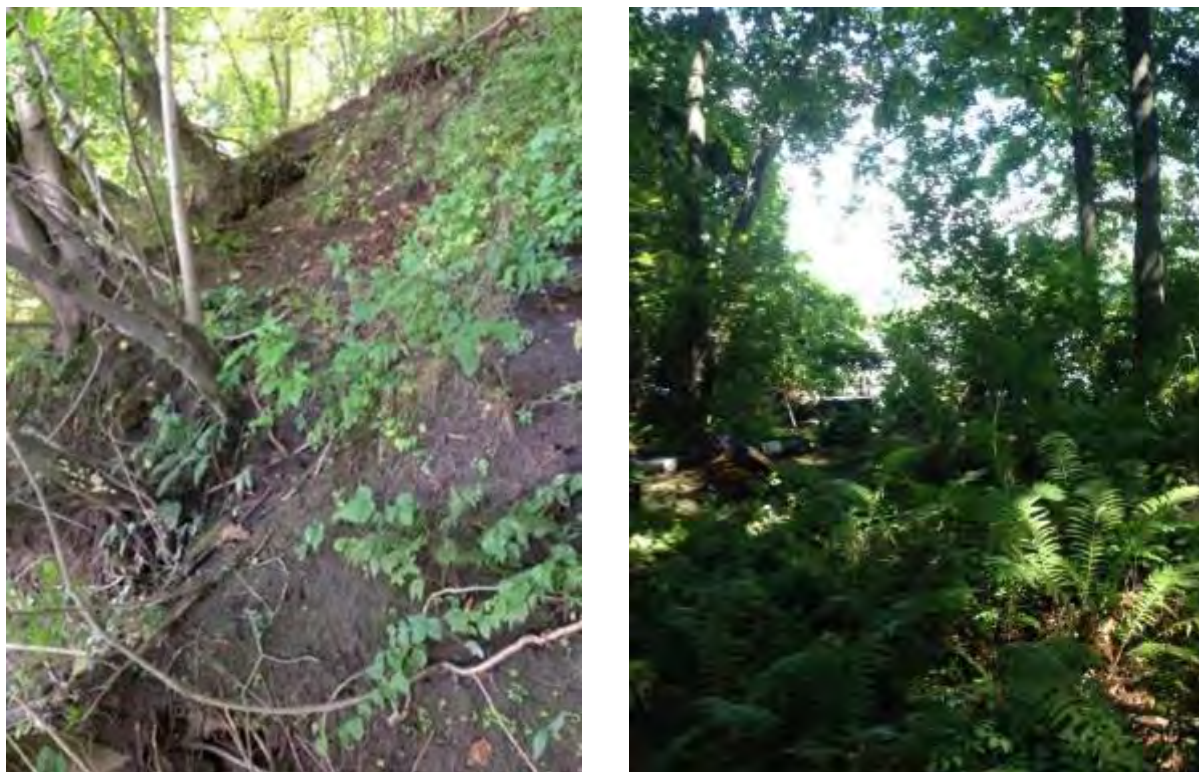
Figure 5.4.3.12-1 Photos at site 5CR

BSTEM runs at this site show that under the Baseline Condition, 105 ft³ of erosion occurred per foot of bank, during the 2002-2014 flow period, averaging 8.61 ft³/ft/y ([Table 5.4.3-1](#)). This results in the 2nd highest erosion rate for the Baseline Condition, placing it between the 95th and 99th percentiles of erosion rates along the reach. The modeling also indicates that roughly 35% (about 3.0 ft³/ft/y) of the erosion is due directly to hydraulic processes, whereas the other 65% (5.6 ft³/ft/y) is the result of geotechnical processes and associated mass failures.

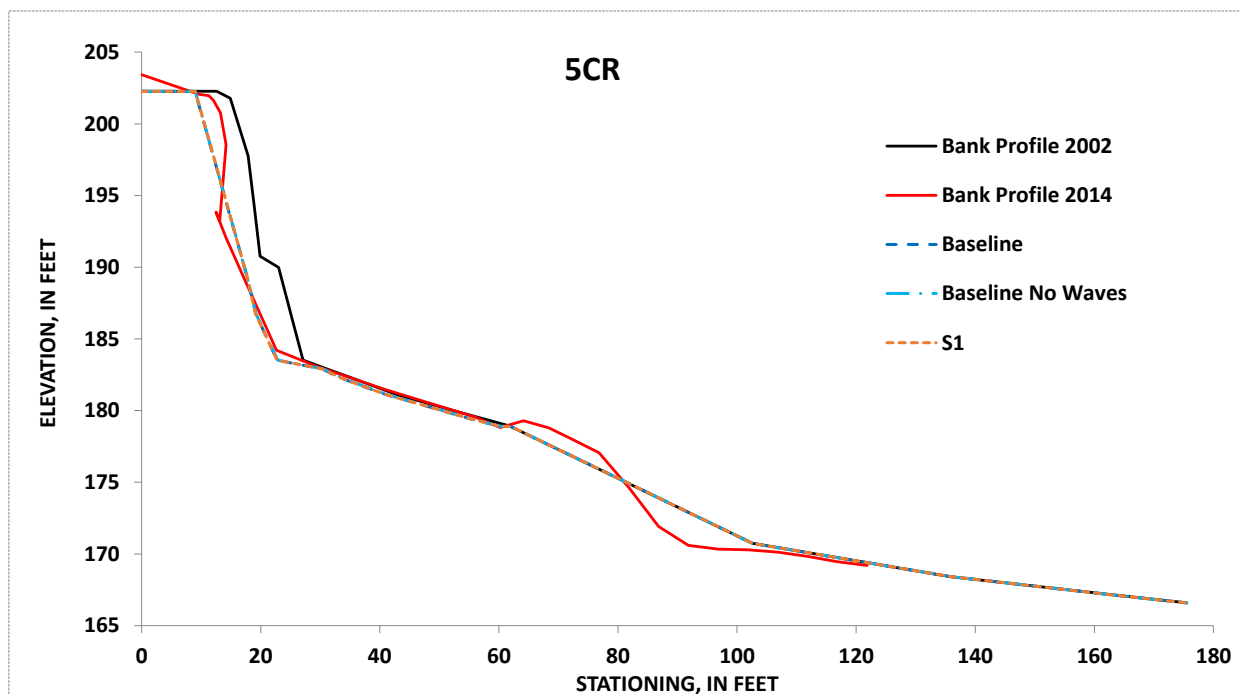
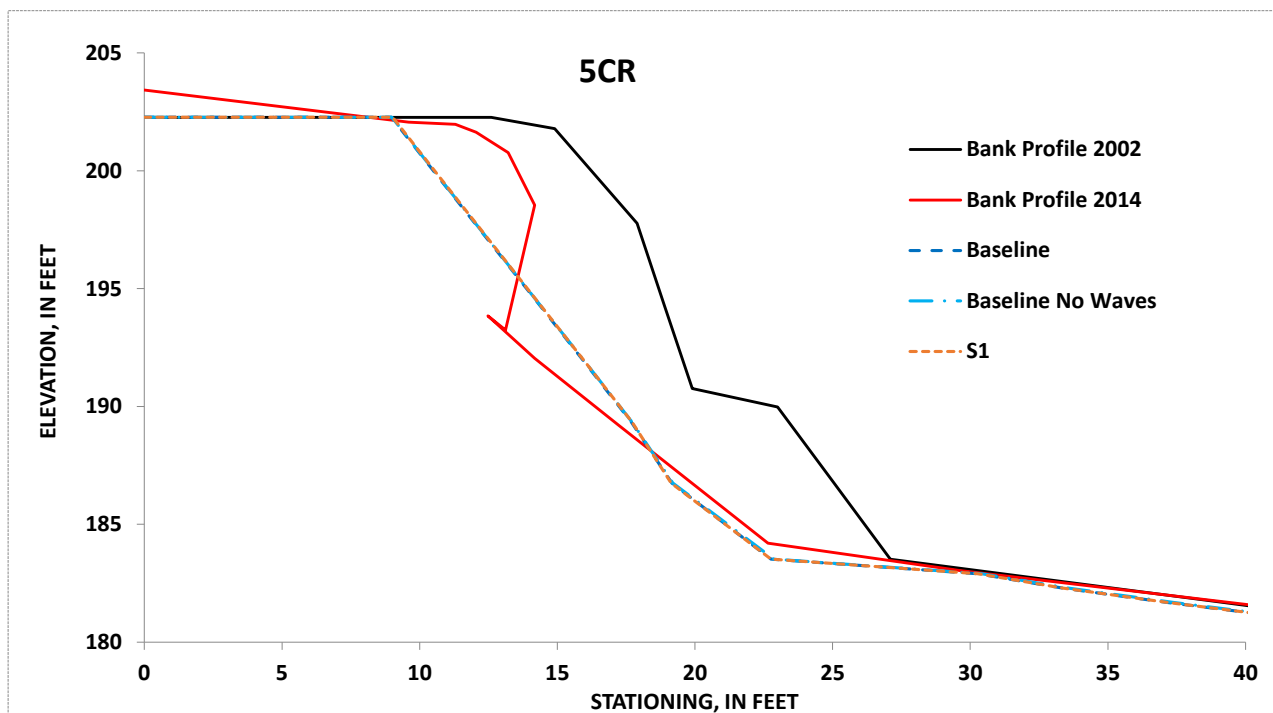
Figure 5.4.3.12-2: Simulated, future unit-erosion for the Baseline Condition (with boat waves on and off) and Scenario 1 at site 5CR for the period 2002-2014

The Baseline Condition (Waves off) resulted in 8.50 ft³/ft/y, with 8.57 ft³/ft/y for Scenario 1 ([Figure 5.4.3.12-2](#) to [Figure 5.4.3.12-3](#)). This resulted in the following percent reductions in erosion rates: 1.23% and 0.46% for Baseline Wave off and Scenario 1 (Note- while this site did show a small reduction in erosion between the BL and S1 Scenarios the total reduction in erosion is well below the measureable/significant rate of 0.161 ft³/ft/yr). Since waves accounted for only about 1% of the total erosion under the Baseline Condition the remaining scenarios were not considered with boat waves off.

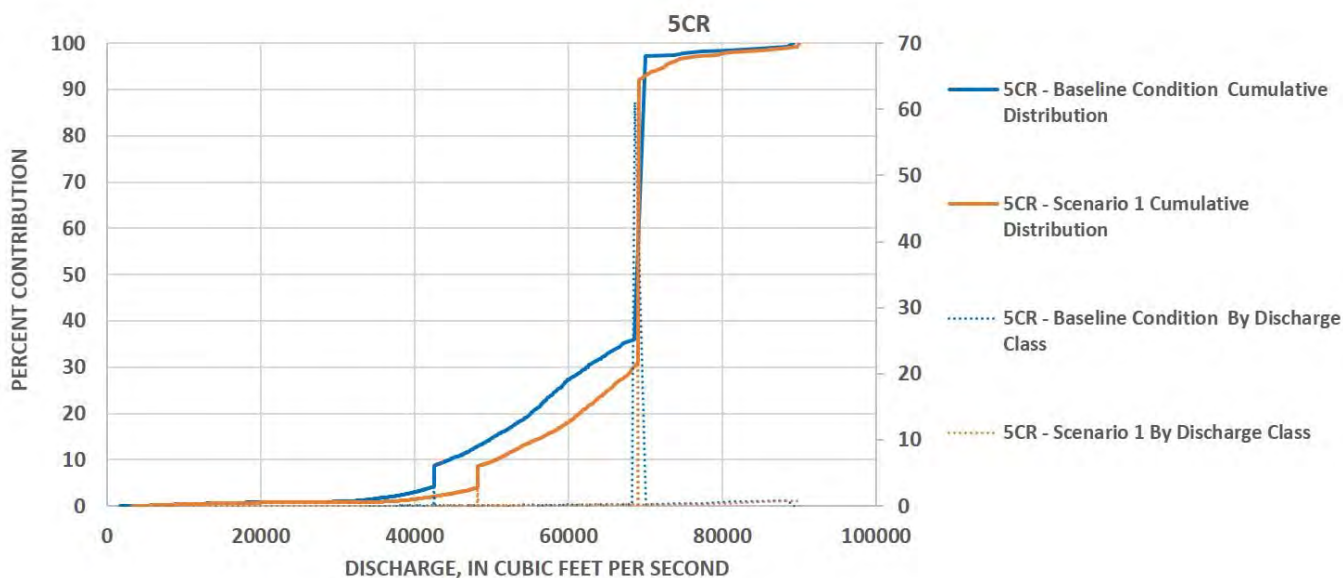
Figure 5.4.3.12-4: Simulated, percent contribution of total erosion by discharge for the Baseline Condition and Scenarios 1 - 3 at site 5CR for the period 2002-2014

For the Baseline Condition, 95% of the total erosion occurs at flows of about 48,000 cfs or greater ([Figure 5.4.3.12-4](#)). Although there is some limited hydraulic erosion at flows below 37,000 cfs, a significant geotechnical failure occurs at 48,000 cfs, with additional hydraulic erosion occurring through 76,000 cfs. At this flow, a large geotechnical failure occurs resulting in roughly 65% of the total erosion at site 5CR. Through this analysis we can conclude that those flows greater than the hydraulic capacity of Vernon and Northfield Mountain are accounting for most of the total erosion. [Table 5.4.3.12-1](#) denotes the flows above which 95%, 50%, and 5% of all erosion occurs at the site as well as the amount of time those flows were exceeded for each year in the modeling period.

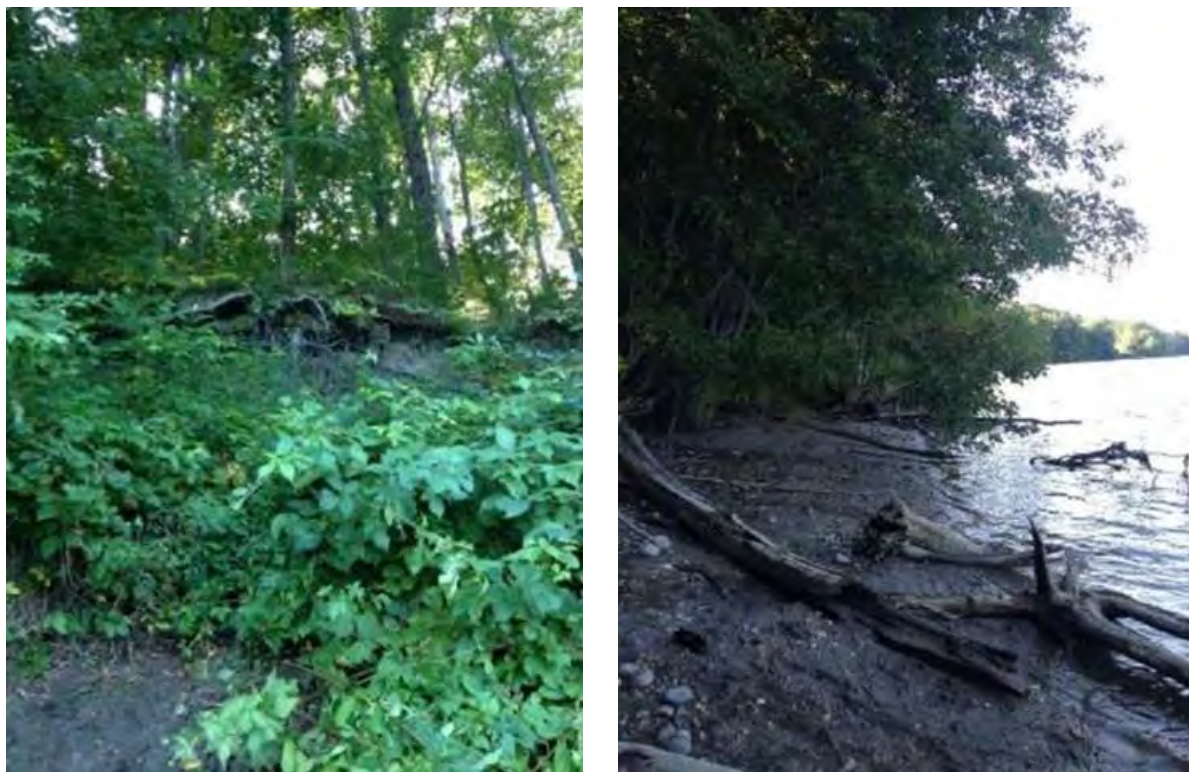
Figure 5.4.3.13-1 Photos at site 26R

BSTEM runs at this site show that under the Baseline Condition, 17.5 ft³ of erosion occurred per foot of bank, during the 2000-2014 flow period, averaging 1.194 ft³/ft/y ([Table 5.4.3-1](#)). This results in the 14th lowest erosion rate for the Baseline Condition, placing it between the 30th and 35th percentiles of erosion rates along the reach. The modeling also indicates that all 100% (1.19 ft³/ft/y) of the erosion is due directly to hydraulic processes, and none of the bank erosion is the result of larger geotechnical failures.

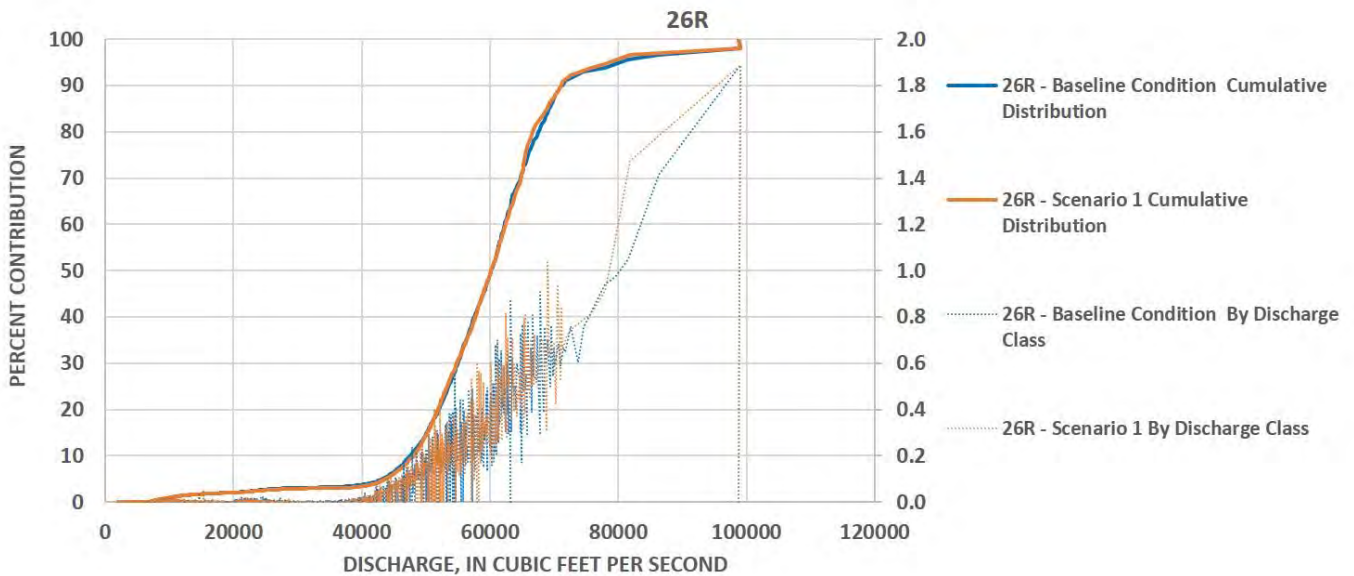
Figure 5.4.3.13-4: Simulated, percent contribution of total erosion by discharge for the Baseline Condition and Scenarios 1 at site 26R for the period 2000-2014

For the Baseline Condition, 96% of the total erosion occurs at flows of about 37,000 cfs or greater ([Figure 5.4.3.13-4](#)). Though there is some limited hydraulic erosion at flows below 37,000 cfs, the erosion rate (albeit moderate) drastically increases at 43,000 cfs and is maintained through 70,000 cfs. Through this analysis we can conclude that those flows greater than the combined hydraulic capacity of Vernon and Northfield Mountain are accounting for most of the total erosion. [Table 5.4.3.13-1](#) denotes the flows above which 95%, 50%, and 5% of all erosion occurs at the site as well as the amount of time those flows were exceeded for each year in the modeling period.

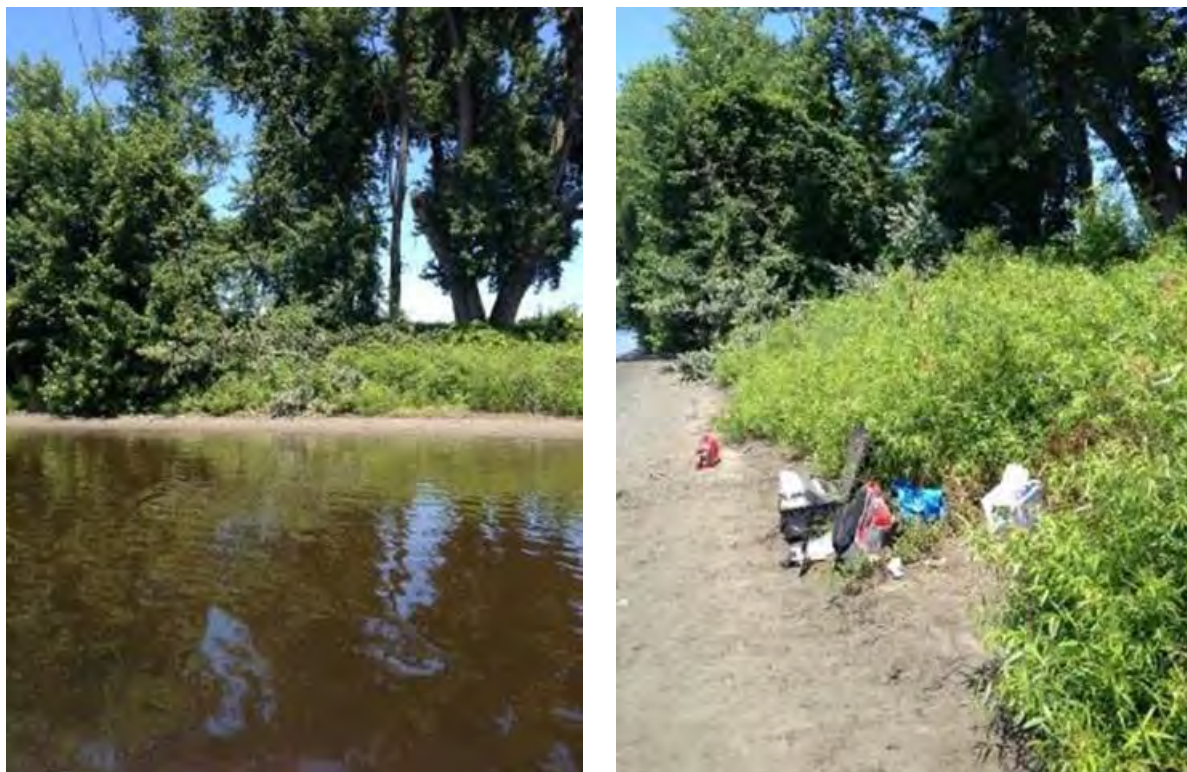
Figure 5.4.3.14-1 Photos at site 10L

BSTEM runs at this site show that under the Baseline Condition, 2.34 ft³ of erosion occurred per foot of bank, during the 2002-2014 flow period, averaging 0.160 ft³/ft/y ([Table 5.4.3-1](#)). This results in the 5th lowest erosion rate for the Baseline Condition, placing it between the 1st and 5th percentiles of erosion rates along the reach. The modeling also indicates that all 100% (0.160 ft³/ft/y) of the erosion is due directly to hydraulic processes, and none of the bank erosion is the result of geotechnical failures.

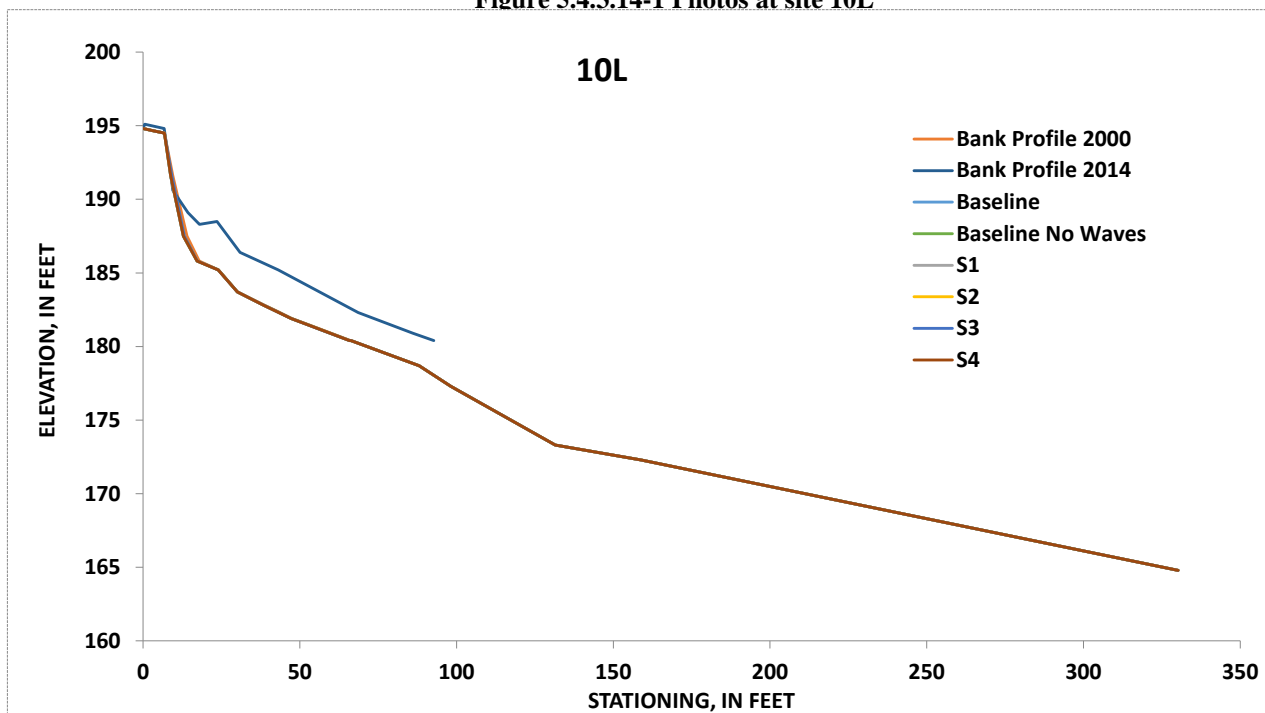
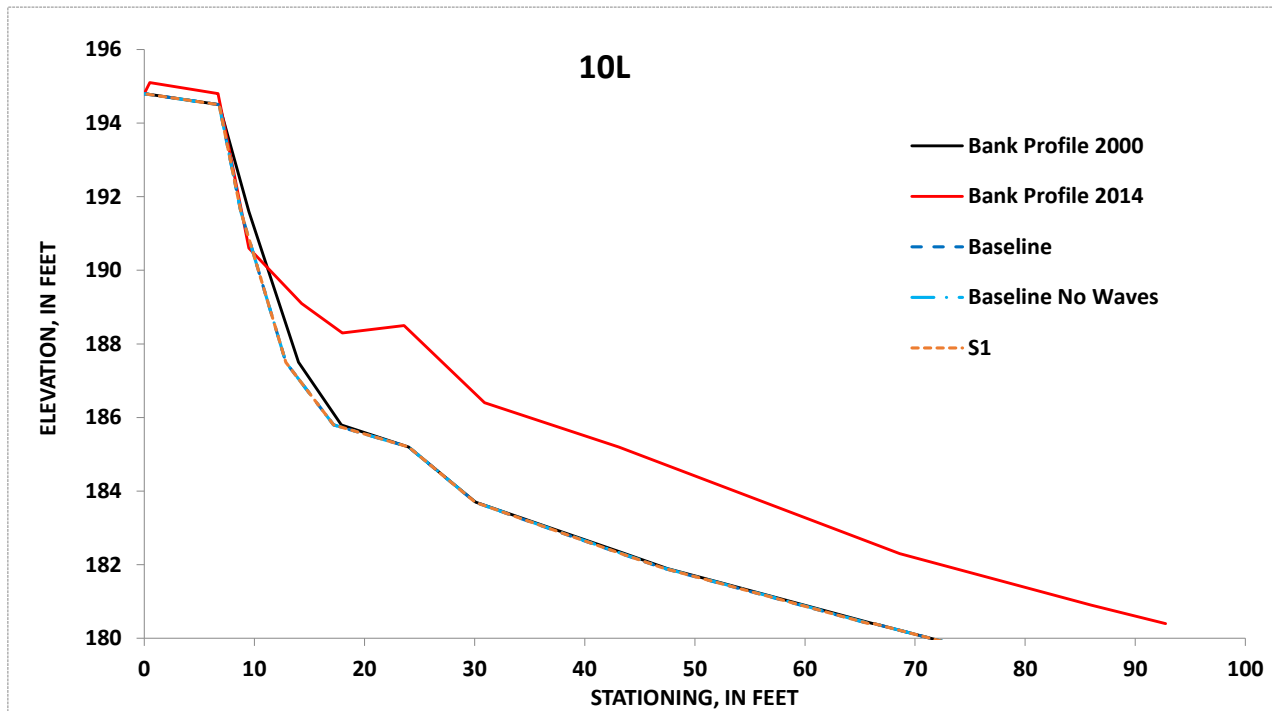
Figure 5.4.3.14-2: Simulated, future unit-erosion for the Baseline Condition (with boat waves on and off) and Scenarios 1 at site 10L for the period 2000-2014

The Baseline Condition (Waves off) resulted in 0.1583 ft³/ft/y, with 0.1579 ft³/ft/y for Scenario 1 ([Figure 5.4.3.14-2](#) to [Figure 5.4.3.14-3](#)). This resulted in the following percent reductions in erosion rates: 0.87% and 1.10%, for Baseline Wave off and Scenario 1. As the Baseline Condition (Waves off) scenario illustrated a very little reduction in erosion, it was concluded that boat waves are not having a significant impact on bank stability, and the remaining scenarios were not considered with boat waves off.

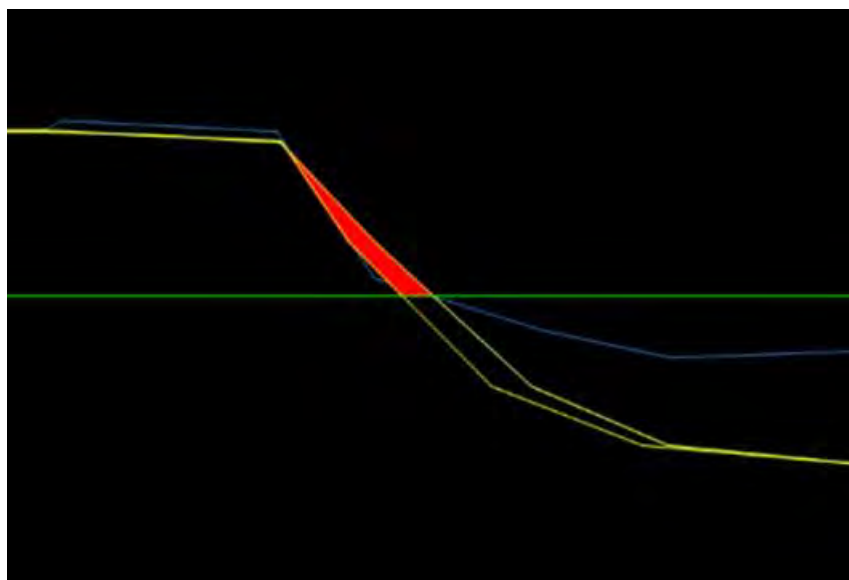
Figure 5.7.14-4 Calculated Erosion above Depositional Layer

Predicted erosion at this site does not account for the deposition of material at the bank toe ([Figure 5.4.3.14-4](#)). Since BSTEM is not a sediment-routing model and as such, it does not predict fluvial deposition. Still, the small amount of erosion that is simulated under the Baseline Condition, represents undercutting at the bank toe. As material from the toe is eroded, however, additional sediment is re-deposited. Thus, little net erosion occurs at this site. Differences in predicted erosion rates are minor given the low rates. For the Baseline Condition, 95% of the total erosion occurs at flows of 59,000 cfs or greater ([Figure 5.4.3.14-5](#)). [Table 5.4.3.14-1](#) denotes the flows above which 95%, 50%, and 5% of all erosion occurs at the site as well as the amount of time those flows were exceeded for each year in the modeling period. Though there is some minor erosion within operational flow limits, this number is somewhat misleading because of the net deposition of material since the original survey in 2000 ([Figure 5.4.3.14-2](#)). The beach has been generally aggrading continually during the modeled period.

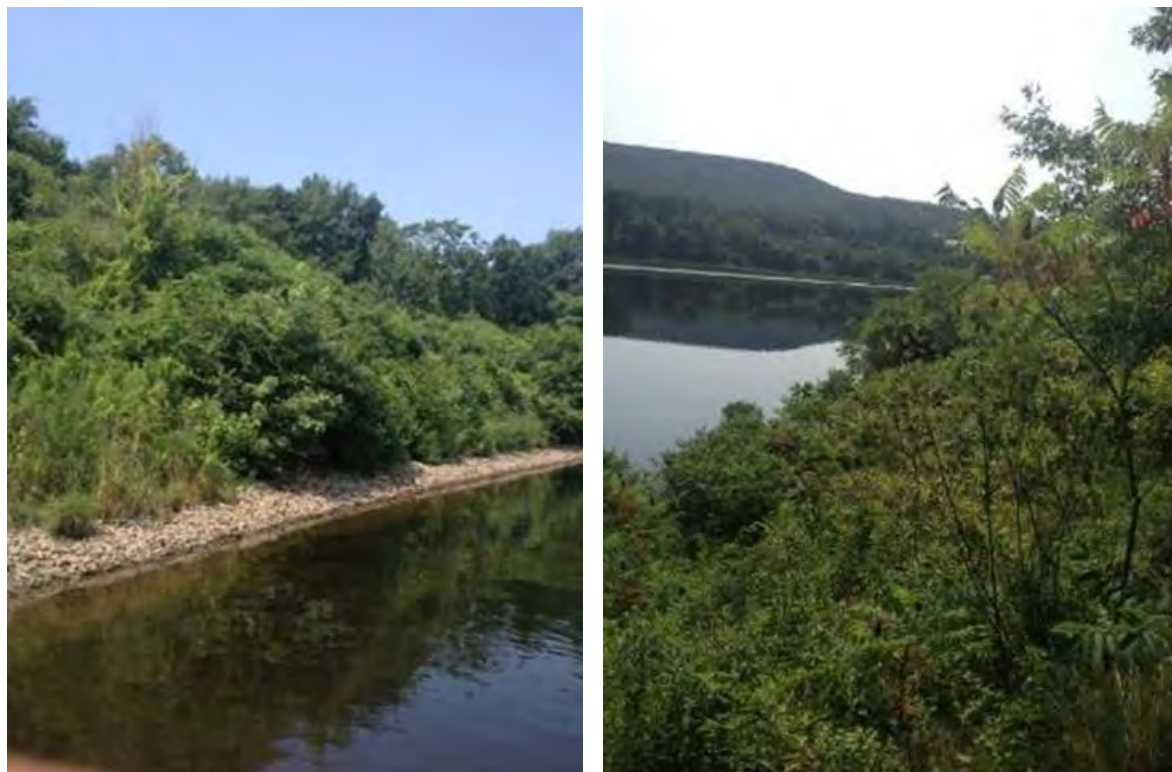
Figure 5.4.3.15-1 Photos at site 10R Post Restoration

BSTEM runs for the Post Restoration condition at this site show that under the Baseline Condition, $3.7E-03$ ft³ of erosion occurred per foot of bank, during the 2001 to 2014 flow period after restoration, averaging $2.8E-04$ ft³/ft/y ([Table 5.4.3-1](#)). This represents virtually no erosion and is the 2th lowest erosion rate for the Baseline Condition. The modeling also indicates that all 100% ($2.82E-04$ ft³/ft/y) of the erosion is due directly to hydraulic processes, and that there are no geotechnical failures.

Erosion values at this site are so low that comparisons of rates are meaningless. Fundamentally, there is no bank erosion at this site and the restoration works have been very successful. For the Baseline Condition, 95% of the total erosion occurs at flows of about 47,000 cfs or greater ([Figure 5.4.3.15-3](#)). [Table 5.4.3.15-1](#) denotes the flows above which 95%, 50%, and 5% of all erosion occurs at the site as well as the amount of time those flows were exceeded for each year in the modeling period.

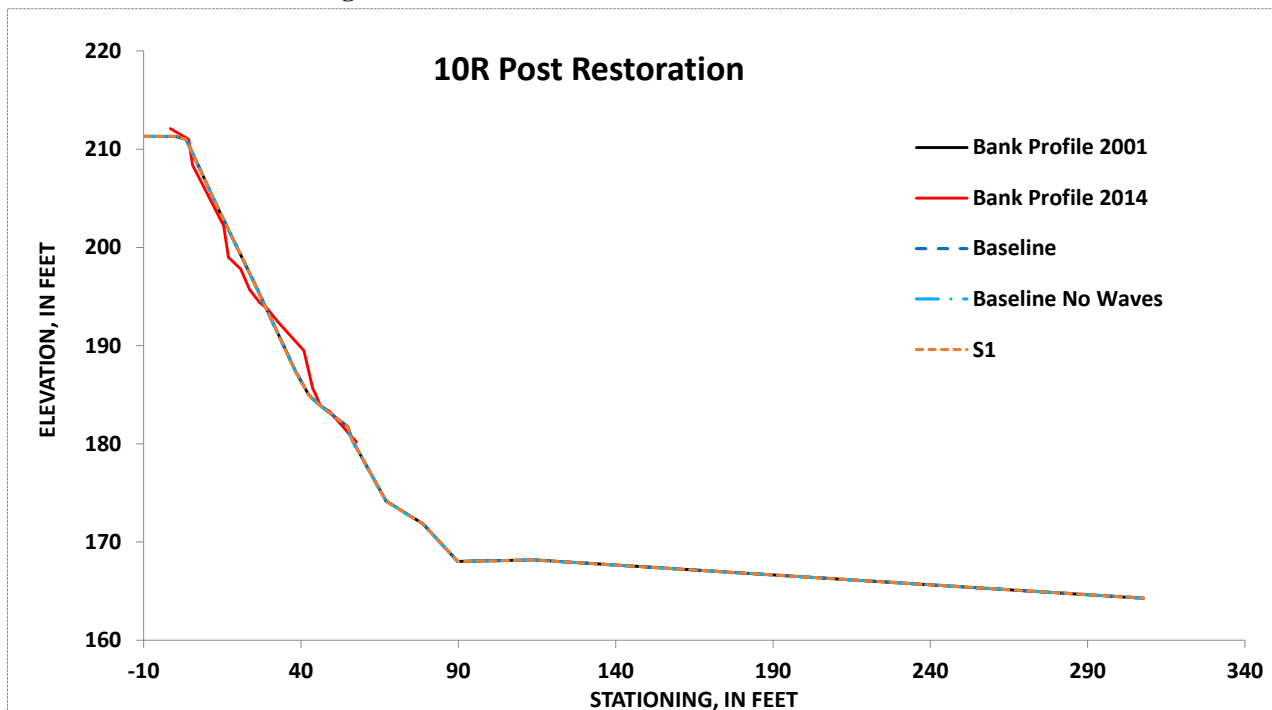
Figure 5.4.3.15-2: Simulated, future unit-erosion for the Baseline Condition (with boat waves on and off) and Scenarios 1 at site 10R for the period 2001-2014

The Baseline Condition (Waves off) resulted in $2.83E-04$ ft³/ft/y, with $3.96E-07$ ft³/ft/y for Scenario 1 ([Figure 5.4.3.15-2](#)). This resulted in reductions in erosion rates of -0.4% for Baseline Wave off and 99.9% for Scenario 1. Baseline simulations with waves off showed virtually no reduction in erosion, it was concluded that boat waves have little effect on erosion processes at this site. Because of this, all of the remaining scenarios were simulated with boat waves on.

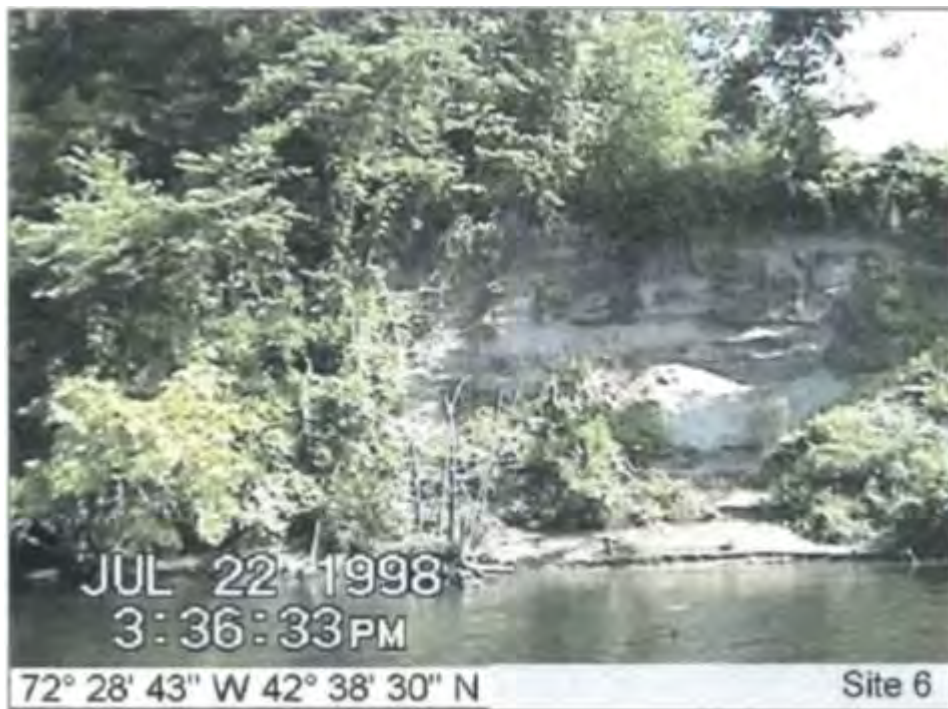
Figure 5.4.3.16-1 Photos at site 6AL Pre Restoration (Labeled as 1998 FRR/ECP-Site 6)

BSTEM runs at this site for the Pre-Restoration Condition show that under the Baseline Condition, 12.0 ft³ of erosion occurred per foot of bank, during the 2000 to 2004 flow period prior to restoration, averaging 2.67 ft³/ft/y ([Table 5.4.3-1](#)). This results in the 12th highest erosion rate for the Baseline Condition, placing it between the 50th and 55th percentiles of erosion rates along the reach. The modeling also indicates that all 100% (2.67 ft³/ft/y) of the erosion is due directly to hydraulic processes, and none of the bank erosion is the result of larger geotechnical failures.

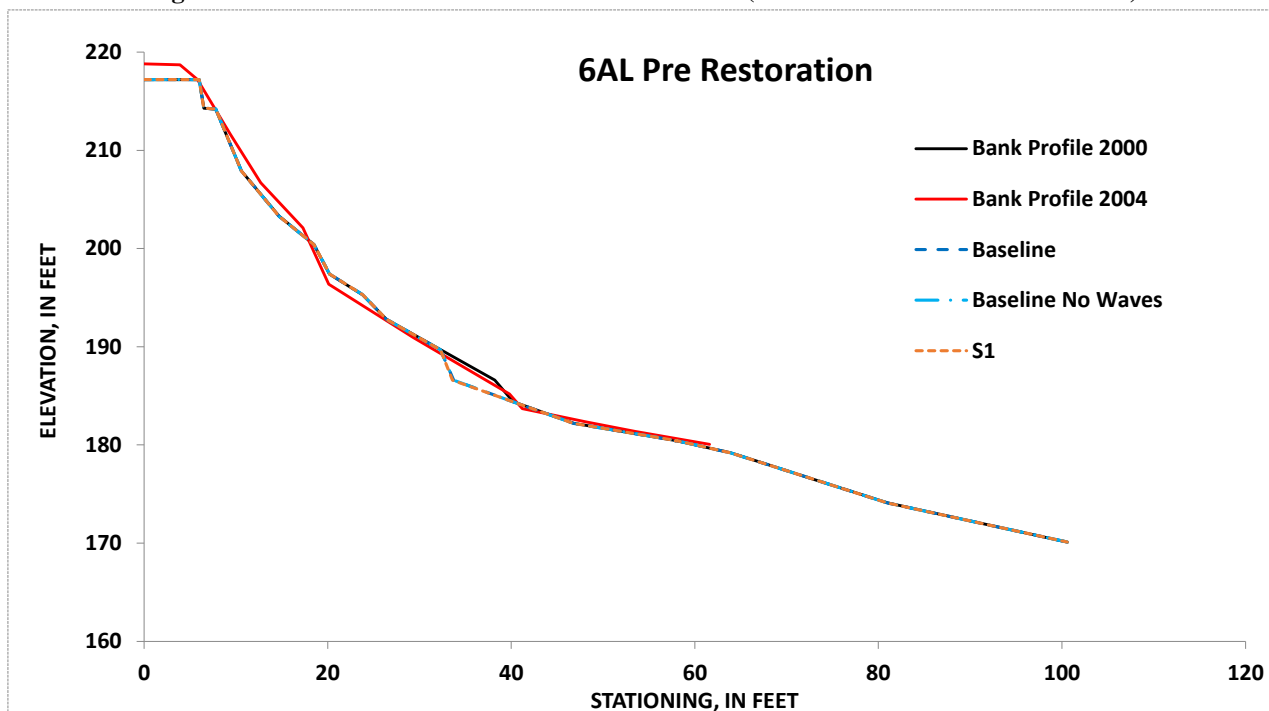
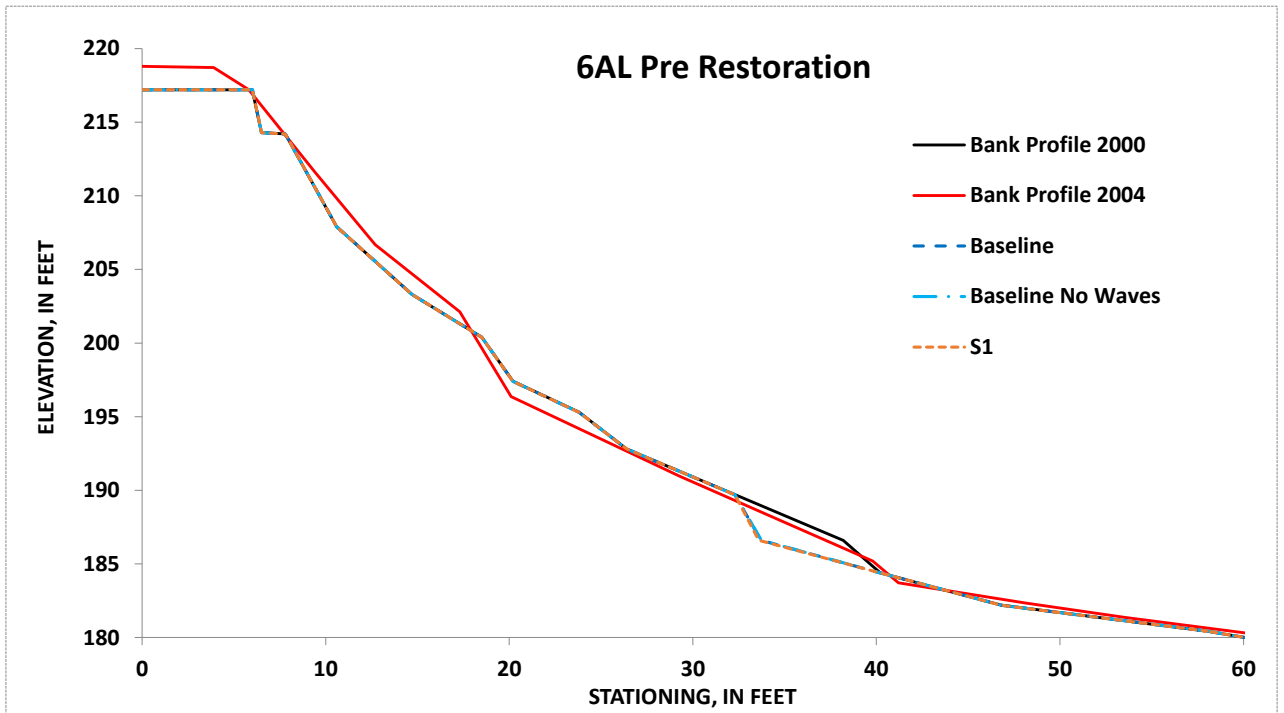
Figure 5.4.3.16-2: Simulated, future unit-erosion for the Baseline Condition (with boat waves on and off) and Scenarios 1 at site 6AL for the period 2000-2004

The Baseline Condition (Waves off) resulted in 2.64 ft³/ft/y, with 2.74 ft³/ft/y for Scenario 1 ([Figure 5.4.3.16-2](#) to [Figure 5.4.3.16-3](#)). This resulted in the following percent reductions in erosion rates: 1.2% and -2.57% for Baseline Wave off and Scenario 1 respectively. Baseline simulations with waves off showed virtually no reduction in erosion, it was concluded that boat waves have little effect on erosion processes at this site. Because of this, all of the remaining scenarios were simulated with boat waves on.

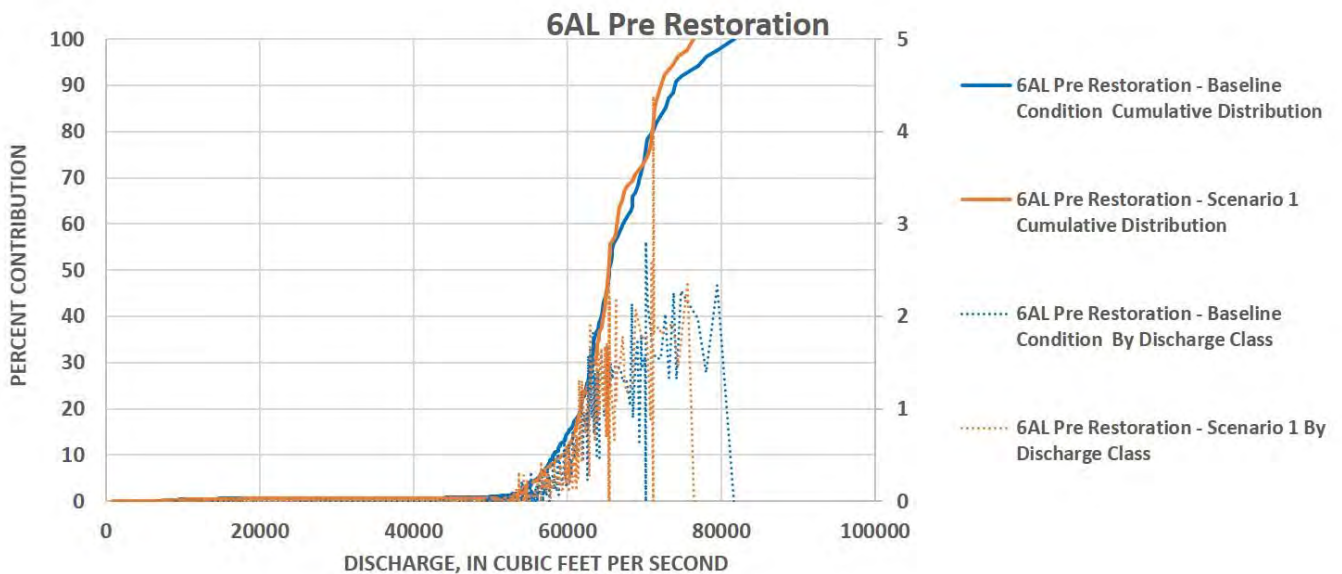
Figure 5.4.3.16-4: Simulated, percent contribution of total erosion by discharge for the Baseline Condition and Scenarios 1 at site 6AL for the period 2000-2004

For the Baseline Condition, 95% of the total erosion occurs at flows of about 56,000 cfs or greater ([Figure 5.4.3.16-4](#)). [Table 5.4.3.16-1](#) denotes the flows above which 95%, 50%, and 5% of all erosion occurs at the site as well as the amount of time those flows were exceeded for each year in the modeling period. The hydraulic erosion occurs across the range of flows above 56,000 cfs. Through this analysis we can conclude that those flows greater than the combined hydraulic capacity of Vernon and Northfield Mountain were accounting for most of the total erosion.
