Relicensing Study 3.1.2

**Northfield Mountain / Turners Falls
Operations Impact on Existing Erosion and
Potential Bank Instability
Study Report**

Volume II – Main Report

**Northfield Mountain Pumped Storage Project (No. 2485) and
Turners Falls Hydroelectric Project (No. 1889)**

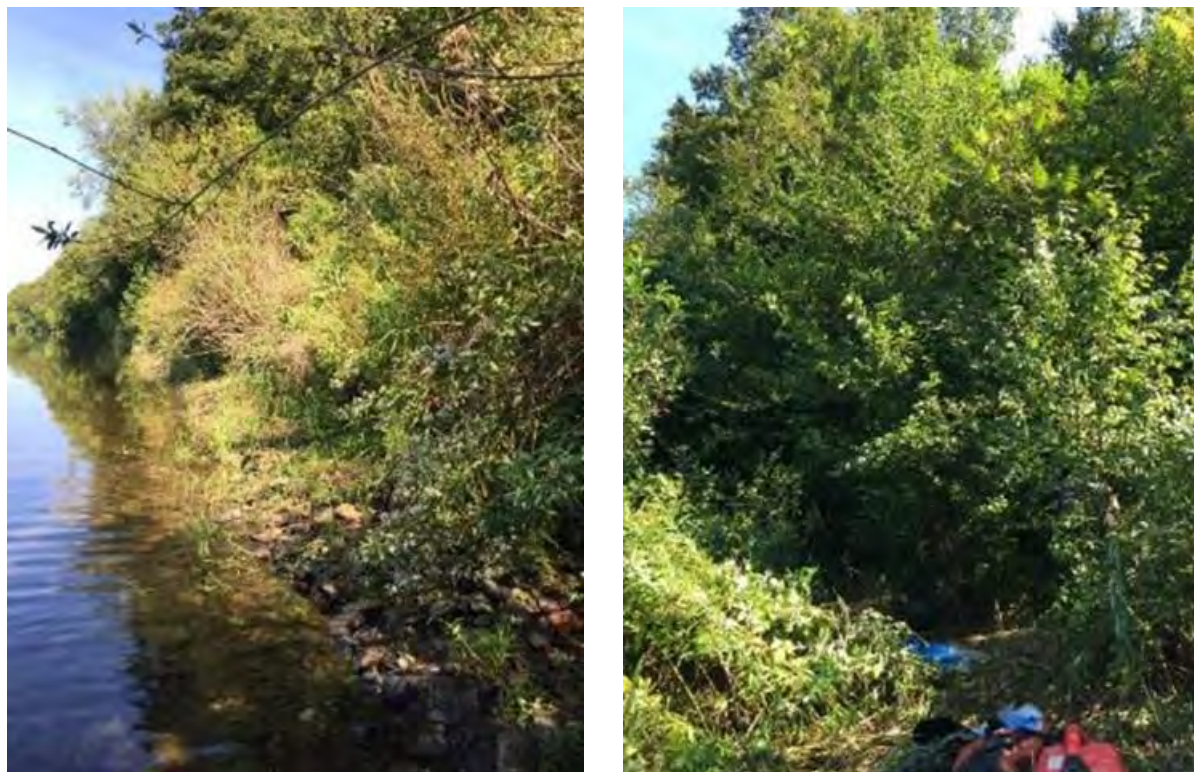
Figure 5.4.3.17-1 Photos at site 6AL Post Restoration

The Post Restoration condition at site 6AL is characterized by steep, heavily vegetated banks. The bank is roughly 37 feet tall, with a rock toe ($d_{50}=55$ mm) and a silt loam bank. The replanted bank is heavily vegetated with large shrubs, Northern red oak, and Sugar maple ([Figure 5.4.3.17-1](#)).

BSTEM runs at this site show that the restoration activities have been highly successful with erosion rates under the Baseline Condition of $5.5E-05$ ft³ per foot of bank, during the 2004 to 2014 flow period, averaging $5.45E-06$ ft³/ft/y ([Table 5.4.3-1](#)). This results in the lowest erosion rate for the Baseline Condition. The modeling also indicates that all 100% ($5.45E-06$ ft³/ft/y) of the erosion is due directly to hydraulic processes, and there are no geotechnical failures.

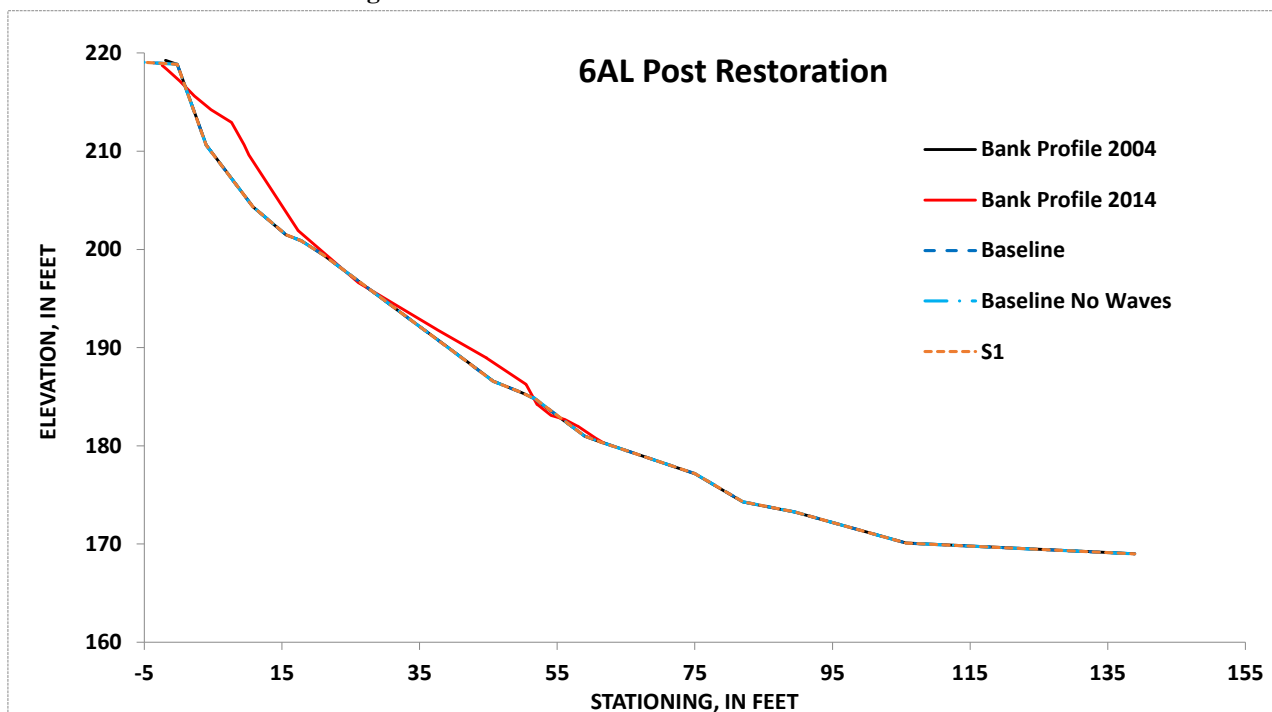
Figure 5.4.3.17-2: Simulated, future unit-erosion for the Baseline Condition (with boat waves on and off) and Scenarios 1 at site 6AL for the period 2004-2014

The Baseline Condition (Waves off) resulted in $0.00E+00$ ft³/ft/y, with $4.42E-06$ ft³/ft/y for Scenario 1 ([Figure 5.4.3.17-2](#)). Baseline simulations with waves off showed virtually no reduction in erosion, it was concluded that boat waves have little effect on erosion processes at this site. Because of this, all of the remaining scenarios were simulated with boat waves on.

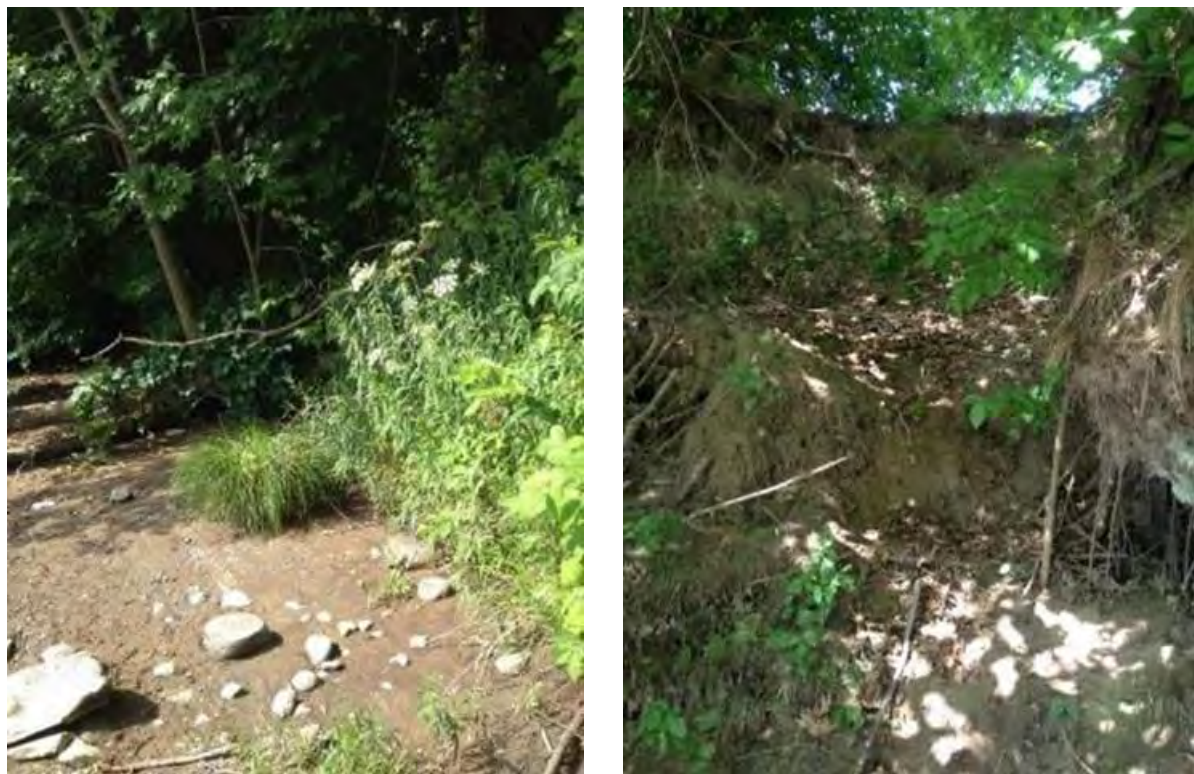
Figure 5.4.3.22-1 Photos at site 8BL

The river at site 8BL (station 32,750) has steep, vegetated banks and is located between Kidds Island and the Northfield Mountain Tailrace, just upstream of Pine Meadow Brook. The bank is roughly 24 feet tall, with a sandy toe and a sandy-loam upper bank. The bank is highly vegetated with 20 to 50 year old Hemlock, Pine, and Silver maple. There was a significant amount of bare soil noted, likely due to the dense tree canopy ([Figure 5.4.3.22-1](#)).

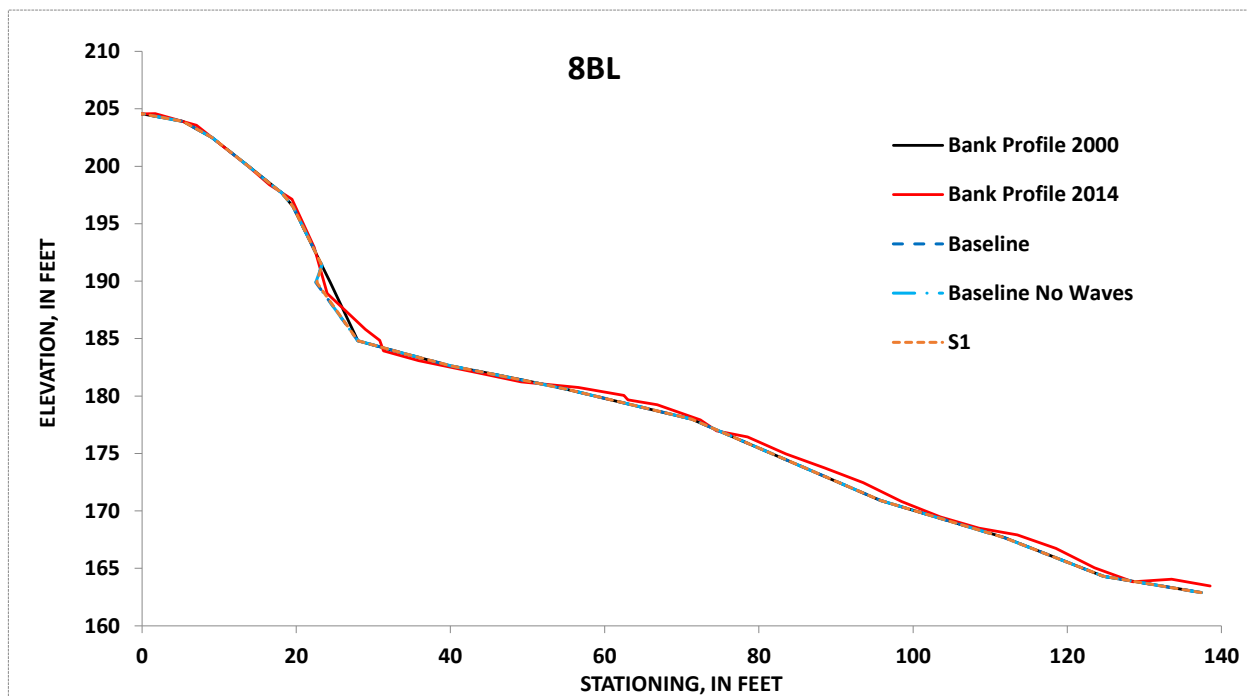
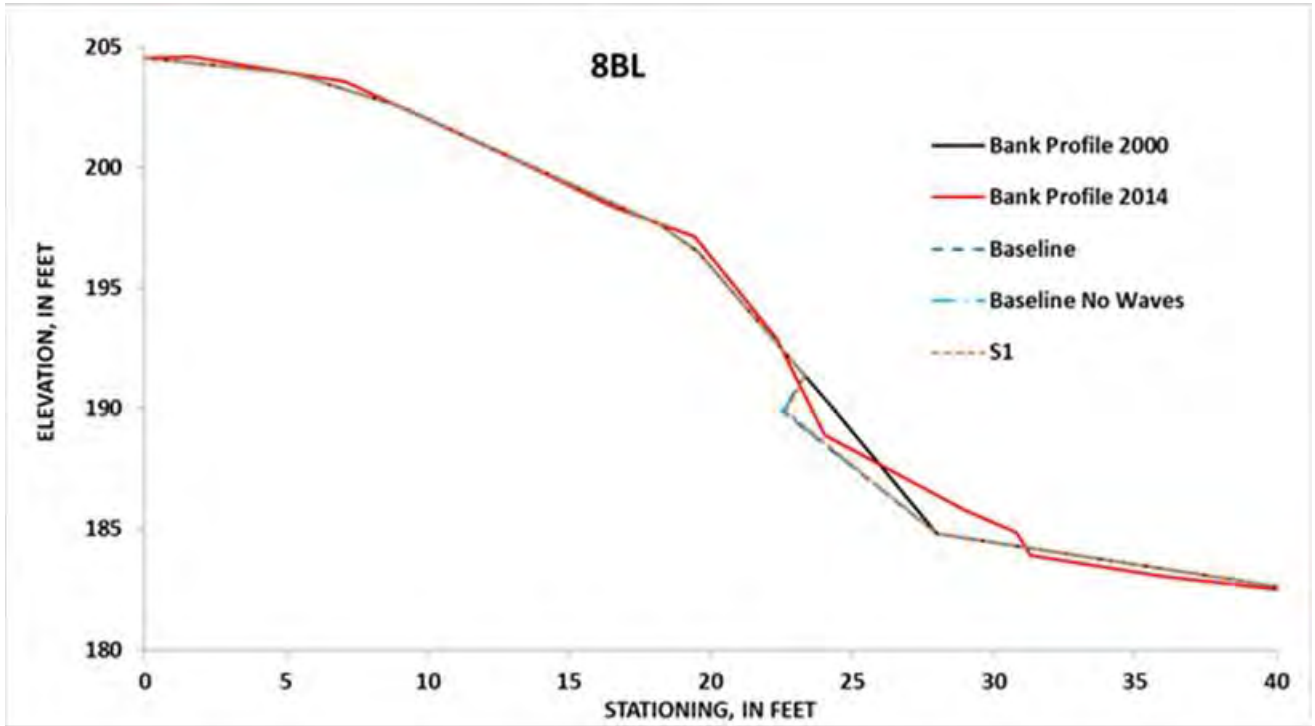
The Baseline Condition (Waves off) resulted in 0.43 ft³/ft/y, with 0.40 ft³/ft/y for Scenario 1 ([Figure 5.4.3.22-2](#) to [Figure 5.4.3.22-3](#)). This resulted in the following percent differences in erosion rates relative to the Baseline Condition: 0.09% and 6.6%, for Baseline Wave off and Scenario 1, respectively. As the Baseline Condition (Waves off) scenario illustrated a very little reduction in erosion, it was concluded that boat waves are not having a significant impact on bank stability, and the remaining scenarios were not considered with boat waves off.

Figure 5.4.3.22-2: Simulated, future unit-erosion for the Baseline Condition (with boat waves on and off) and Scenario 1 at site 8BL for the period 2000-2014

Figure 5.4.3.22-3: Simulated, future erosion for the Baseline Condition (with boat waves on and off) and Scenario 1 at site 8BL for the period 2000-2014. Zoomed in at area of erosion for illustrative purposes

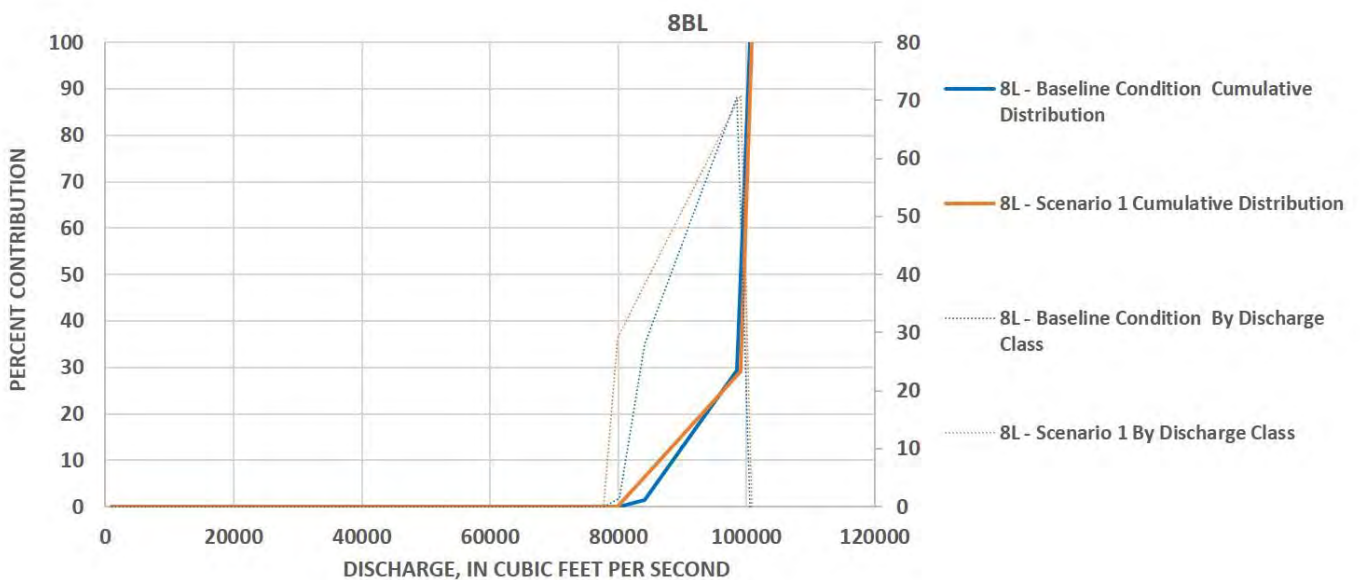
The important role of high flows in bank-erosion rates can be seen in the Baseline Condition erosion results, 93% of the total erosion occurs at flows of 37,000 cfs or greater ([Figure 5.4.3.22-4](#)). [Table 5.4.3.22-1](#) denotes the flows above which 95%, 50%, and 5% of all erosion occurs at the site as well as the amount of time those flows were exceeded for each year in the modeling period. Through this analysis we can conclude that those flows greater than the combined hydraulic capacity of Vernon and Northfield Mountain are accounting for most of the total erosion with a small percent of erosion (6.6%) contributed by Northfield Mountain Project operations.

Figure 5.4.3.22-4: Simulated, percent contribution of total erosion by discharge for the Baseline Condition and Scenario 1 at site 8BL for the period 2000-2014

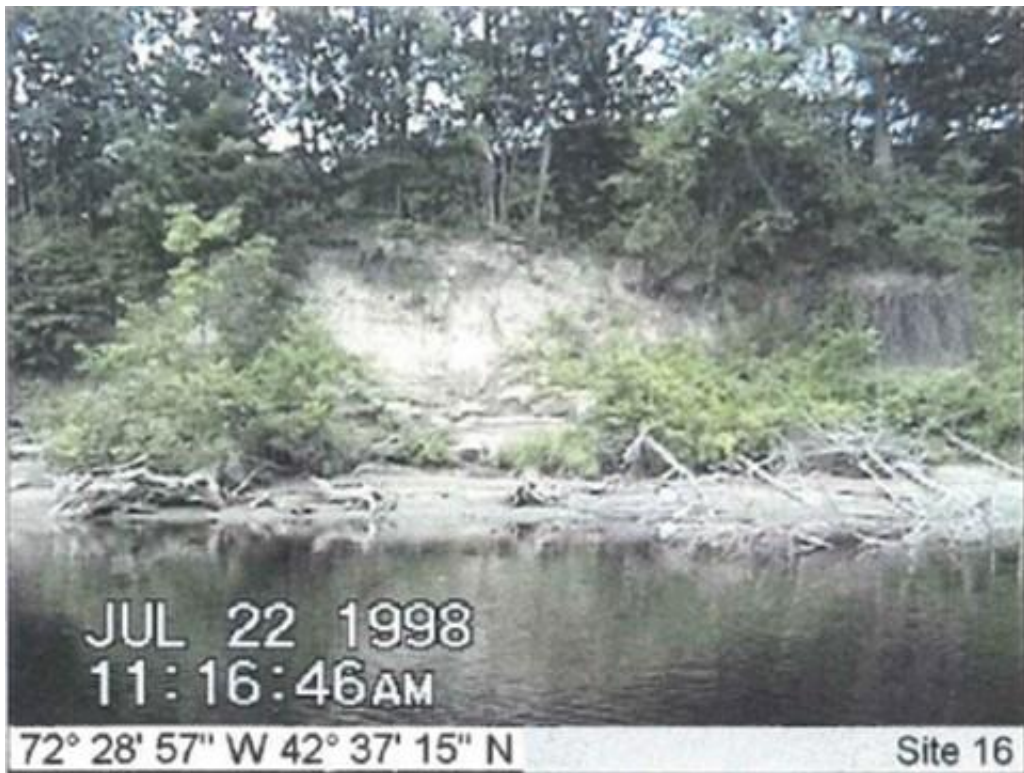
Figure 5.4.3.23-1 Photos at site 8BR Pre Restoration (Labeled as 1998 FRR/ECP-Site 16)

The river at site 8BR (station 32,750) has steep, sparsely vegetated banks and is located between Kidds Island and Northfield Mountain Tailrace, just upstream of Pine Meadow Brook. The bank is roughly 19 feet tall, with a sandy toe and a sandy-loam upper bank. The bank is thinly vegetated with Northern red oak and Green ash. There was also significant amount of bare soil noted ([Figure 5.4.3.23-1](#)).

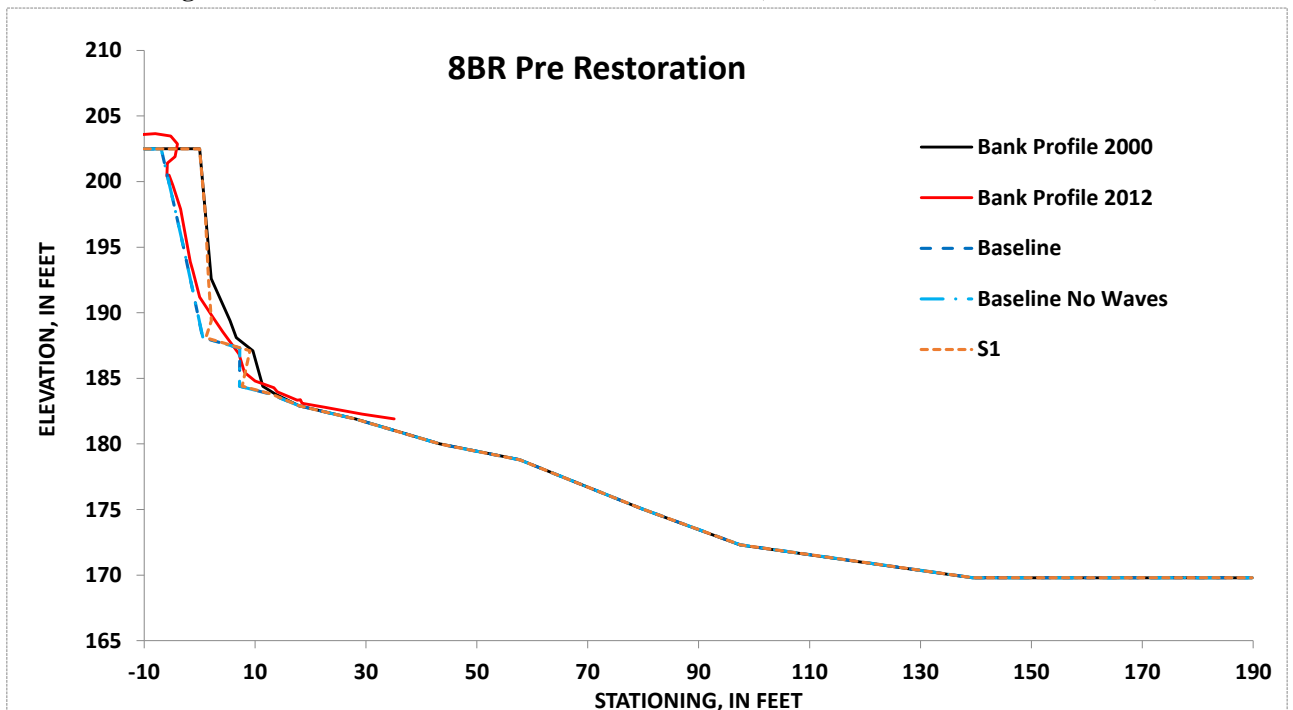
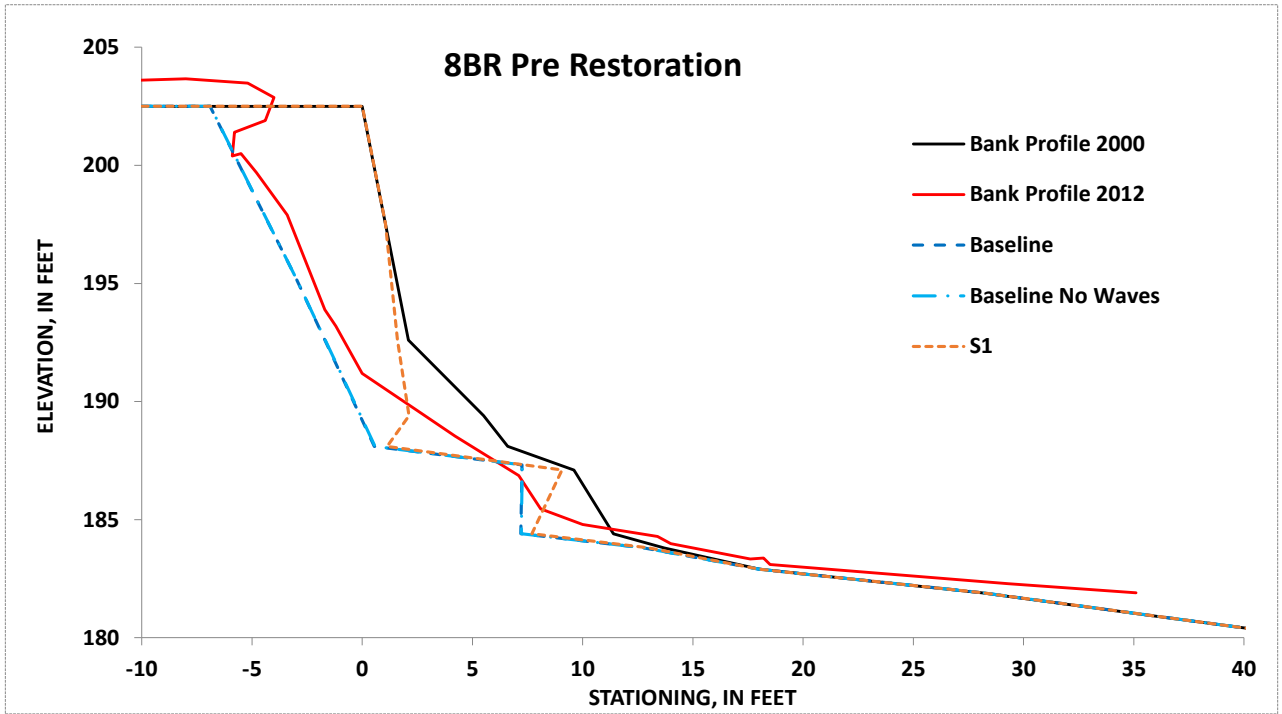
The Baseline Condition (Waves off) resulted in 7.39 ft³/ft/y, with 1.95 ft³/ft/y for Scenario 1 ([Figure 5.4.3.23-2](#) to [Figure 5.4.3.23-3](#)). This resulted in the following percent reductions in erosion rates: 0.28% and 73.6% for Baseline Wave off and Scenario 1, respectively. The drastic difference between bank-erosion rates for the Baseline Condition and Scenarios 1, can be attributed to what happened at 8R during Hurricane Irene in 2011. As this site is in the Northfield Mountain reach, it appears that a significant failure occurs during Baseline Conditions that does not occur during the other Operational scenario when the effects of Northfield Mountain are not included. This difference is attributed to the lack of rapid fluctuations in water-surface elevations for Scenario 1 (because Northfield Mountain is idle) ([Figure 5.4.3.23-4](#)). The figure shows that a large failure occurs here under the Baseline Condition, when peaking operations are combined with extreme high flows.

Figure 5.4.3.23-2: Simulated, future unit-erosion for the Baseline Condition (with boat waves on and off) and Scenario 1 at site 8BR for the period 2000-2012

Figure 5.4.3.23-3: Simulated, future erosion for the Baseline Condition (with boat waves on and off) and Scenario 1 at site 8BR for the period 2000-2012. Zoomed in at area of erosion for illustrative purposes

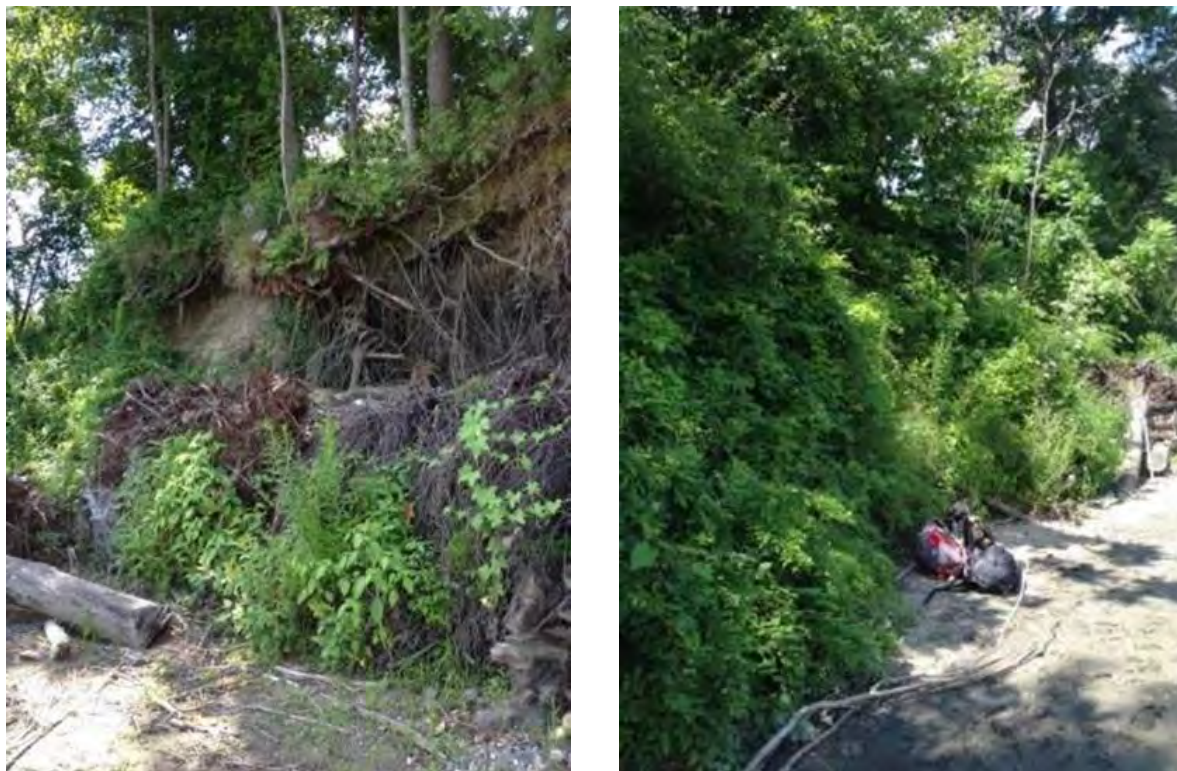
Figure 5.4.3.24-1 Photos at site 8BR Post Restoration

For the Post Restoration condition at site 8R gravel materials ($d_{50} = 13$ mm) were placed on the bank toe along with anchored, large woody debris. Vegetation was also added to the lower bank ([Figure 5.4.3.24-1](#)).

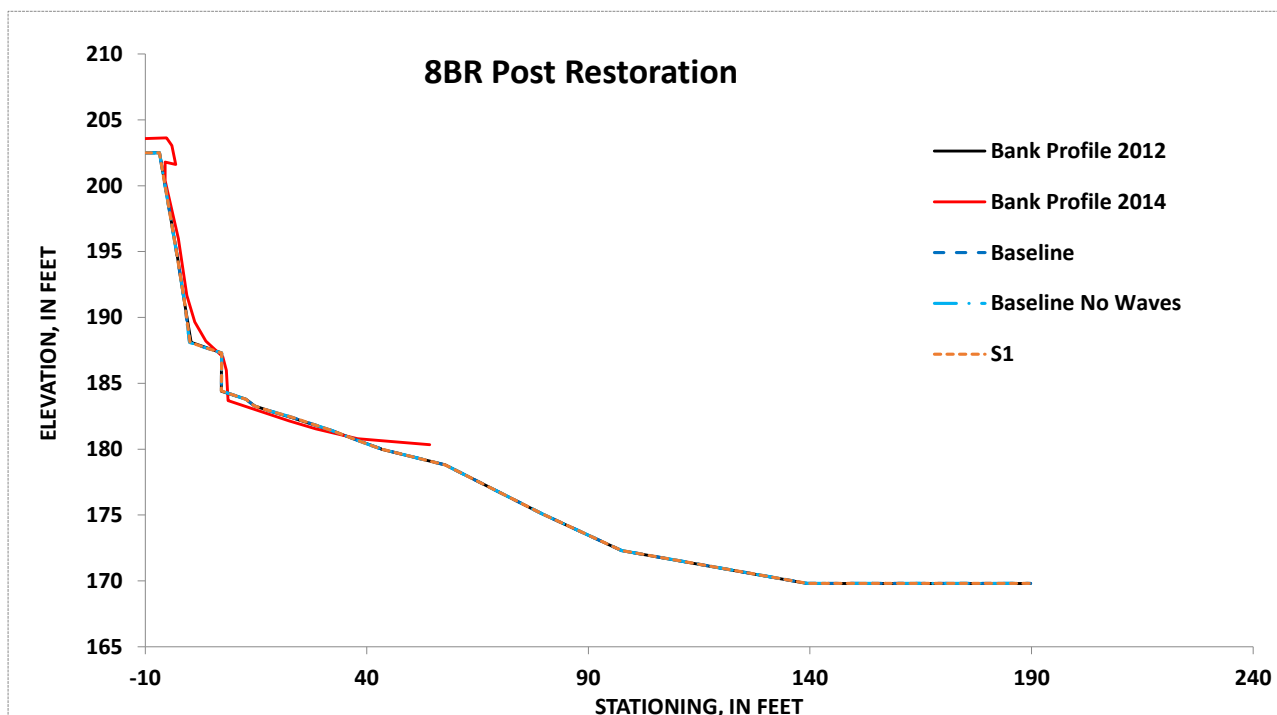
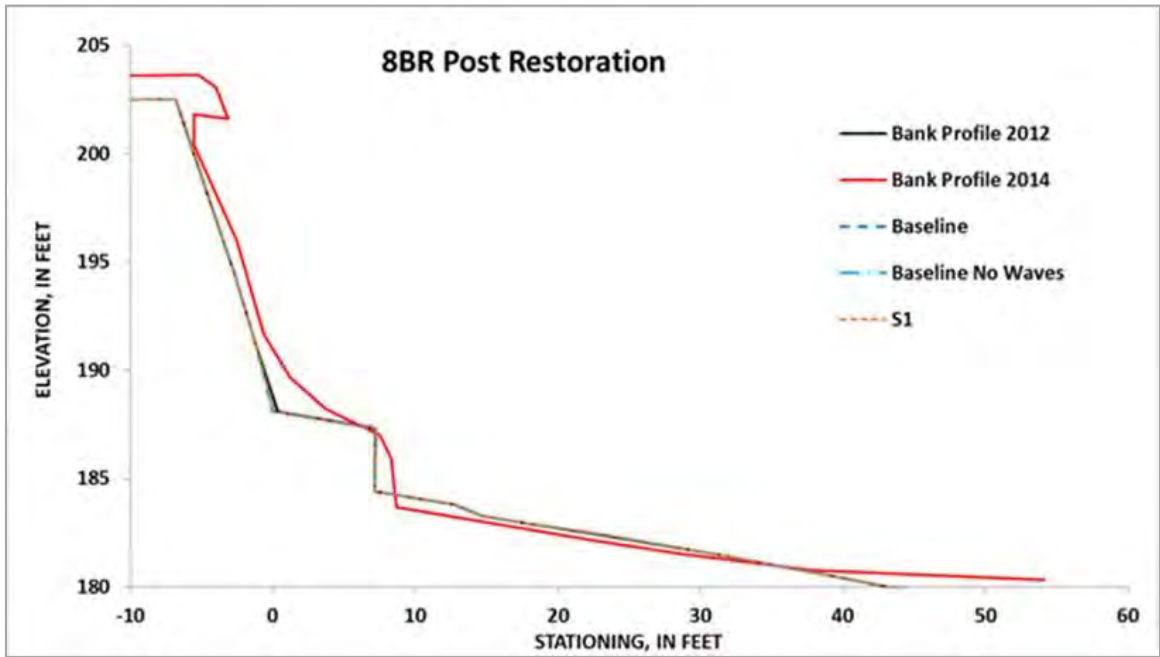
The Baseline Condition (Waves off) resulted in $0.312 \text{ ft}^3/\text{ft}/\text{y}$, with $0.248 \text{ ft}^3/\text{ft}/\text{y}$ for Scenario 1 ([Figure 5.4.3.24-2](#) to [Figure 5.4.3.24-3](#)). This resulted in the differences in erosion rates relative to the Baseline Condition of 0.0% and 20.4%, for Baseline Wave off and Scenario 1 respectively. As Baseline Condition (Waves off) scenario illustrated no reduction in erosion, it was concluded that boat waves are not having a significant impact on bank stability, and the remaining scenarios were not considered with boat waves off.

Figure 5.4.3.24-2: Simulated, future unit-erosion for the Baseline Condition (with boat waves on and off) and Scenario 1 at site 8BR Post Restoration for the period 2012-2014

Figure 5.4.3.24-3: Simulated, future erosion for the Baseline Condition (with boat waves on and off) and Scenario 1 at site 8BR Post Restoration for the period 2012-2014. Zoomed in at area of erosion for illustrative purposes

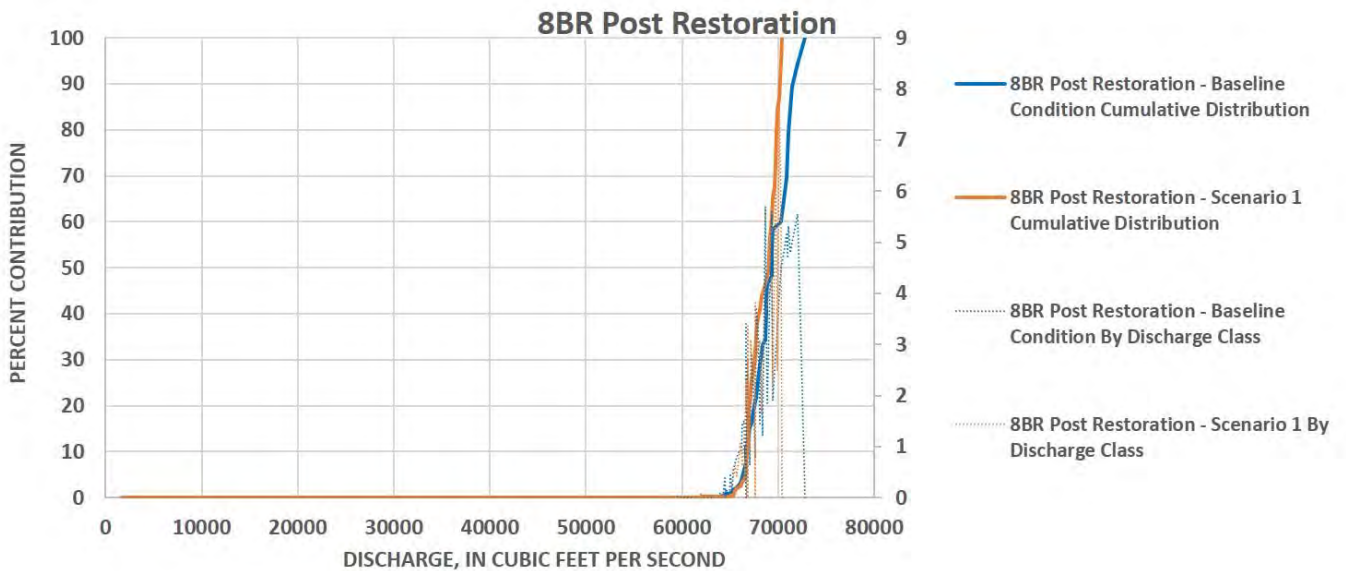
For the Baseline Condition, 95% of the total erosion occurs at flows of about 66,000 cfs or greater ([Figure 5.4.3.24-4](#)). [Table 5.4.3.24-1](#) denotes the flows above which 95%, 50%, and 5% of all erosion occurs at the site as well as the amount of time those flows were exceeded for each year in the modeling period. The hydraulic erosion is fairly consistent across the range of flows above 50,000 cfs. Through this analysis we can conclude that those flows greater than the combined hydraulic capacity of Vernon and Northfield Mountain are accounting for most of the total erosion. Scenario 1 contributes 20.4% of the erosion and suggests that Northfield Mountain is a contributing factor to the total erosion.

Figure 5.4.3.24-4: Simulated, percent contribution of total erosion by discharge for the Baseline Condition and Scenario 1 at site 8BR Post Restoration for the period 2012-2014

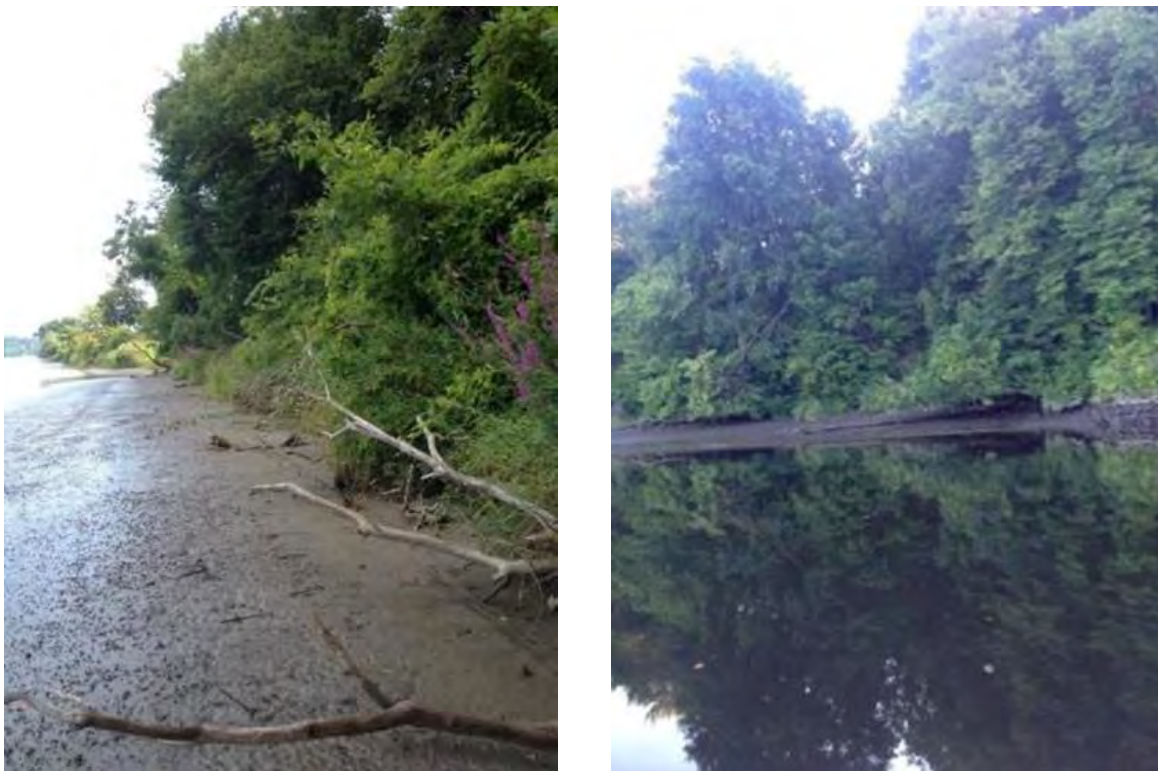
Figure 5.4.3.25-1 Photos at site 87BL Post Restoration

The river at site 87BL (station 30,750) has a steep bank face with an extensive beach, sparsely vegetated banks ([Figure 5.4.3.25-1](#)). The site is located between Kidds Island and Northfield Mountain Tailrace, just downstream of Pine Meadow Brook. The bank is roughly 20 feet tall, with a sandy-loam toe and a silt-loam bank. The bank is vegetated with tall grasses and a few American elms. There was a significant amount of bare soil noted. The toe material appears to be depositional. No historical cross sections existed for this site and a 2014 survey was used, therefore, as the initial bank geometry for modeling.

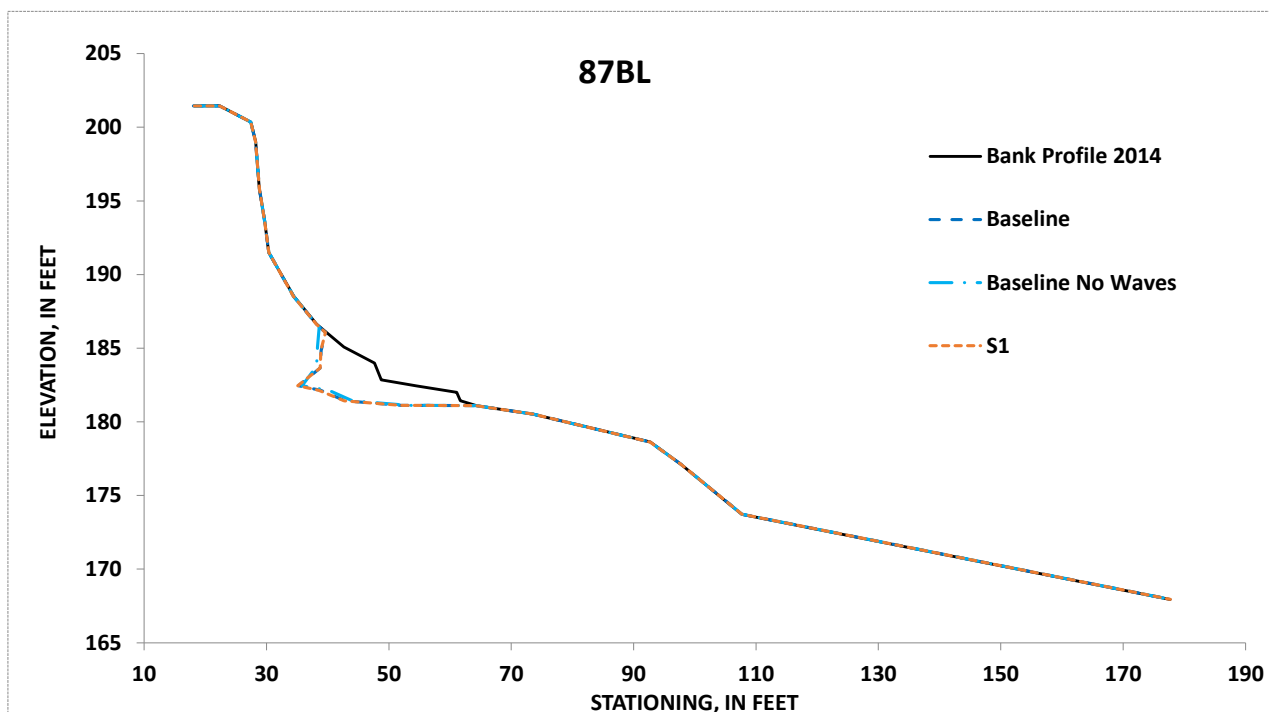
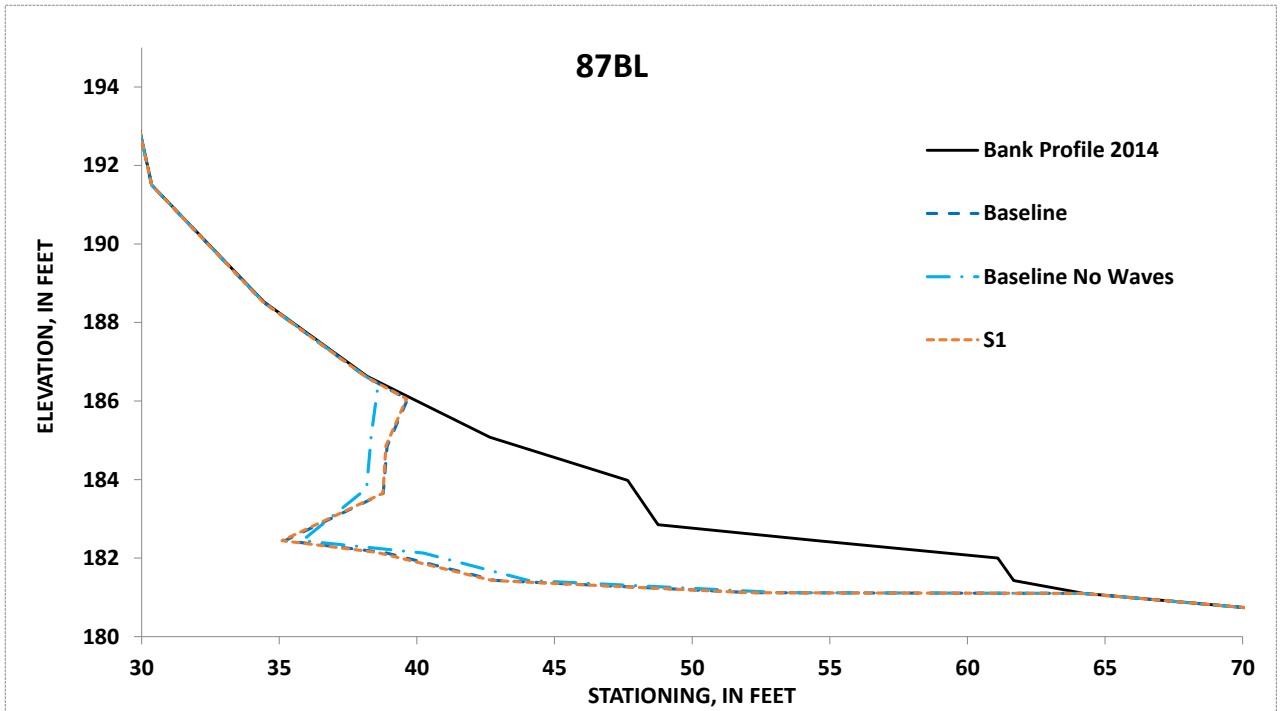
The Baseline Condition (Waves off) resulted in 3.61 ft³/ft/y, with 3.60 ft³/ft/y for Scenario 1 ([Figure 5.4.3.25-2](#) to [Figure 5.4.3.25-3](#)). This resulted in the following percent differences in erosion rates relative to the Baseline Condition: -1.01% and -0.76% for Baseline Wave off and Scenario 1, respectively. As Baseline Condition (Waves off) scenario and Scenario 1 resulted in a slightly higher erosion rate (about 1%) that is certainly within model limitations and does not indicate that erosion would be greater without boat waves and Northfield Mountain operations.

Figure 5.4.3.25-2: Simulated, future unit-erosion for the Baseline Condition (with boat waves on and off) and Scenario 1 at site 87BL for the period 2000-2014

Figure 5.4.3.25-3: Simulated, future erosion for the Baseline Condition (with boat waves on and off) and Scenario 1 at site 87BL for the period 2000-2014. Zoomed in at area of erosion for illustrative purposes

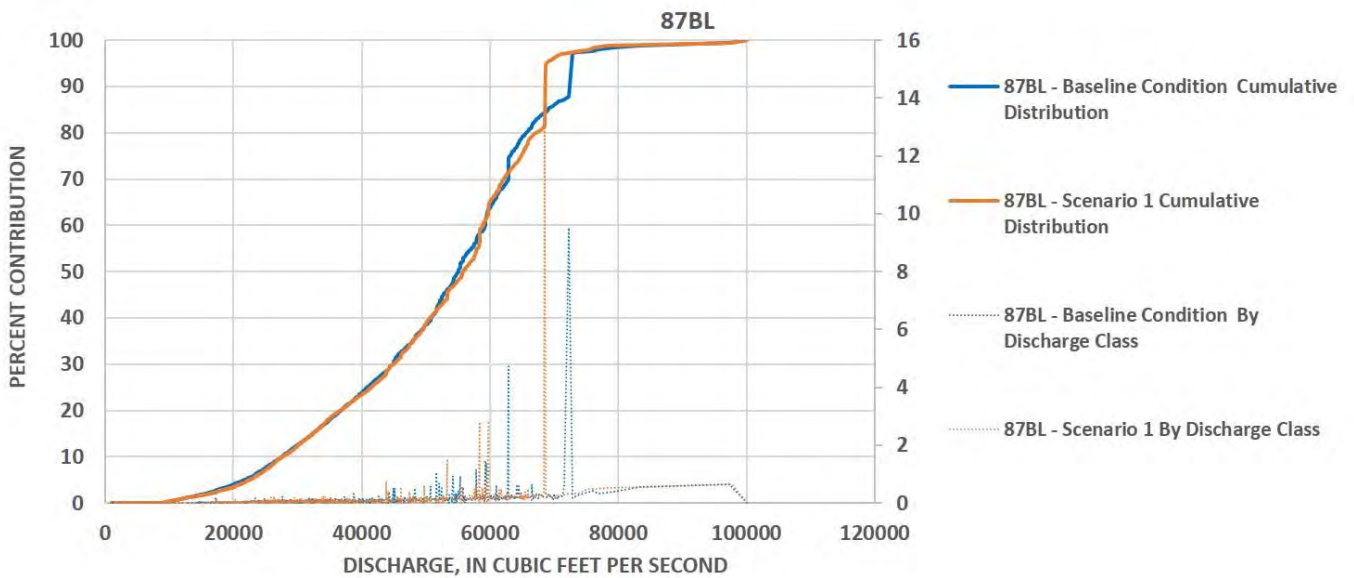
Erosion rates for all Operational scenarios are similar. For the Baseline Condition, 80% of the total erosion occurs at flows of about 37,000 cfs or greater ([Figure 5.4.3.25-4](#)). [Table 5.4.3.25-1](#) denotes the flows above which 95%, 50%, and 5% of all erosion occurs at the site as well as the amount of time those flows were exceeded for each year in the modeling period. The geotechnical failures that account for the 27% of the total erosion, occur at the extreme high flows, whereas hydraulic erosion is fairly consistent across the range of flows above 10,000 cfs, resulting in undercutting of the lower bank ([Figures 5.4.3.25-2](#) and [Figures 5.4.3.25-3](#)). Evaluating the moderate flow contribution to the total erosion it was determined that Northfield Mountain operations occurred about 17% of the time over the modeled period of record. This equates to about 3.5% of the total erosion during the moderate flows. The Northfield Mountain contribution was adjusted by this 3.5% to better estimate contributions from the project resulting in a total contribution of about 3%.

Figure 5.4.3.25-4: Simulated, percent contribution of total erosion by discharge for the Baseline Condition and Scenario 1 at site 87BL for the period 2000-2014

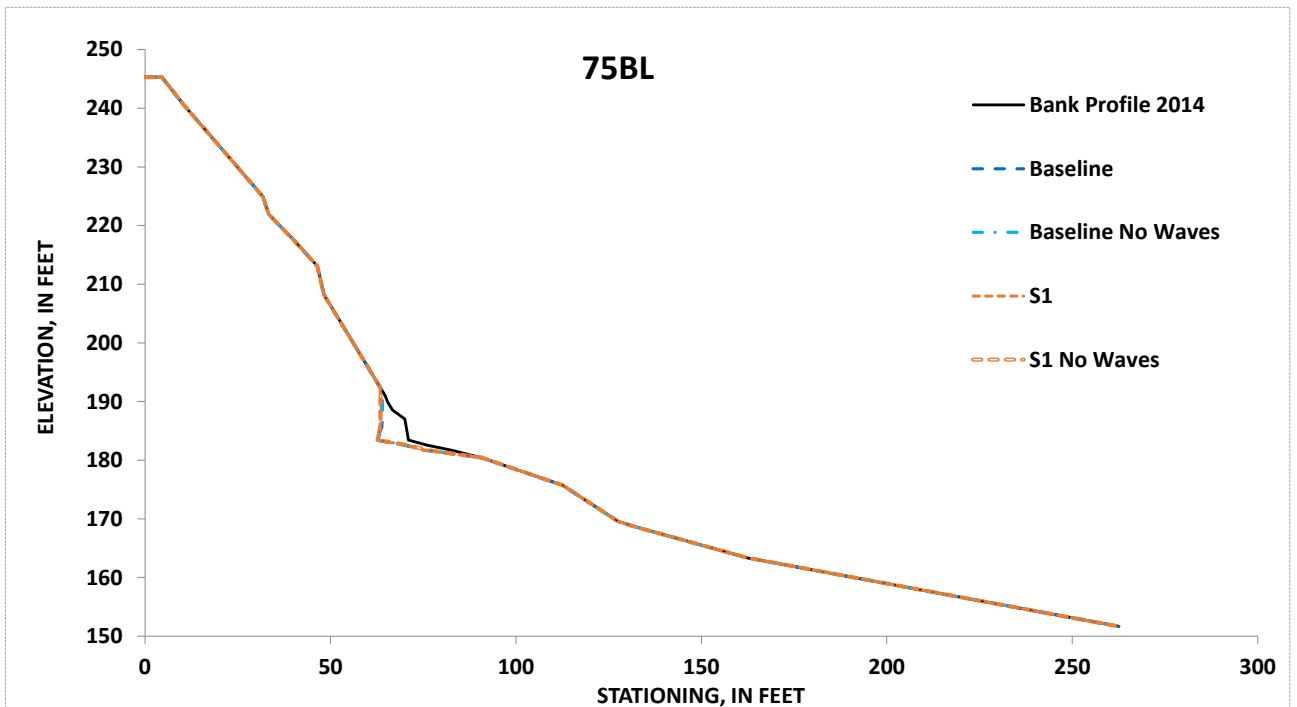
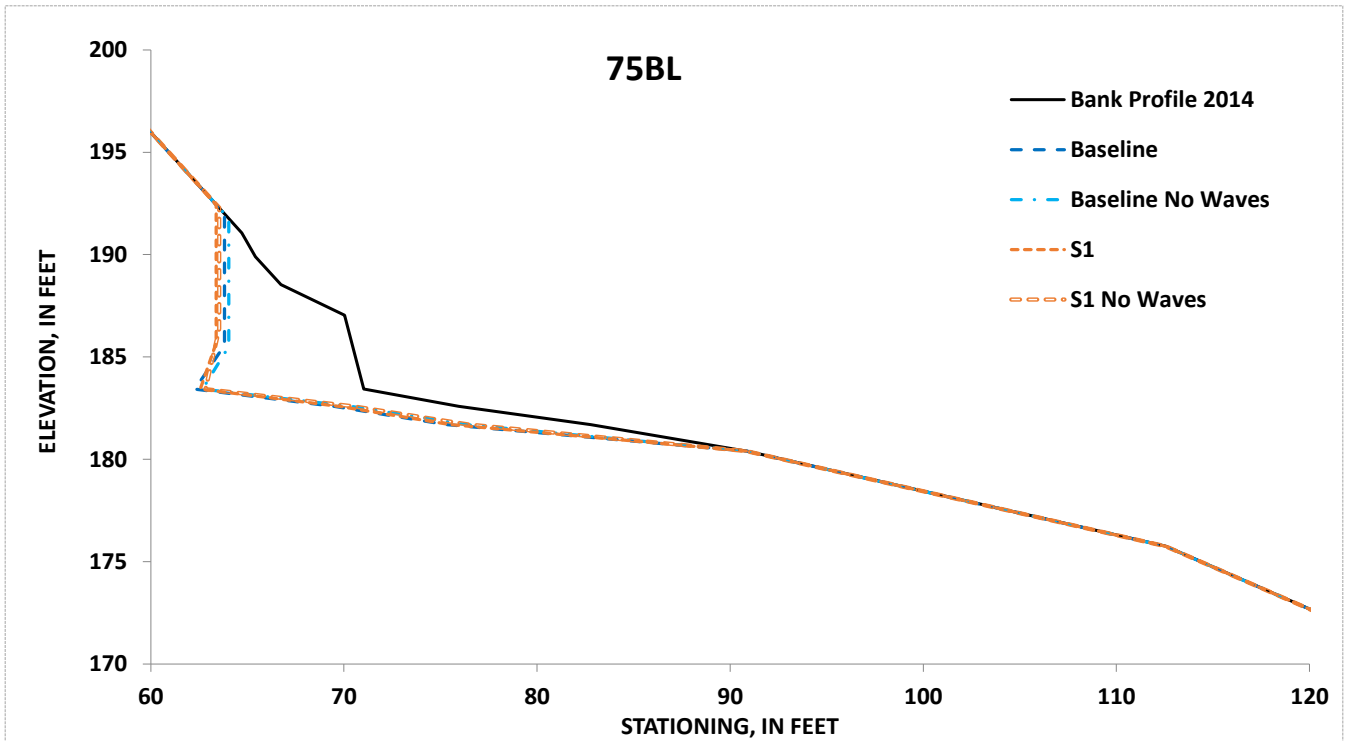
For Scenario 1, 3.93 ft³/ft/y of erosion occurred ([Figure 5.4.3.26-2](#) to [Figure 5.4.3.26-3](#)) resulting in a percent difference in erosion rate relative to the Baseline Condition of -4.6%. The Baseline Condition (Waves off) resulted in 3.48 ft³/ft/y. Bank-erosion rates for the Baseline Condition with boat waves was 7.5% greater than without waves, a small, but measurable amount. Because of this, Scenario 1 was also run without the effects of boat waves. With waves off Scenario 1 resulted in 3.72 ft³/ft/y. A comparison of results showed that bank-erosion rates were about 5.3% greater with boat waves than without for Scenario 1. As these numbers are not drastically different from the runs with the boat waves turned on, this location is likely at or near the upstream limit of where boat waves are having a significant impact on bank stability.

Figure 5.4.3.26-2: Simulated, future unit-erosion for the Baseline Condition (with boat waves on and off) and Scenario 1 at site 75BL for the period 2000-2014

Figure 5.4.3.26-3: Simulated, future erosion for the Baseline Condition (with boat waves on and off) and Scenario 1 at site 75BL for the period 2000-2014. Zoomed in at area of erosion for illustrative purposes

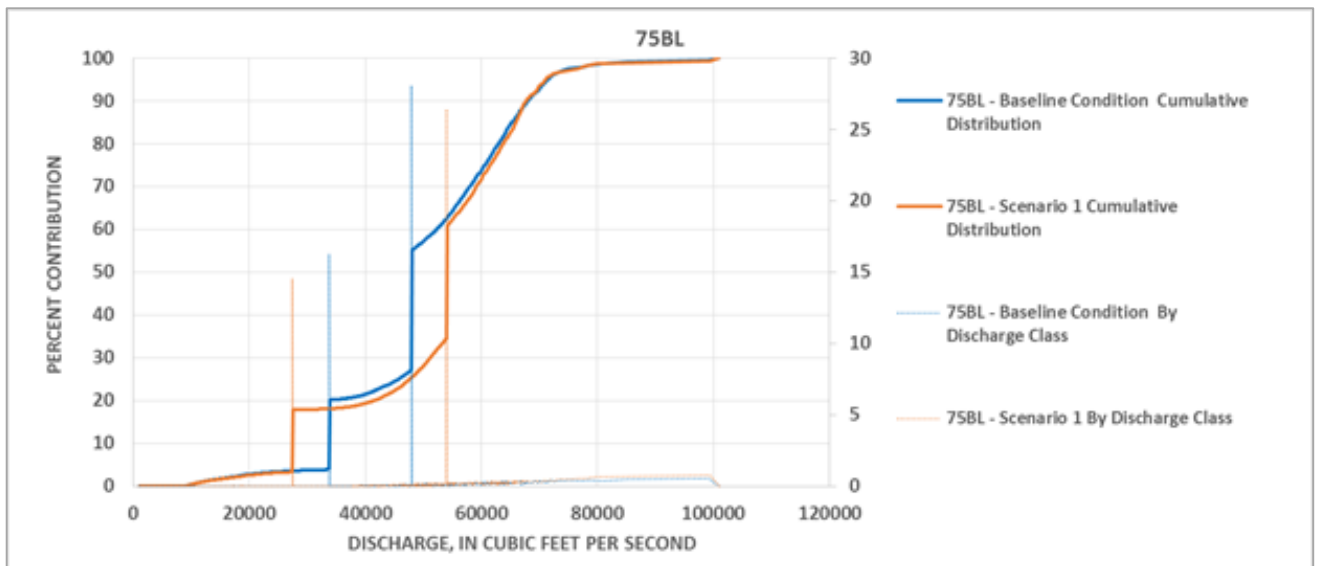
For the Baseline Condition, 79.5% of the total erosion occurs at flows of about 37,000 cfs or greater ([Figure 5.4.3.26-4](#)). [Table 5.4.3.26-1](#) denotes the flows above which 95%, 50%, and 5% of all erosion occurs at the site as well as the amount of time those flows were exceeded for each year in the modeling period. There are two significant geotechnical failures that account for the bulk of the geotechnical erosion, whereas hydraulic erosion is fairly consistent across the range of flows above 37,000 cfs, with a larger peak between 48,000 and 72,000 cfs. Through this analysis we can conclude that those flows greater than the combined hydraulic capacity of Vernon and Northfield Mountain are accounting for most of the total erosion. The same additional moderate flow analysis completed for site 119BL and 87BL was performed on this site. Moderate flows at 75BL contribute about 13% of the total erosion. Northfield Mountain operations were reviewed and determined to occur about 1.2% of the time over the period of record under moderate flows. This equates to about 0.16% additional contribution by Northfield Mountain resulting in no significant change to the Scenario 1 results.

Figure 5.4.3.26-4: Simulated, percent contribution of total erosion by discharge for the Baseline Condition and Scenario 1 at site 75BL for the period 2000-2014
