Relicensing Study 3.1.2

**Northfield Mountain / Turners Falls
Operations Impact on Existing Erosion and
Potential Bank Instability
Study Report**

Volume II – Main Report

**Northfield Mountain Pumped Storage Project (No. 2485) and
Turners Falls Hydroelectric Project (No. 1889)**

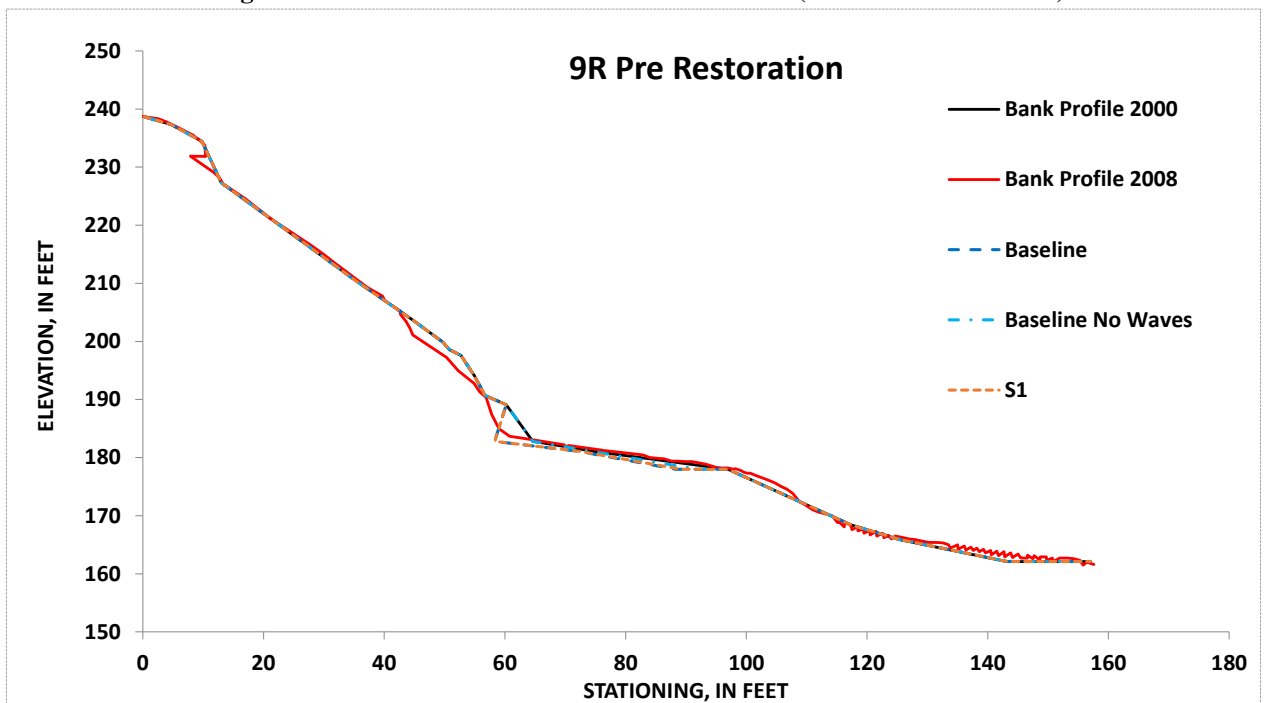
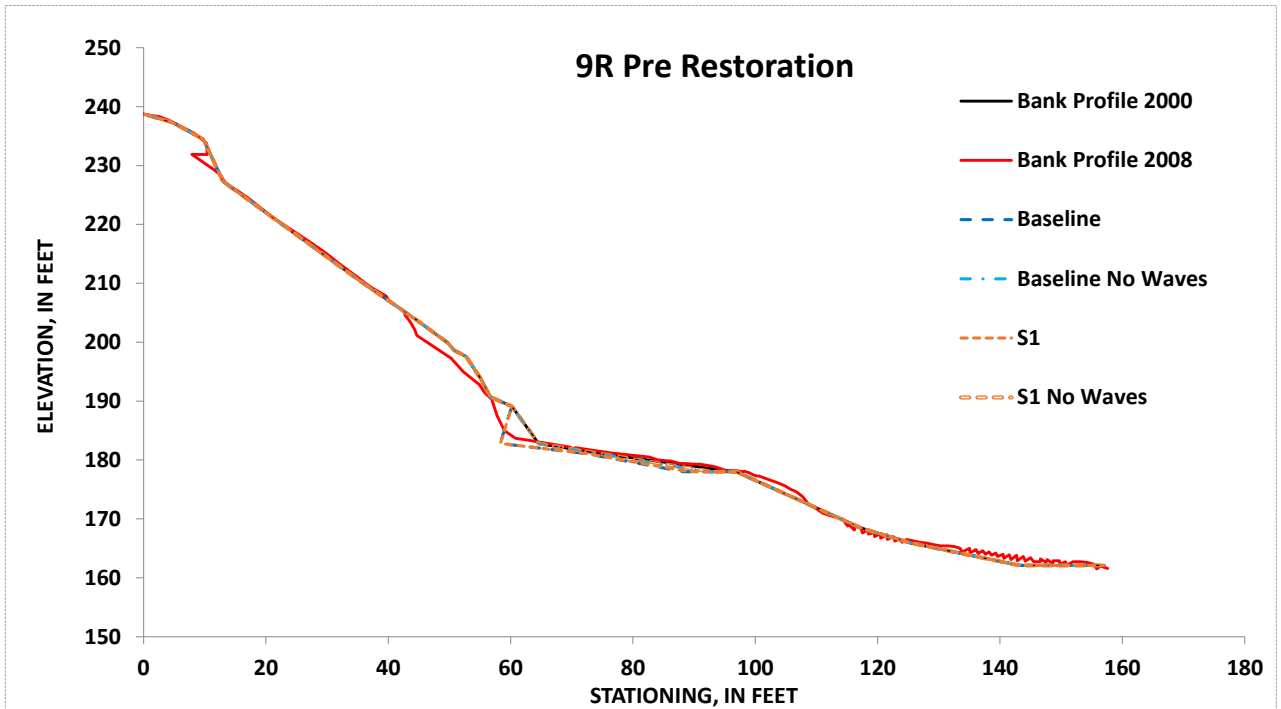
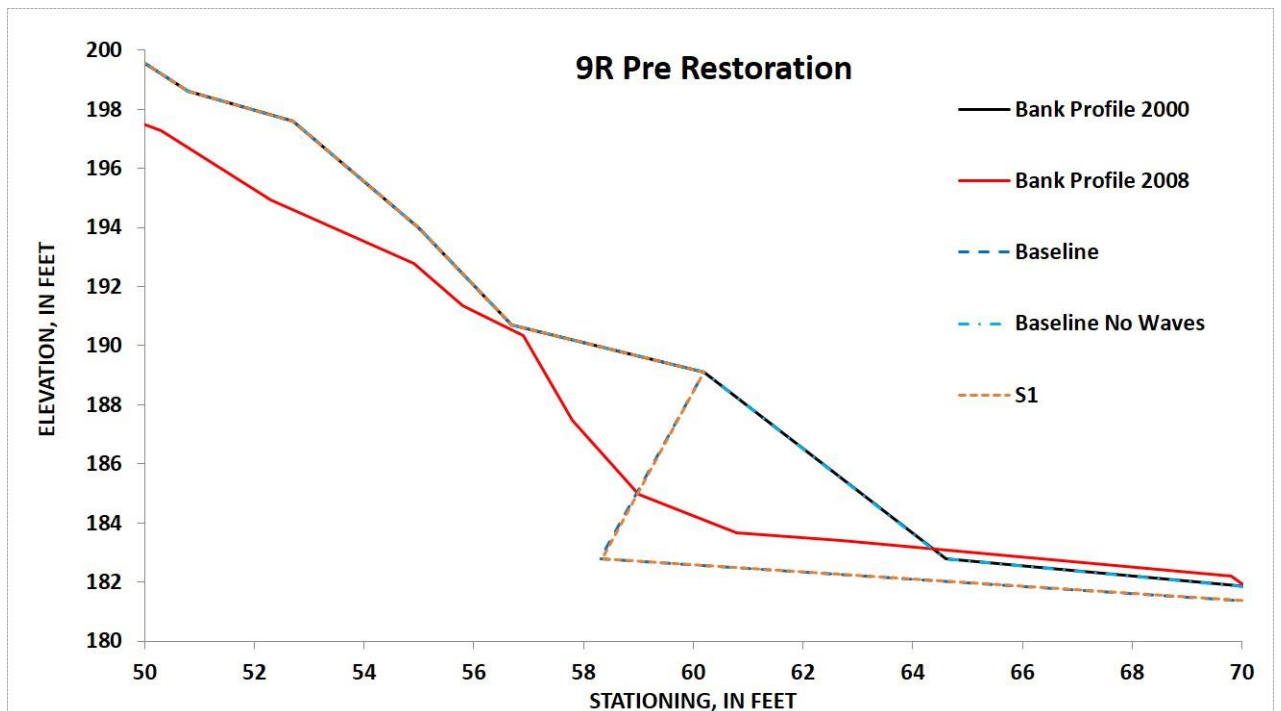
Scenario 1 produced an erosion rate of 5.19 ft³/ft/y ([Figure 5.4.3.27-2](#) to [Figure 5.4.3.27-4](#)) resulting in a difference in an erosion rate relative to the Baseline Condition of 4.3%. Without the impact of boat waves, erosion rates for the Baseline Condition (Waves off) resulted in 0.967 ft³/ft/y, indicating that boat-generated waves are an important contributor to erosion at this site. As there was a large difference between the Baseline Condition (Waves on) and Baseline Condition (Waves off), Scenario 1 was also investigated for the waves-off condition. With waves off the bank-erosion rate for Scenario 1 was 0.77 ft³/ft/y. While the Baseline Condition had 82% more erosion with boat waves, Scenario 1 showed that bank-erosion rates were greater by 85% with waves.

Figure 5.4.3.27-2: Simulated, future unit-erosion for the Baseline Condition and Scenario 1 (with boat waves on) at site 9R Pre Restoration for the period 2000-2008

Figure 5.4.3.27-3: Simulated, future unit-erosion for the Baseline Condition (with boat waves on and off) and Scenario 1 at site 9R Pre Restoration for the period 2000-2008

Figure 5.4.3.27-4: Simulated, future erosion for the Baseline Condition and Scenario 1 (with boat waves on) at site 9R Pre Restoration for the period 2000-2008. Zoomed in at area of erosion for illustrative purposes

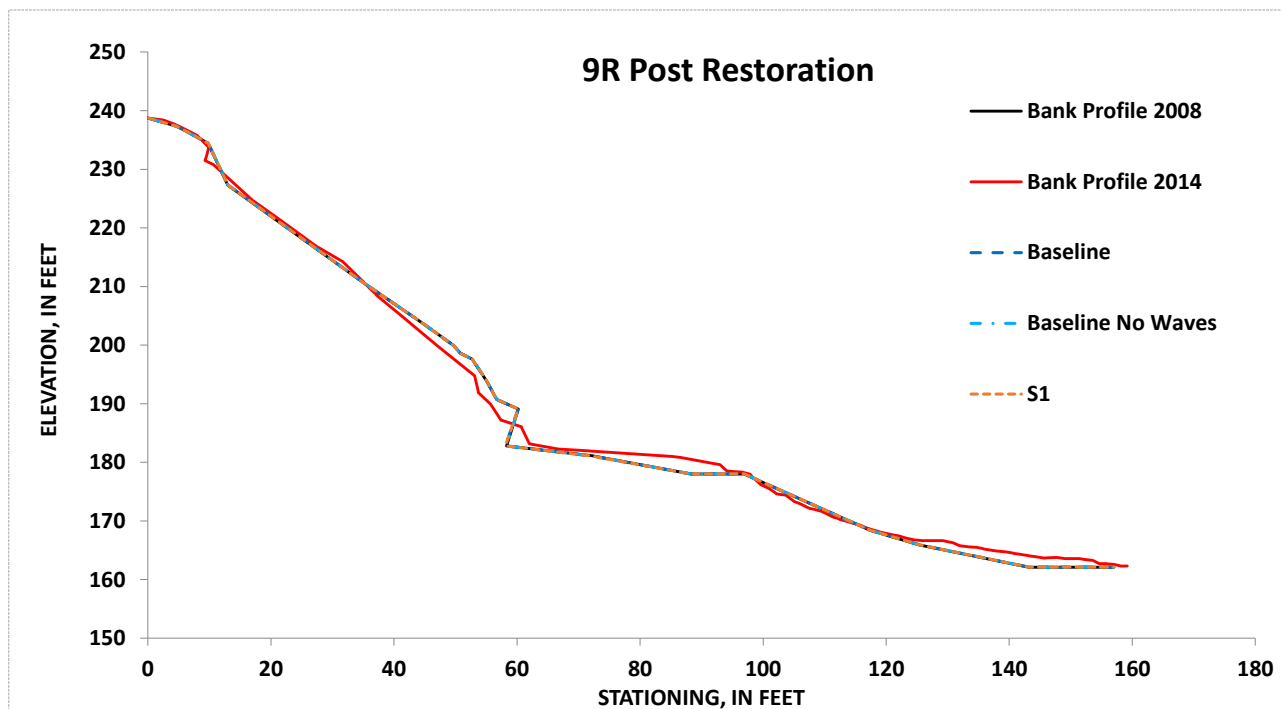
Scenario 1 had a resulting erosion amount of 0.224 ft³/ft/y ([Figure 5.4.3.28-2](#)). The Baseline Condition (Waves off) resulted in 0.002 ft³/ft/y, indicating a substantial reduction in bank-erosion rates with the removal of the impacts from boat-generated waves. As there was a large difference between the Baseline Condition (Waves on) and Baseline Condition (Waves off), Scenario 1 was investigated for the waves off condition as well. This resulted in 1.50 x10⁻³ ft³/ft/y of erosion for Scenario 1 (Note- while this site did show a small reduction in erosion between the BL and S1 Scenarios the total reduction in erosion is well below the measureable/significant rate of 0.161 ft³/ft/yr). The highest water surface elevation for this period occurred at 184.5 ft. Most of the measured erosion for this site appears to occur above 190 feet. This erosion does not appear to be a function of the TFI hydraulics. For erosion to be present above the high water line, toe erosion would need to occur and then a geotechnical failure would occur above. The toe for this site, based on survey data, has not eroded significantly since the restoration to the point where a geotechnical failure would occur.

Figure 5.4.3.28-2: Simulated, future unit-erosion for the Baseline Condition (with boat waves on and off) and Scenario 1 at site 9R Post Restoration for the period 2008-2014, with a minimum water surface elevation of 176.9 feet and a maximum water surface elevation of 184.5 feet.

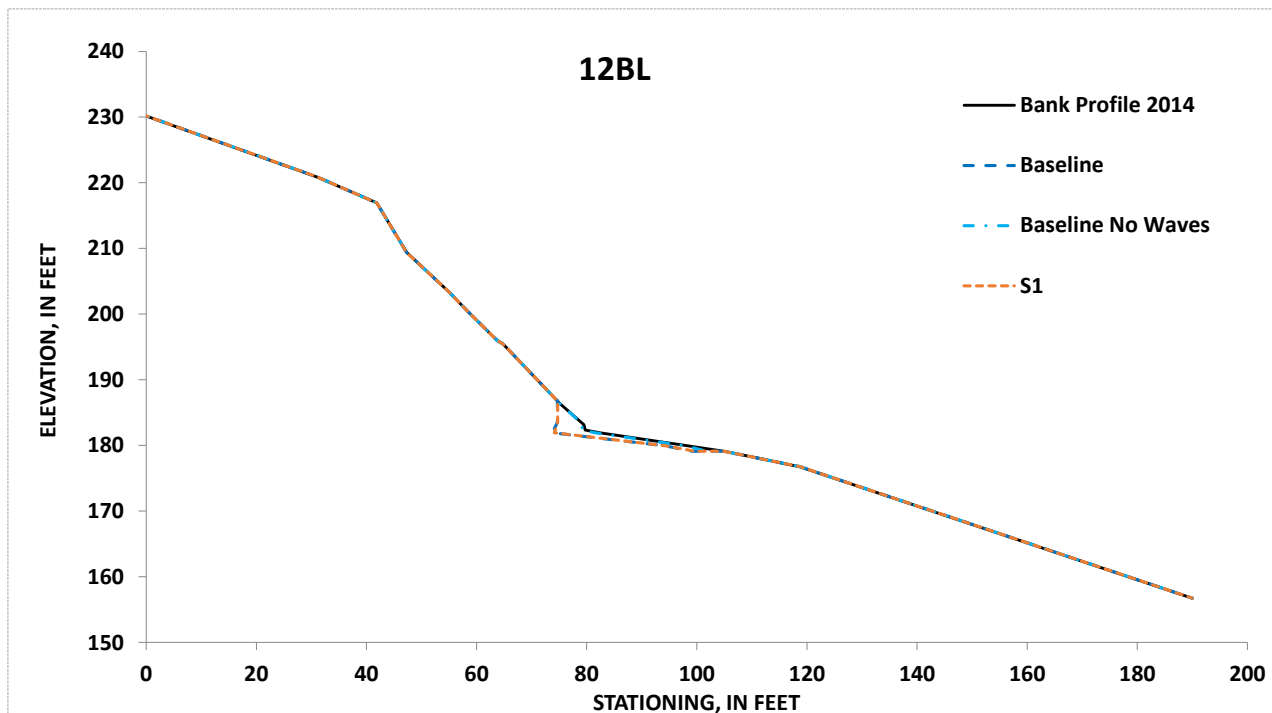
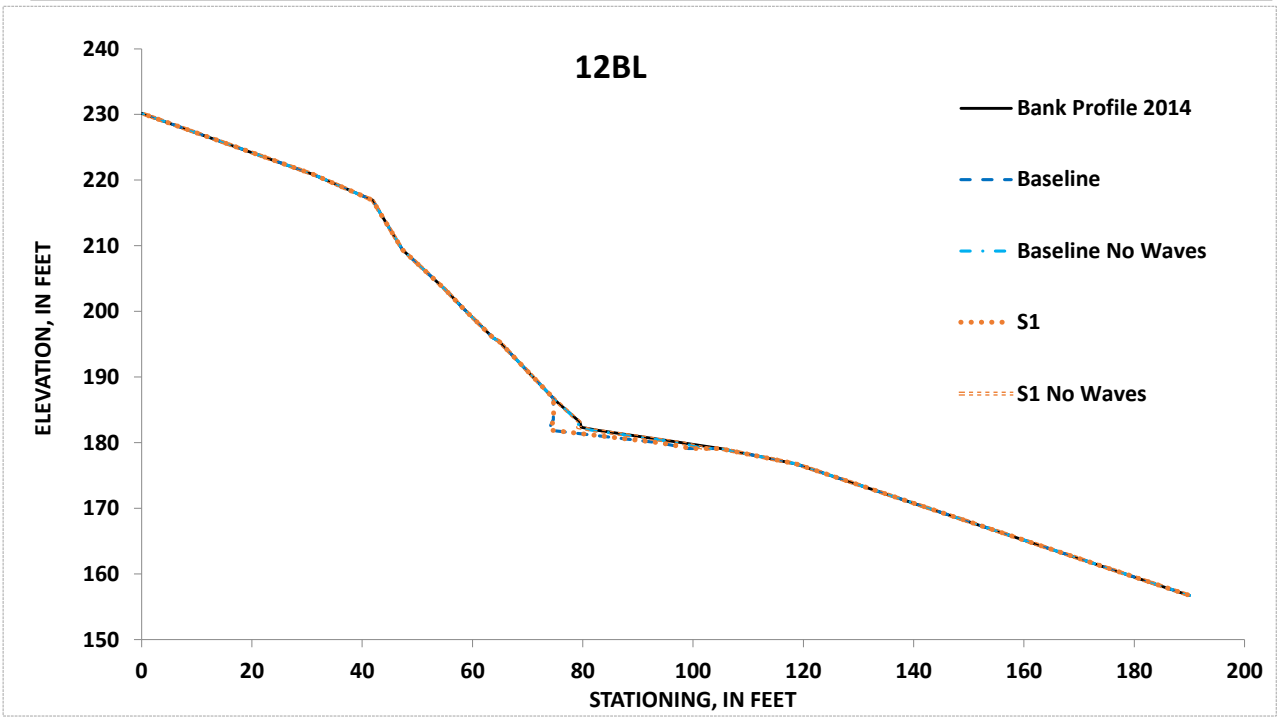
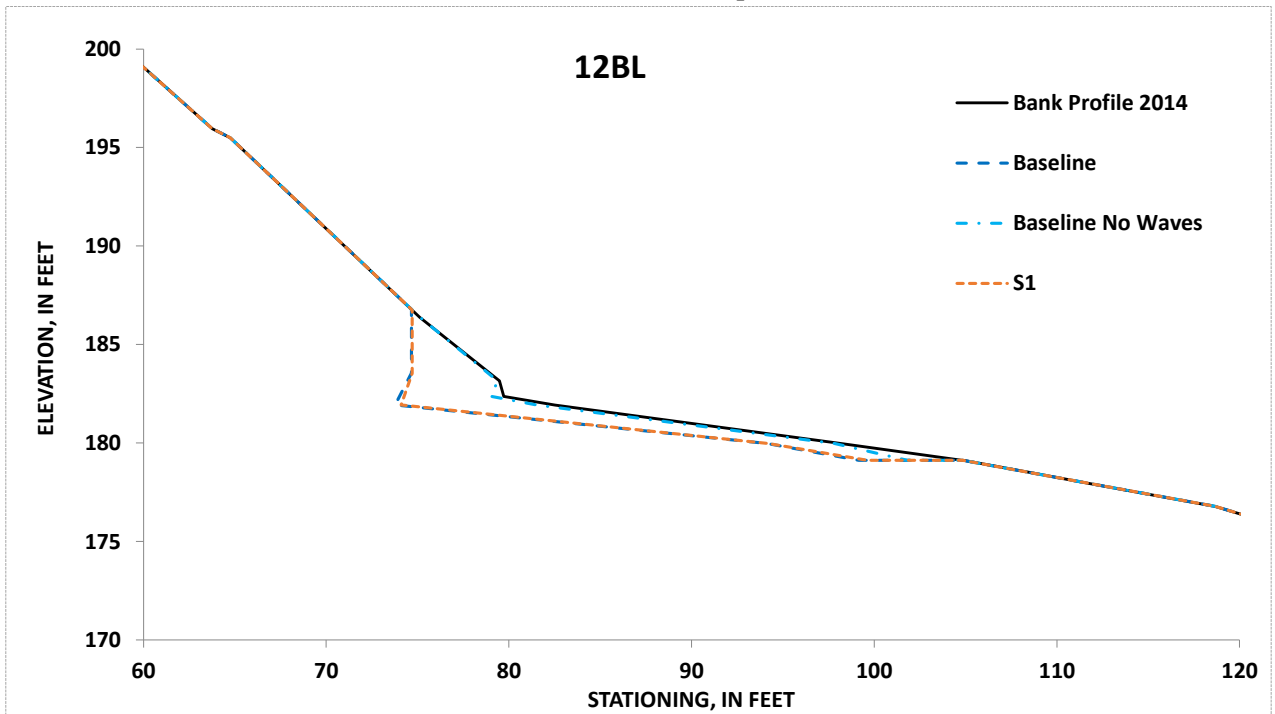
For Scenario 1, 2.15 ft³/ft/y of erosion occurred ([Figure 5.4.3.29-2](#) to [Figure 5.4.3.29-4](#)) resulting in about 3% of the total erosion (Note- while this site did show a small reduction in erosion between the BL and S1 Scenarios the total reduction in erosion is well below the measureable/significant rate of 0.161 ft³/ft/yr). With the lower variability in water surface fluctuations at this site we see a bigger wave influence. The Baseline Condition (Waves off) resulted in 0.239 ft³/ft/y representing about 89% of the total erosion, attesting to the important role of boat-generated waves in inducing erosion at this site. As Baseline Condition (Waves off) scenario illustrated a significant reduction in erosion, Scenario 1 was also run without the effects of boat waves. With waves off the model run for Scenario 1 resulted in 0.194 ft³/ft/y. Clearly, boat waves are significant for all Operational scenarios and, therefore, protection of the bank-toe region could limit further bank erosion at this site.

Figure 5.4.3.29-2: Simulated, future unit-erosion for the Baseline Condition and Scenario 1 (with boat waves on) at site 12BL for the period 2000-2014

Figure 5.4.3.29-3: Simulated, future unit-erosion for the Baseline Condition (with boat waves on and off) and Scenario 1 at site 12BL for the period 2000-2014

Figure 5.4.3.29-4: Simulated, future erosion for the Baseline Condition and Scenario 1 (with boat waves on) at site 12BL for the period 2000-2014. Zoomed in at area of erosion for illustrative purposes.

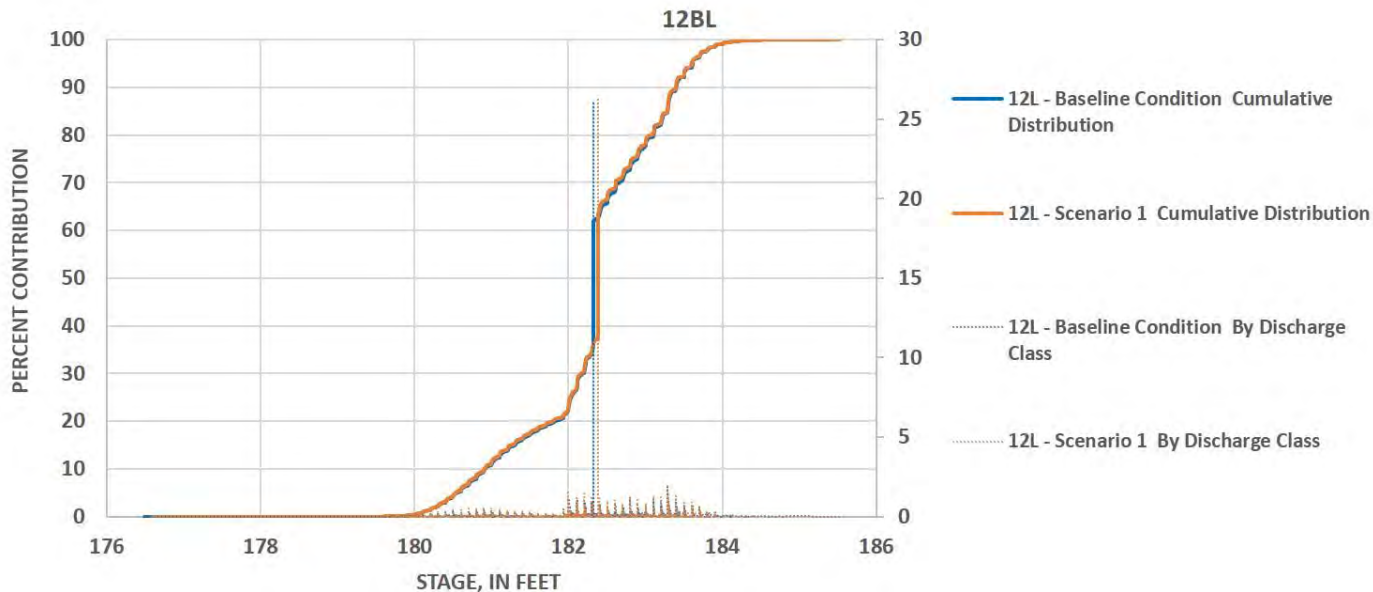
As a stage-discharge relation could not be developed for site 12BL, the high flow analysis is presented according to stage data only ([Figure 5.4.3.29-5](#)). Boat-generated waves are a dominant factor in erosion rates at this site producing 89% of the erosion. While moderate to high flow erosion rates could not be determined for this site, based on the trend throughout the impoundment in reaches 2, 3, and 4 it is likely that moderate to high flows still play a contributing role in total erosion.

Figure 5.4.3.29-5: Simulated, percent contribution of total erosion by stage for the Baseline Condition and Scenario 1 at site 12BL for the period 2000-2014. As no stage-discharge relationship could be developed, stage was used.

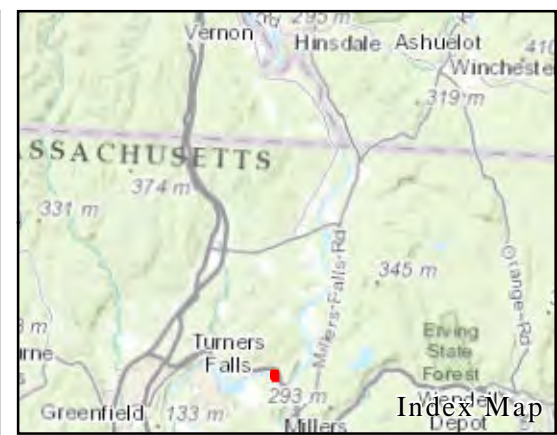
Recirculation corresponds with location of King Philip's Abyss.

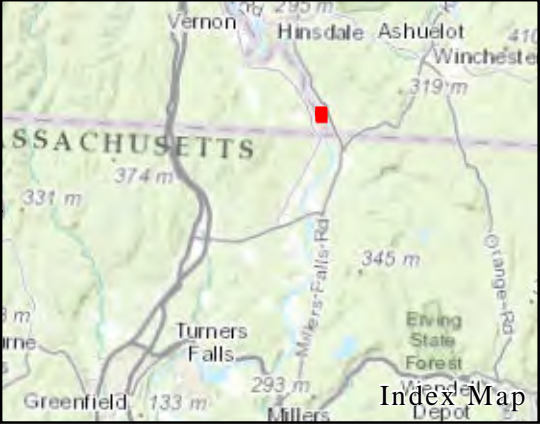
Recirculation dissipated with higher flows.

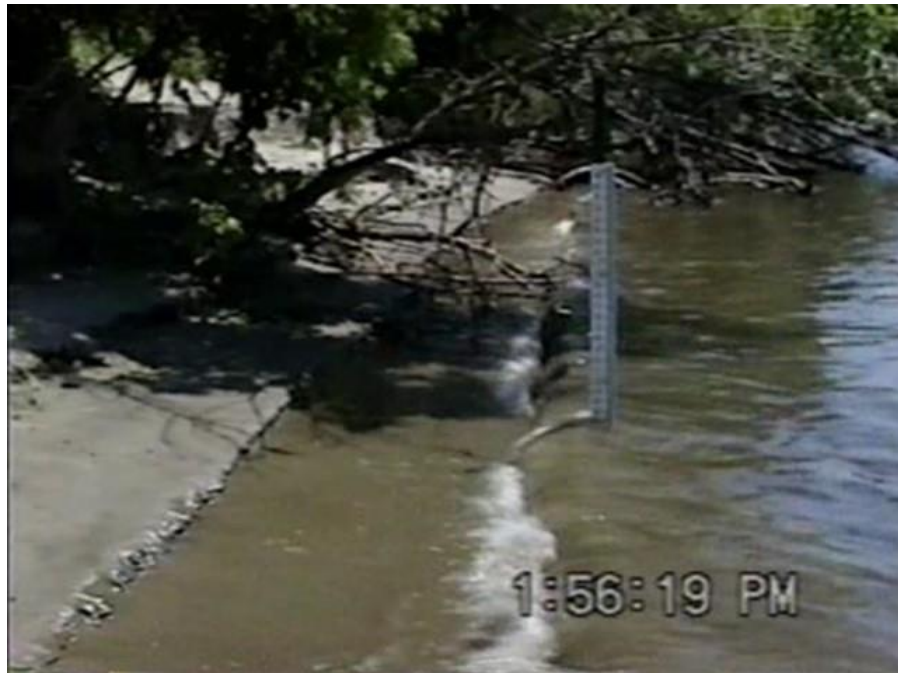
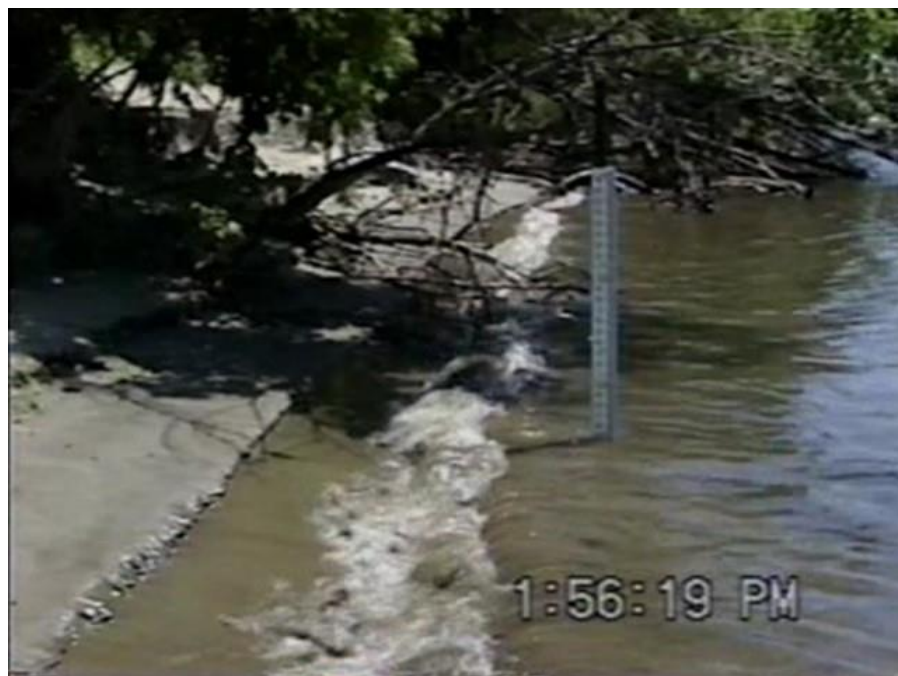
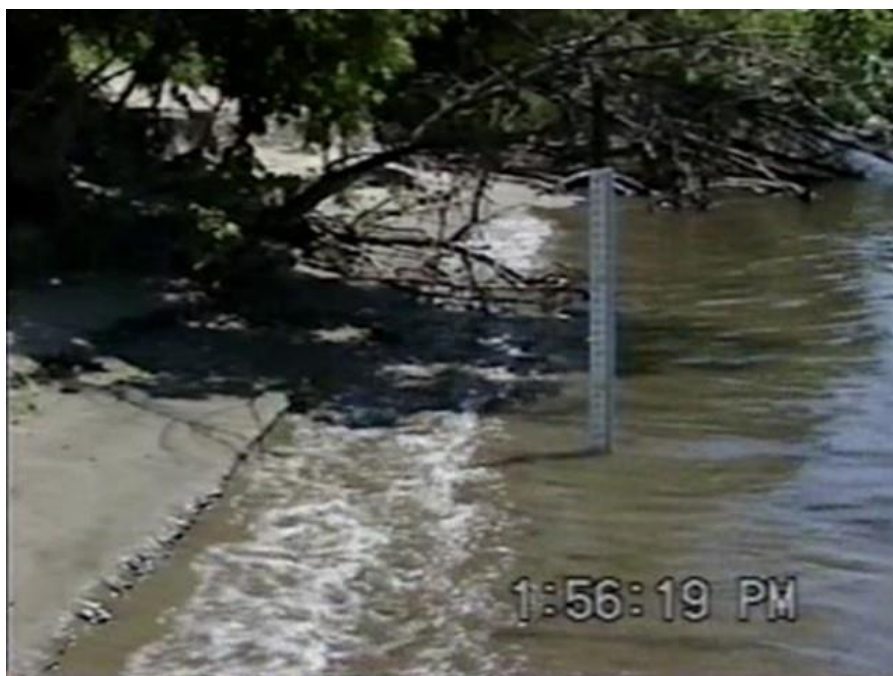
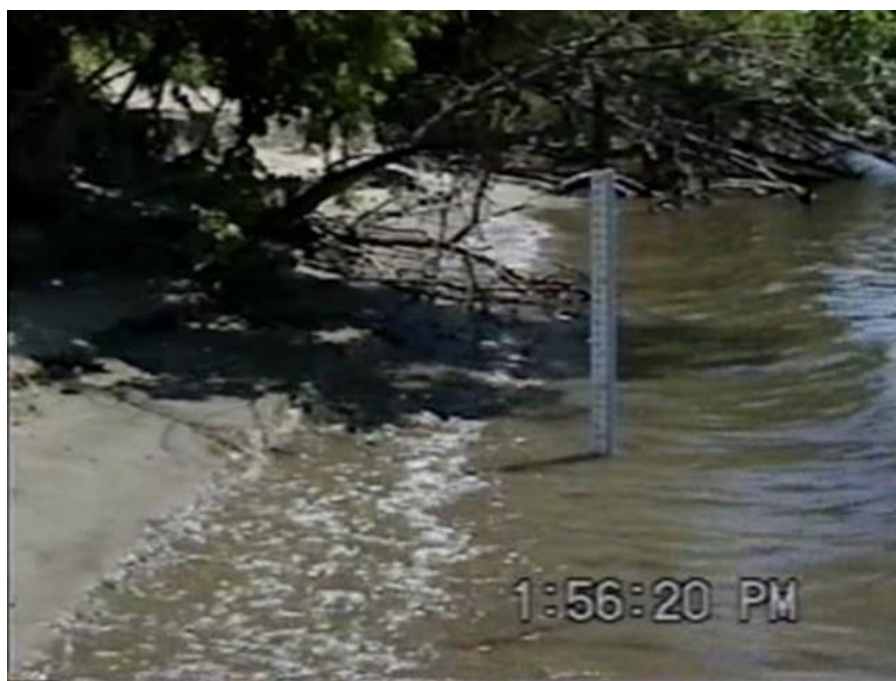
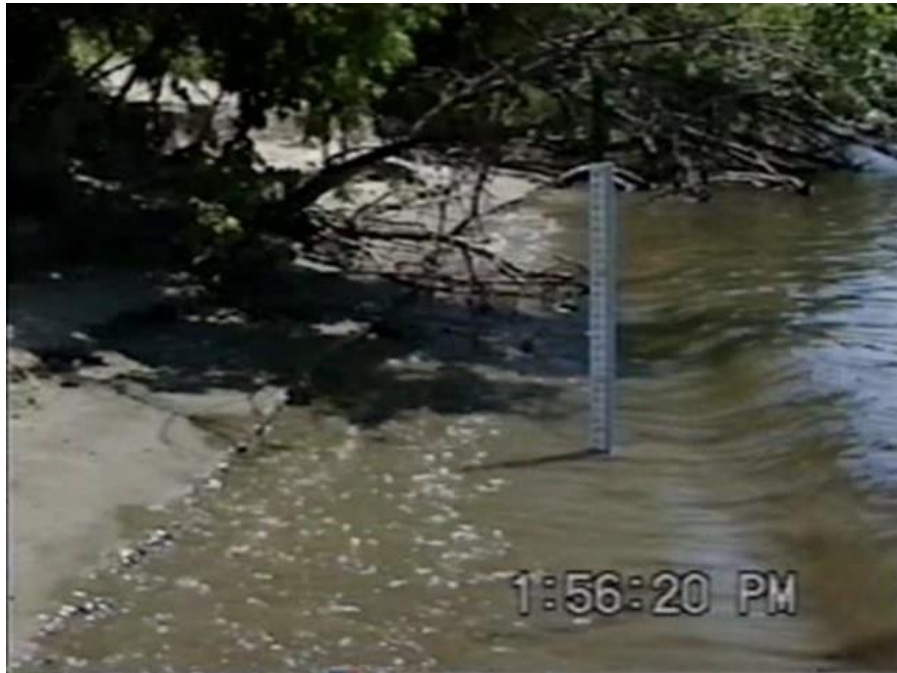
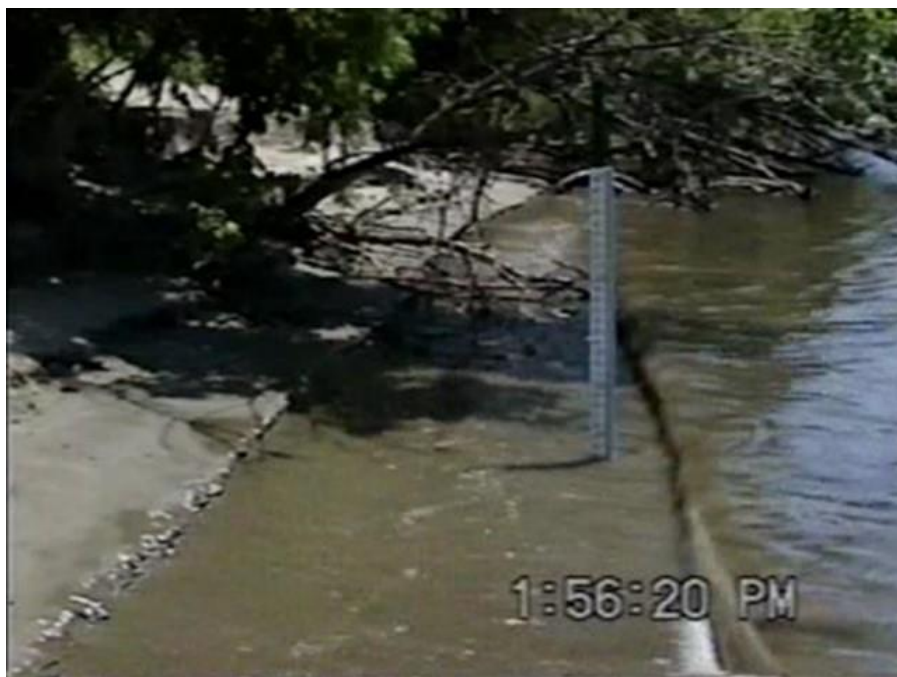
Figure 5.5.3-2a: Boat Wave Data Collection, July 1997

A series of six photos showing the sequence of a wave impacting the lower riverbank over a period of about 2 seconds is found in [Figure 5.5.3-2a](#) through [c](#). Given that the general water level that day was on the lower riverbank, as the waves moved towards the bank they would break on the lower bank and erode a short notch into the bank. As each progressive wave would impact this small notch, some of the vertical face would frequently break off and collapse onto the beach where the water would move sediment particles back down the beach where they would generally deposit. During these low flow conditions the downstream velocity of the flow was negligible so no significant downstream transport of the detached and mobile sediment occurred. Even during this period of relatively low flow and water surface elevation, there was evidence of larger notches cut by the waves in the transition area between the lower and upper riverbanks ([Figure 5.5.3-3](#)).

When the water level is on the lower bank (beach) and boat waves occur, erosion limited in size and damage to the overall riverbank occurs (as shown in [Figures 5.5.3-2 a](#) through [c](#)). Under conditions with waves breaking on the beach, erosion is typically on the order of an inch or two high and may move on the order of an inch up to a foot in an episode of erosion up the beach. The sediment movement, in this scenario; is from wherever on the beach the wave breaks, down to lower portions of the beach. Since the waves break on the beach, the upper riverbank is not undercut to any significant degree.

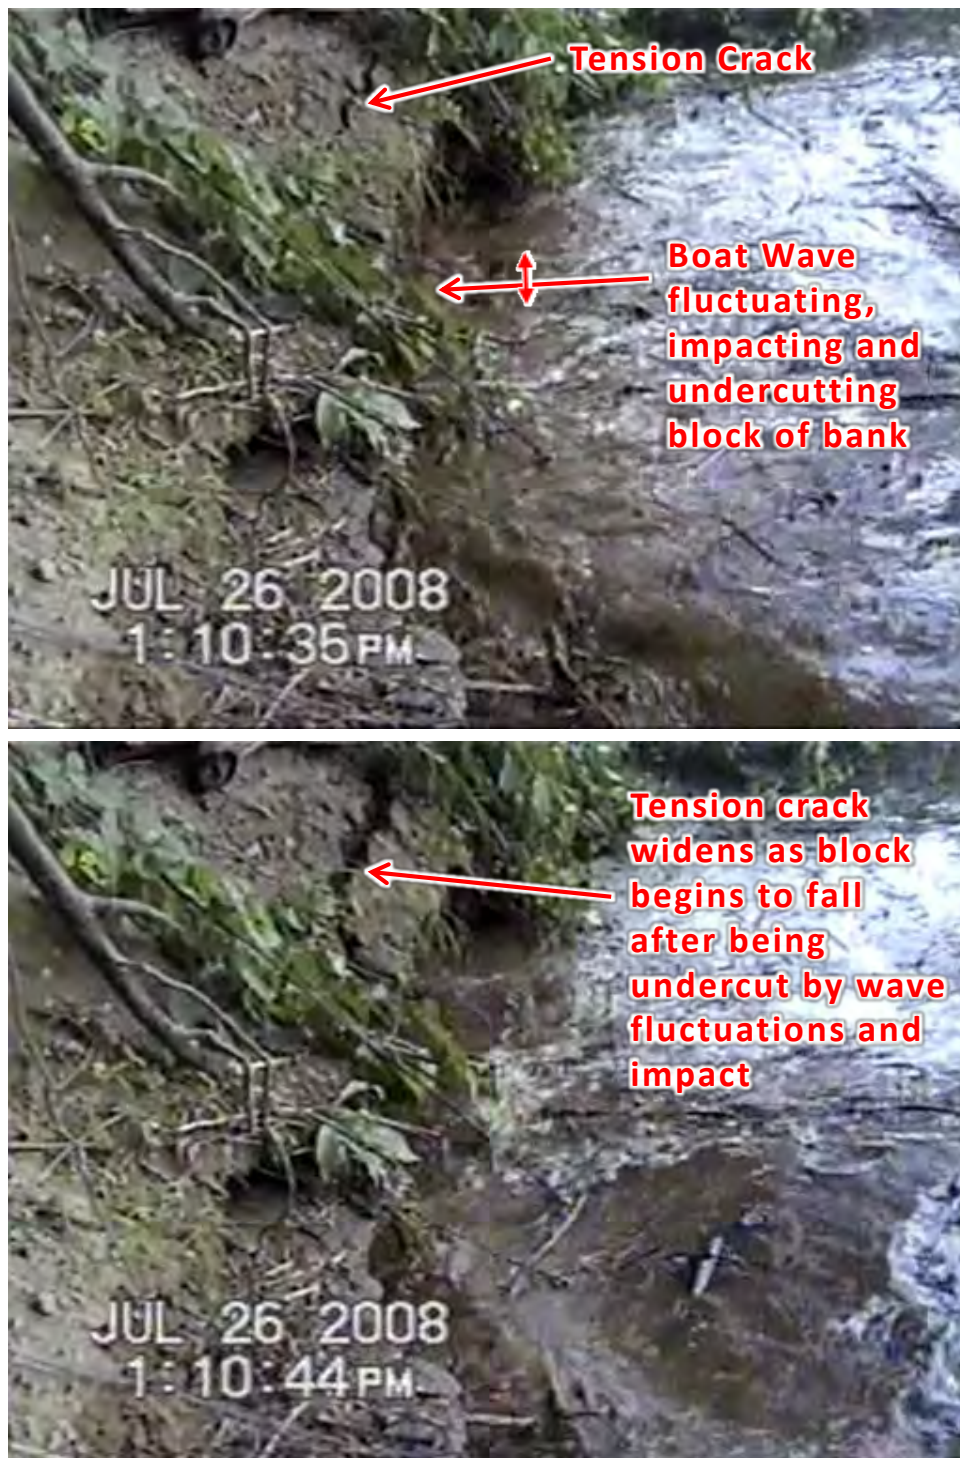
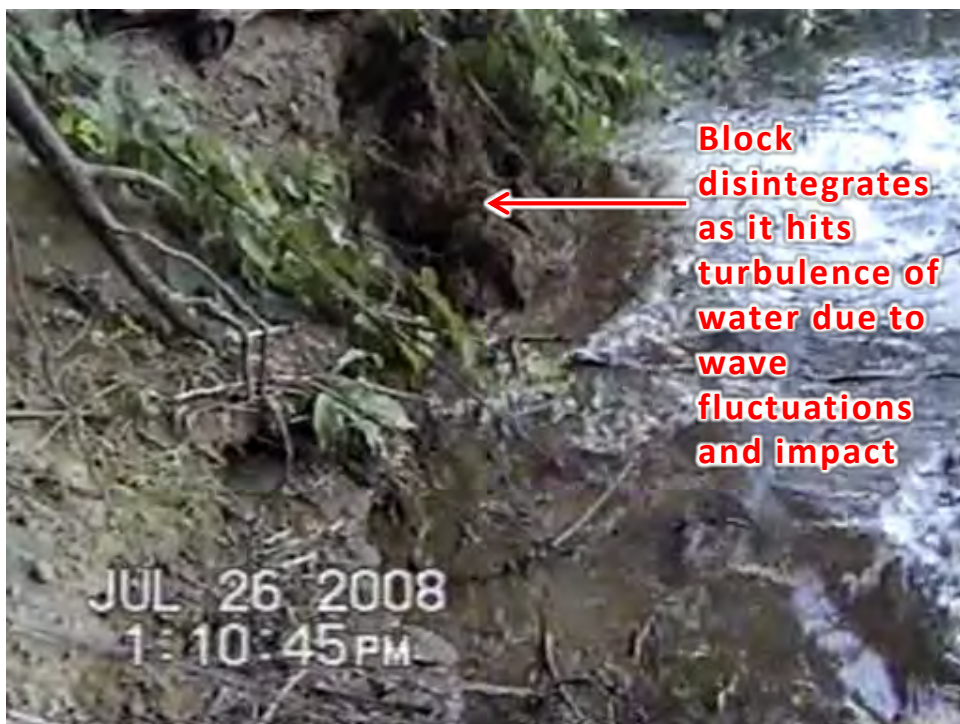
Figure 5.5.3-6a: Boat Wave Erosion Sequence

The boat traffic was relatively light for a weekend in July due to cool temperatures and occasional rain. Despite the light boat traffic, significant erosion was observed due to boat waves. [Figures 5.5.3-6a](#) and [5.5.3-6b](#)) show a sequence of boat wave impact and erosion photos captured from the video taken these two days. This sequence of photos covers a period of about 10 seconds. The first photo in the sequence shows that a piece of riverbank about 4 to 6 inches in thickness and about a foot or more in height was being undercut by waves at its base had begun to crack loose from the riverbank. As the waves continue to impact the base of this riverbank the crack widens and then the piece falls into the turbulent water. Because the water level was on the upper bank, boat waves undercut the bank and easily caused pieces of bank to fail. As a result, erosion was quite significant over this two day period at the observation site. Hours of video tape are available showing the significant and progressive erosion that resulted from boat waves that impacted the upper bank during a moderately high flow event in July 2008. During these two days, no significant erosion was observed due to the current or the slow rise and fall of the water surface. Significant erosion was observed consistently, however, whenever boat waves impacted and undercut the riverbank. This can be clearly seen in the DVD documenting the study.

On the other hand, when the water level is on the upper bank, boat waves break against a much steeper slope on the upper bank and waves, under this scenario; can and do cause significant erosion and damage to the riverbank. As shown in [Figures 5.5.3-6a](#) through [b](#), blocks of sediment on the order of a foot high and several inches back into the bank are broken loose from the upper bank which then fall and disintegrate into individual particles as they hit the turbulent water below. A portion of this eroded material may stay on the upper beach, but when flows are high, the velocity of flow is correspondingly higher than low flow conditions and some of the sediment that is produced by wave action on the upper bank is then transported downstream and away from the beach. Again, no direct erosion of the upper riverbank was observed due to the current or the slowly rising or falling water levels. Significant erosion was observed whenever boat waves impacted and undercut the upper riverbank.

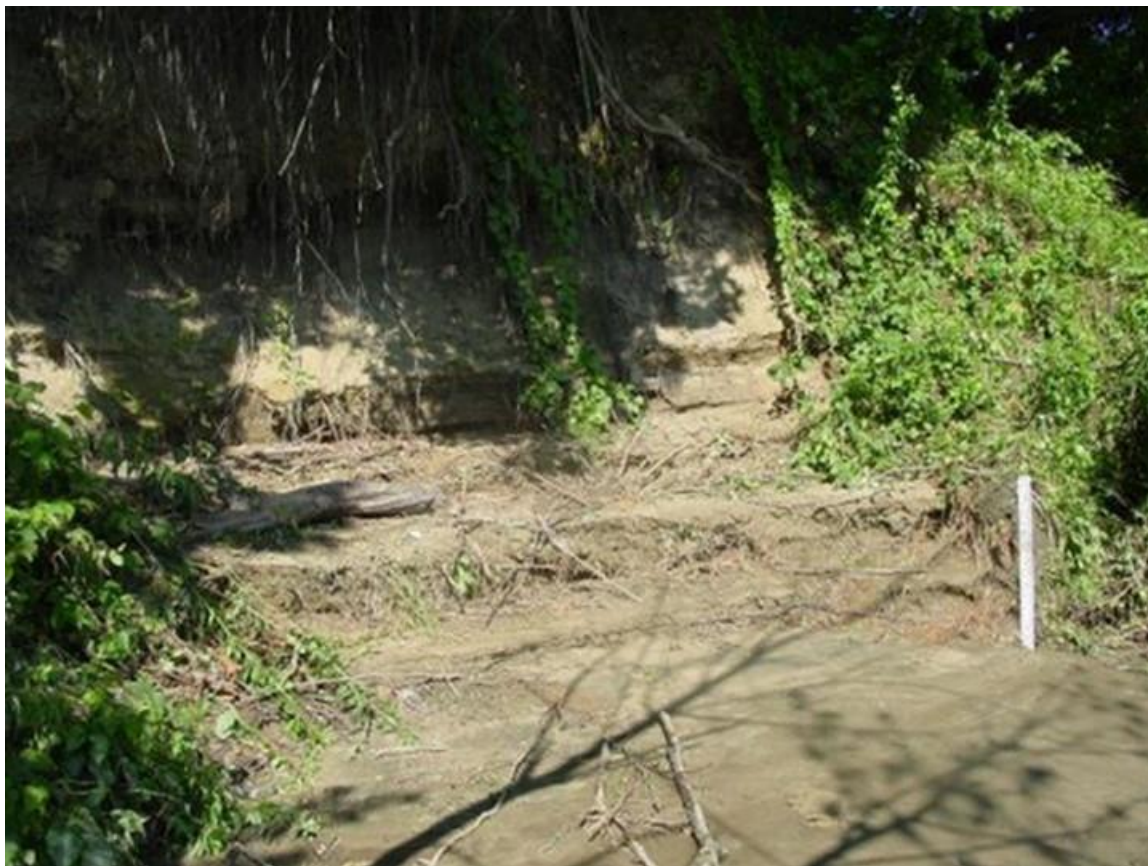
After the water had receded further, a photograph of this same area shows that about 4 vertical benches were eroded into the riverbank as waves impacted the bank at different levels as the water level varied with flow ([Figure 5.5.3-7](#)). Note that tree roots are observed dangling beneath the overhanging bank at the top of the photograph. It is apparent that other higher flow events have eroded this riverbank resulting in the overhanging bank. A view from a little farther out shows the notches cut into the riverbank by boat waves and the hanging roots from the undercut tree above the portion of the bank recently impacted by boat waves ([Figure 5.5.3-8](#)).

Figure 5.5.3-7: Example of Boat Wave Erosion

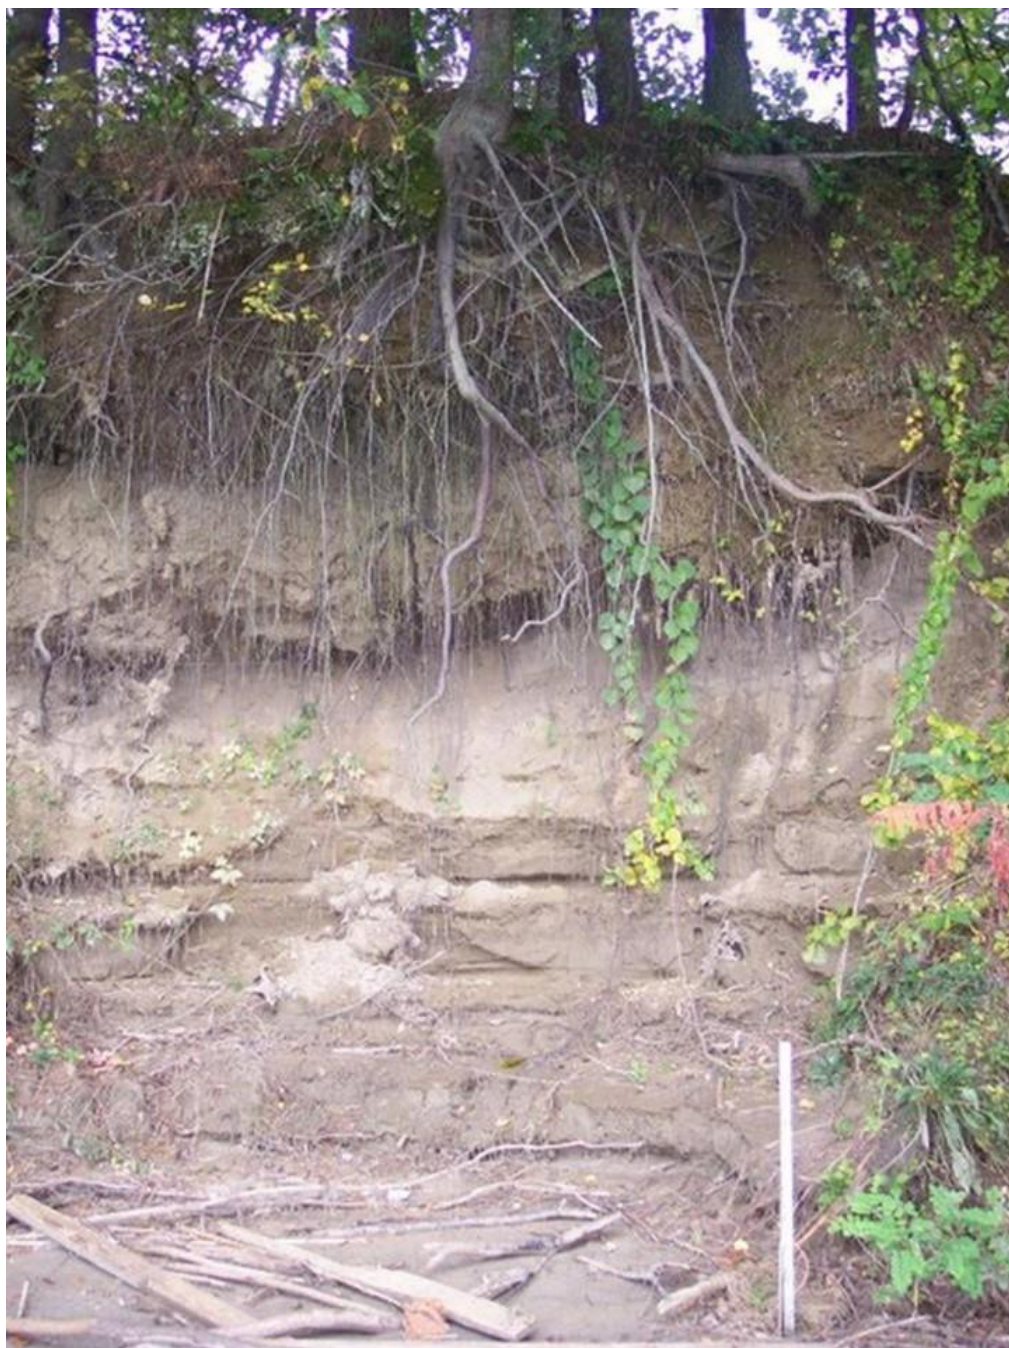
Figure 5.5.3-8: Example of Boat Wave Erosion

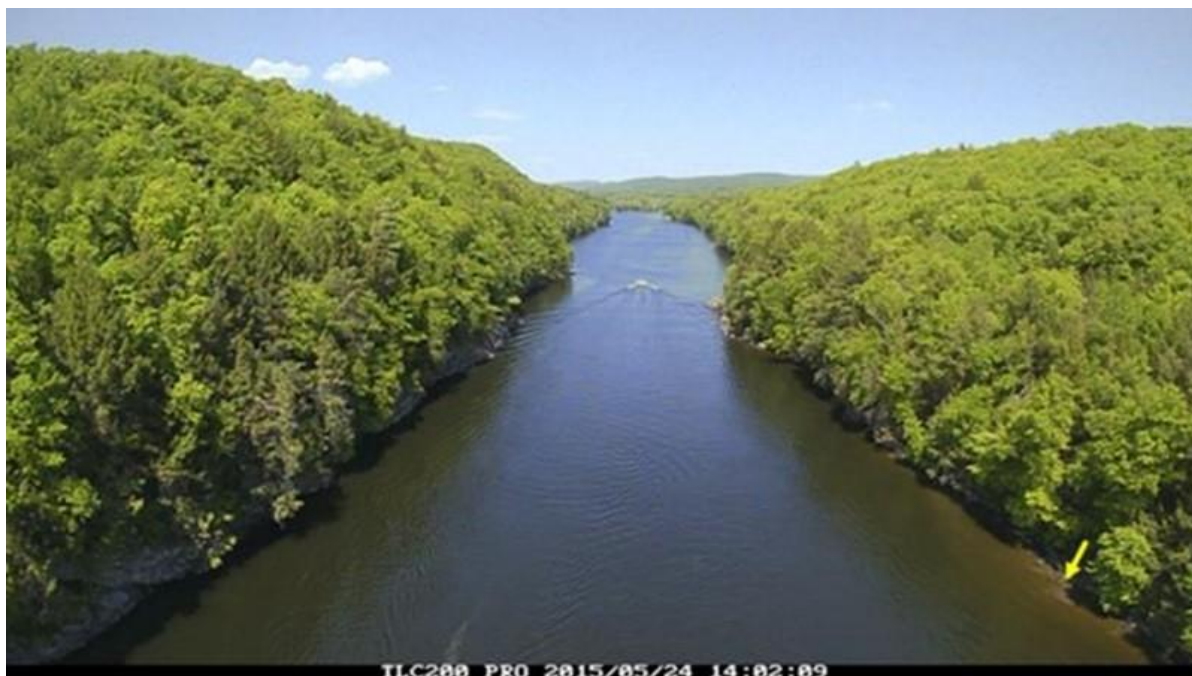
In 2015 detailed boat traffic and wave data were collected as discussed in [Section 4.2.8](#). As part of this data collection effort, cameras were placed on three bridges throughout the TFI to document boat traffic over time. Images from this effort provide further perspective into the fact that boat waves cause some erosion along the riverbanks of the TFI. [Figures 5.5.3-9](#) through [5.5.3-12](#), taken from the French King Bridge, provide evidence of the impact boat waves can have on erosion. As illustrated by the arrow in the figures, the waves breaking on the shore from the recently passed boat appear to result in a sediment plume emanating from the riverbank. As time progresses so too does the size of the plume.

Figure 5.5.3-9: Plume of Suspended Sediment Begins from Bank Erosion Induced by Waves

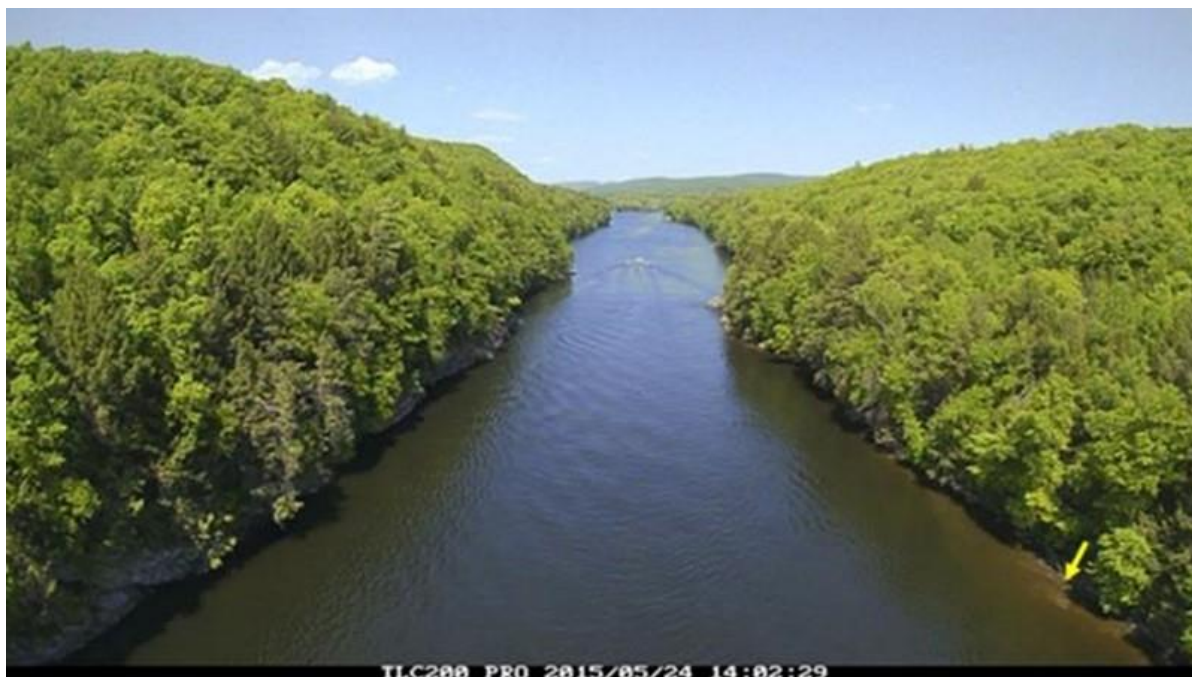
Figure 5.5.3-10: Suspended Sediment Plume Expands

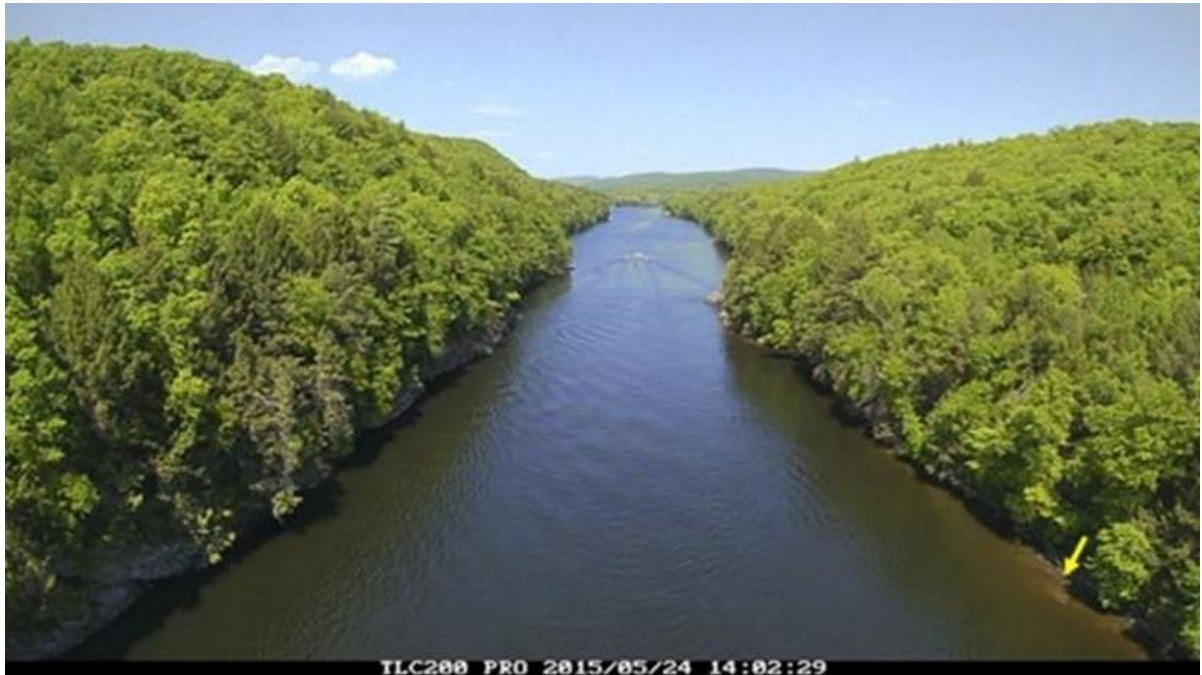
Figure 5.5.3-11: Further Expansion of Suspended Sediment Plume

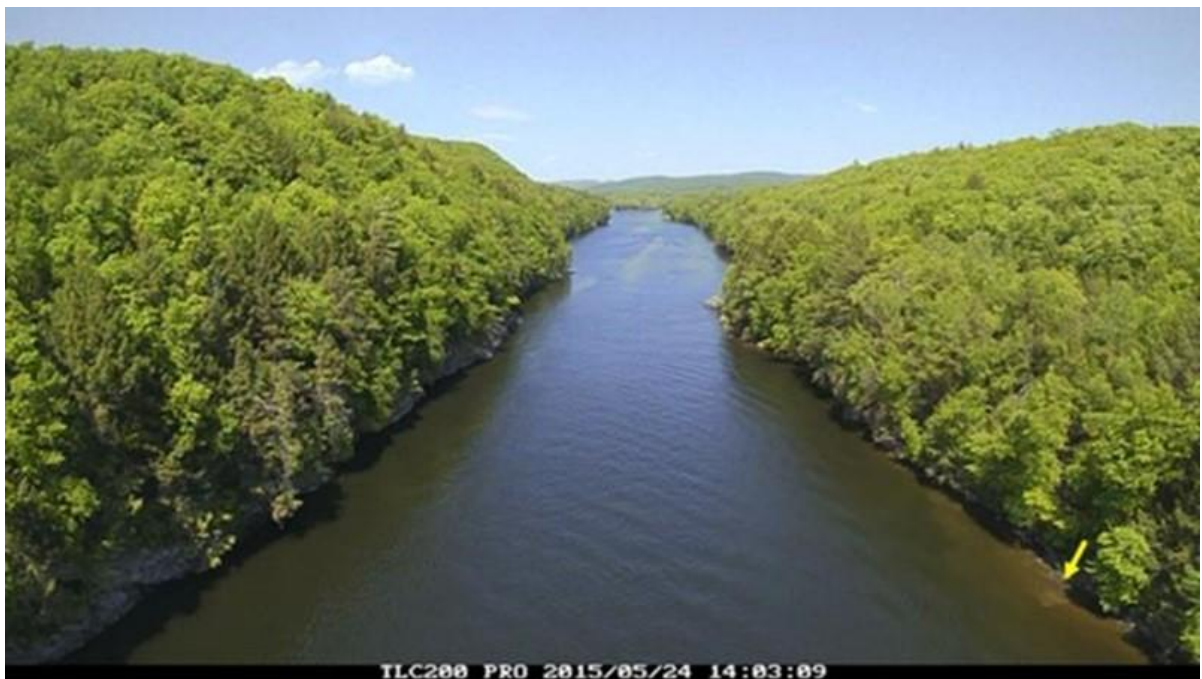
Figure 5.5.3-12: Suspended Sediment Plume Expands Farther Out From Banks
