Relicensing Study 3.1.2

**Northfield Mountain / Turners Falls
Operations Impact on Existing Erosion and
Potential Bank Instability
Study Report**

Volume II – Main Report

**Northfield Mountain Pumped Storage Project (No. 2485) and
Turners Falls Hydroelectric Project (No. 1889)**

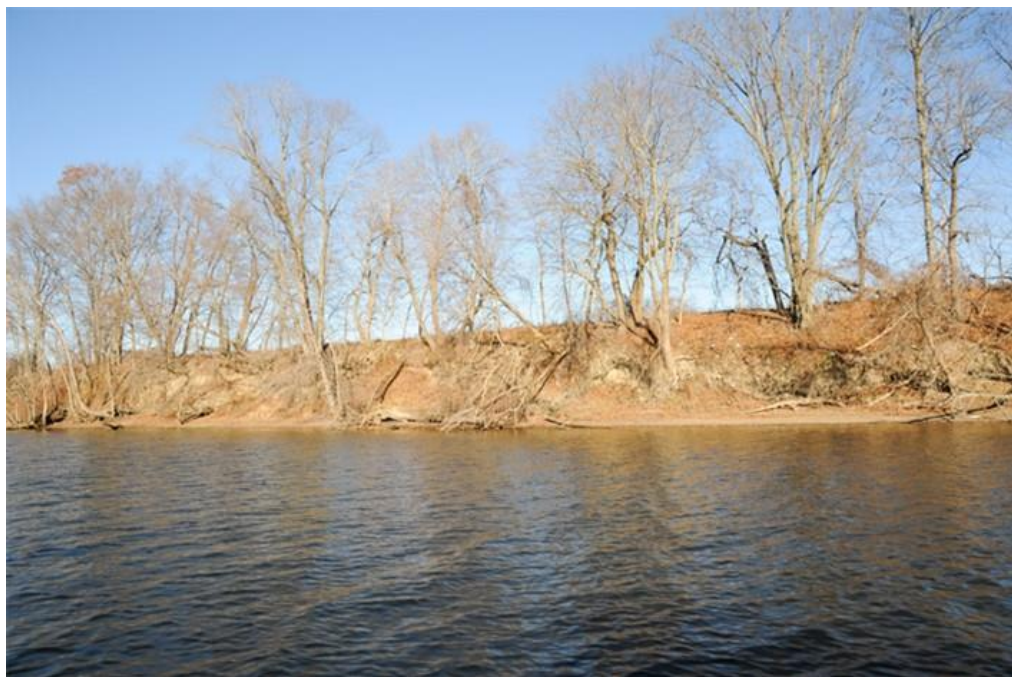
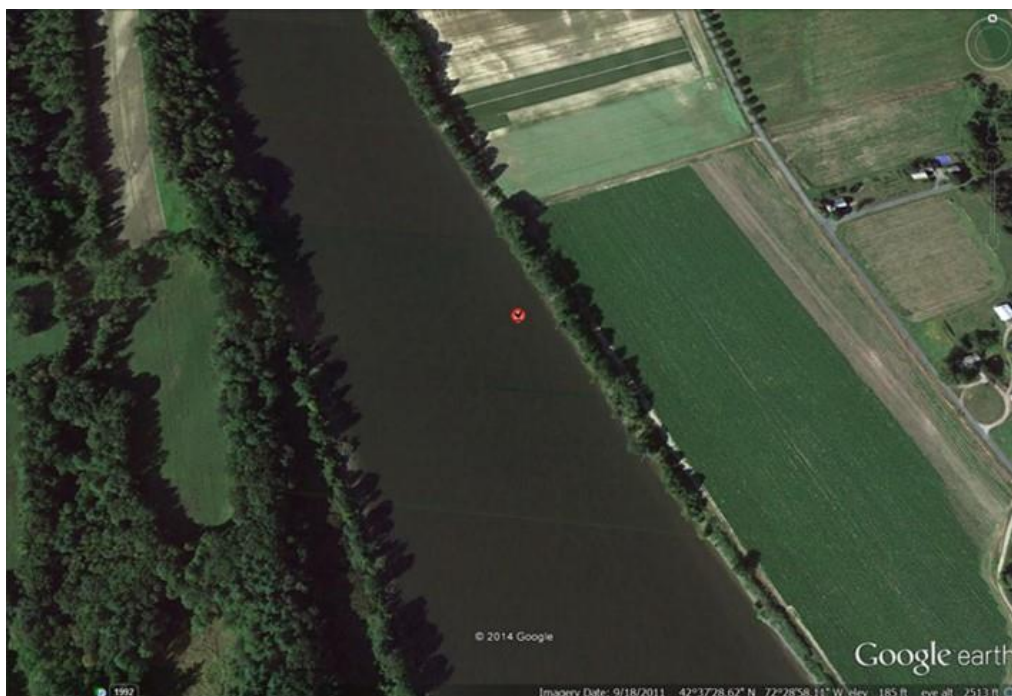
As observed in [Tables 5.5.4-1](#) and [5.5.4-2](#), 27.5% of TFI riverbanks were classified as either cropland or pasture with 38% of riverbanks exhibiting a riparian buffer less than 50 ft. Frequently riverbanks in areas with narrow or non-existent riparian buffers consist of steep to overhanging banks consisting of silty/sandy soils that are easily erodible unless sufficient vegetation is present to reinforce the soil and provide some buffering of hydraulic forces. An example of erosion that has occurred where the agricultural land-use exists can be seen in [Figure 5.5.4-3](#).

Figure 5.5.4-3: Erosion Adjacent to Agricultural Land-use

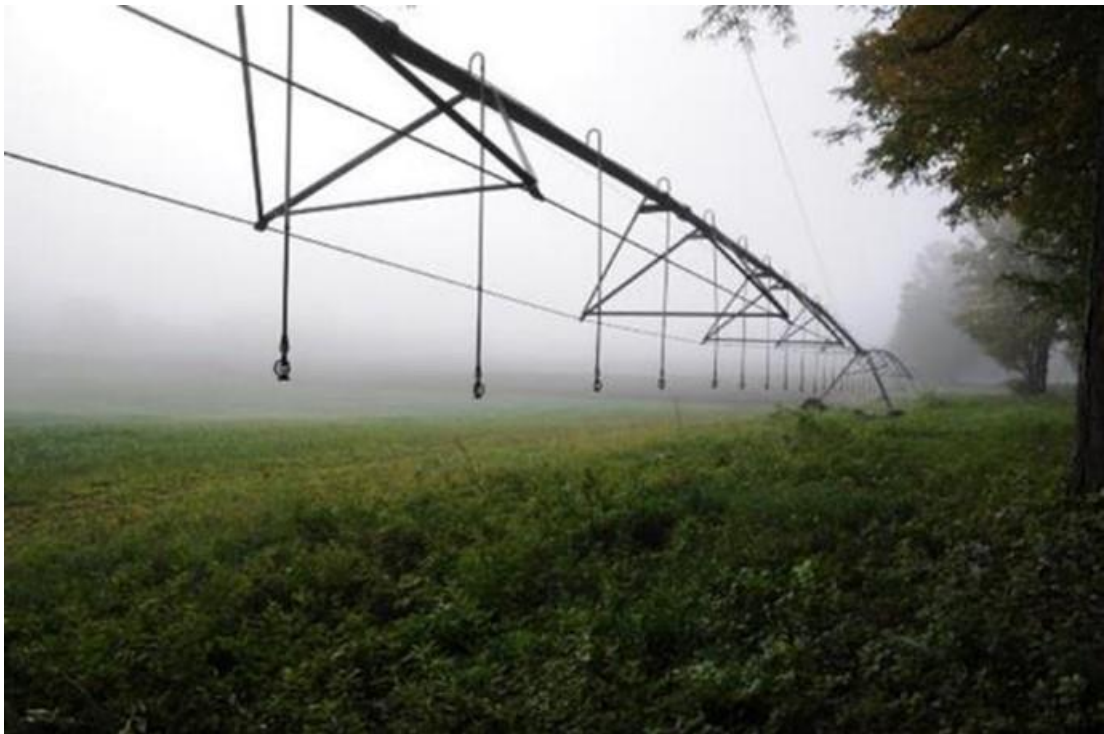
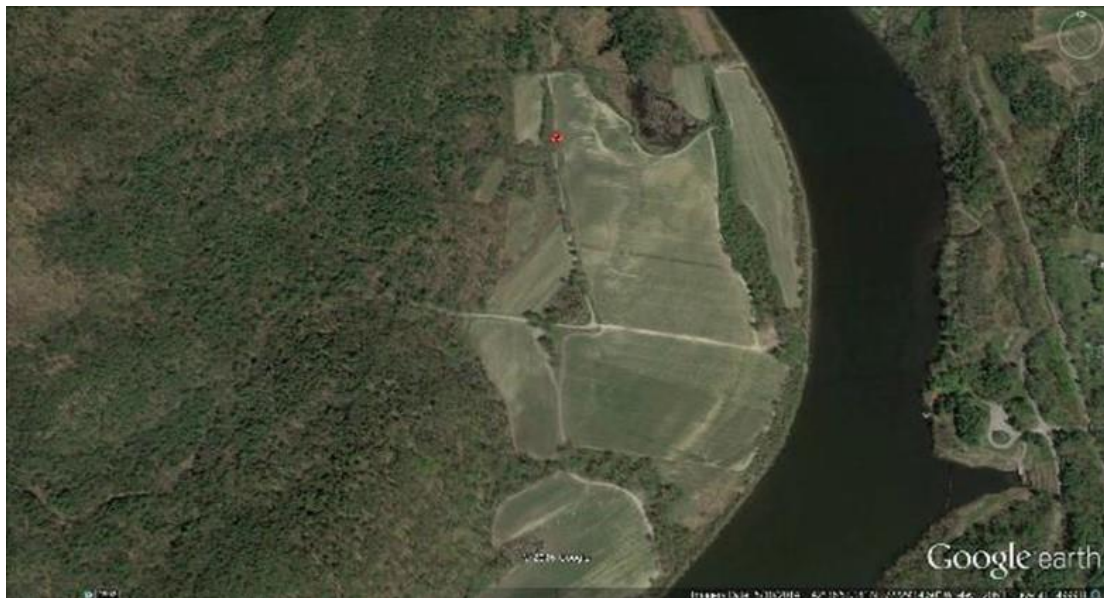
supplement rainfall which adds to wetter soil conditions. Some of the irrigation water provides water to crops and in this process a portion of the water goes to evapo-transpiration while some of it infiltrates deeper into the soil and flows back towards the river. Irrigation therefore increases soil moisture and the quantity of water that may seep through the banks which could adversely affect riverbank stability in these localized areas.

Figure 5.5.4-4: Irrigation on agricultural field adjacent to the Connecticut River and Location on Google Earth, Photo 48

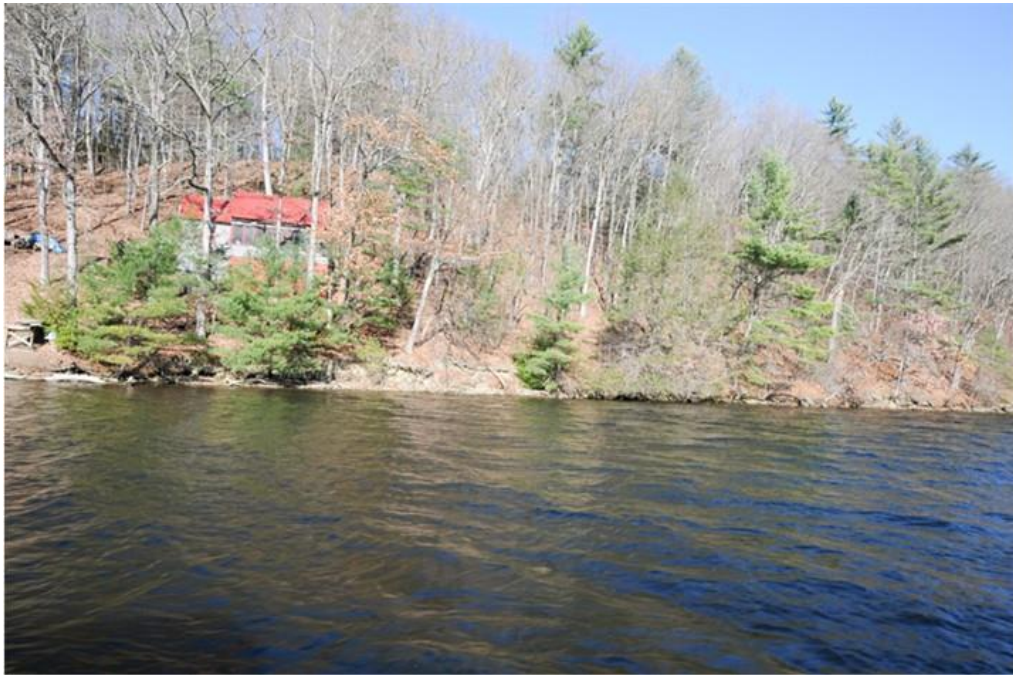
Figure 5.5.4-14: Erosion adjacent to seasonal Camp 2-W

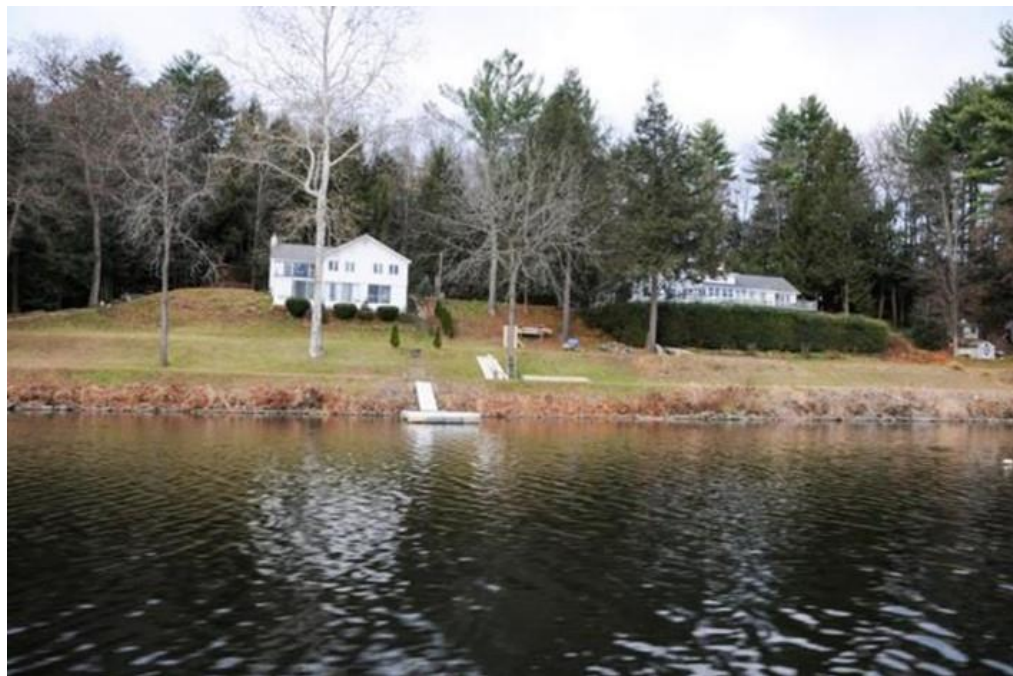
Figure 5.5.4-15: Development thinning or removing riparian vegetation

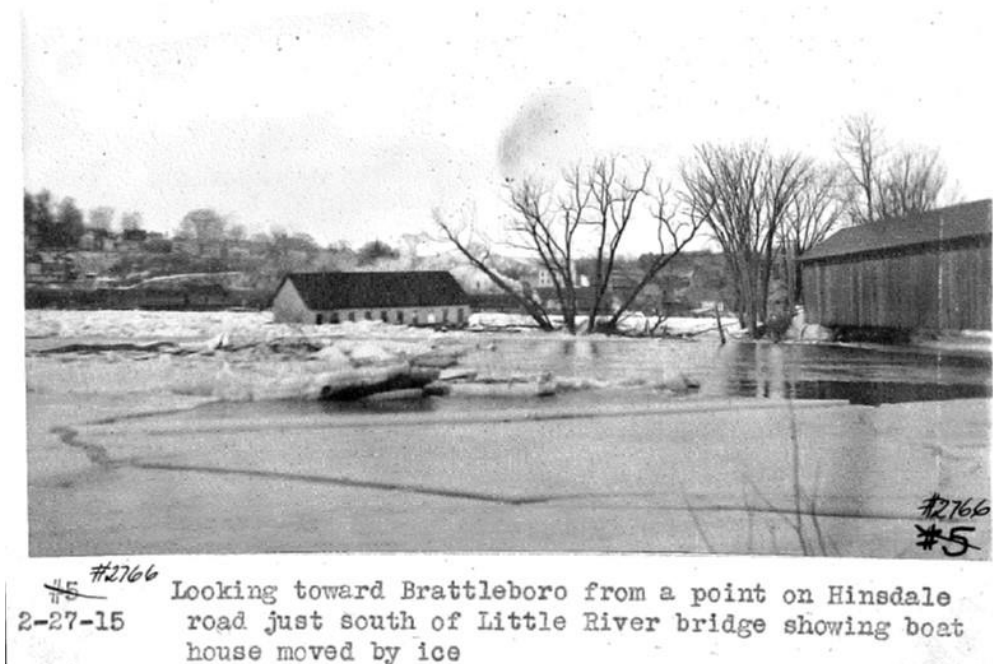
Much of the information contained in the TransCanada files consisted of photographs of ice jams, ice damage and erosion that occurred as a result of ice. One of the earliest set of photos from TransCanada showing ice was taken in 1915 at Brattleboro, VT ([Figure 5.5.5.2-1](#)), which is located in the Vernon Impoundment and just downstream of the West River confluence. Ice had moved a boat house adjacent to the river and ice had been forced over the riverbanks causing damage to trees as shown in [Figures 5.5.5.2-2](#) and [5.5.5.2-3](#).

Figure 5.5.5.2-2 Connecticut River Boat House Moved by Ice – 1915 (TransCanada)

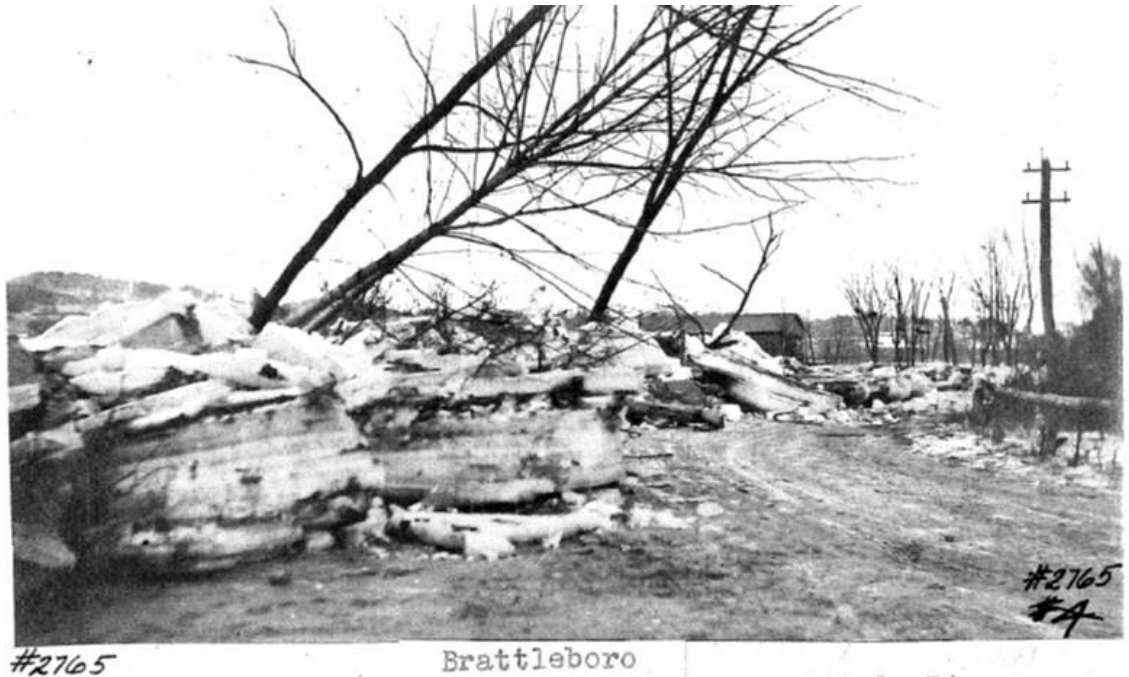
Figure 5.5.5.2-3 Ice along riverbanks showing damage to trees, 1915 (after TransCanada)

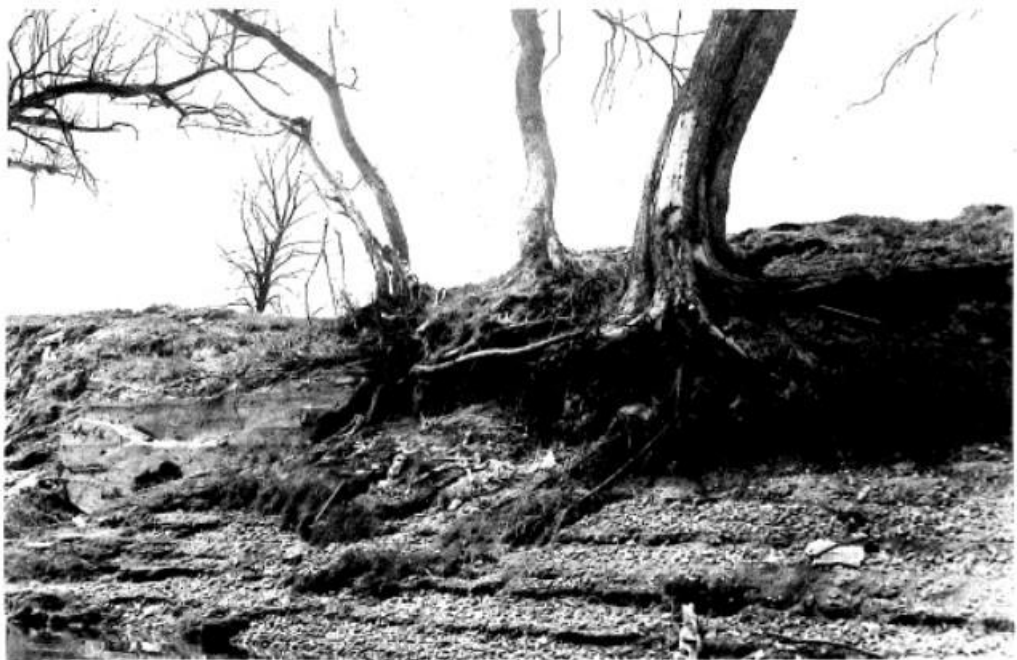
Figure 5.5.5.2-14 Connecticut River near Windsor, VT – April 24, 1946 (TransCanada)

Ice also has an adverse effect on riparian vegetation (as shown in previously referenced [Figure 5.5.5.2-14](#), [5.5.5.2-19](#), and [5.5.5.2-20](#)). As noted in R. Ettema, 2002:

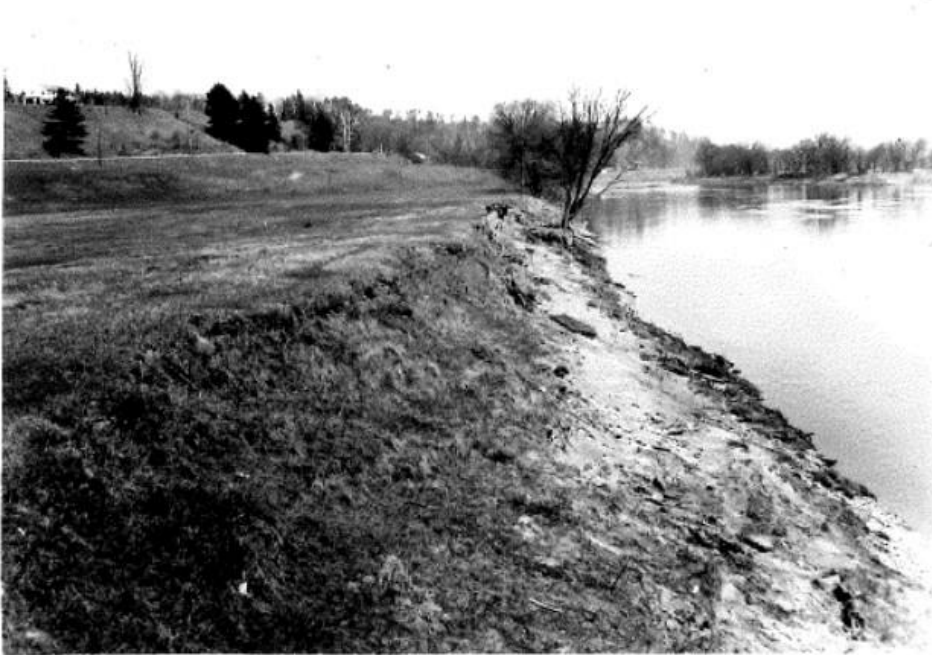
Figure 5.5.5.2-15 Connecticut River near Windsor, VT – April 24, 1946 (TransCanada)

Another phenomenon discussed in R. Ettema, 2002 was that ice may cause erosion to riverbanks by abrasion or gouging. The review specifically noted that “*during heavy ice runs resulting from ice-cover breakup or ice-jam release, large pieces of ice potentially may gouge and abrade channel banks. There exists significant evidence showing that ice runs may substantially affect riverbank morphology* (Marusenko 1956; Hamelin 1979; Smith 1979; U.S. 1983; Doyle 1988; Wuebben 1995; Uunila 1997)” (R. Ettema, 2002). Ice flowing downstream, or being forced into the banks, was clearly seen in historic and recent photographs shown previously in this report (see [Figures 5.5.5.2-1](#) through [5.5.5.2-4](#), [5.5.5.2-9](#) through [5.5.5.2-11](#), and [5.5.5.2-23](#)). Damage associated with these ice events can be observed in previous figures ([Figure 5.5.5.2-13](#), [5.5.5.2-15](#) through [5.5.5.2-18](#), and [5.5.5.2-22](#) through [5.5.5.2-23](#)).

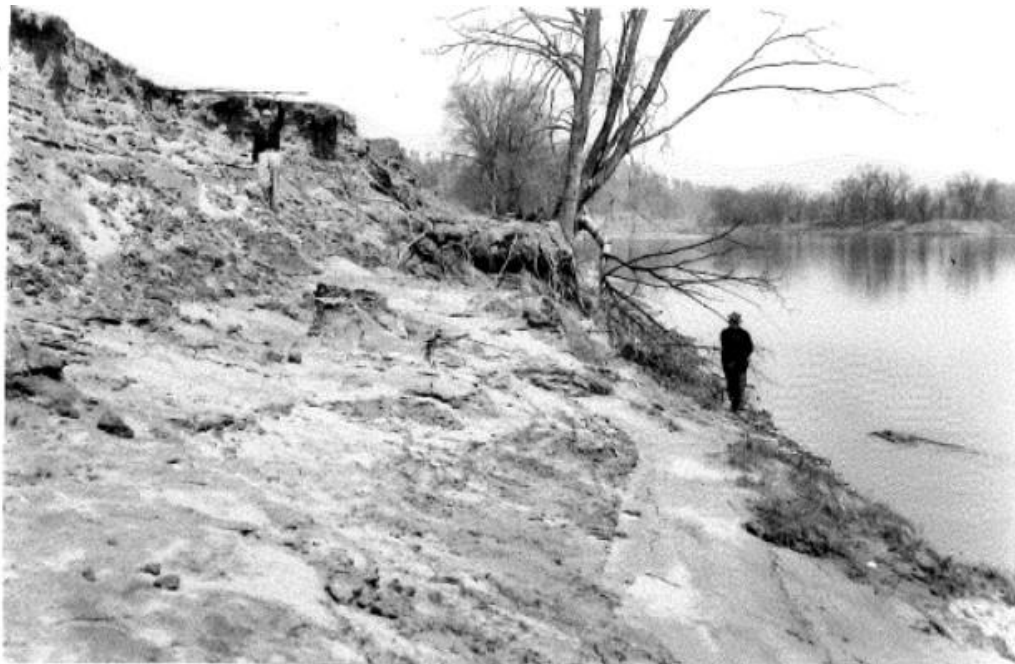
Figure 5.5.5.2-16 Connecticut River near Windsor, VT – April 24, 1946 (TransCanada)

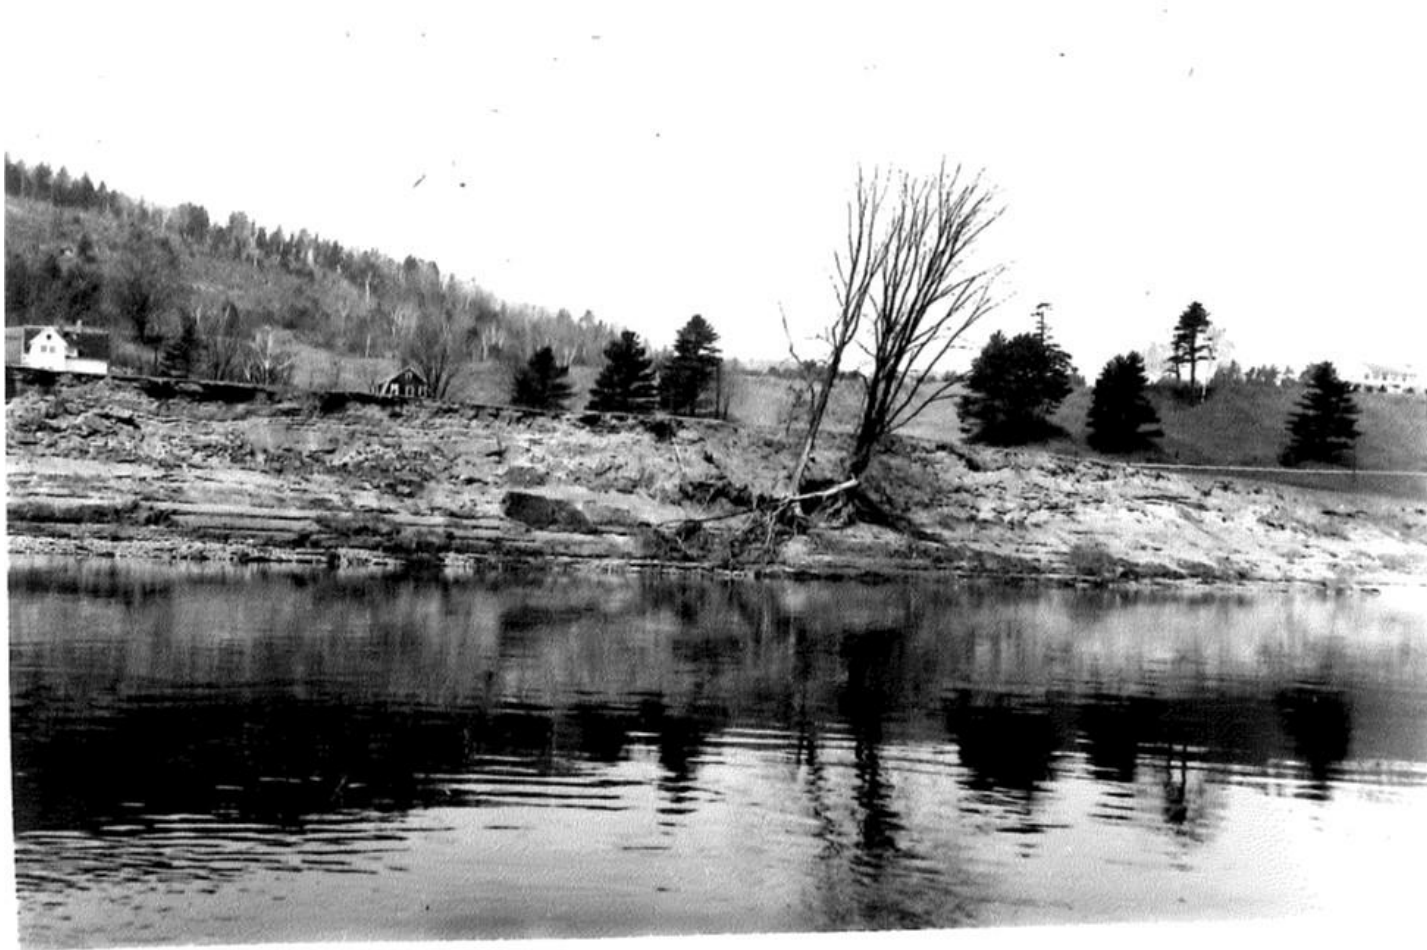
Figure 5.5.5.2-17 Connecticut River near Windsor, VT – April 24, 1946 (TransCanada)

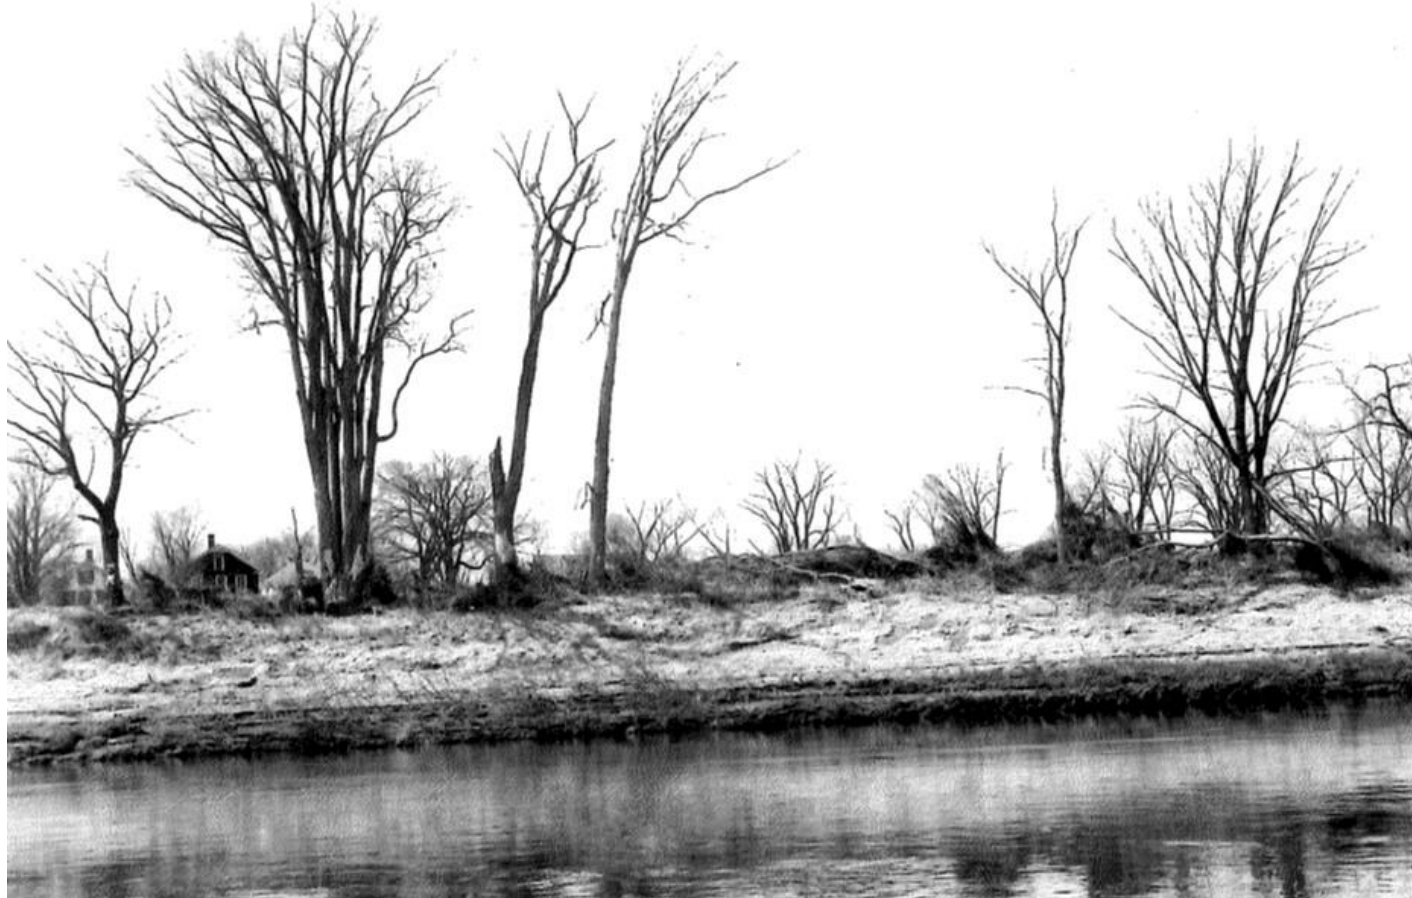
Figure 5.5.5.2-18 Connecticut River near Windsor, VT – April 24, 1946 (TransCanada)

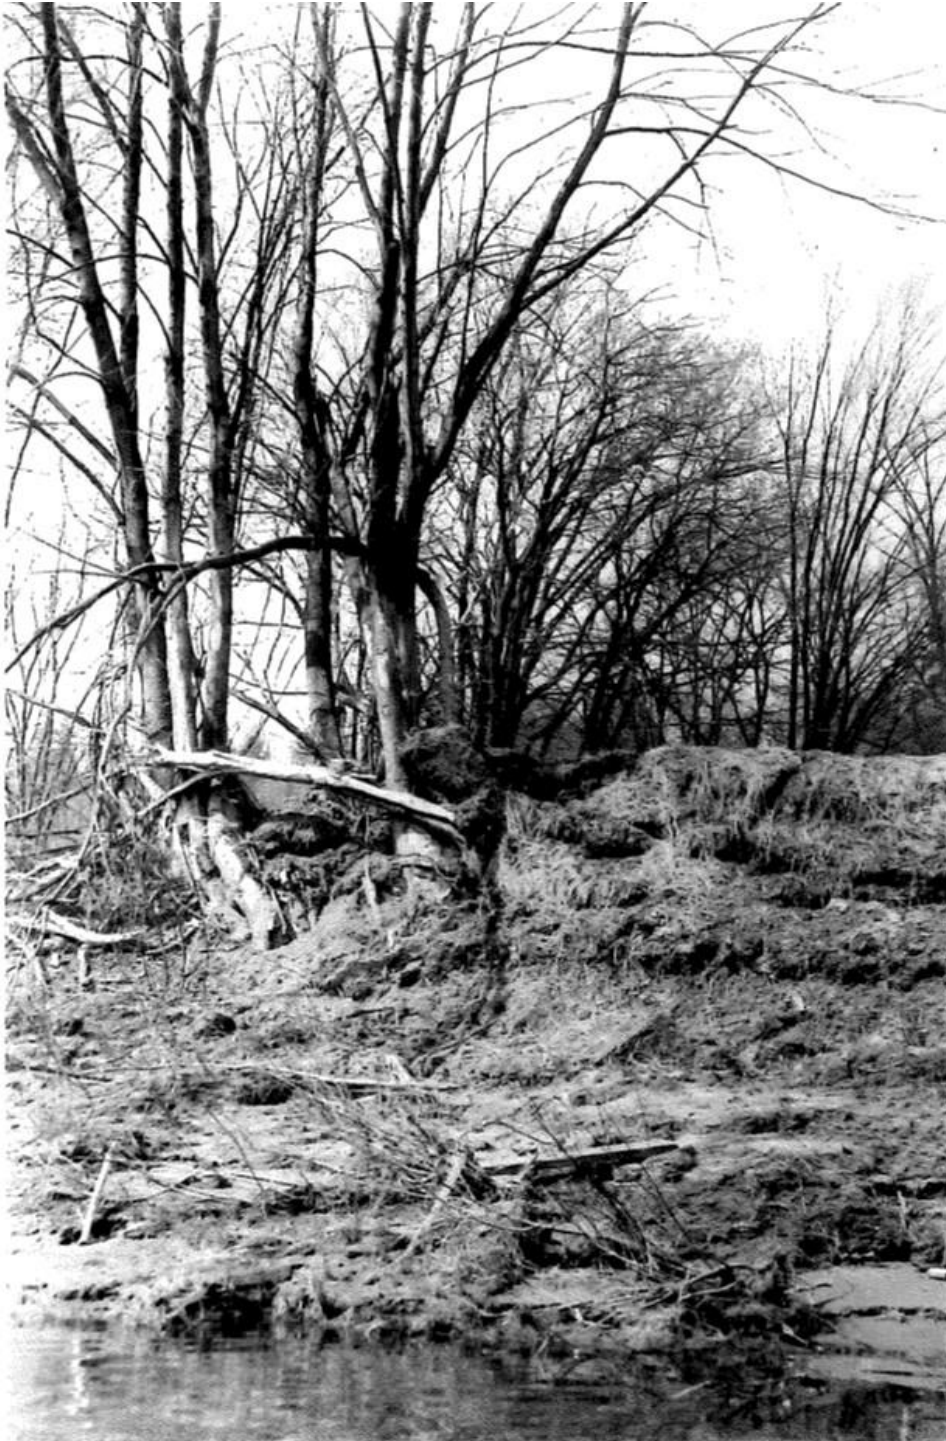
Figure 5.5.2-20 Connecticut River near Windsor, VT – April 23, 1946 (TransCanada)

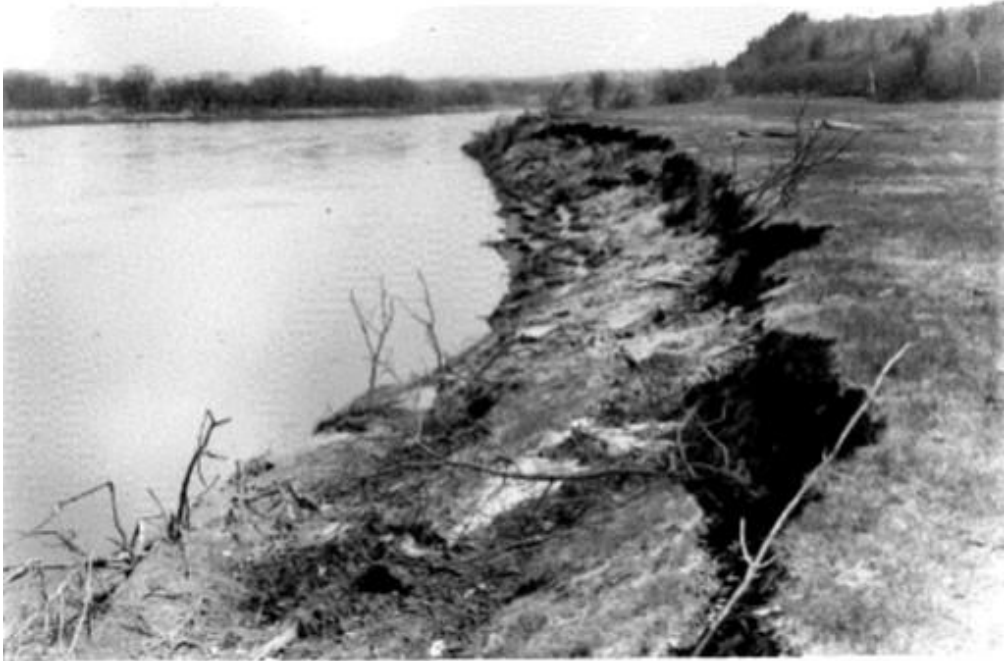
Figure 5.5.5.2-22 Connecticut River near Cornish, NH – April 25, 1946 (TransCanada)

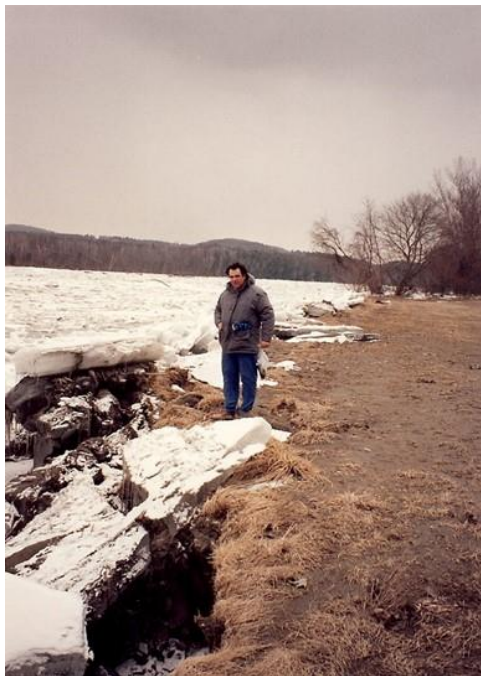
Damage to riverbanks near Cornish, NH in 1946 look very similar to what was observed farther downstream in the Bellows Falls Impoundment in the study conducted by Simons & Associates, [1992](#), "*Analysis of Bank Erosion at the Skitchwaug Site in the Bellows Falls Pool of the Connecticut River.*" The destruction of vegetation and the jagged nature of the top of bank in 1946 ([Figure 5.5.5.2-22](#)) following the ice event that year look similar to the lack of vegetation and ice pushed into the banks in 1992 ([Figure 5.5.5.2-23](#)). We believe the impacts at this location in 1992 were similar to that depicted in the 1946 photo.

Figure 5.5.5.2-23 Ice-Riverbank Interaction in Bellows Falls Impoundment – 1992 (TransCanada)

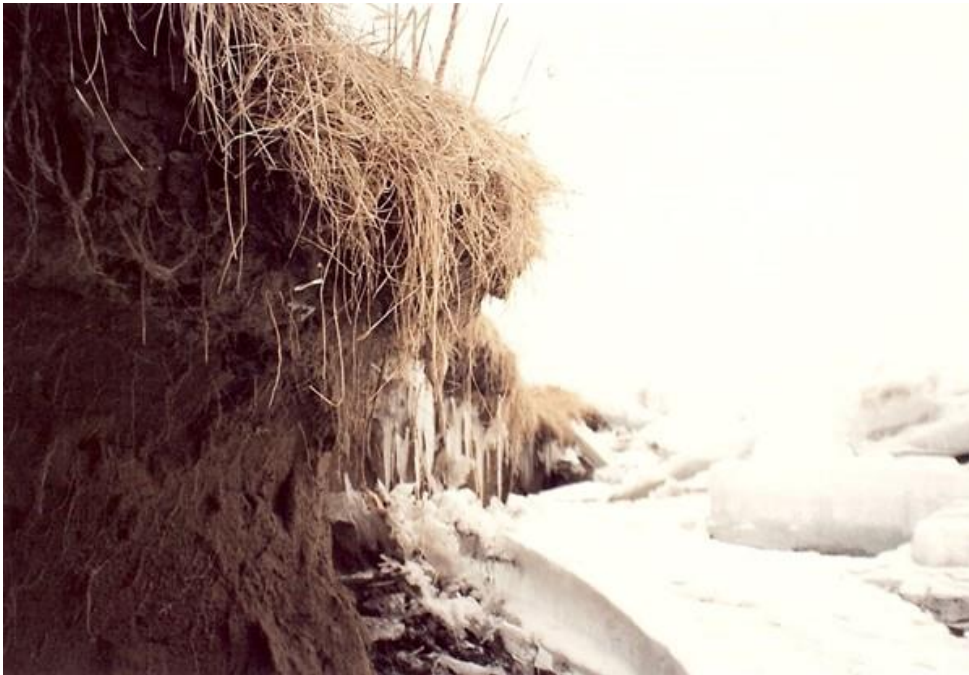
Figure 5.5.5.3-1 Icicles Hanging from Upper Bank

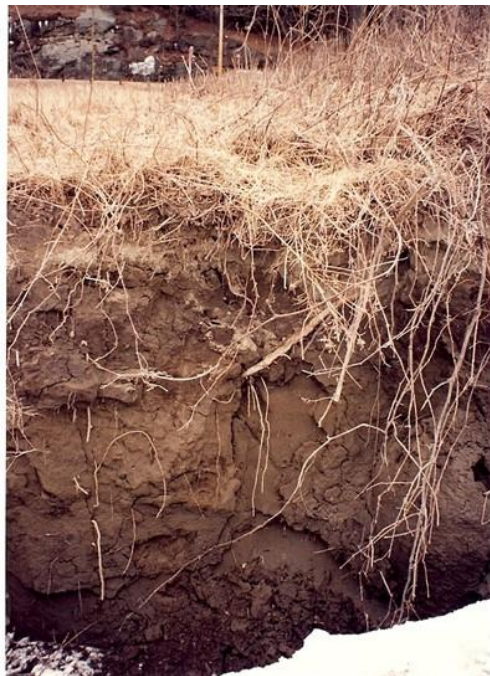
Figure 5.5.5.3-2 Cracks in a Riverbank Potentially Associated with Freeze-Thaw

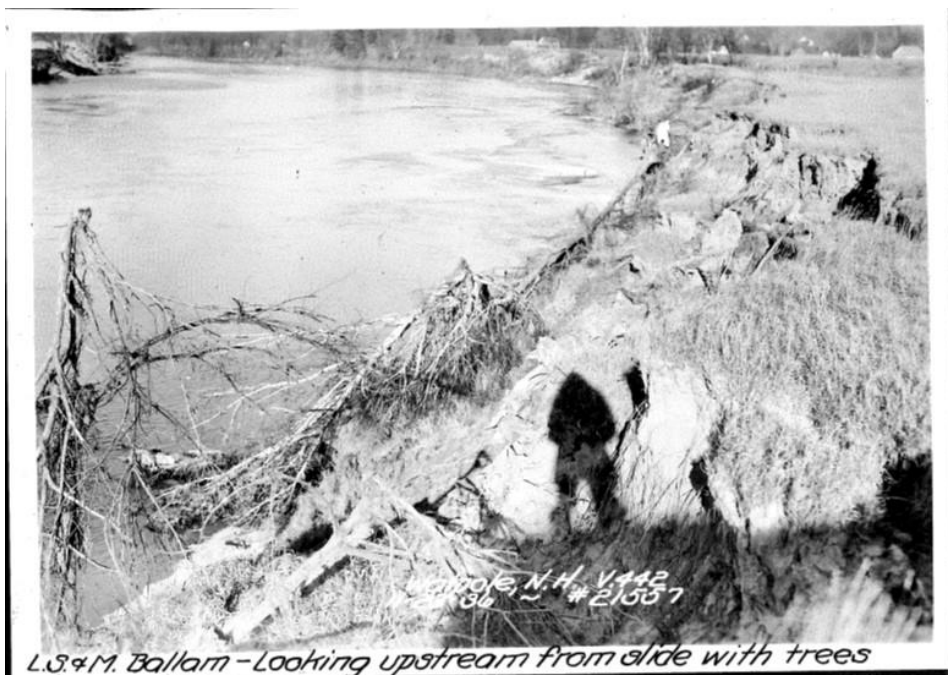
The CRREL report categorized the 1936 flood as the highest level of damage due to ice breakup. Erosion damage due to the 1936 event is similar to damage shown on the 1946 photographs ([Figure 5.5.5.5-1](#)). Field (2007) discussed erosion resulting from the 1936 flood in the form of avulsions in the TFI. He stated that “*The flood of 1936 spread across the floodplain with sufficient force to scour a new channel 20 feet deep across Moose Plain around Schell Bridge in part the result of floating debris that had accumulated under the bridge.*” Since ice was a significant factor in the 1936 event, it is likely that ice was the primary component of the floating debris observed at the Schell Bridge (especially since there are only two widely spaced bridge piers at a narrow section of the river where there is also a sharp bend and a significant mid-channel bar downstream of Schell Bridge, see Figure 16 from Field). Ice jams frequently occur as a result of constrictions, bends, and shallow areas of a river where ice floes are restricted. An avulsion occurs when a river abandons (or partially abandons) an existing river channel and forms a new channel through a process of rapid erosion (see [Figure 5.5.5.5-2](#)). Field described several avulsion channels that resulted from rapid and significant erosion as a result of floods such as the 1936 flood. Potential erosion scars from the flood of 1936 are visible on a 1939 aerial photograph ([Figure 5.5.5.5-3](#)).

Figure 5.5.5.5-1 Erosion Damage – 1936 Flood

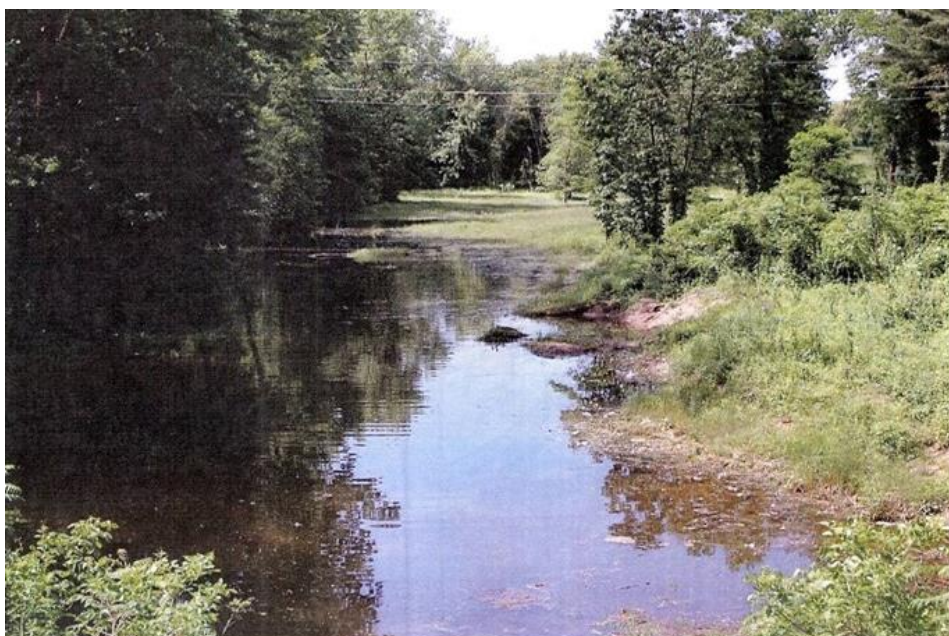
Figure 6: Abandoned avulsion channel formed across Moose Plain during the 1936 flood.

Figure 5.5.5.5-2 Abandoned Avulsion Channel – 1936 Flood (Field, 2007)

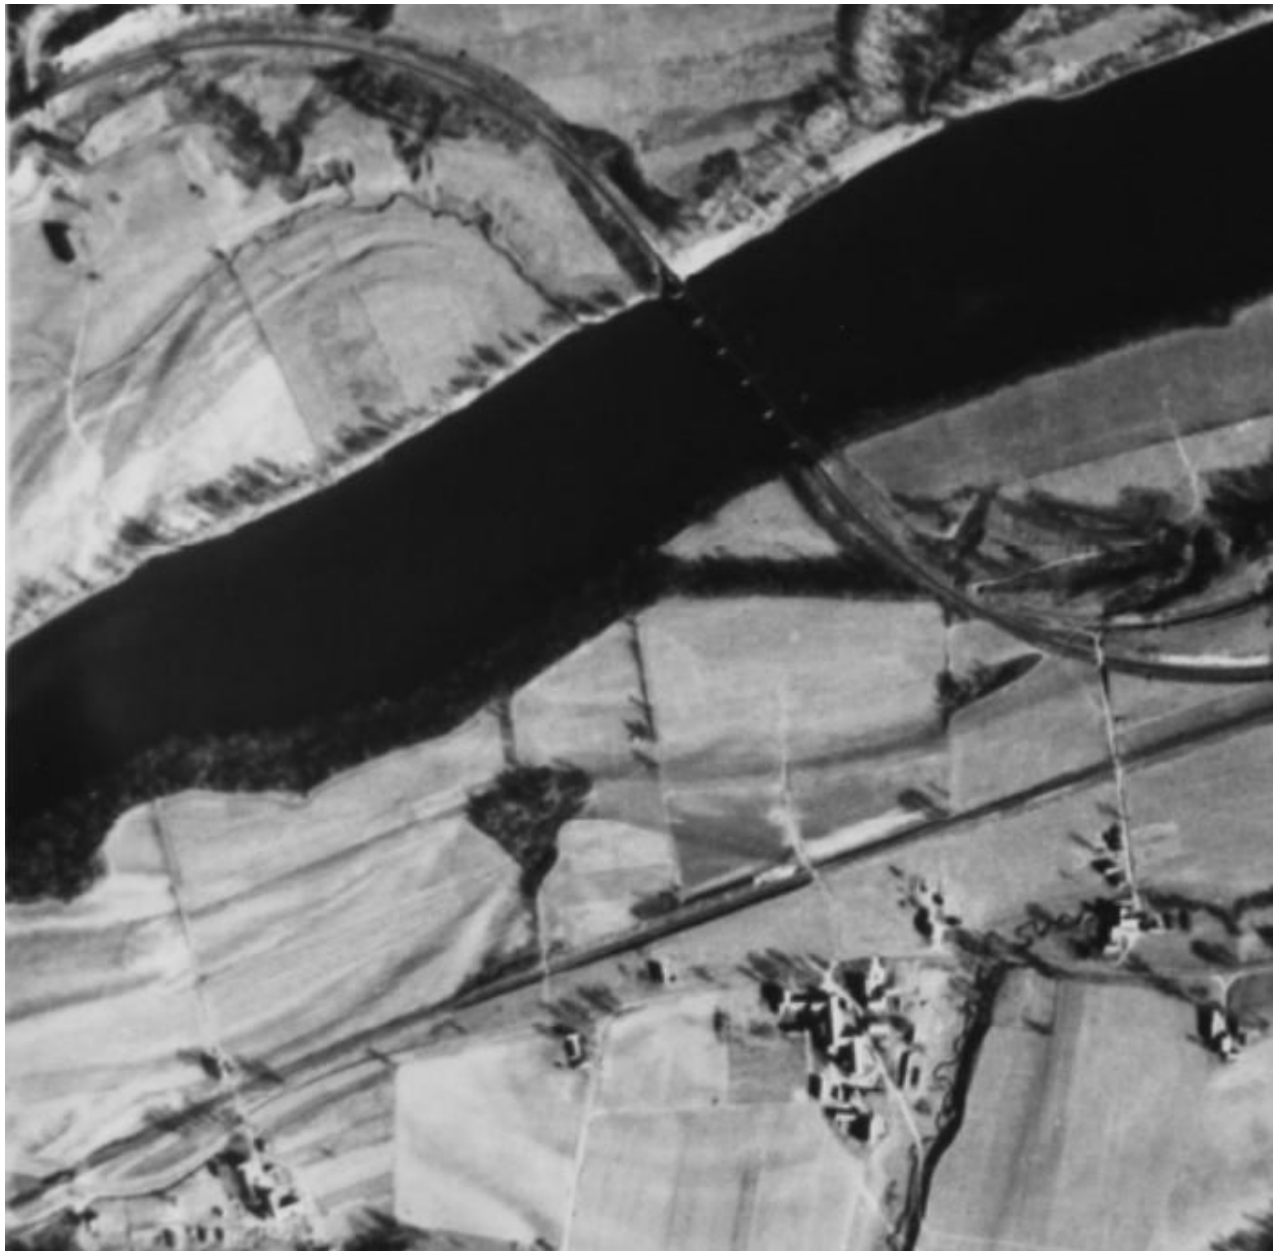
Figure 5.5.5.3 Aerial Photo Showing Erosion Scars on Floodplain - 1939

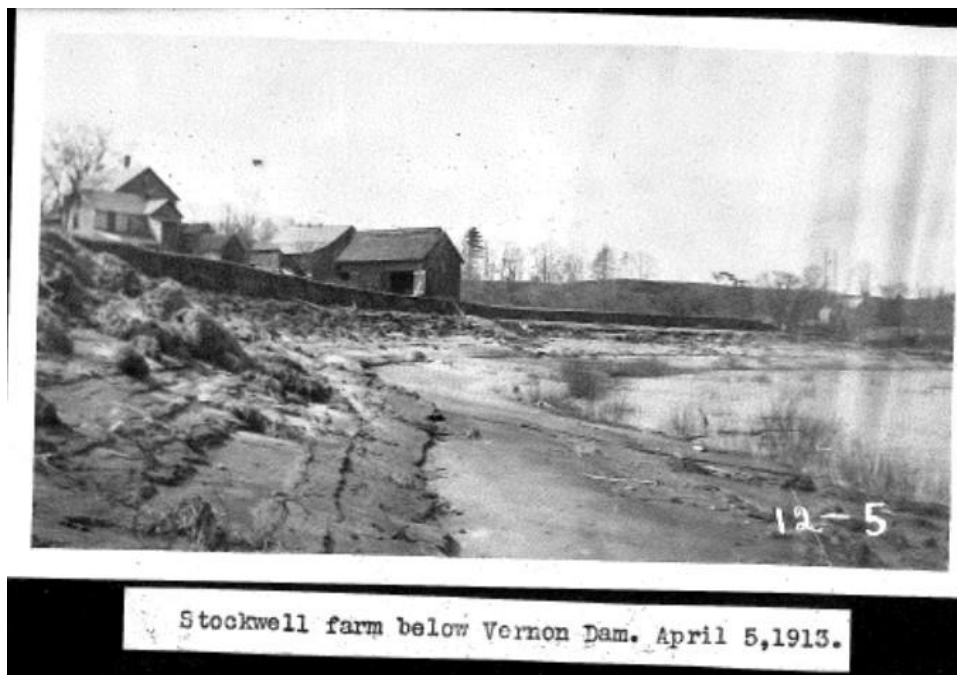
Figure 5.5.5-5 Eroded Bank in Turners Falls Impoundment Downstream of Vernon Dam – April 5, 1913 (TransCanada)

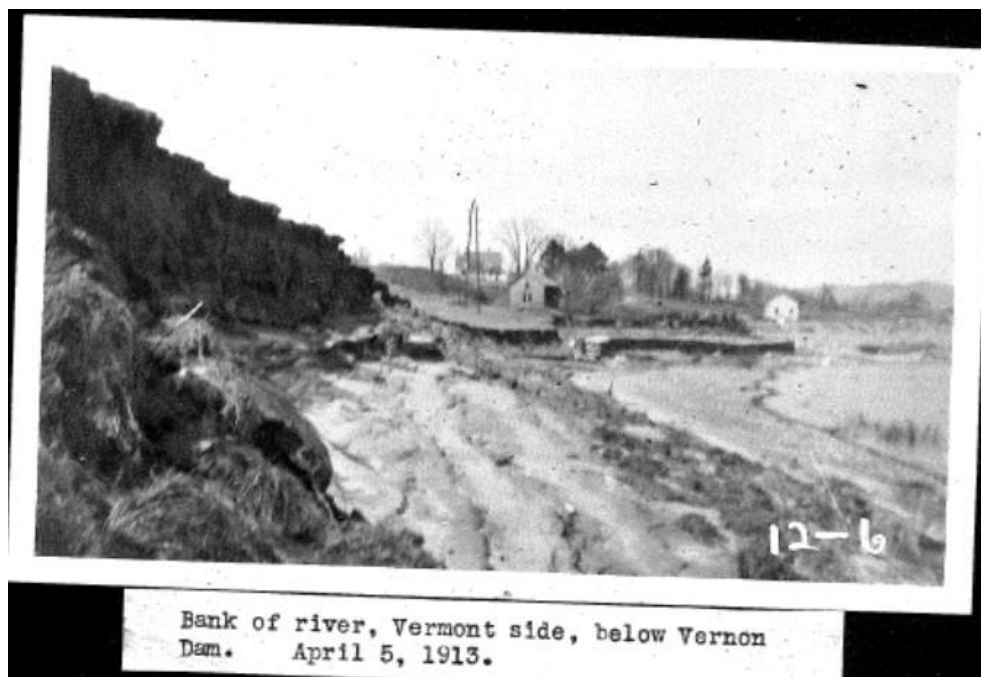
Figure 5.5.5-6 Eroded Bank in Turners Falls Impoundment Downstream of Vernon Dam – April 5, 1913 (TransCanada)

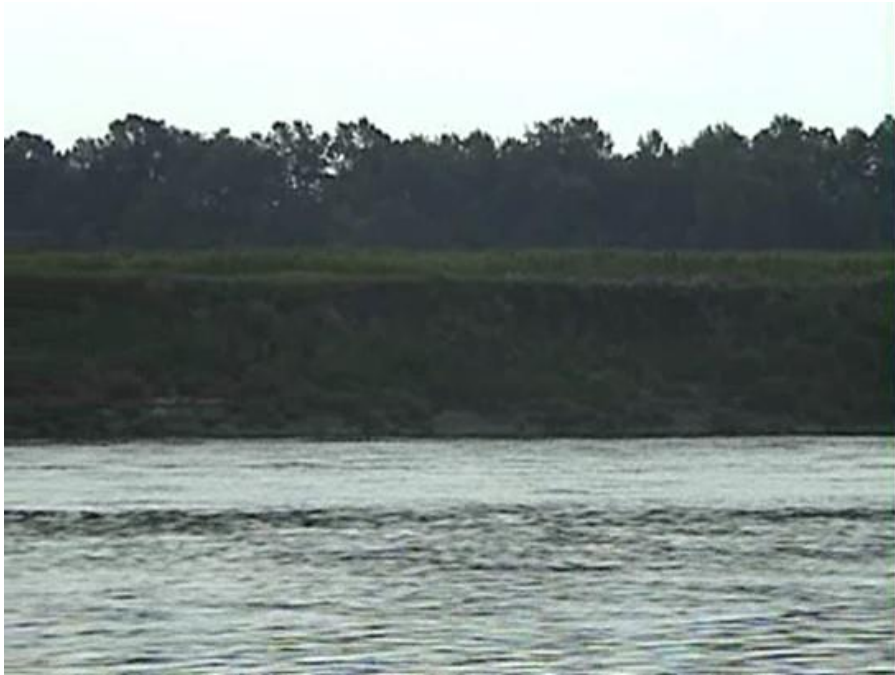
This area of the river was noted in the 2008 FRR when it was compared to the 1998 image showing that this area was naturally revegetating and becoming more stable over time. These photos, as well as a photo from 2013 show this area over the past 15 years ([Figures 5.5.5.5-9](#) through [5.5.5.5-14](#)). The comparison over time, from 1998 through 2013, show increasing vegetation over this period indicating increasing riverbank stability in this area of the river and significant improvement compared to the barren, eroded conditions seen in the 1929 and 1952 photographs. Other areas that were eroded and lacked riparian vegetation, but now support a zone of riparian vegetation through natural stabilization processes were documented in Section 2.3.4. Documentation of the establishment and growth of new riparian vegetation is provided in Volume III (Appendix J).

Figure 5.5.5-11 Right Bank Near Downstream End of Stebbins Island – 1998

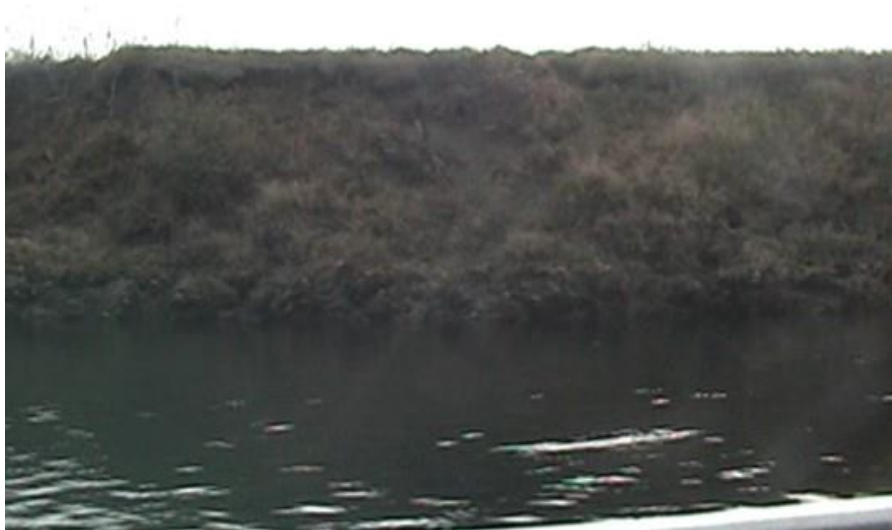
Figure 5.5.5-12 Right Bank Near Downstream End of Stebbins Island – 2008

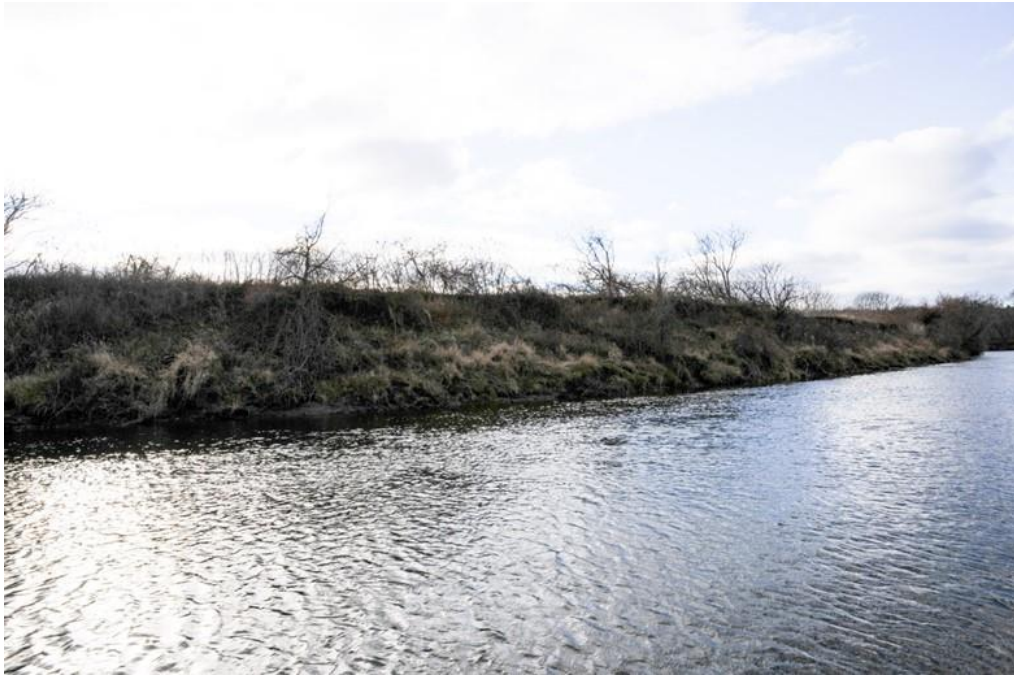
Figure 5.5.5-13 Right Bank near Downstream End of Stebbins Island – 2013

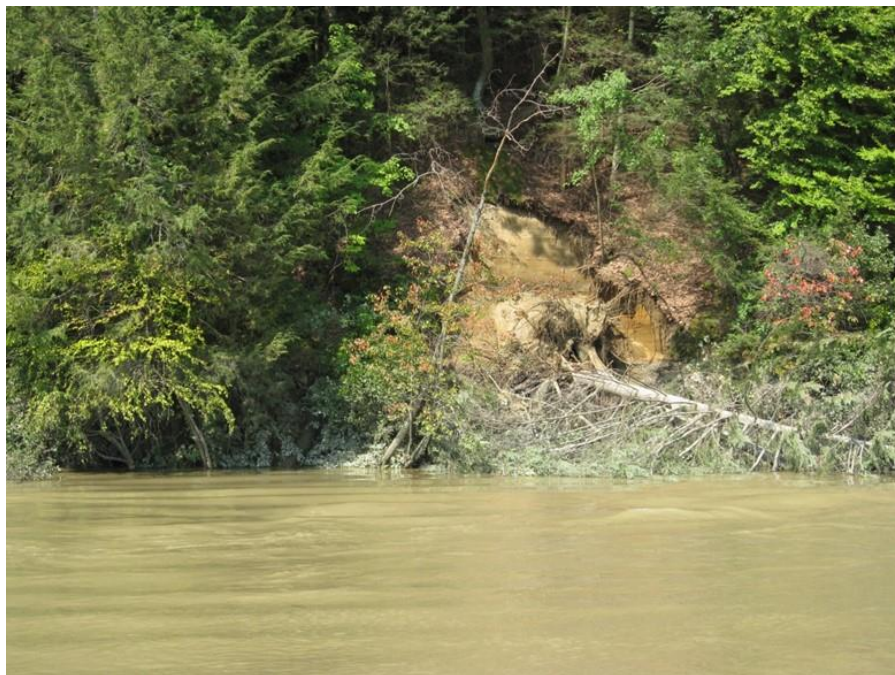
Figure 5.5.5.5-16 Erosion Due to High Flow in 2011

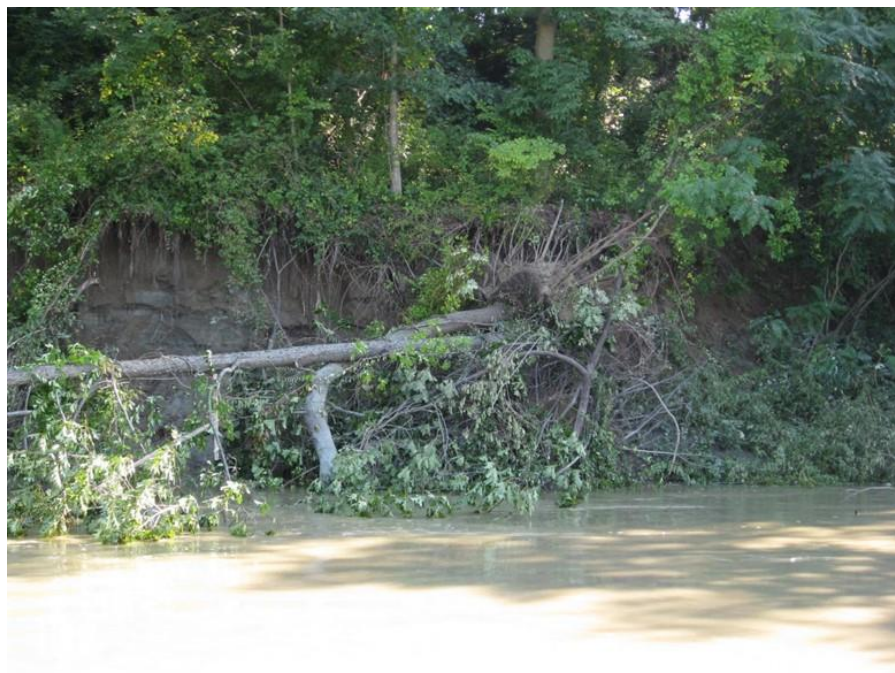
Figure 5.5.5.5-17 Erosion Due to High Flow in 2011
