Relicensing Study 3.1.2

**Northfield Mountain / Turners Falls
Operations Impact on Existing Erosion and
Potential Bank Instability
Study Report**

Volume II – Main Report

**Northfield Mountain Pumped Storage Project (No. 2485) and
Turners Falls Hydroelectric Project (No. 1889)**

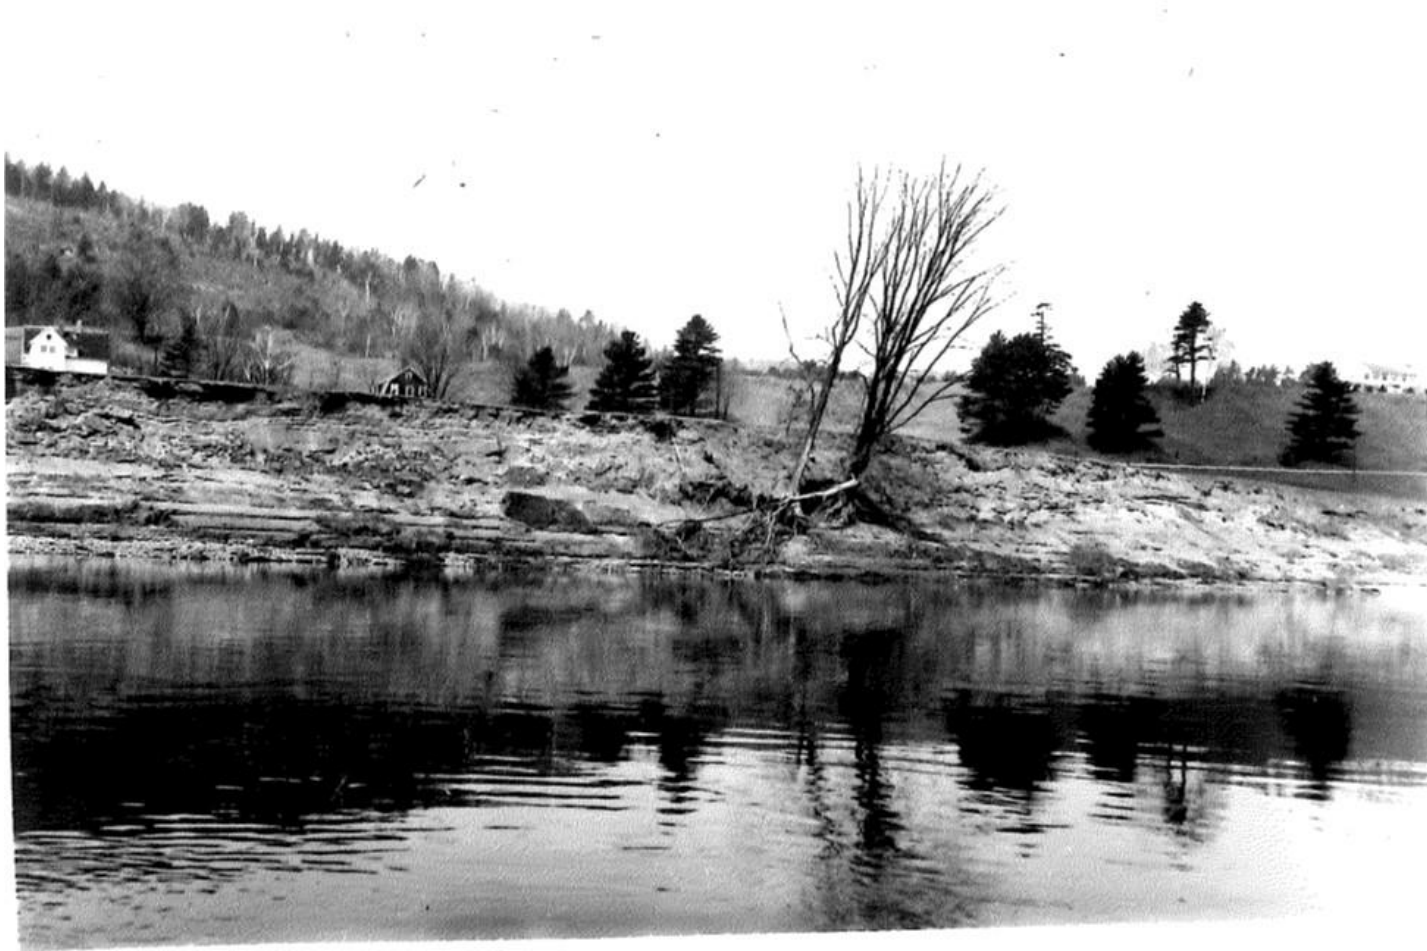
While the erosion photos from 1946 are quite dramatic and severe, the question of whether this erosion is due to ice or perhaps high flow should be considered. The previously presented photos in 1946 showed ice floes in the river and ice pushing up, into and over the riverbanks on March 8th and 10th, 1946 ([Figures 5.5.5.2-9](#) through [5.5.5.2-11](#)). A series of photos were taken shortly thereafter on April 23rd through 25th, 1946 ([Figures 5.5.5.2-13](#) through [5.5.5.2-20](#) and [5.5.5.2-22](#)). These photos show the eroded banks and damaged vegetation with evidence of ice gouging and scarring of trees as a result of ice. This combination of ice survey data, photographs of ice on the river, followed by photos of riverbank damage about a month after the ice event show that ice and associated damage was the focus of this set of information. The peak flow of 71,000 cfs (at Montague) in 1946 is below the long-term (1904-1960) average peak flow (97,600 cfs). For a number of years prior to 1946, the peak flows were likewise quite low ([Table 5.5.5.5-1](#)).

The fact that an effort was made to document riverbank conditions immediately after the ice event of 1946, coupled with flow data showing that for a period of 6 consecutive years from 1941 through 1946 peak flows

were below average; indicate that the eroded and damaged condition of the riverbanks and riparian vegetation shown in the April 1946 photographs resulted primarily from ice.

Figure 5.5.5-18 Erosion in 1946 Due to Ice (TransCanada)

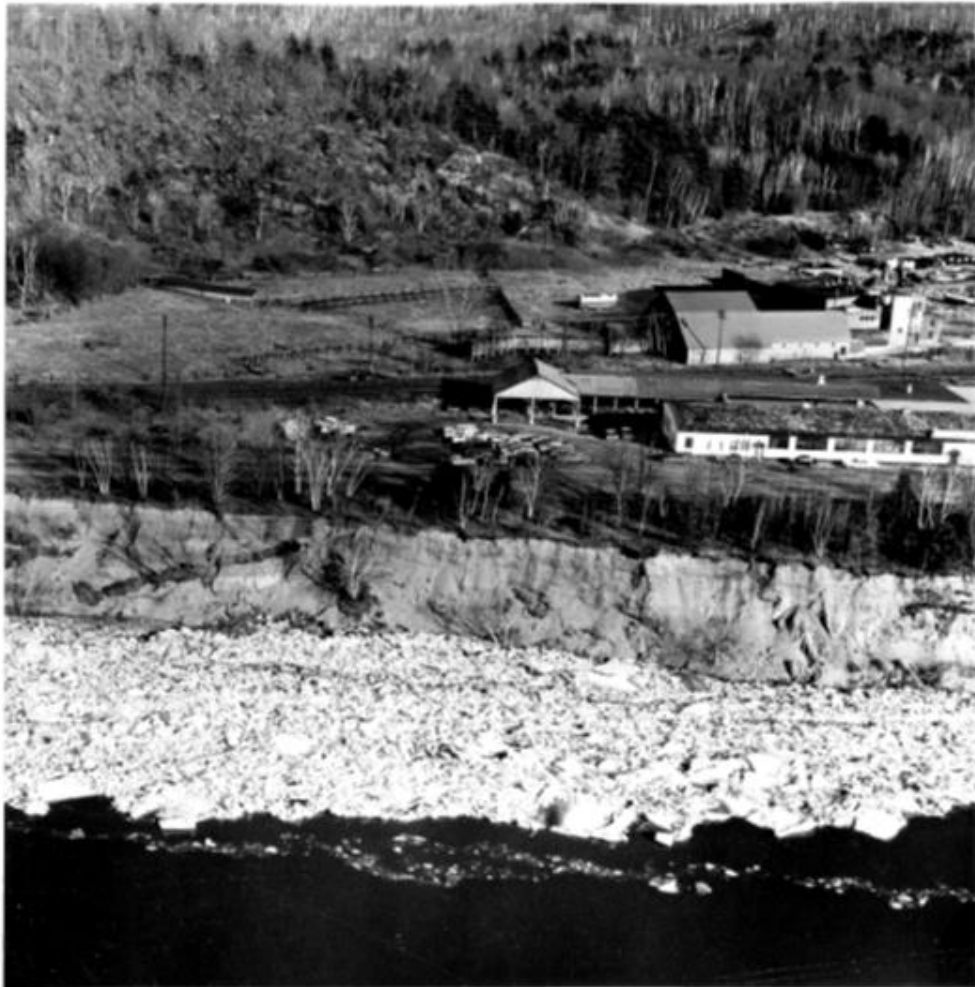
A - 3

March 25, 1968 - Eroded banks on N.E.P.
property just north of Gray banks.

Figure 5.5.5-23 Ice and erosion damage, 1968

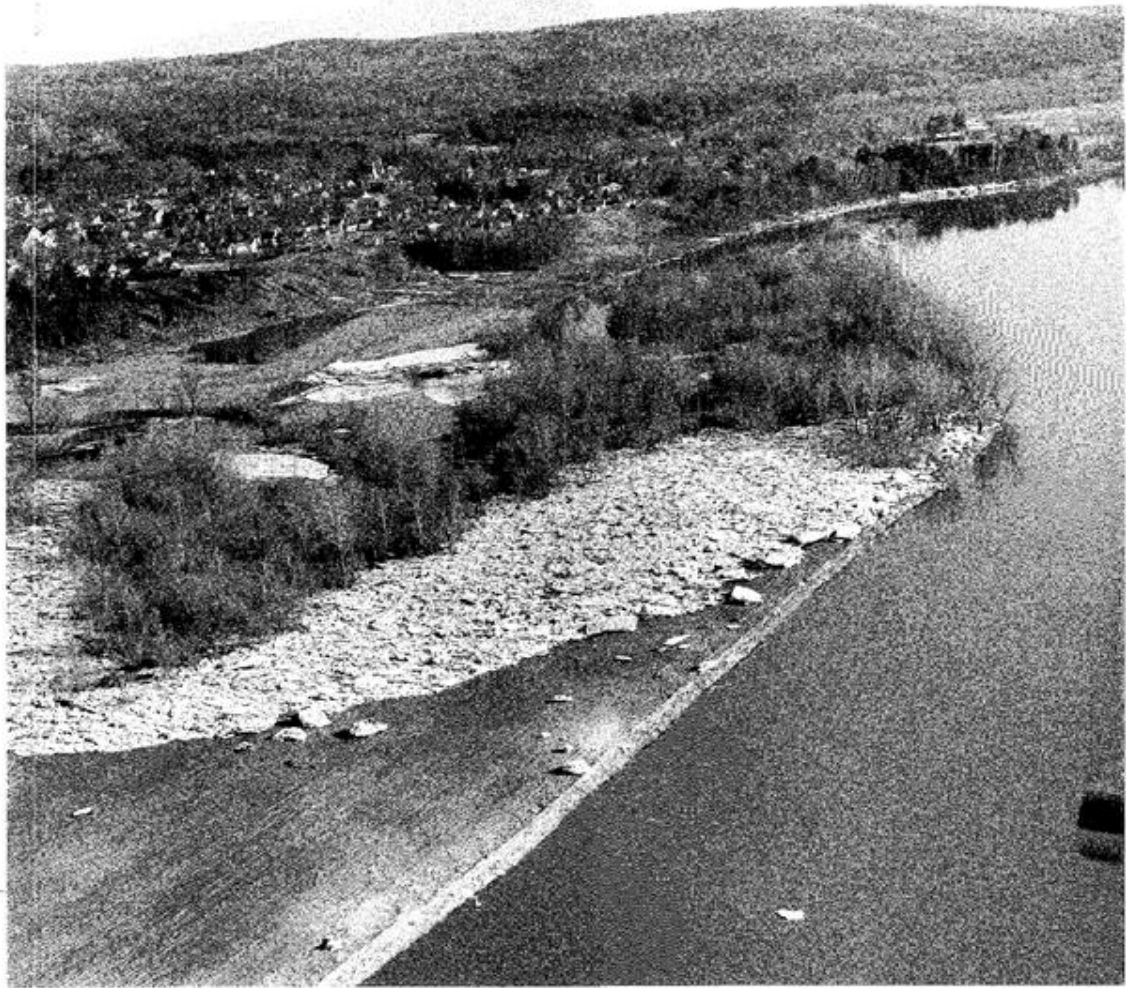
A - 15

Evidence of low bank erosion opposite
Charlestown.

Figure 5.5.5-24 Ice and erosion damage, 1968

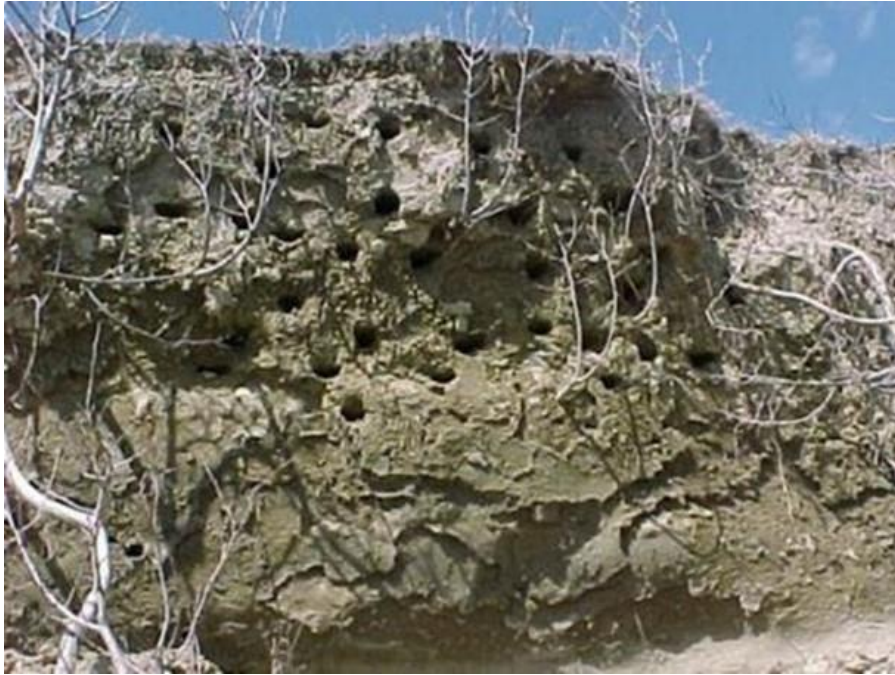
As part of the 2013 FRR, the locations of sensitive receptors found along or near the TFI riverbanks were mapped. A sensitive receptor was defined as important wildlife habitat located at or near the riverbank. Many wildlife features were observed during this survey including bank swallow and belted kingfisher nesting sites and bald eagle nest and perch sites. Of particular interest to this study were the bank swallow and belted kingfisher nesting sites since they are reliant on eroding banks for habitat. Belted kingfishers and bank swallows excavate cavities to use as nests in sheer banks lacking vegetation and containing appropriate soil conditions. [Figure 5.5.6-1](#) depicts the locations of the sensitive receptors identified during the 2013 FRR. An example of a bank swallow nesting site is found in [Figure 5.5.6-2](#).

Figure 5.5.6-2: Bank swallow nests – Flagg erosion site near Kidds Island, Turners Falls Impoundment

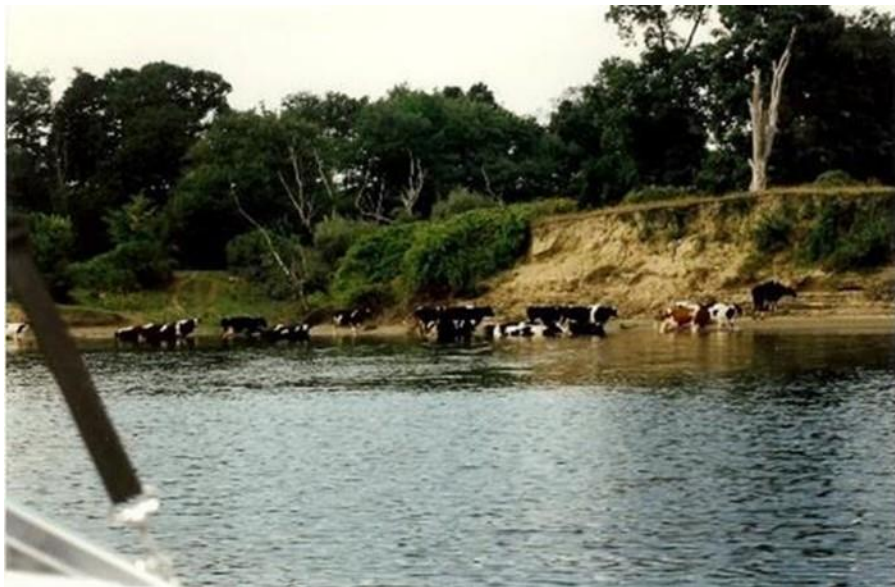
Along agricultural fields, paths are frequently created by animals traveling between fields and the river. Examples of this activity are shown in [Figure 5.5.6-3](#) and again in [Figures 5.5.6-4](#) through [5.5.6-12](#). [Figure 5.5.6-13](#) shows the location where each of the photos in [Figures 5.5.6-4](#) through [5.5.6-12](#) were taken. At the agricultural field found in [Figures 5.5.6-4](#) through [5.5.6-12](#) it was observed that there were a number of animal paths over the length of the field. Based on the width of the riparian zone adjacent to this particular field, the animal paths were found where the riparian zone was narrow while no animal paths were observed where the riparian zone was wider.

Figure 5.5.6-3: Cattle using riverbank area along Connecticut River – Flagg erosion site near Kidds Island, Turners Falls Impoundment

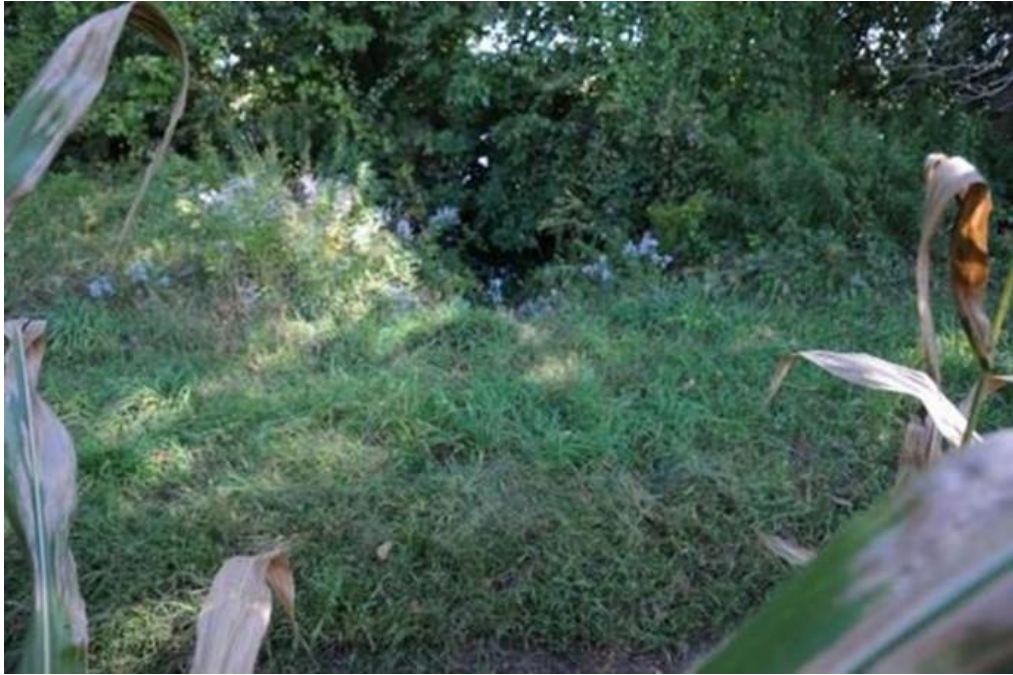
Animals cause damage to riverbanks in a number of ways. Animal trails leading to the river can create concentrated runoff that cause gullies to form along the trail. Removal or damage to vegetation above ground reduces the protective effect against erosion that vegetation offers which, in turn, can result in root damage and decrease in the binding effect that roots have on the soil matrix. Burrowing of animals or birds into the riverbank can also create disturbance to the riverbank or can create points where seepage may more easily develop resulting in concentration of such flows down the riverbank slope and corresponding erosion.

Figure 5.5.6-4: Animal path from river to field, Photo 101

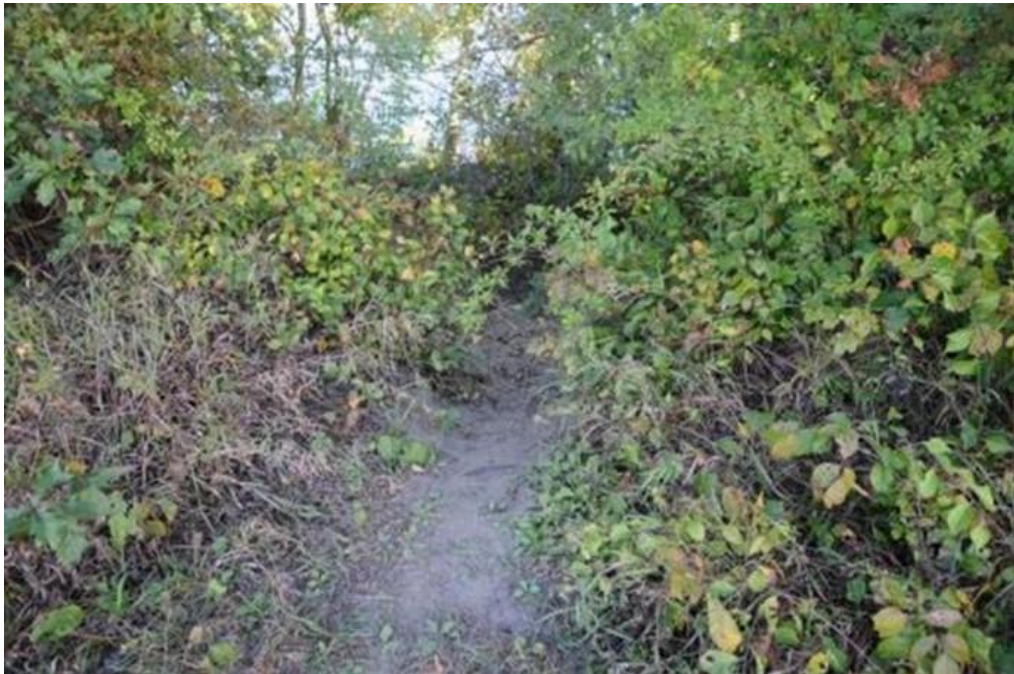
Figure 5.5.6-5: Animal path from river to field, Photo 109

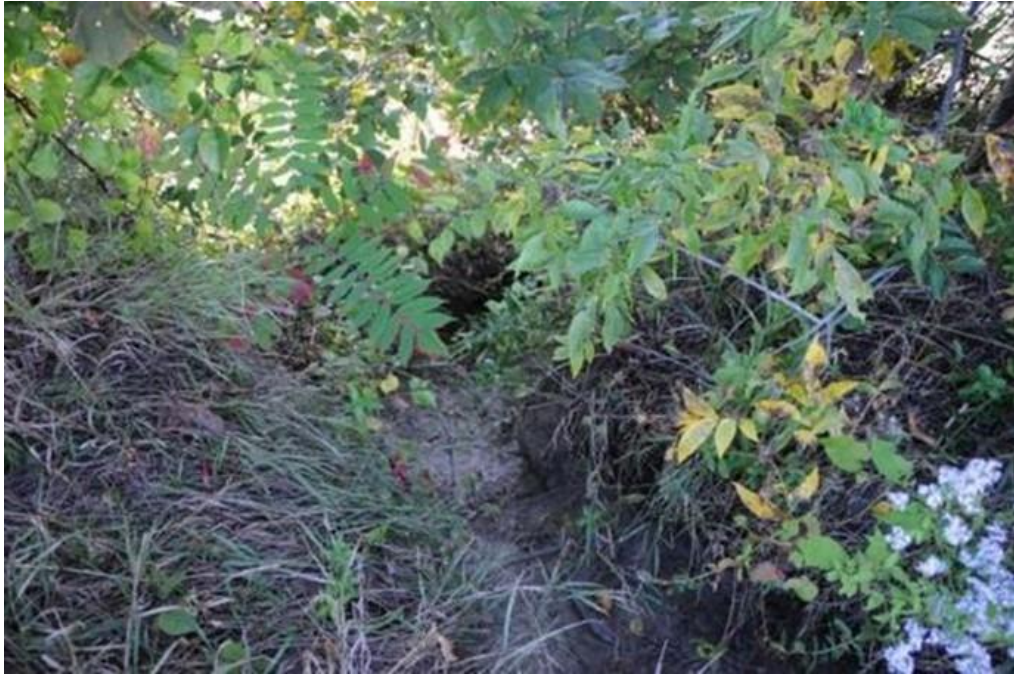
Figure 5.5.6-6: Animal path from river to field, Photo 117

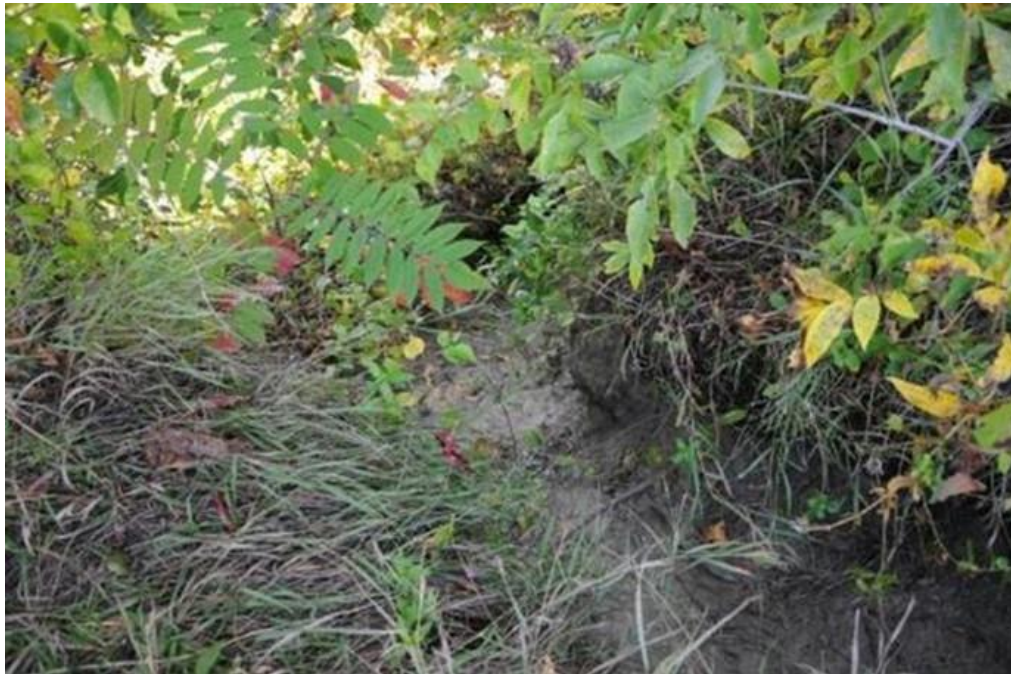
Figure 5.5.5-6-7: Animal path from river to field, Photo 119

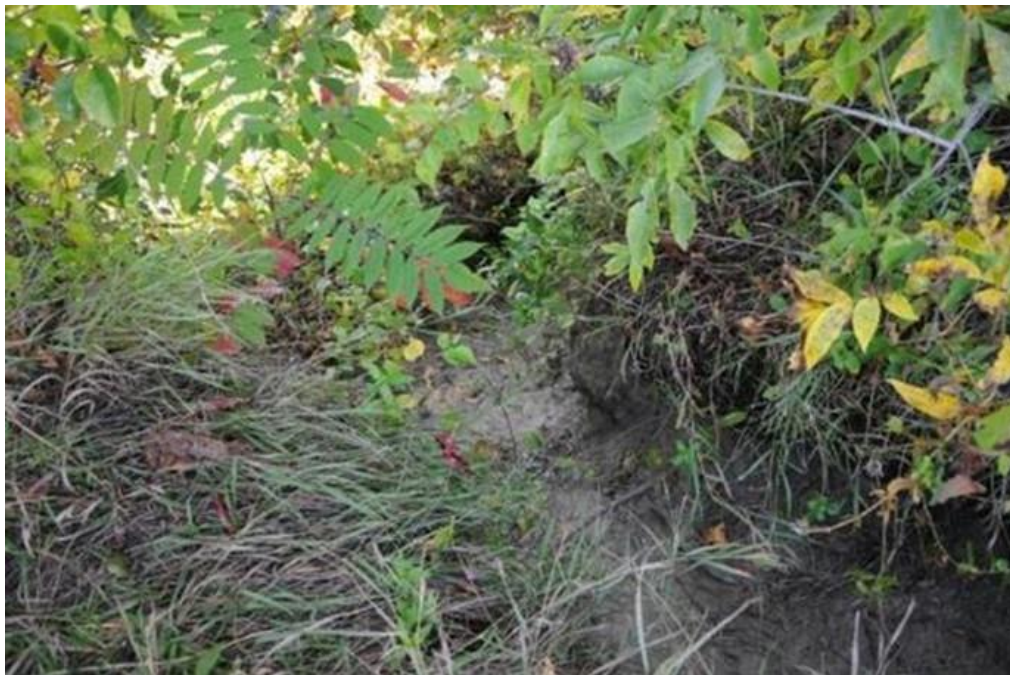
Figure 5.5.6-8: Animal path from river to field, Photo 120

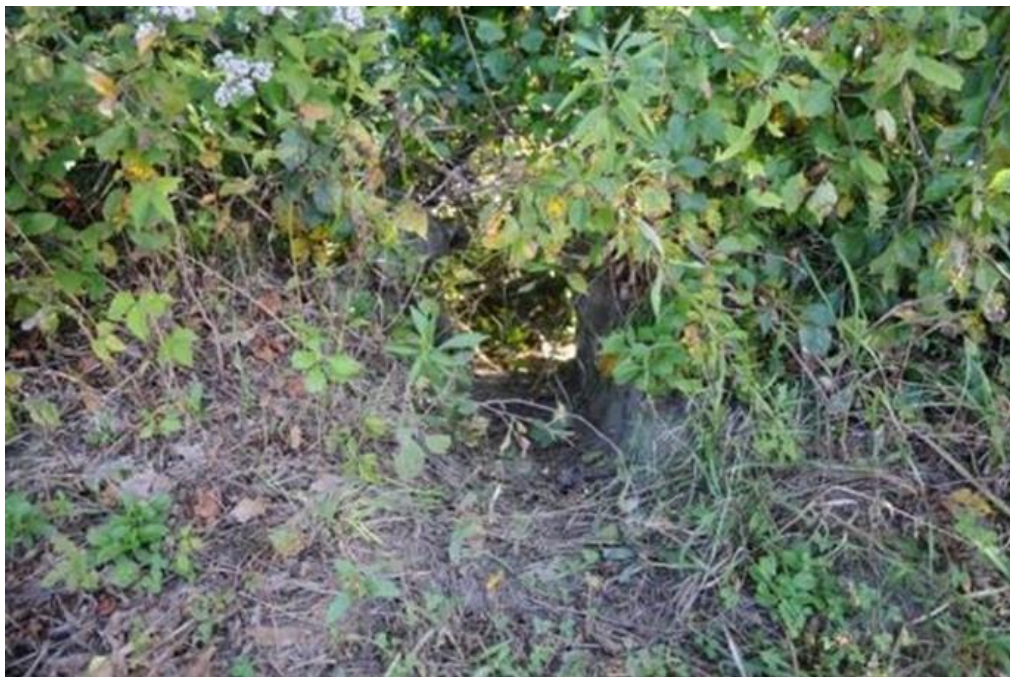
Figure 5.5.6-9: Animal path from river to field, Photo 124

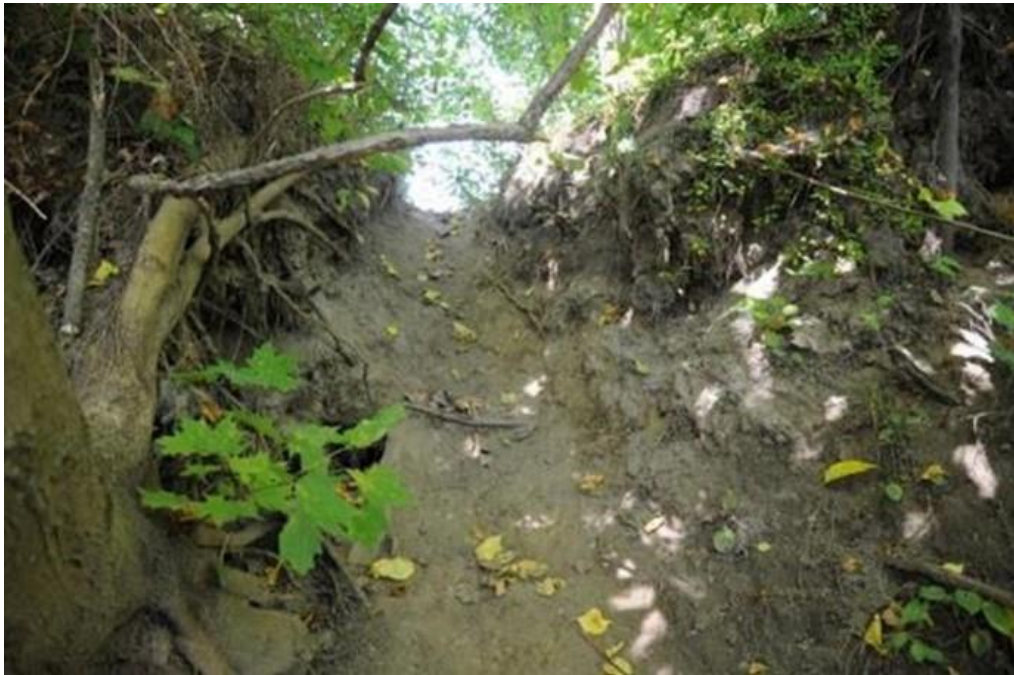
Figure 5.5.6-10: Animal path from river to field, Photo 128

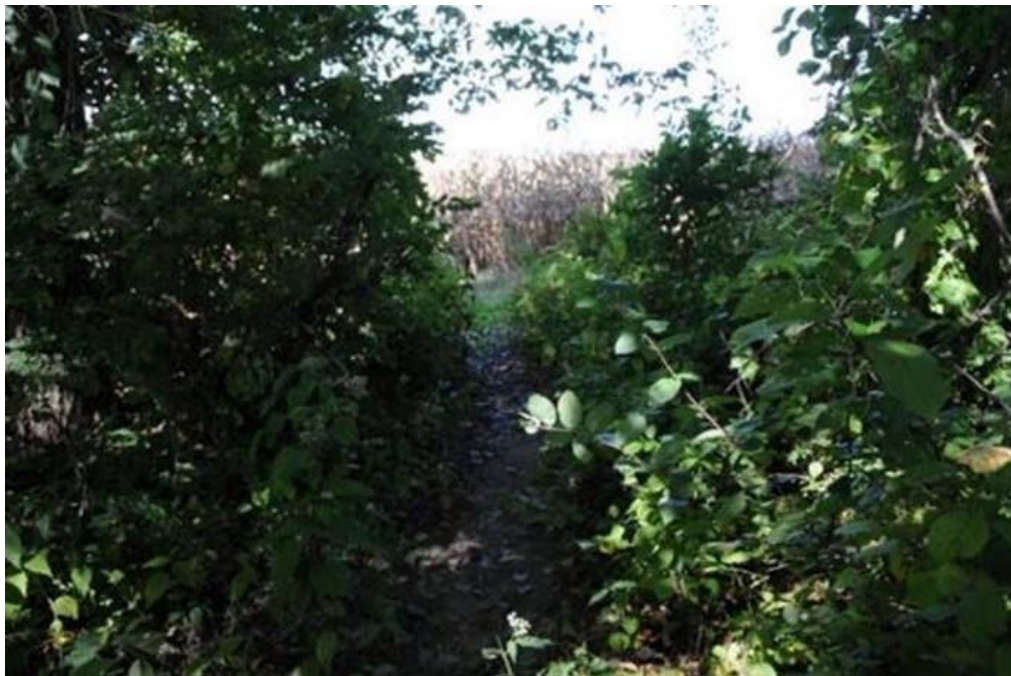
Figure 5.5.6-11: Animal path from river to field, Photo 130

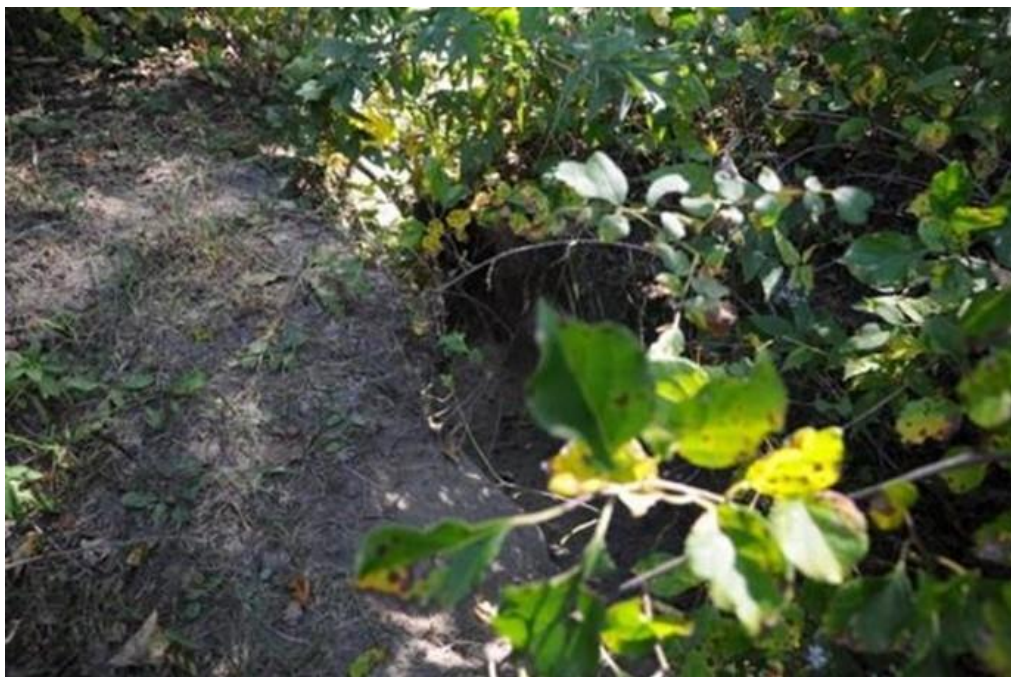
Figure 5.5.6-12: Animal path from river to field, Photo 135

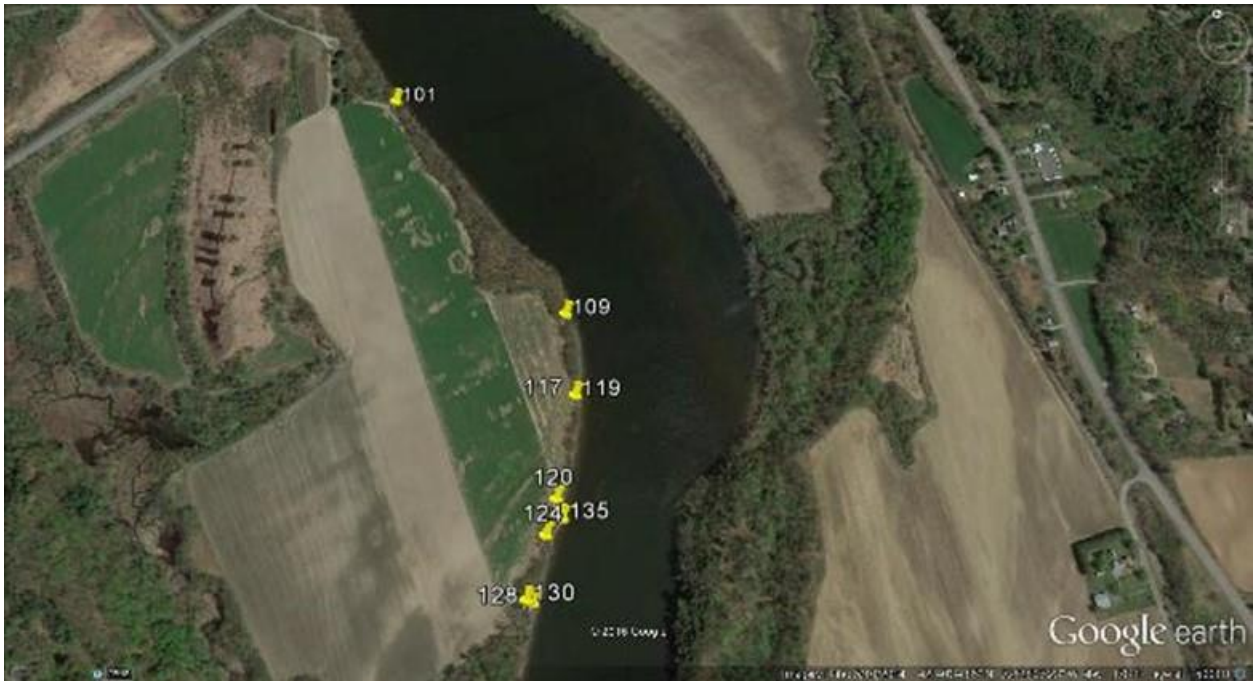
Figure 5.5.6-13: Location of Animal Paths along Field
