# Relicensing Study 3.3.17

## ASSESS THE IMPACTS OF TURNERS FALLS PROJECT AND NORTHFIELD MOUNTAIN PROJECT OPERATIONS ON TRIBUTARY AND BACKWATER AREA ACCESS AND HABITAT

### Study Report

Northfield Mountain Pumped Storage Project (No. 2485)  
and Turners Falls Hydroelectric Project (No. 1889)

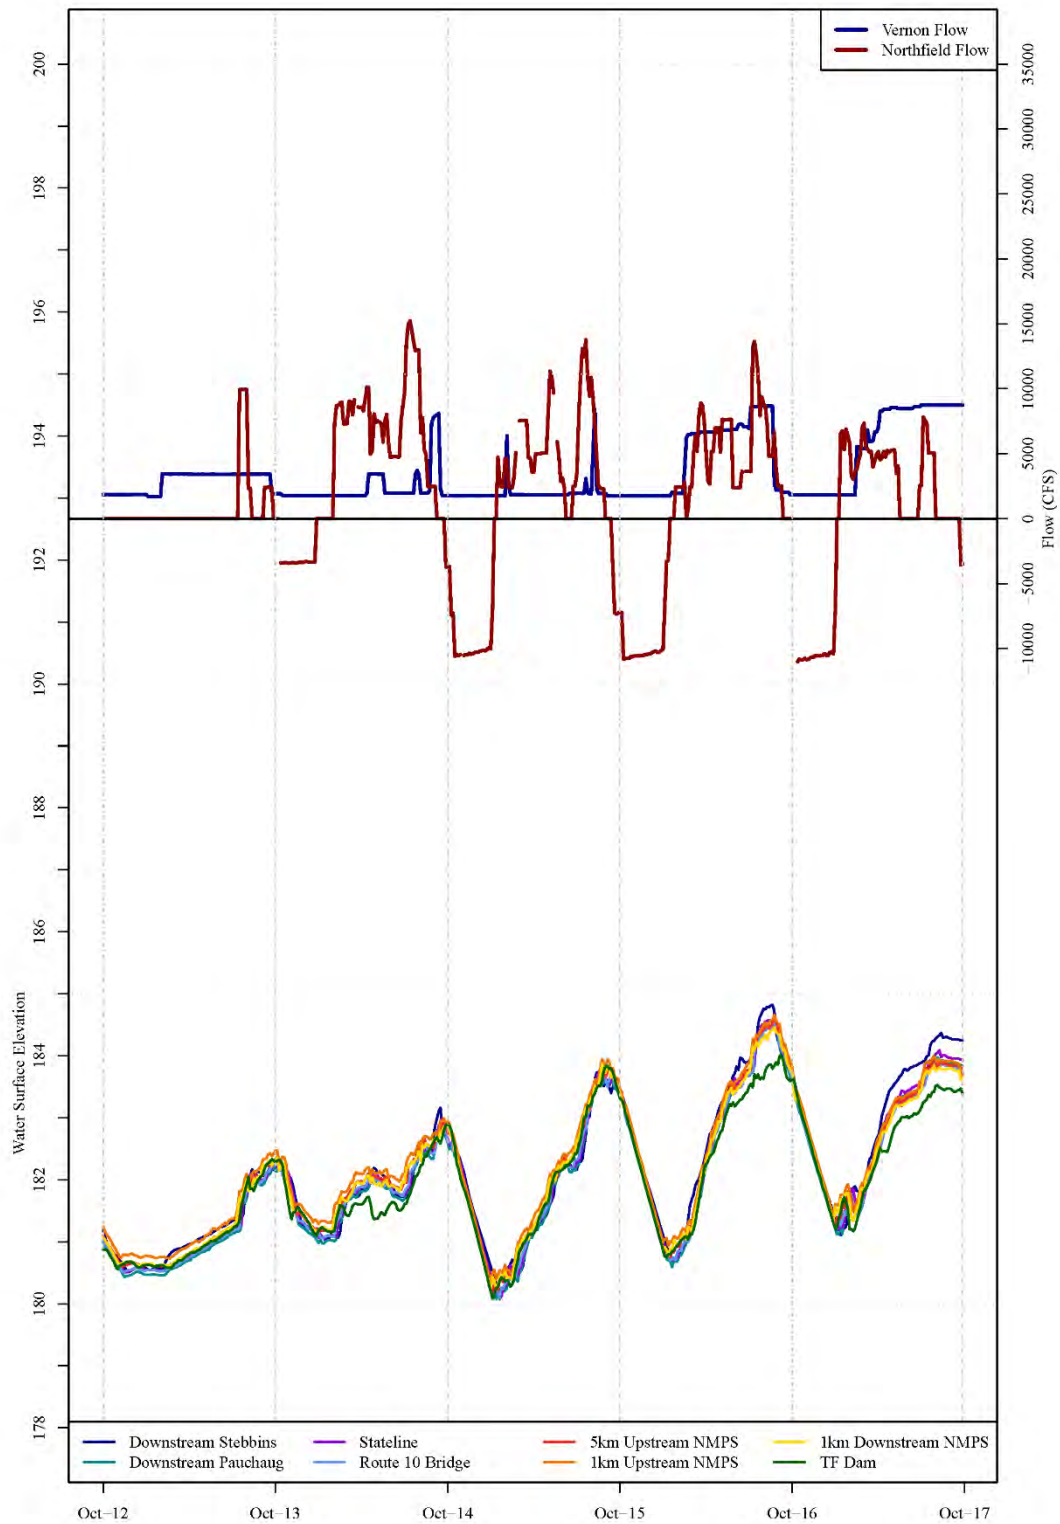
Figure 5.1-5: WSELs in Turners Falls Impoundment during the fall survey period (October 12-16, 2014).

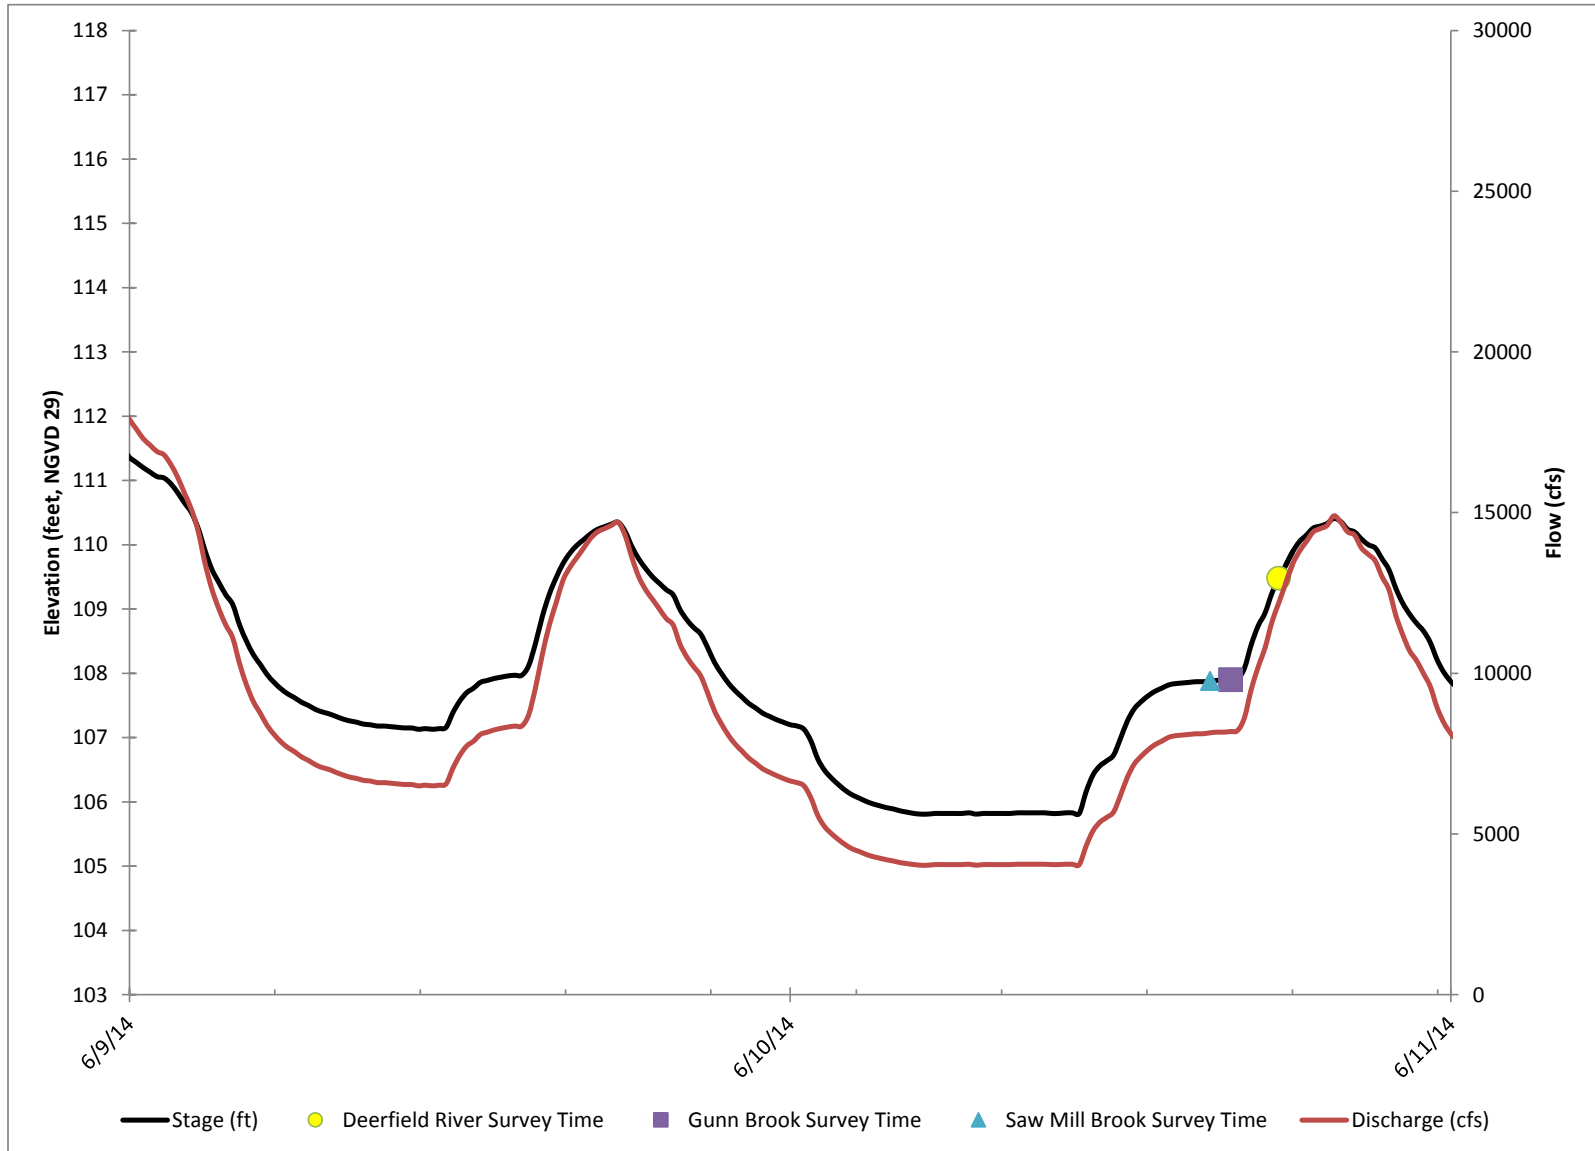
Figure 5.1-6: WSELs at the USGS gage in Montague City, MA during the spring survey period.

WSELs below the Turners Falls Project were measured at the Montague City USGS gage. Data were obtained at 15 minute intervals and plotted for each seasonal survey period. [Table 5.1-1](#) shows the instantaneous WSEL as reported from the Montague City gage on the date/time of survey. Downstream tributaries were surveyed during rising WSEL conditions during the spring and fall surveys, but were surveyed under low flow, stable conditions during the summer survey ([Figures 5.1-6](#) through [5.1-8](#)).

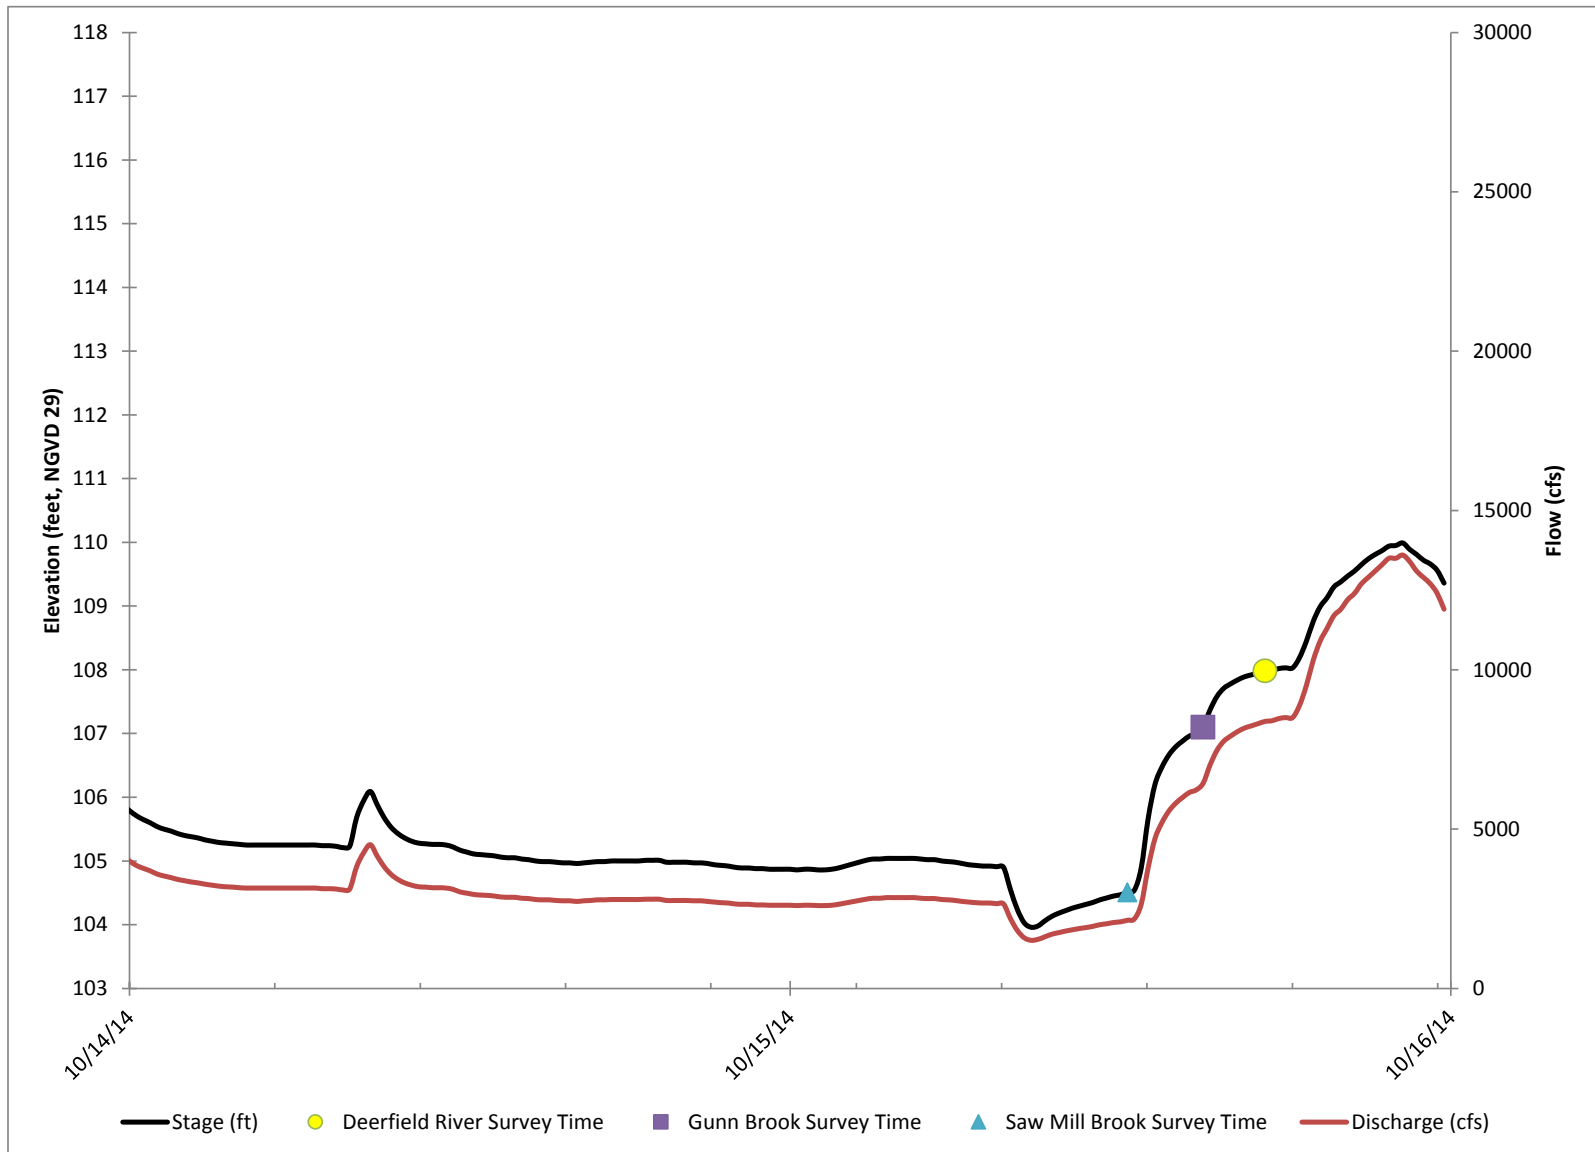
**Figure 5.1-8: WSELs at the USGS gage in Montague City, MA during the fall survey.**

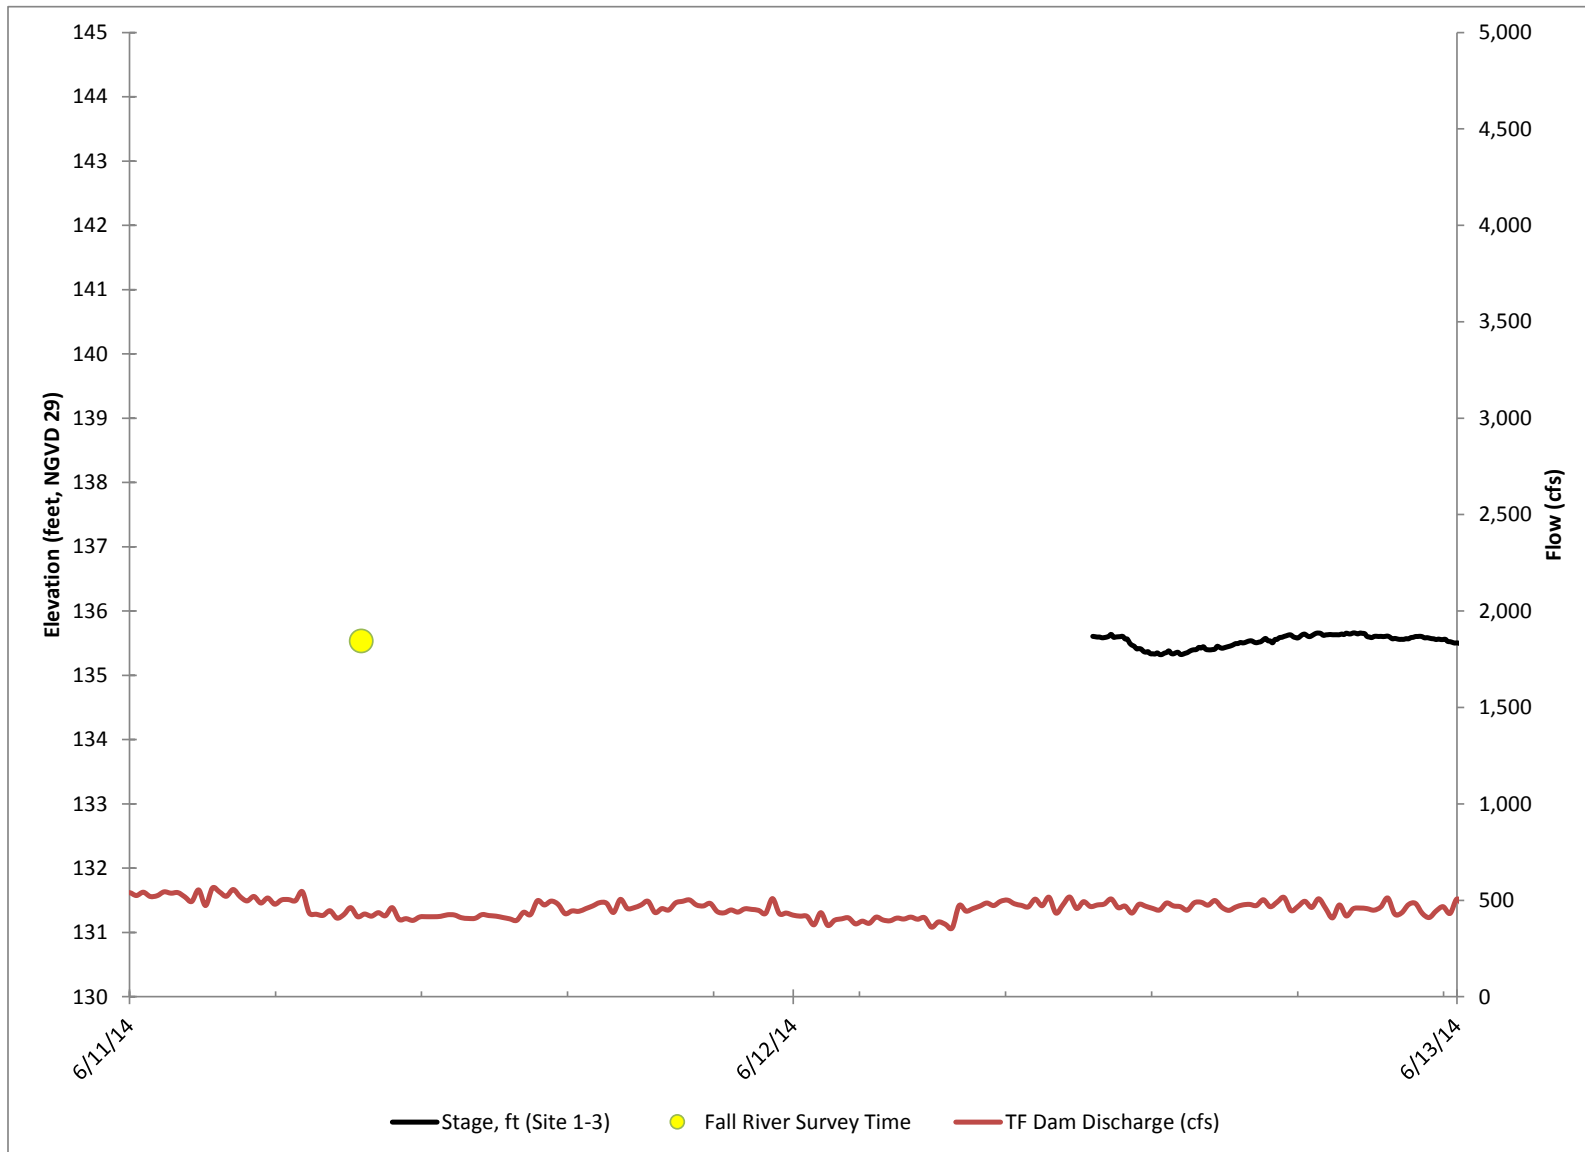
Figure 5.1-9: WSELs at the Turners Falls Bypass Reach near Fall River during the spring survey.

For the Fall River, which enters the Turners Falls Project bypass reach, water level fluctuations were characterized by stage data collected with temporary water level loggers installed for another relicensing study, and by FirstLight operations data ([Figures 5.1-9](#) through [5.1-11](#)). The Fall River surveys were conducted under minimum bypass flow conditions (400 cfs in the spring and 120 cfs in the summer and fall).

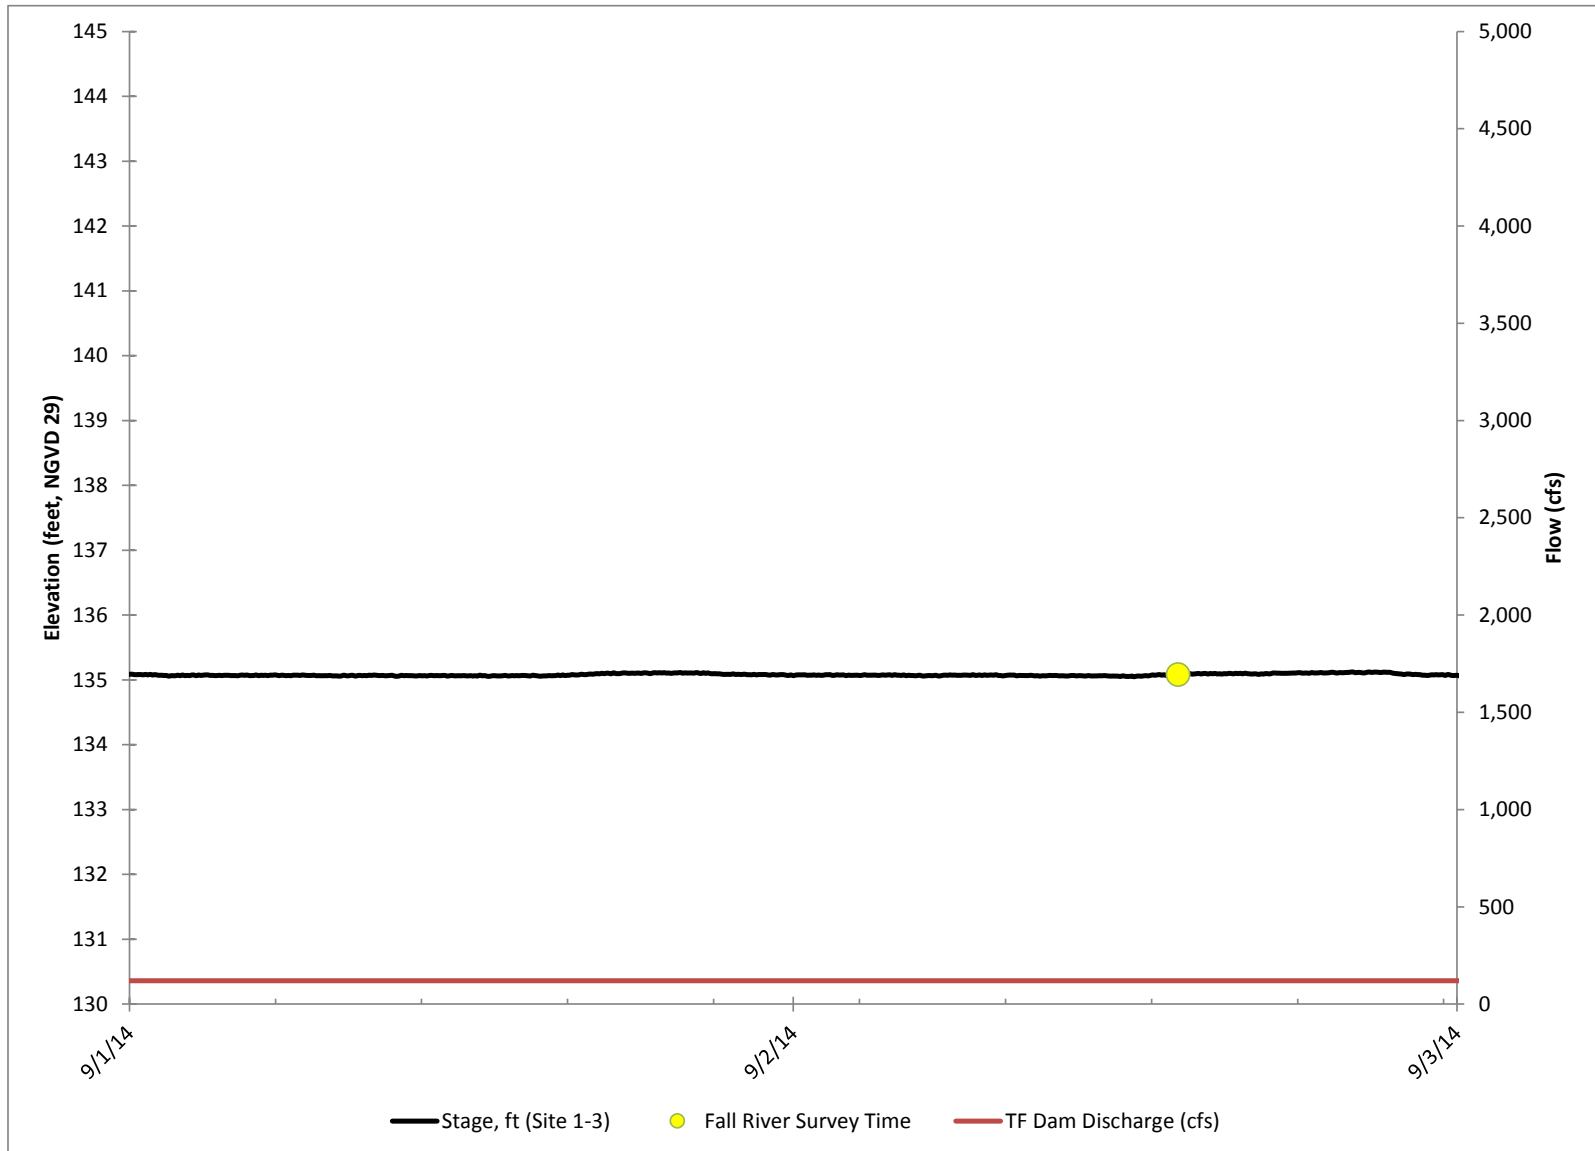
Figure 5.1-10: WSELs at the Turners Falls Bypass Reach near Fall River during the summer survey.

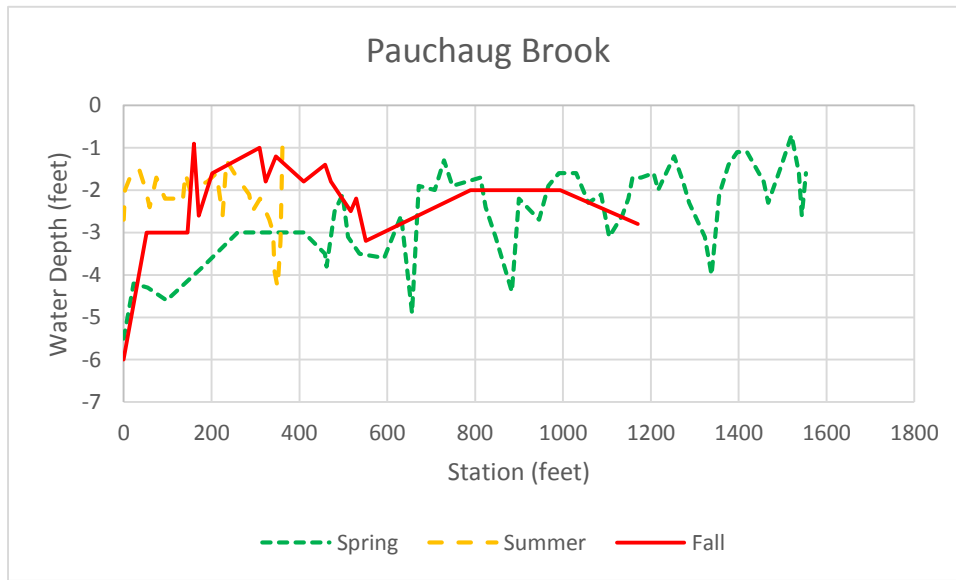
Figure 5.3.1.3-1. Longitudinal thalweg profiles Pauchaug Brook during spring, summer, and fall conditions

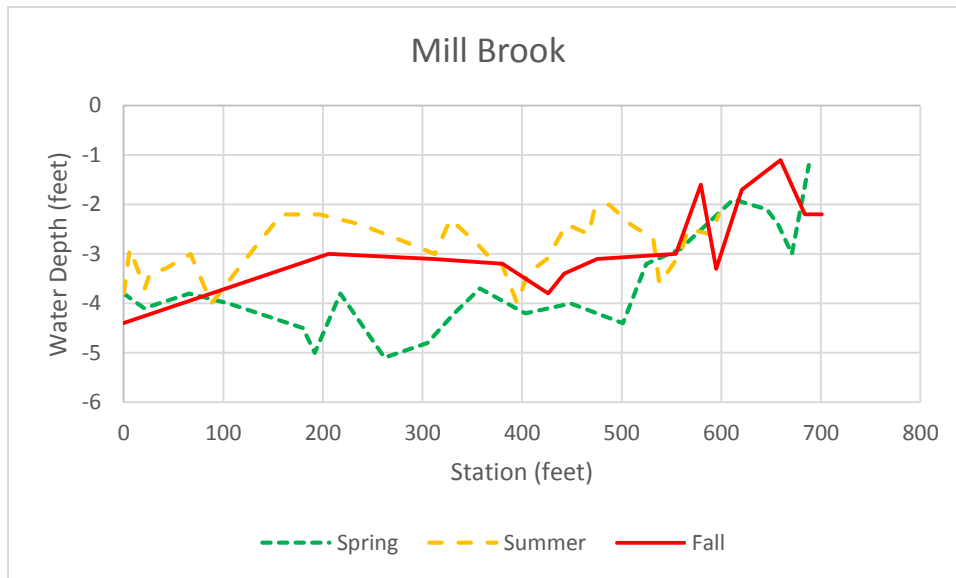
Figure 5.3.1.5-1. Longitudinal thalweg profiles Mill Brook during spring, summer, and fall conditions

Mill Brook flows into the Connecticut River from the east ([Figure 3.0-1](#)). The upstream end of the confluence was delineated by a change in flow characteristics as low gradient conditions gave rise to increased velocities and riffle habitat marked by a change in elevation and substrate, as sands and mud in the lower confluence transitioned to gravel and sands. The maximum zone of backwater influence was recorded during the spring, where the upstream extent was measured approximately 700 ft upstream from the confluence with the Connecticut River ([Appendix B](#)). The fall survey recorded similar conditions with the zone of influence reaching approximately 700 ft upstream. Summer influence was not as pronounced, with an upstream extent of approximately 600 ft. Depth profiles surveyed in the confluence revealed no barriers to fish movement ([Figure 5.3.1.5-1](#)). [Appendix A](#) contains photos illustrating the seasonal conditions at the Mill Brook confluence.

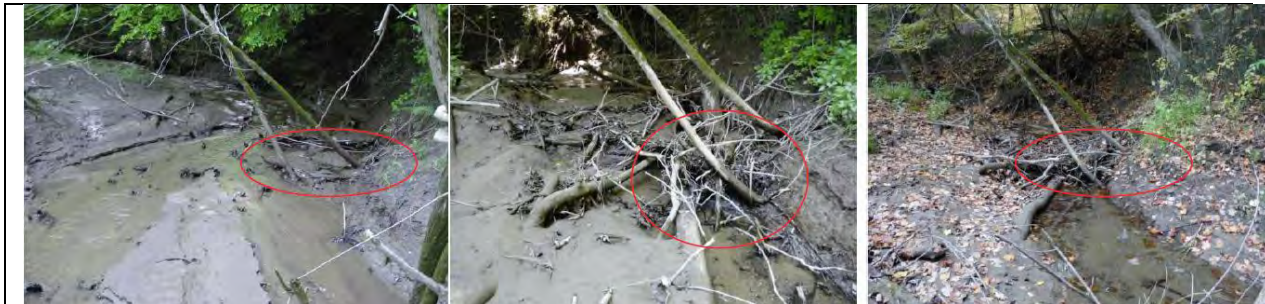
Figure 5.3.1.6-2. Seasonal photos of a location upstream of the of Mallory Brook confluence, but still within the zone of influence under spring freshet flows and impoundment levels

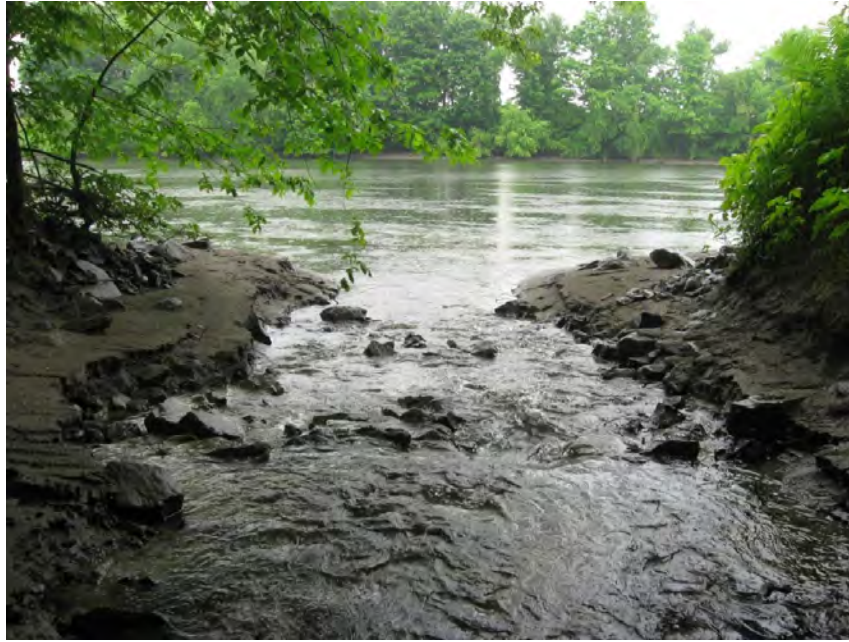
**Figure 5.3.1.9-3. Conditions at Merriam Brook Confluence during the spring survey period**

Connectivity to the impoundment was not affected in the spring when tributary flow was seasonally high (Figure 5.3.1.9-3) but was limited during low-flow tributary conditions during the summer and fall (Figures 5.3.1.9-4 and 5.3.1.9-5). Water depths collected along a transect (Figure 5.3.1.9-6) within the upper extent of the tributary confluence were less than 0.25 feet with water velocities ranging from 0.33 to 1.25 fps in the fall (Table 5.3.1.9-1). The tributary water velocities during the fall low flow season, when these data were collected, are not a barrier to most fishes but the shallow depth is likely a barrier. However, these conditions are characteristic of the stream itself and not due to impoundment fluctuation. Impoundment WSEL does affect the depth of the confluence and its extent such that the higher the impoundment level, the deeper the lower confluence and the further backwatering occurs up into the tributary. This effect results in an increase in lentic habitat and a decrease in riverine habitat within the confluence but does not provide better access to the tributary because upstream reaches outside of the Project influence were shallow and

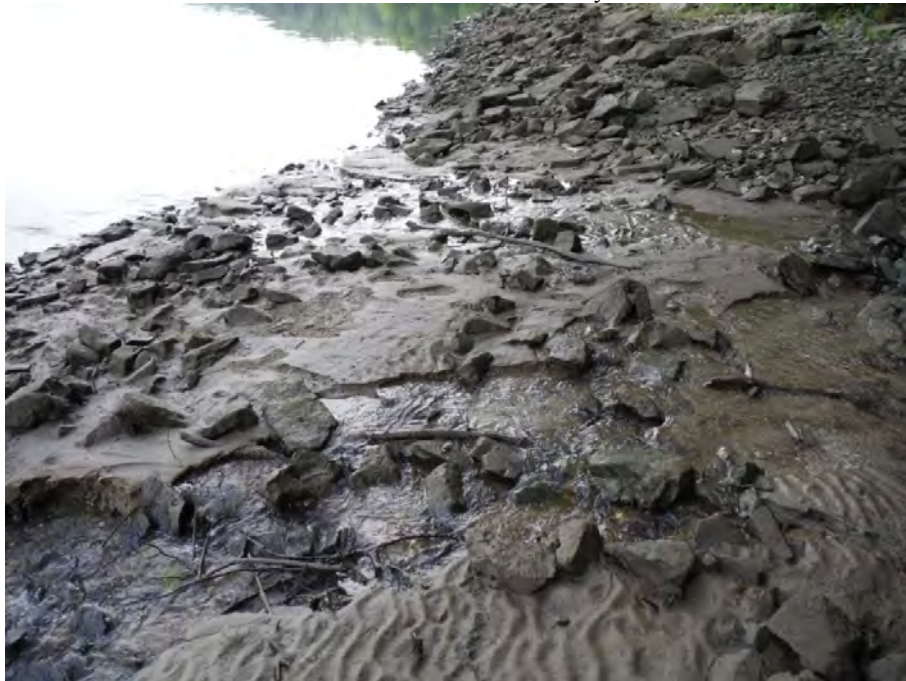
**Figure 5.3.1.9-4. Conditions at Merriam Brook Confluence during the summer survey period**

Substrates at the confluence were composed primarily of cobble, gravel and fines including sand and silt. The coarse substrates were overlain and embedded in fine sediments presumably deposited during the spring freshet when high flows in the river move large volumes of sediment. This conclusion was supported by field observation of a reduction in fine sediments in the confluence area as the seasonal surveys progressed and is evident when comparing Figures [5.3.1.9-4](#) through [5.3.1.9-6](#).

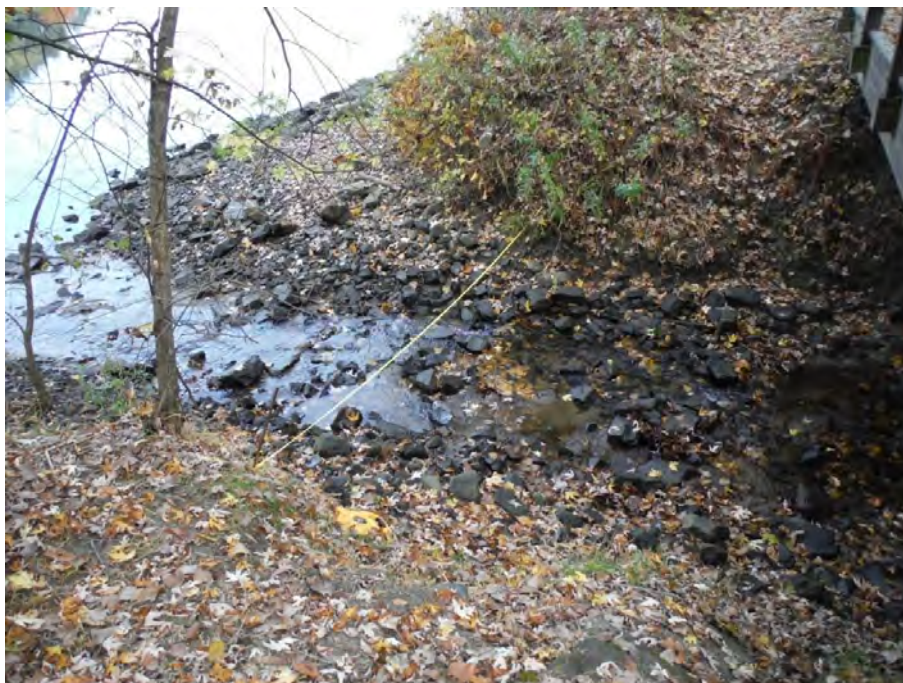
**Figure 5.3.1.9-5. Conditions at Merriam Brook Confluence during the fall survey period**

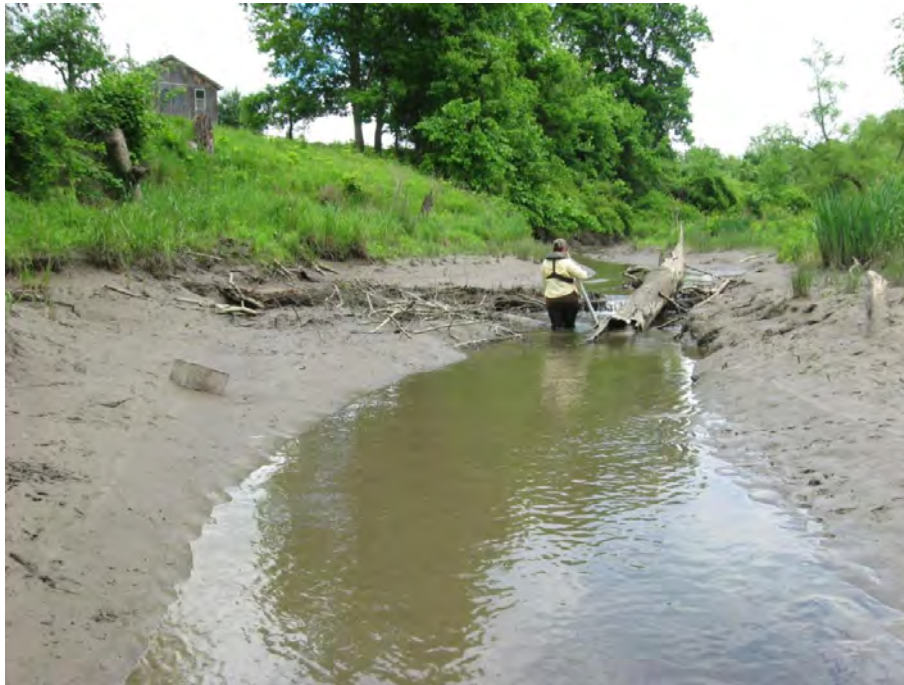
**Figure 5.3.1.13-2. Conditions at Pine Meadow Brook Confluence during the spring survey period, impoundment WSEL of 180.53 ft (NGVD29)**

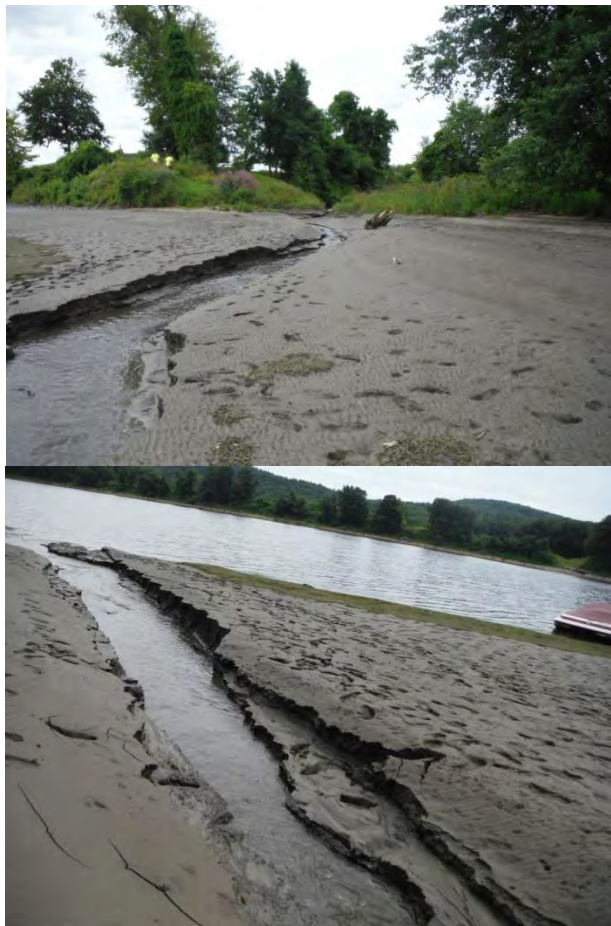
**Figure 5.3.1.13-3. Conditions at Pine Meadow Brook Confluence on August 12, 2014**  
Impoundment WSEL 179.15 ft (NGVD29) as measured downstream at the nearest water level gage.

No barriers were observed at the mouth of the confluence during any of the seasonal surveys; however, the flow in the lower confluence becomes channelized and shallow during low pond and low tributary flow periods ([Figure 5.3.1.13-3](#)). A woody debris jam was present approximately 183 ft upstream from the impoundment that restricts access to the rest of the tributary under low-flow conditions ([Figure 5.3.1.13-4](#)). The top of the debris jam is at an elevation of 180 ft ([Figure 5.3.1.13-5](#)). [Figure 5.3.1.13-6](#) is a representative photo of the confluence at higher impoundment elevation (182.13 ft) at which elevation the debris jam is not a barrier. Removal of the small debris jam would likely facilitate fish access to upstream portions of Pine Meadow Brook.

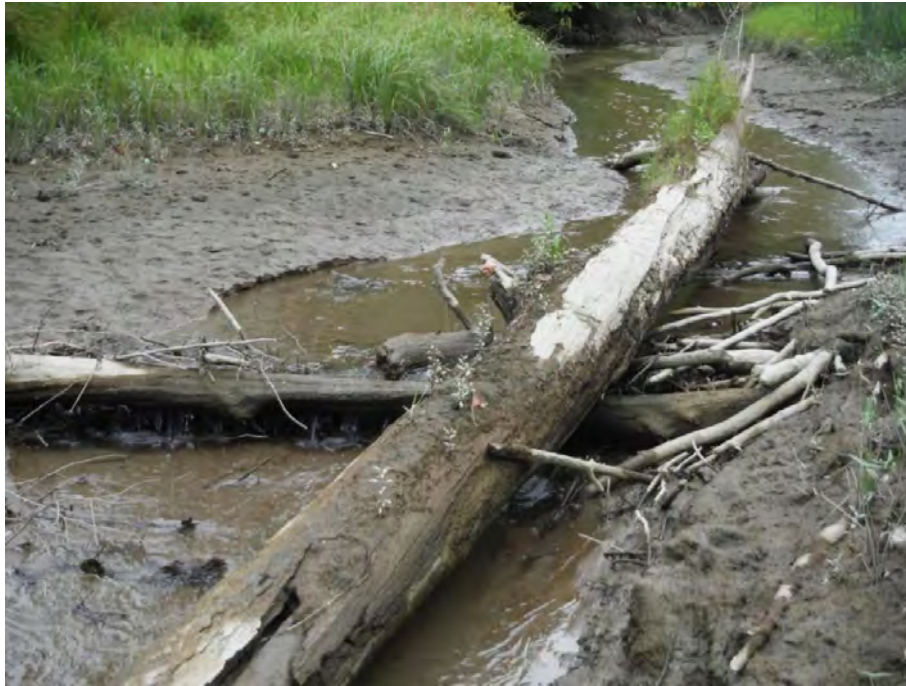
Figure 5.3.1.13-4. Conditions at Pine Meadow Brook Confluence on August 12, 2014

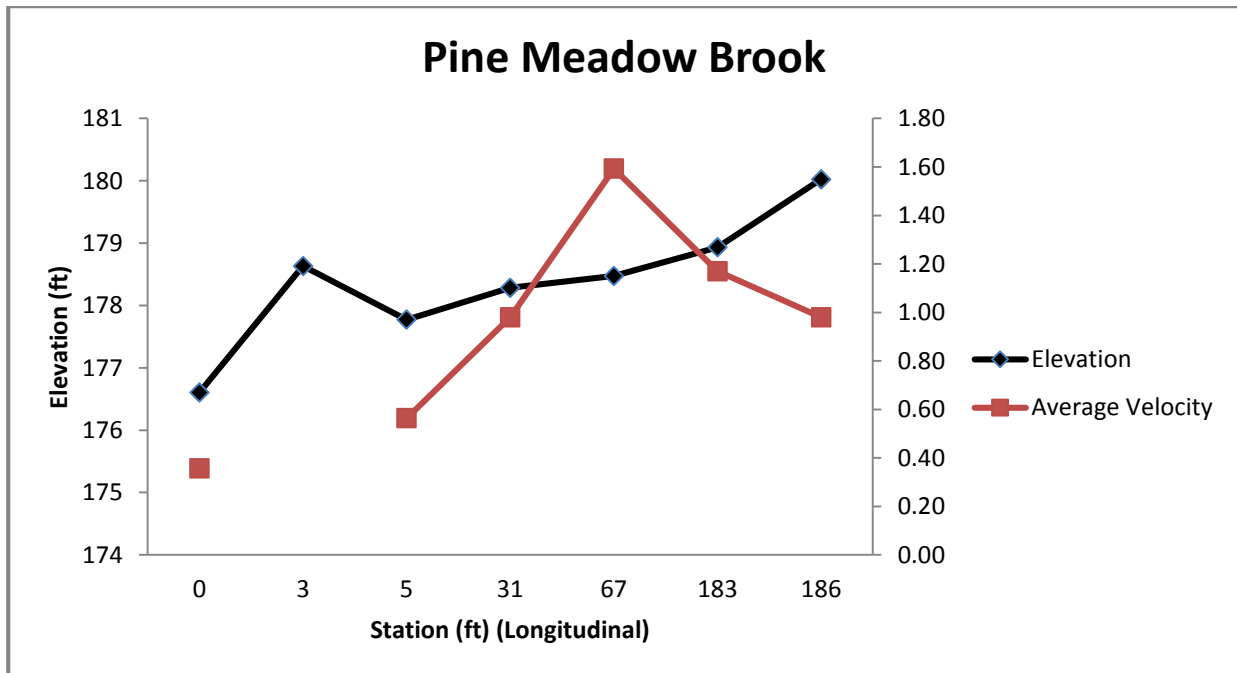
Figure 5.3.1.13-5. The longitudinal bed profile of Pine Meadow Brook on August 12, 2014. Stations 183 and 186 represent the base and top of the woody debris jam, respectively.

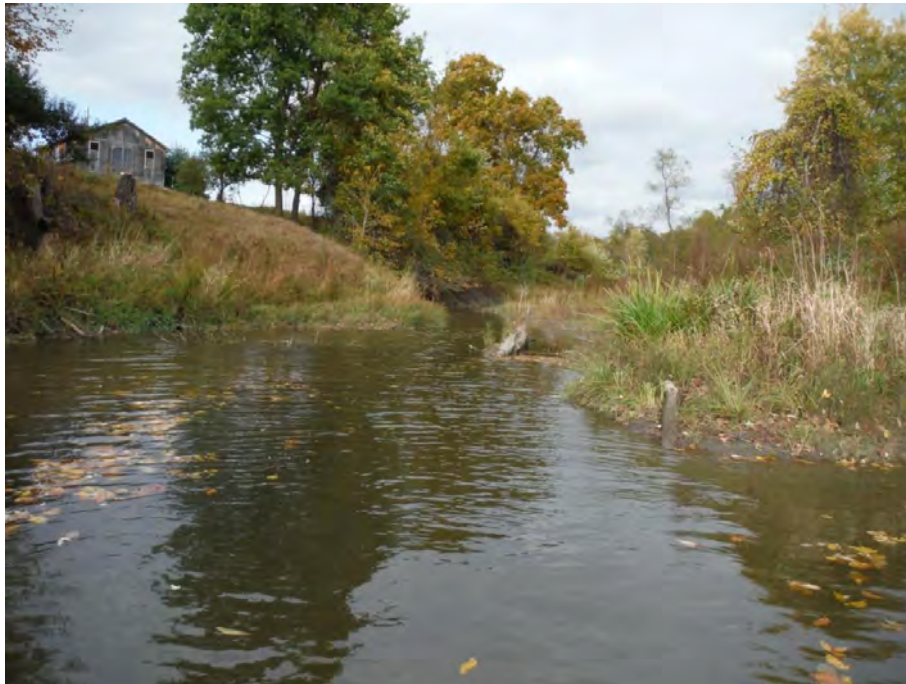
**Figure 5.3.1.13-6. Conditions at Pine Meadow Brook confluence on October 14, 2014**

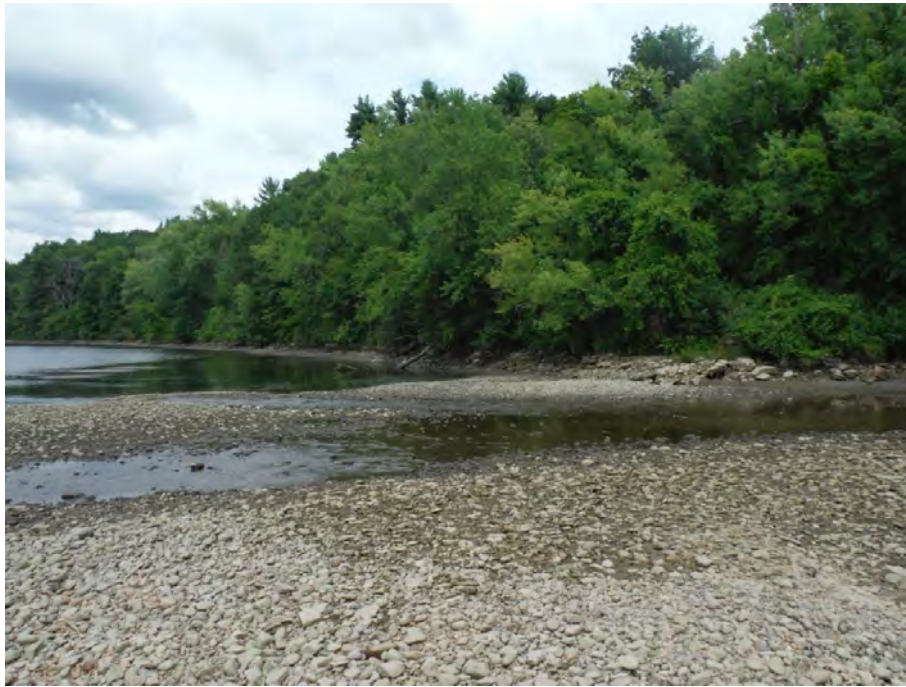
**Figure 5.3.1.14-2. Condition at Fourmile Brook confluence on August 12, 2014**  
The impoundment level was 178.97 ft at the time of the photo.

During the low-flow/impoundment conditions in summer (impoundment elevation 178.97 ft) the average water depth along the tributary confluence was 0.64 ft with an average water velocity of 0.72 fps ([Table 5.3.1.14-1](#)). Substrates at the Fourmile Brook confluence are composed primarily of cobble-gravel with some fines (e.g., sand and silt) that form the perched cobble bar at the tributary mouth.

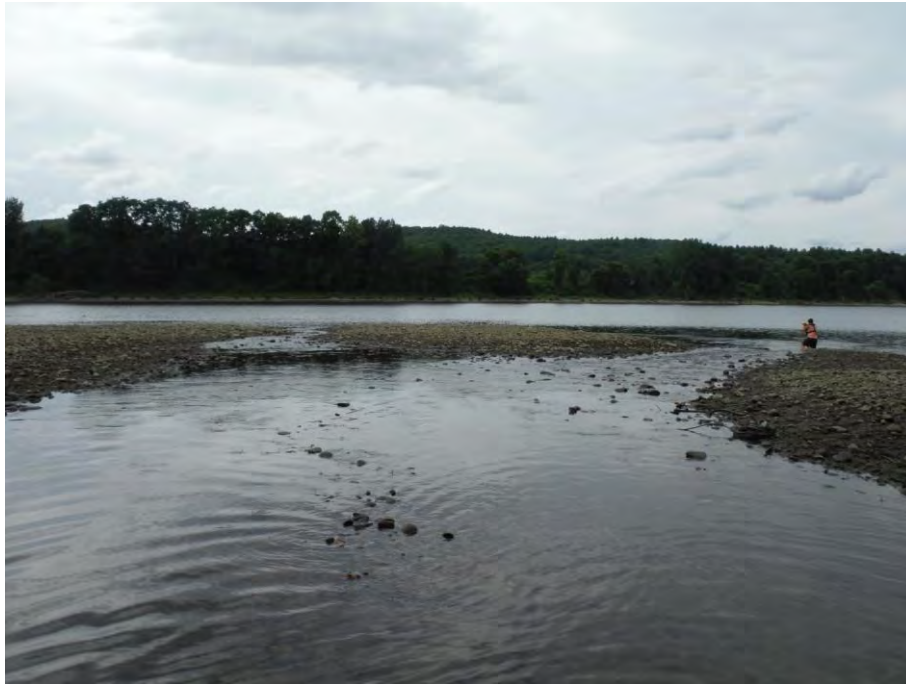
**Figure 5.3.1.14-3. Condition at Fourmile Brook confluence on August 12, 2014**

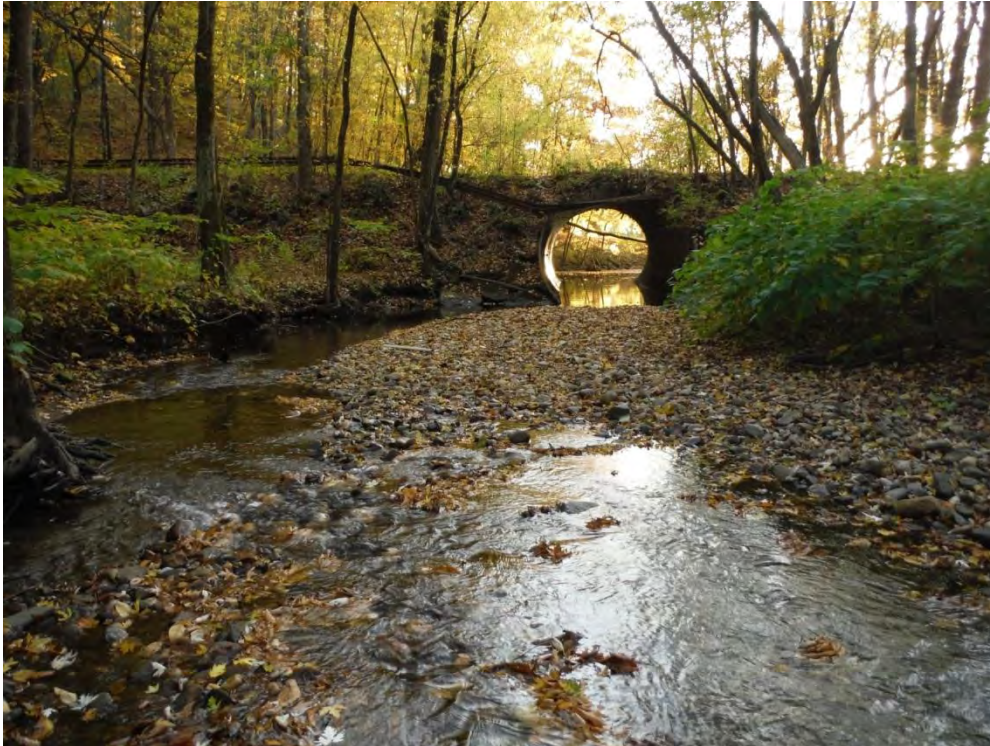
**Figure 5.3.1.14-5. Conditions at Fourmile Brook on October 14, 2014**

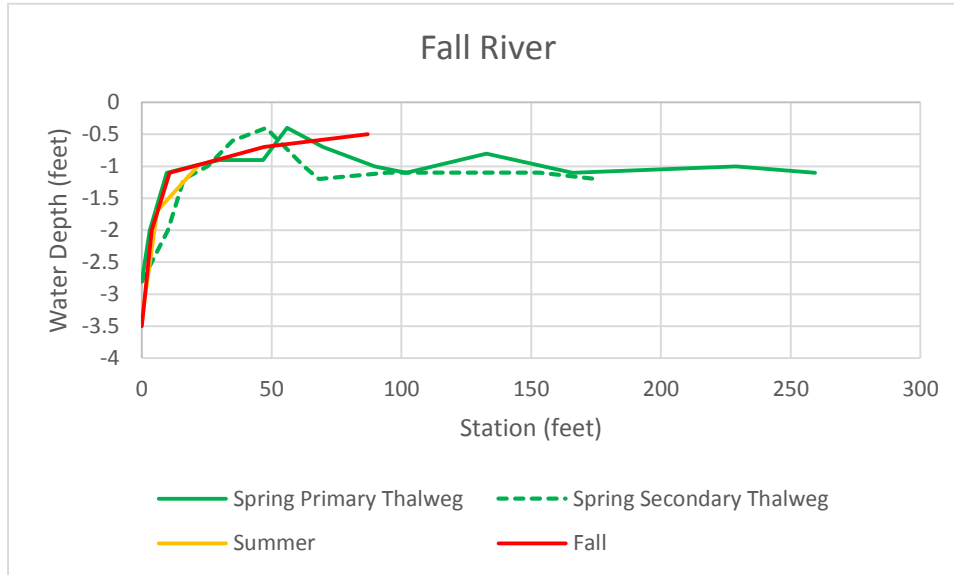
Figure 5.3.2.1-1. Longitudinal thalweg profiles Fall River during spring, summer, and fall conditions

The Fall River is the first tributary located downstream of the Turners Falls Dam ([Figure 3.0-2](#)) and drains into the bypass reach; its drainage area is 34.2 mi<sup>2</sup>. As the area below the dam is not affected by fluctuating impoundment levels, WSEL remained relatively stable during seasonal surveys. The surveys were conducted under minimum bypass flow conditions (400 cfs in the spring and 120 cfs in the summer and fall). However, spill events at the dam have a significant effect on WSEL in the bypass reach and the Fall River confluence, and the extent of the confluence is affected by the amount of spill. Seasonal fluctuations in the size and extent of the confluence were documented, such that the zone of influence was greatest in spring, extending approximately 250-300 ft upstream ([Appendix B](#)). A gravel bar in the center of the lower confluence area that created a pool between the upstream riffle and the gravel bar was observed during the

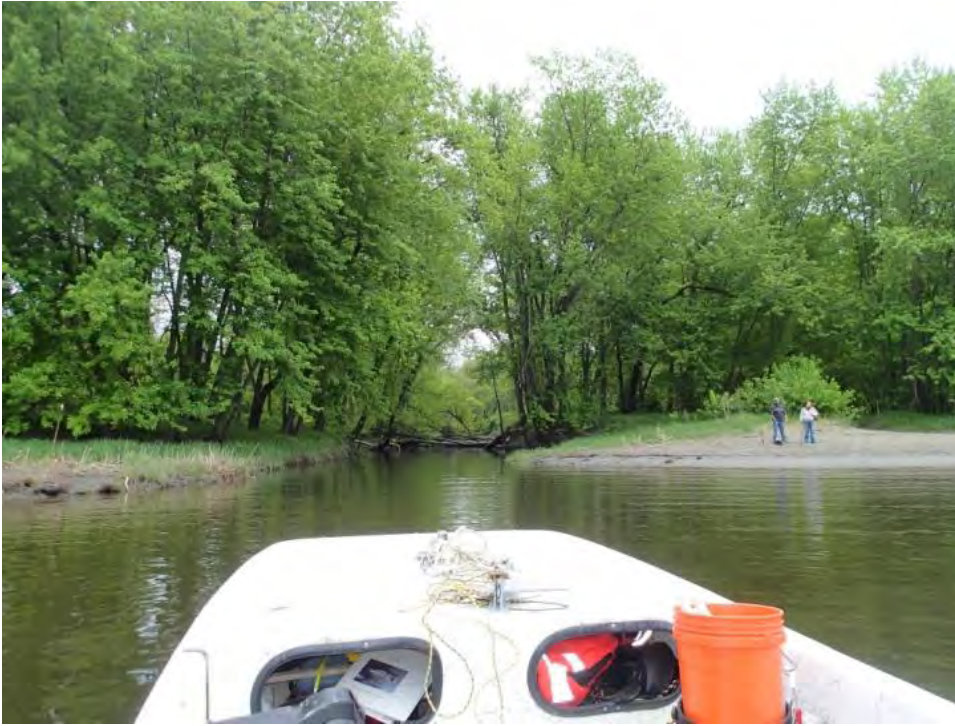
Pauchaug Brook during the spring survey, photo was taken on 6/4/2014, with an impoundment WSEL of 182.65 ft (NGVD 29) as measured from the nearest monitoring station.
