RELICENSING STUDY 3.1.1

2013 FULL RIVER RECONNAISSANCE

**Northfield Mountain Pumped Storage Project (No. 2485)
and Turners Falls Hydroelectric Project (No. 1889)**

SEPTEMBER 2014

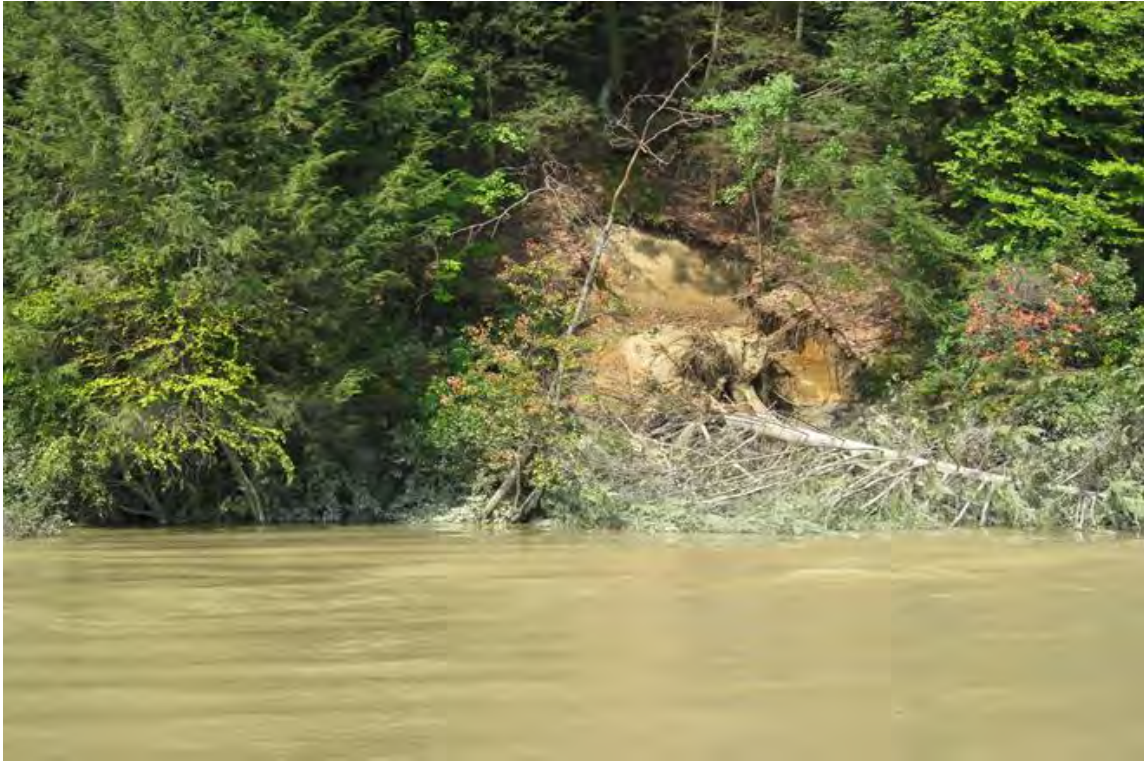
Figure 6.8 Erosion during Tropical Storm Irene

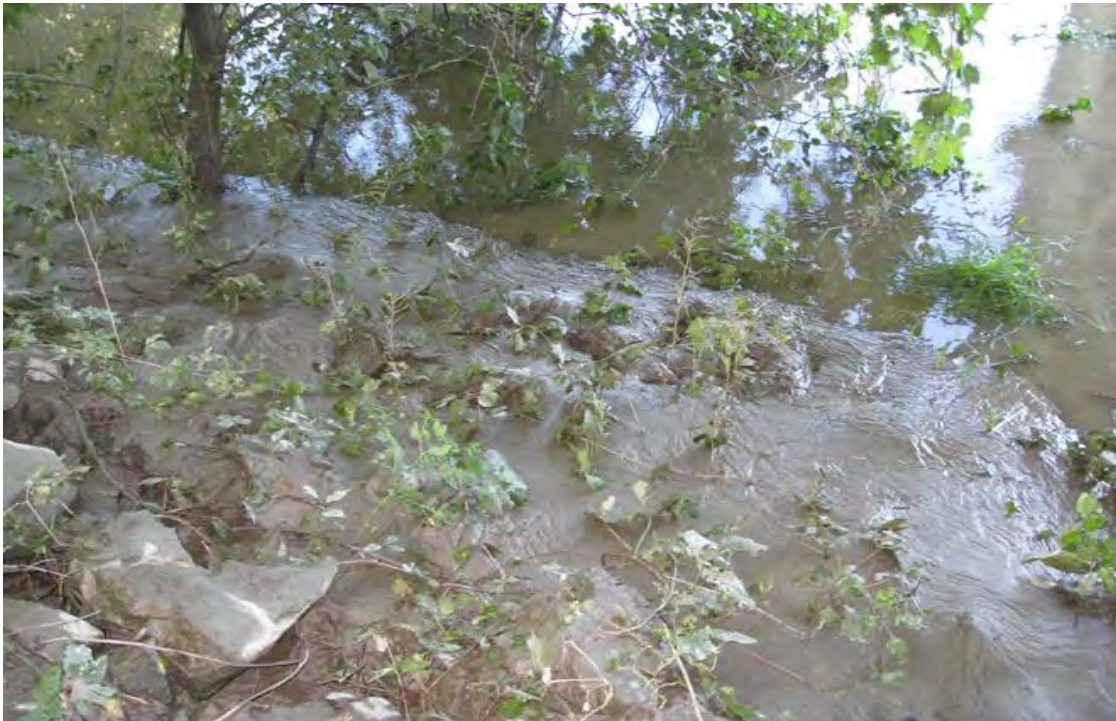
HI photo 366

Examples of lower riverbank deposition resulting from Irene can be found in [Figures 6.9 - 6.11](#). While some of the sediment deposited as a result of Tropical Storm Irene was subsequently washed away, some of it remained and provided additional media for recruitment of aquatic or other low-lying riparian vegetation. This vegetation was found to have colonized and is growing on the layer of deposited sediment.

Figure 6.9 Sediment deposition due to Tropical Storm Irene

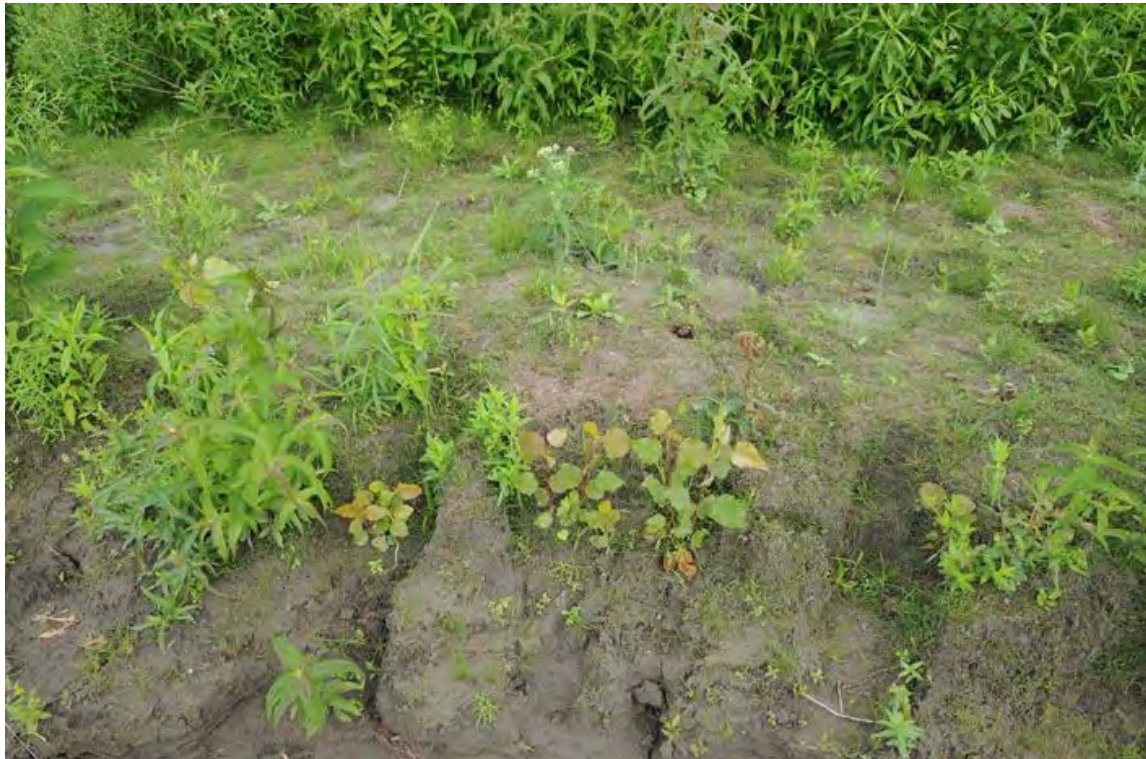
Lower Split River restoration site – 60 cm deposition

Figure 6.11 Sediment deposition and vegetation including cottonwood seedlings

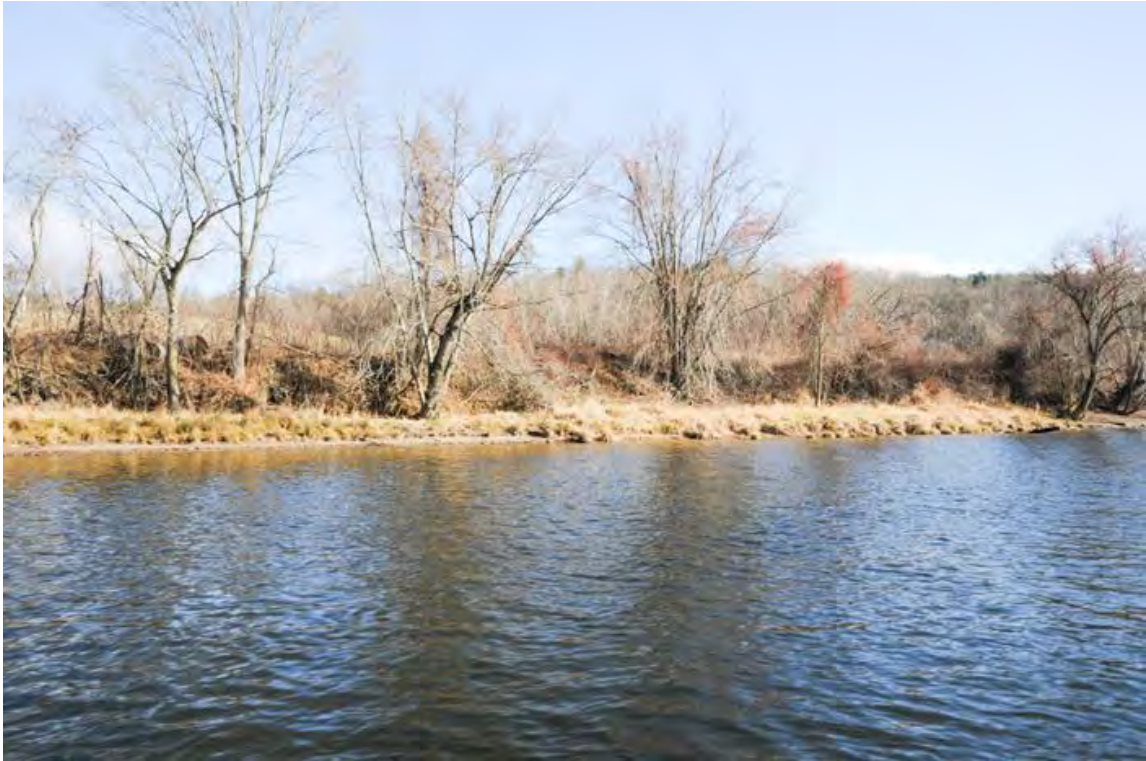
photo 6586

Although riverbank segments where lower riverbank vegetation currently exists remain a relatively small portion of the Impoundment, there has been a significant increase in lower riverbank vegetation. This increase in vegetation is a result of the sediment deposition due to Tropical Storm Irene combined with the frequency and magnitude of flows since Irene which have allowed the majority of the deposited sediment to remain in place and vegetation to establish. Examples of new lower riverbank vegetation at a number of locations throughout the Impoundment are shown in [Figures 6.12 and 6.13](#).

Figure 6.12 Sediment deposition and vegetation

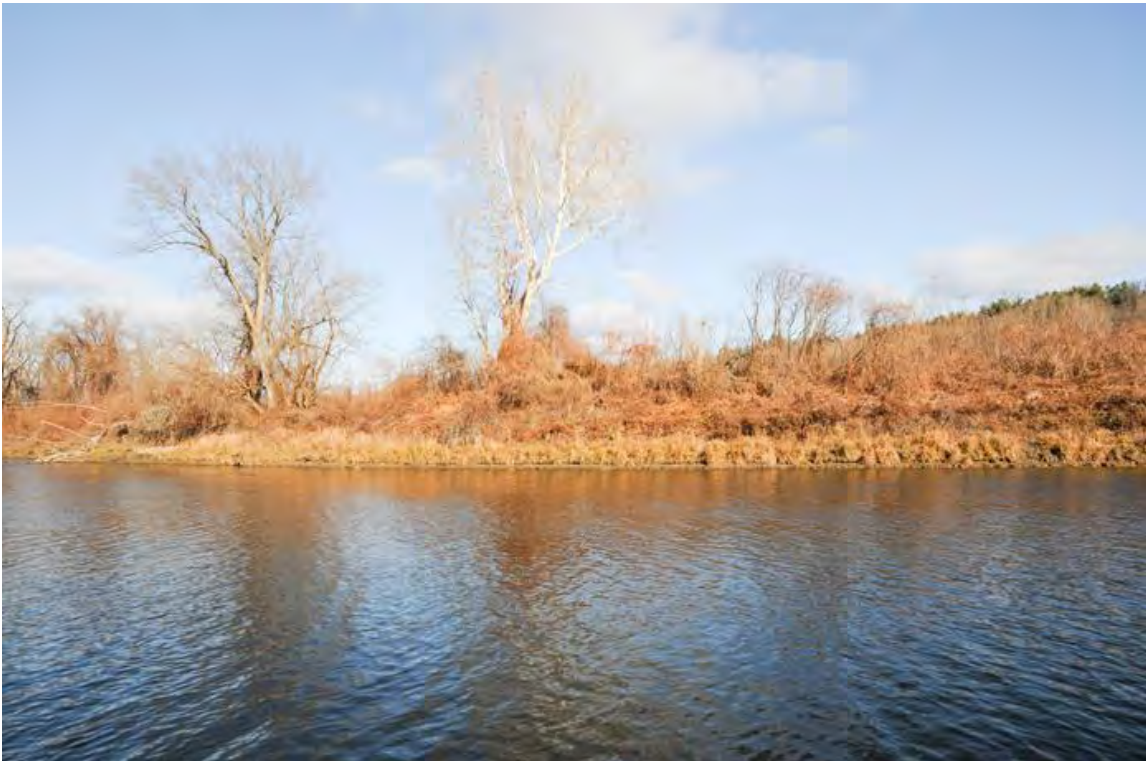
Segment 303, FRR photo 1577

Figure 6.13 Sediment deposition and vegetation

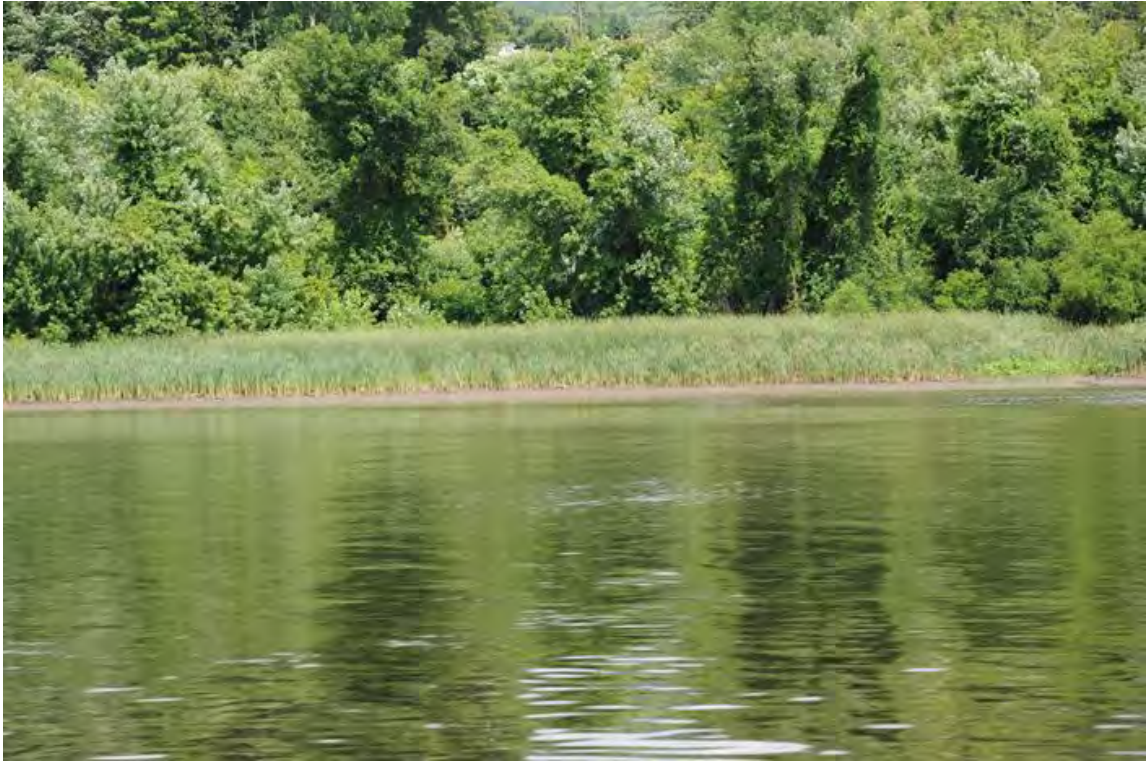
FRR photo 1546

Vegetation at this portion of the riverbank, which is primarily located at the transition between the lower and upper riverbank, provides significant erosion protection by damping or attenuating hydraulic forces from the current and boat waves, increasing resistance to erosion due to root density and strength, and encouraging additional sediment deposition. Sediment deposition and growth of vegetation at this key location on the riverbank provides support to the toe of the upper riverbank which increases stability and discourages erosion. The density of a patch of such vegetation in the summer is shown in [Figure 6.14](#).

Figure 6.14 Lower riverbank vegetation, summer 2014

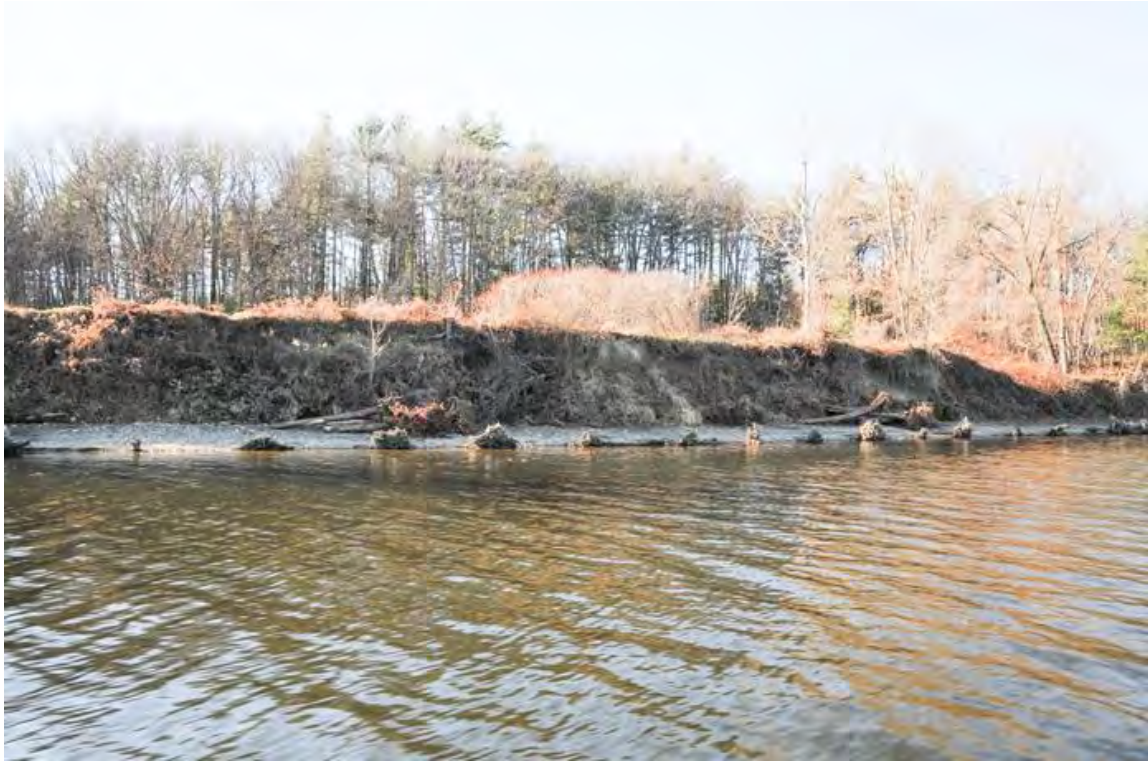
photo 1056

One factor in evaluating the stability of a riverbank is the resistance to erosion of the lower riverbank. If a lower riverbank consists of non- or less-erodible material it is less erodible and provides support to the upper riverbank. There has been an increase in lower riverbanks consisting of gravel from 2008 to 2013 and less in the silt/sand category. From 2008 to 2013 there has been a decrease in silt/sand of approximately 6% and a corresponding increase in gravel of approximately 5%. Much of this change is due to gravel placement on the lower riverbanks (along with anchored woody debris and vegetation) due to the construction of several stabilization projects during this time frame (Lower Split River Farm, Upper Split River Farm, Bathory/Gallagher). Placement of gravel on the lower riverbank along with anchored woody debris before planting of vegetation is shown in [Figure 6.16](#).

Figure 6.16 Gravel placement

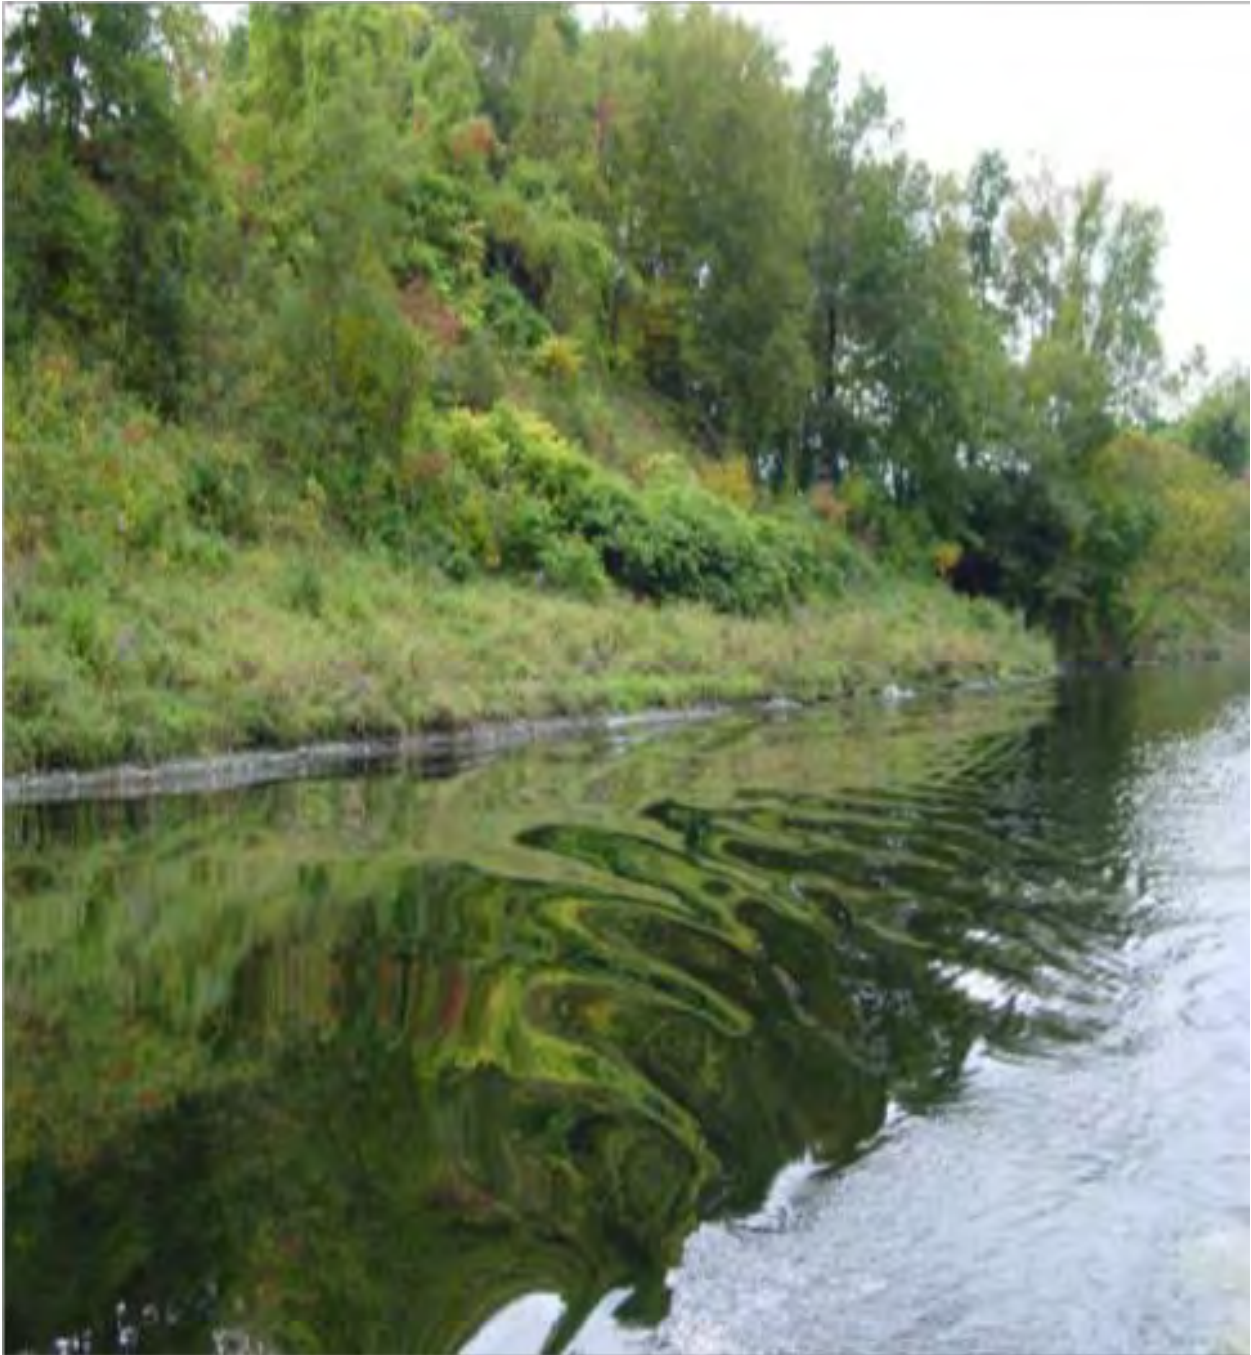
Figure 6.18 Example of Erosion Site after stabilization (Skalski, 2008)

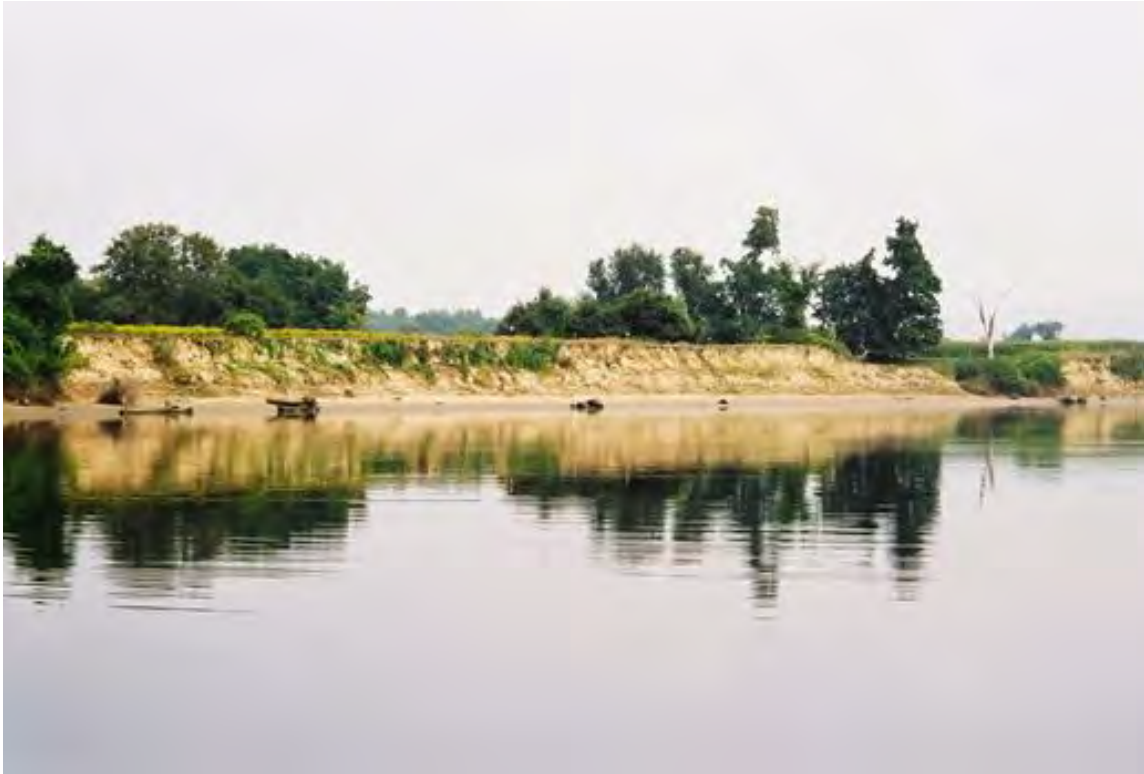
In 1998, 20 sites were identified with the greatest severity of erosion. Since that time most of the previously identified sites have been stabilized. While some of these sites remain un-stabilized (i.e. downstream of Vernon Dam and at the Route 10 Bridge) most of the eroding sites that remain in 2013 are less severely eroding and of smaller lengths than the initial set of sites. [Figures 6.19](#) and [6.20](#) compare examples of eroded areas in 1998 to 2013.

Figure 6.19 Flagg Site in 1998

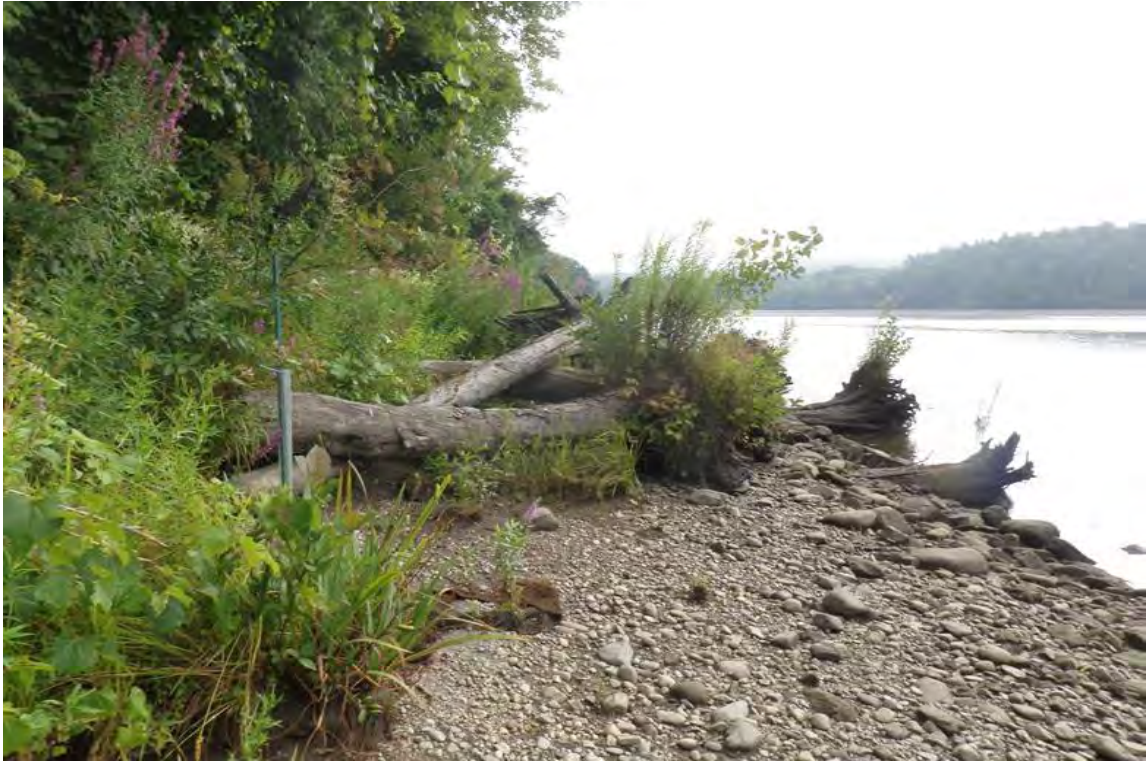
encourages the establishment of vegetation on the lower riverbank areas. In addition, lower riverbank vegetation has been planted and seeds distributed to increase the coverage and density of this important component of vegetation as an integral part of the riverbank stabilization process ([Figures 6.21](#) and [6.22](#)).

Figure 6.21 Vegetation planted on lower riverbank at stabilization site

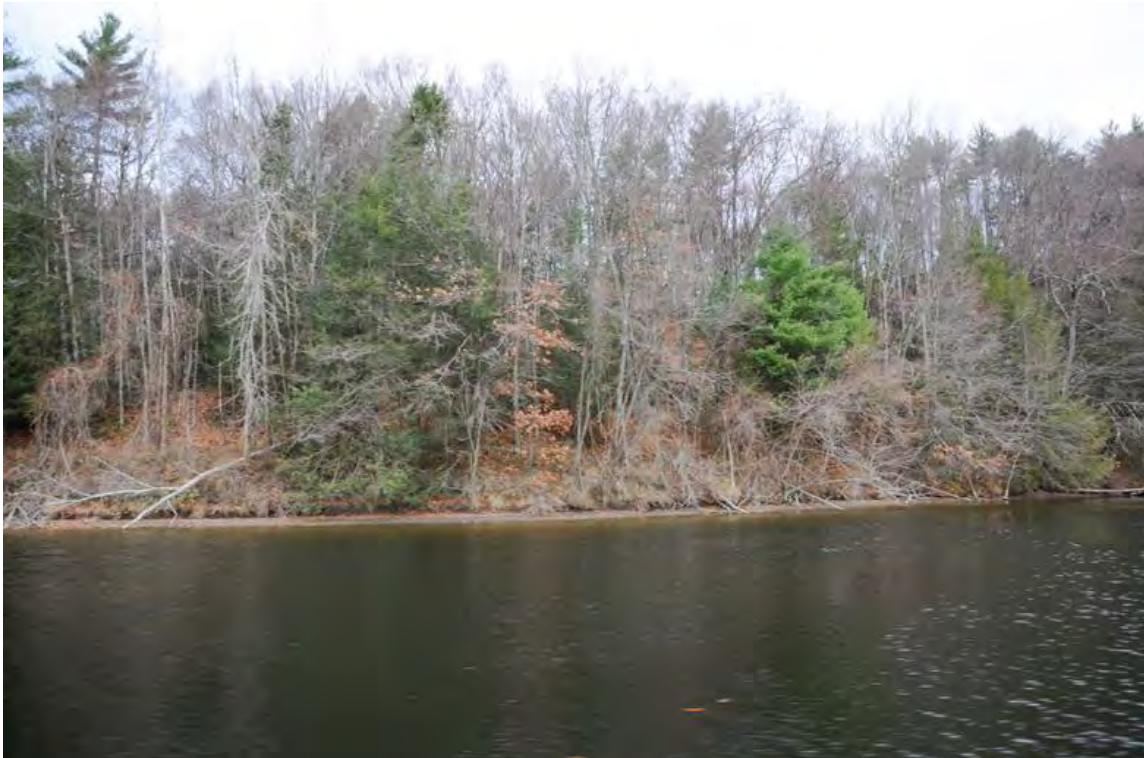
993

Figure 6.24 Moderate slope, vegetated bank

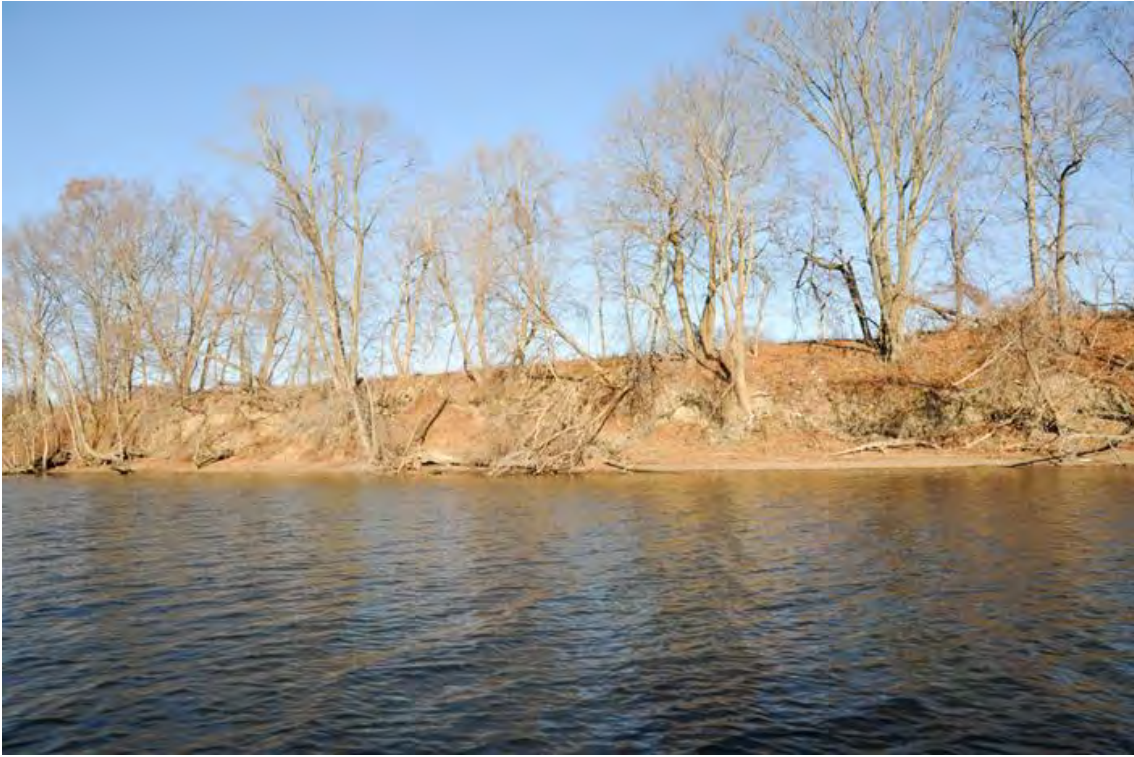
621

The strongest correlation between land-use and erosion has been observed in agricultural areas. Agriculture along the river typically is located on relatively flat floodplain terraces with only a narrow or virtually non-existent zone of riparian vegetation. Frequently the riverbanks in these areas are steep to overhanging and consist of silty/sandy soils that are easily erodible unless sufficient vegetation is present to reinforce the soil and provide some buffering of hydraulic forces. An example of erosion that has occurred where the agricultural land-use exists can be seen in [Figure 6.30](#).

Figure 6.30 Erosion adjacent to agricultural land-use

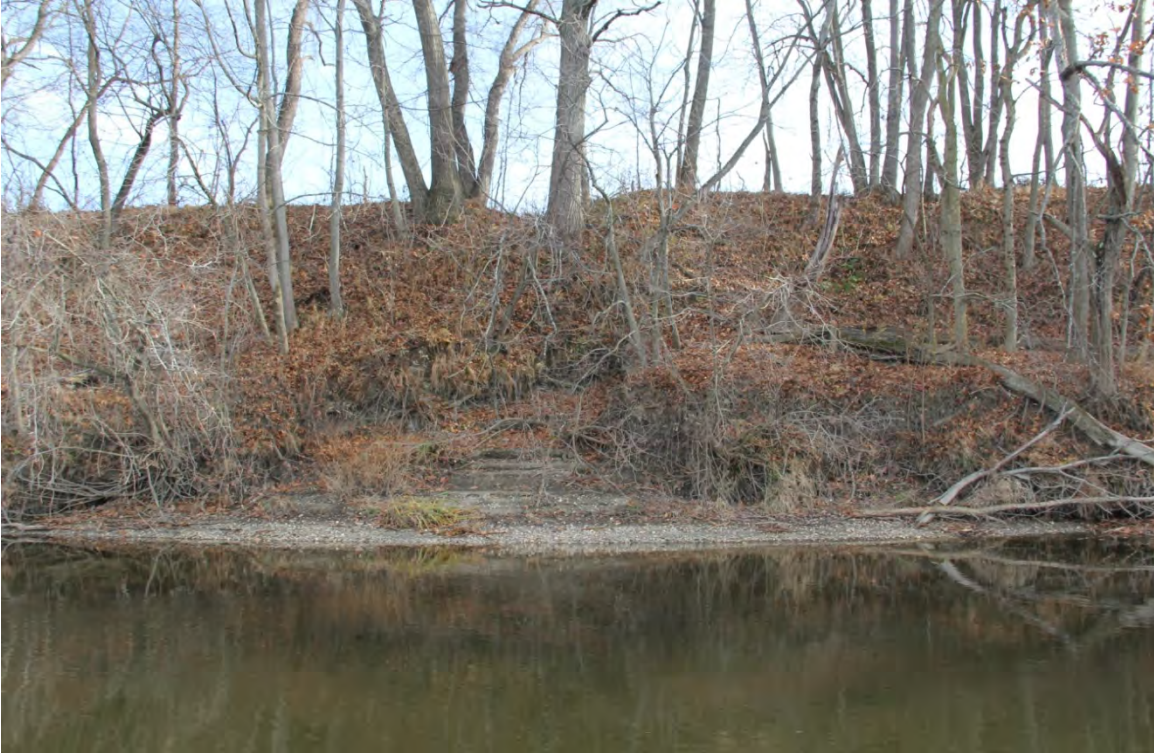
None/Little (<10%)

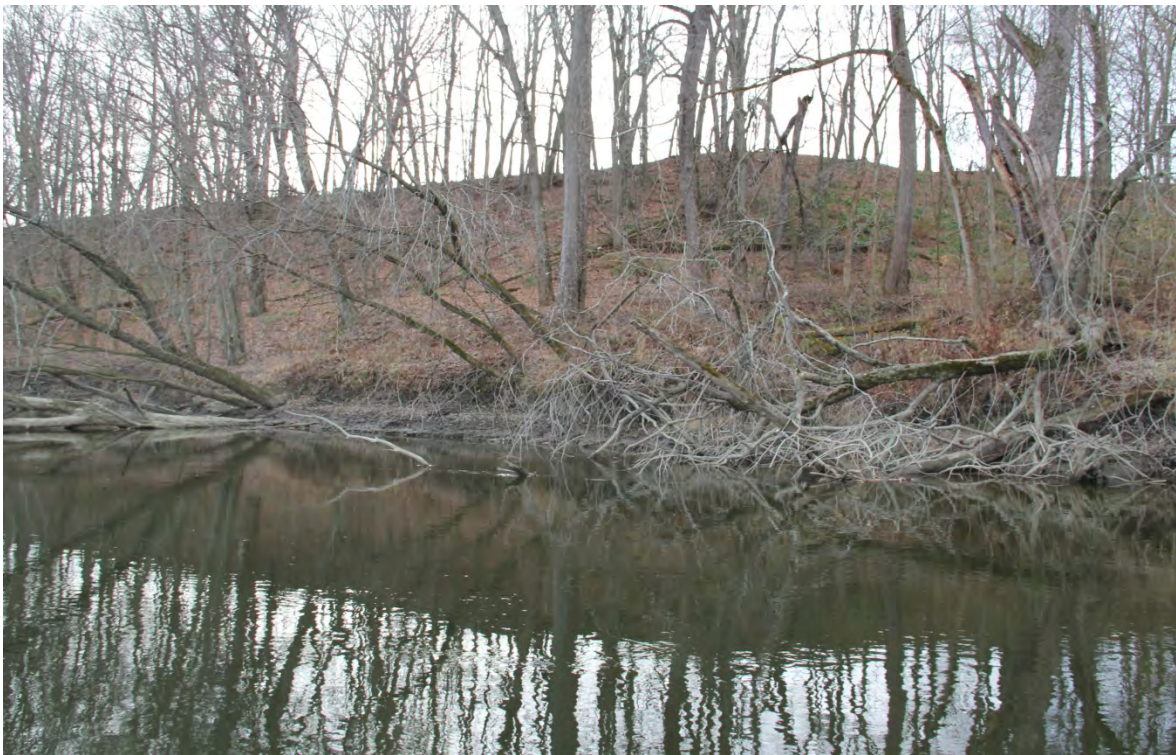
None/Little (<10%)

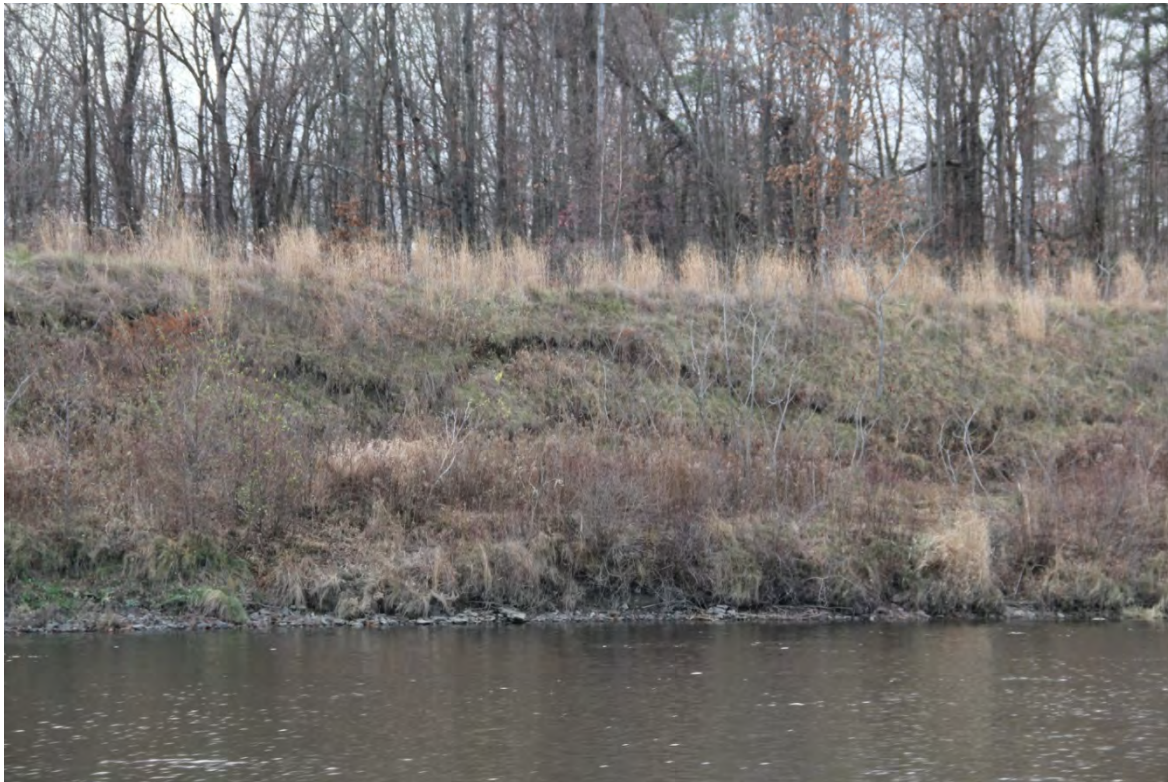
None/Little (<10%)

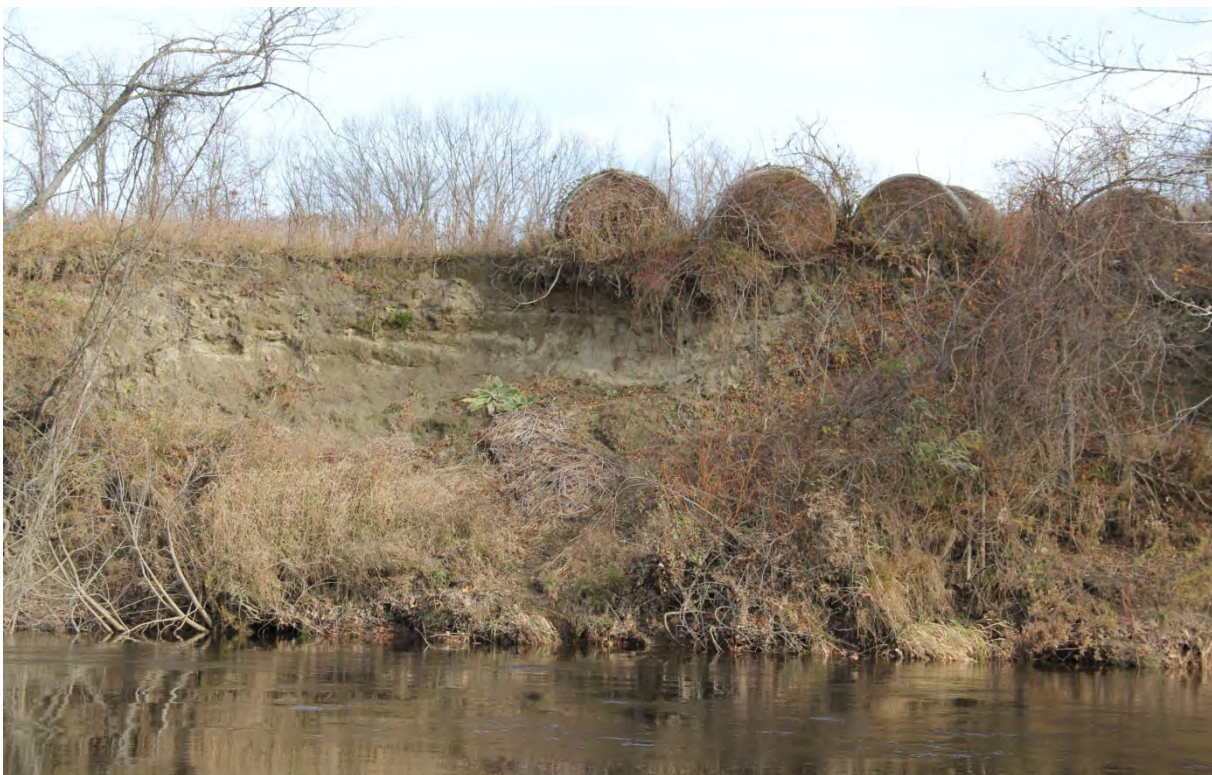
Some (10%-40%)

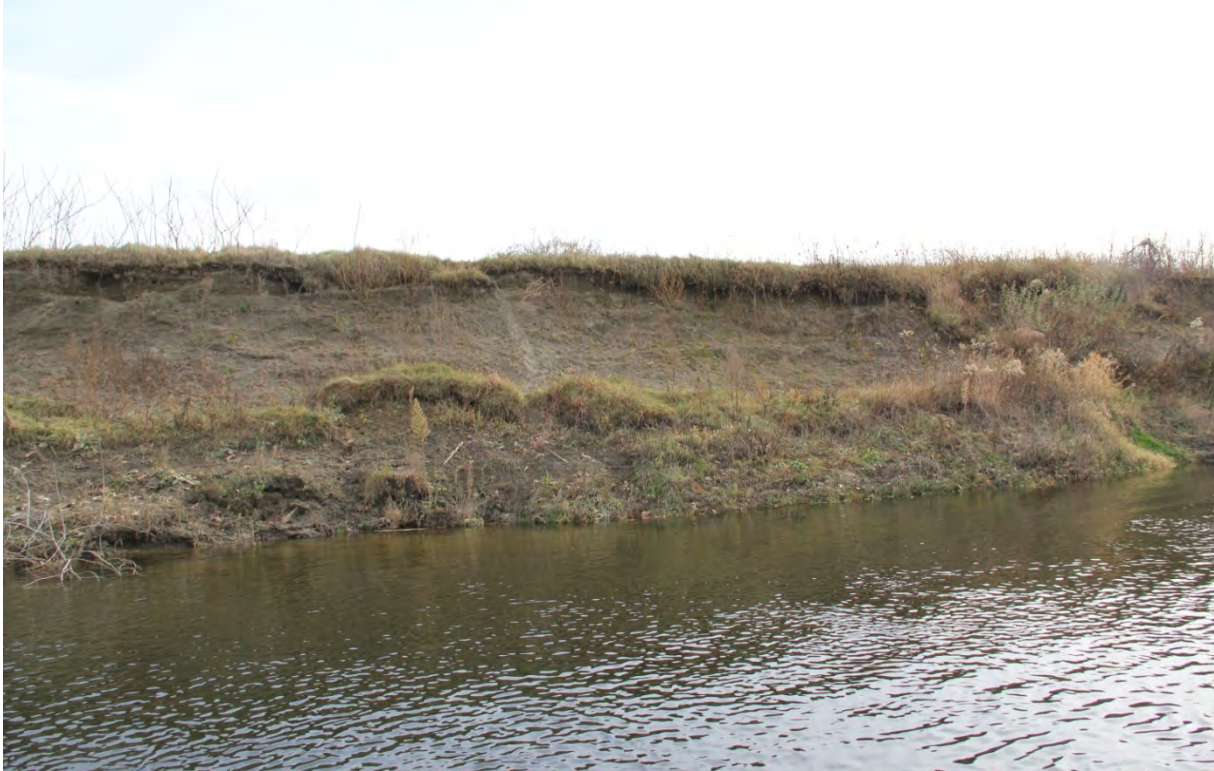
Some to Extensive (40%-70%)

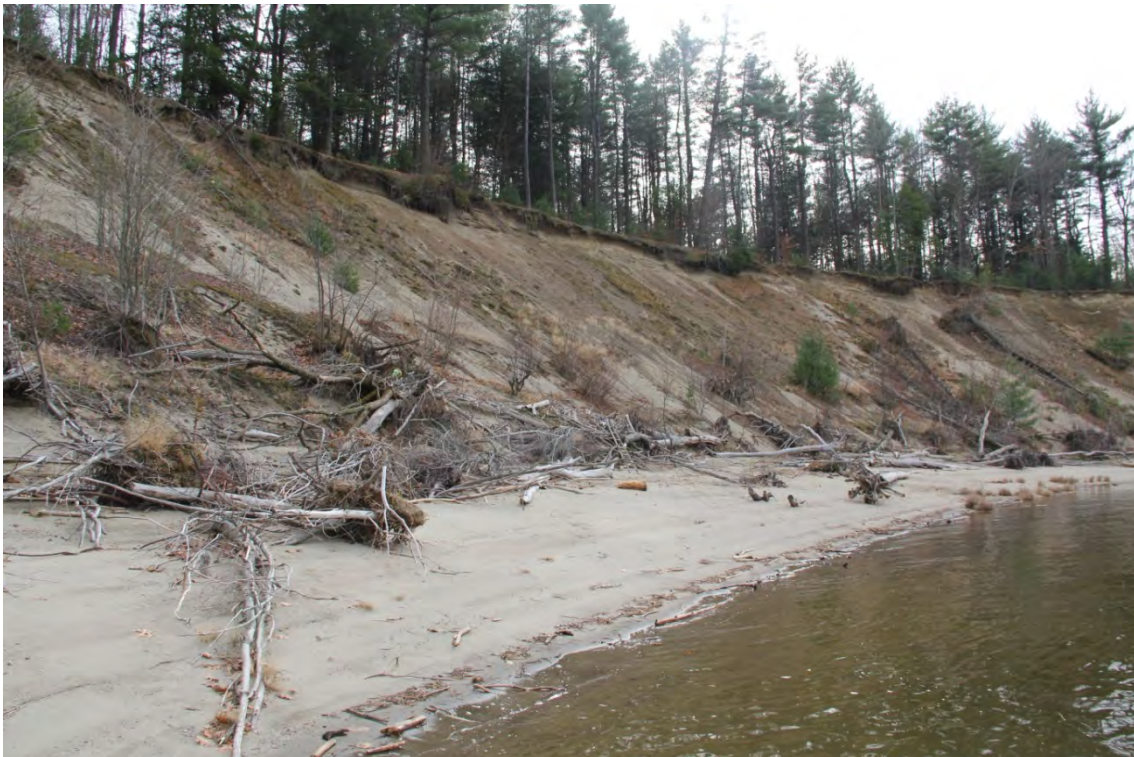
Extensive (>70%)

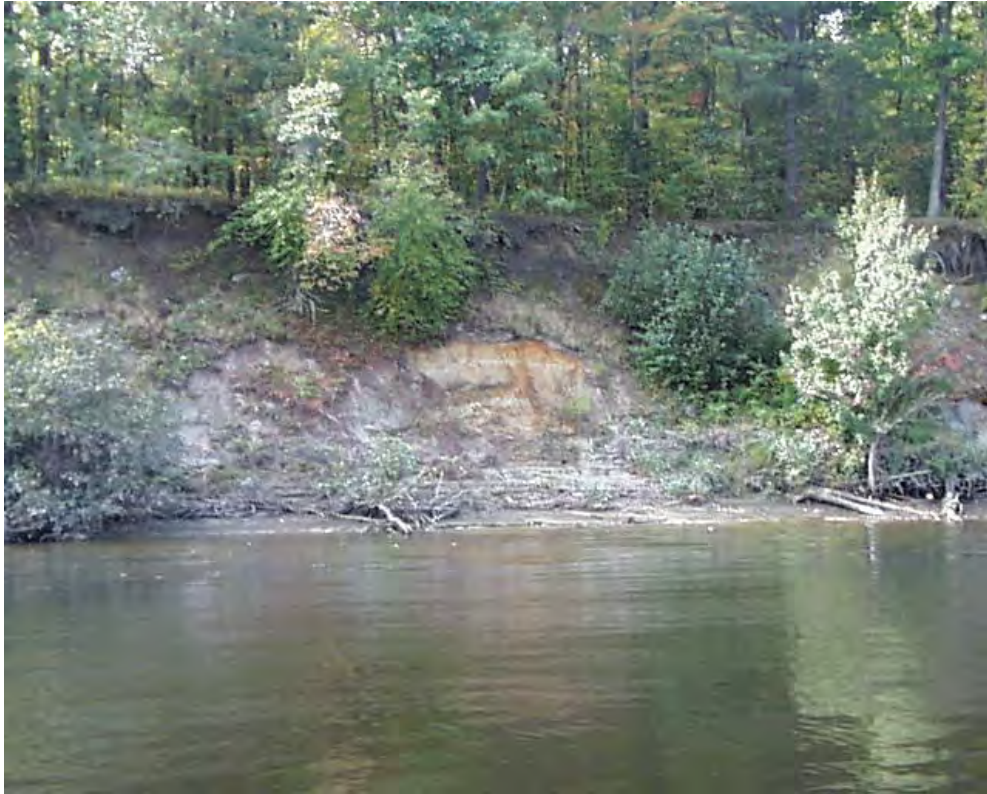
Extensive (>70%)

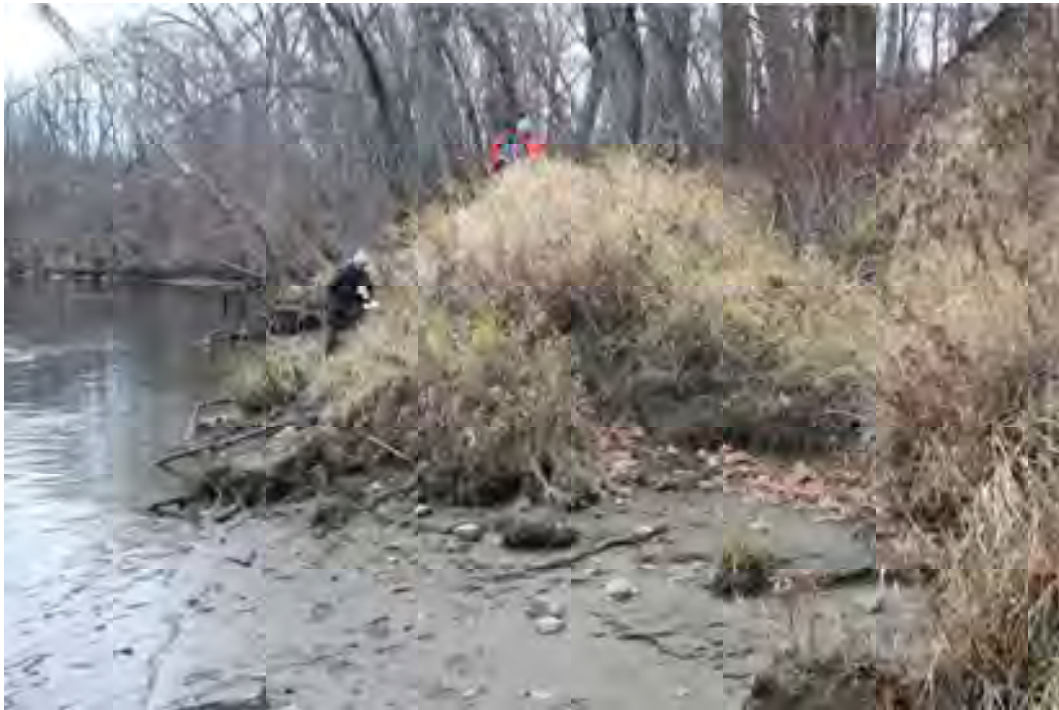
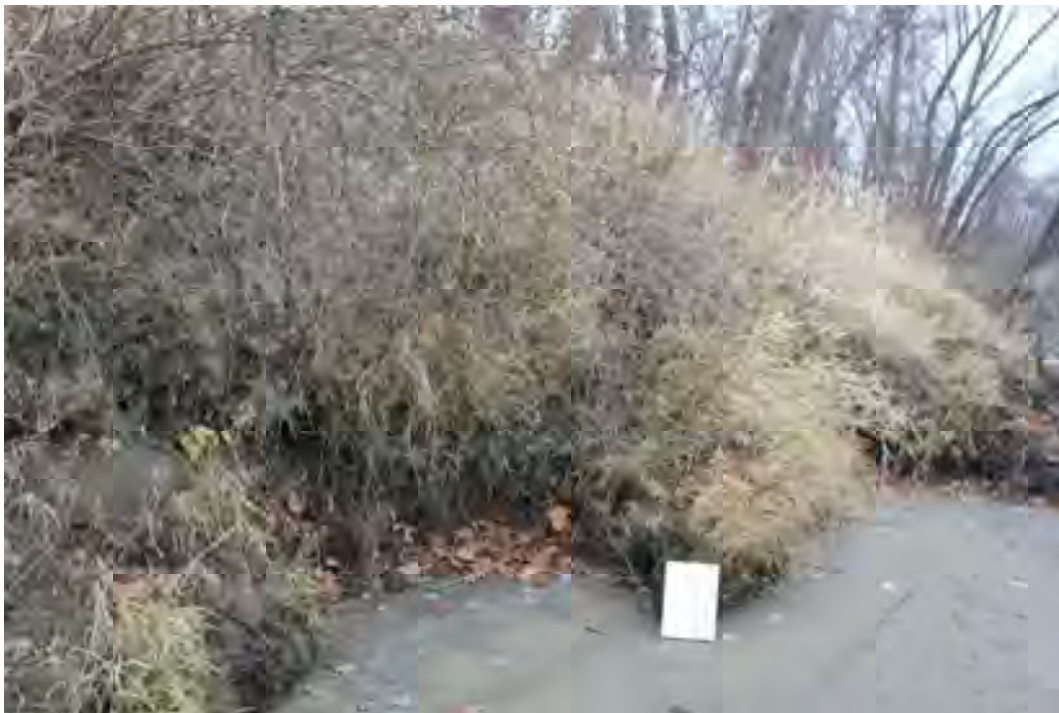
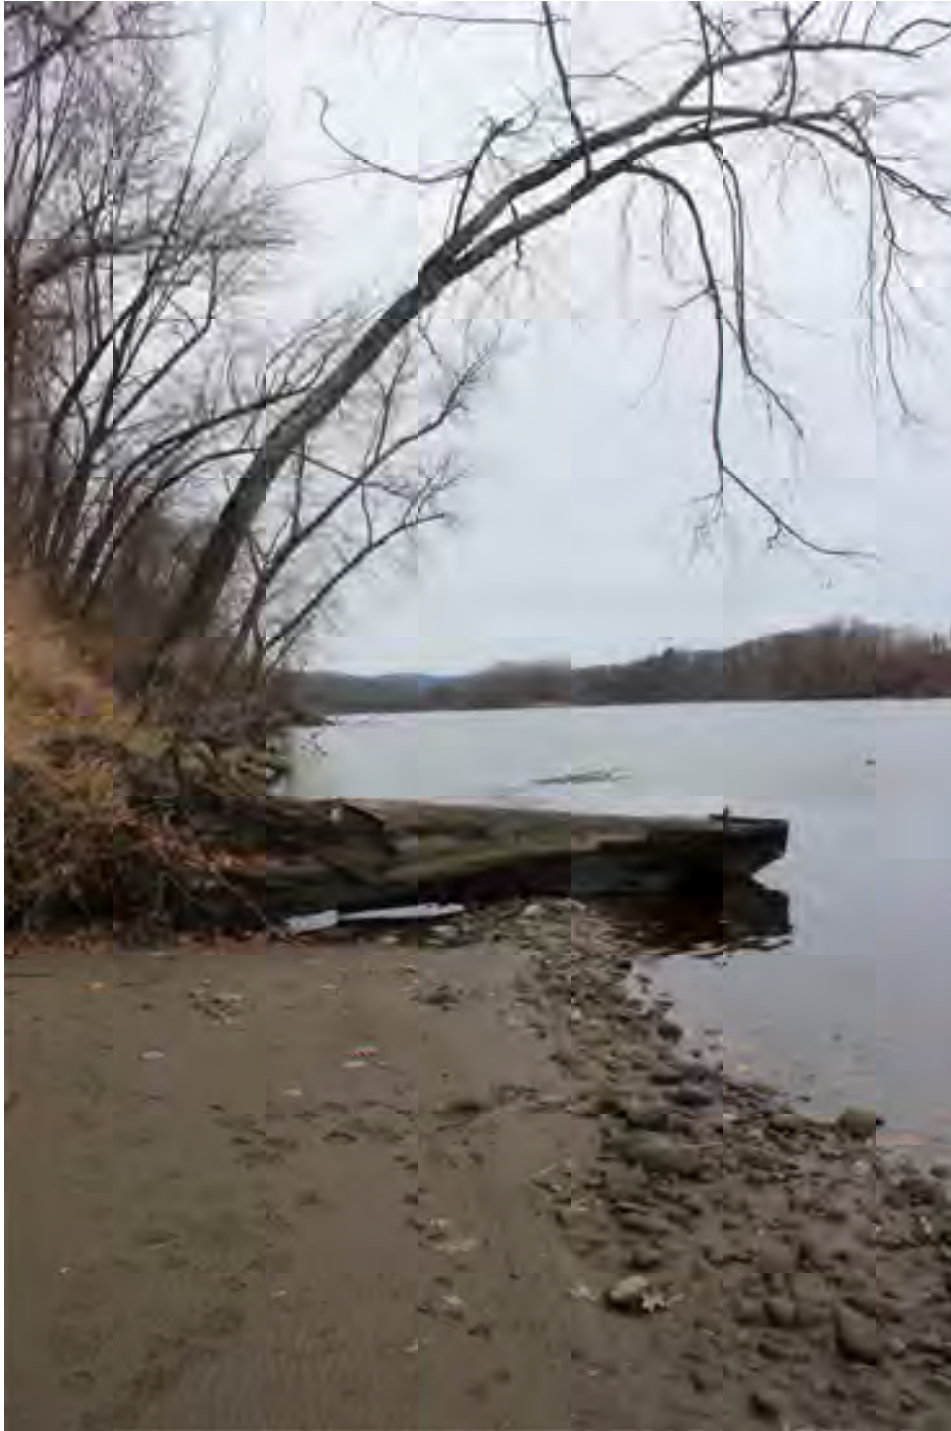
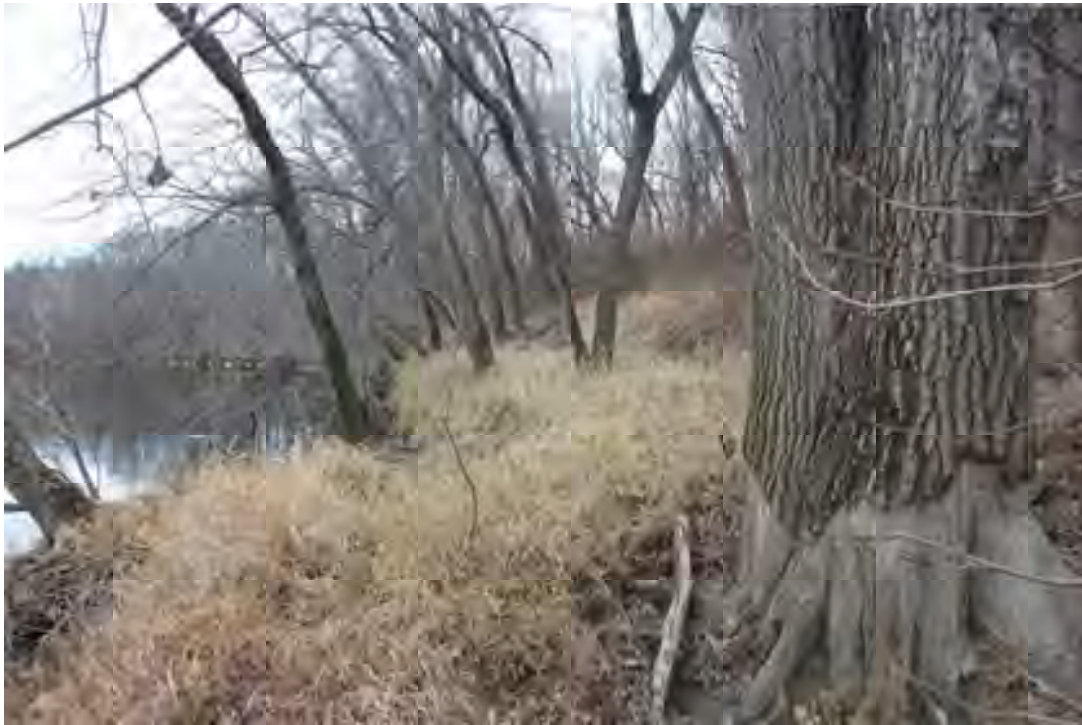
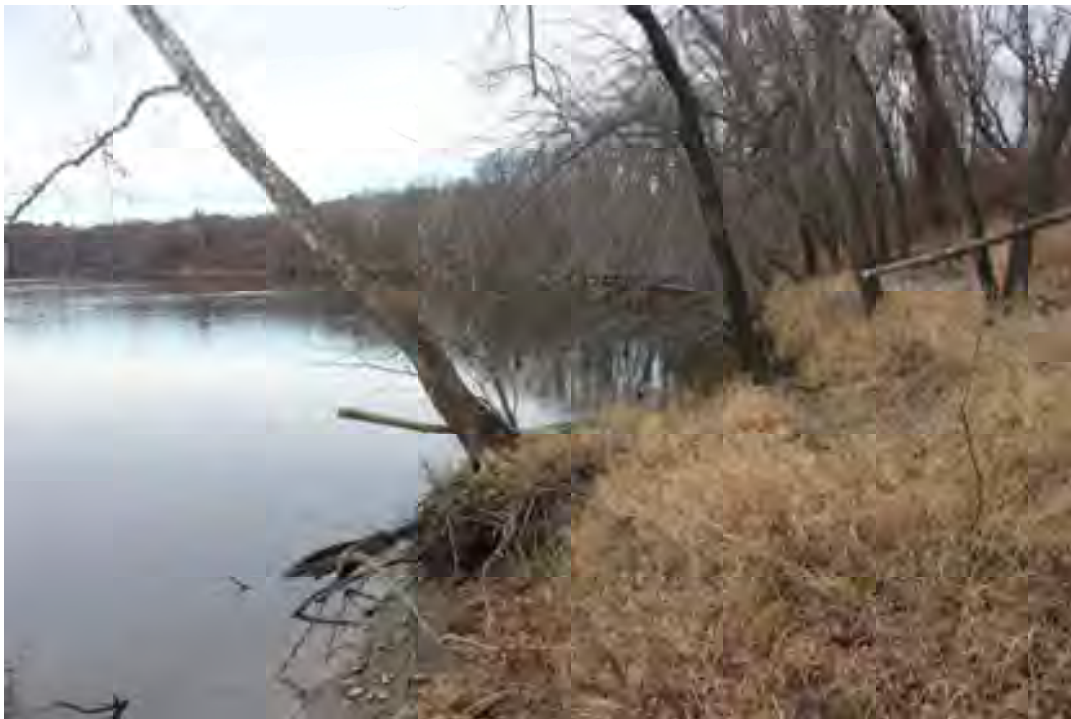
2013 Connecticut River Full River Reconnaissance
Land-Based Observations Photographs Reference No. 521 – 525
Observation Point No. 1 - November 12, 2013

Near vertical erosion scarps at bottom of upper bank, 5-10' high. Slumping, mass wasting, erosion gullies, leaning/downed trees at river level.
