RELICENSING STUDY 3.1.1

2013 FULL RIVER RECONNAISSANCE

**Northfield Mountain Pumped Storage Project (No. 2485)
and Turners Falls Hydroelectric Project (No. 1889)**

SEPTEMBER 2014

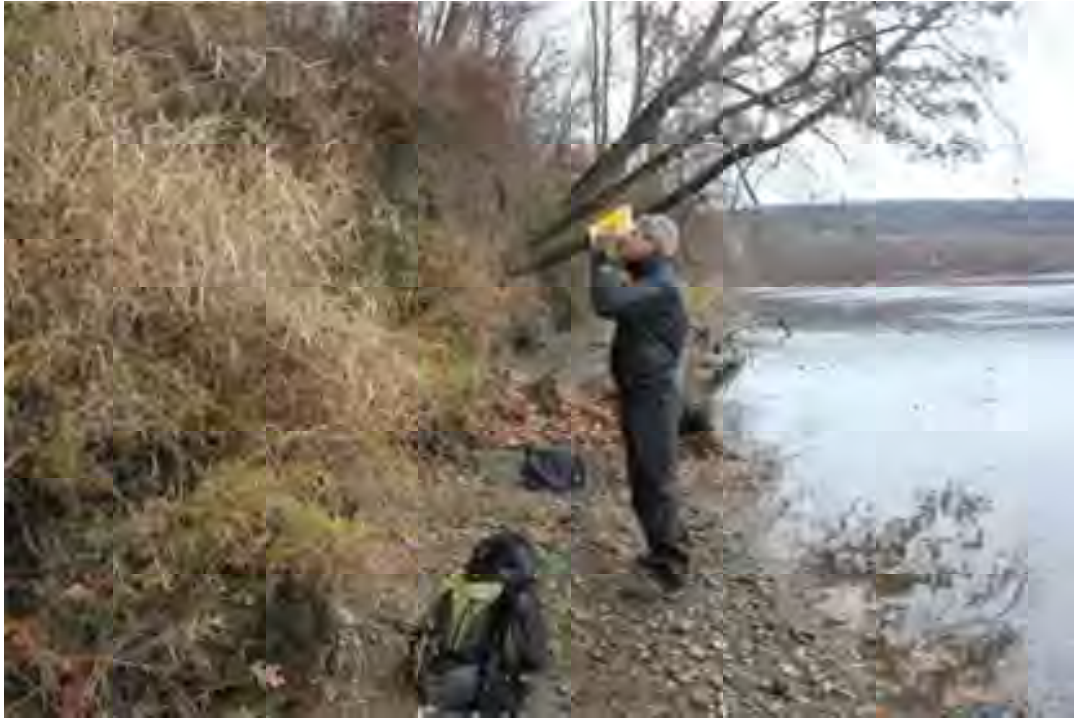
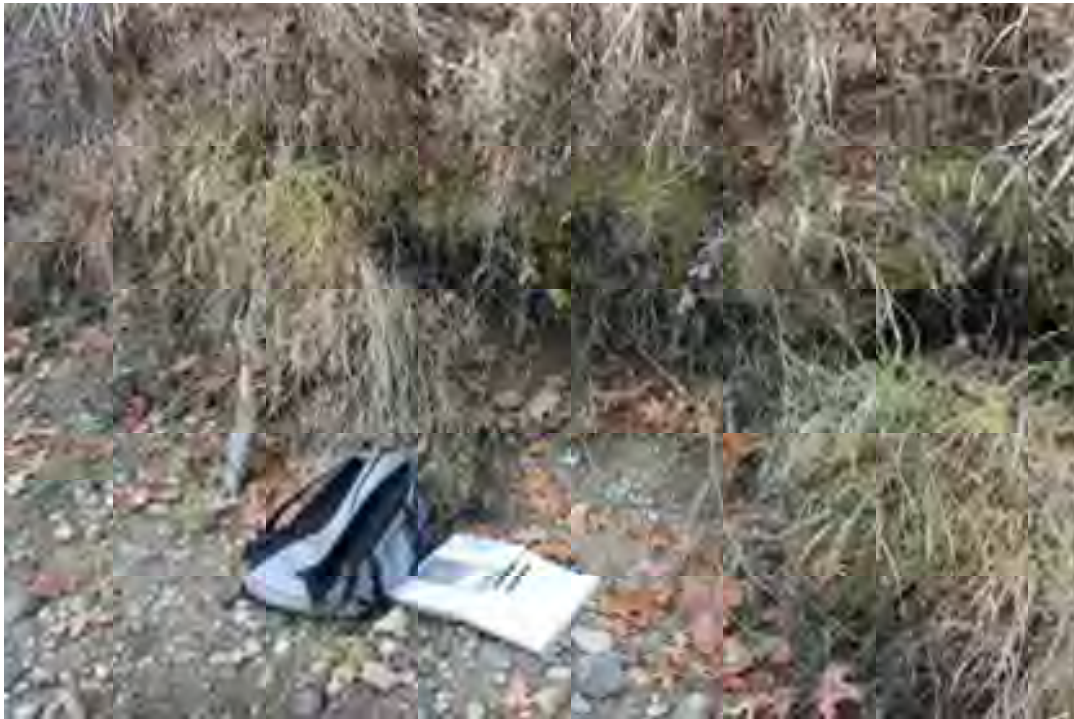
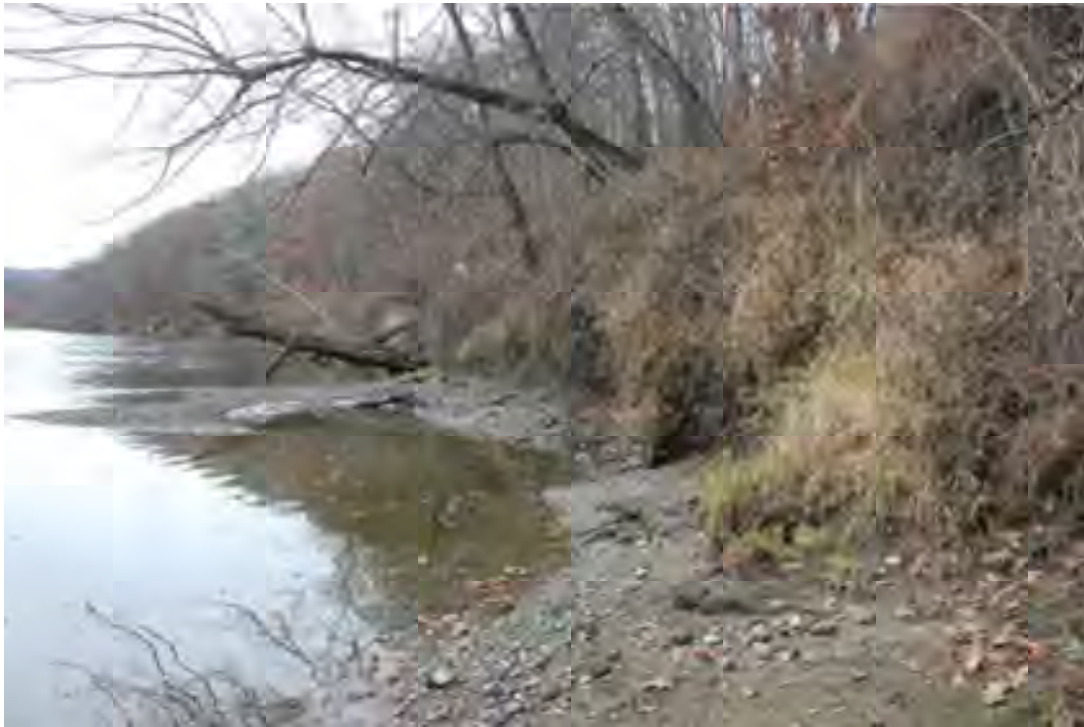
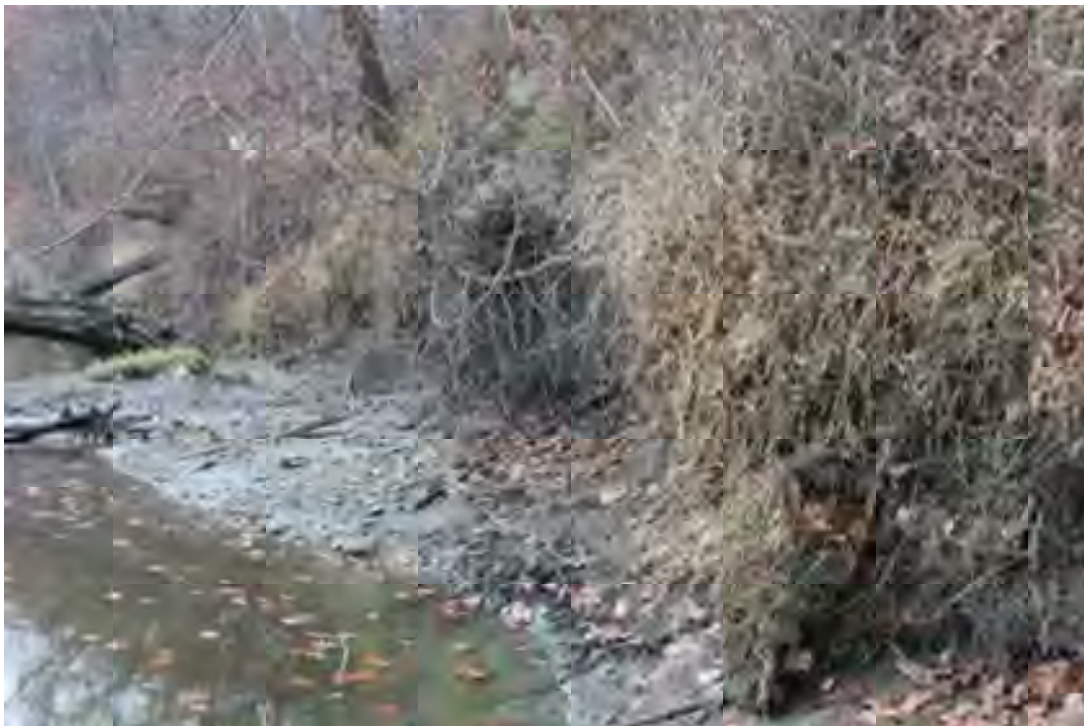
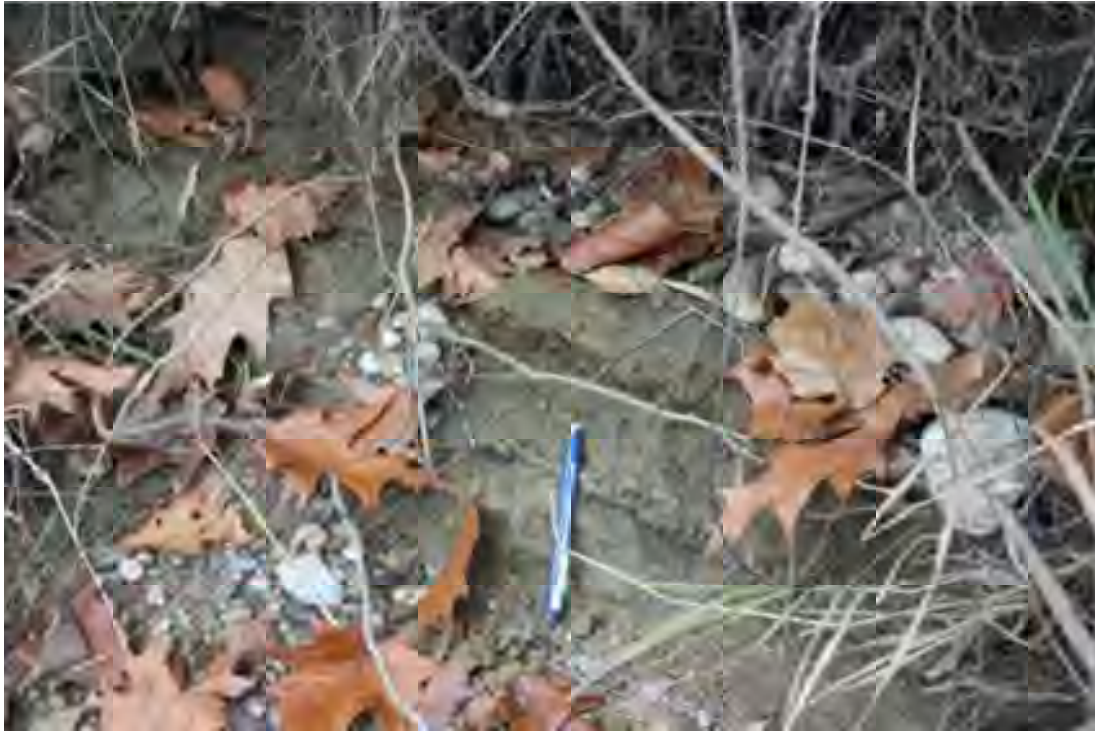
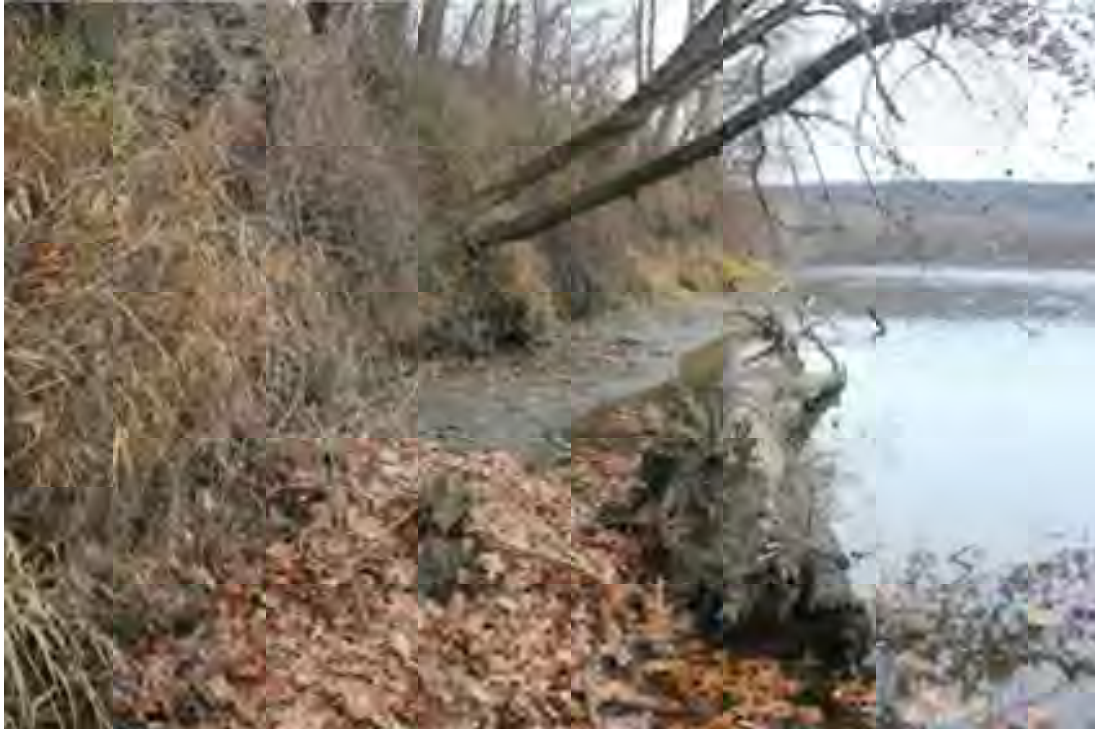
2013 Connecticut River Full River Reconnaissance
Land-Based Observations Photographs Reference No. 526 - 531
Observation Point No. 2 - November 12, 2013

Upland forest, gravel toe.

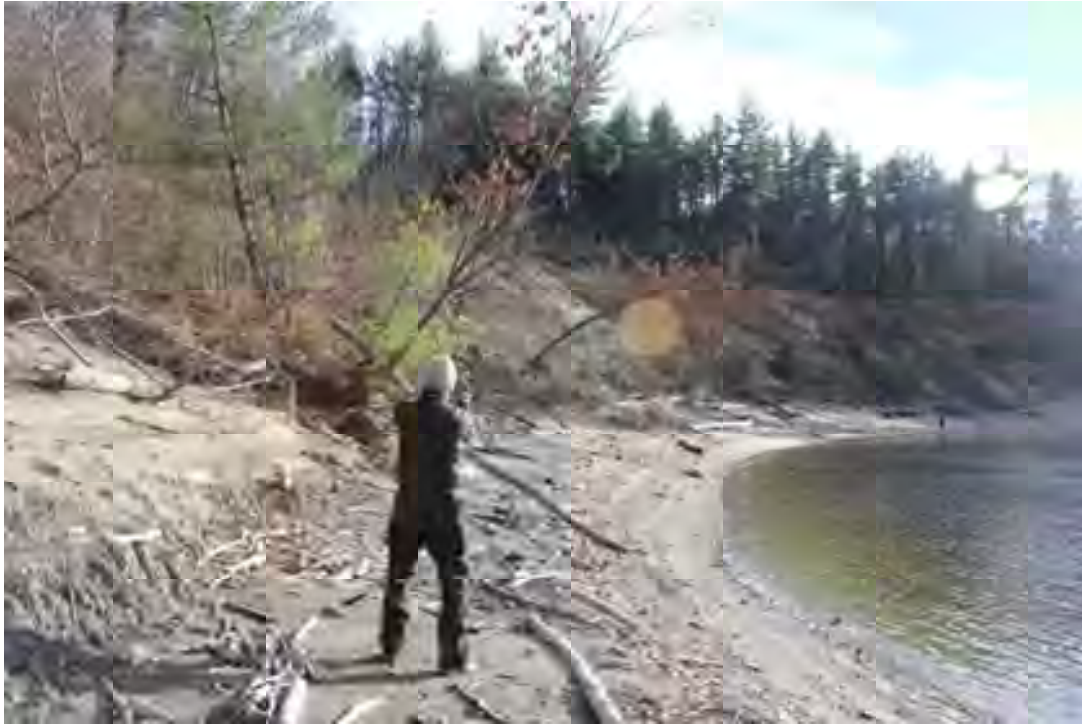
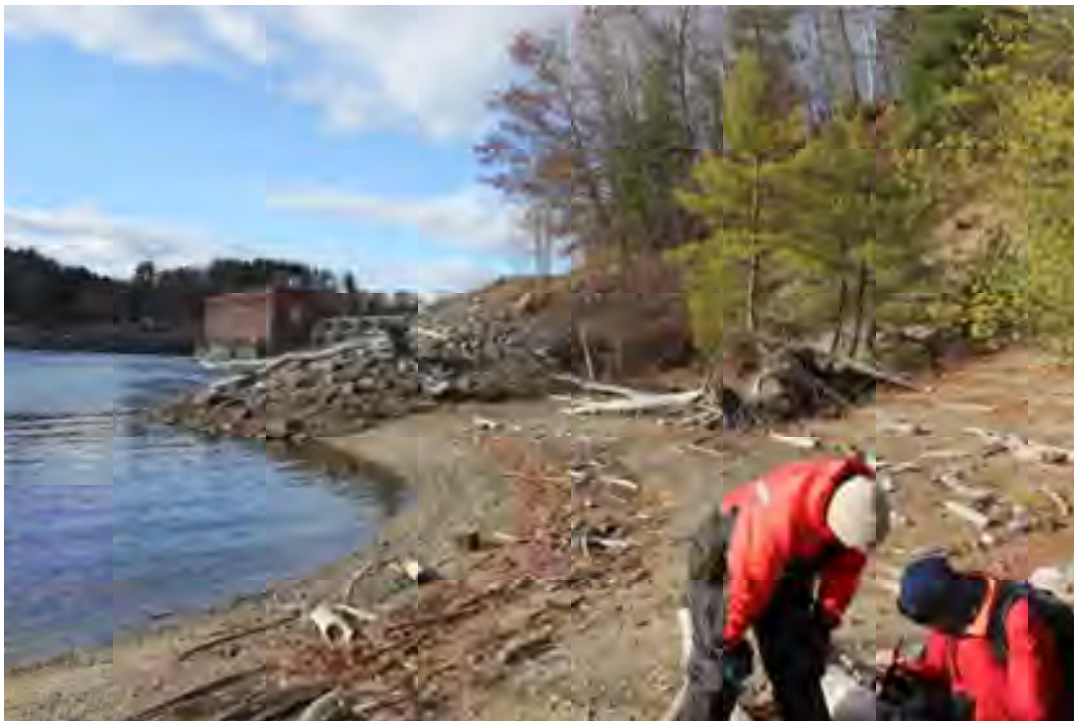
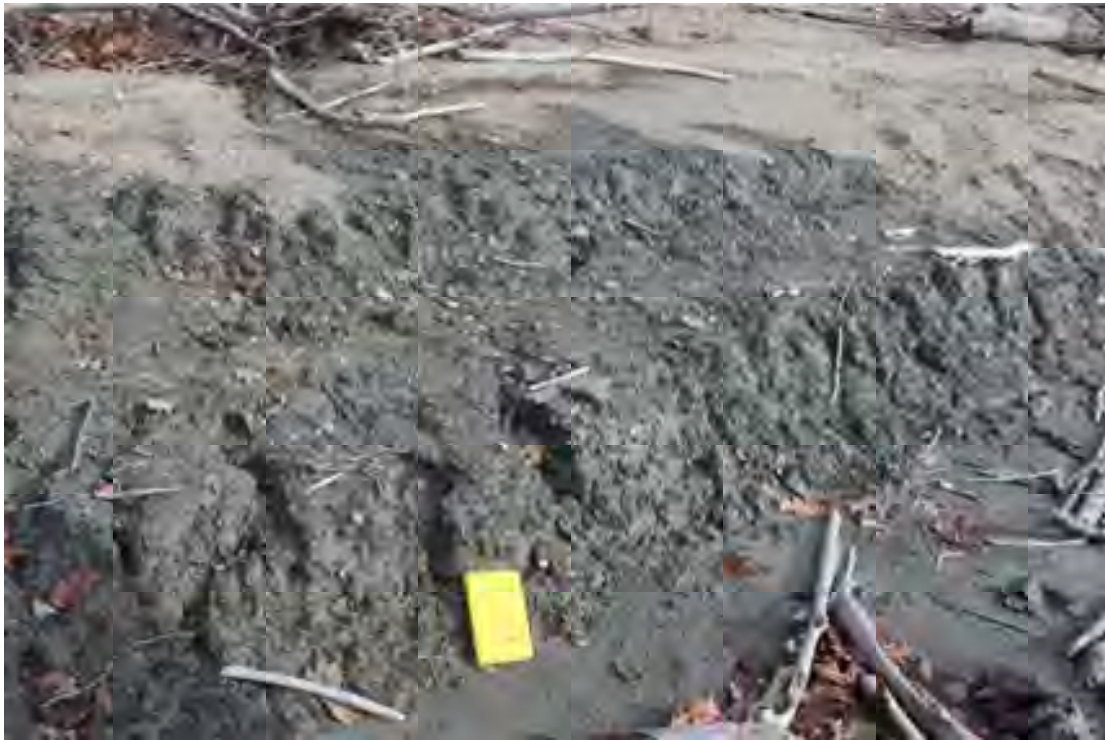
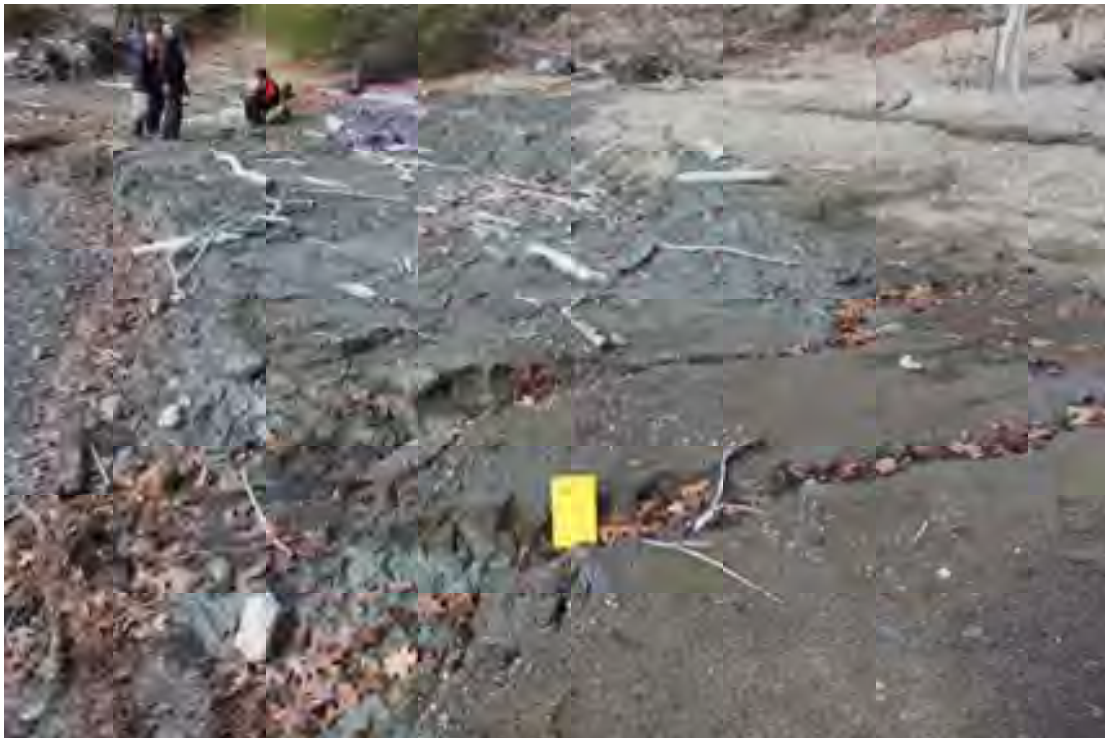
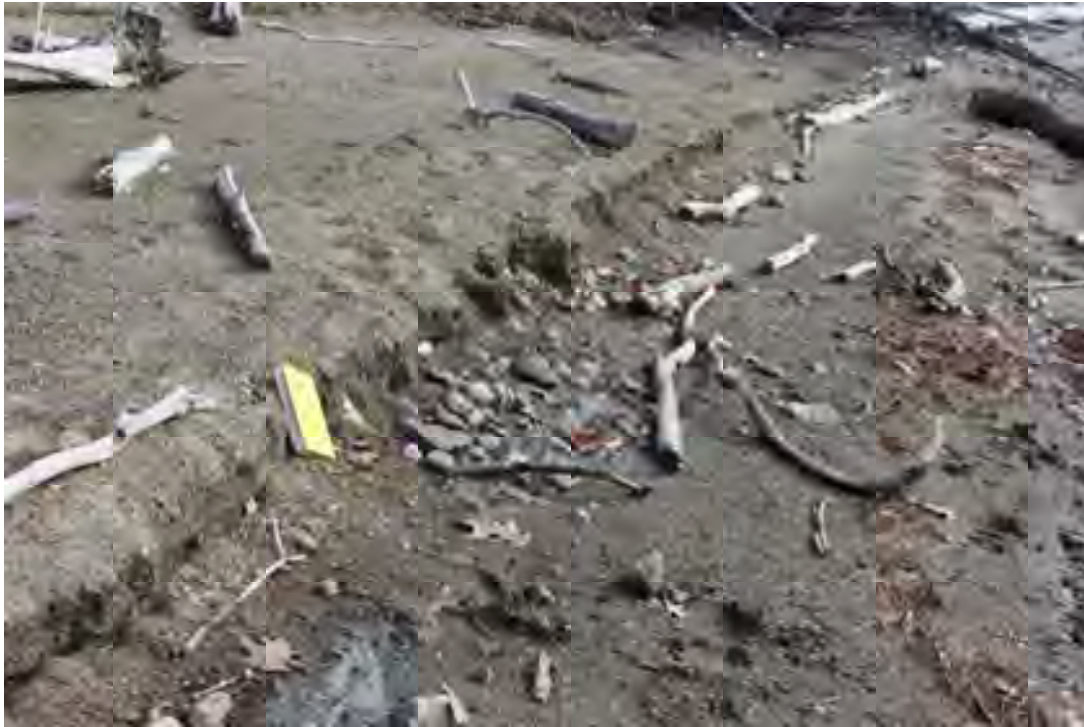
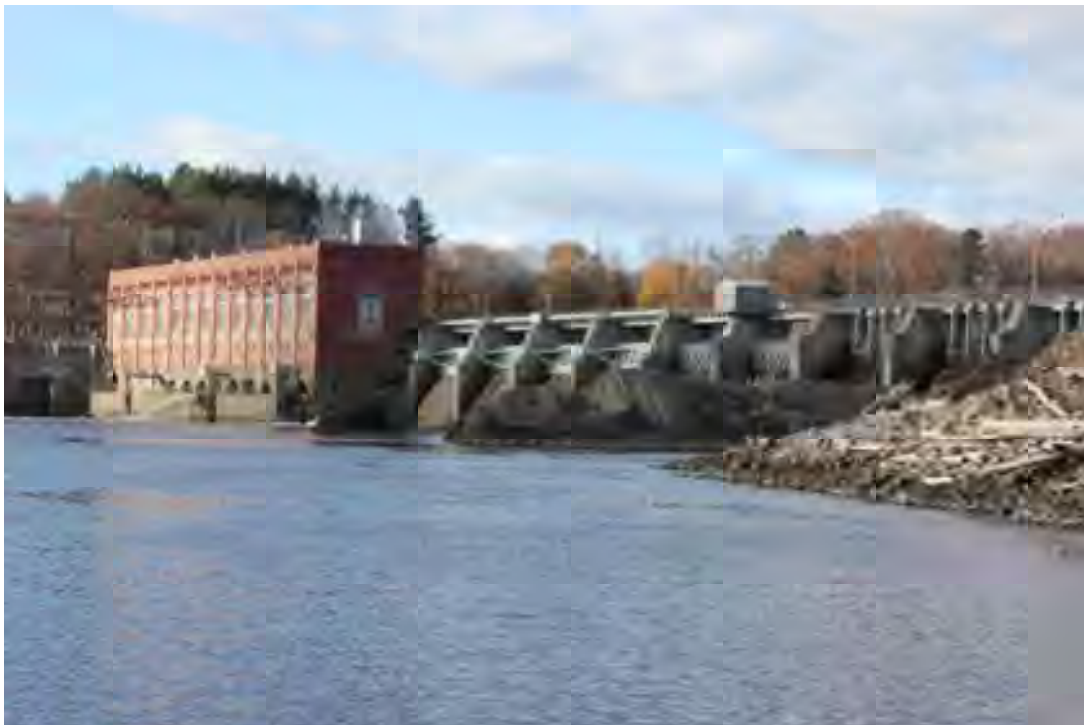
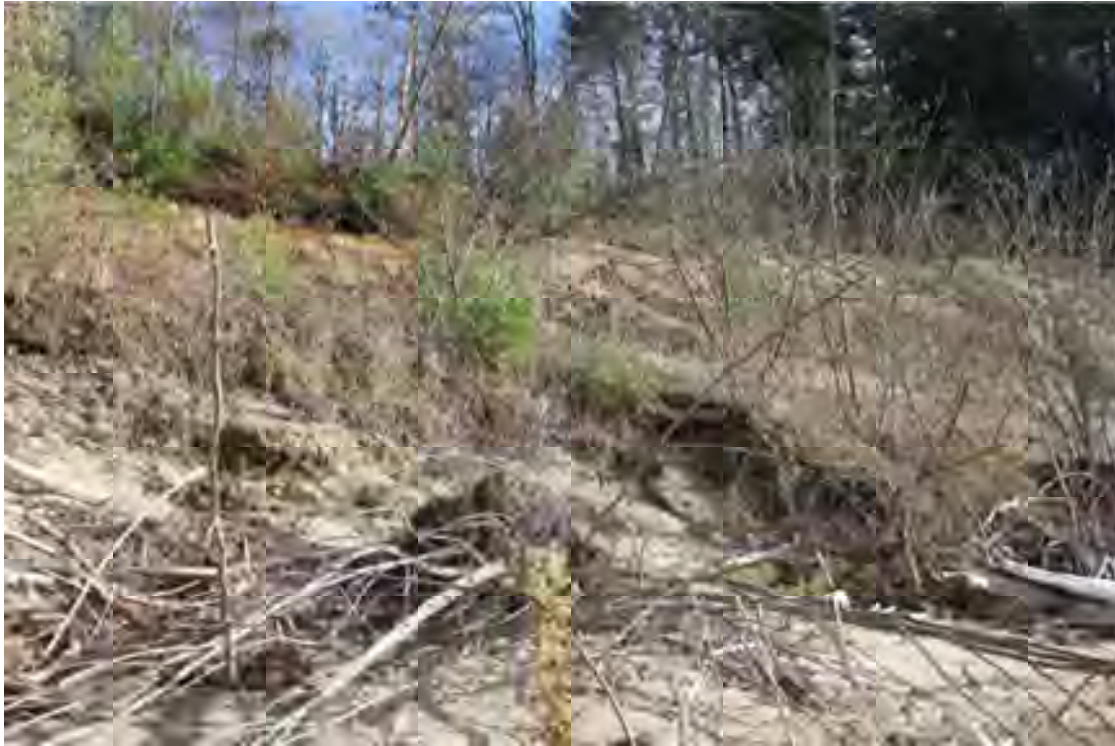
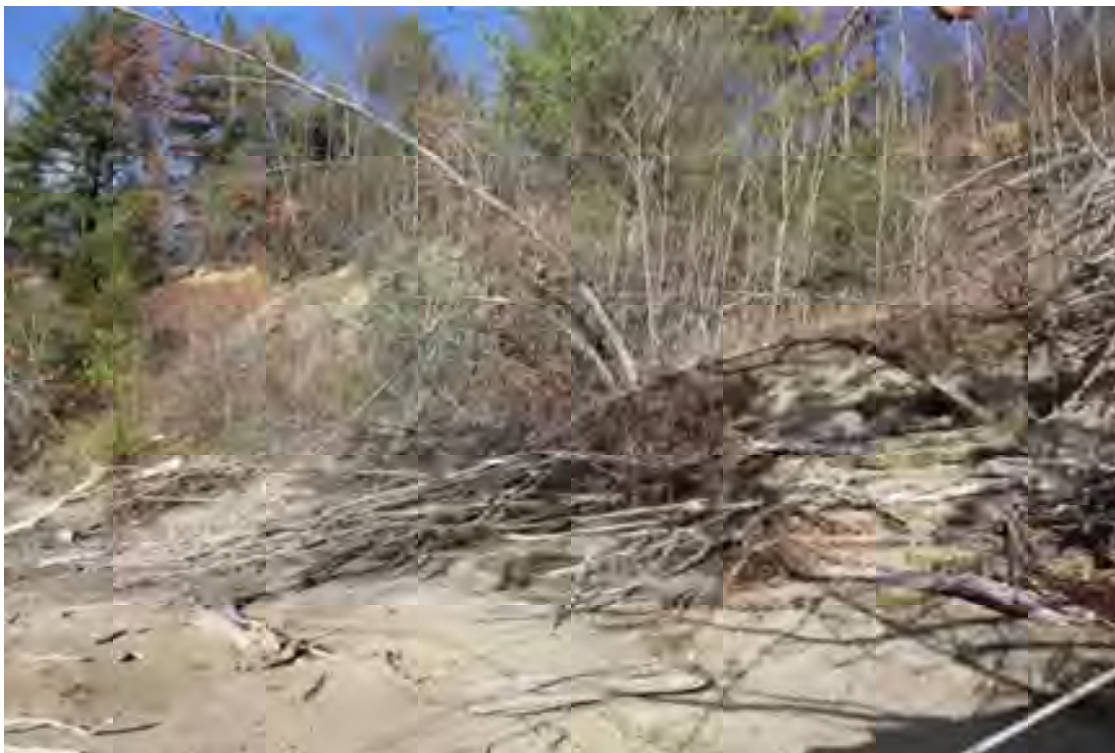
2013 Connecticut River Full River Reconnaissance
Land-Based Observations Photographs Reference No. 536 – 543
Observation Point No. 3 - November 12, 2013

Erosion wall ~100' high with a near-vertical face, sandy material

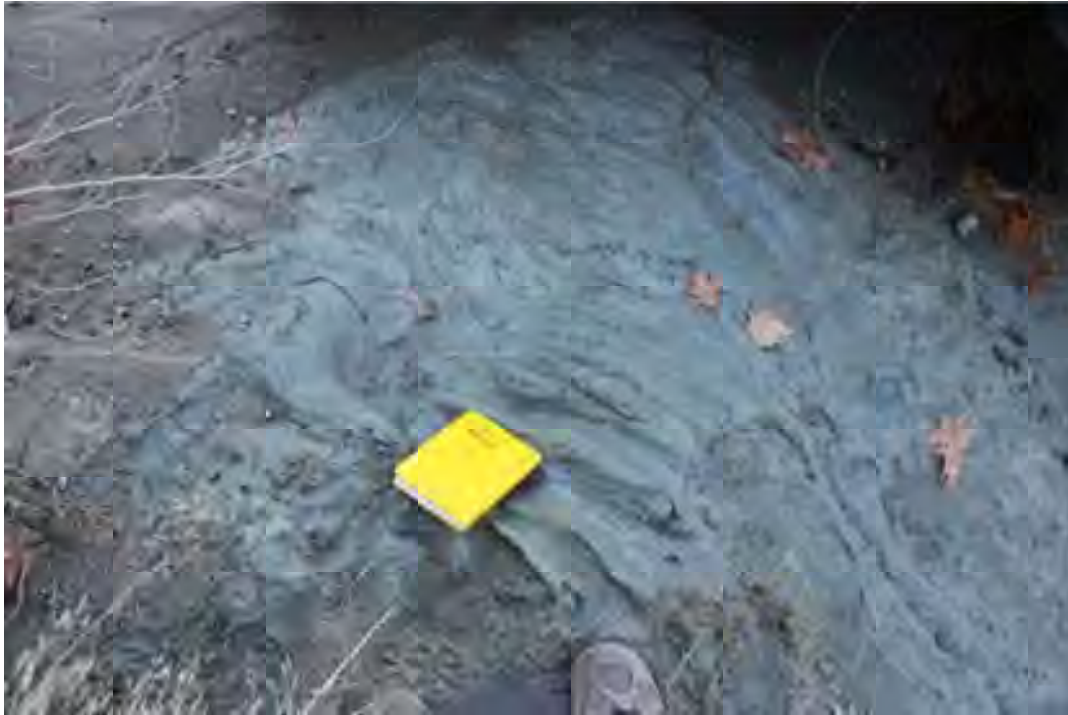
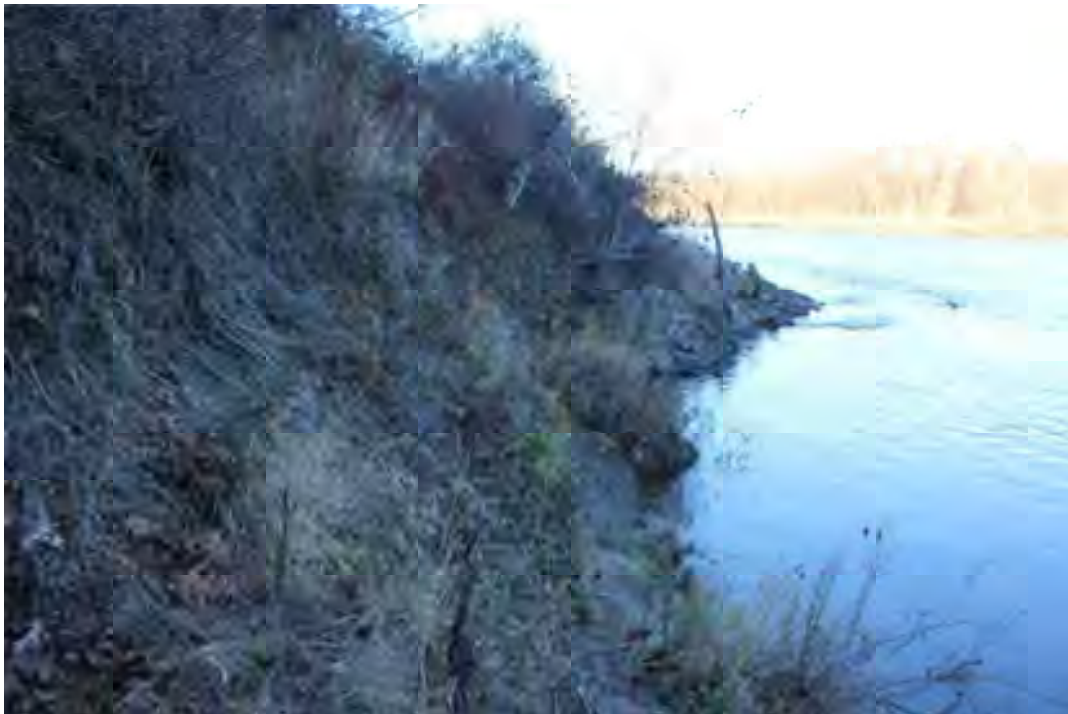
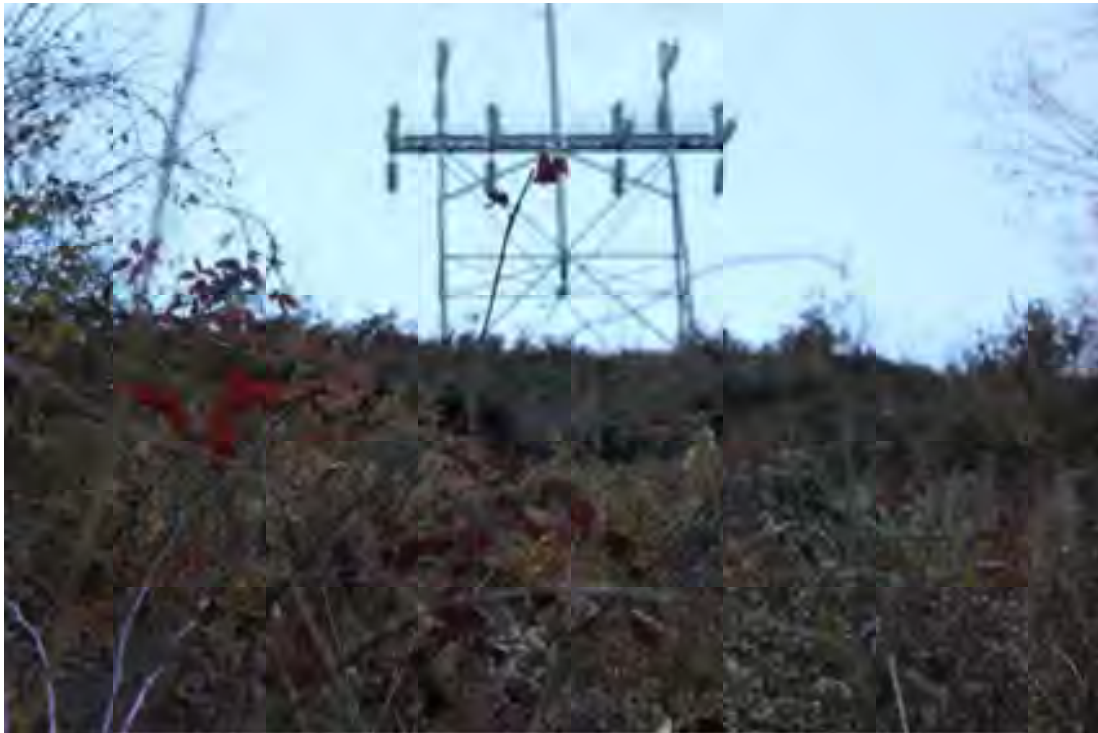
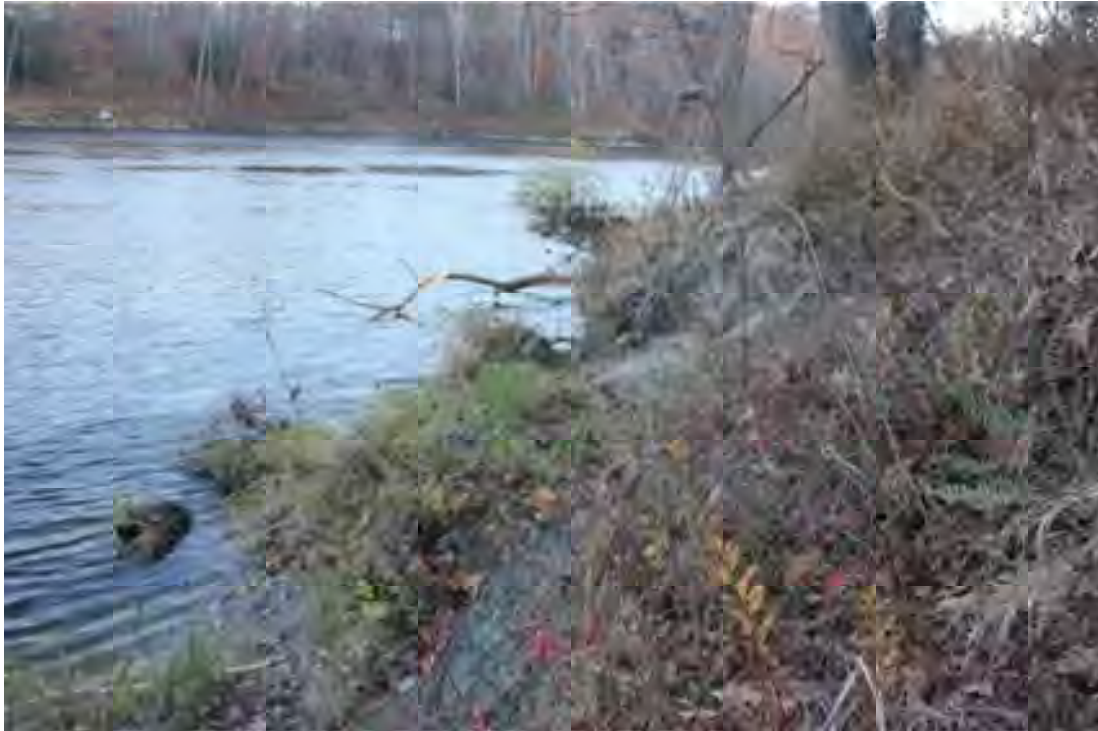
**2013 Connecticut River Full River Reconnaissance
Land-Based Observations Photographs Reference No. 545 - 548
Observation Point No. 4 - November 12, 2013**

4	1028+00	Left	No	<ul style="list-style-type: none"> Minor localized bank erosion near river level. Ground surface was hummocky at shoreline, but no vertical scarps. Near vertical erosion scarp near the top of slope, just below power line. 	SAND (SP), CLAY (CL, CH)
5	295+00	Left	Yes	<ul style="list-style-type: none"> Shallow erosion just above riprap where roots from vegetation were lacking. 	SILT (ML), SAND (SP), sound riprap with little displacement or deterioration
6	350+00	Left	No	<ul style="list-style-type: none"> Near-vertical scarps, with several intermediate benches from mass-wasting and slumping. Some down timber and leaning trees. Little grass, but some shrubs between trees Some exposed tree roots on upper scarps near top of bank. 	SILT (ML)

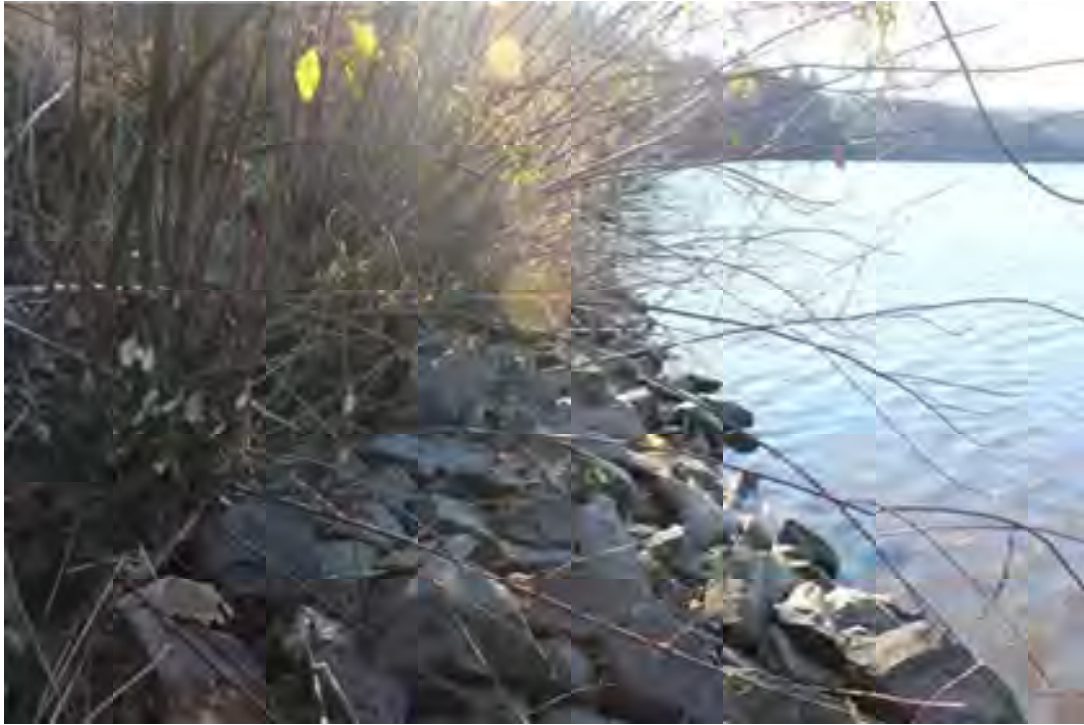
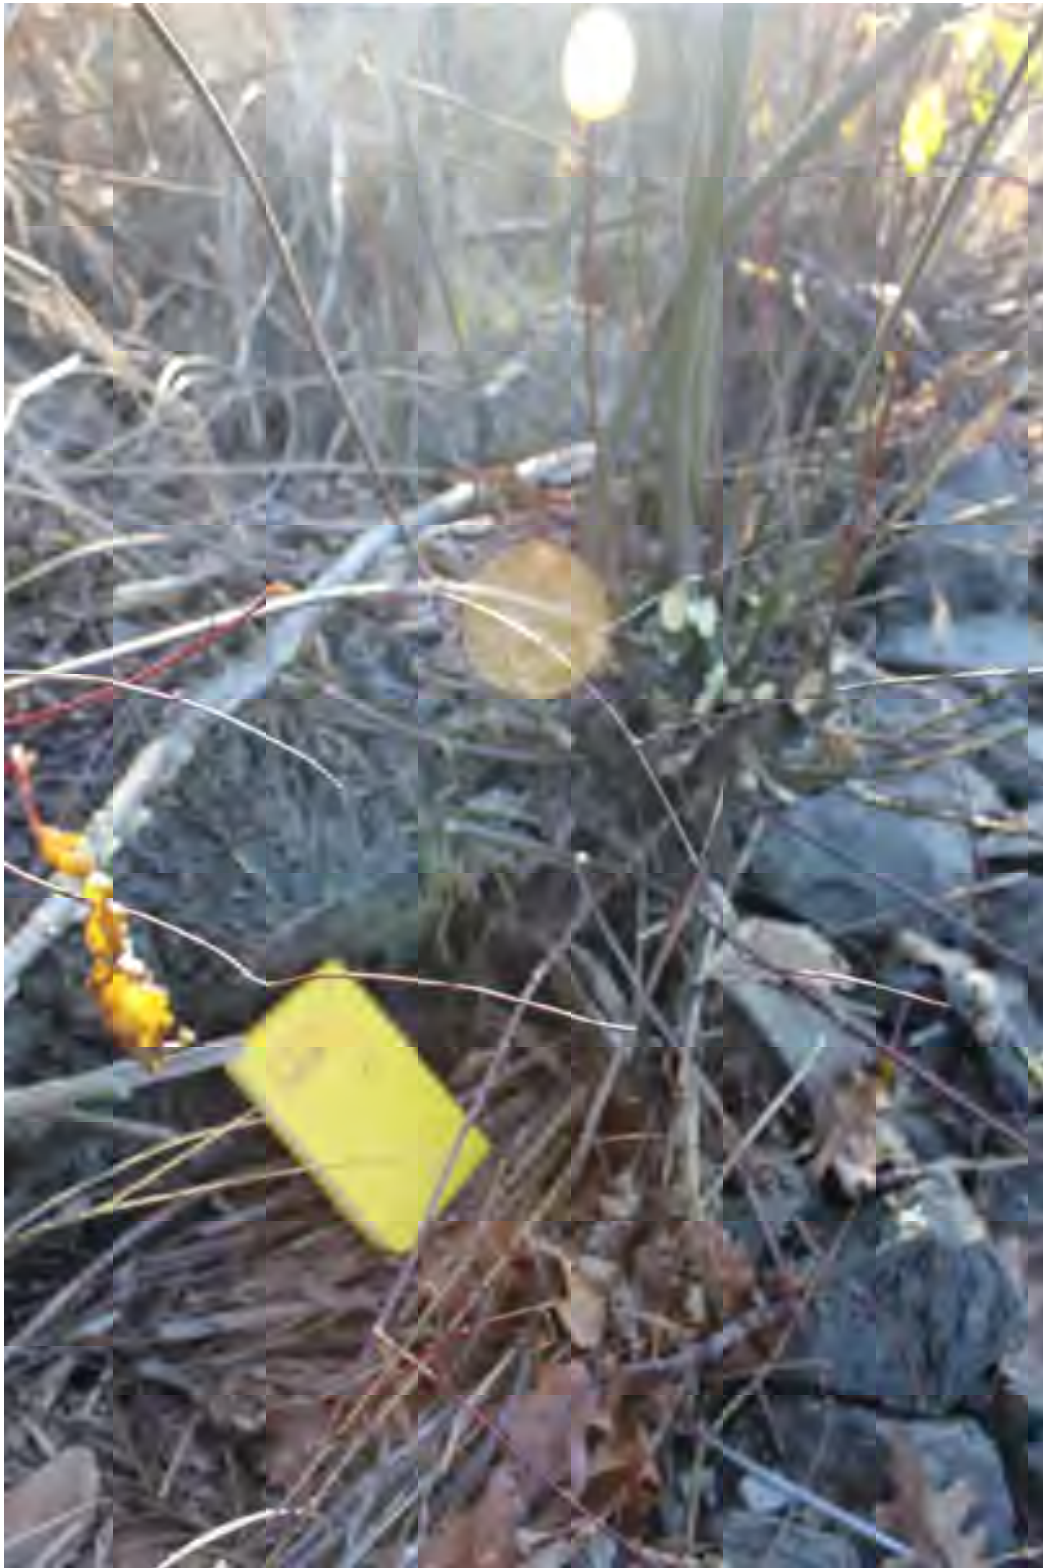
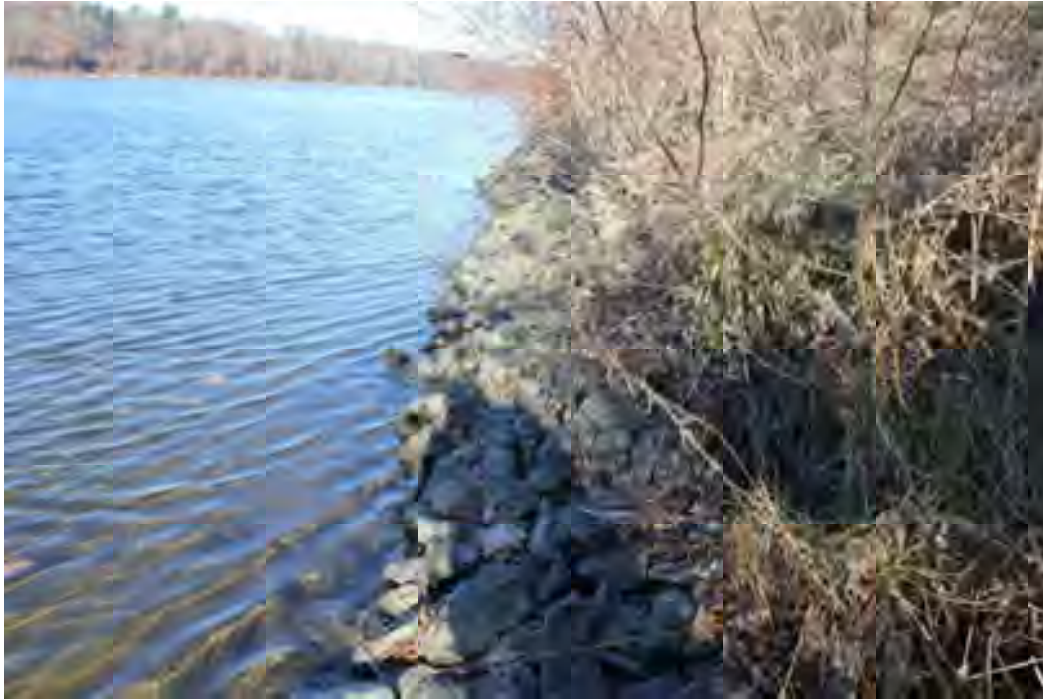
**2013 Connecticut River Full River Reconnaissance
Land-Based Observations Photographs Reference No. 549 - 551
Observation Point No. 5 - November 13, 2013**

Riprap toe
