RELICENSING STUDY 3.1.1

2013 FULL RIVER RECONNAISSANCE

**Northfield Mountain Pumped Storage Project (No. 2485)
and Turners Falls Hydroelectric Project (No. 1889)**

SEPTEMBER 2014

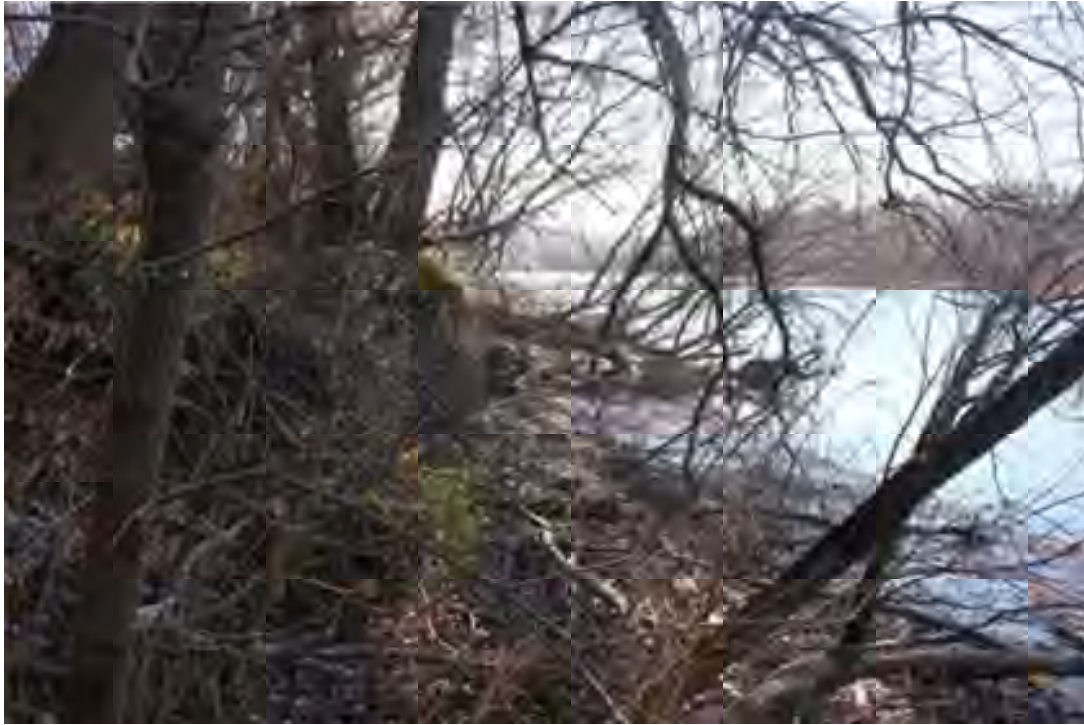
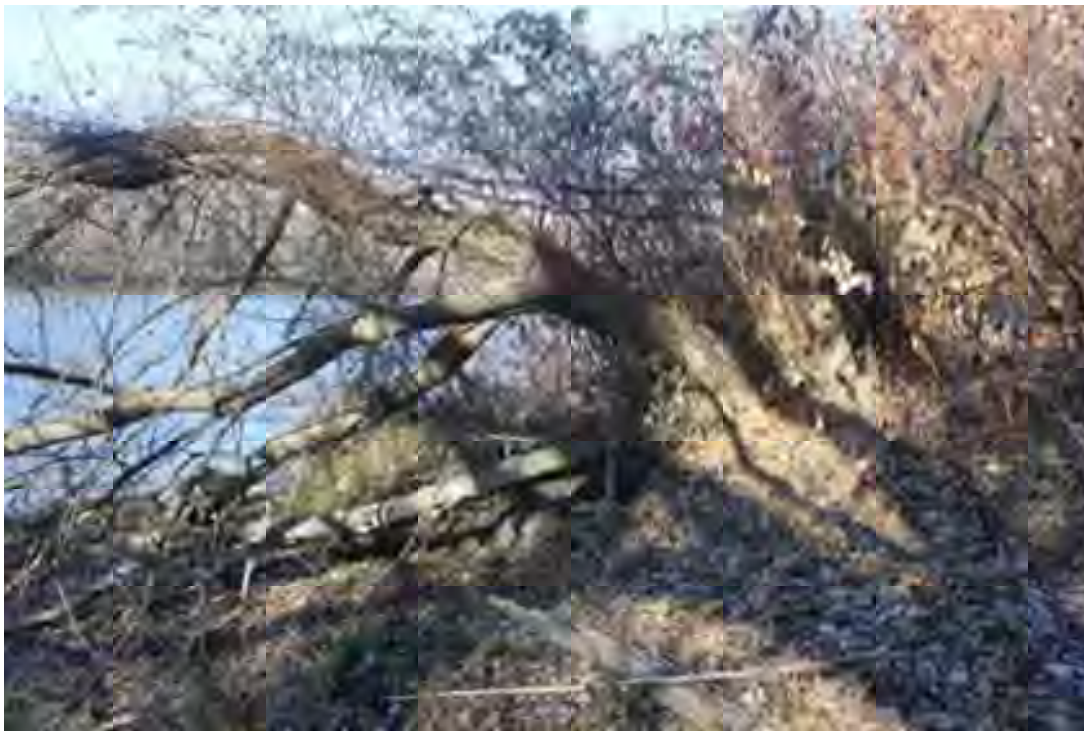
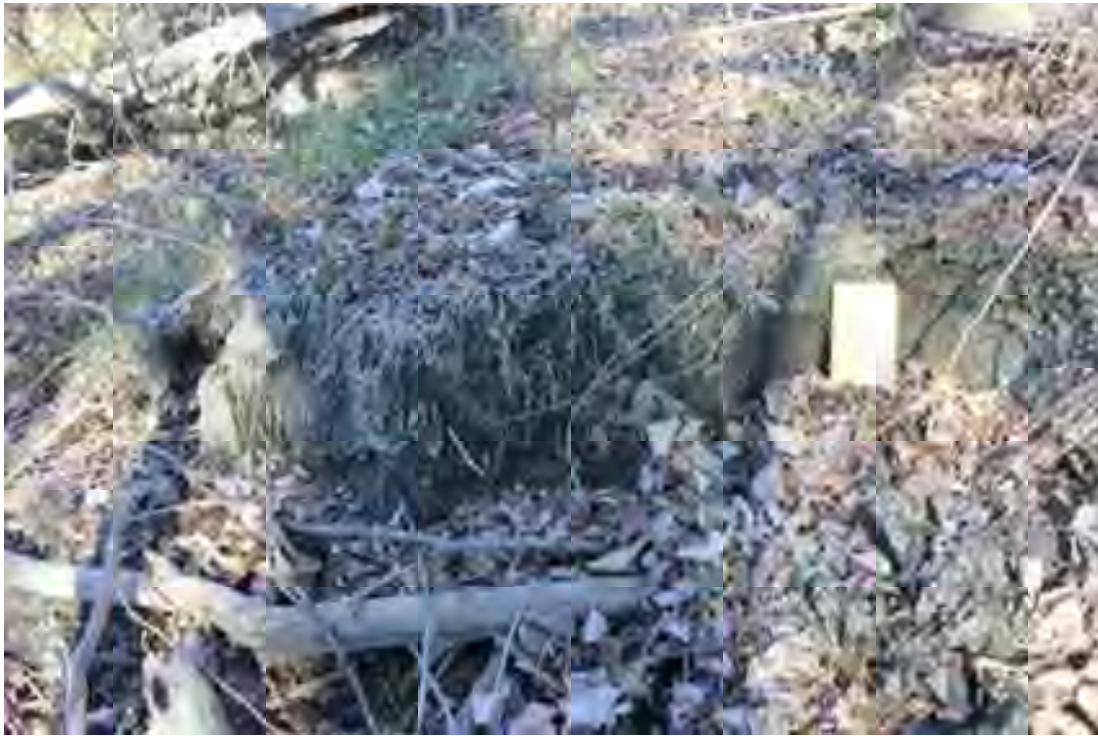
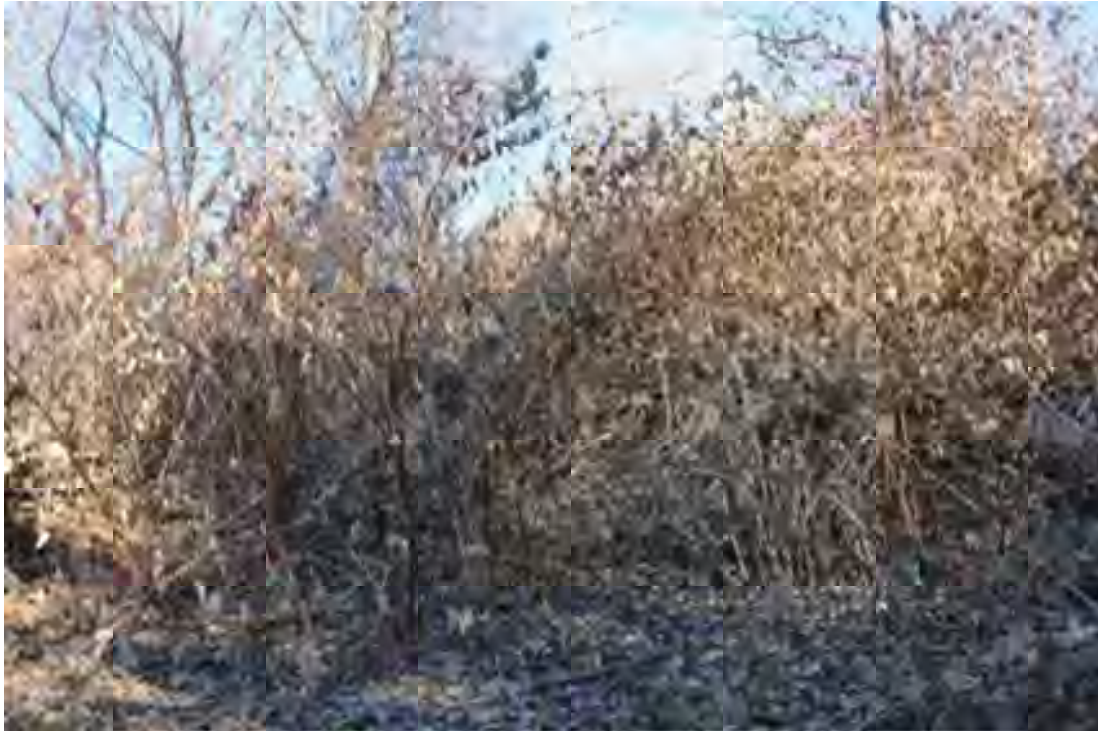
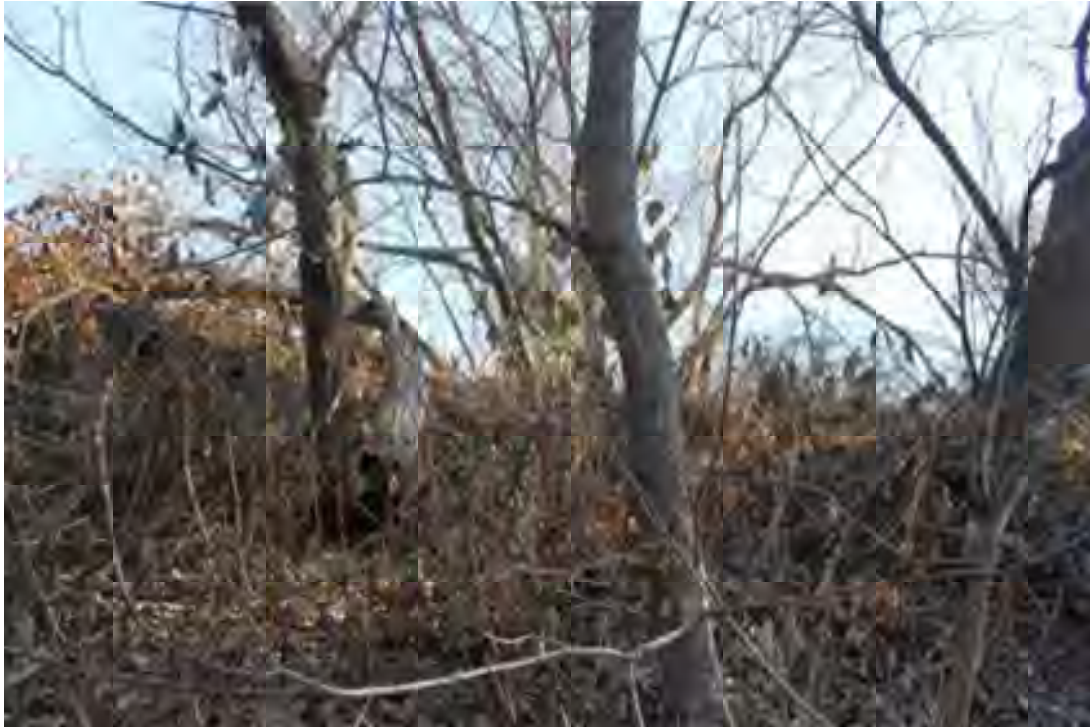
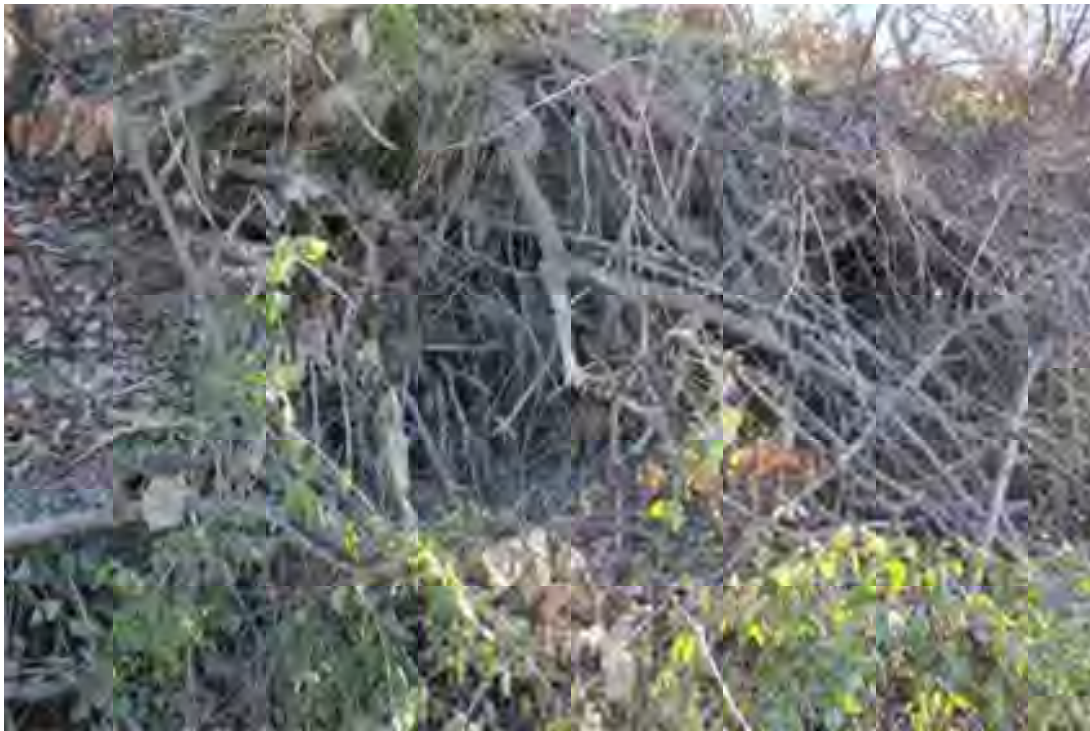
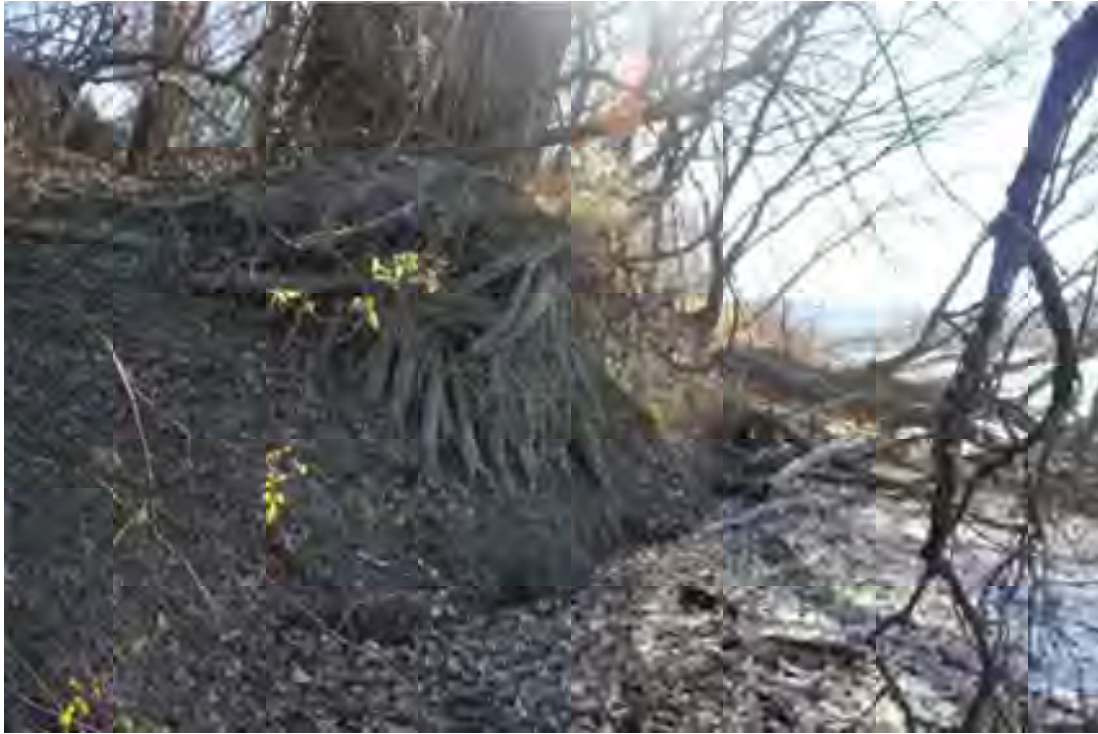
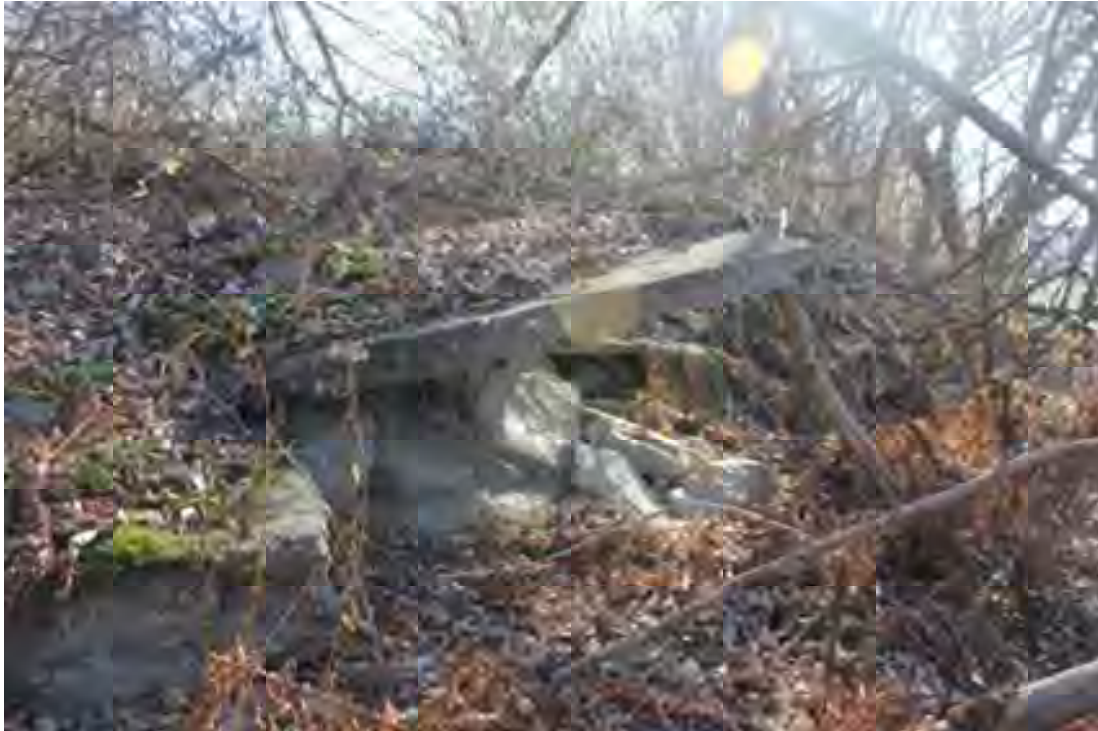
2013 Connecticut River Full River Reconnaissance
Land-Based Observations Photographs Reference No. 552 - 559
Observation Point No. 6 - November 13, 2013

Eroded, vertical bank at Shearer Farm

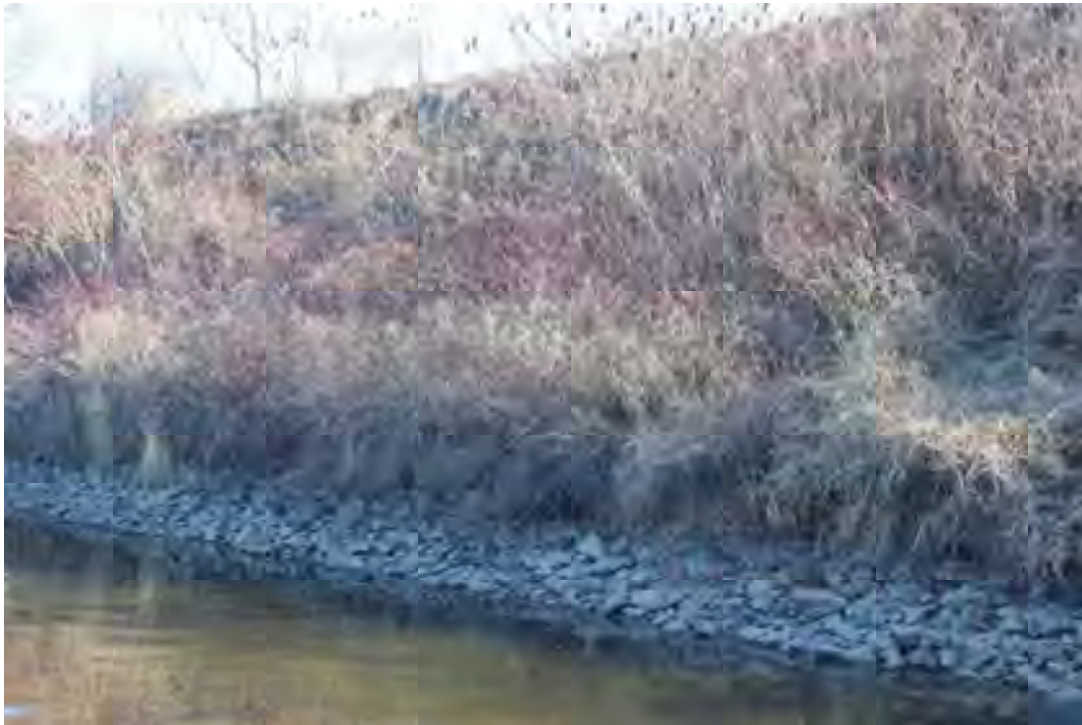
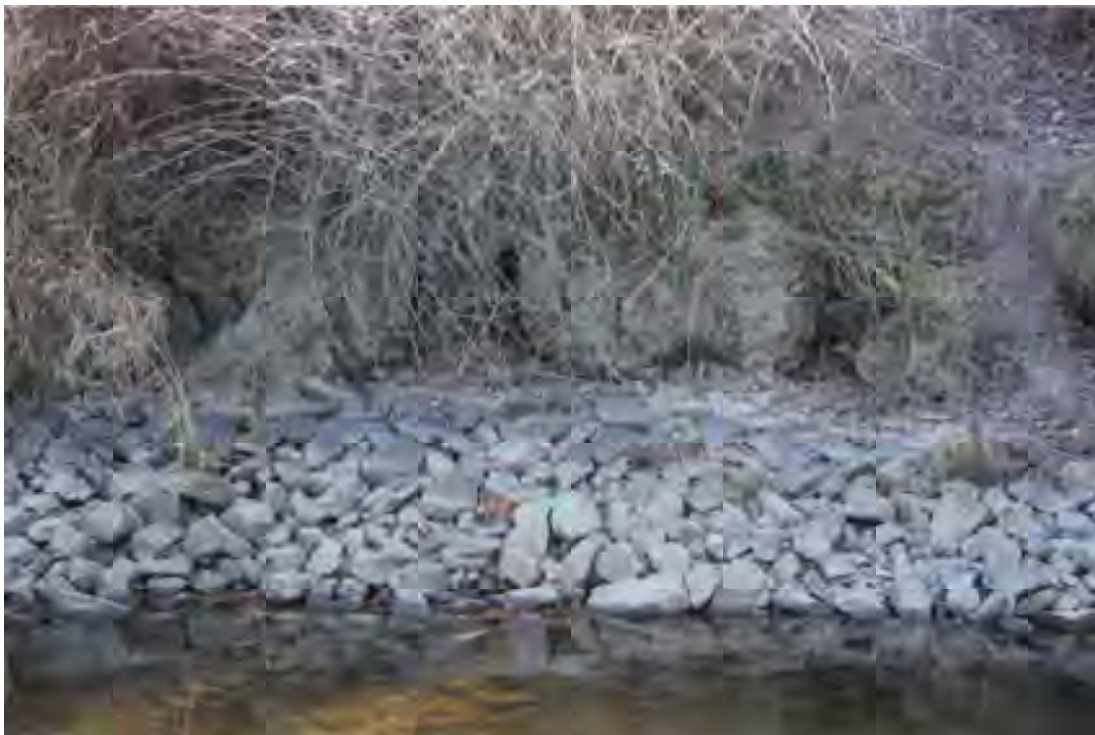
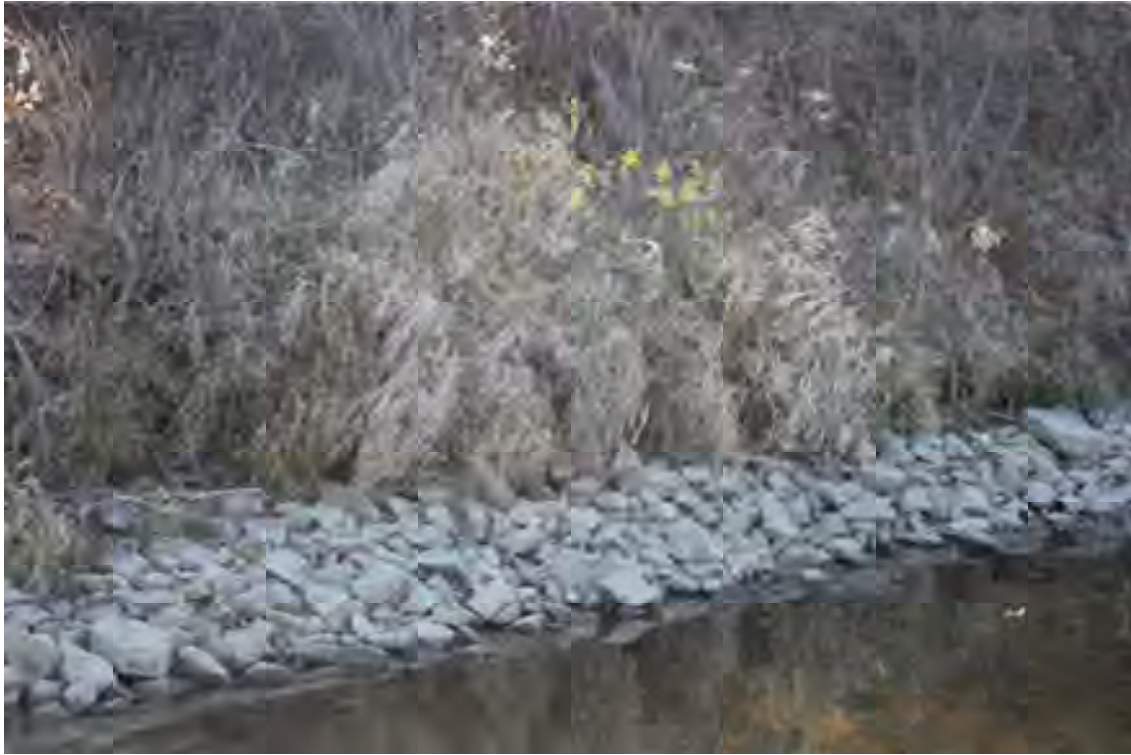
**2013 Connecticut River Full River Reconnaissance
Land-Based Observations Photographs Reference No. 560 - 562
Observation Point No. 7 - November 13, 2013**

Observation Point No. (Note 3)	Station (Note 1)	Left or Right Bank (Note 2)	Previously Stabilized?	Observed Erosion Features	Geotechnical Observations
7	385+00	Left	Yes	<ul style="list-style-type: none"> • Little to no erosion. Stabilization appeared to be performing well. 	Upper bank soils not observed. Some recent sediments (ML) along shoreline. Riprap toe in good conditions.
9	435+00	Left	No	<ul style="list-style-type: none"> • Near-vertical scarps up to about 8' high from river level, with undercuts. • Leaning trees to down timber, with exposed tree roots along erosion scarps. • A relatively flat bench at about mid-slope, may be from mass-wasting and slumping. 	SILT (ML), SAND (SP)
10	484+00	Left	No	<ul style="list-style-type: none"> • Little to no erosion. Flat bench just above river completely covered with cattails and native grass. 	SILT (ML)
11	505+00	Left	No	<ul style="list-style-type: none"> • Erosion scarps just below top of bank, very steep. • Exposed roots. • Some trees with bent trunks, may be indication of land creep. • Down timber 	SILT (ML), some recent sediments (ML)

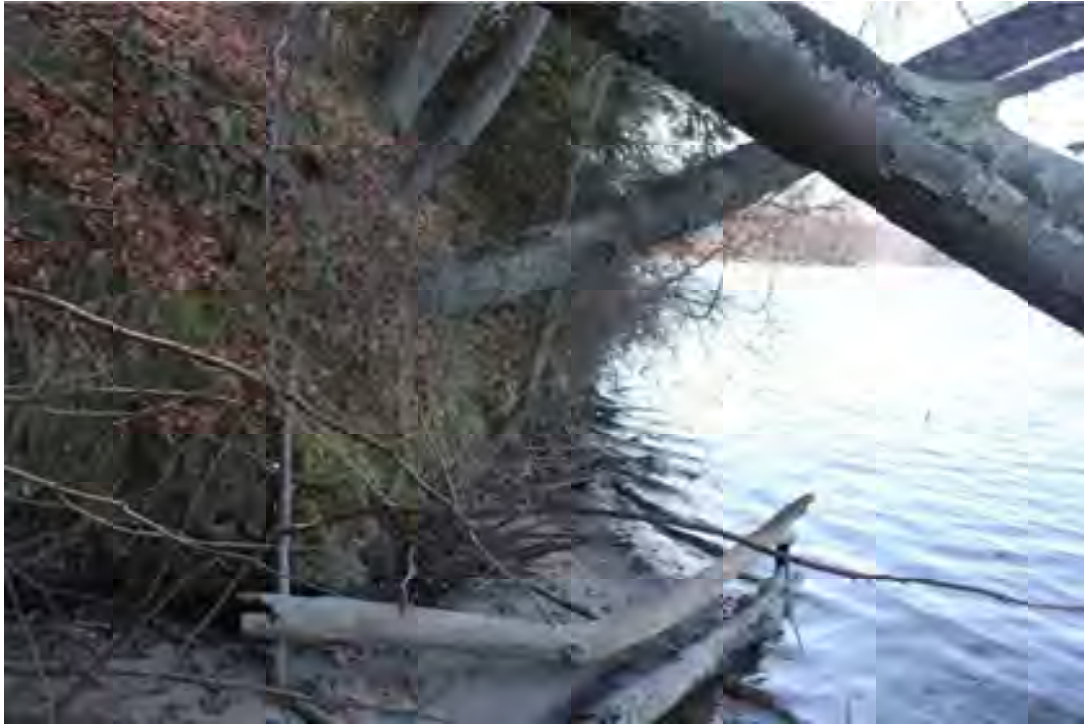
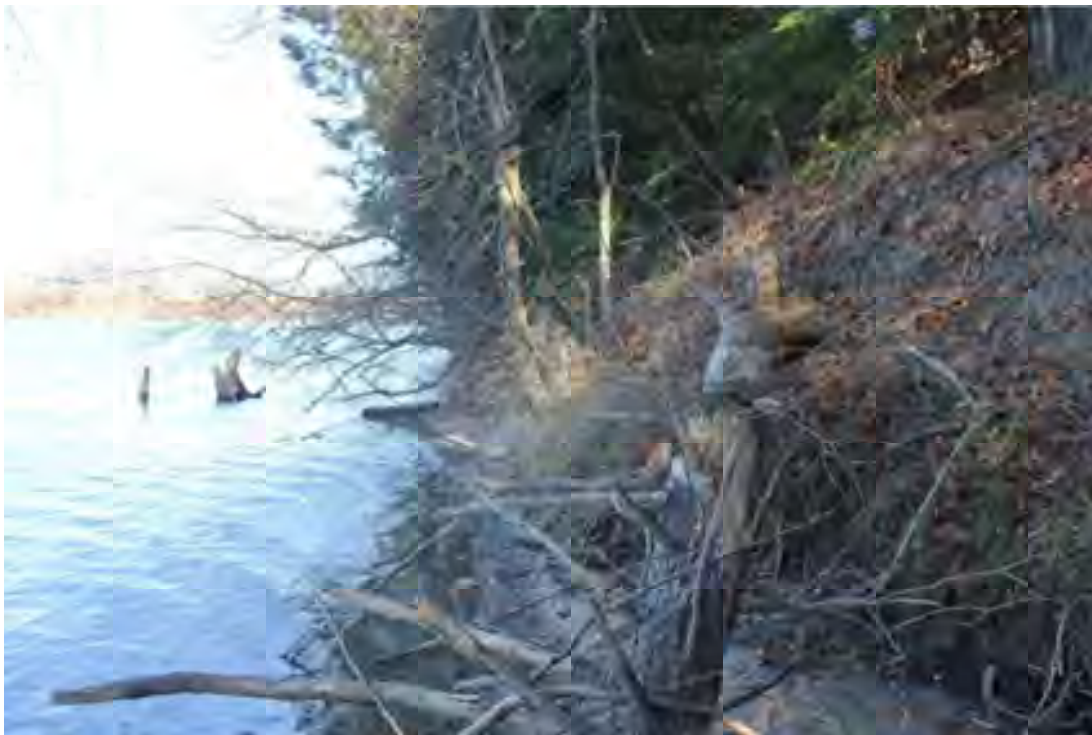
2013 Connecticut River Full River Reconnaissance
Land-Based Observations Photographs Reference No. 568 - 575
Observation Point No. 9 - November 13, 2013

Forested riparian buffer at top, pockets of eroded bank, many gullies especially at stream/tributary inlet where there is a very deep gorge ~100' deep

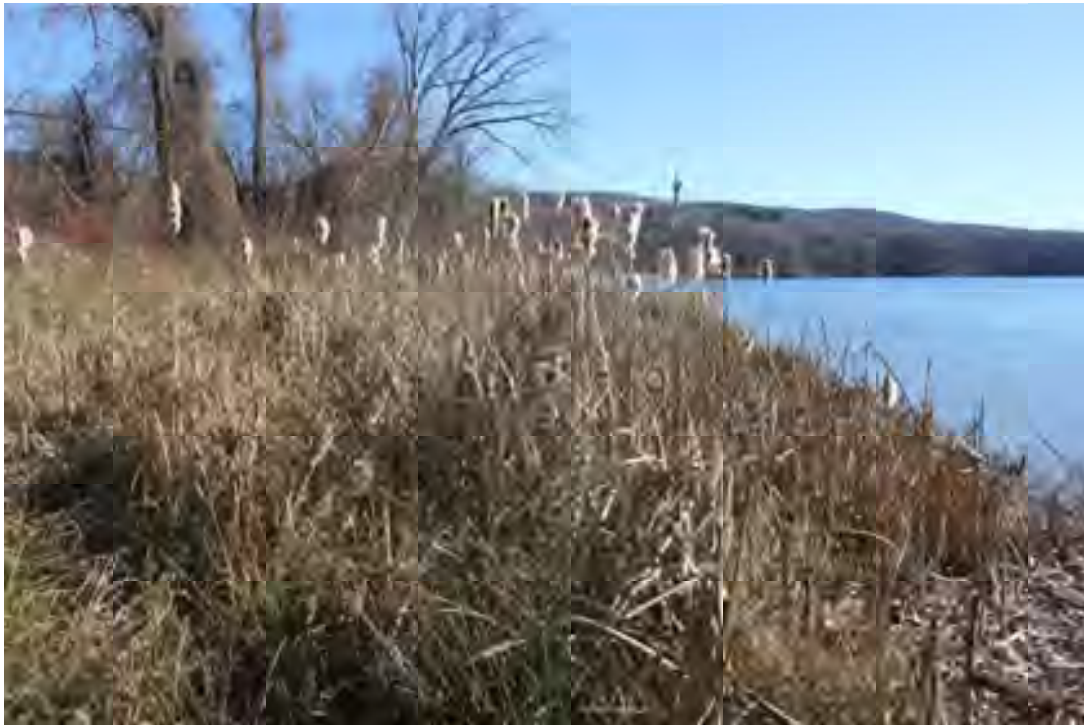
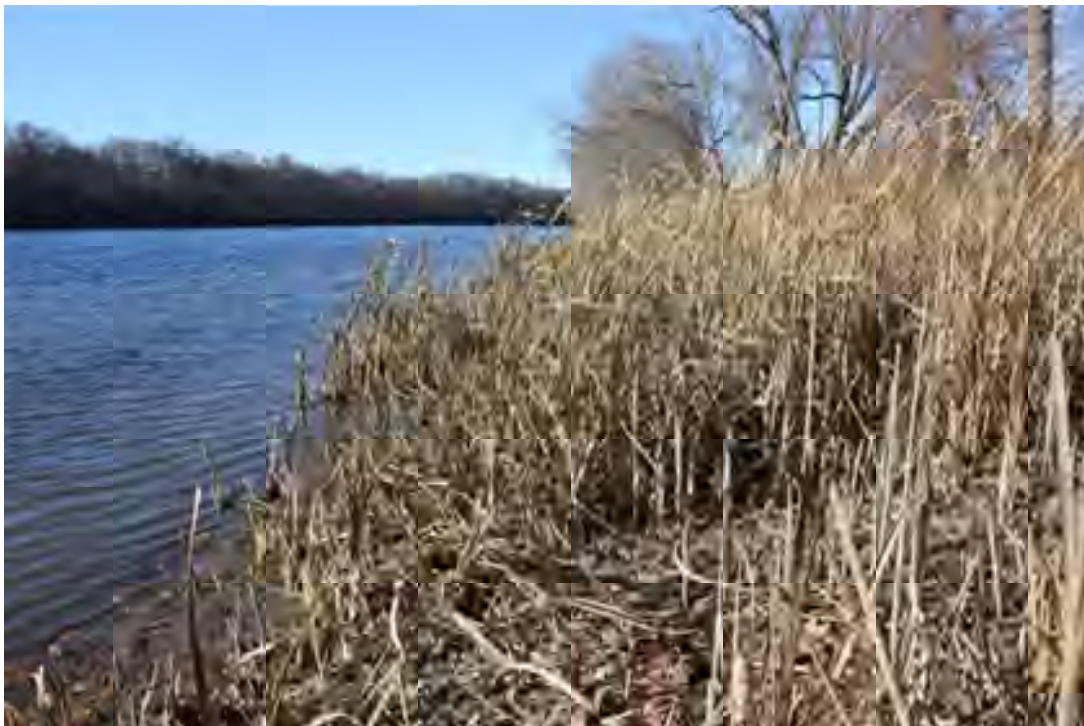
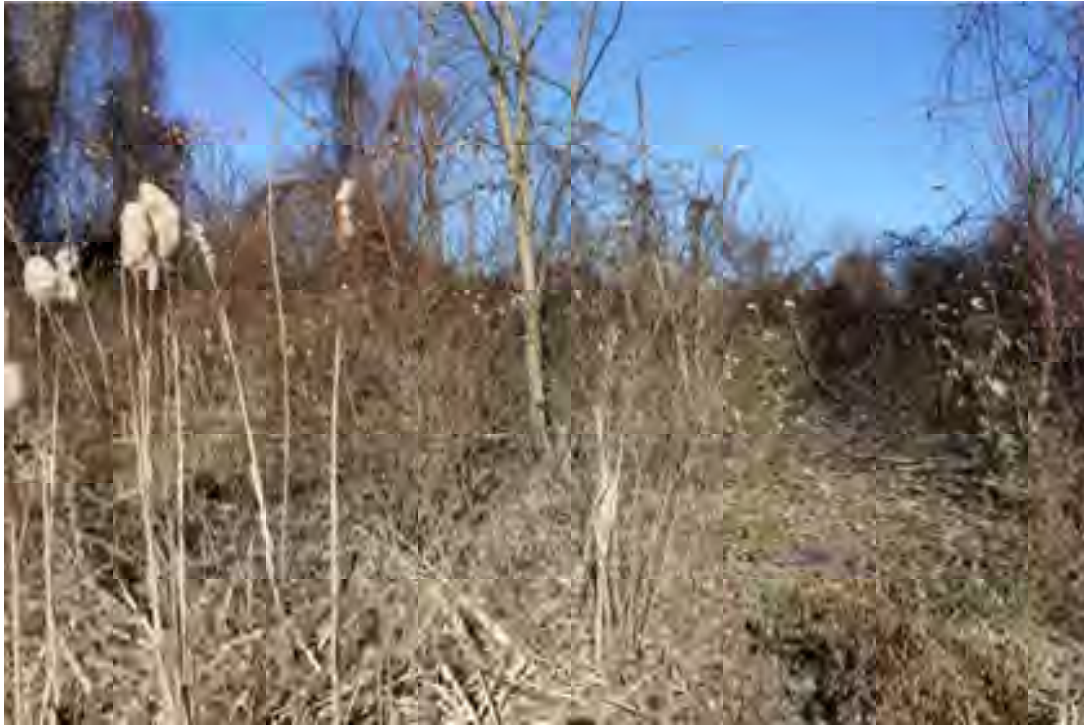
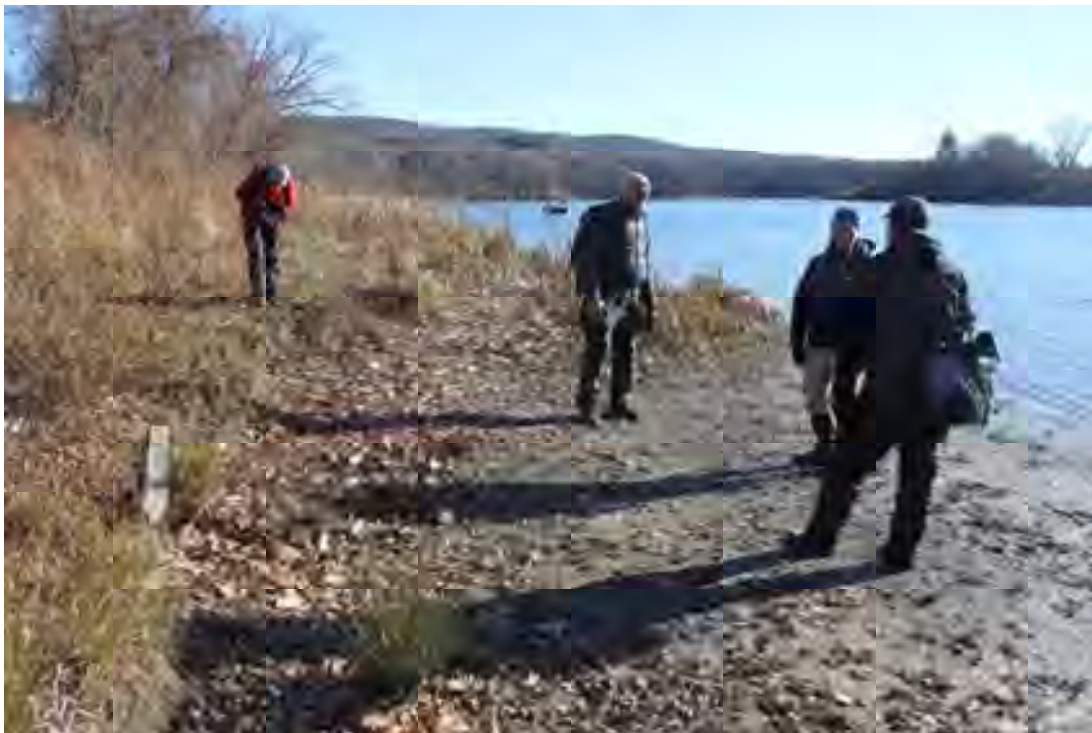
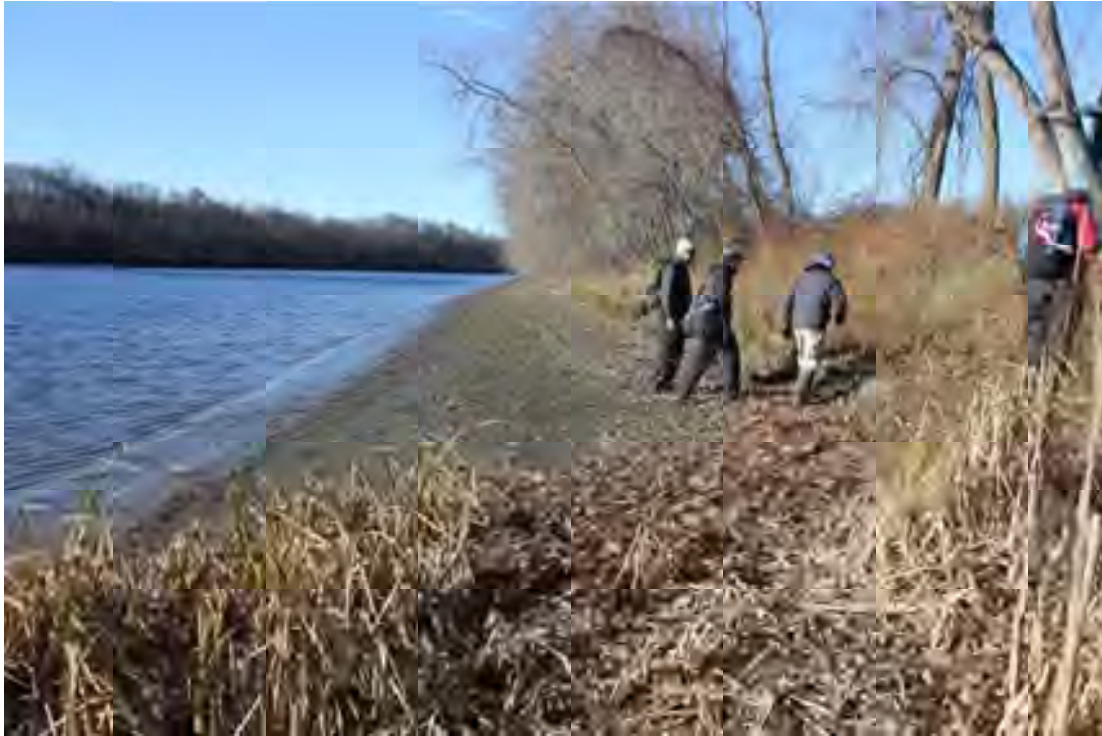
Notes: Depositional zone with thin forested riparian buffer but excellent persistent emergent shelf leads to stable bank, retention of land and retention of soils

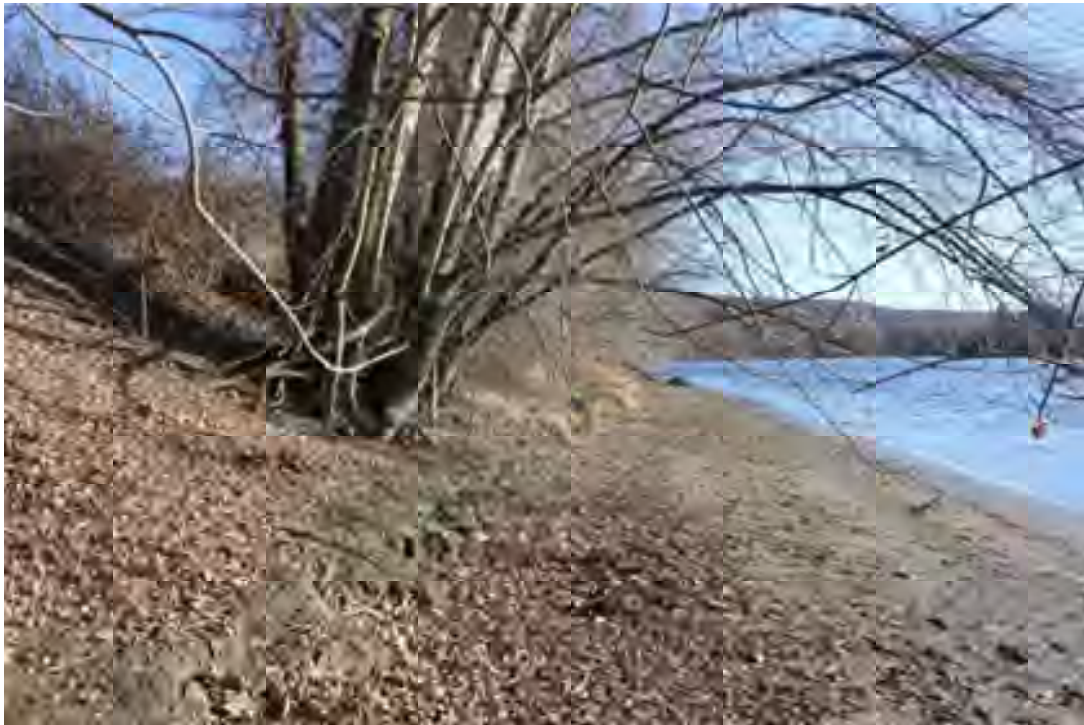
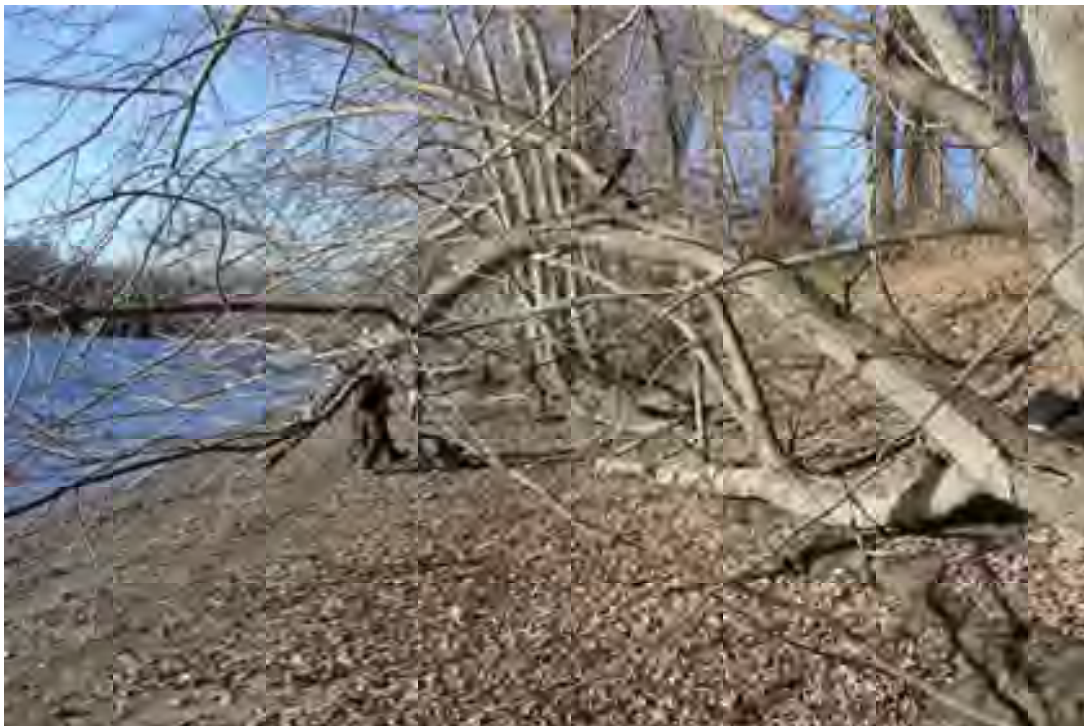
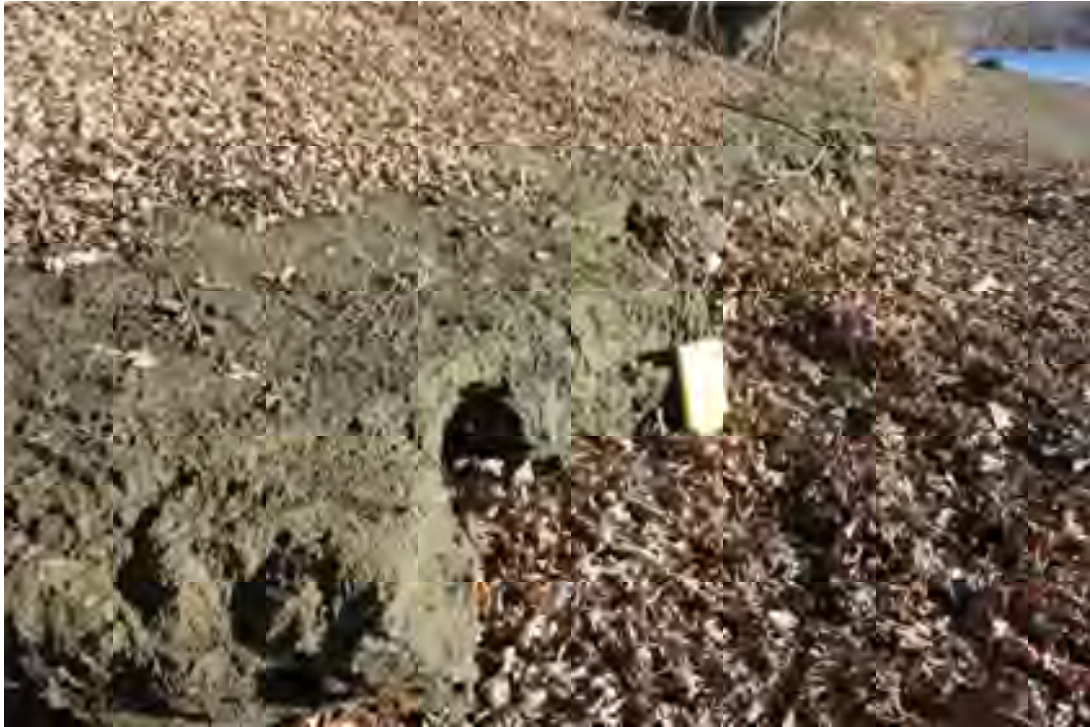
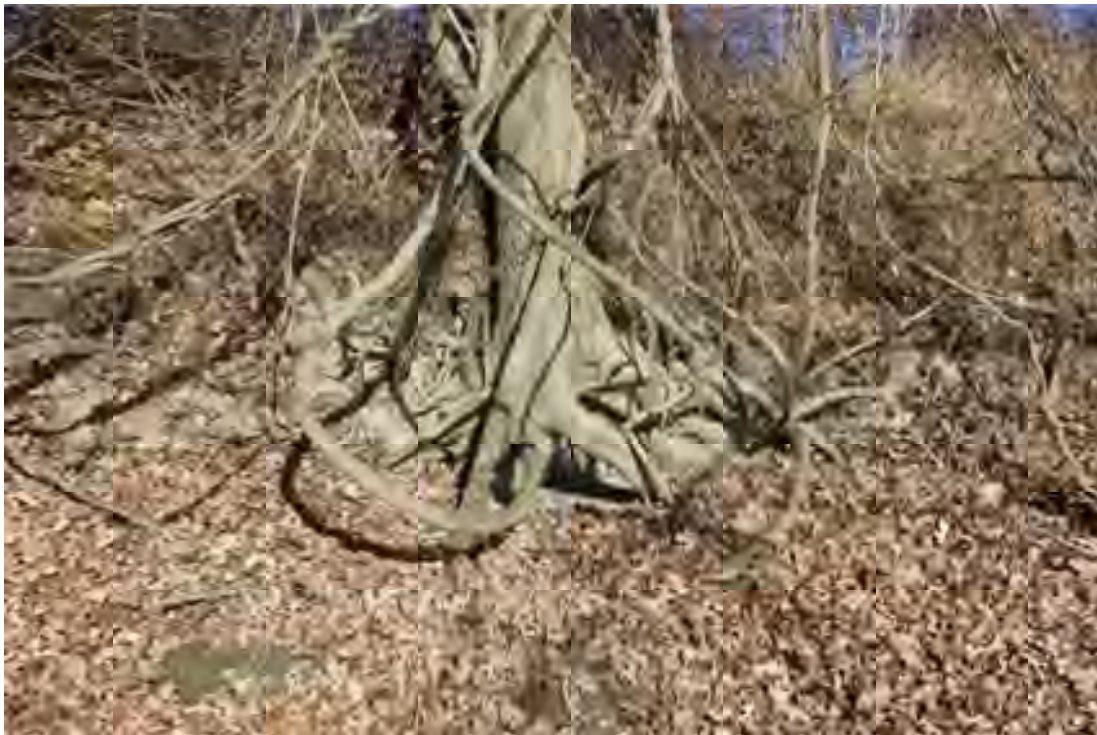
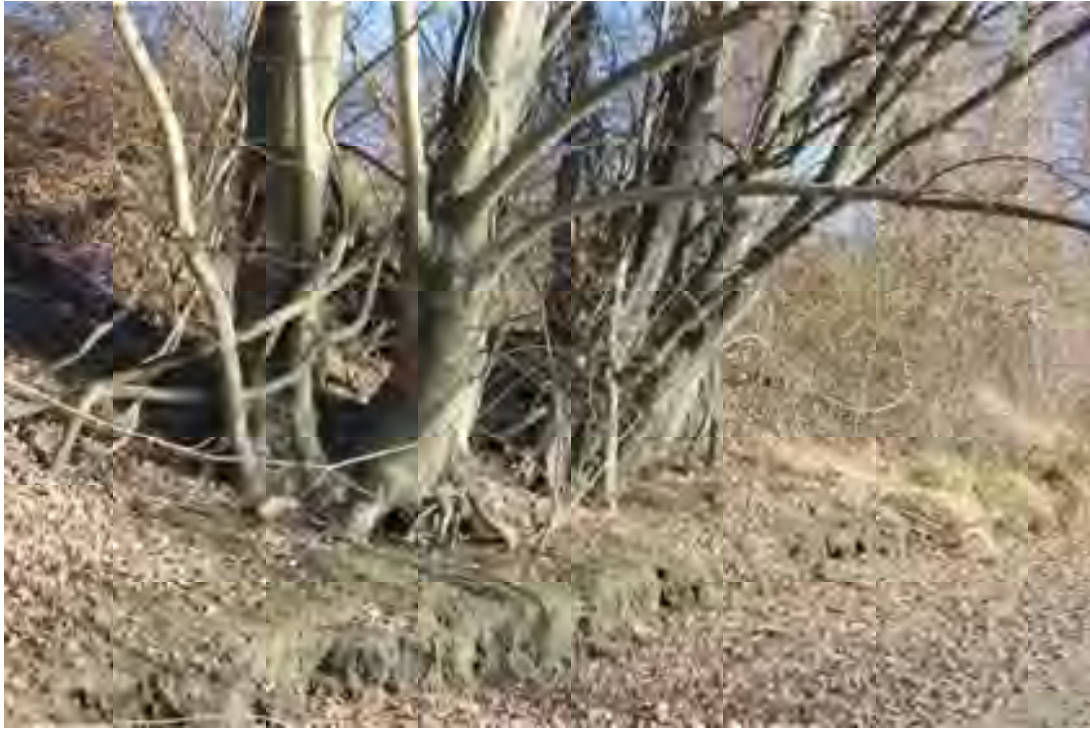
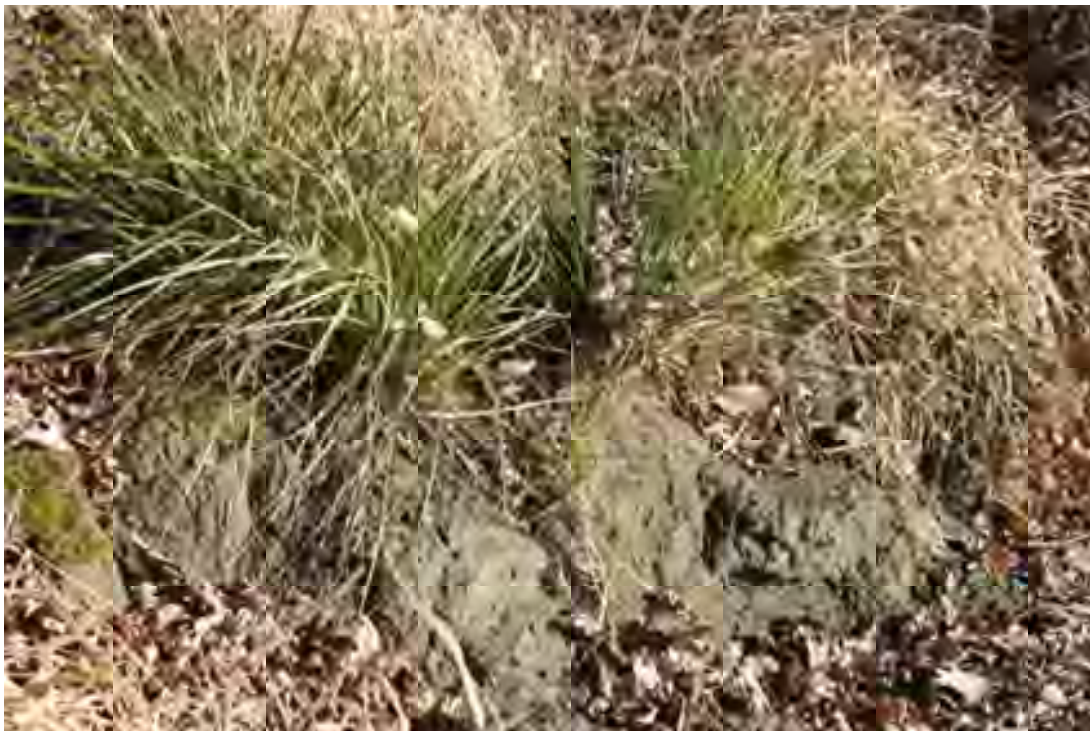
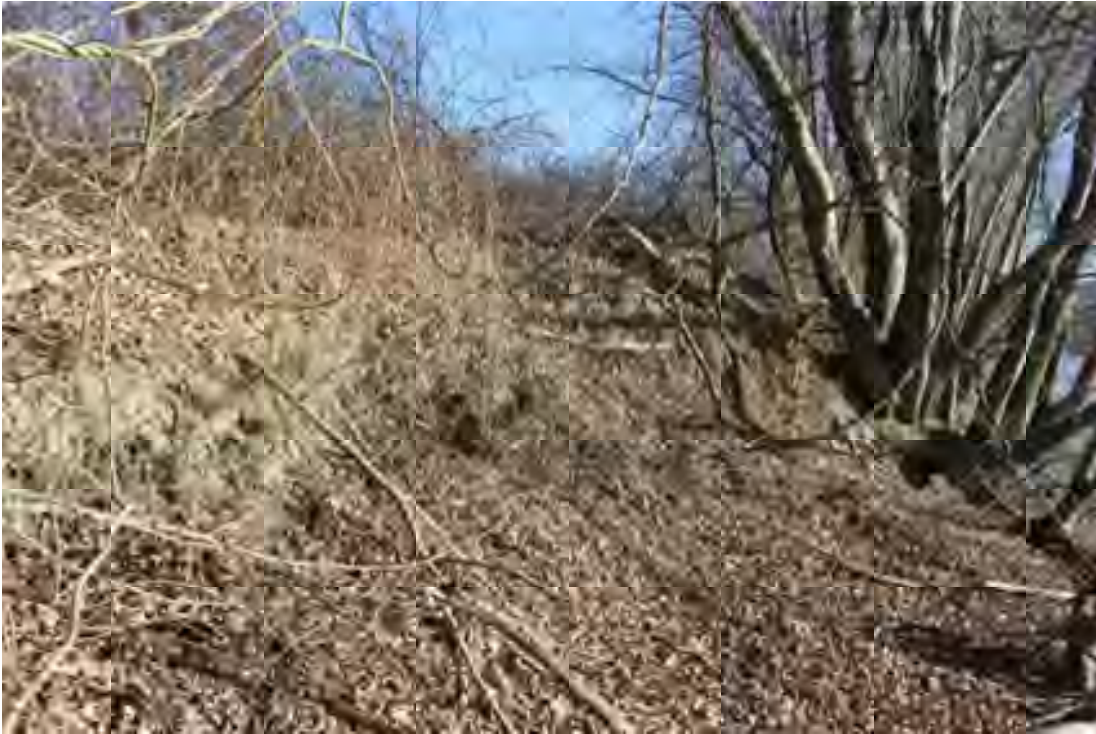
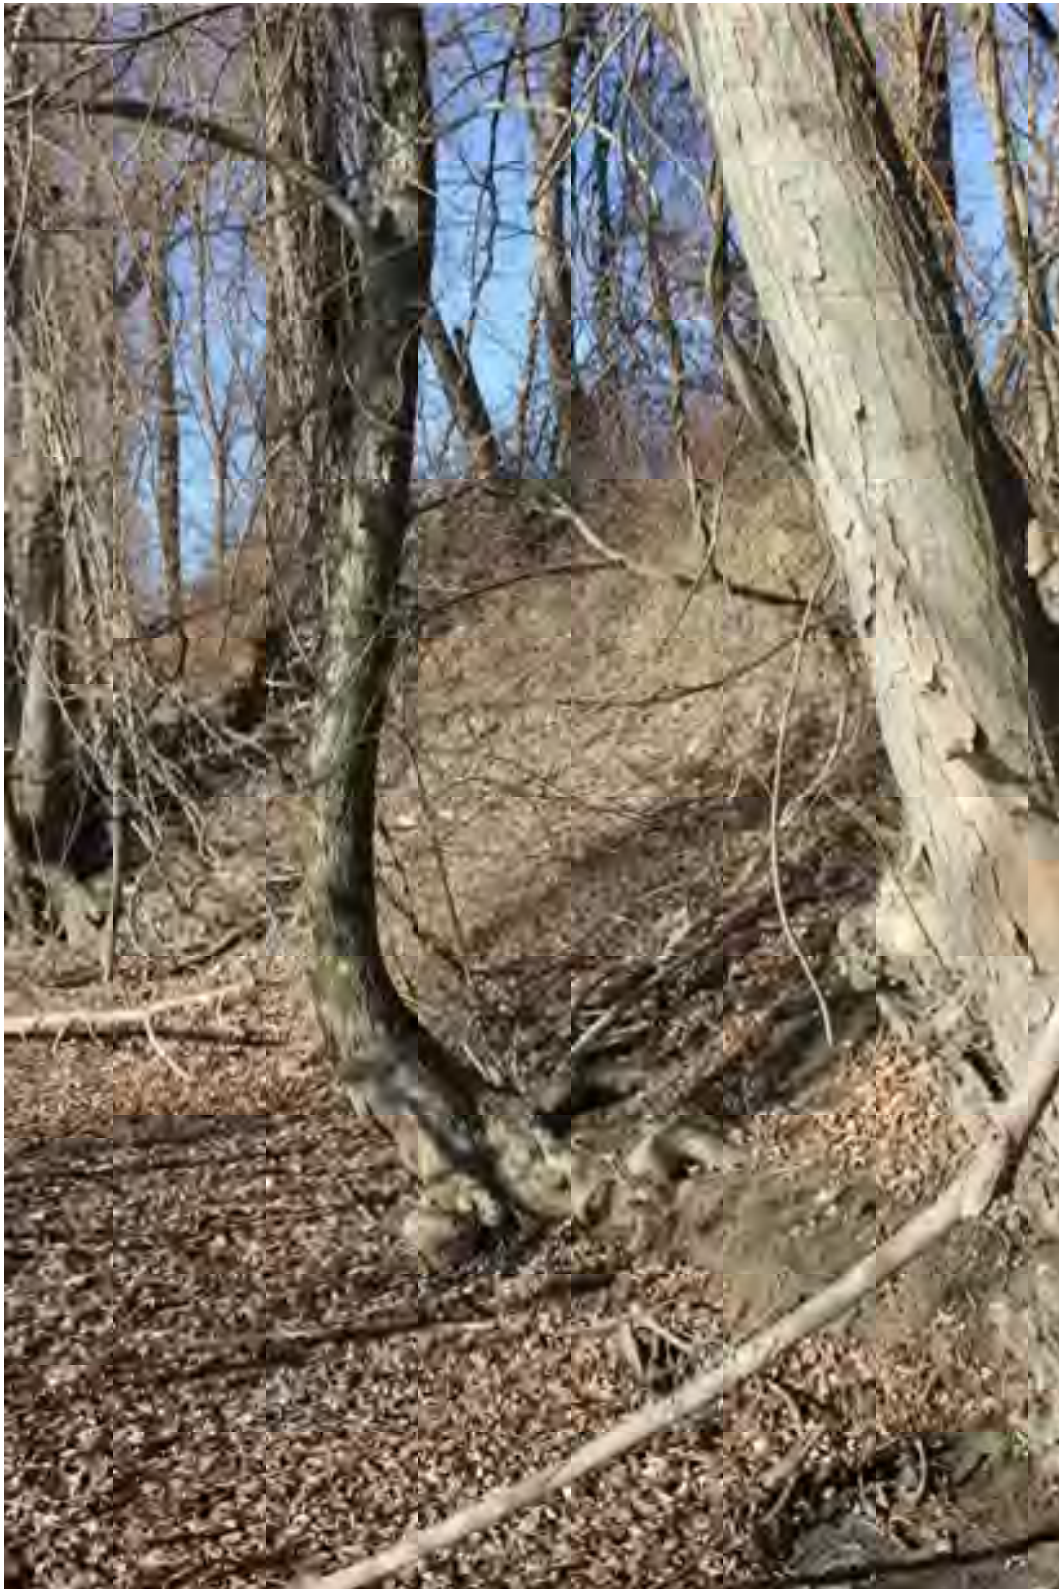
Notes: Transitional zone with emergent vegetation growing on recent deposition of sediments from Hurricane Irene
