RELICENSING STUDY 3.1.1

2013 FULL RIVER RECONNAISSANCE

**Northfield Mountain Pumped Storage Project (No. 2485)
and Turners Falls Hydroelectric Project (No. 1889)**

SEPTEMBER 2014

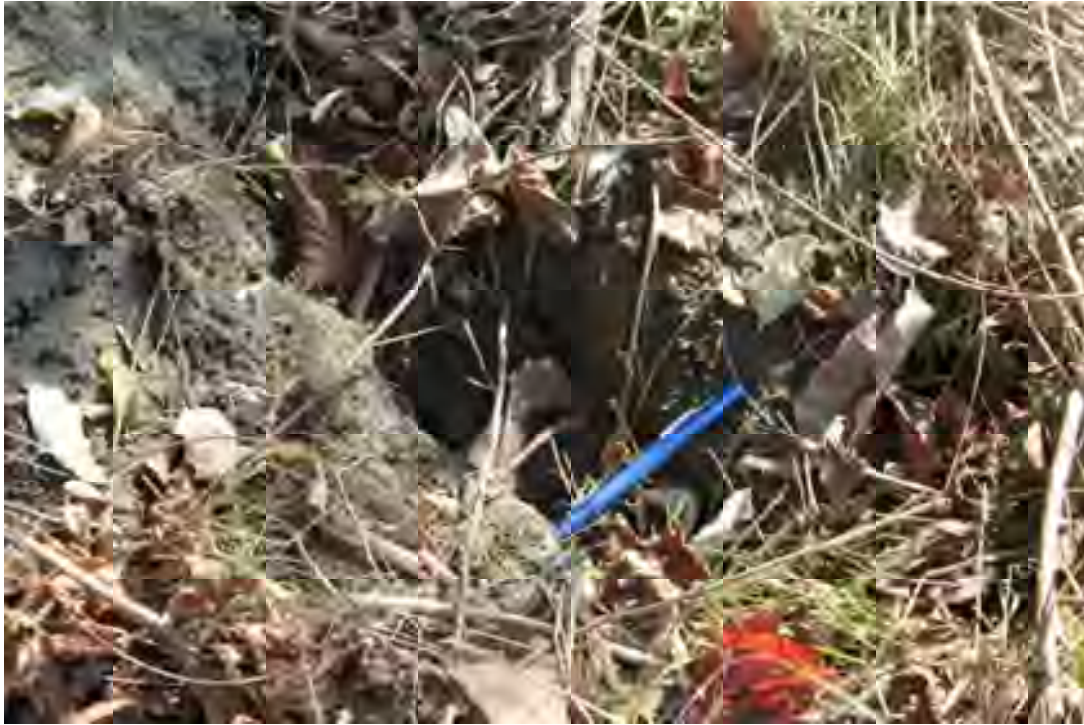
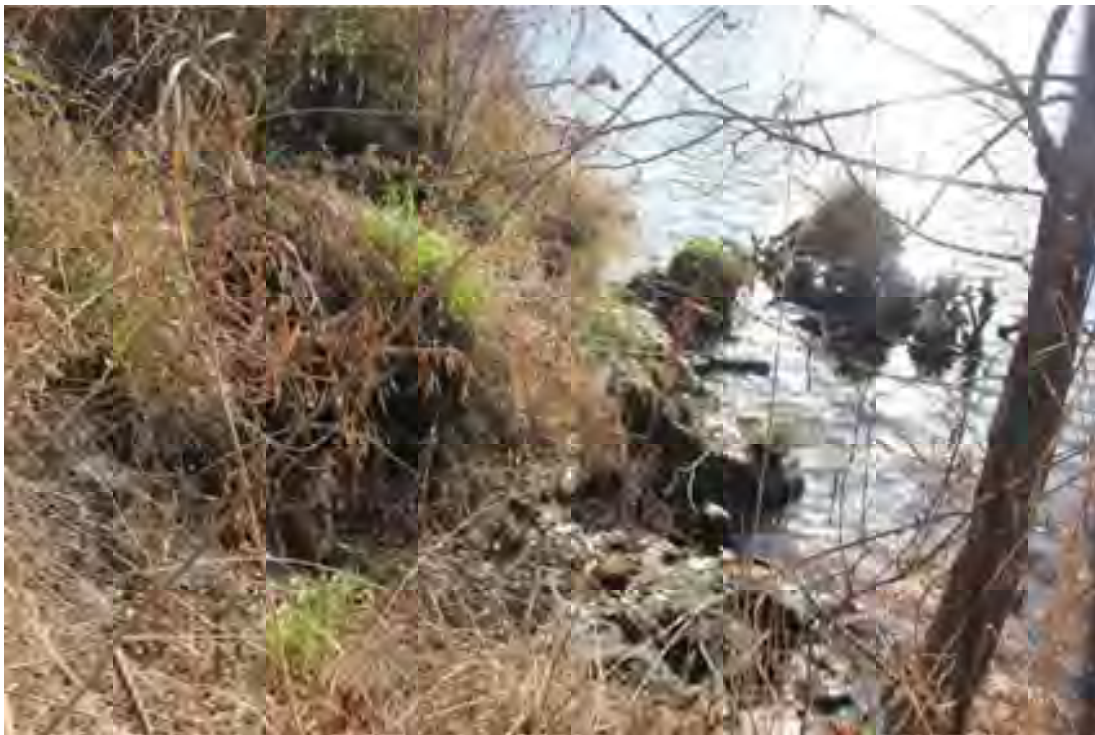
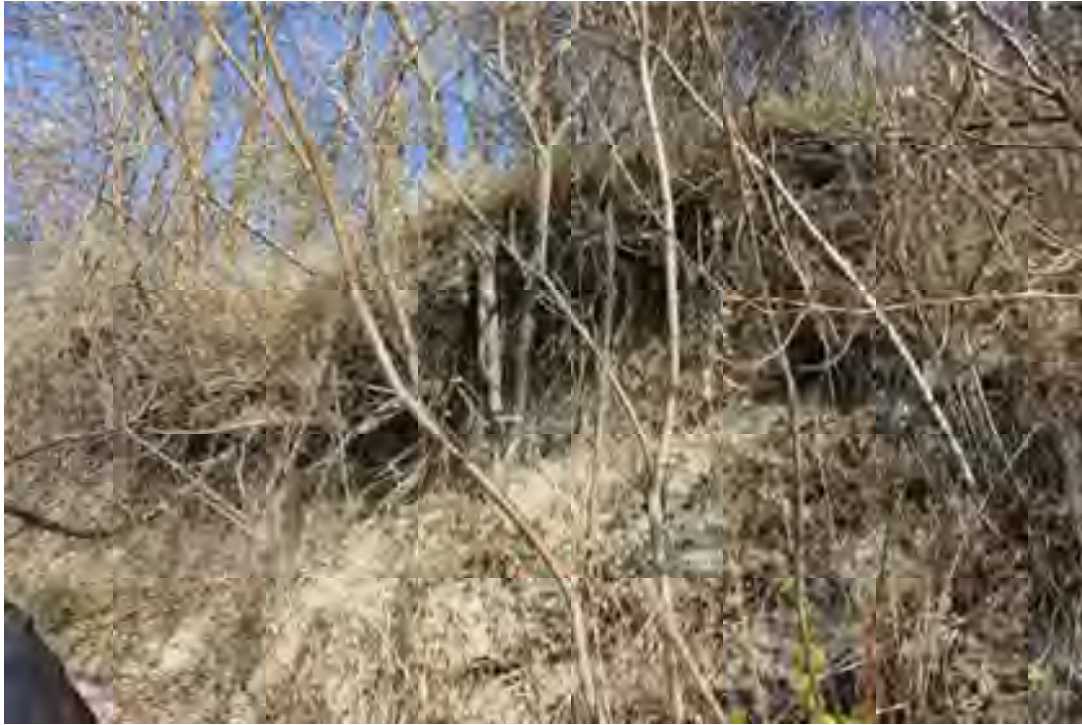
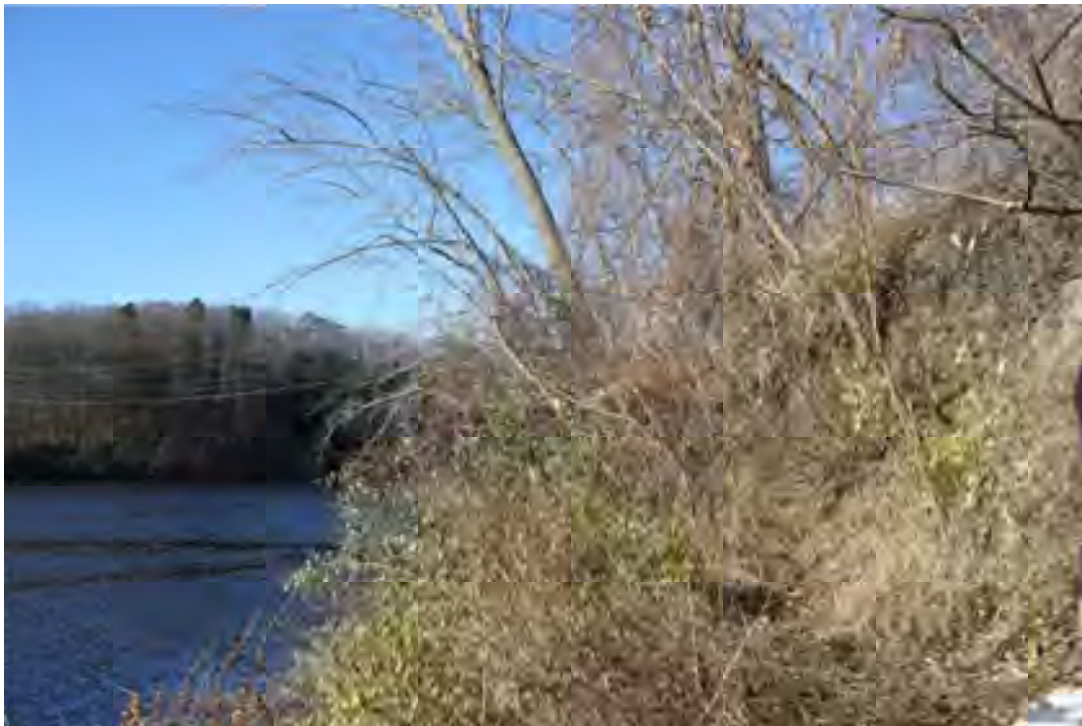
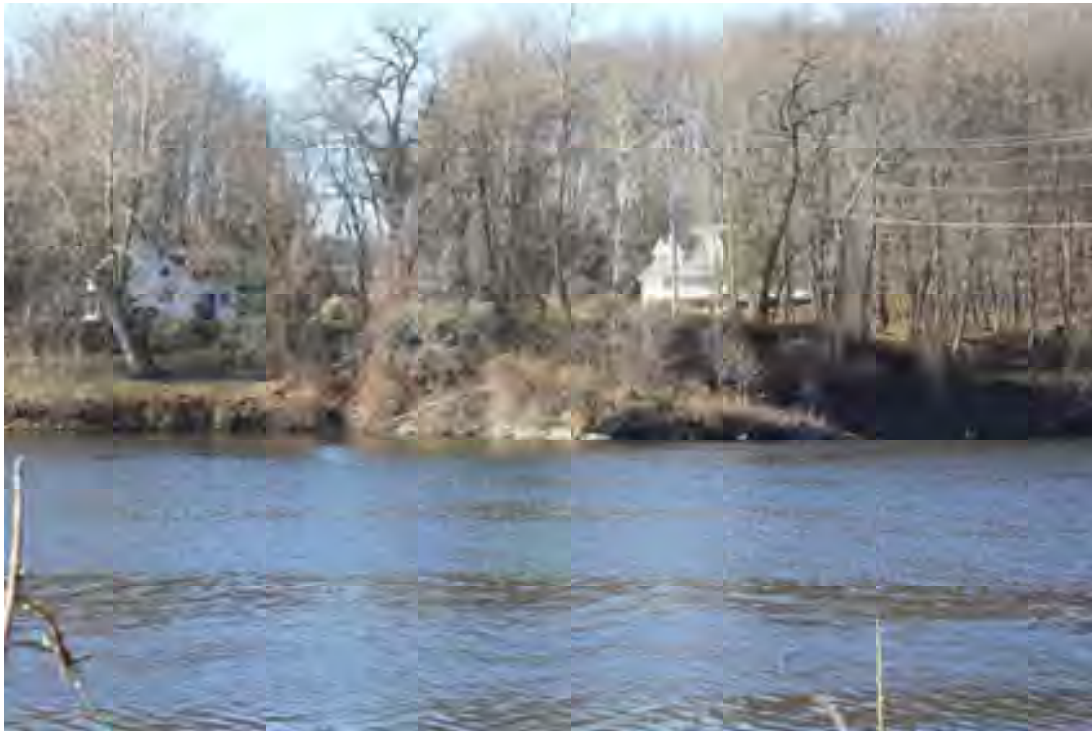
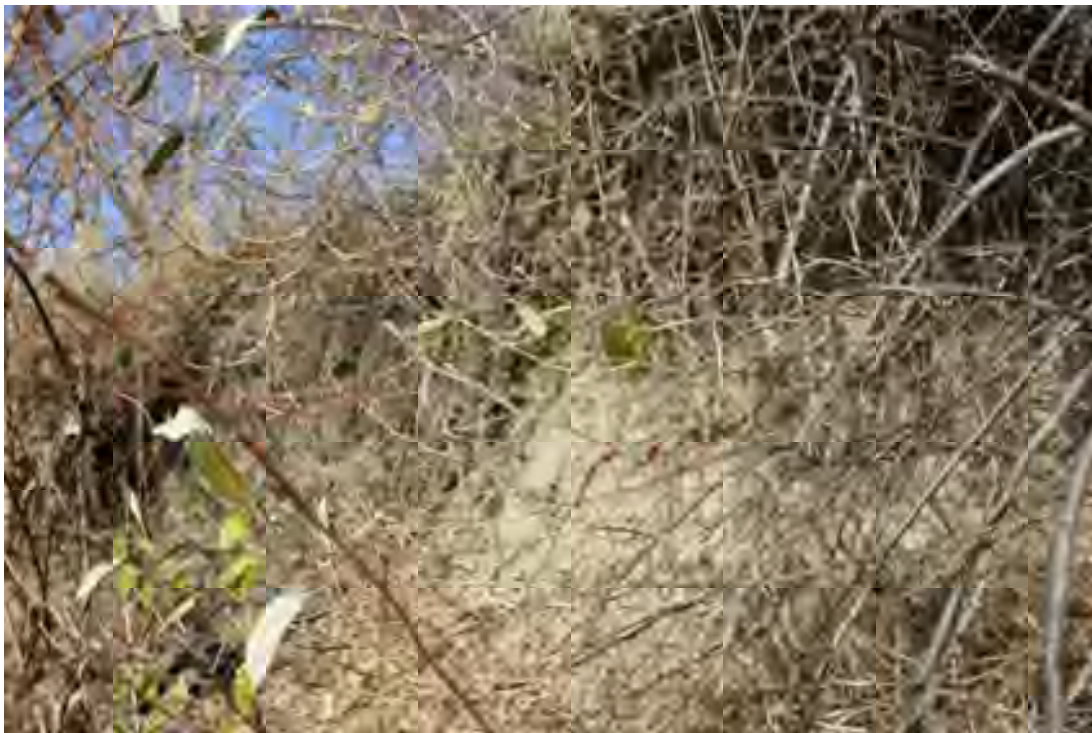
Old bridge abutment here and pile of concrete blocks

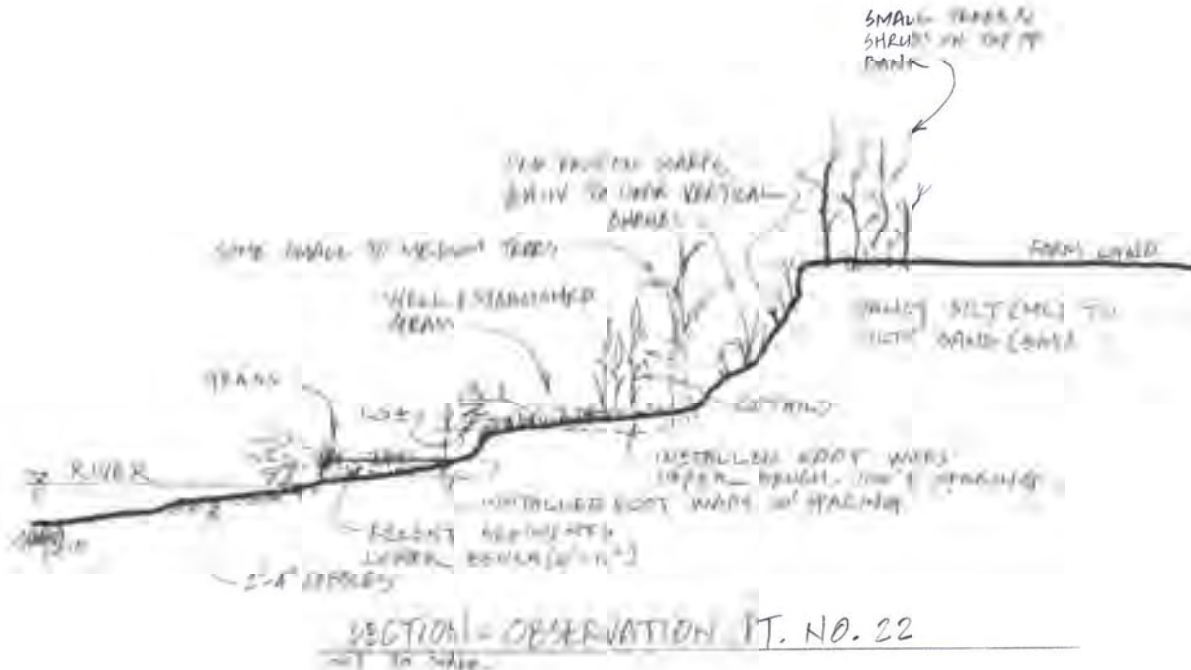
Site Sketch:

- Little to no recent erosion. Repair appeared to be effective in controlling erosion along this segment.

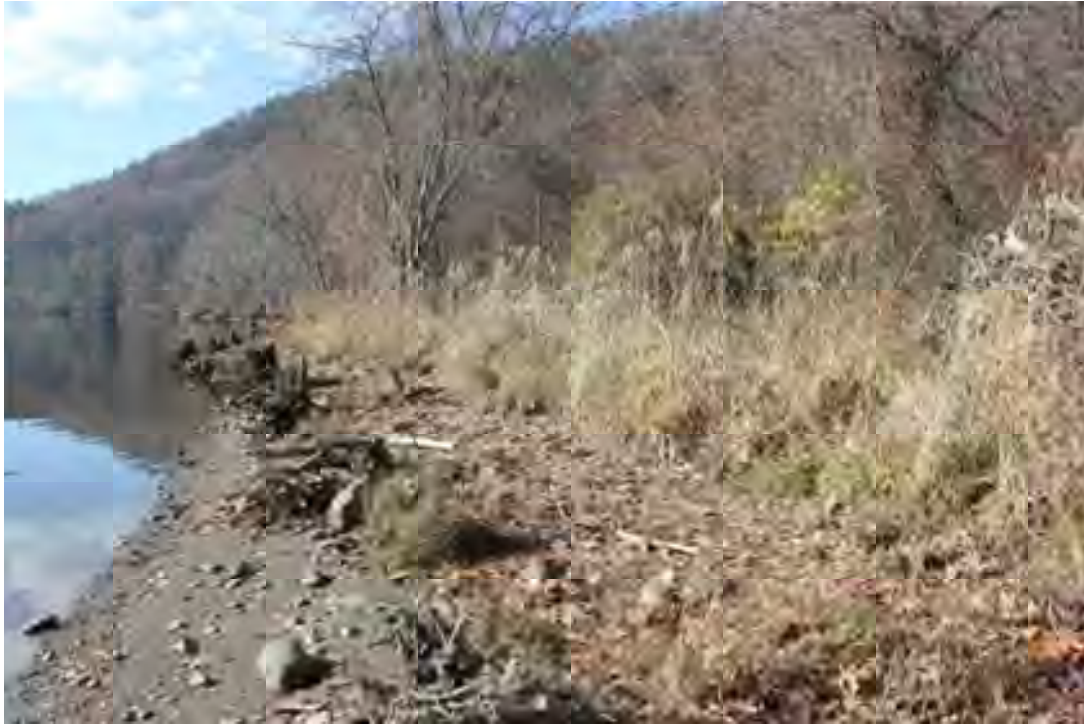
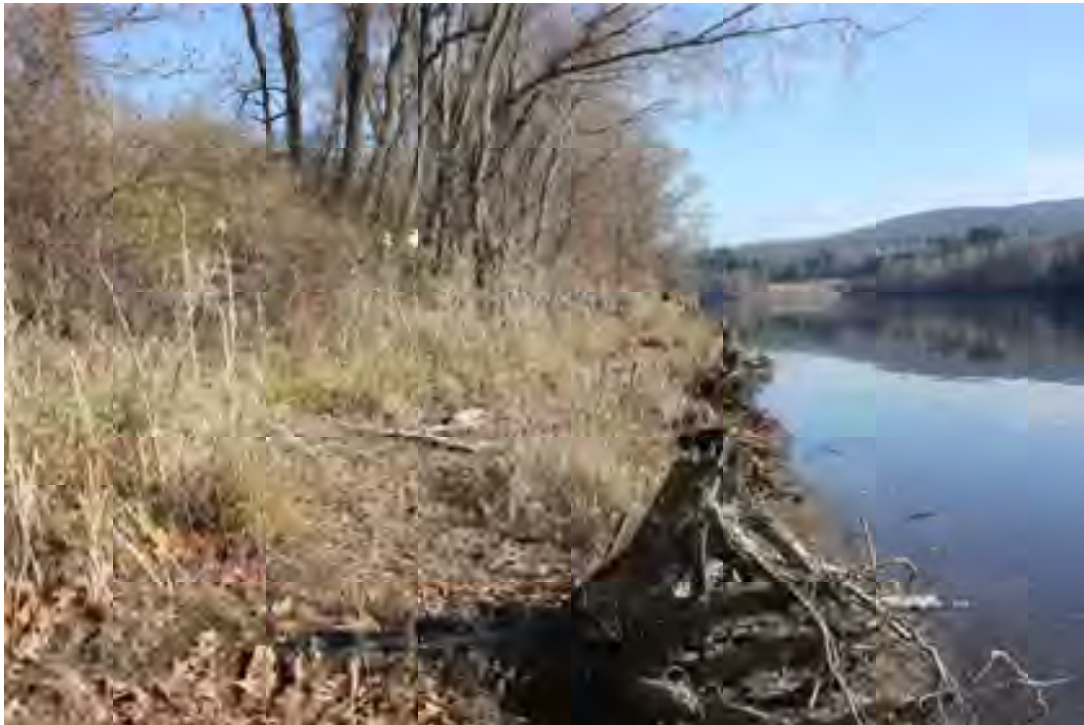
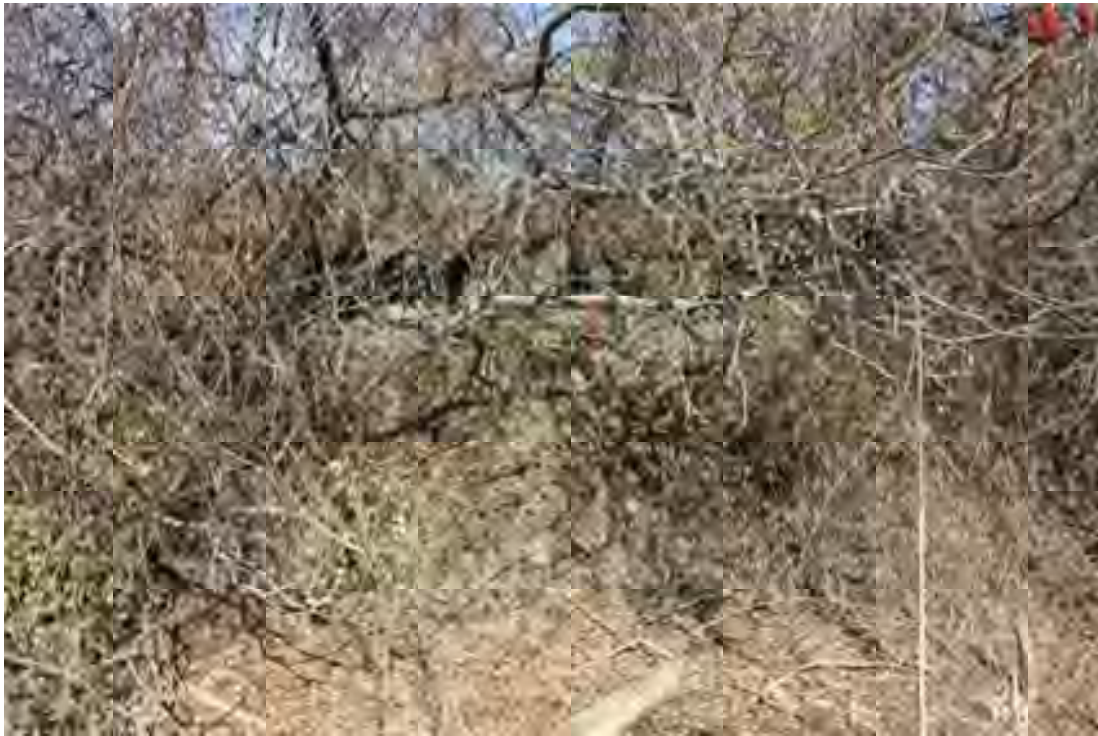
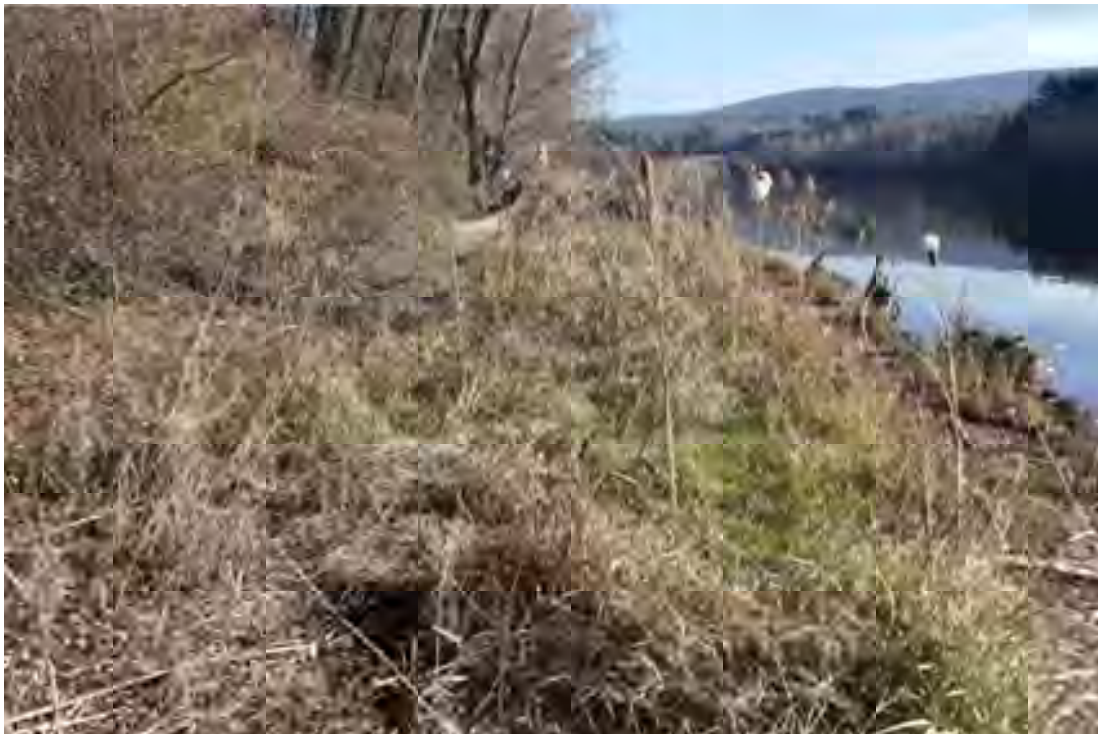
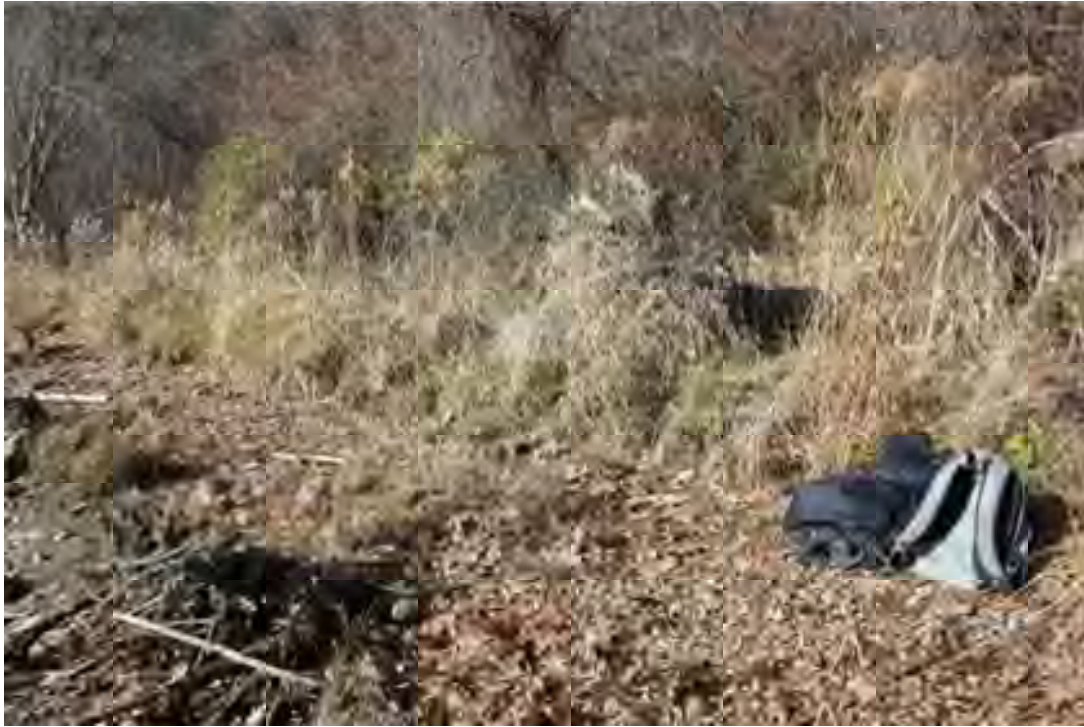
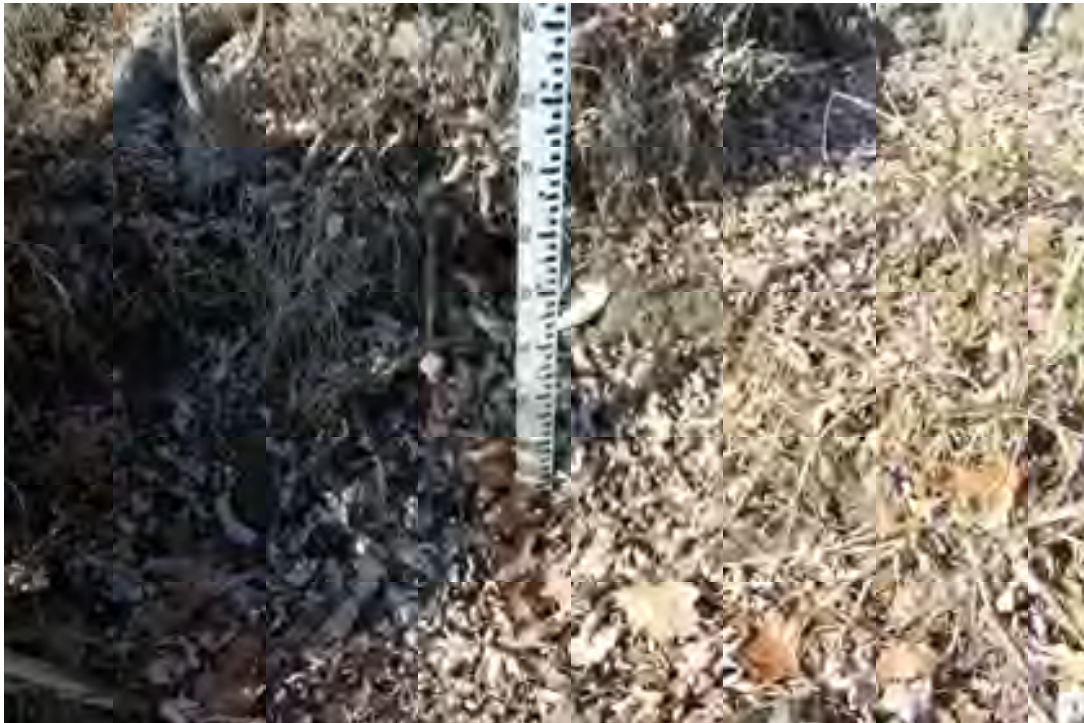
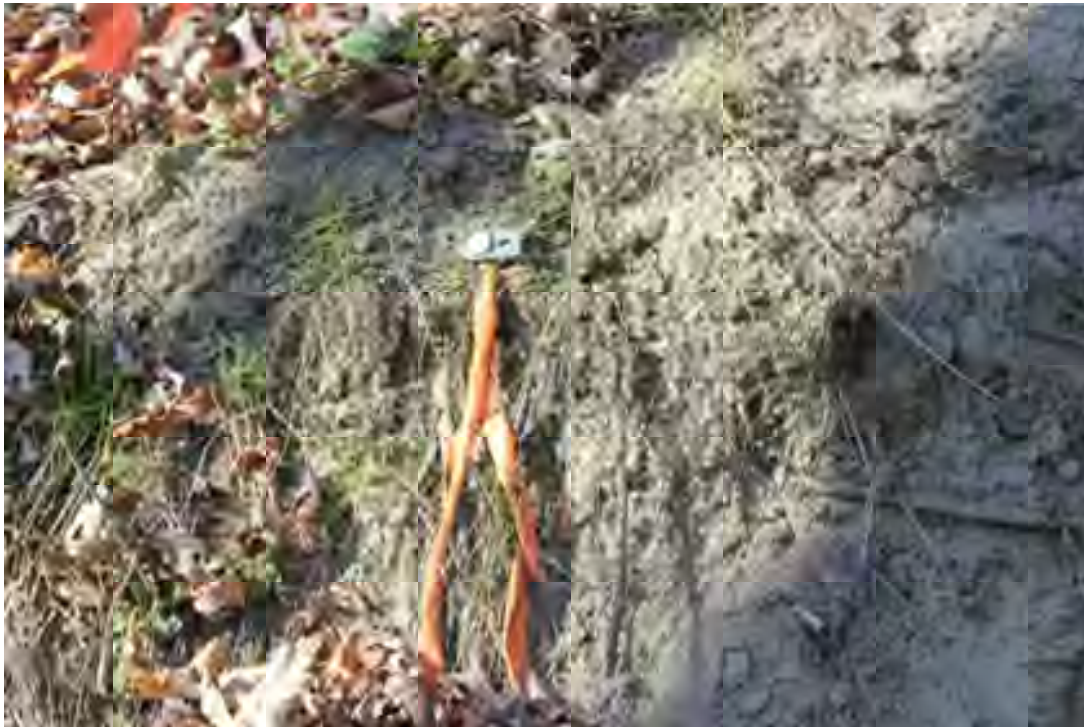
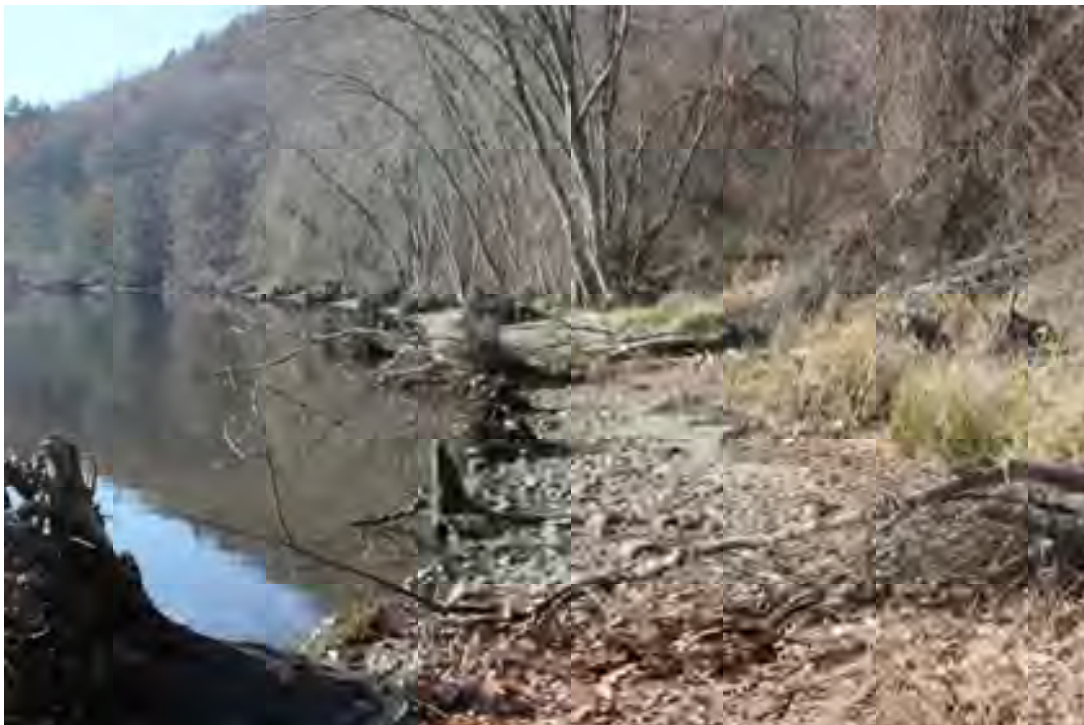
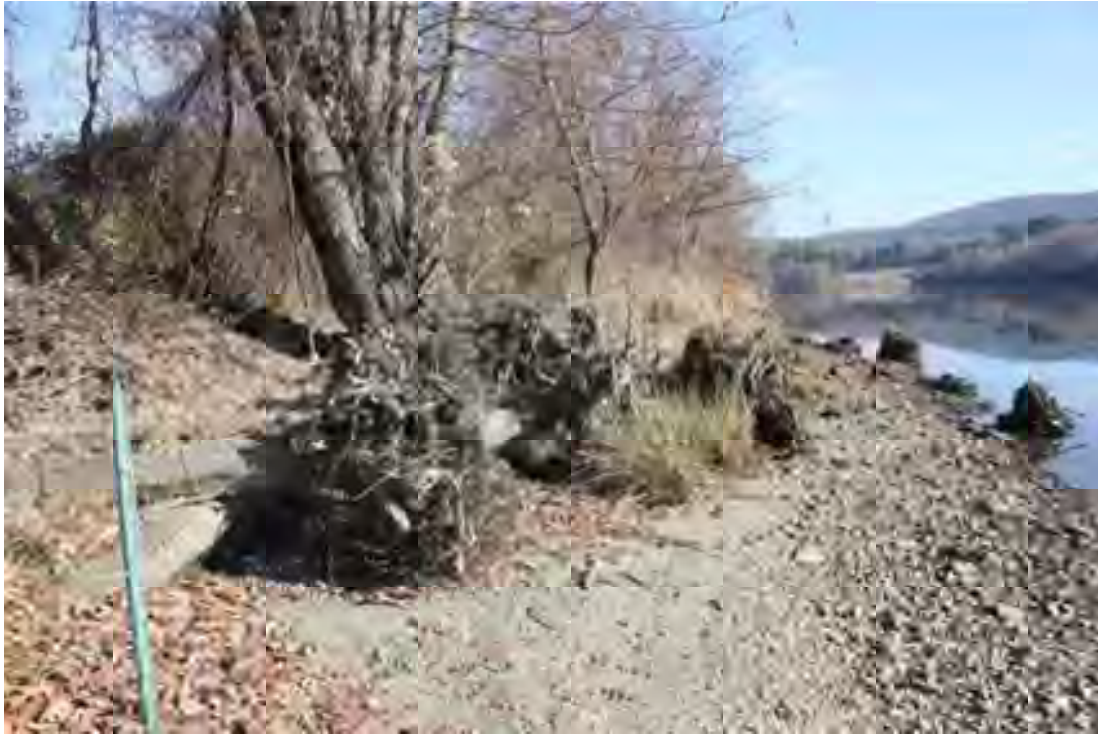
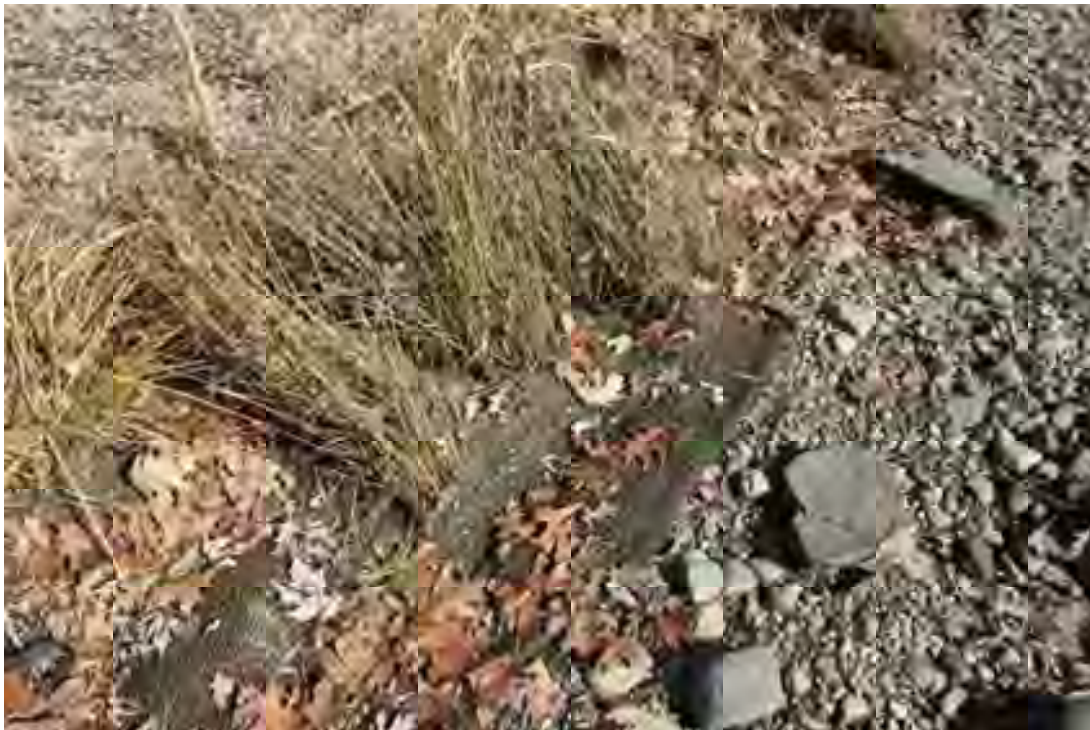
Restoration site w/o hard armor such as riprap, but bioengineering techniques (CWD)

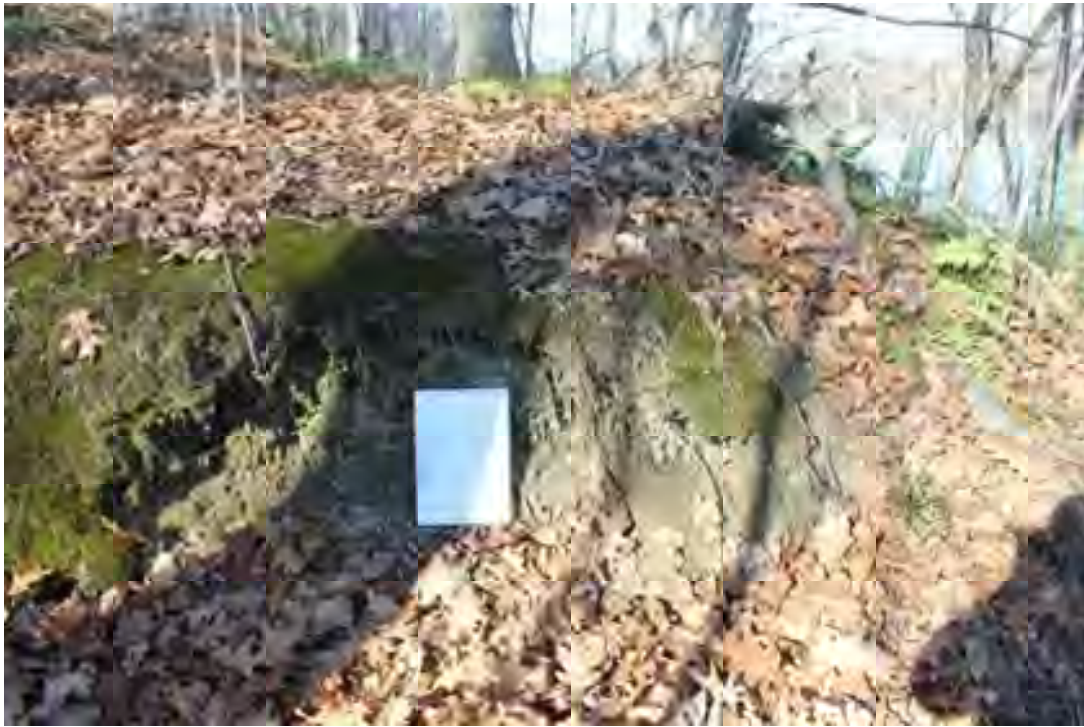
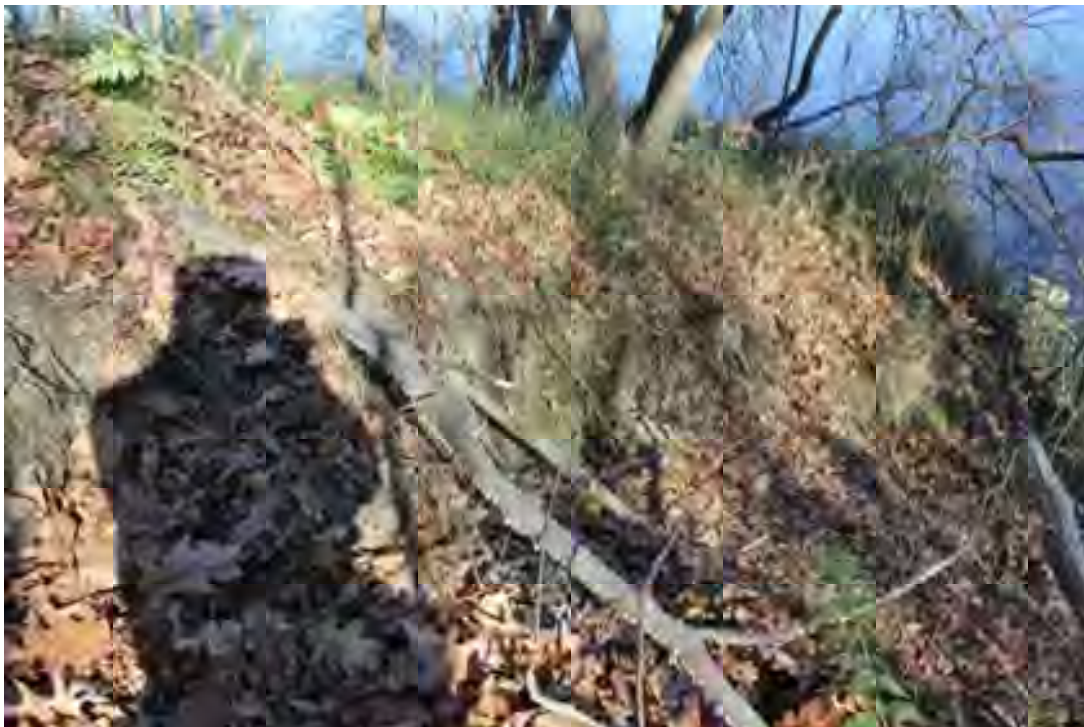
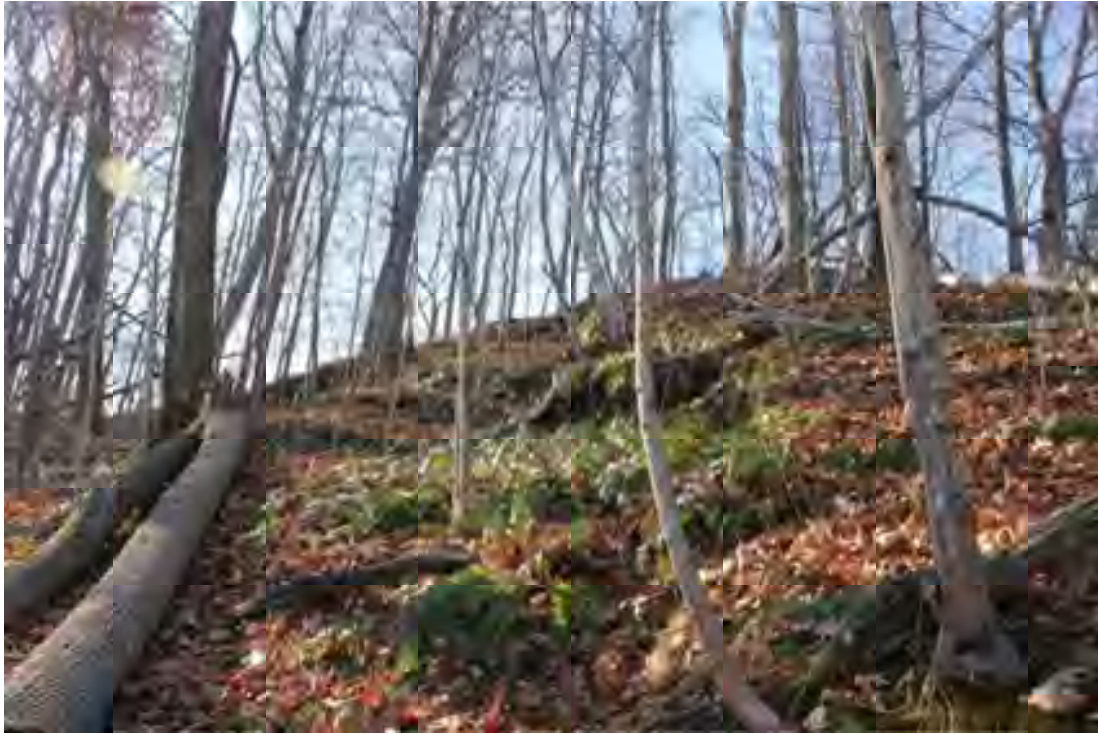
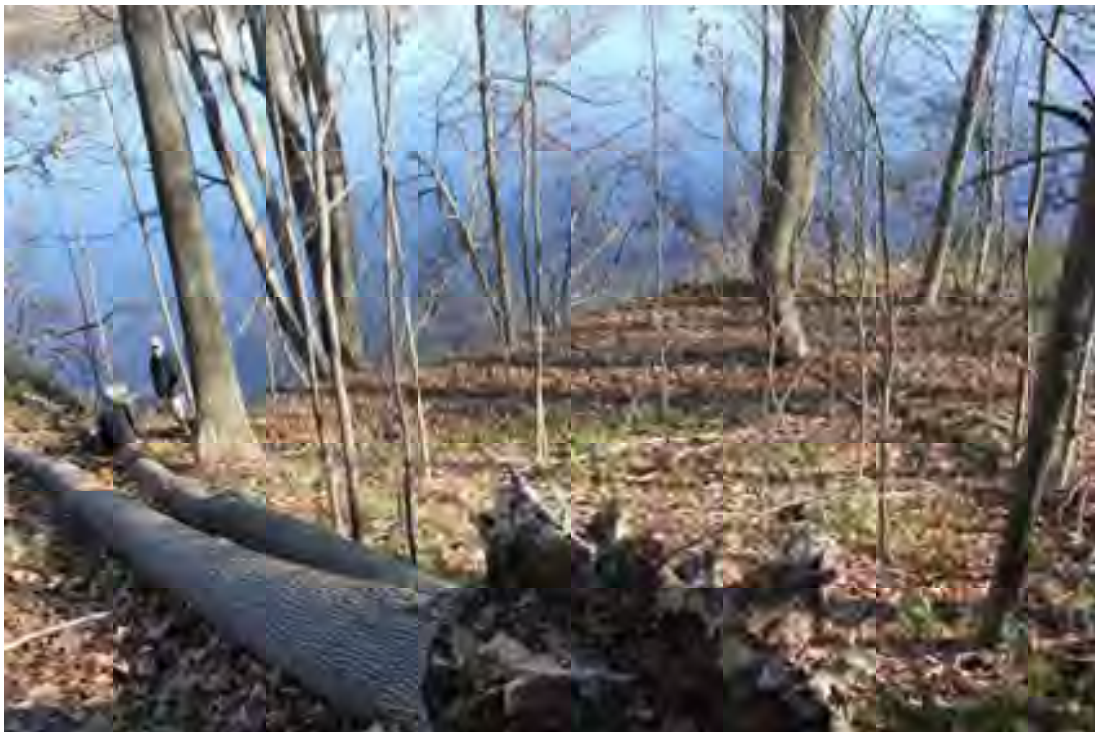
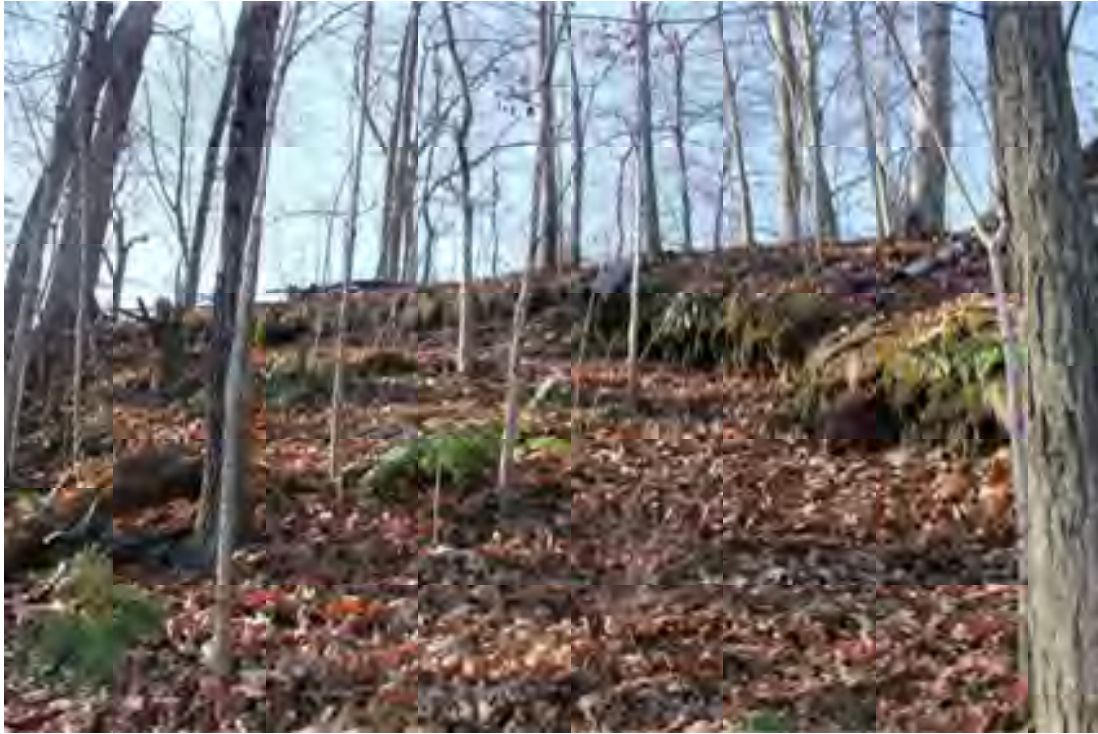
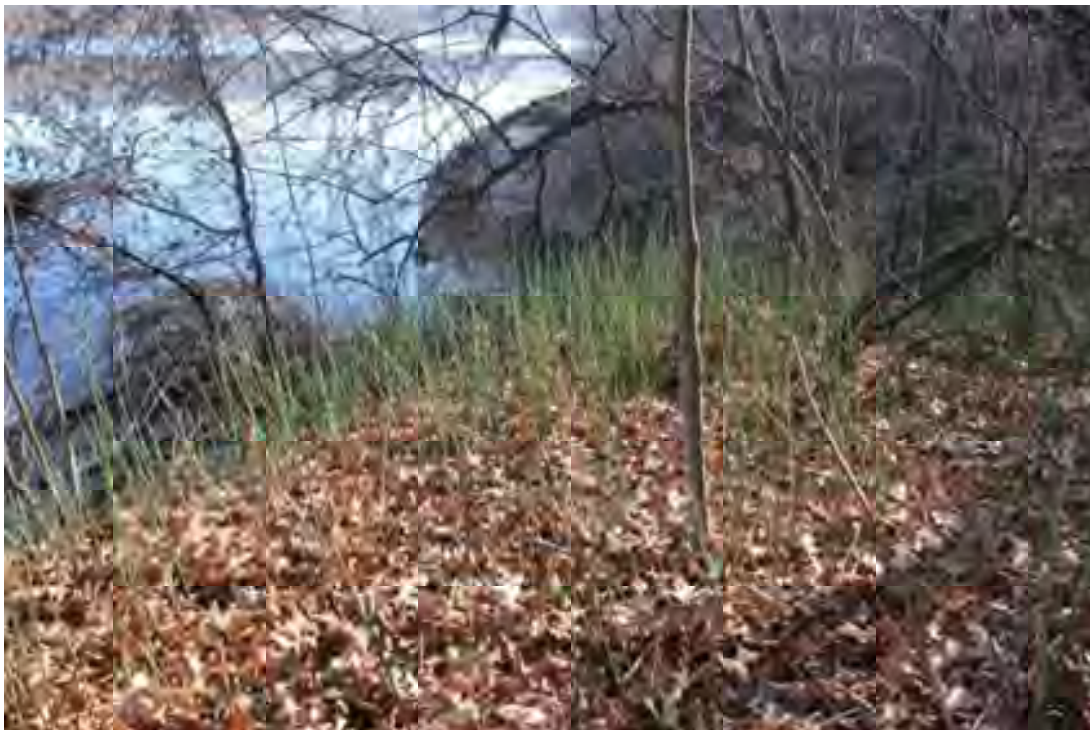
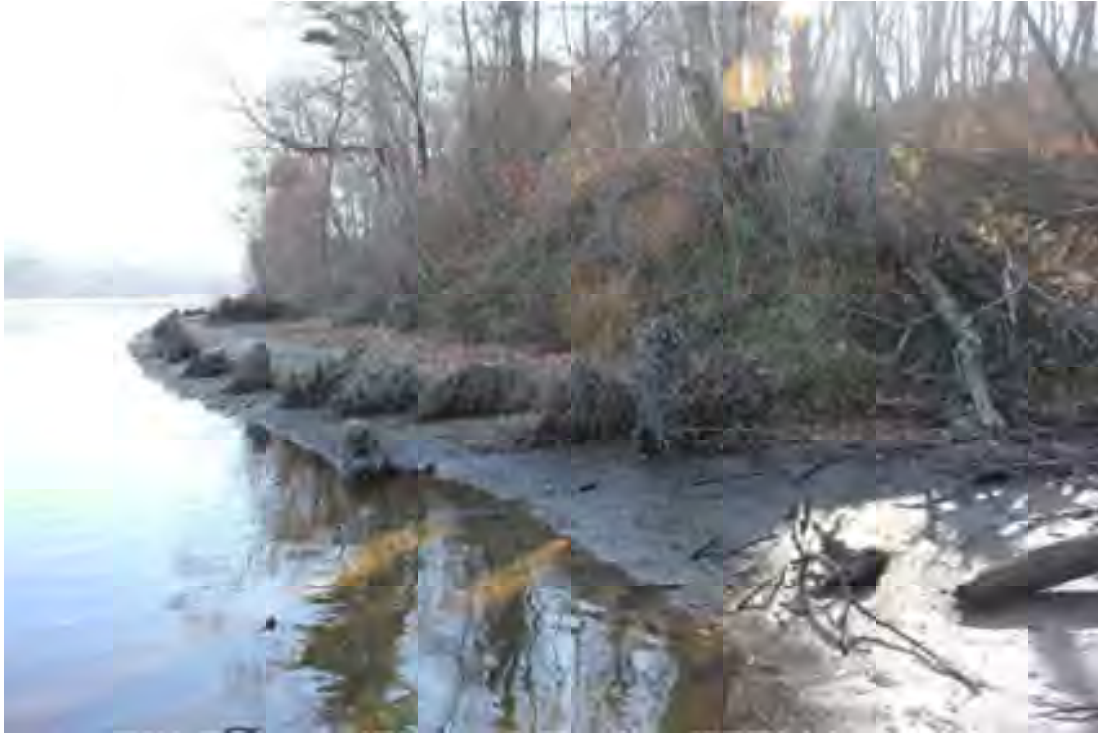
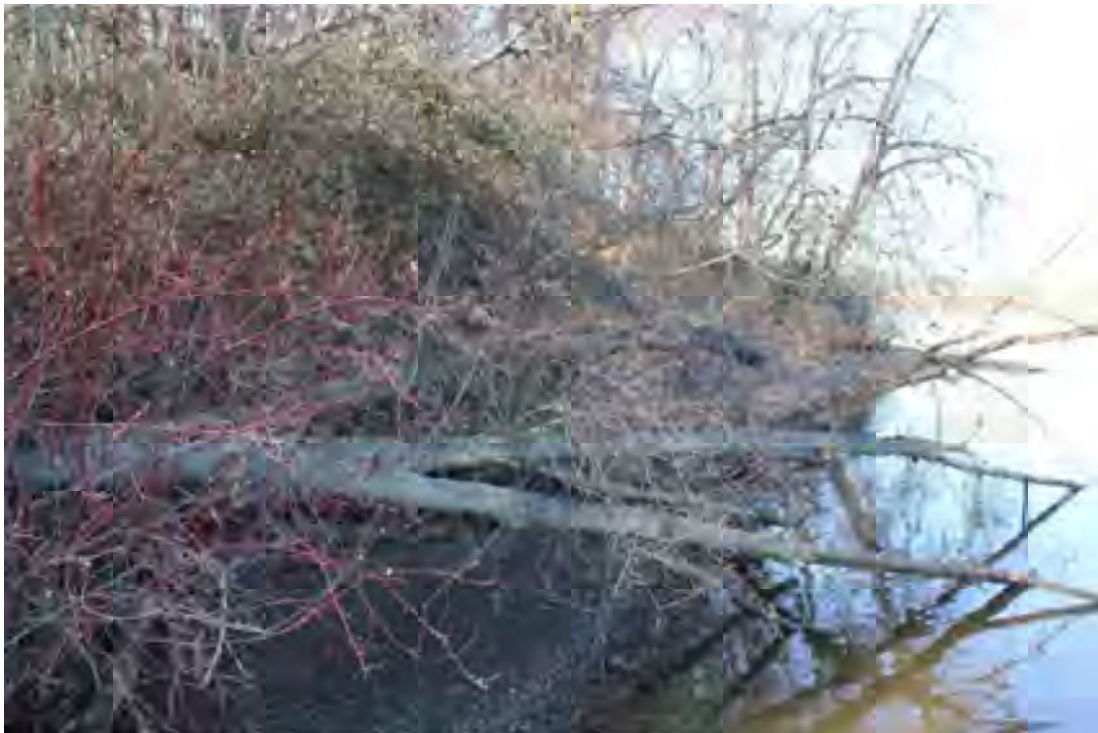
High terrace and evidence of landslides characterized by rotational slip from top of hillside down to river
