RELICENSING STUDY 3.1.1

2013 FULL RIVER RECONNAISSANCE

**Northfield Mountain Pumped Storage Project (No. 2485)
and Turners Falls Hydroelectric Project (No. 1889)**

SEPTEMBER 2014

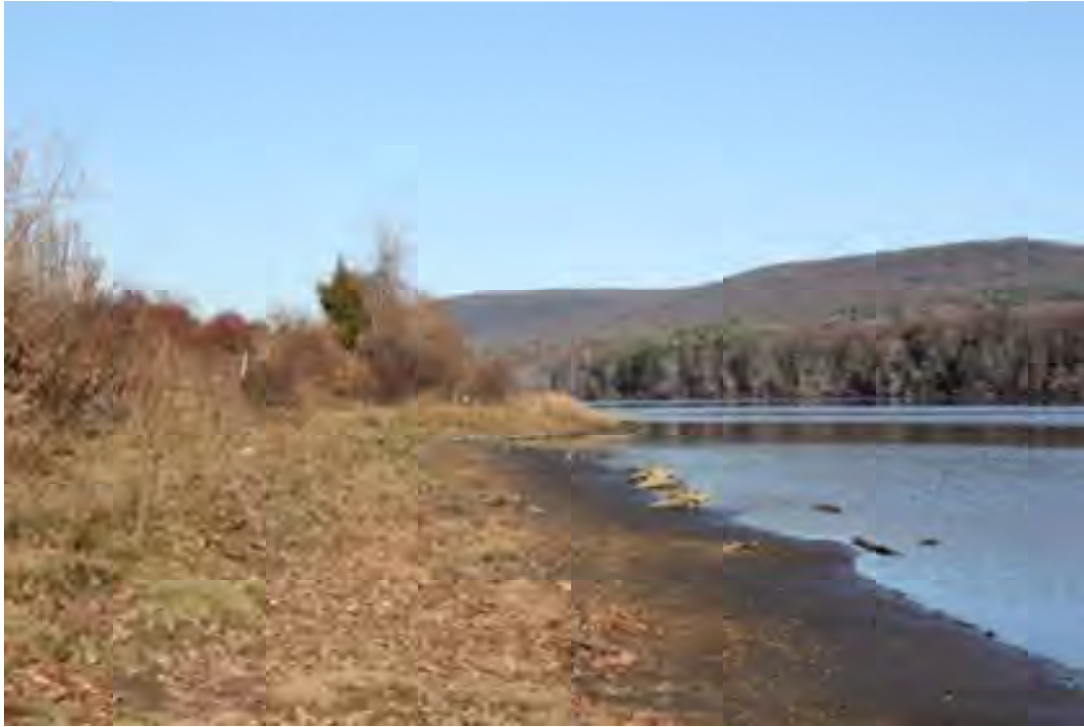
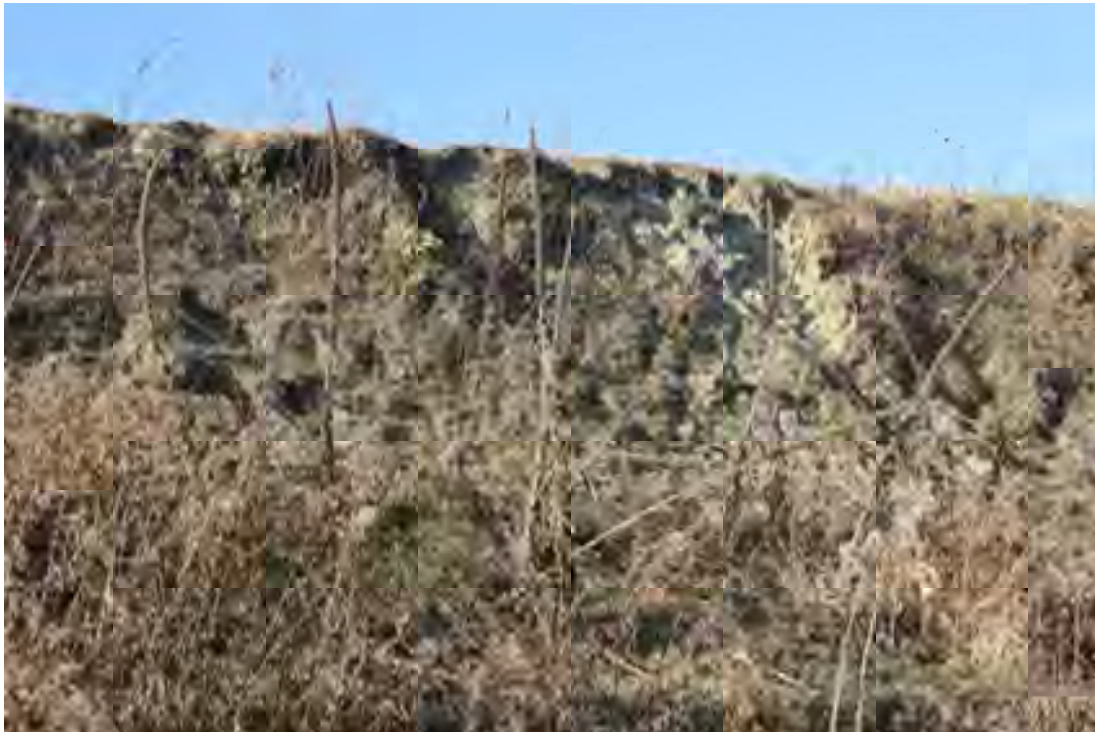
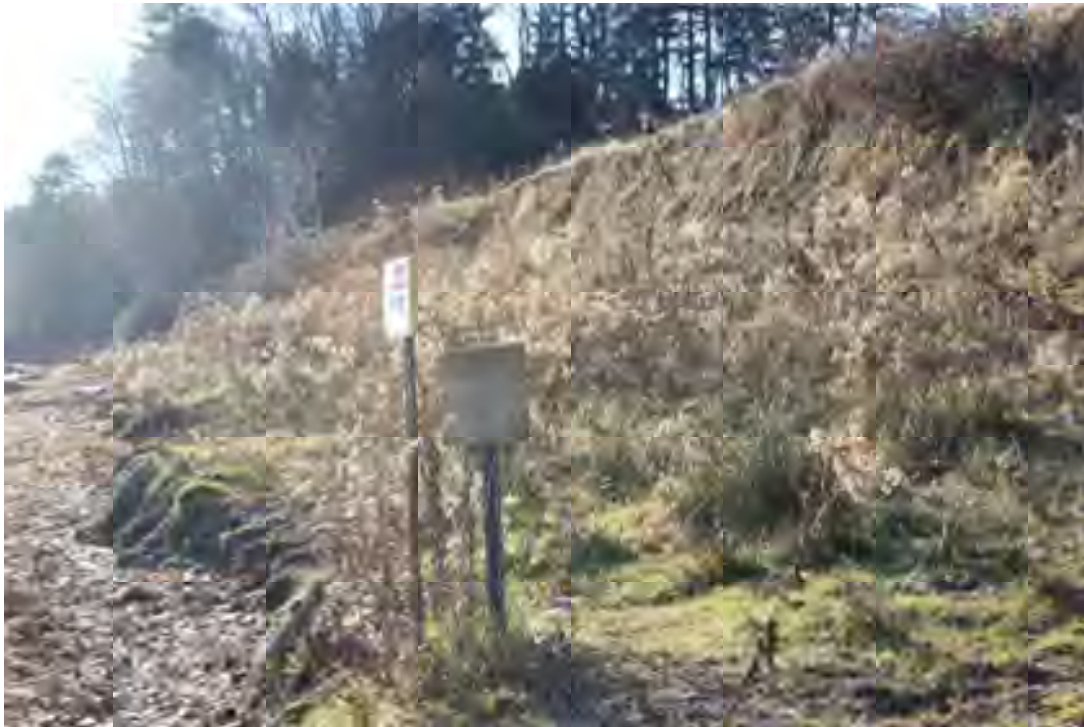
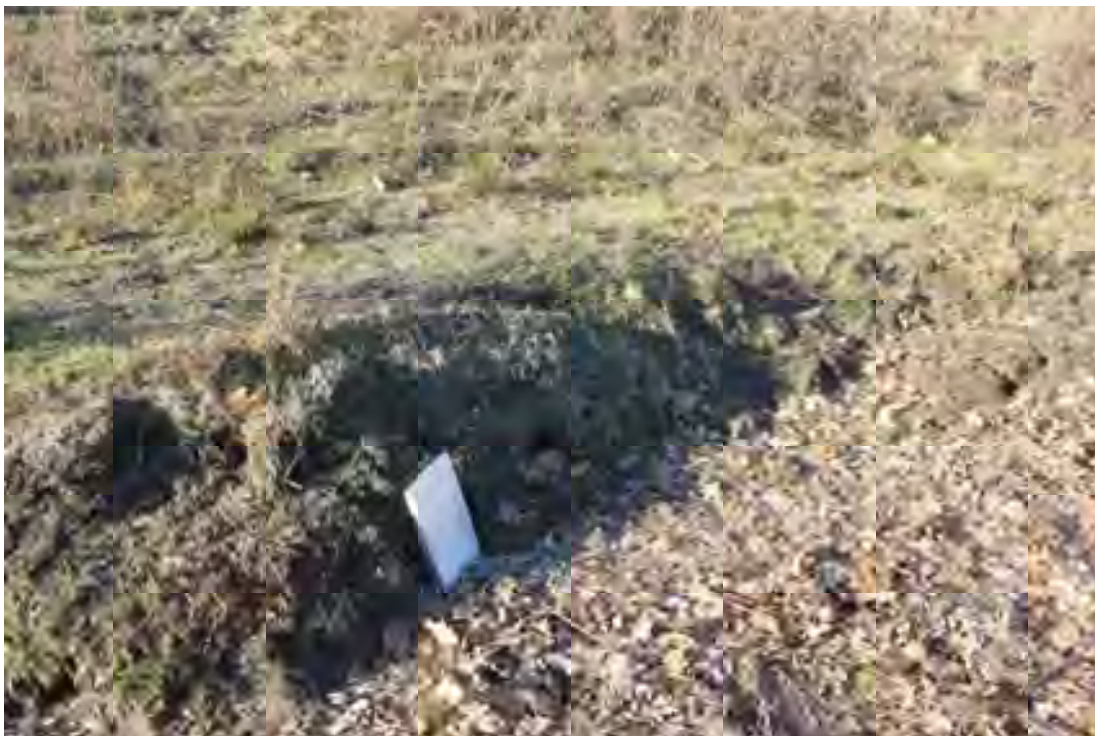
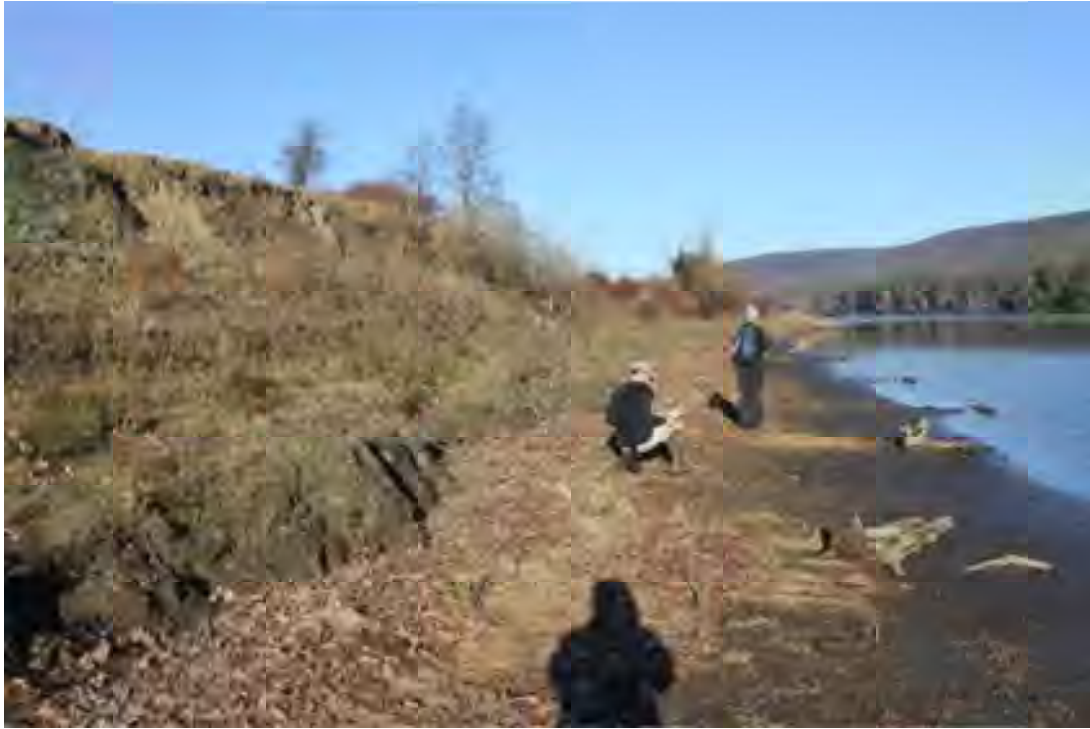
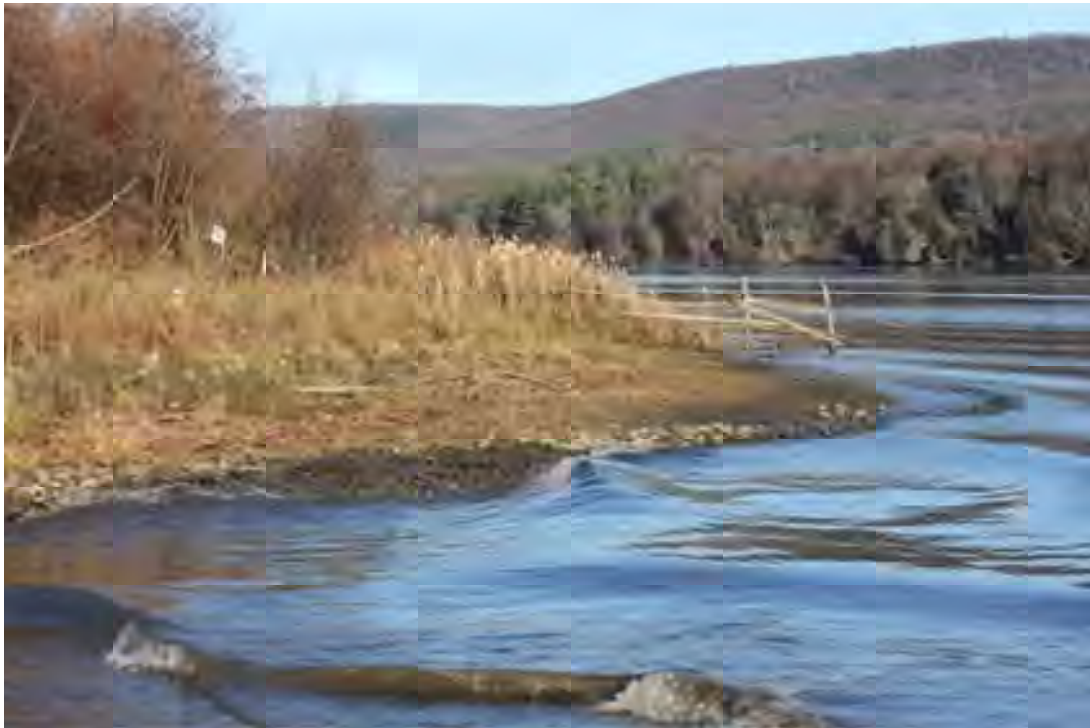
Steep, vertical, actively failing sandy bank face with steep, vertical scarps at top half of bank (appear to predate restoration)

Portion of the lower bank material was eroded after grazing

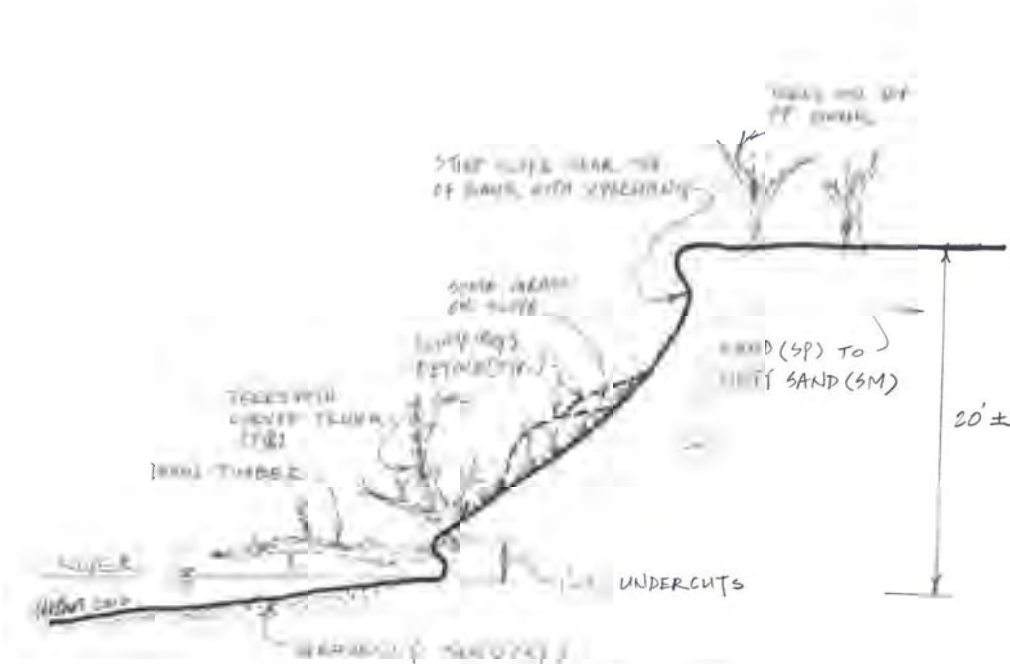
SECTION - OBSERVATION PT. No. 26
NOT TO SCALE

- Mass-wasting and slumping.
- Near-vertical scarp and overhang along top portion of upper bank.
- Undercuts at toe of bank at river level, especially under fell trees.
- Down timber, leaning and curved tree trunks indicated past ground movements.

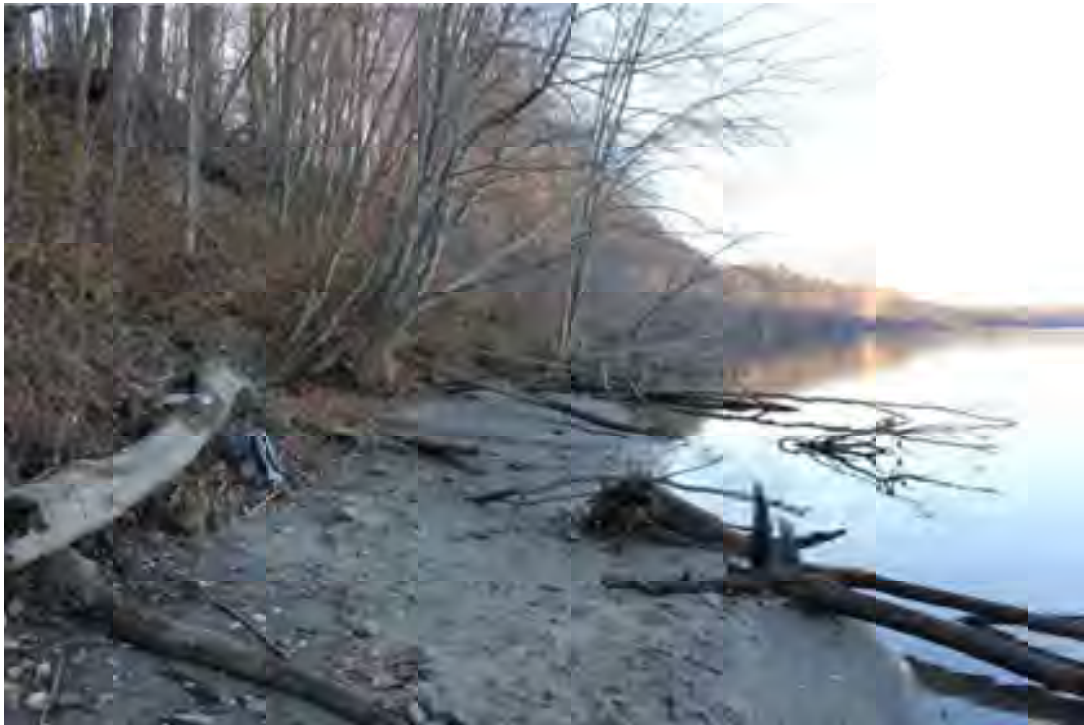
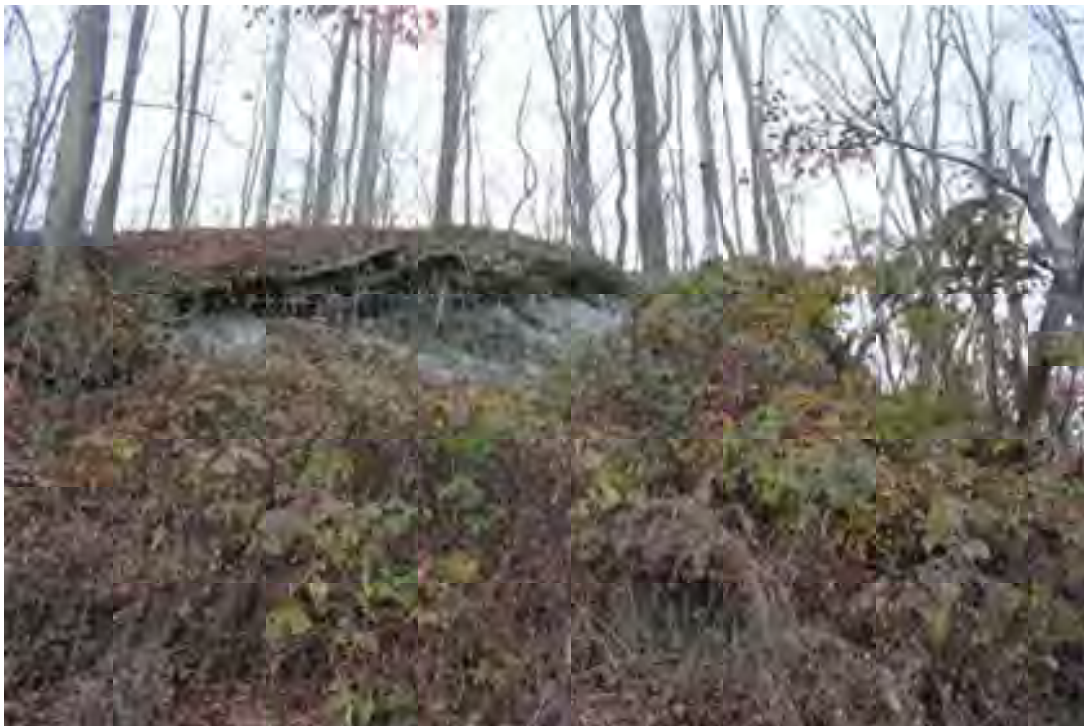
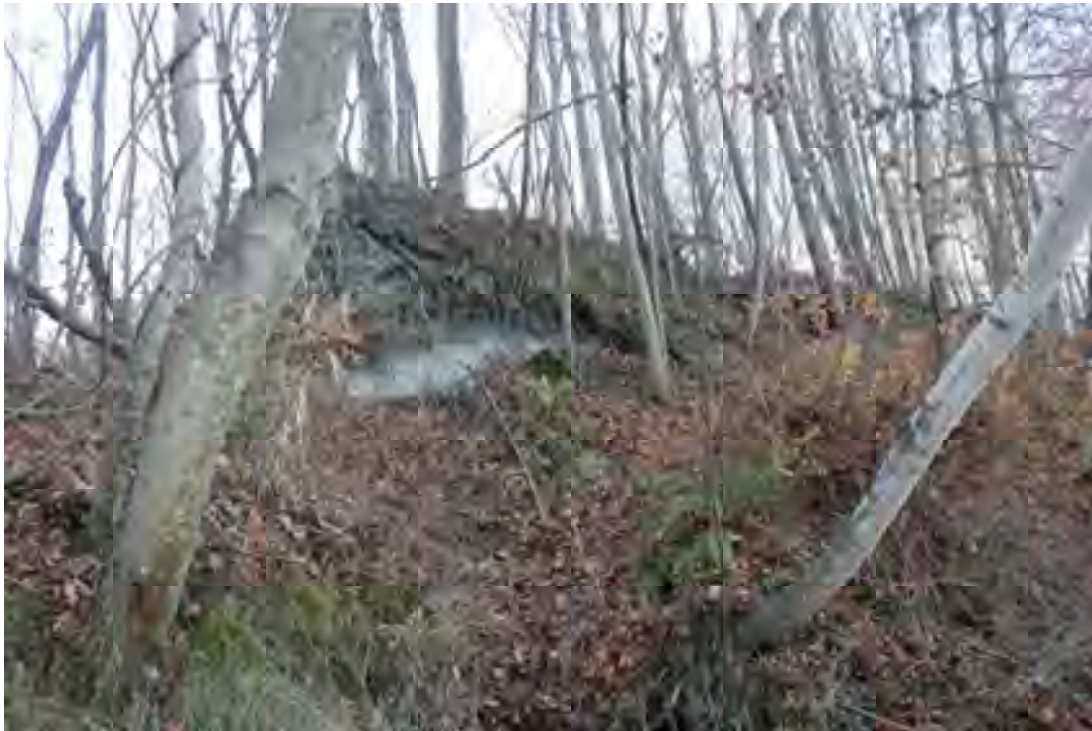
Notes: recent failure, mostly mass wasting. Some minor fluvial erosion but mostly geomorphological bank failure (Irene, ~2 yrs)

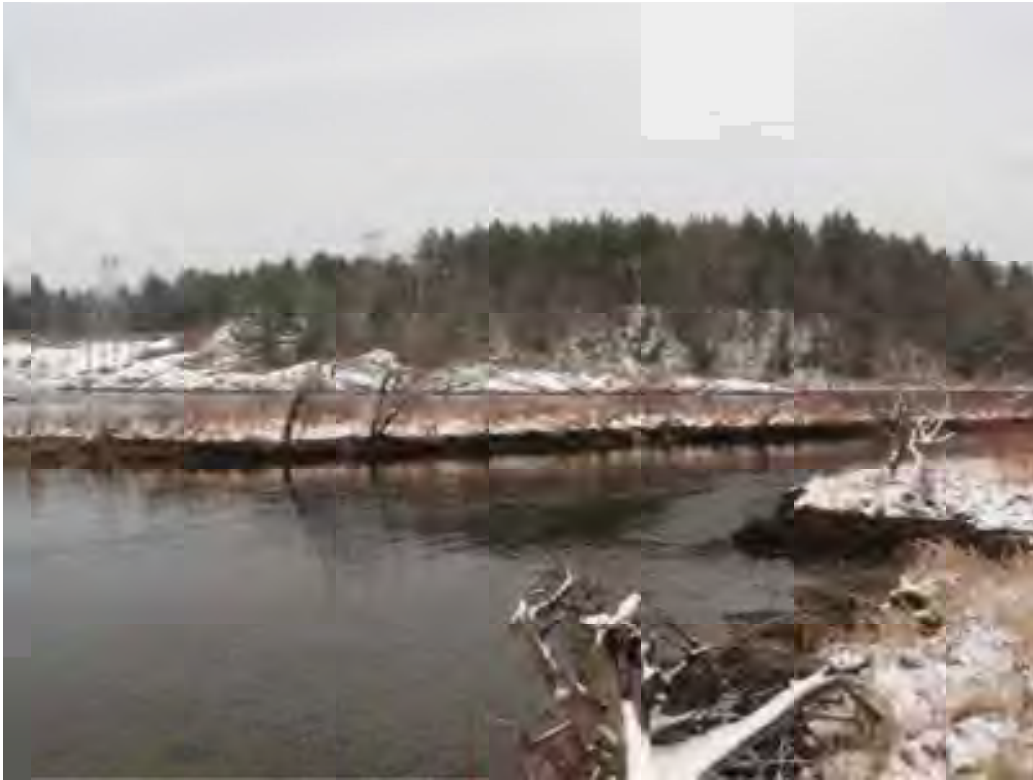
Photo No. 58 (*Island left bank, note stunted crushed sycamores*)

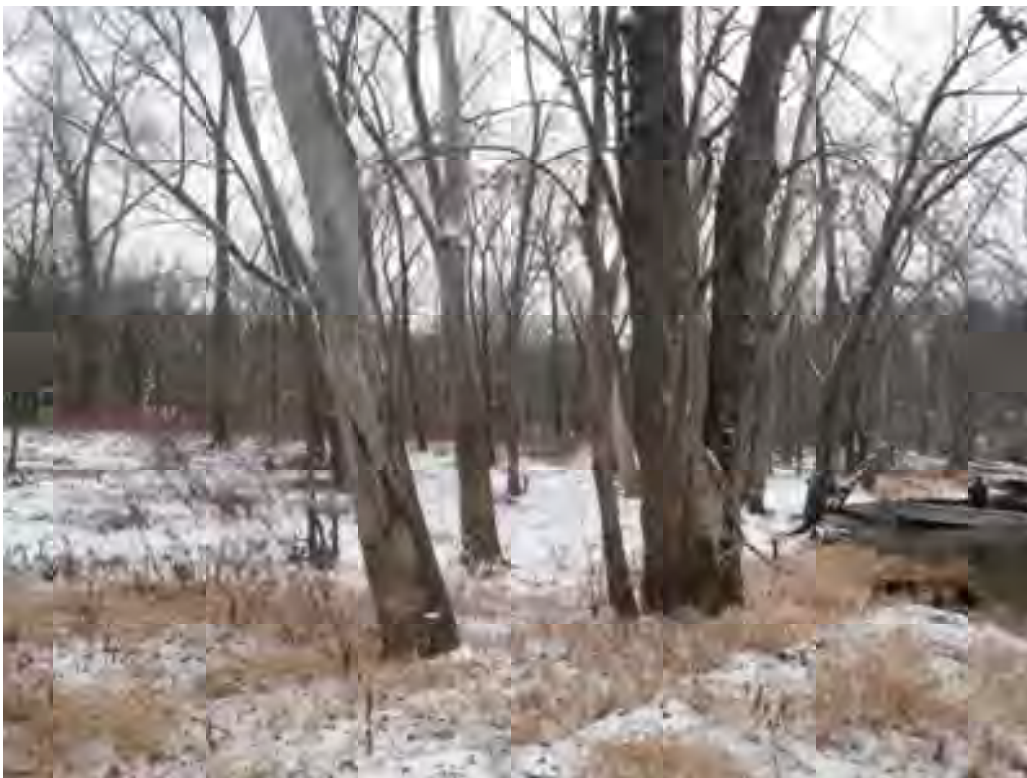
Photo No. 57 (*mature floodplain forest along island left bank*)

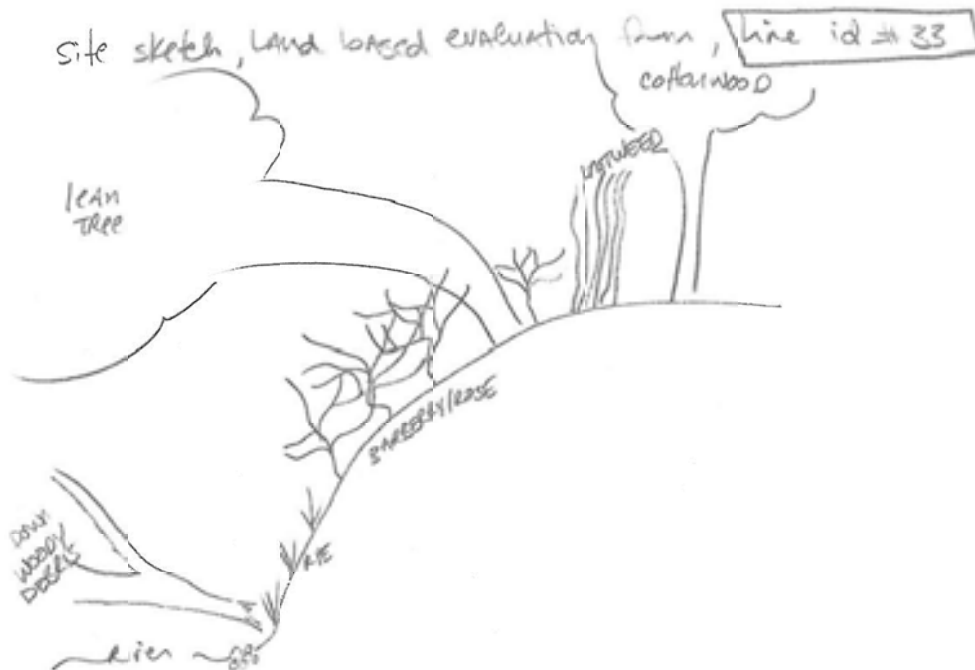
- Steeper bank on right bank than left (island left is a gradual graded slope with floodplain forest and few-no invasive veg; island right is steep, eroding, densely colonized with invasive plants. Both fluvial and mass wasting on island right)
- Bank approximately 12' high and densely colonized with barberry, multiflora rose, knotweed and bittersweet in understory. Canopy is mix of cottonwood and red oak with few sycamores.
- Minor fluvial erosion at toe; pockets of mass wasting

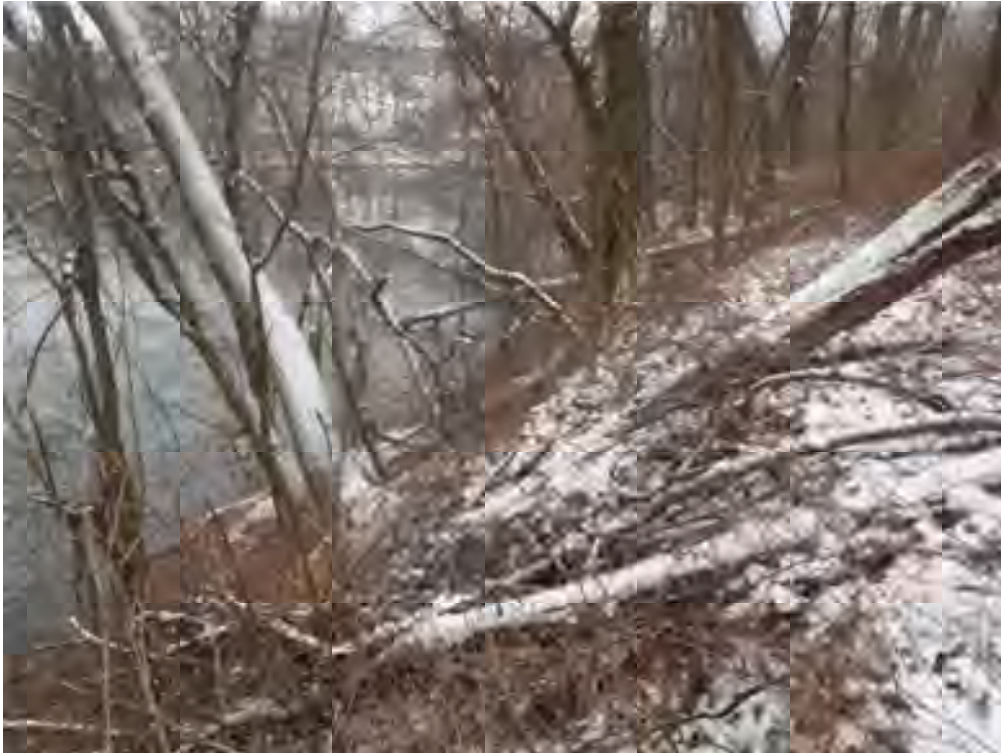
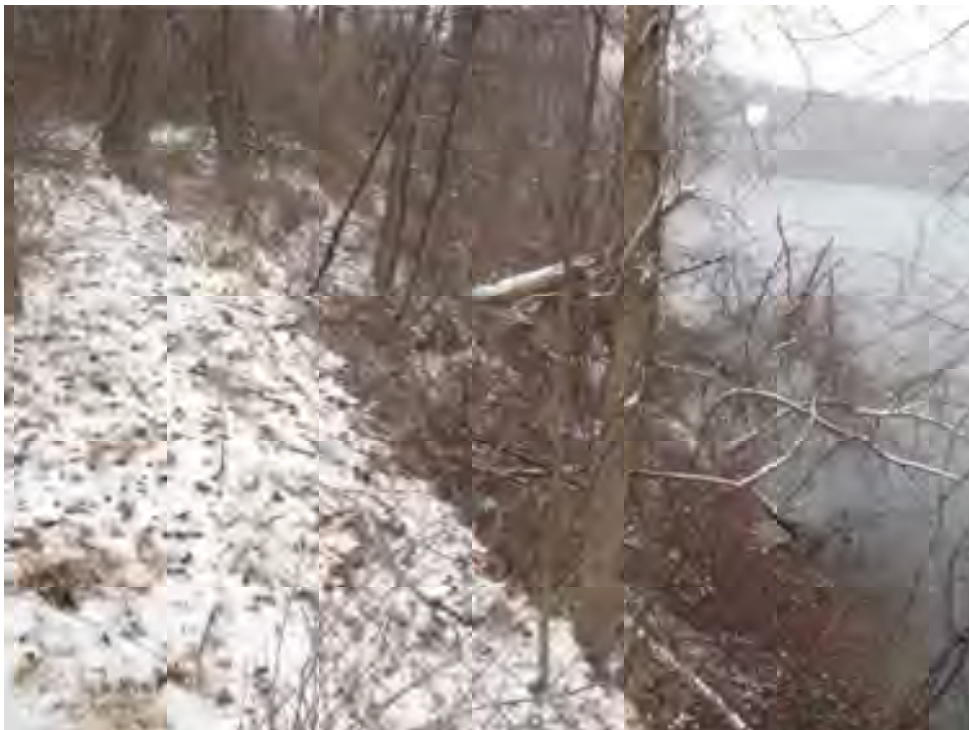
The opposite side of the island has a low bank with a floodplain forest and this side has a higher, steeper bank populated with non-native shrubs/vines

Photo No. 72 (*Stebbins Island right bank*)

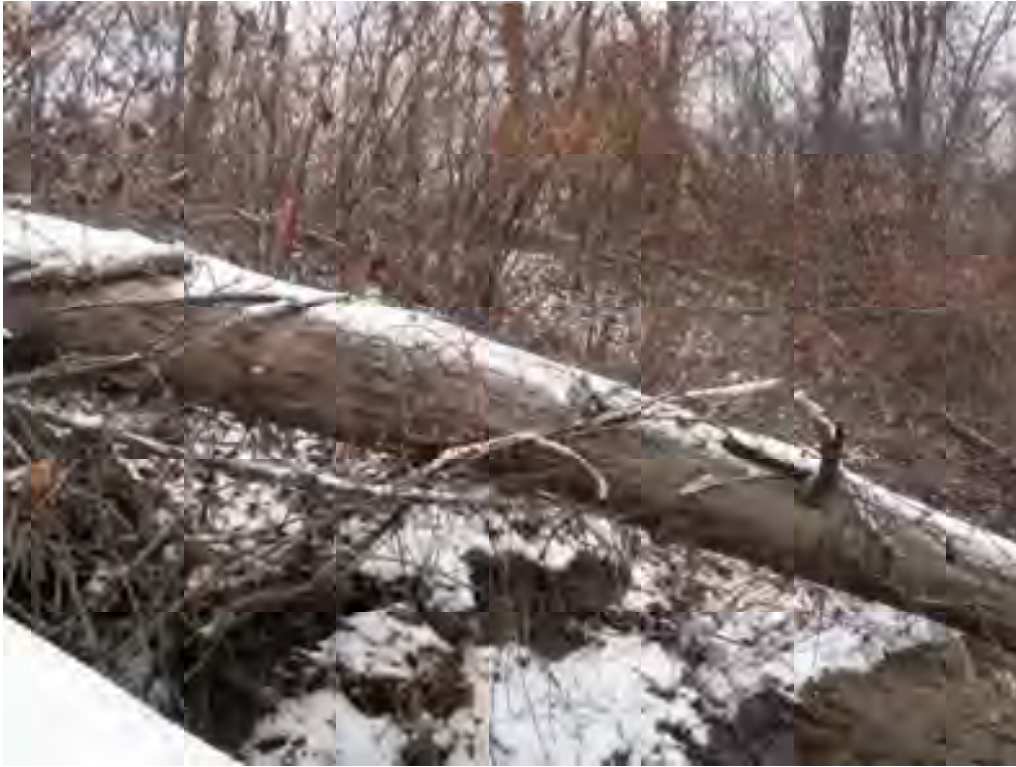
Photo No. 74 (*Stebbins Island right bank, location of soil sample*)

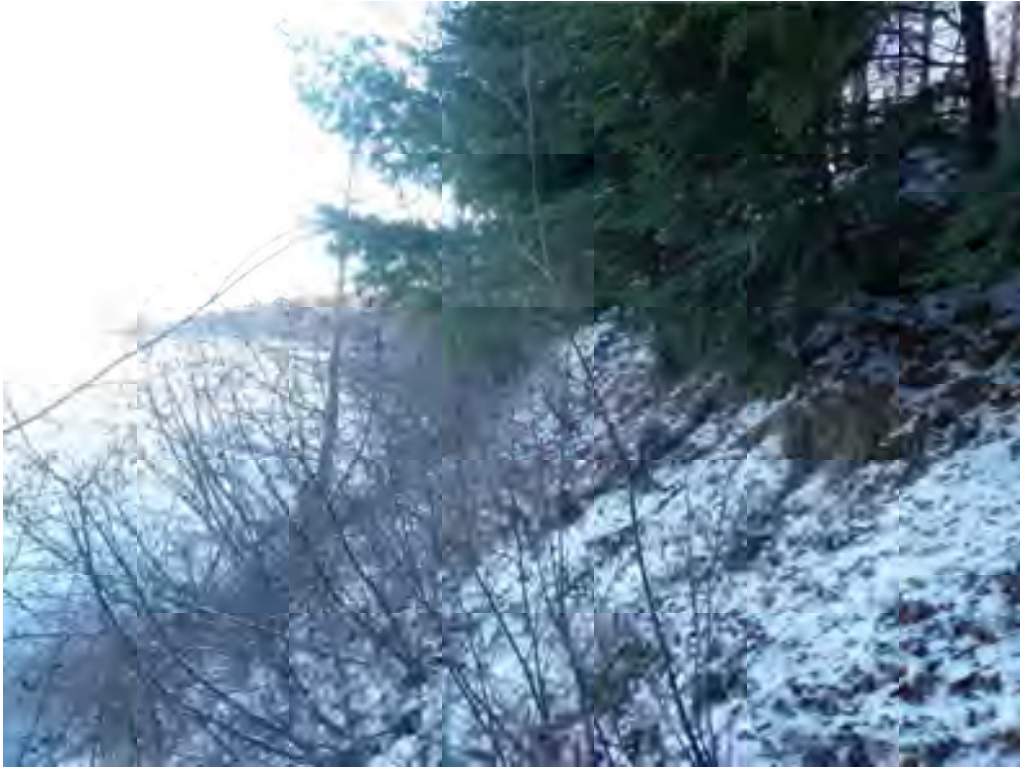
Notes: Slides, failed bank, very high steep hillside behind the bank (potential tension crack? – snow cover makes this not possible to investigate)

Photo No. 75 (*left bank, downstream from Riverview near station 272+00*)

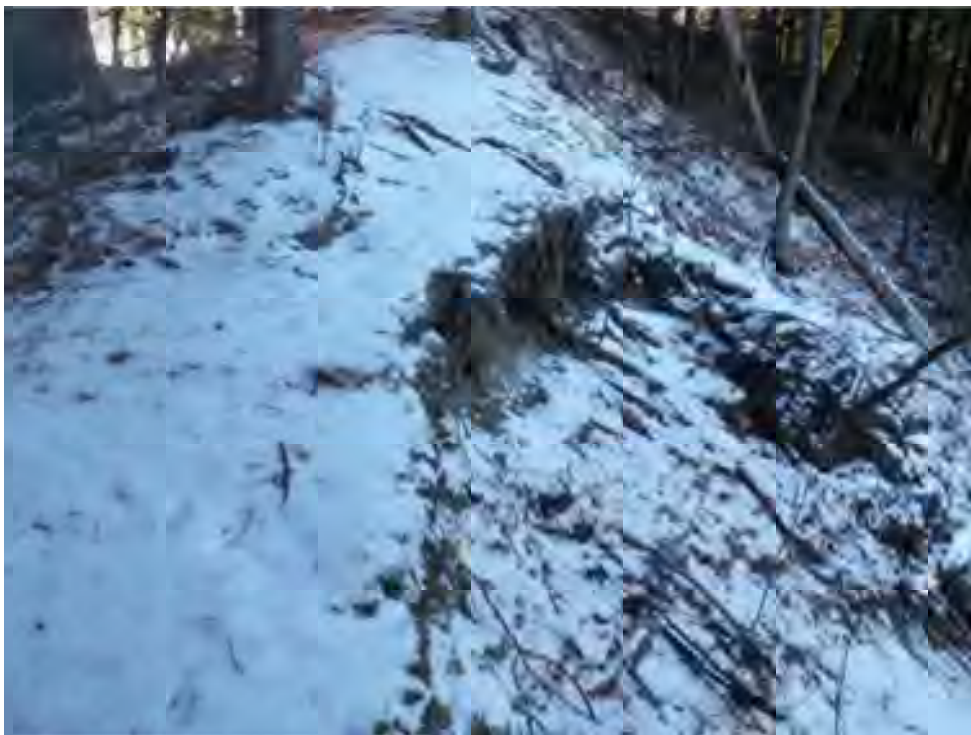
Photo No. 78 (*top of the hillside back from river edge*)

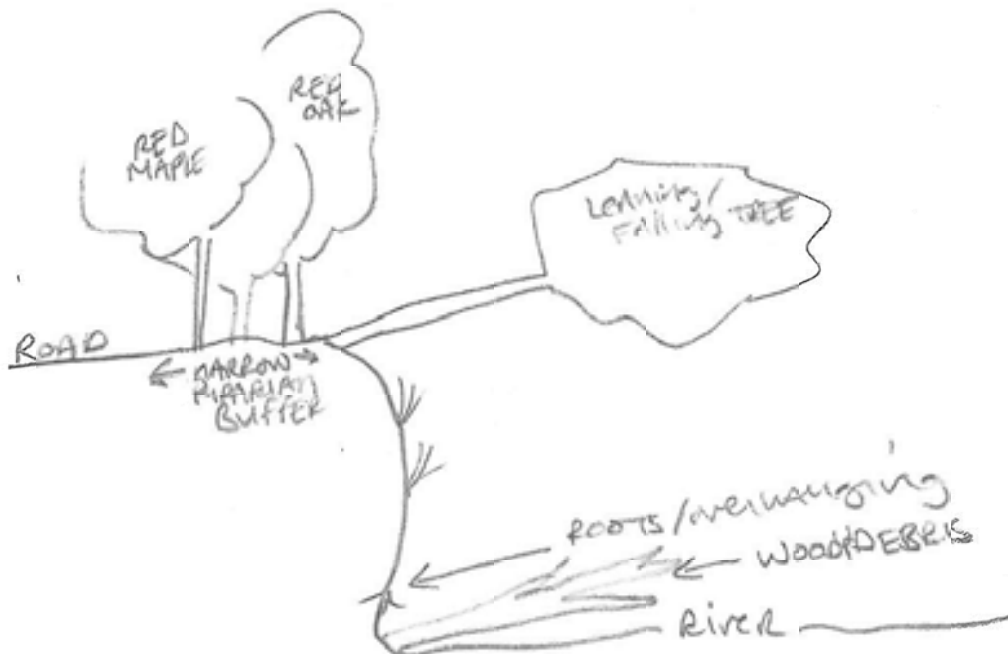
Site sketch, land based evaluations, wie 10 # 36

- Nearly vertical bank with active failures, bank shape is almost convex it is so steep and falling into river
- Treefalls
- Sandy, silty soils
- Lots of invasive vegetation along this reach (mostly shrub and vine layer) under deciduous canopy cover

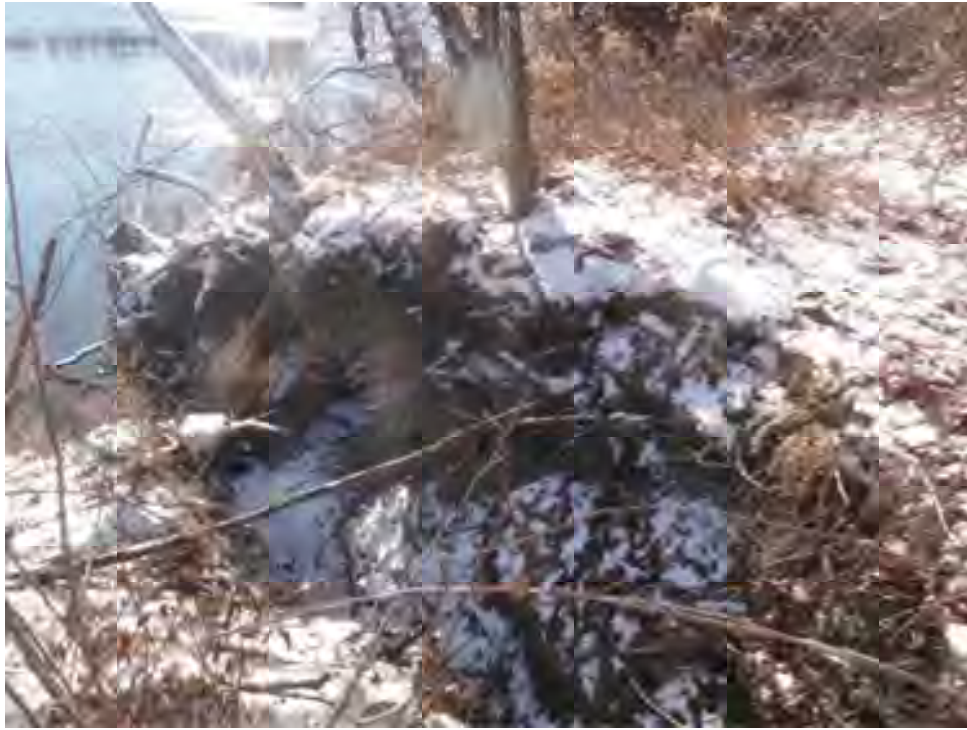
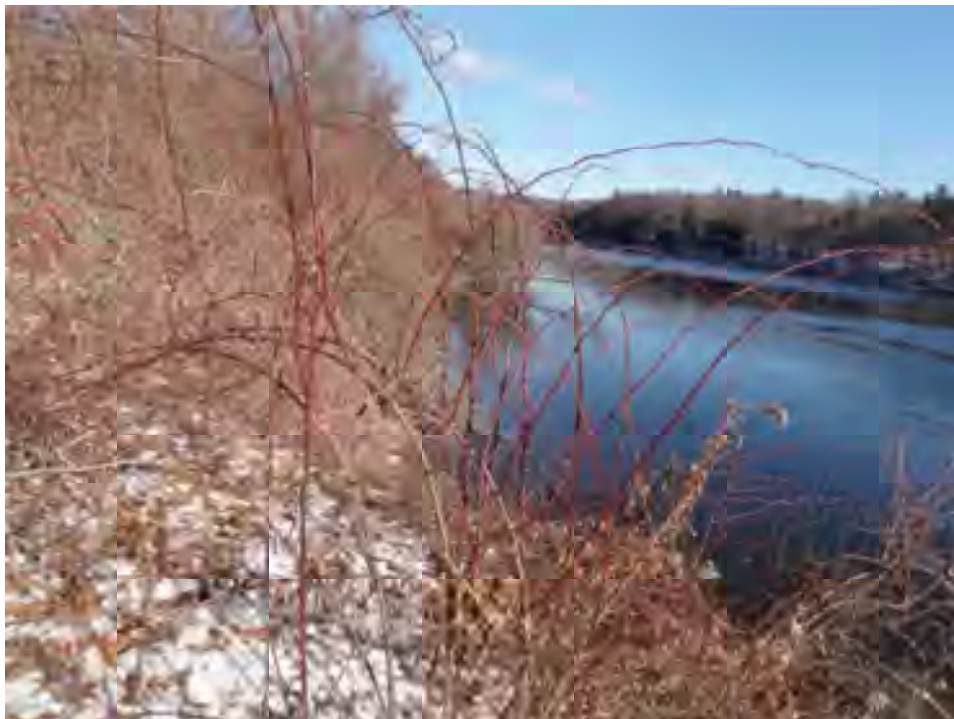
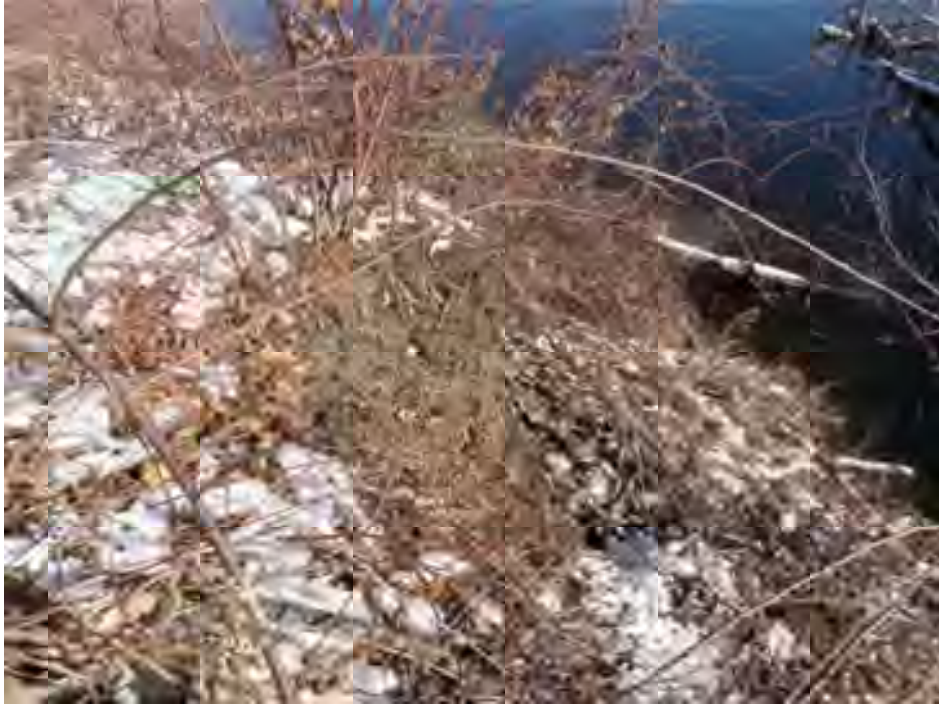
**2013 Connecticut River Full River Reconnaissance
Land-Based Observations Photographs Reference No. 88 through 90 (CM)
Observation Point No. 36 – December 12, 2013**

Additional Notes: steep (nearly 1:1) almost convex and in the process of falling into the river through active failures and throughout the reach

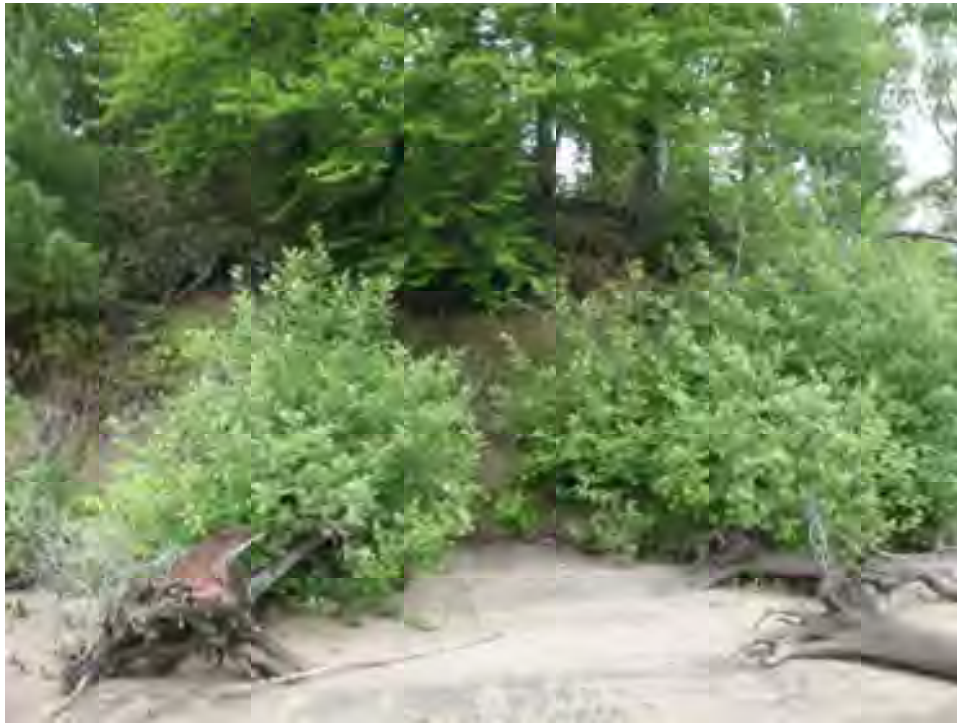
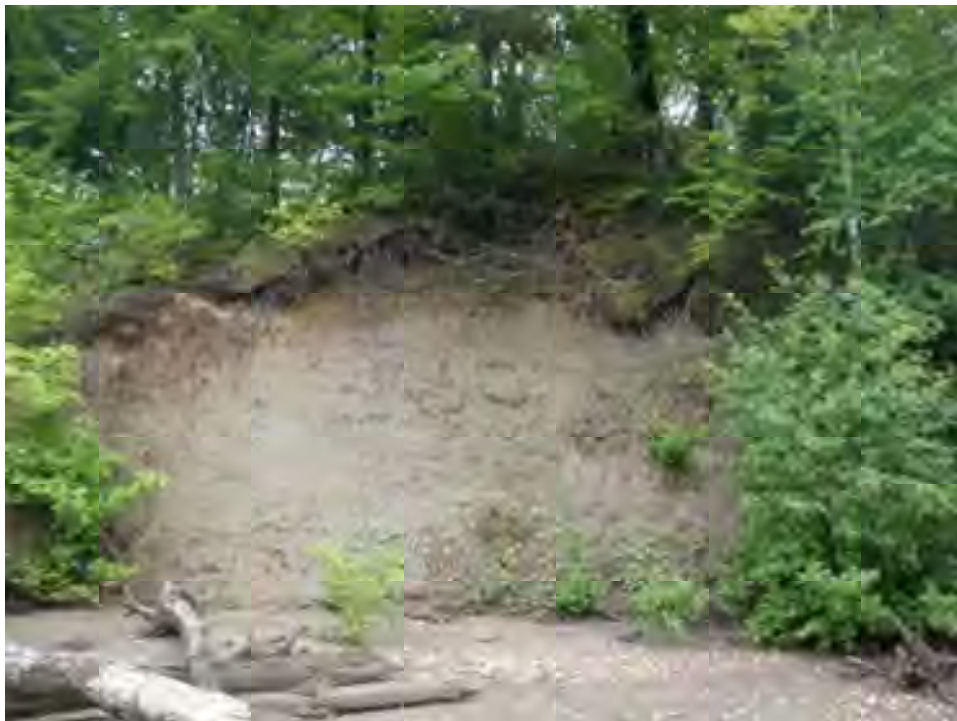
**2013/2014 Connecticut River Full River Reconnaissance
Land-Based Observations Photographs Reference No. 125 & 126 (CM)
Observation Point No. 37 – June 4, 2014**

There was a bank swallow colony nesting site observed here in November/December 2013. However, a recent slide has collapsed the nest sites and the cavities cannot be observed today.

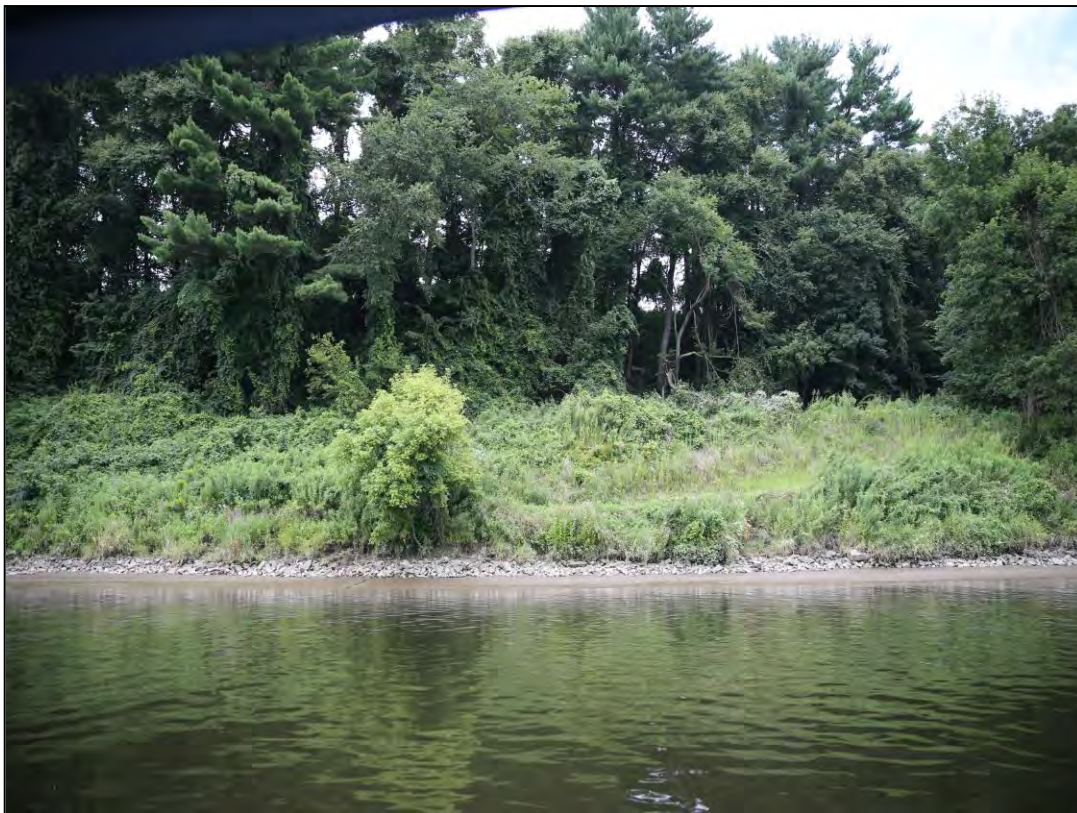
Photo 2: Wickey-Post Construction 2014

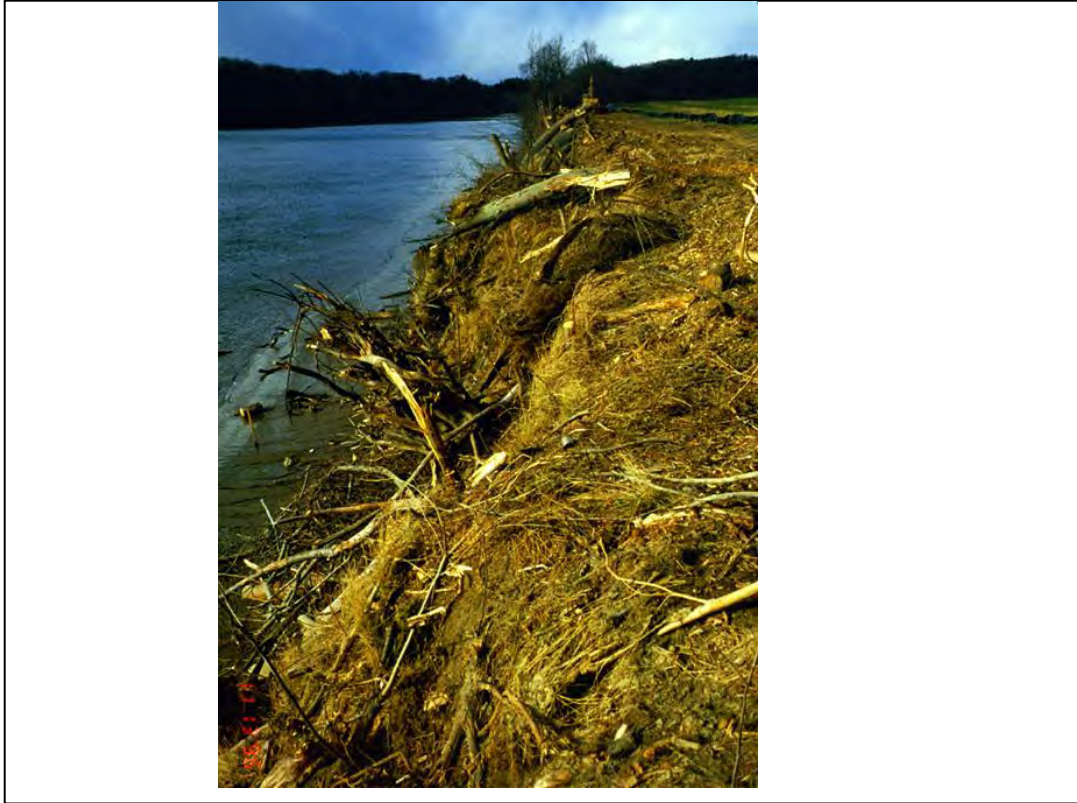
Photo 3: Shearer pre-construction, 1996

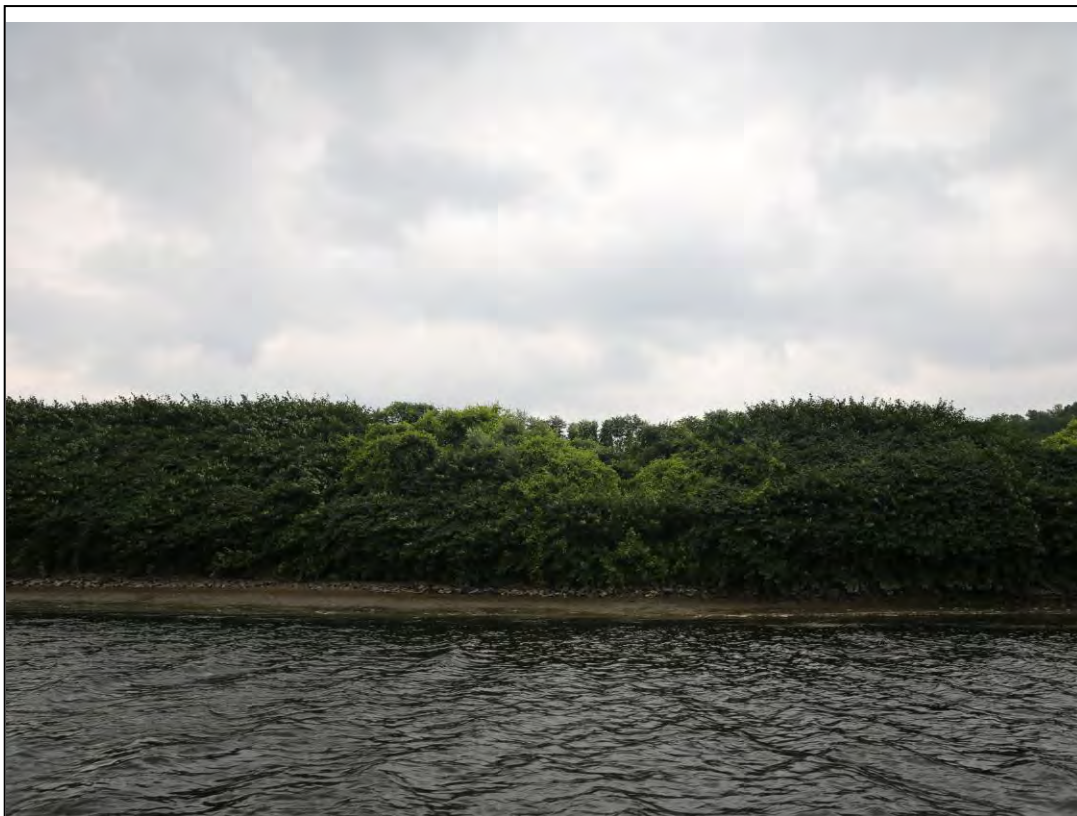
Photo 4: Shearer-Post Construction 2014

Shearer (Segment 89, repair of previously stabilized site)

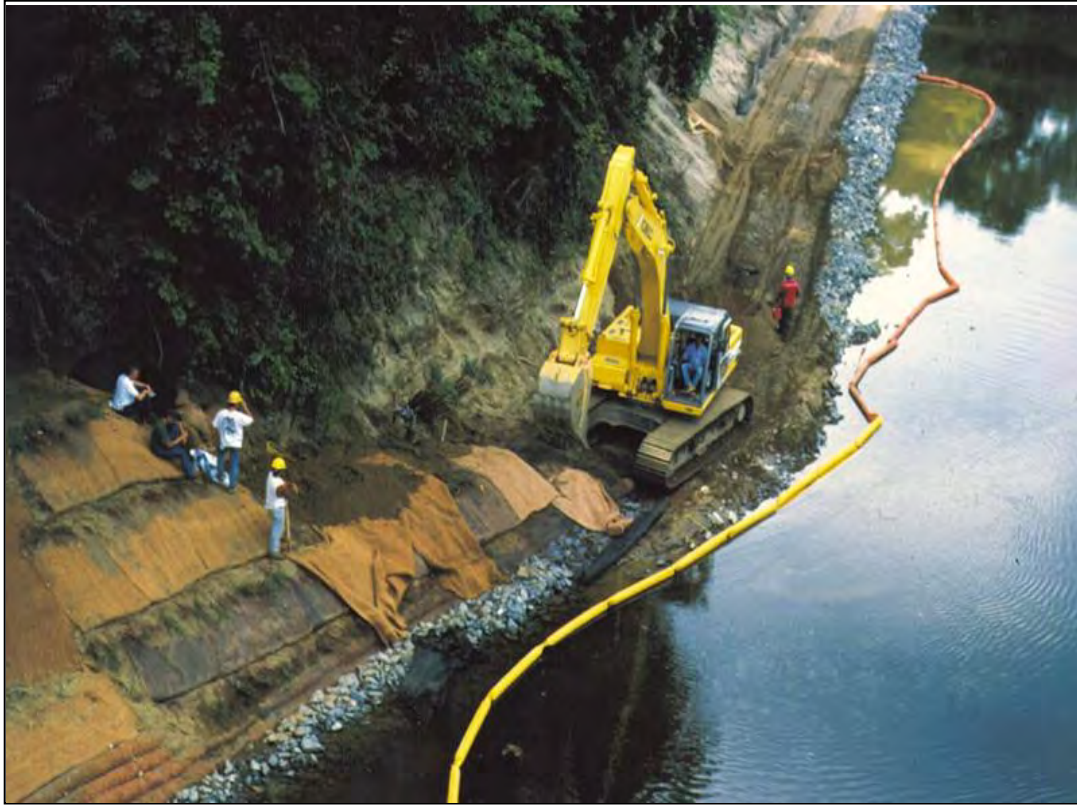
Photo 5: Crooker during-construction, 1997

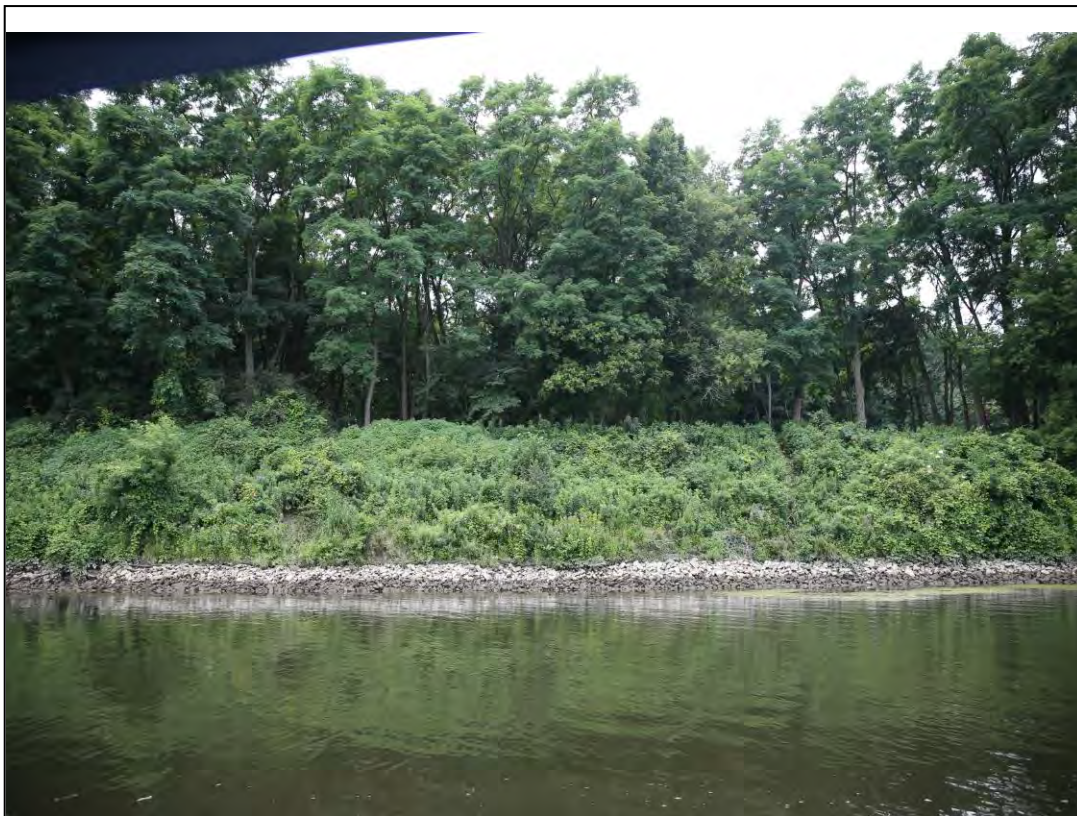
Photo 6: Crooker-Post Construction 2014
