RELICENSING STUDY 3.1.1

2013 FULL RIVER RECONNAISSANCE

**Northfield Mountain Pumped Storage Project (No. 2485)
and Turners Falls Hydroelectric Project (No. 1889)**

SEPTEMBER 2014

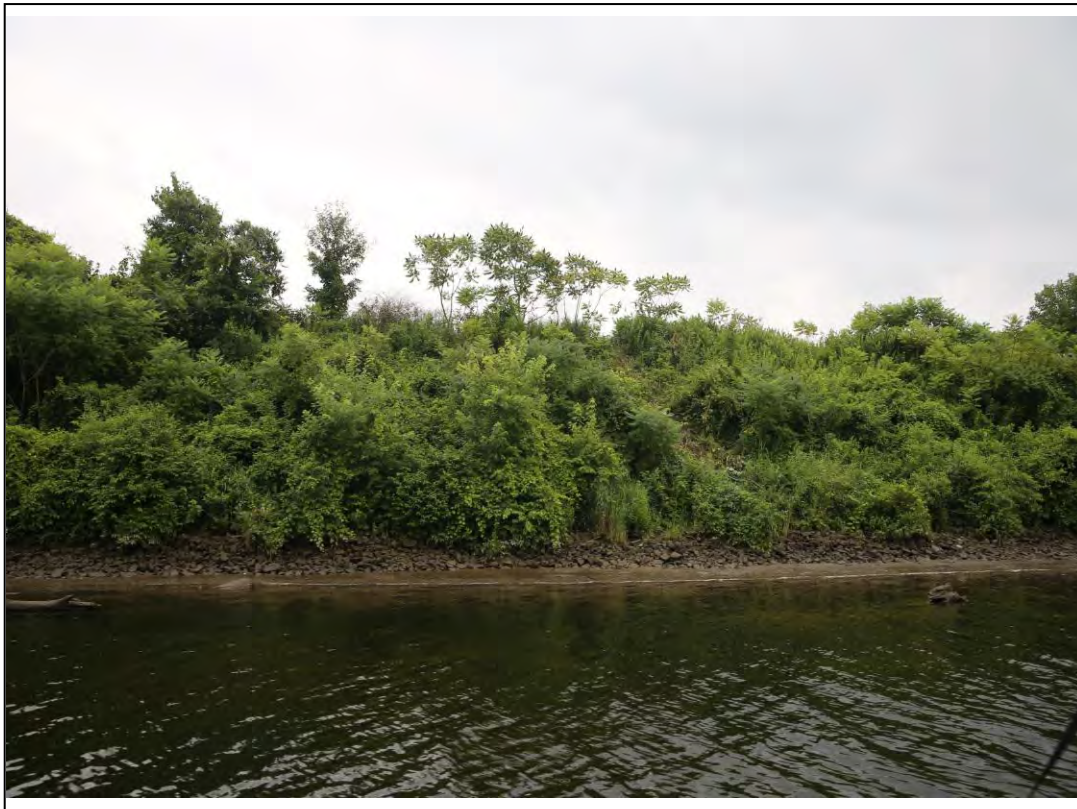
Photo 8: L'Etoile -Post Construction 2014

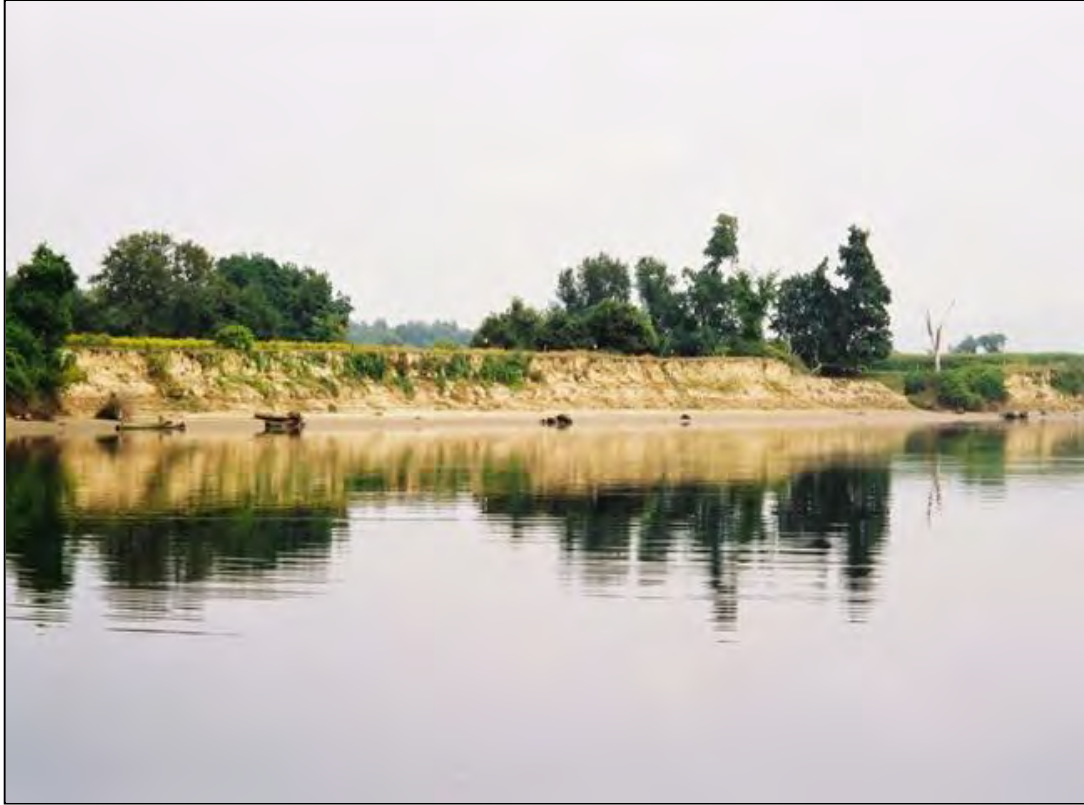
Photo 9: Flagg Farm, 1998 Pre-Construction

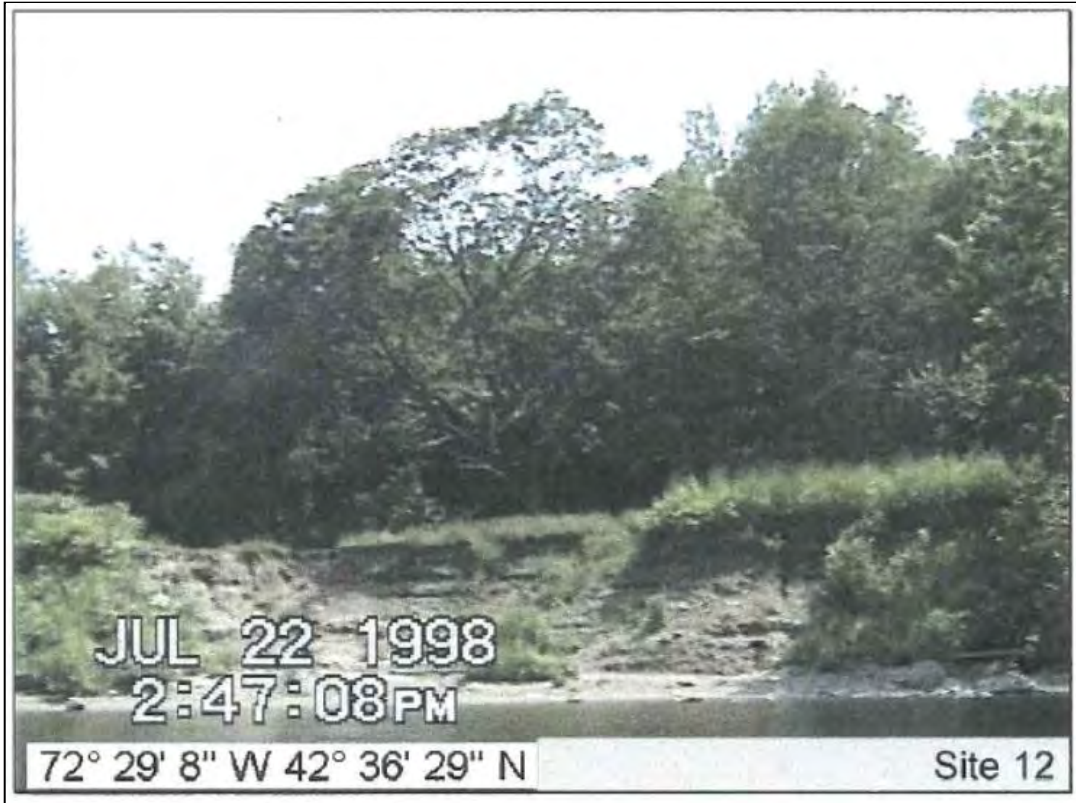
Photo 13: Durkee Point pre- construction, 1998

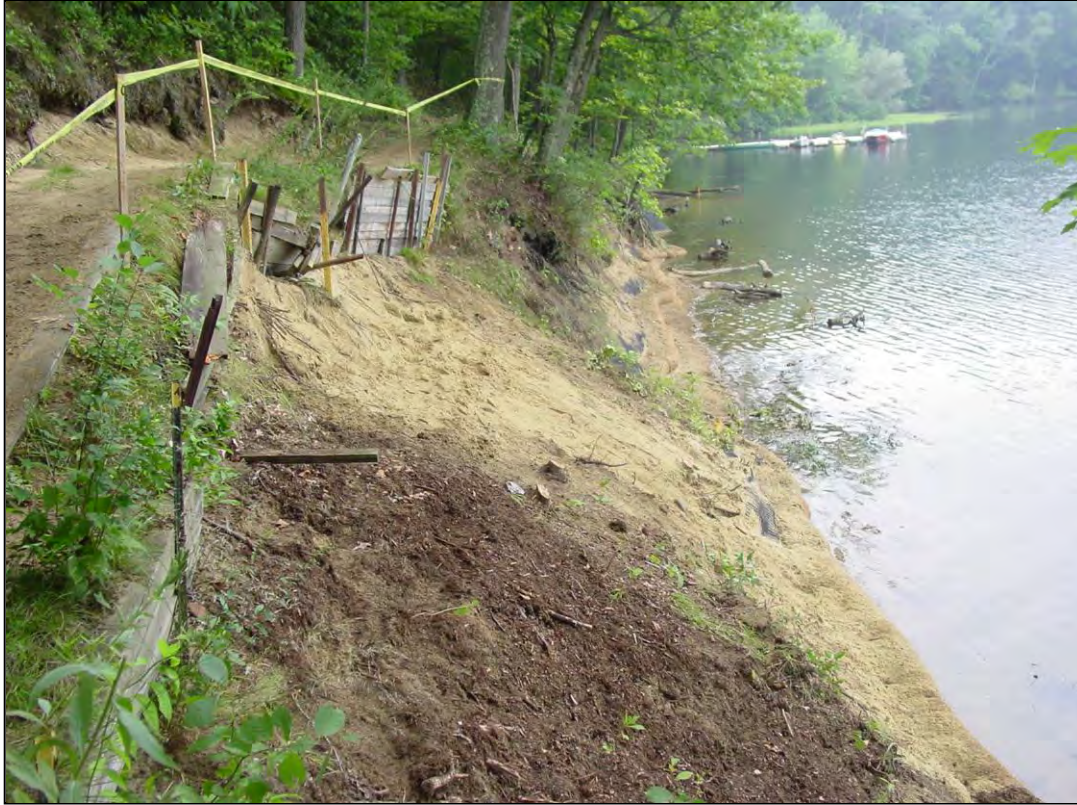
Photo 17: Rod & Gun Club (Camp 2E) pre- construction, 2004

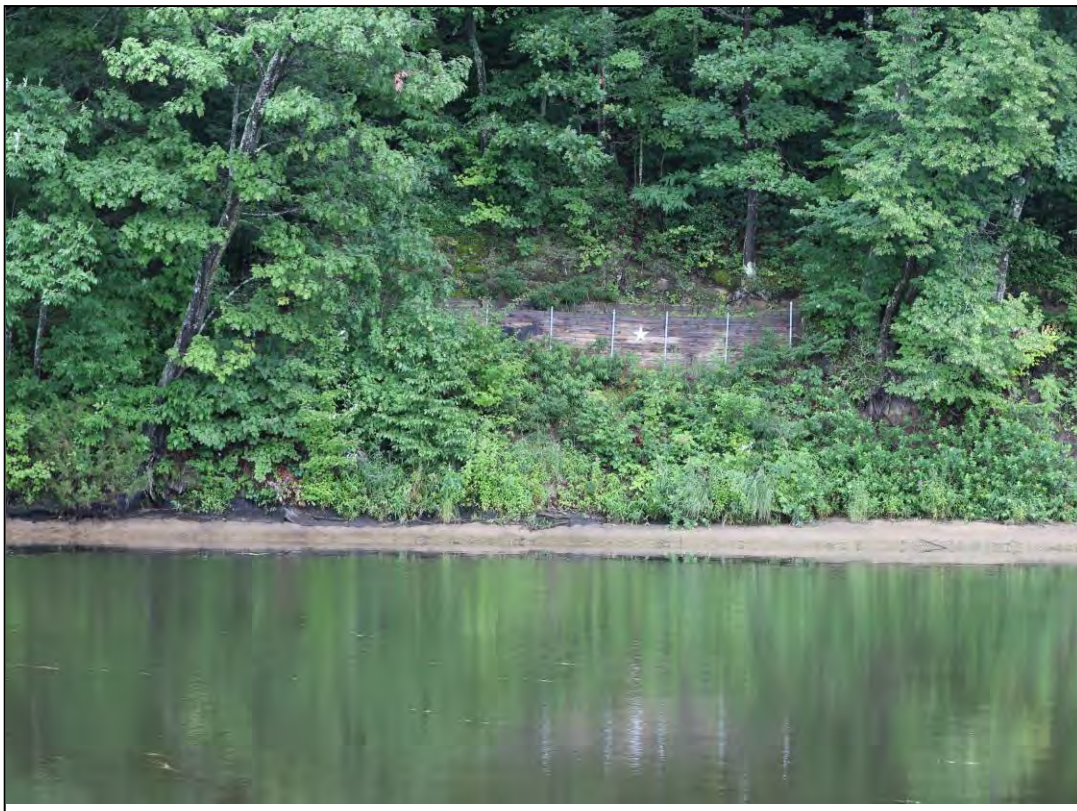
Photo 18: Rod & Gun Club (Camp 2E) Post Construction 2014

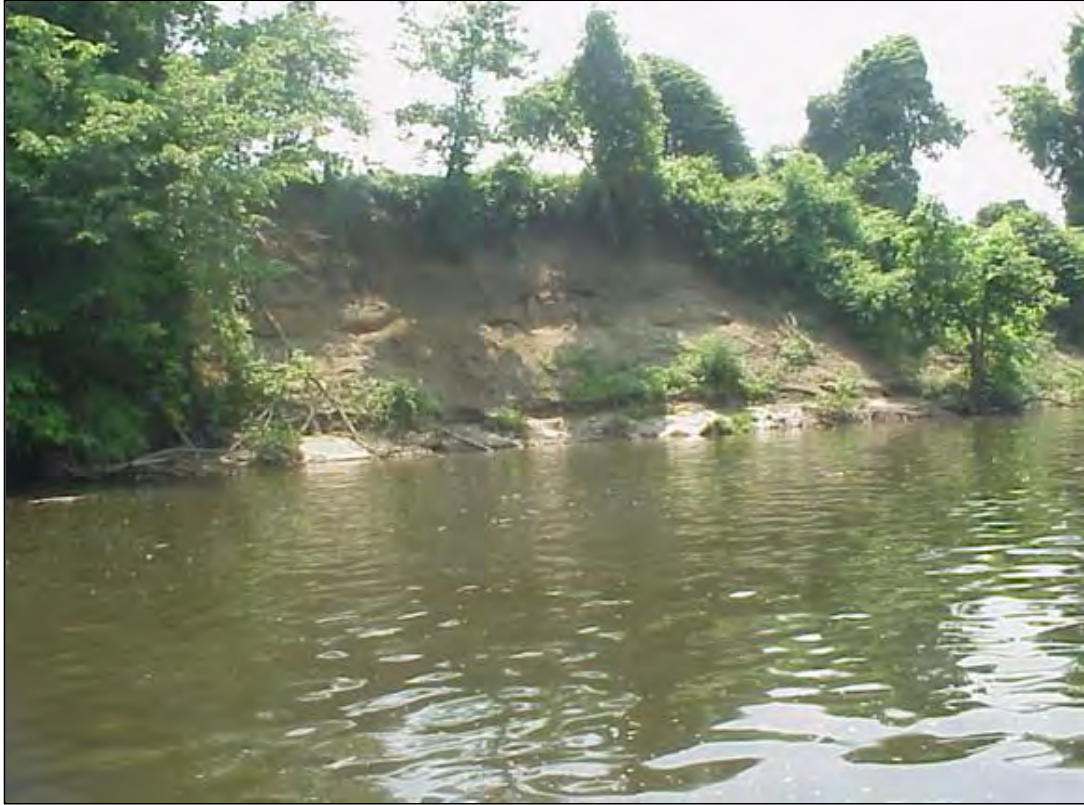
Photo 19: Skalski pre-construction, 1998

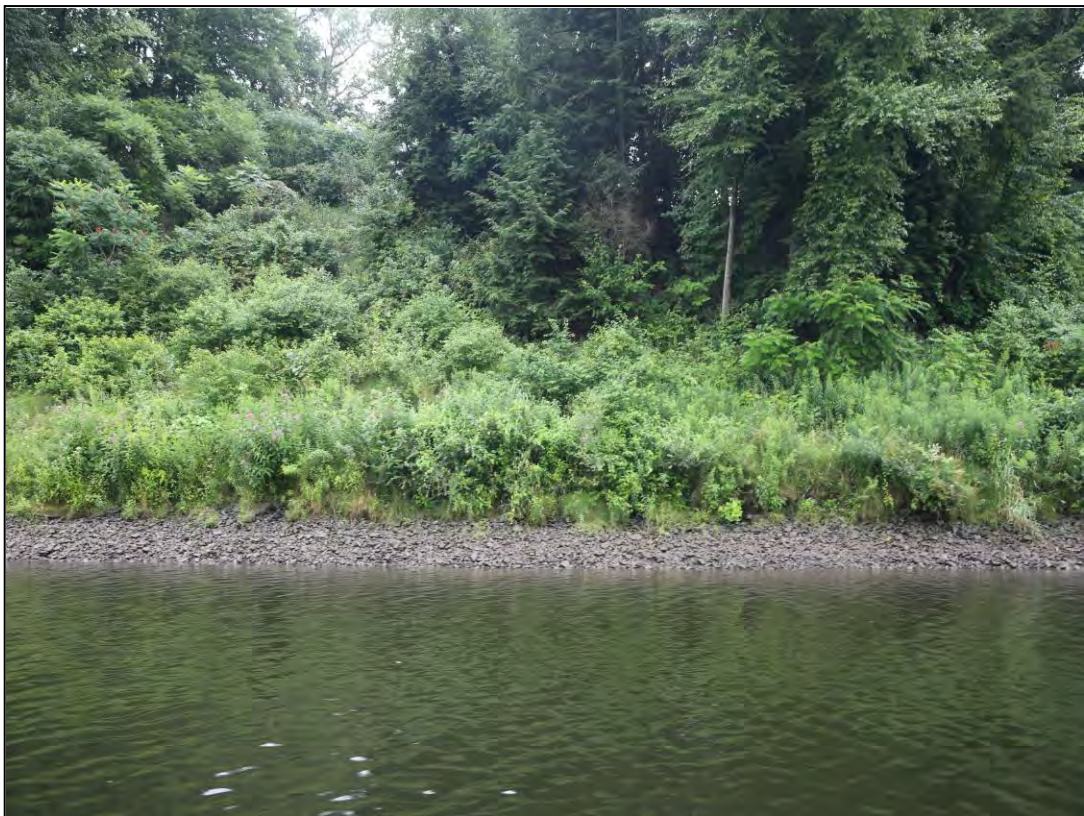
Photo 20: Skalski Post Construction 2014

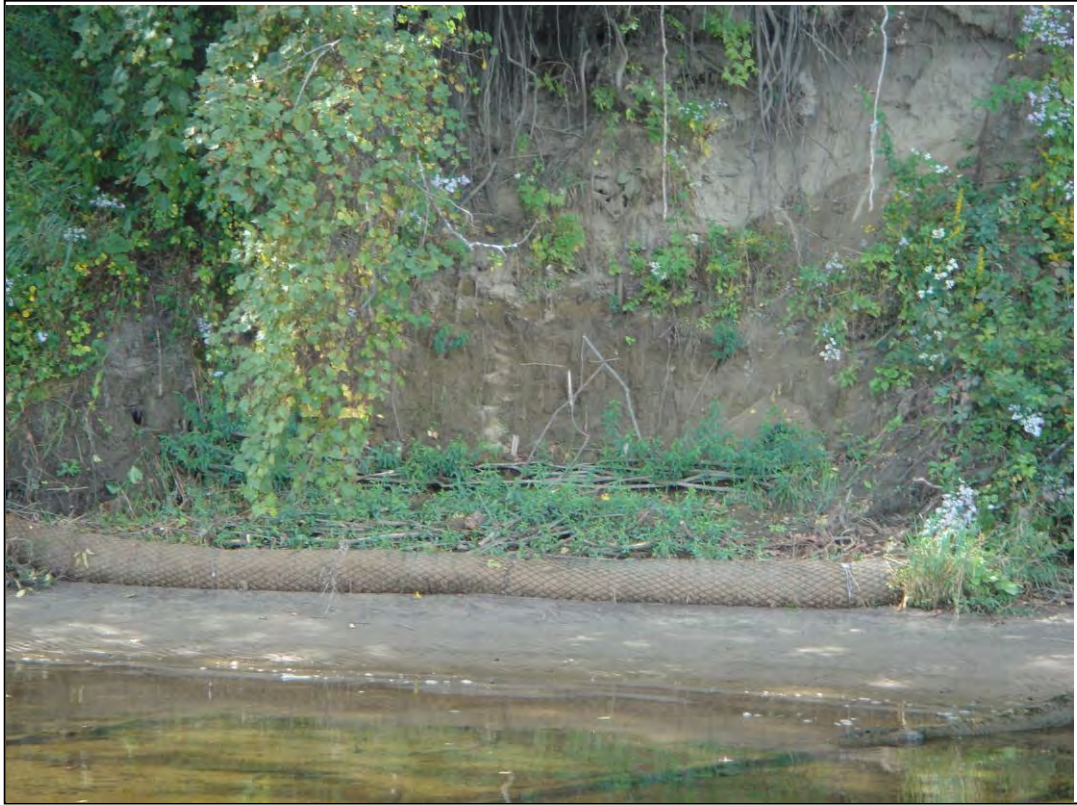
Photo 21: Bennett Meadow during-construction, 2005

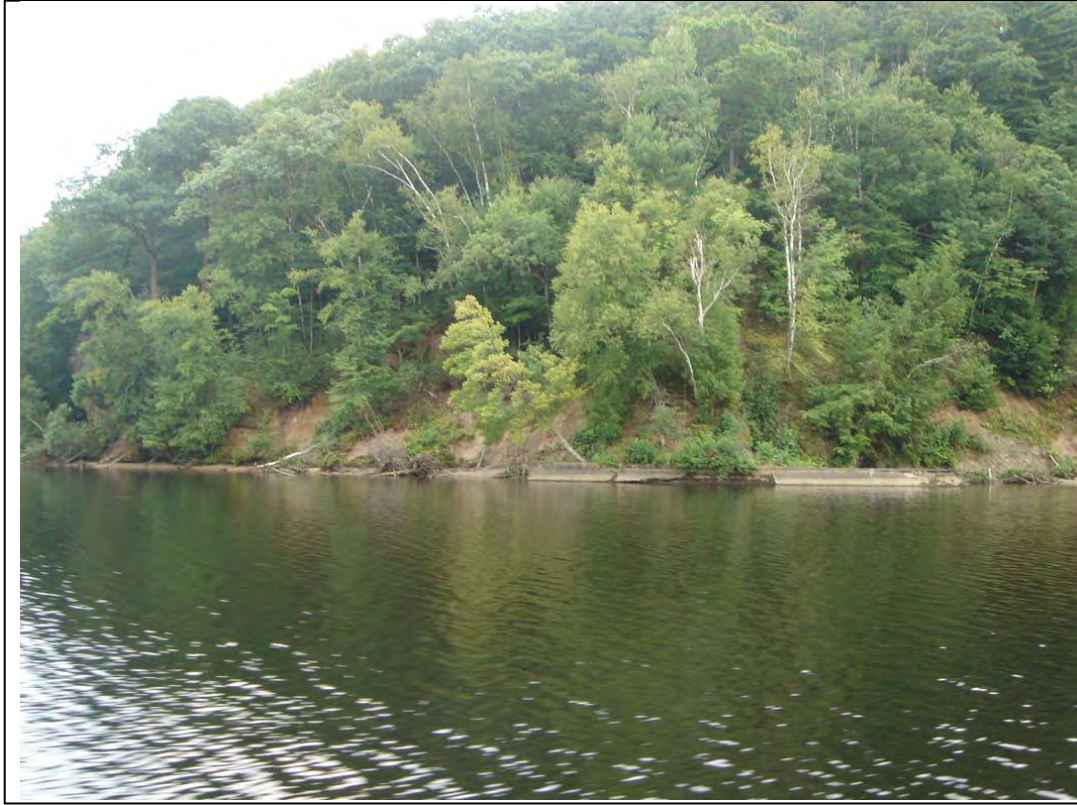
Photo 29: Montague Rod & Gun Club Point- pre-construction, 2008

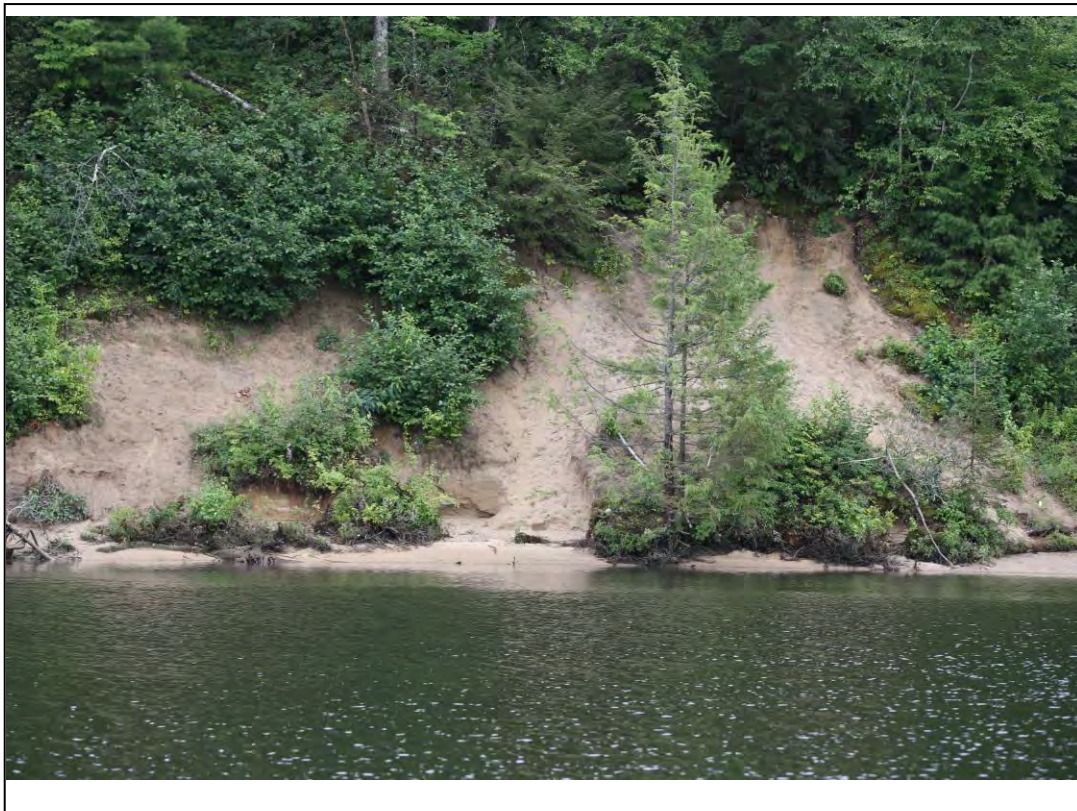
Photo 30: - Montague Rod & Gun Club Point (eroded segment)- Post Construction 2014

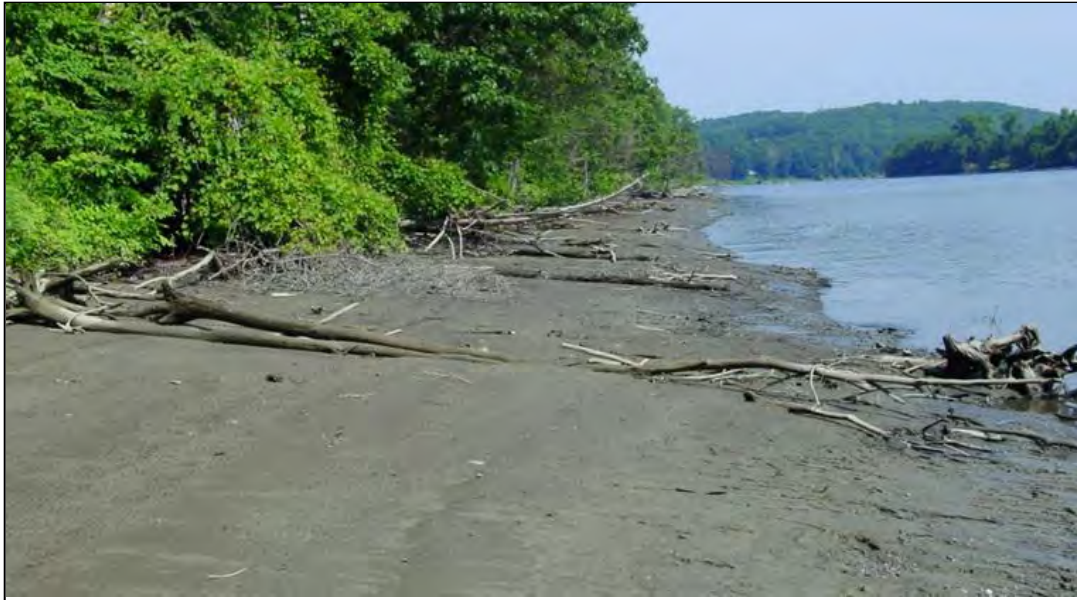
Photo 35: Upper Split River Farm I and II 2010

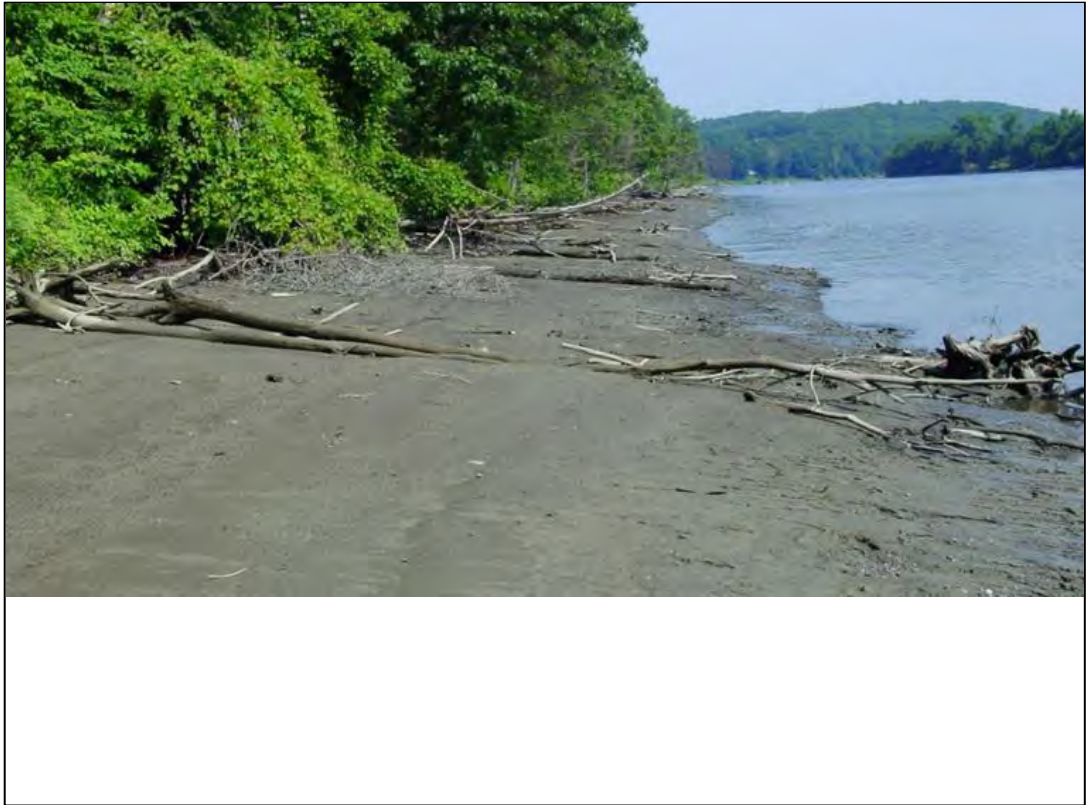
Photo 37: Upper Split River Farm I and II 2010

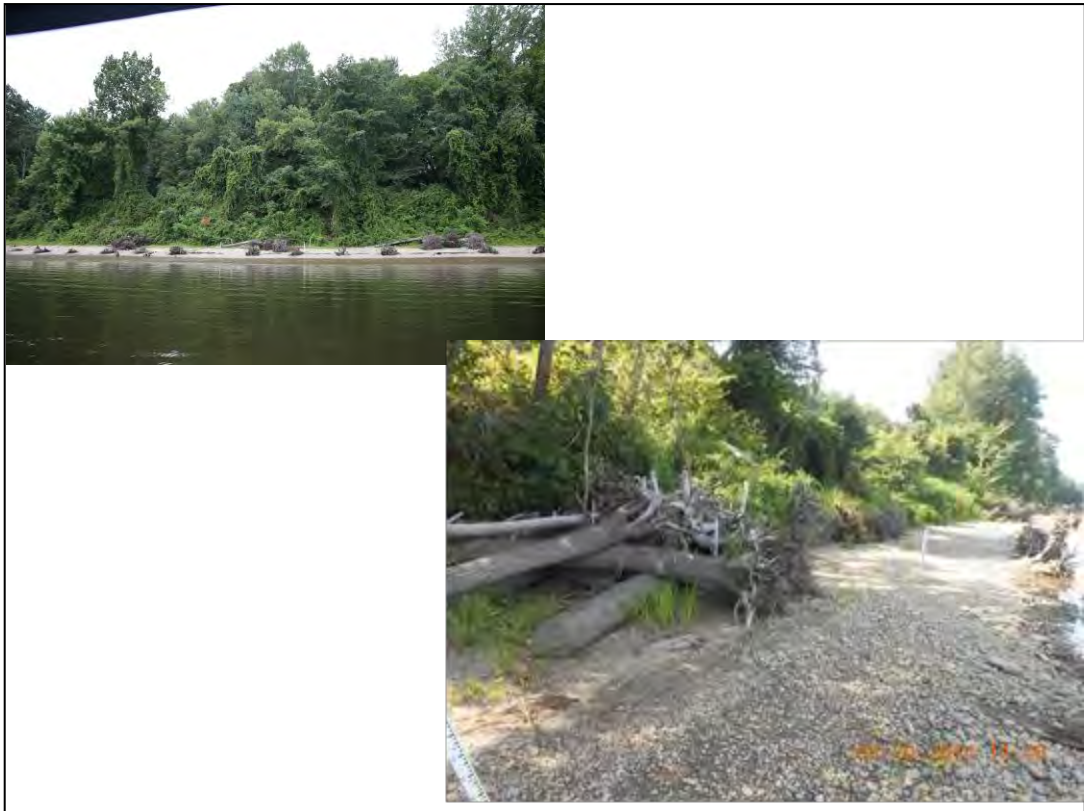
Photo 40: Bathory/Gallagher & Wallace/Watson Post Construction 2014. Detail from August, 2014

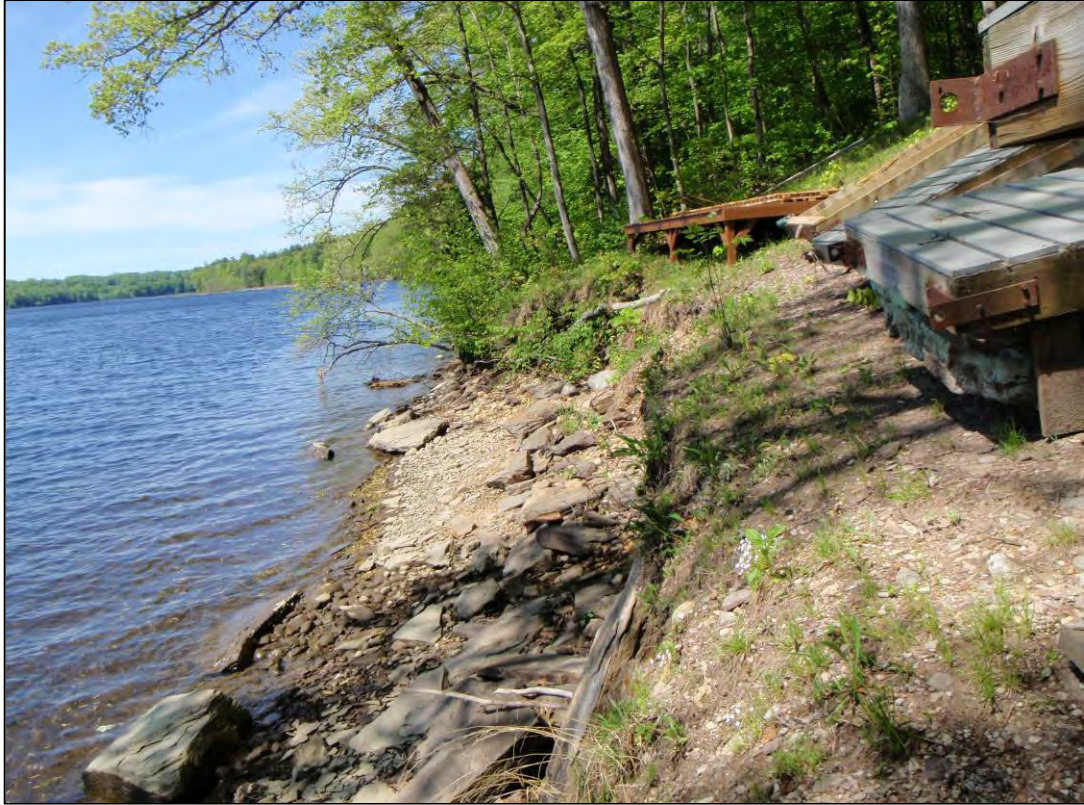
Photo 41: Camp 2W pre-construction 2011

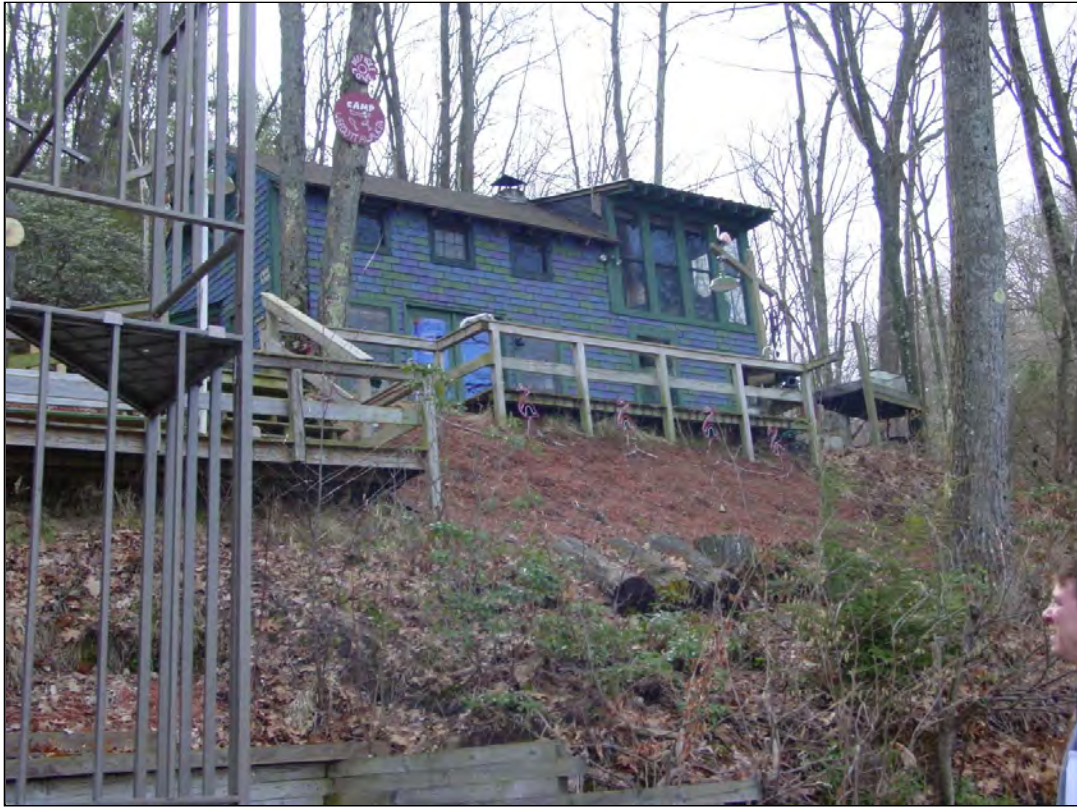
Photo 43: Camp 2E pre-construction 2011

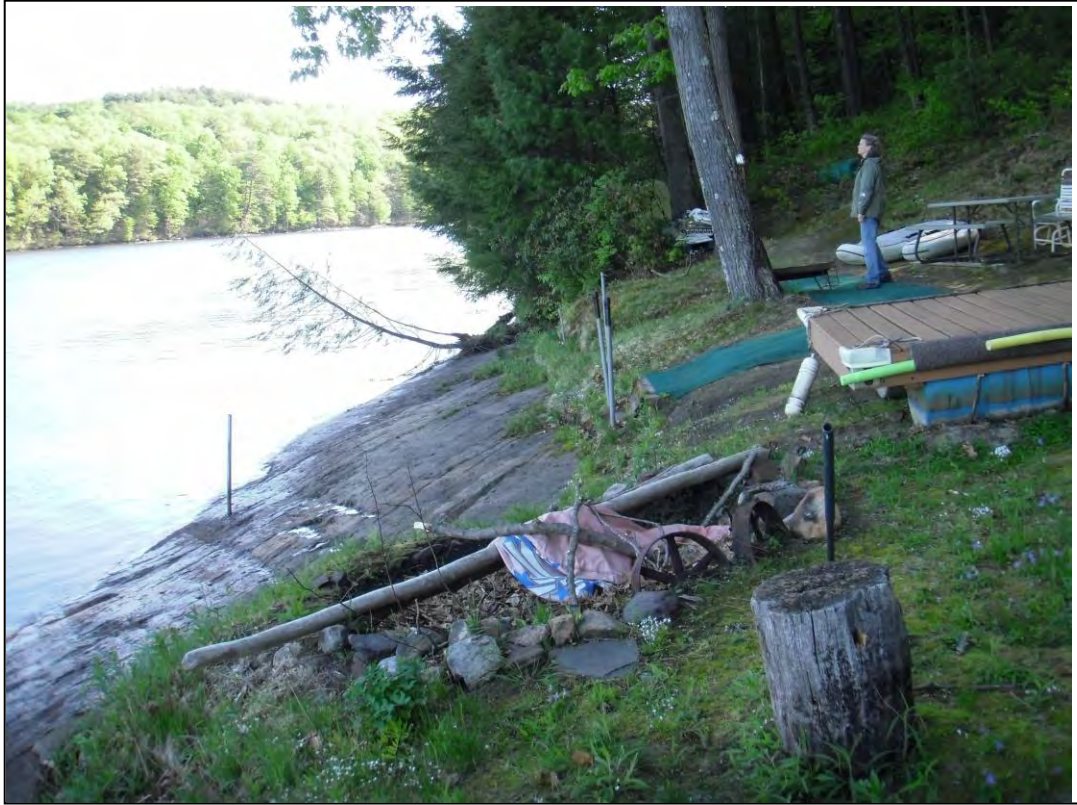
Photo 45: Camp 6E pre-construction 2011

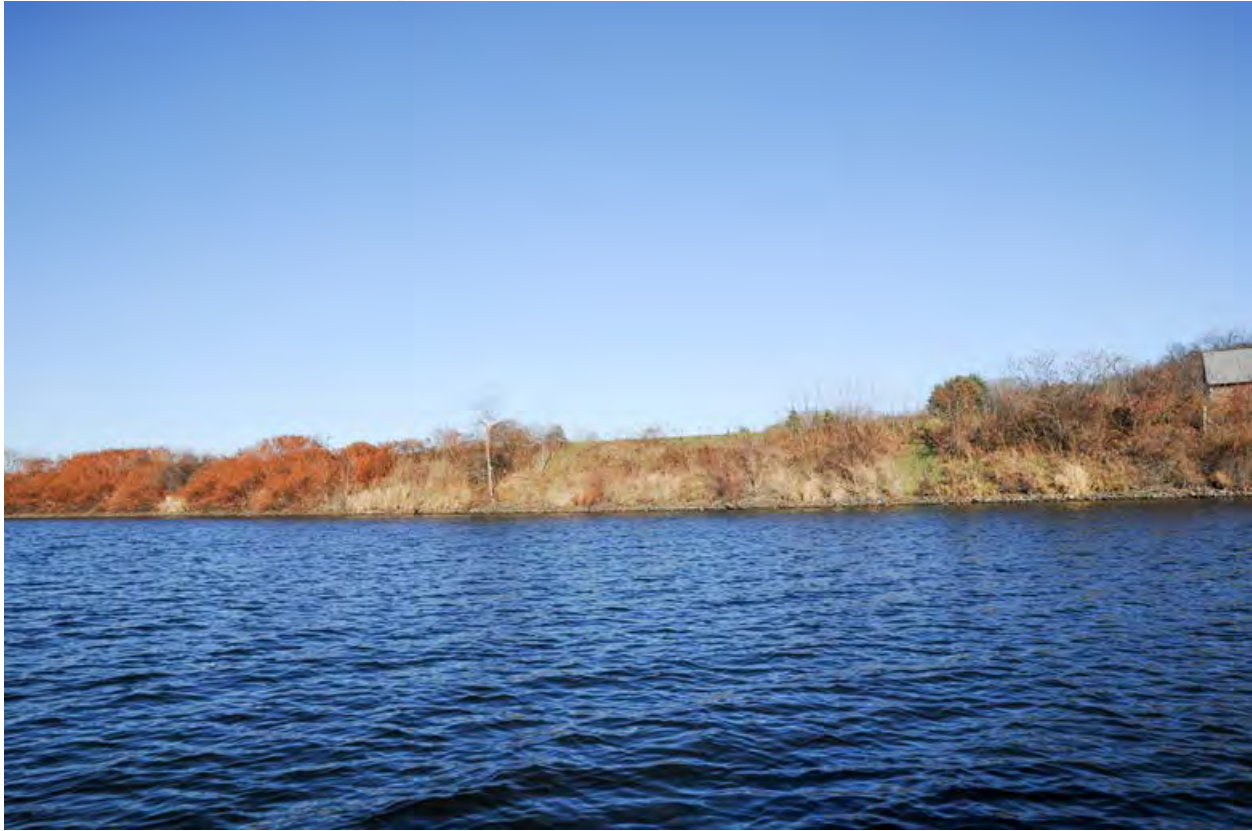
Shearer (Segment 89, repair of previously stabilized site)

Riverbank Features	Characteristics
Upper Riverbank Slope	Moderate
Upper Riverbank Height	High
Upper Riverbank Sediment	Silt/Sand
Upper Riverbank Vegetation	Heavy
Lower Riverbank Slope	Moderate
Lower Riverbank Sediment	Cobbles
Lower Riverbank Vegetation	None-Very Sparse
Type of Erosion	Undercut
Potential Erosion Indicators	None
Stage of Erosion	Stable
Extent of Erosion	None/Little

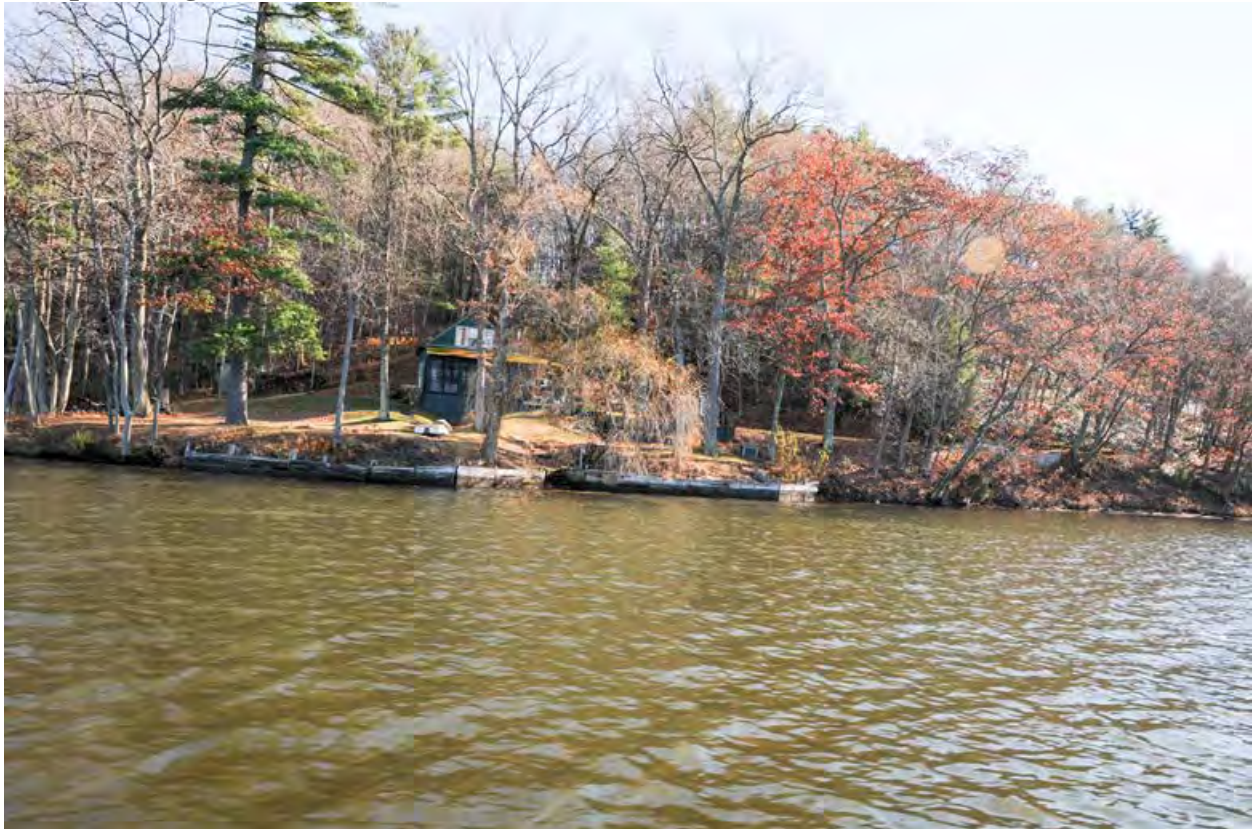
Camp 3E (Segment 19)

Riverbank Features	Characteristics
Upper Riverbank Slope	Moderate
Upper Riverbank Height	Medium
Upper Riverbank Sediment	Silt/Sand
Upper Riverbank Vegetation	Heavy
Lower Riverbank Slope	Vertical
Lower Riverbank Sediment	Bedrock (wood wall)
Lower Riverbank Vegetation	None-Very Sparse
Type of Erosion	Slide
Potential Erosion Indicators	Other
Stage of Erosion	Eroded
Extent of Erosion	Some

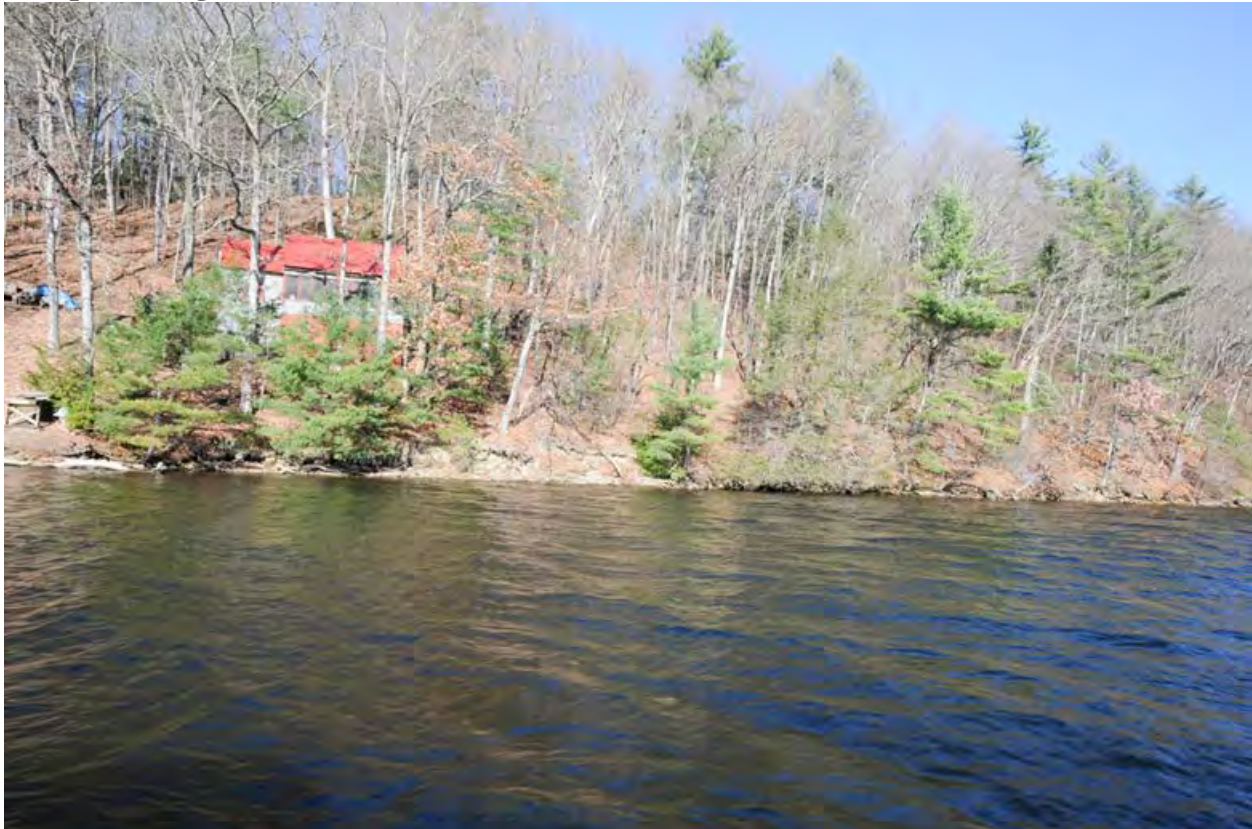
Camp 2W (Segment 387-388)

Riverbank Features	Characteristics
Upper Riverbank Slope	Moderate
Upper Riverbank Height	High
Upper Riverbank Sediment	Silt/Sand
Upper Riverbank Vegetation	Heavy
Lower Riverbank Slope	Moderate
Lower Riverbank Sediment	Boulders
Lower Riverbank Vegetation	None-Very Sparse
Type of Erosion	Undercut
Potential Erosion Indicators	Overhanging Bank, Exposed Roots
Stage of Erosion	Potential Future Erosion
Extent of Erosion	Some

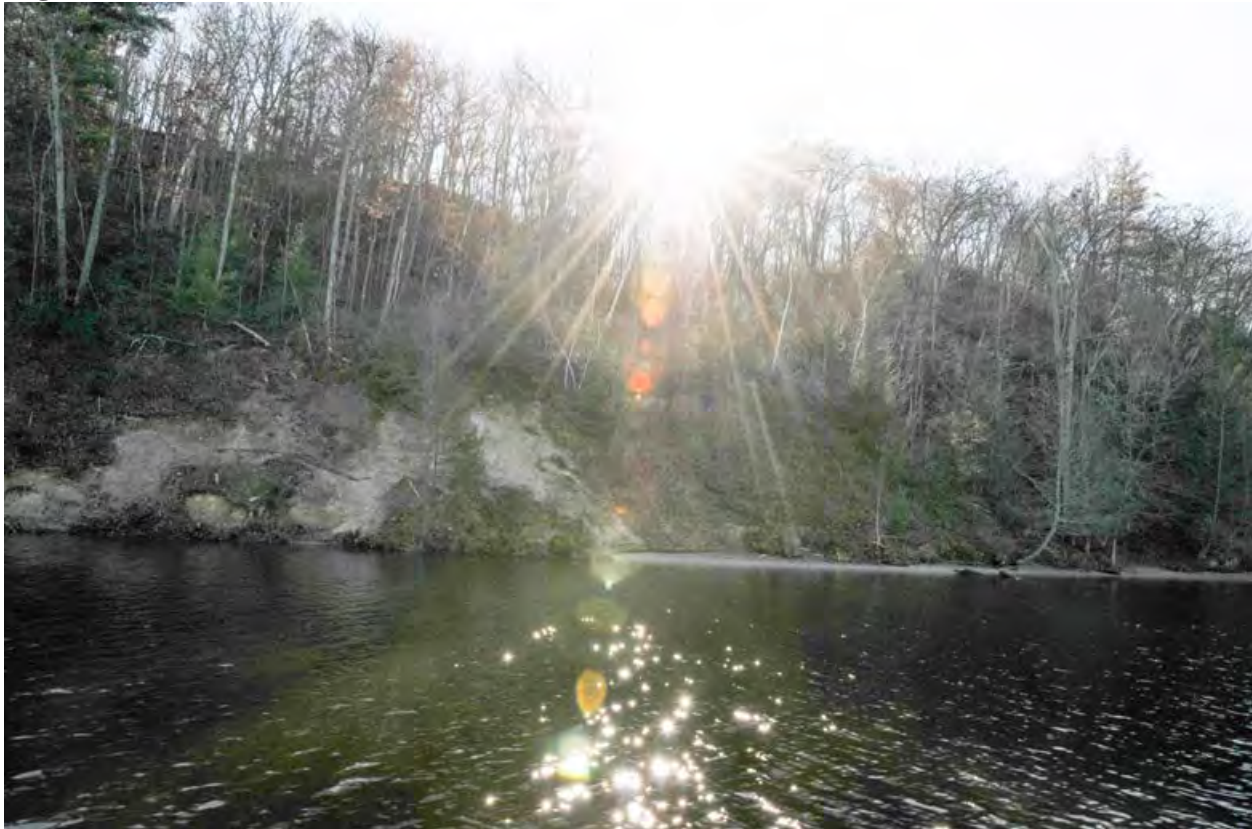
Segment #12 Riverbank features and characteristics

Riverbank Features	Characteristics
Upper Riverbank Slope	Steep
Upper Riverbank Height	High
Upper Riverbank Sediment	Silt/Sand
Upper Riverbank Vegetation	Sparse
Lower Riverbank Slope	Flat/Beach
Lower Riverbank Sediment	Silt/Sand
Lower Riverbank Vegetation	None-Very Sparse
Type of Erosion	Planar Slip, Overhanging Bank
Potential Erosion Indicators	Overhanging Bank, Creep/Leaning Trees, Exposed Roots, Other
Stage of Erosion	Active Erosion
Extent of Erosion	Extensive

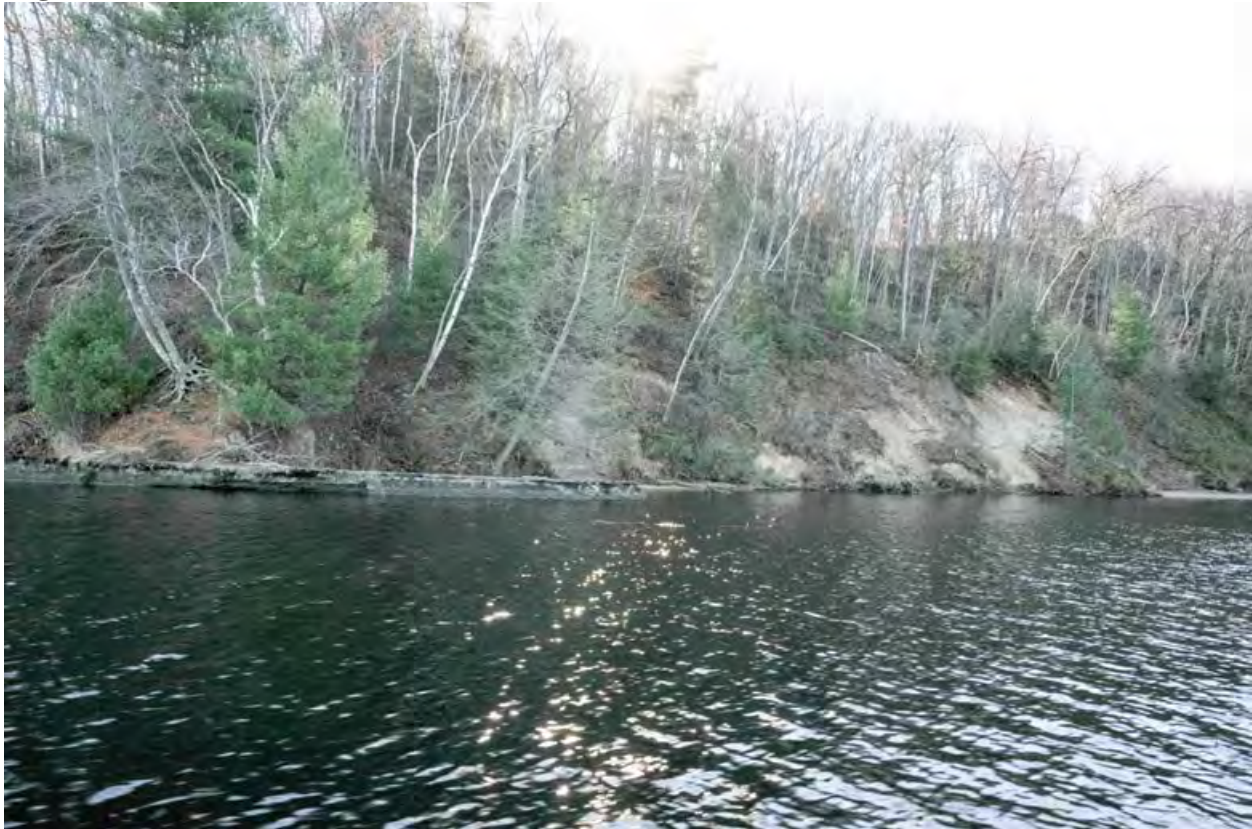
Segment #13 Riverbank features and characteristics

Riverbank Features	Characteristics
Upper Riverbank Slope	Moderate
Upper Riverbank Height	High
Upper Riverbank Sediment	Silt/Sand
Upper Riverbank Vegetation	Moderate
Lower Riverbank Slope	Steep
Lower Riverbank Sediment	Bedrock
Lower Riverbank Vegetation	None-Very Sparse
Type of Erosion	Planar Slip, Overhanging Bank
Potential Erosion Indicators	Overhanging Bank, Creep/Leaning Trees, Exposed Roots
Stage of Erosion	Active Erosion
Extent of Erosion	Extensive

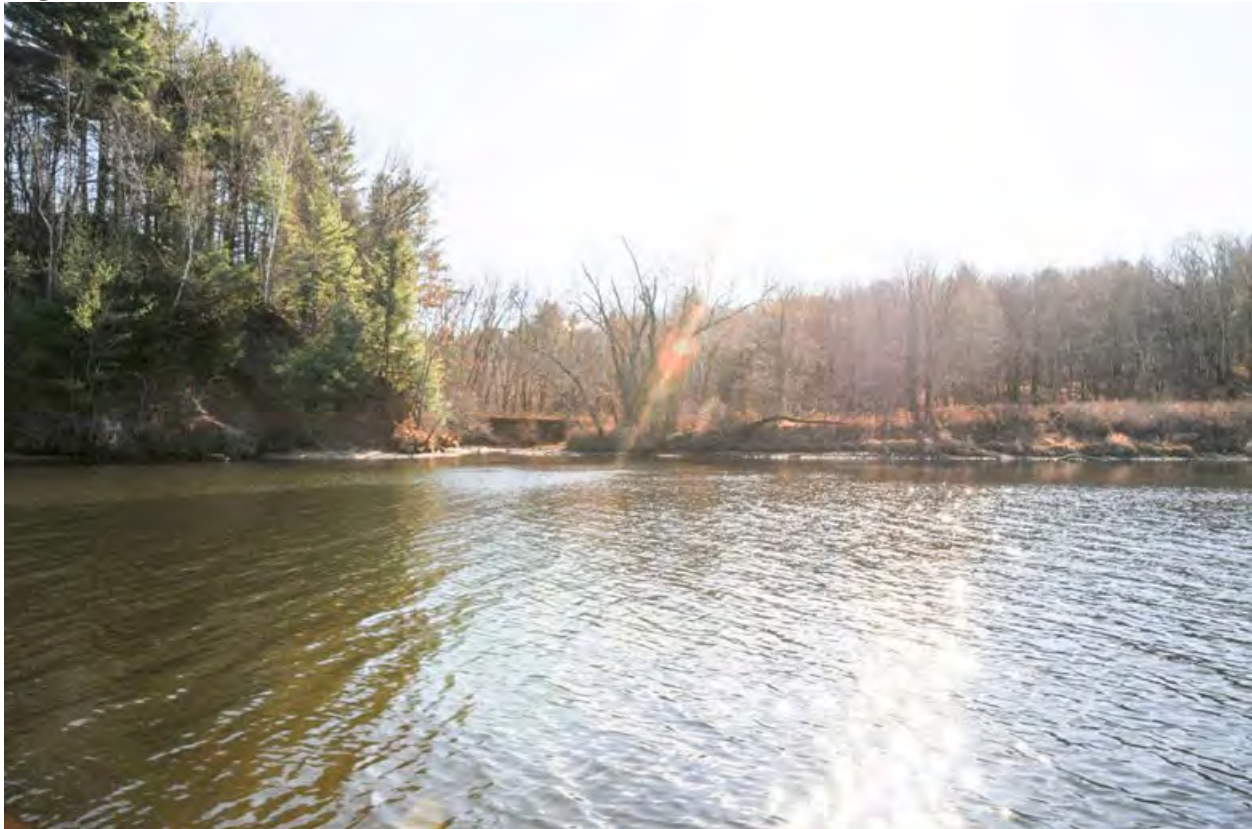
Segment #70 Riverbank features and characteristics

Riverbank Features	Characteristics
Upper Riverbank Slope	Steep
Upper Riverbank Height	High
Upper Riverbank Sediment	Silt/Sand
Upper Riverbank Vegetation	Sparse
Lower Riverbank Slope	Flat/Beach
Lower Riverbank Sediment	Gravel
Lower Riverbank Vegetation	None-Very Sparse
Type of Erosion	Slide
Potential Erosion Indicators	Creep/Leaning Trees, Overhanging Bank, Exposed Roots
Stage of Erosion	Active Erosion
Extent of Erosion	Extensive

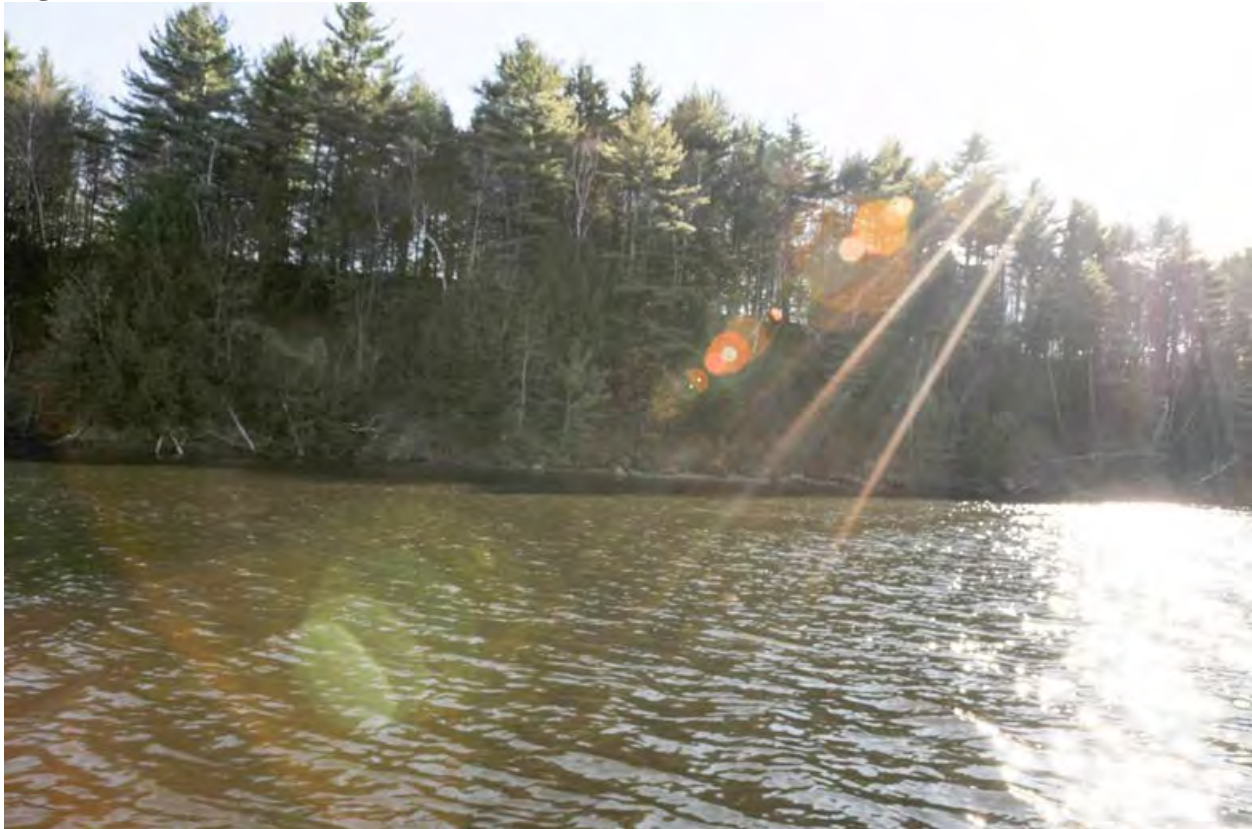
Segment #75 Riverbank features and characteristics

Riverbank Features	Characteristics
Upper Riverbank Slope	Vertical
Upper Riverbank Height	High
Upper Riverbank Sediment	Silt/Sand
Upper Riverbank Vegetation	Sparse
Lower Riverbank Slope	Flat/Beach
Lower Riverbank Sediment	Silt/Sand
Lower Riverbank Vegetation	None-Very Sparse
Type of Erosion	Topple
Potential Erosion Indicators	Creep/Leaning Trees, Overhanging Bank, Exposed Roots
Stage of Erosion	Active Erosion
Extent of Erosion	Extensive

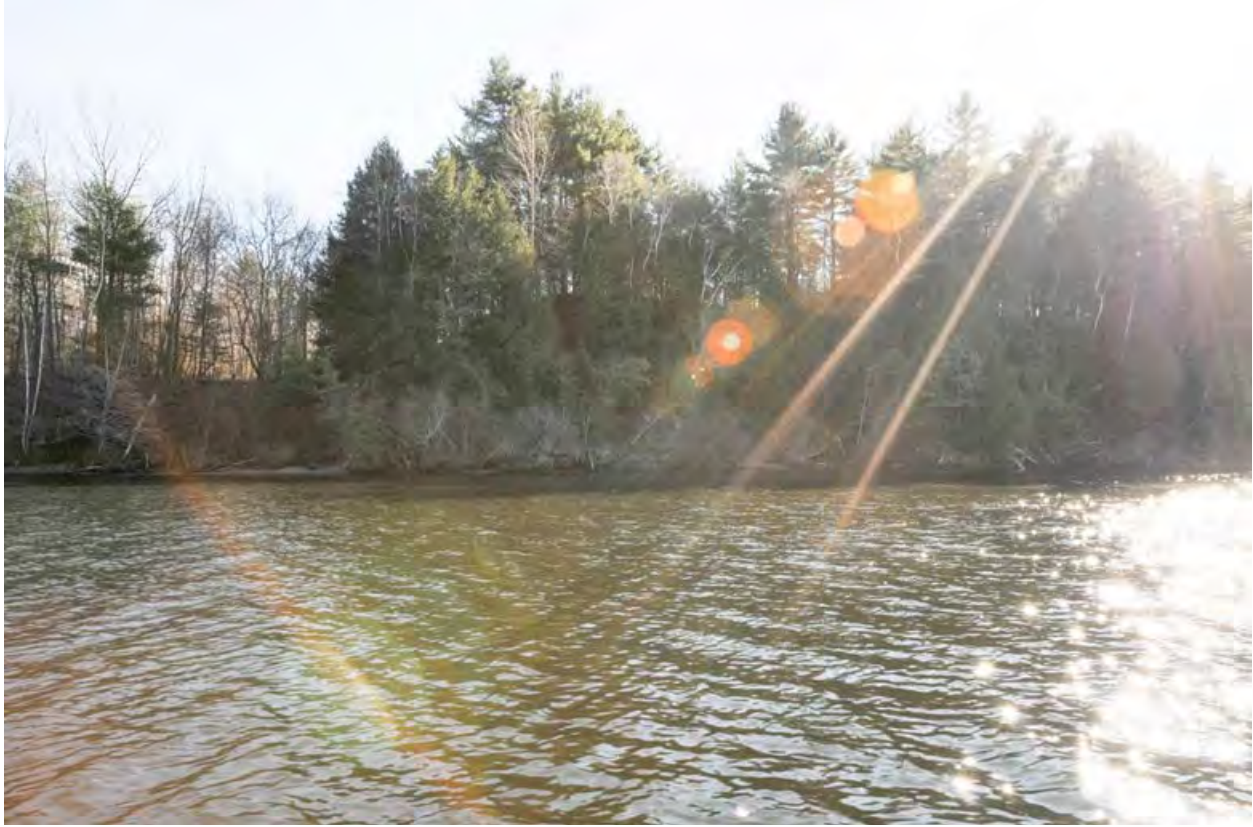
Segment #77 Riverbank features and characteristics

Riverbank Features	Characteristics
Upper Riverbank Slope	Steep
Upper Riverbank Height	High
Upper Riverbank Sediment	Silt/Sand
Upper Riverbank Vegetation	Sparse
Lower Riverbank Slope	Flat/Beach
Lower Riverbank Sediment	Gravel
Lower Riverbank Vegetation	None-Very Sparse
Type of Erosion	Slide
Potential Erosion Indicators	Creep/Leaning Trees
Stage of Erosion	Eroded
Extent of Erosion	Some to Extensive
